# JERICO IMEX LTD.

Montree Bari Road, South Shalna, Shalna Bazar, Gazipur  
(24.031292, 90.390023)

20<sup>th</sup> September 2016

# **Insufficient documents and discrepancies between drawings & site observations**

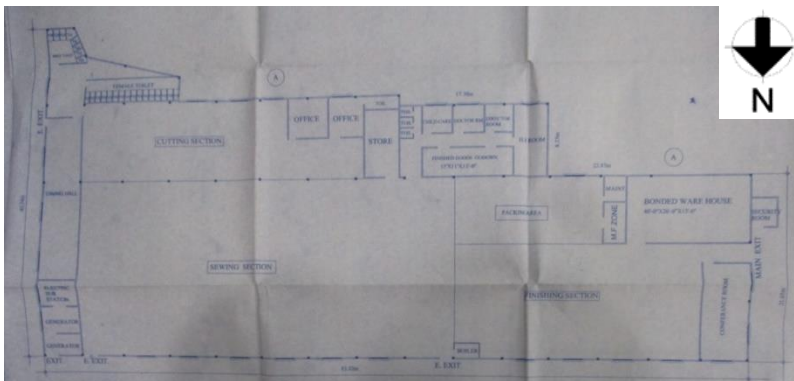
Layout plan from permit drawing (LGED, Gazipur)

Provided permit drawings don't match with as built condition. Column layout and nos. of grids are not matched with drawings.

| Item No. | Observation | Recommended Action Plan | Recommended Timeline |
|---|---|---|---|
| 1 | Insufficient documents and discrepancies between drawings & site observations. | Building Engineer to survey as constructed building and prepare a set of as-built drawings. | 6-weeks |

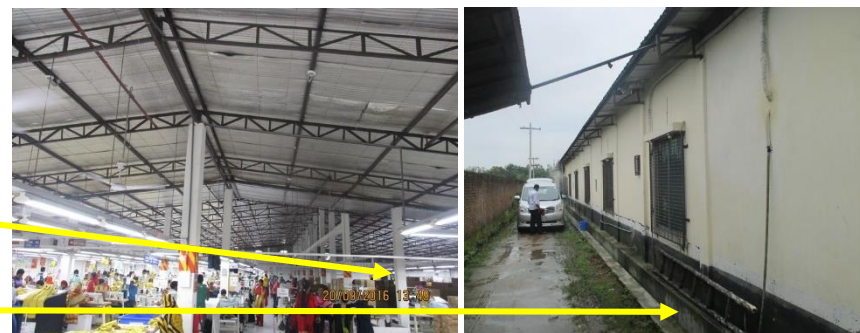
Red marked columns are not shown in drawing.

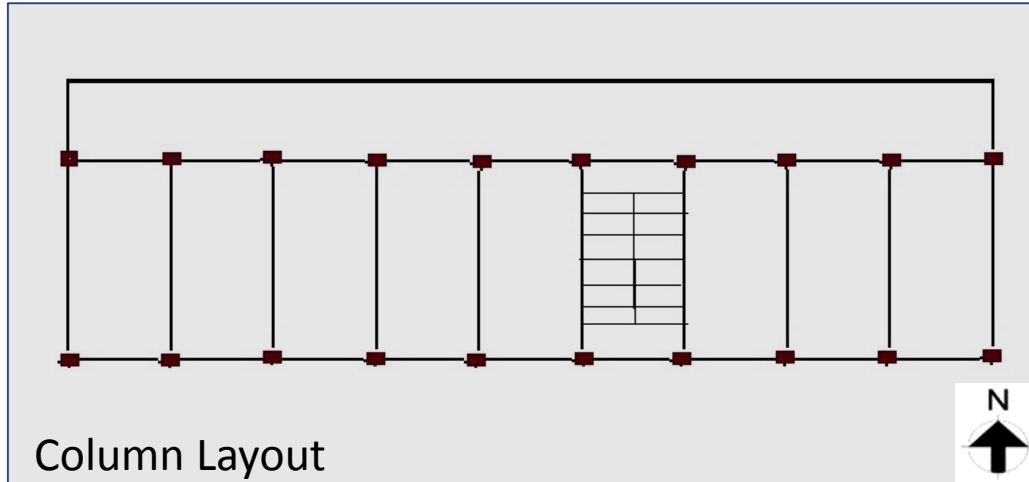
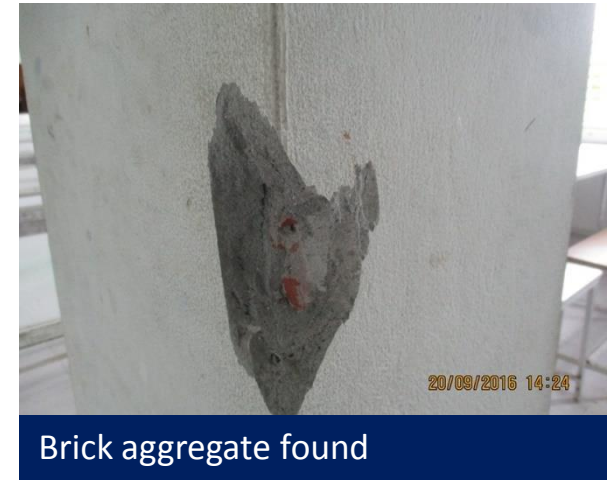
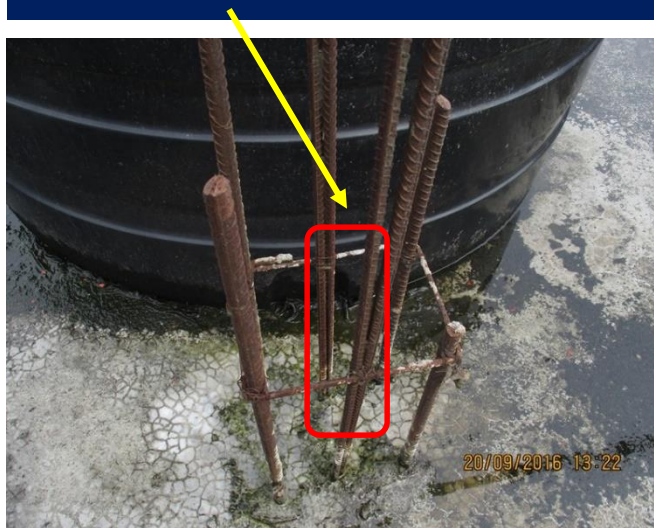
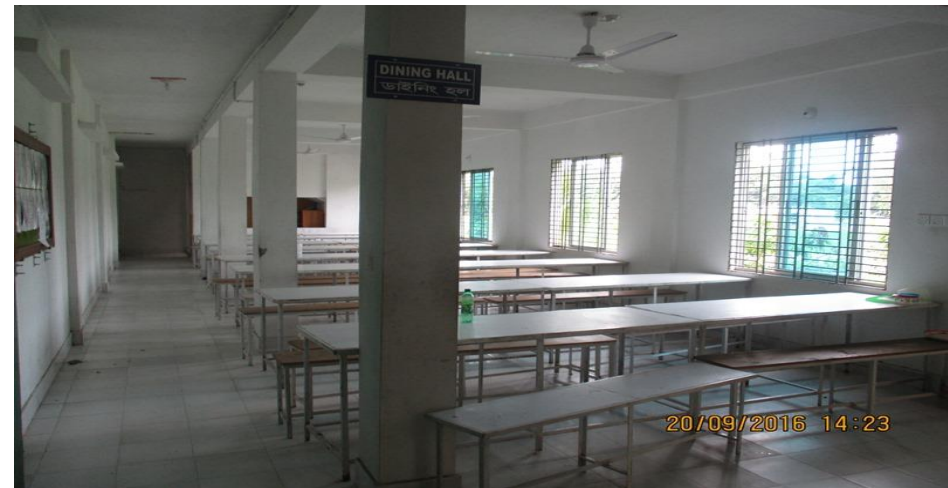
Structural and architectural drawings were not found for RCC part of the factory. Practically column sizes are measured 12"X10" and 3x2 nos. of rebar were observed by ferro scanner. At roof 12mm rebar was exposed at middle in few column.

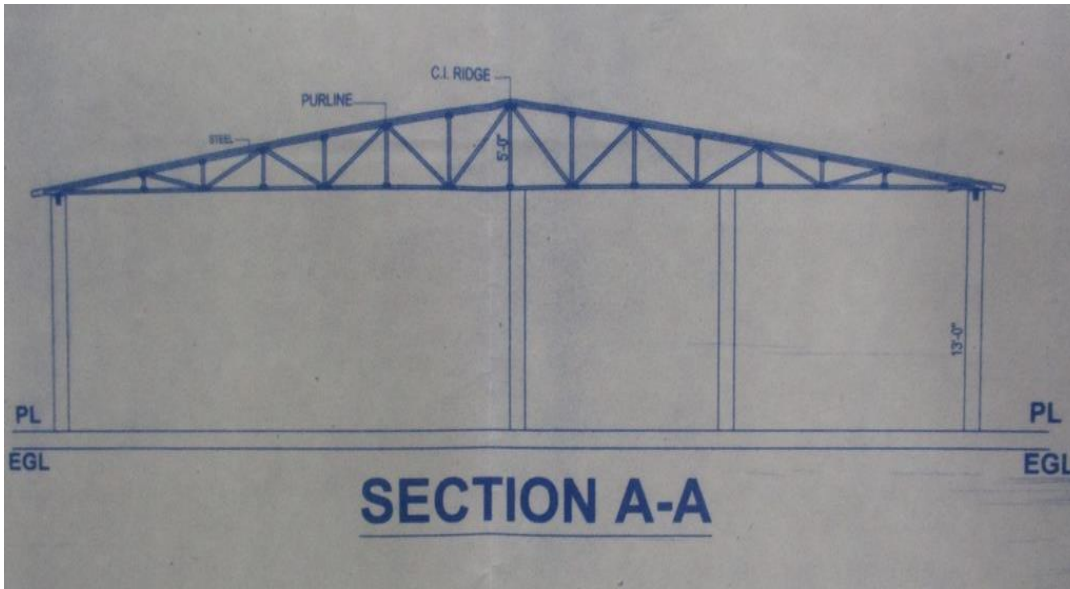
Existing truss sections are not matched with drawings.

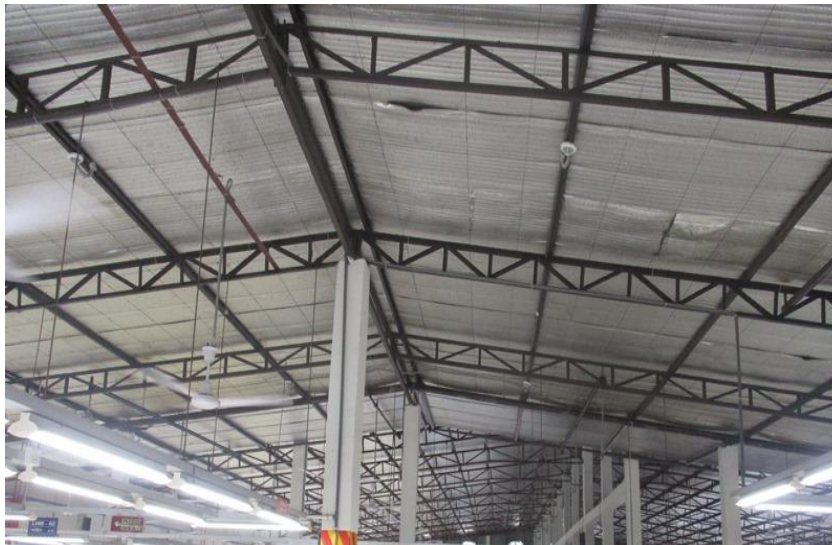
Roof at West

No roof bracings were observed for both west and east part of the shed.

| Item No. | Observation | Recommended Action Plan | Recommended Timeline |
|---|---|---|---|
| 2 | Lack of lateral stability observed | Carry out an Engineering Assessment on the buildings to verify that they are stable under lateral loading | 6-weeks |
| 3 | Lack of lateral stability observed | Carry out all recommendations of the Engineering Assessment | 6-months |

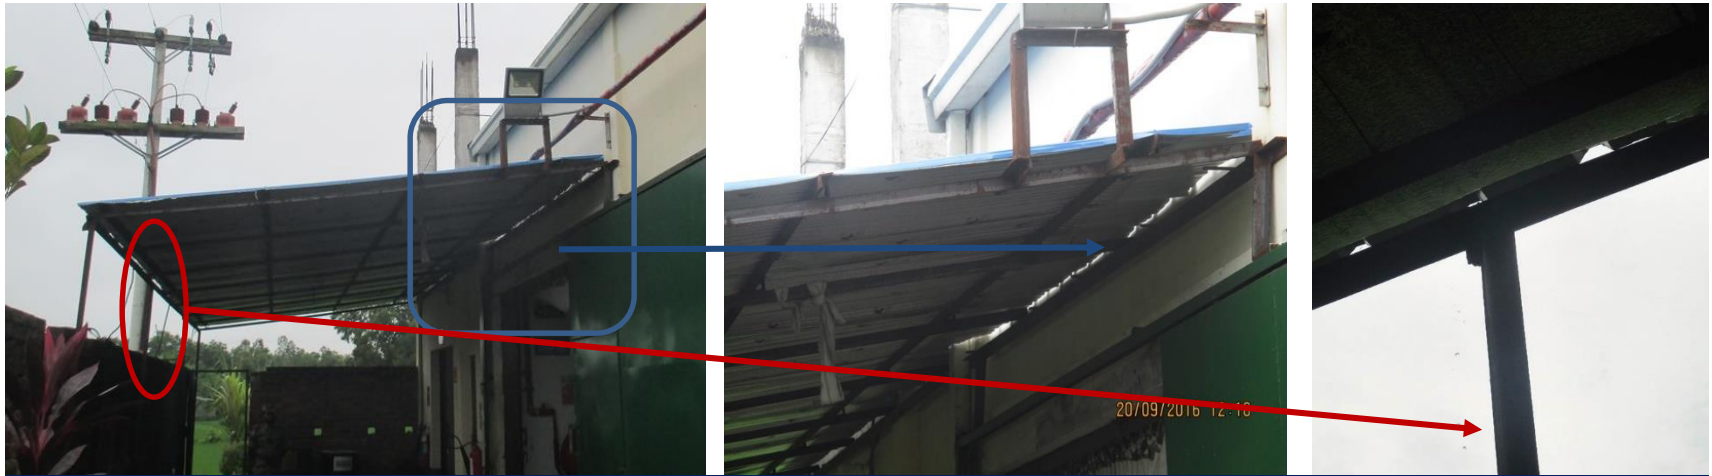
Light weight canopy poorly connected with lintel and boundary wall by steel angle

Non-Engineered  
Lightweight  
steel structures  
found at toilet  
block, stair roof  
and canopy .

| Item No. | Observation | Recommended Action Plan | Recommended Timeline |
|---|---|---|---|
| 4 | Non-Engineered Lightweight steel structures | Engage a qualified structural engineer to confirm satisfactory structural performance of the buildings under wind loading. | 6-weeks |
| 5 | Non-Engineered Lightweight steel structures | Remedial works to be carried out if required. | 6-months |

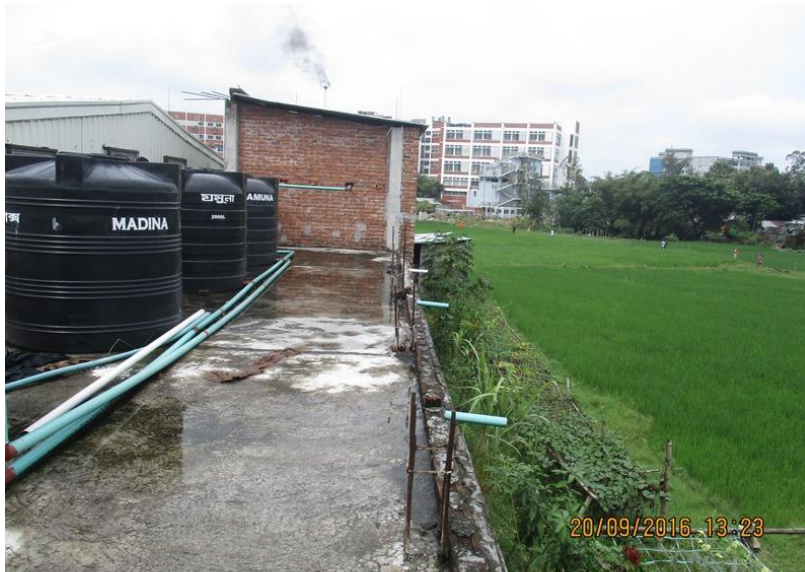
No edge protection on roof.

| Item No. | Observation | Recommended Action Plan | Recommended Timeline |
|---|---|---|---|
| 6 | Falling hazards on the roof & water ponding and protect reinforcement & steel member from corrosion | Provide immediate edge protection to the roof | Immediate - Now |

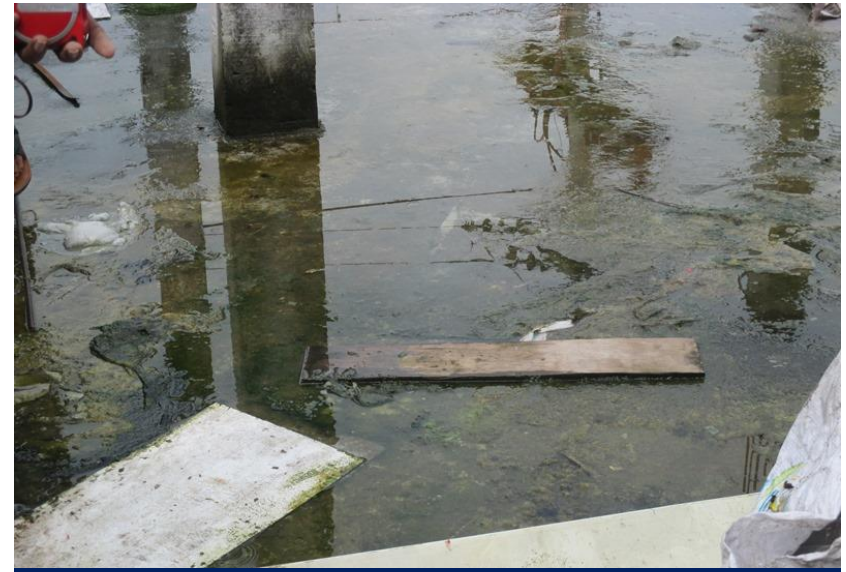
Water ponding on roof

| Item No. | Observation | Recommended Action Plan | Recommended Timeline |
|---|---|---|---|
| 7 | Falling hazards on the roof & water ponding and protect reinforcement & steel member from corrosion | Factory engineer to identify the cause of water ponding & suggest appropriate remedial action. | 6-weeks |

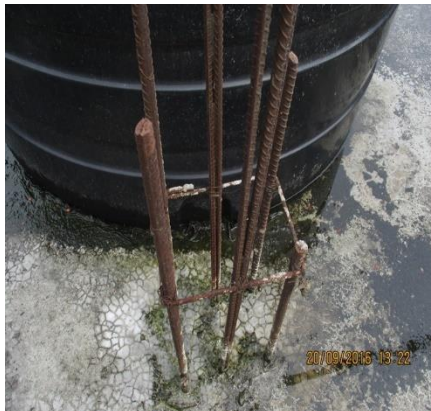
Unprotected column rebar

| Item No. | Observation | Recommended Action Plan | Recommended Timeline |
|---|---|---|---|
| 8 | Falling hazards on the roof & water ponding and protect reinforcement & steel member from corrosion | All exposed reinforcement is to be protected from corrosion which may cause degradation of the concrete. | 6-weeks |

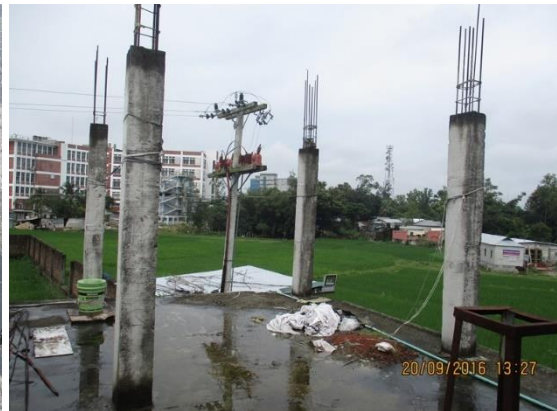
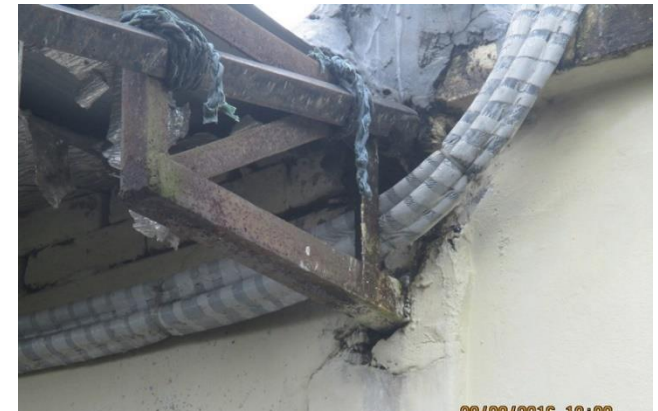
Corrosion in steel member
