BD Knit Design Ltd(New)

Sharitpur, National University, Gazipur
(23.965860N, 90.368274E)
4th September, 2016

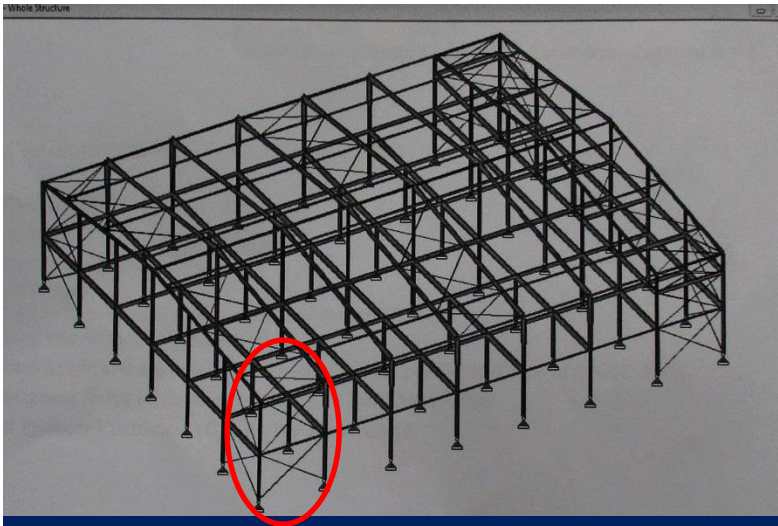
Analysis 3D view image which was found in a document review does not match with on site condition.

Item No.	Observation	Recommended Action Plan	Recommended Timeline
1	Overall stability of the structure	Building Engineer to review bracing system for lateral wind loading as per BNBC with consideration for minor axis bending of rafters due to eccentricity of members at node points. Review design of rafter considering compression flange restraint	6-weeks
2	Overall stability of the structure	Building Engineer to design and detail structural upgrading work where necessary to ensure adequate stiffness of bracing system.	6-weeks
3	Overall stability of the structure	Where required, remedial measures to steelwork to be carried out.	6-months
4	Loose cable bracing	Existing cables in braced bays to be tightened	6-weeks
5	Missing bolts and defected shear clip connection observed	Building Engineer to identify all the omissions and supervise remedial works to the missing bolts in the connections and defective shear clip	6-weeks

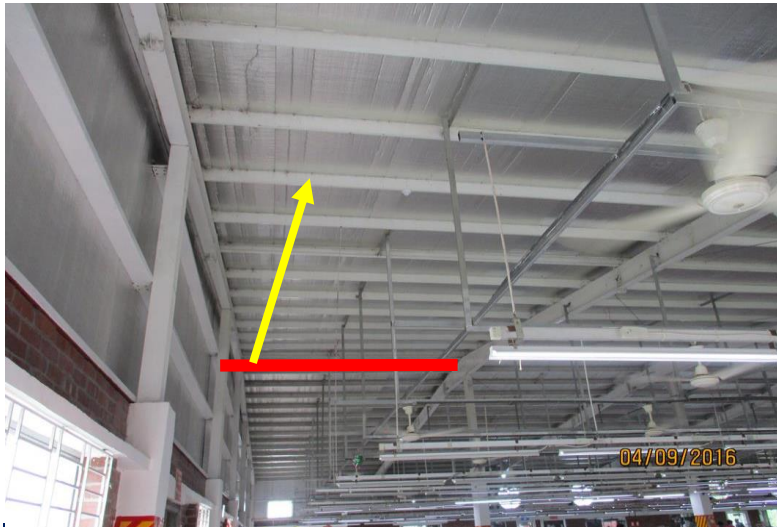
Missing compression strut at end bays

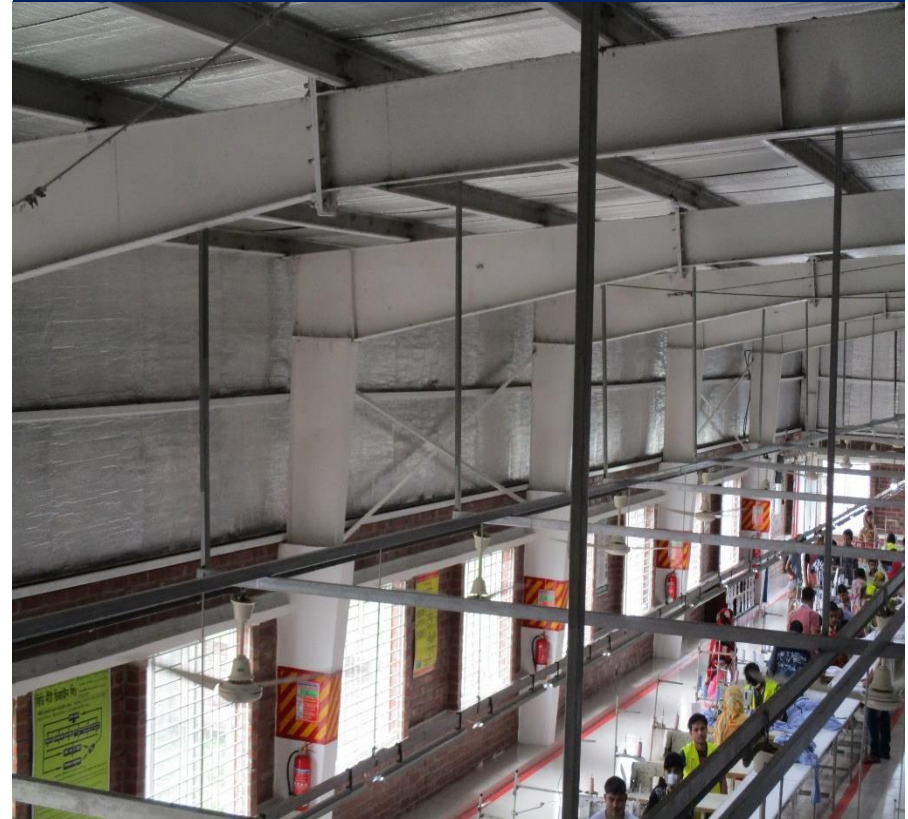
Bracing substantially away from supports. End part of the bracing connected to mid height of the column.

There are significant eccentricities of bracing connections may causing minor axis bending to portal frame members. Compression flange braces required for rafters at braced bays also not provided.

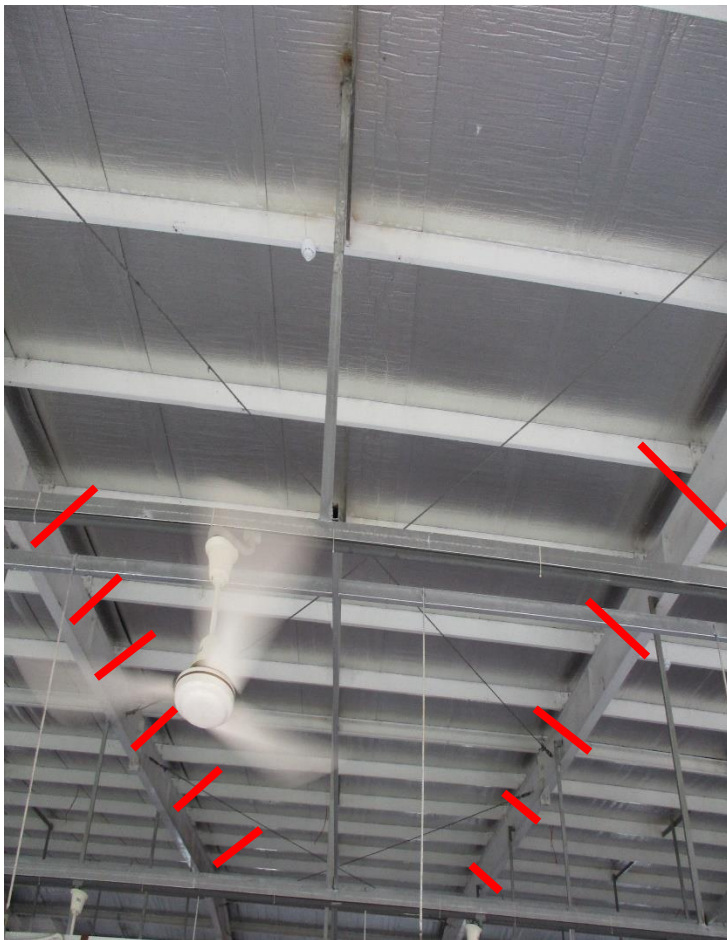
Missing compression flange braces

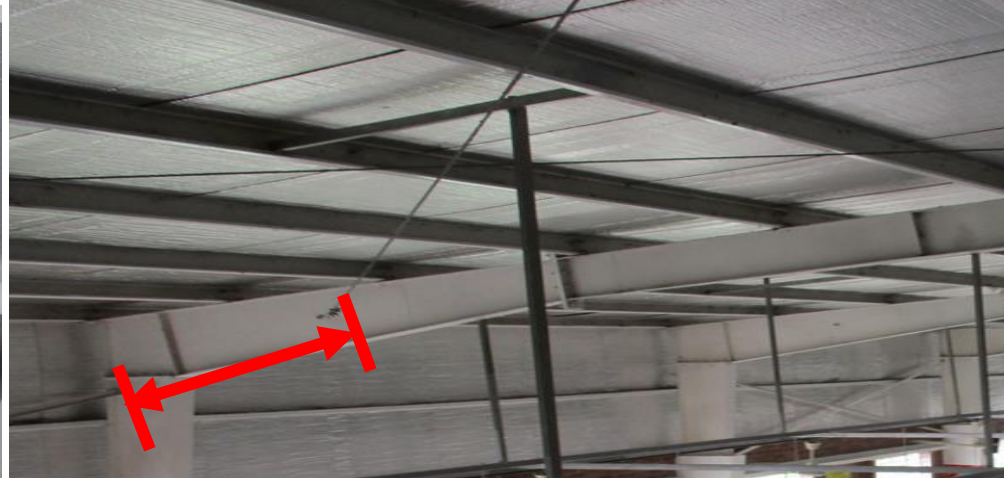
Plan bracing substantially away from vertical supports

Significant eccentricity to plan bracings

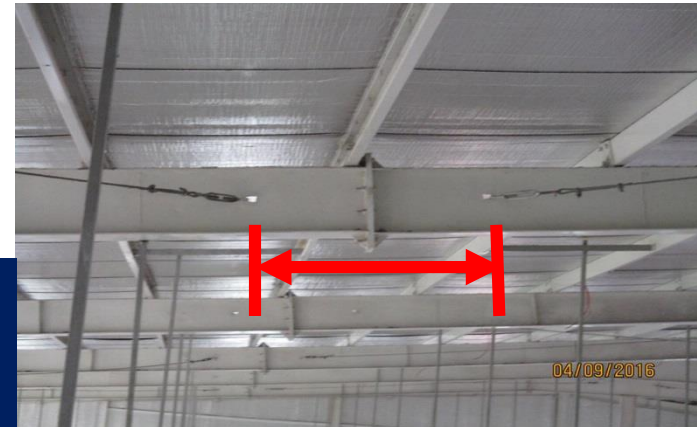
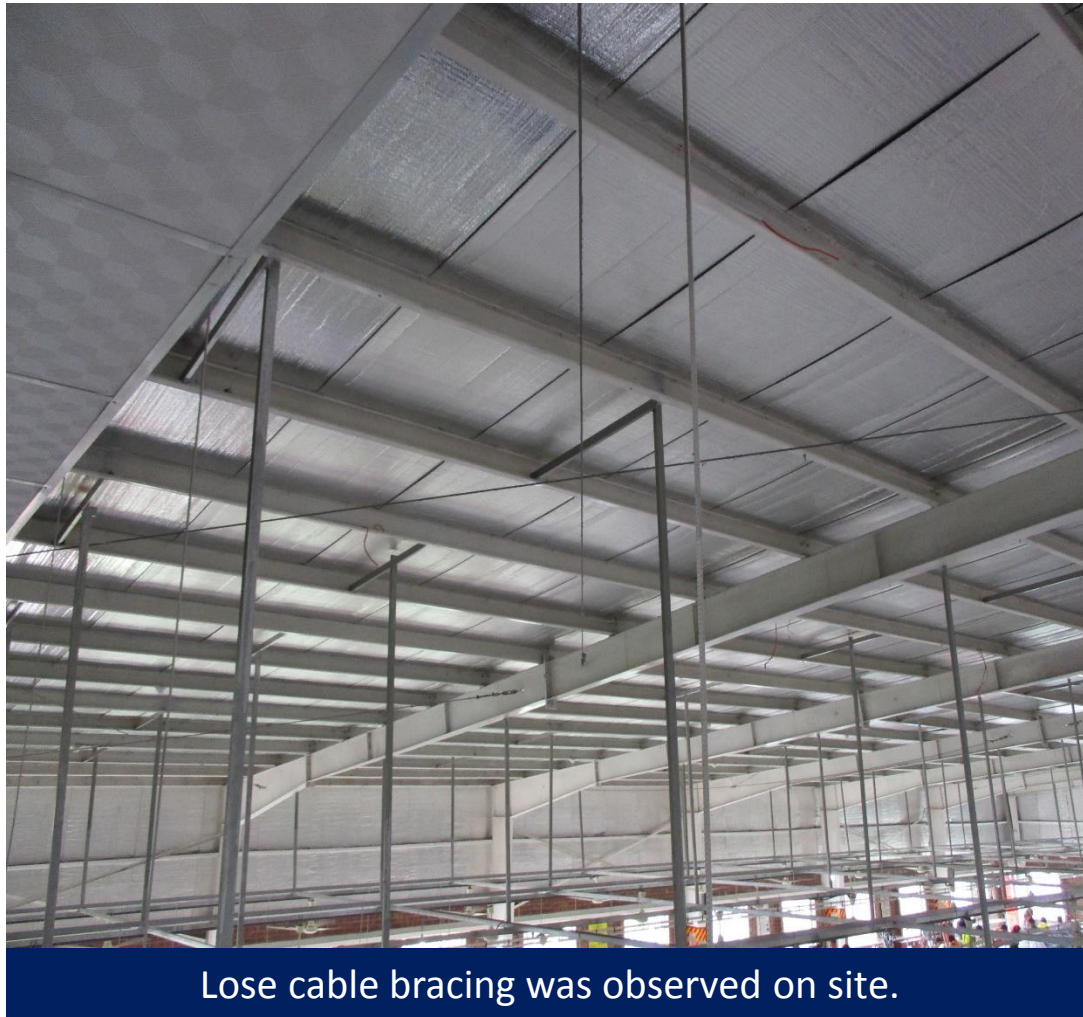
Loose cable bracing

Lose cable bracing was observed on site.

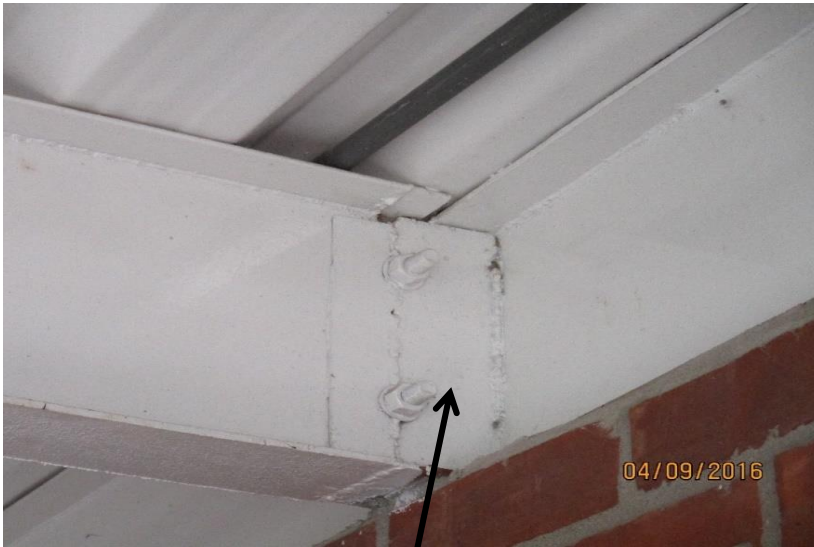
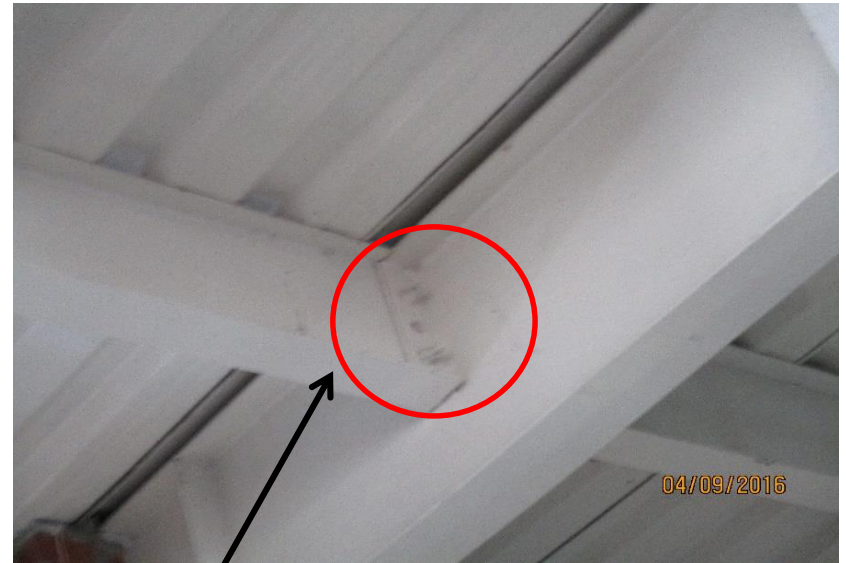
Defected shear clip in critical shear path at bolted connection was observed.

Bolt missing was observed in connection of rafter to rafter and beam to beam connection.

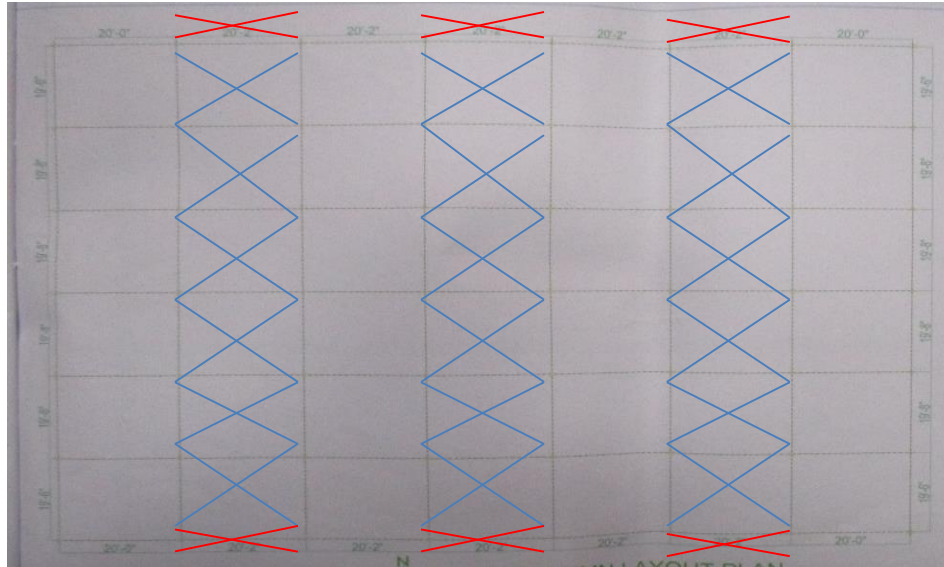
Both horizontal & vertical bracings at 2nd, 4th and 6th bay not shown in drawing.

6	Discrepancies between drawings & on-site observations	Engage a Building Engineer to survey the structure and prepare a full set of "as-constructed" drawings	6-weeks

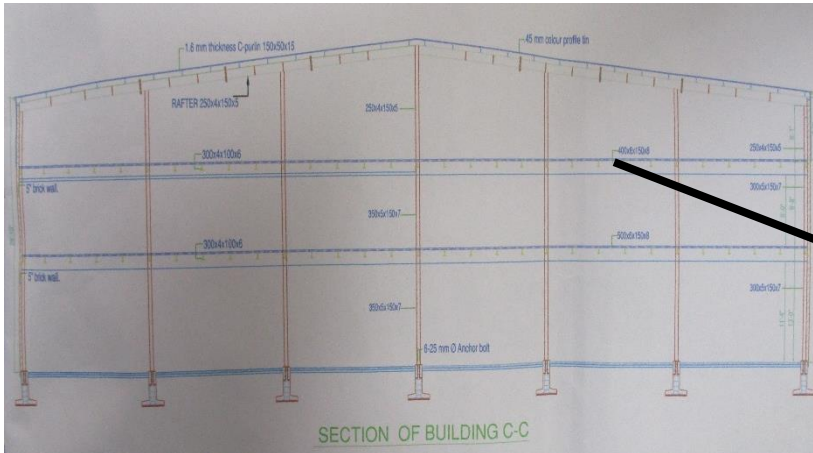
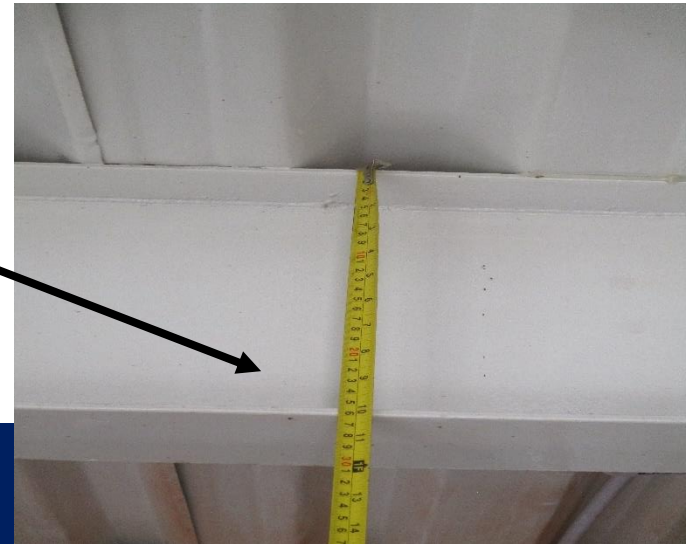
On site secondary beam depth on mezzanine floor found 250mm, however drawing shows 300 mm.

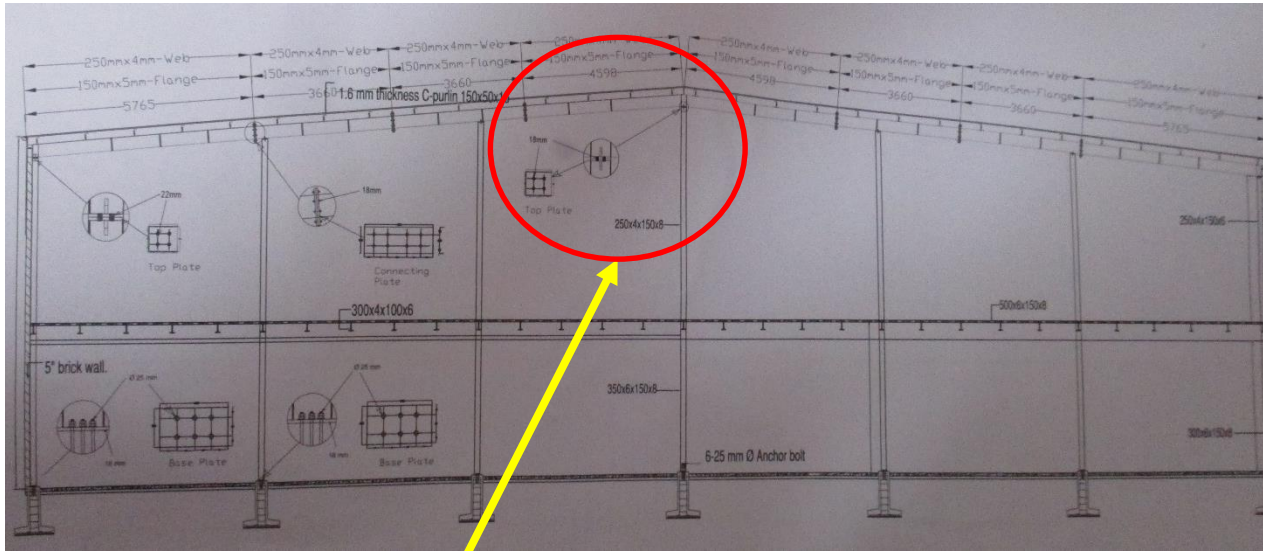
On drawing shows rafter-column joints at ridge are bottom connection, however several side connection have observed on site.

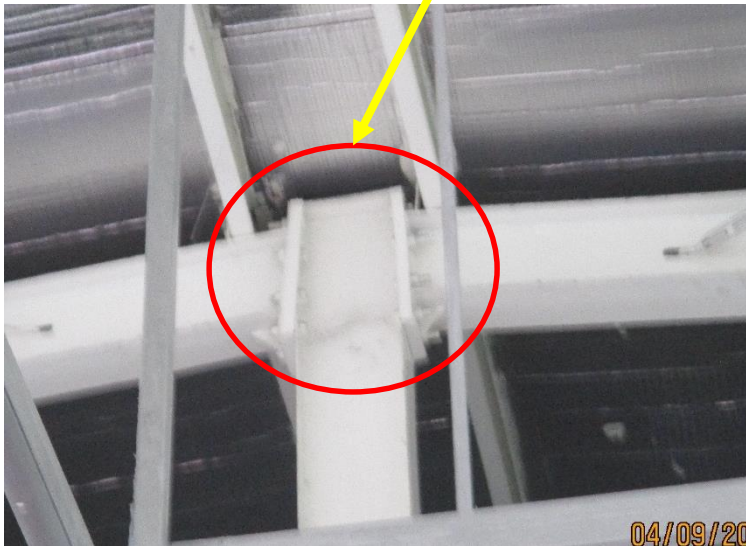
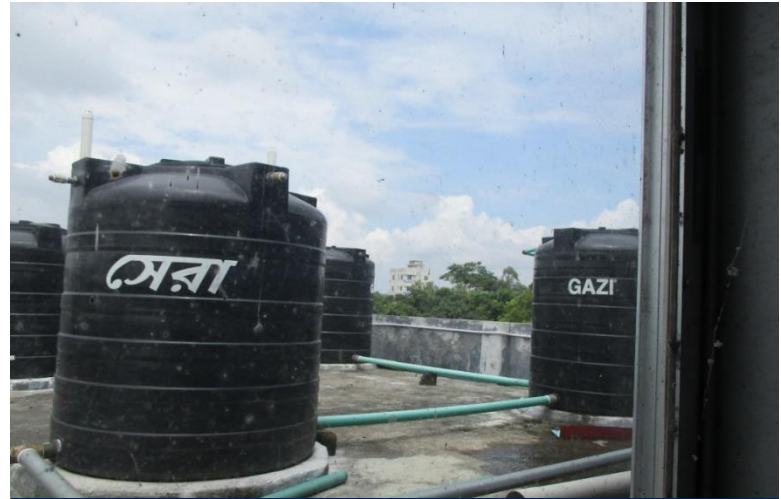
Undocumented water tanks above masonry toilet block.

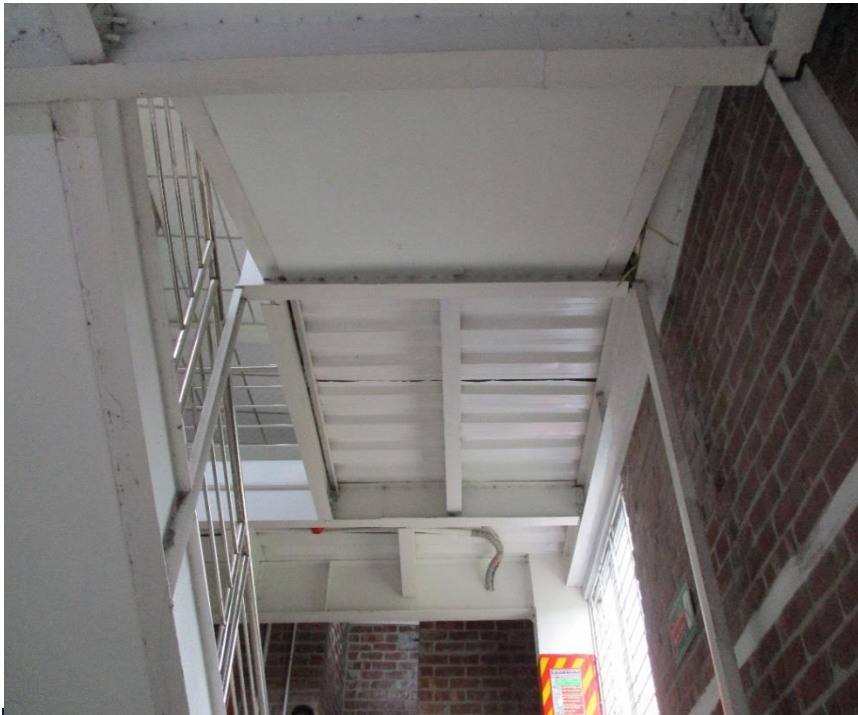
Stair case

The load path and connection of the stair is unclear. Factory engineer requires to be checked the adequacy of stair.

Item No.	Observation	Recommended Action Plan	Recommended Timeline
7	Adequacy required to be check for the extra Steel column and connection of Stair	Factory engineer to review design, loads, columns stresses and check the steel connections adequacy.	6-weeks
8	Adequacy required to be check for the extra Steel column and connection of Stair	Carry out remedial works where required.	6-months
9	Non-engineered steel roof at utility shed and fire scape steel stair	Engage a Building Engineer to check the capacity of the lightweight steel roof structure/connection details and wall/connection details for both utility shed and fire scape steel stair.	6-weeks
10	Non-engineered steel roof at utility shed and fire scape steel stair	Make any necessary alterations as required.	6-months

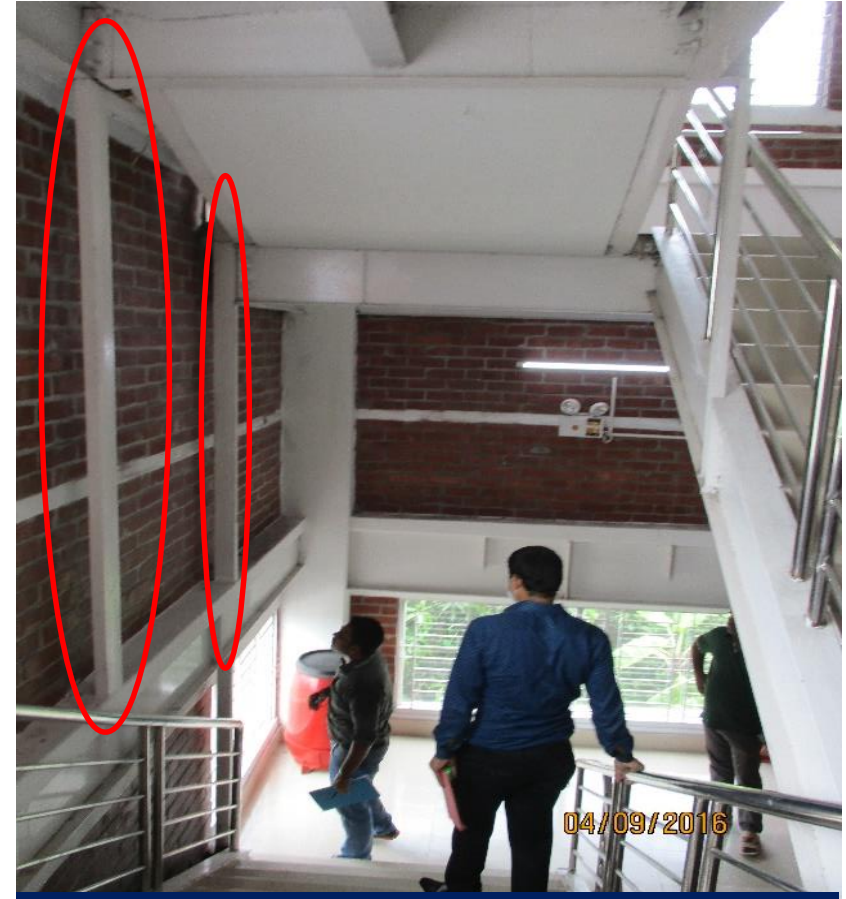
Extra steel column support steel stair

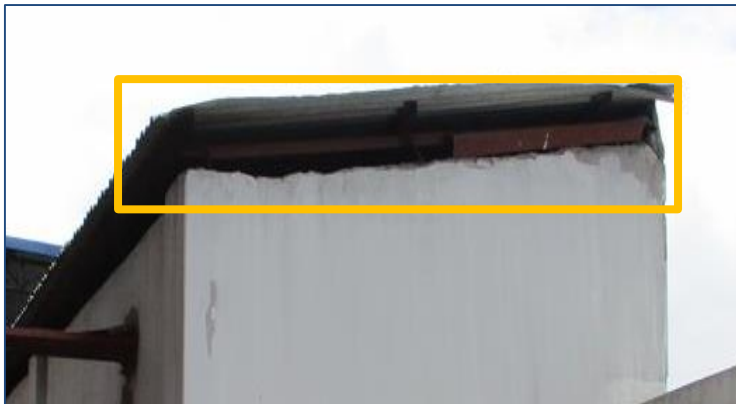
Poor connection between brick wall and steel roof.

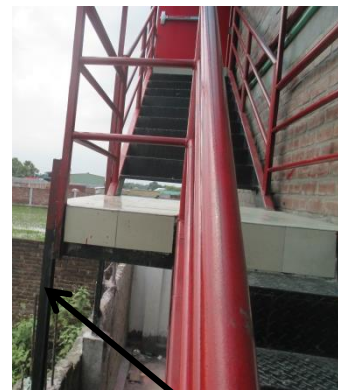
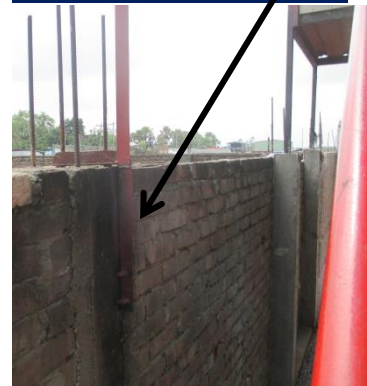
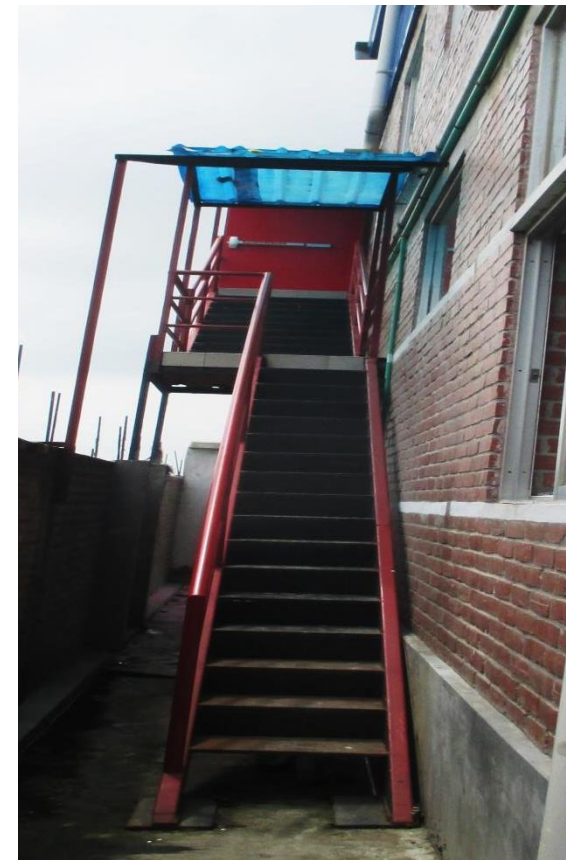
Connection

The steel stair supported on 50mm X 50mm angle with poor connection. The steel connection and structural member required to be checked against vertical and lateral load.

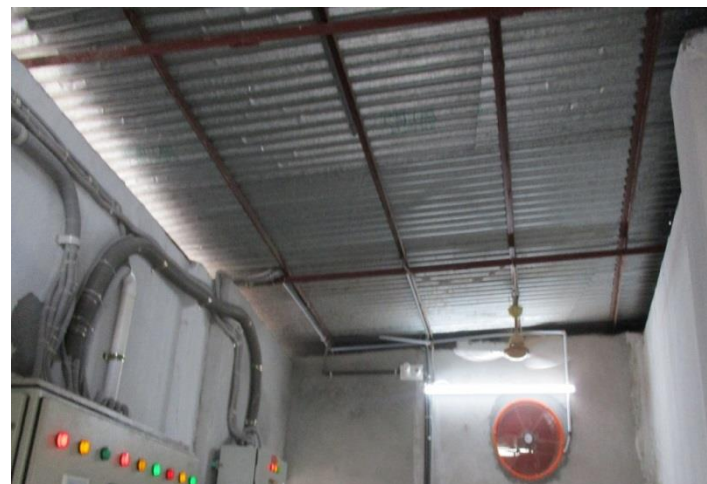
Non engineered steel roof of utility shed required to be checked against wind load.
