# Chaity Composite Ltd.

Chotto Silmondi Tripurdi, Sonargaon, Narayangonj, Dhaka.

18 March 2014

# Observations Made

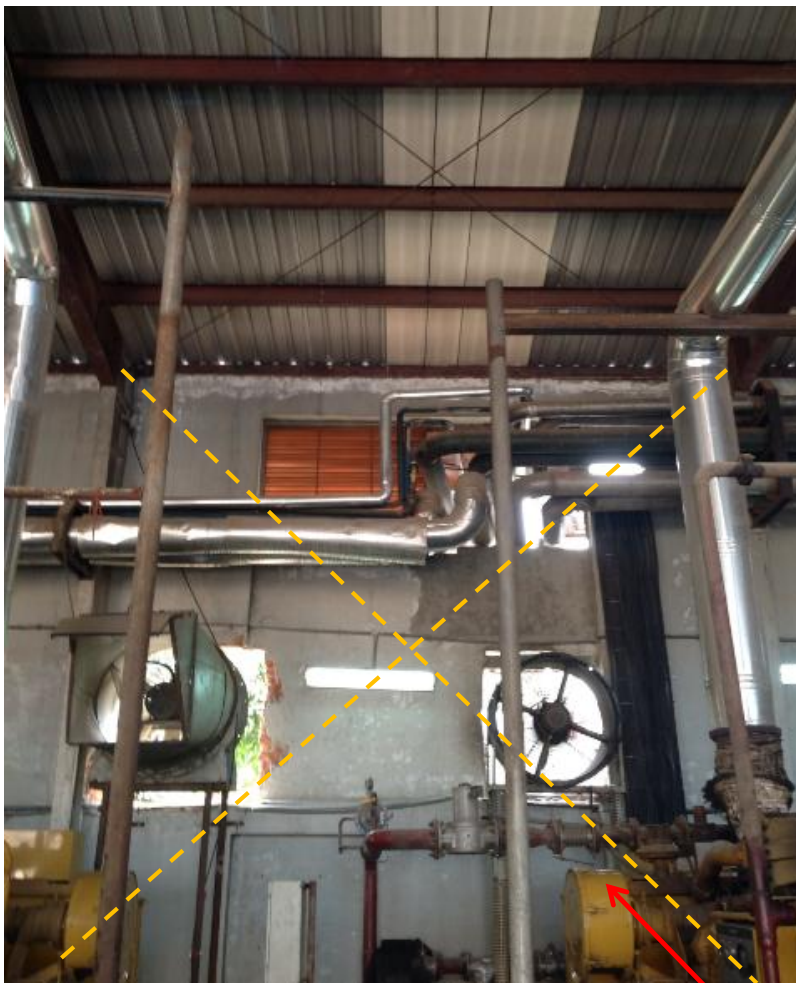
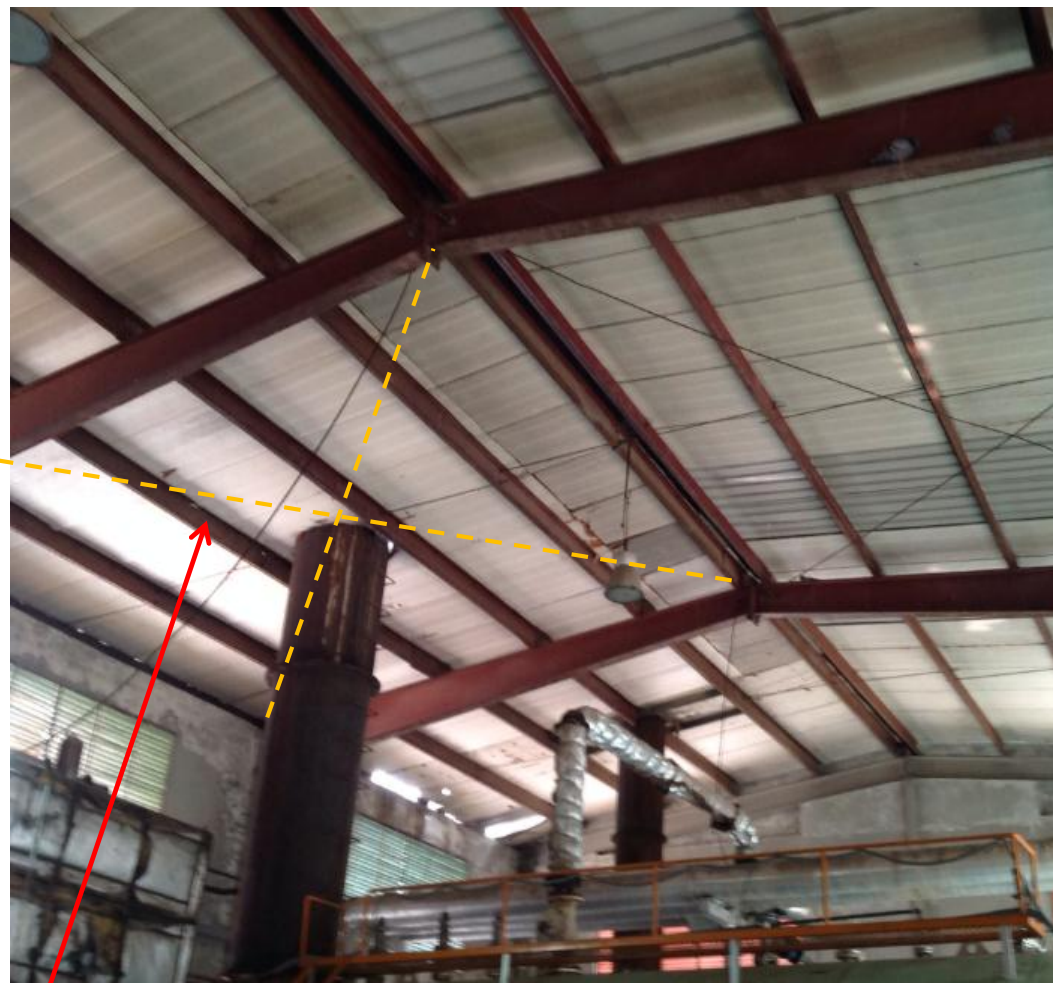
# Bracing Elements in Utility Building missing

**Bracing Elements appear to have been removed and should be checked to see if replacements are needed**

**Ties in Utility Building missing**

| | Observation | Recommended Action Plan | Priority |
|---|---|---|---|
| 4 | Bracing Elements in Utility Building missing | Building Engineer to assess the need to replace steel bracing elements with the original element or similar. | 6-weeks |
| 5 | Bracing Elements in Utility Building missing | Building Engineer to confirm that bracing replacement has been carried out if required. | 6-months |
