# **FIRE SAFETY INSPECTION REPORT**

**INTEGRA APPARELS LTD.**

**PLOT#742 DHOUR NAYANAGAR, NISHATNAGAR  
TURAG, DHAKA-BANGLADESH**

March 22, 2014

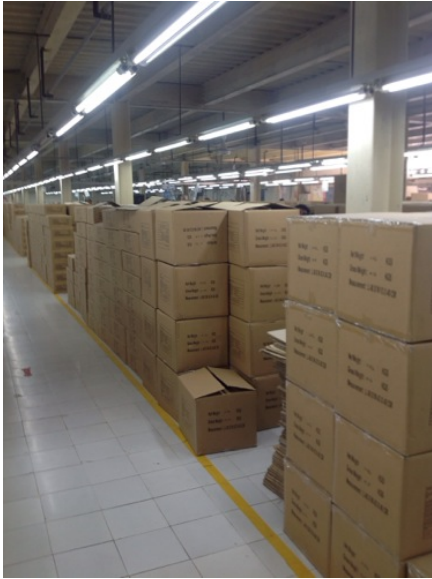
| No. | Category | Finding | Recommendation | Remediation Timeframe |
|---|---|---|---|---|
| F-1 | Fire Rated Construction | Work area on first floor had excessive amount of storage on work floor greatly increasing the fire load. | Remove stock and only have what is needed for a days work. Enclose storage rooms or limit size of storage piles. | Immediate |

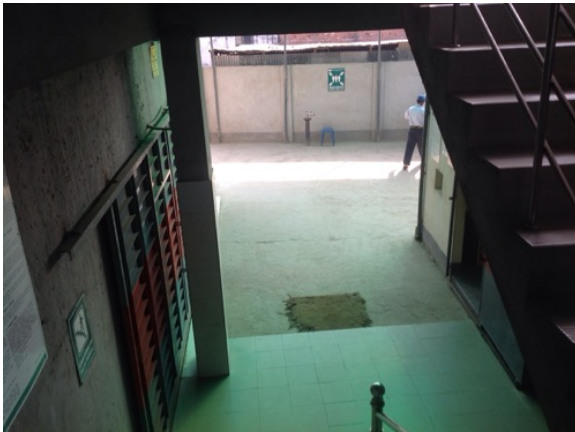
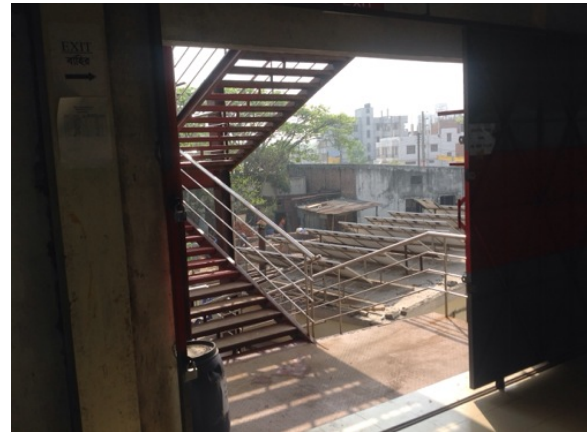
| F-2 | Fire Rated Construction | The exit stairs are not separated from work areas, other spaces on each floor by fire-rated construction. | <p>Provide minimum 1.5-hr fire rated doors and seal all unprotected openings to separate the exit stairs from work areas and other building spaces on all floor levels. Ensure that the fire doors are self-closing and positive latching and that they are provided with fire exit (panic) hardware where serving production floors.</p> <p>If fire doors are required to be held open for functional reasons, provide automatic-closing devices tied to the fire alarm system.</p> | Within 3 months |

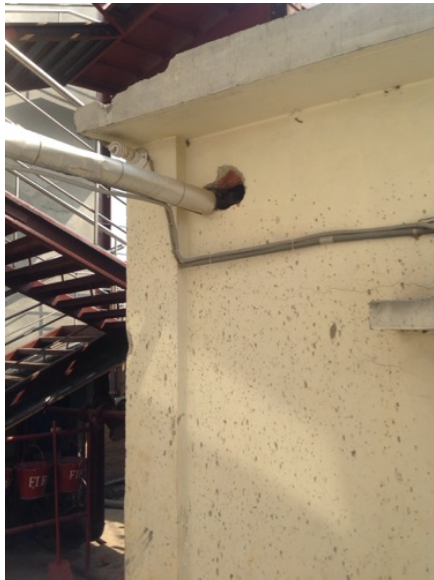
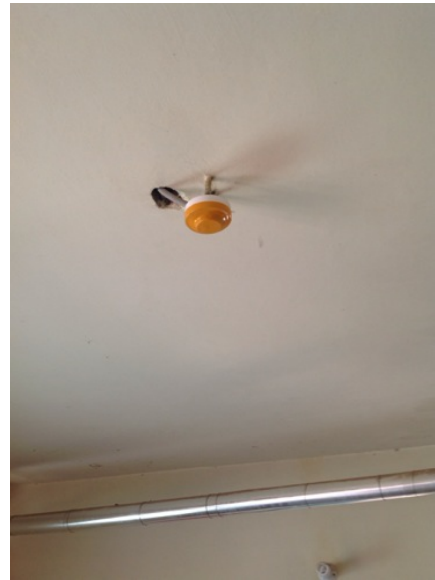
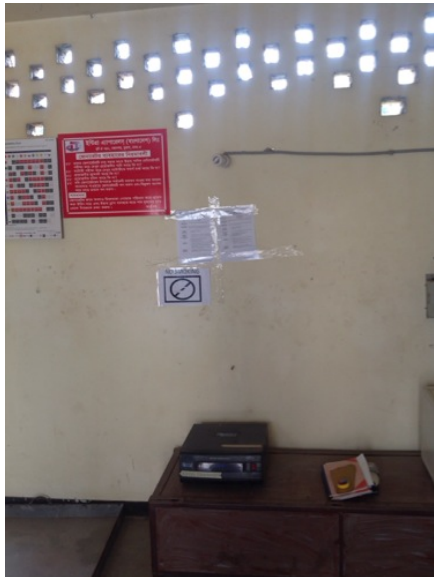
| F-3 | Fire Rated Construction | Unsealed penetrations and openings are located in the fire-rated walls and floor/ceiling assemblies. This was found on the first and ground floors. | <p>Provide a minimum 2-hr fire-rated shaft to separate the utility risers from each floor level.</p> <p>Seal all penetrations and openings in floor/ceiling assemblies to maintain the fire separation.</p> | Within 3 months |

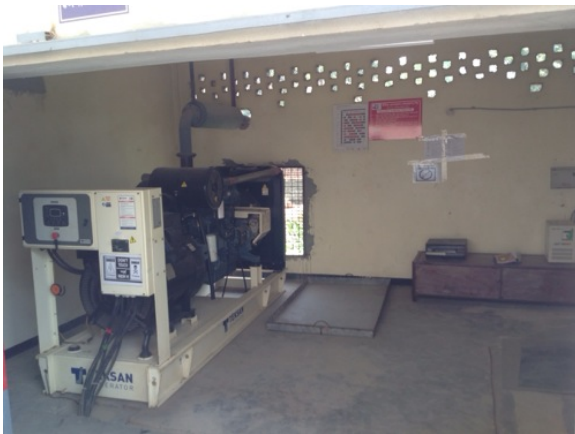
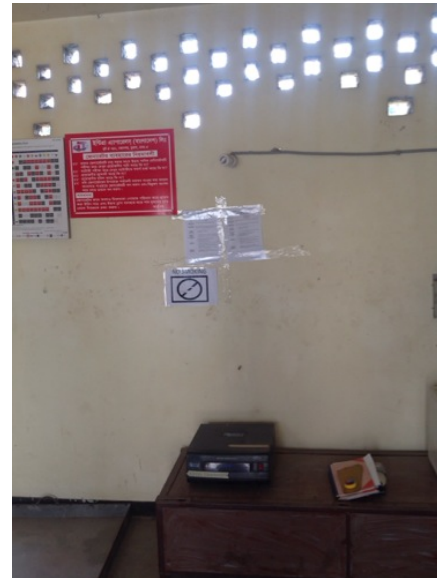
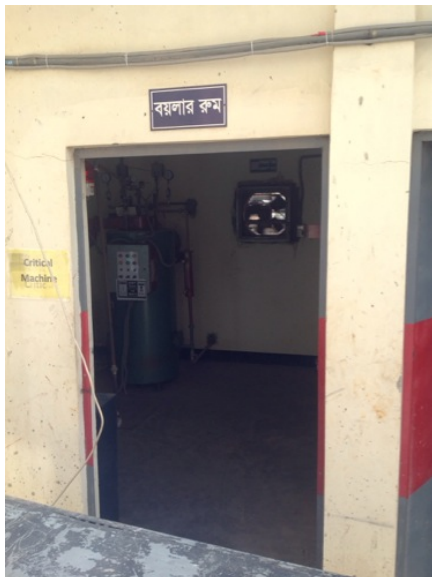
| F-4 | Fire Rated Construction | Generator, boiler, and transformer rooms not constructed of proper fire rated materials. Several penetrations and other deficiencies compromise integrity of the room which could lead to increased fire spread. | Provide minimum 1hr fire rated room and seal all unprotected openings to separate from work areas and other building spaces on all floor levels. Ensure that the fire doors are self-closing and fire rated for use. | Within 6 months |

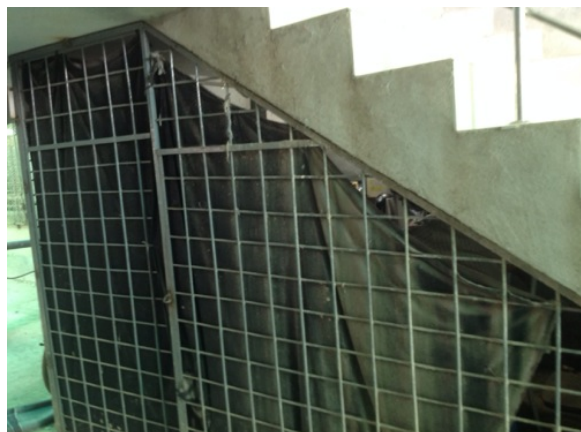
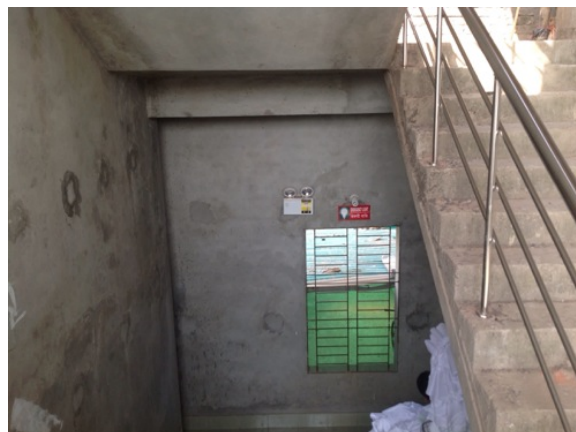
| F-6 | Egress | Storage were located in the exit stairwells of both exits. | Remove all storage from exit stairs and egress paths. | Immediate |

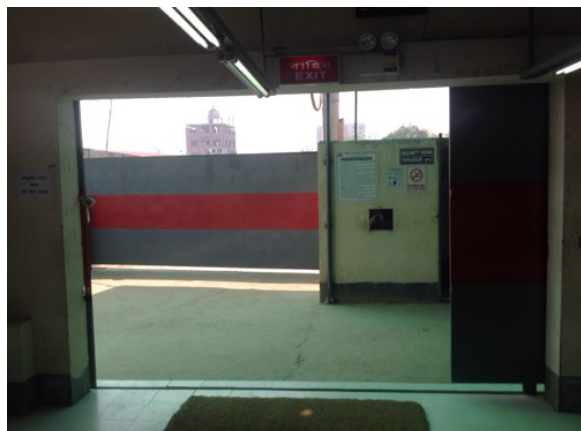
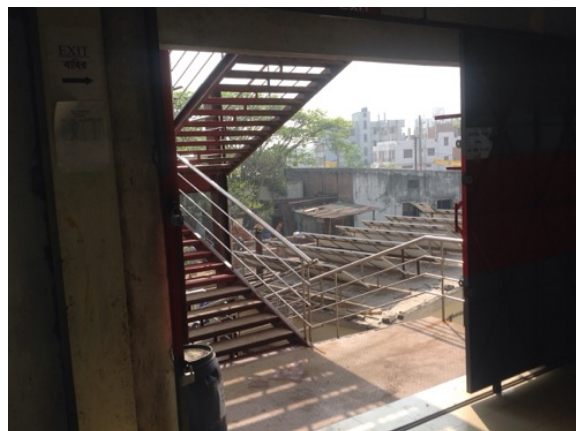
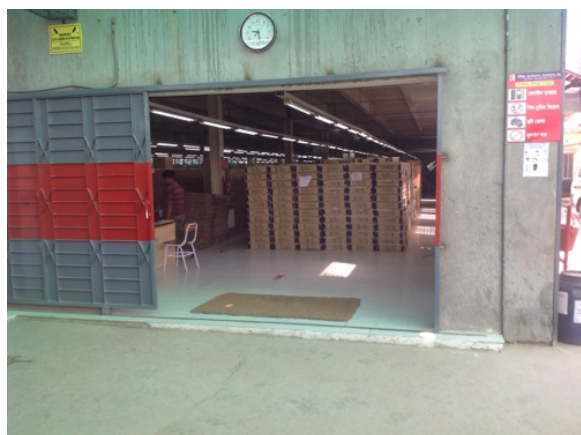
| F-7 | Egress | Egress doors / gates with locking features are provided at all building exits, exit stairs, along egress routes, exit discharge. | Remove locking features from all egress doors / gates.<br><br>If locks are required for security reasons, utilize special door locking features complying with NFPA 101. | Immediate |

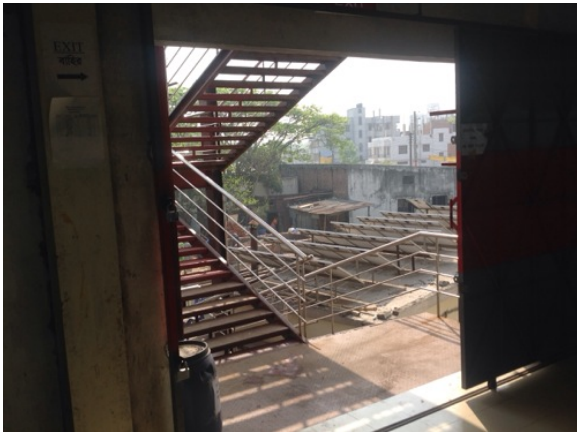
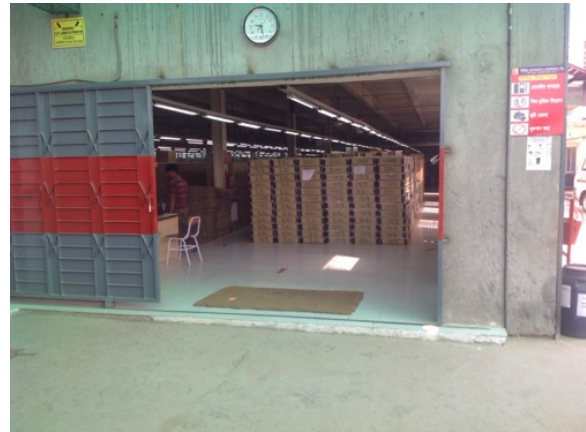
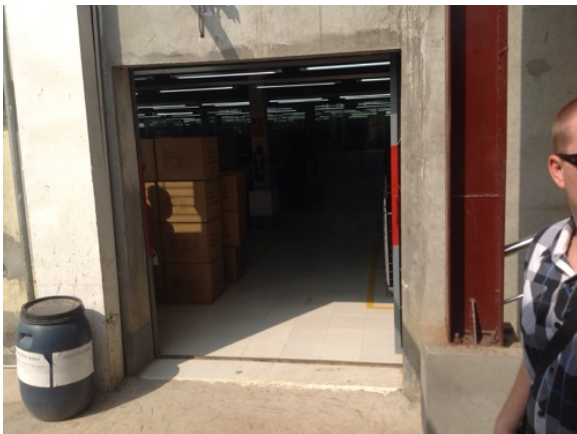
| F-8 | Egress | Collapsible gates / sliding doors are provided at all building exits, exit stairs, along egress routes, exit discharges throughout the factory. | Replace all gates / sliding doors along the means of egress with side-hinged, swinging egress doors.<br><br>If locks are required for security reasons, utilize special door locking features complying with NFPA 101. | Within 1 month |

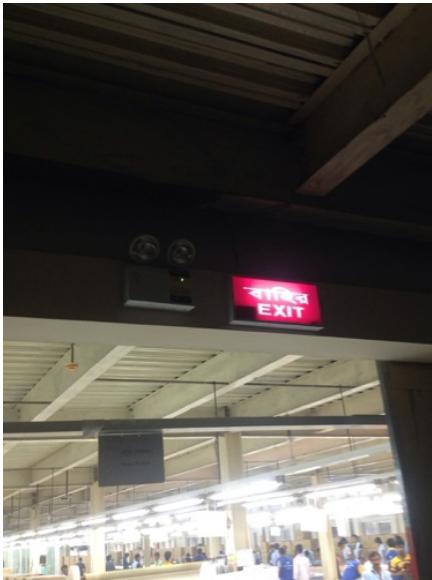
| F-9 | Egress | Emergency lighting did not function in test mode in storage room. | Regularly test the emergency lighting system on each floor and replace/repair lights as needed. | Within 3 months |

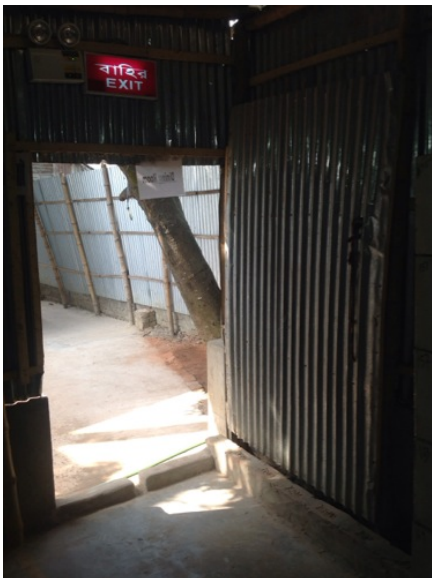
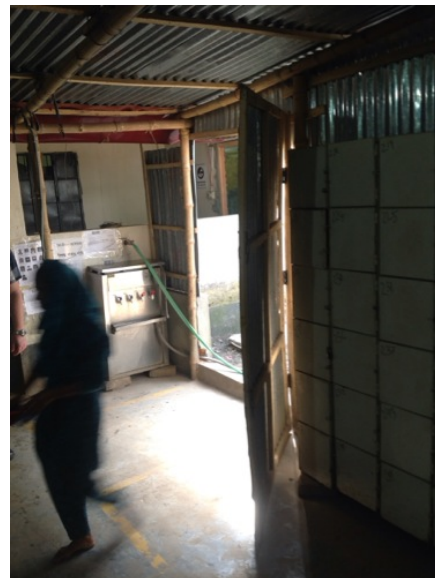
| F-10 | Egress | Exit door serving 50 or more occupants does not swing in the direction of egress travel in the dinning room ground floor. | Modify the egress door to swing in the direction of egress travel. | Within 3 months |

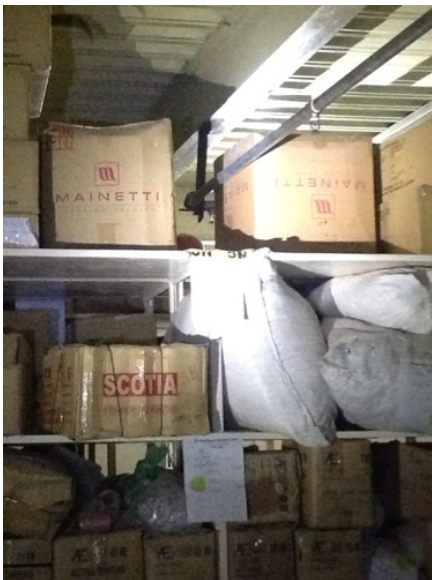
| F-12 | Fire Protection | Storage in the storage room is too close, within 18" of sprinkler heads. | Reorganize storage room to provide proper clearance for sprinkler head to achieve full pattern if activated. | Immediate |

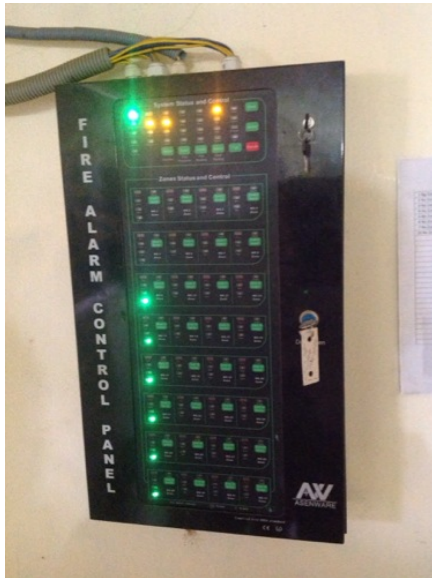
| F-13 | Fire Protection | The fire alarm system did not function correctly during testing. The alarm panel is in trouble mode. | Return system to service and ensure it meets requirements of fire alarm system in accordance with NFPA 72. | Within 3 months |

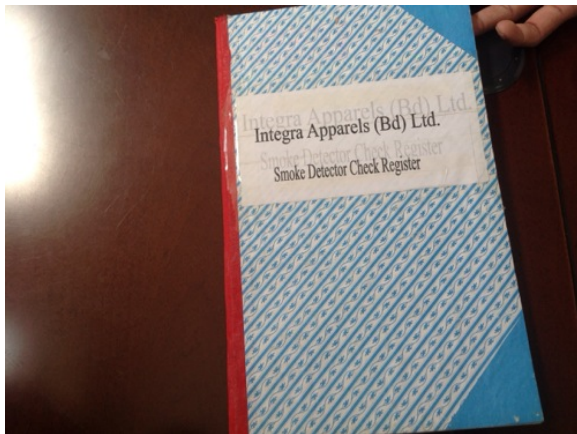
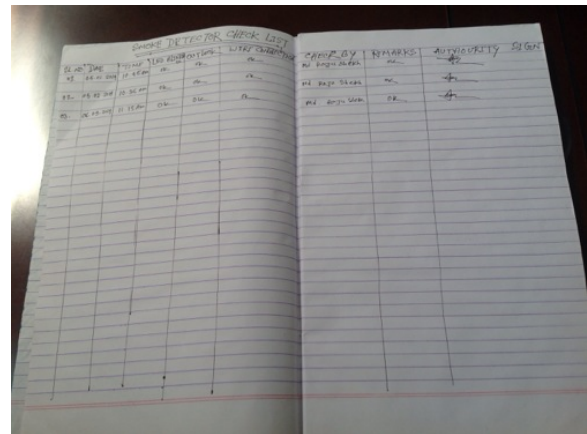
| F-14 | Fire Protection | Inspection, testing, and maintenance for the fire alarm system. | Inspect, test and maintain the fire alarm system, and keep written records on-site, in accordance with NFPA 72. | Within 3 months |
