# **FIRE SAFETY INSPECTION REPORT**

**Factory Name: Apparel Promoters Limited**

**ACCORD ID: 12587**

**Date: 2nd October 2016**

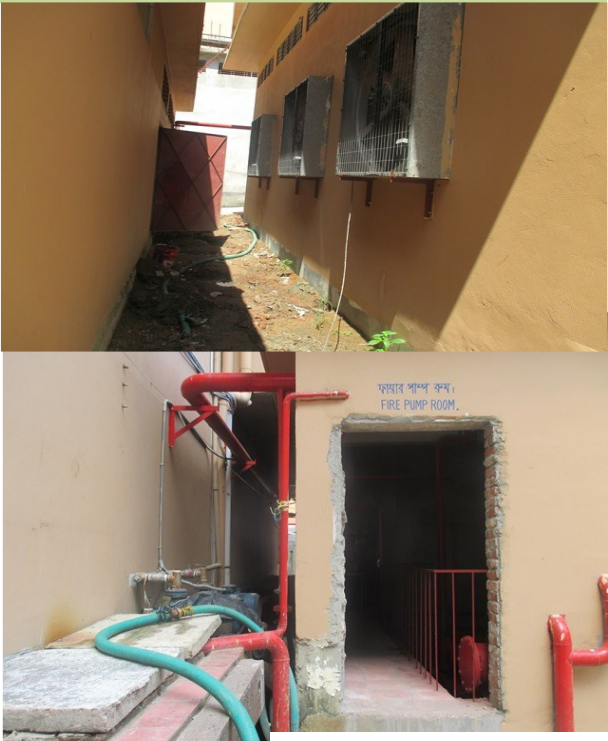
| SI No. | Category | Findings | Required Action | Remediation Time Frame | Pictorial Evidence |
|---|---|---|---|---|---|
| 1 | Fire Rated Construction | The fire pump room & fire control room is not separated from the building.<br>Location: Utility Building. | Provide minimum 2-hr fire rated doors and seal all unprotected openings to separate the exit stairs from work areas and other building spaces on all floor levels.<br>Ensure that the fire doors are self-closing and positive latching and that they are provided with fire exit (panic) hardware where serving production floors.<br>If fire doors are required to be held open for functional reasons, provide automatic closing devices tied to the fire alarm system. | Within 2 months | |

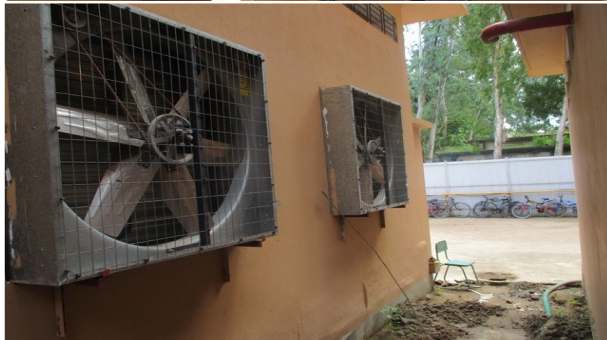
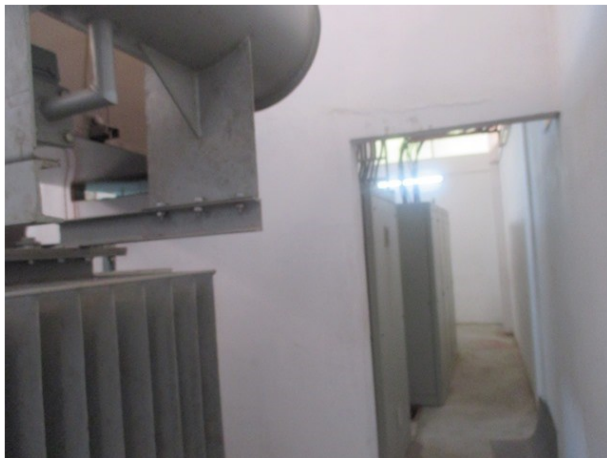
| Sl No. | Category | Findings | Required Action | Remediation Time Frame | Pictorial Evidence |
|---|---|---|---|---|---|
| 2 | Fire Rated Construction | Generator/ transformer/Boiler/Compressor room is not properly separated by fire rated construction from the stair which is used for going to the prayer room at south-east corner of the factory premises. | <p>Generator/ transformer room shall be separated from the stair by a minimum 2-hr fire rated construction (wall, floor, slab etc.). Seal all penetrations and openings (door, window etc.) shall be protected by 1.5-hr fire rated materials to maintain the fire separation if required. All exhaust systems shall discharge to the exterior of the building in a safe location.</p> <p>Or, relocate the prayer room in a safe place.</p> | Within 2 months | |

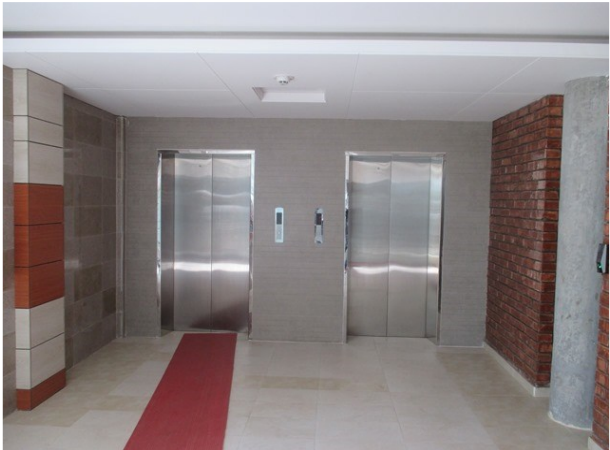
| Sl No. | Category | Findings | Required Action | Remediation Time Frame | Pictorial Evidence |
|---|---|---|---|---|---|
| 4 | Fire Rated Construction | The elevator shaft is not separated from [work areas, other spaces] on each floor by fire-rated construction. Location: Building-1 office floor. | Seal all penetrations and openings in the wall of exit enclosure walls (full thickness of the wall) by fire rated materials to maintain the fire resistance rating. | Within 2 month | |

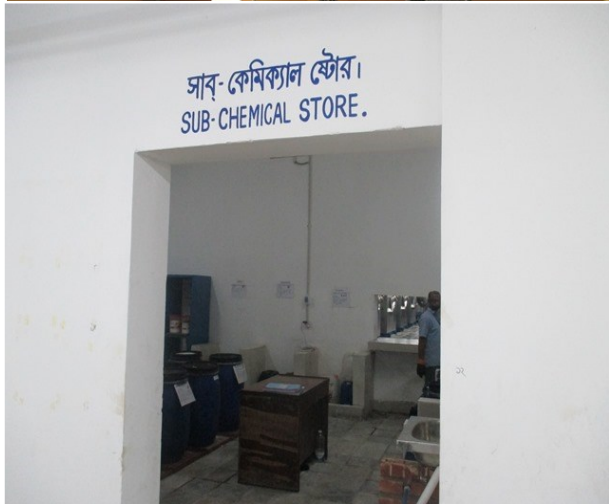
| Sl No. | Category | Findings | Required Action | Remediation Time Frame | Pictorial Evidence |
|---|---|---|---|---|---|
| 5 | Fire Rated Construction | Chemical storage area is not separated by fire-rated construction having non rated door and unsealed penetrations and openings.<br>(Location: Building-2, ground floor). | Separate the chemical storage room by 2-hr fire rated construction. Seal all penetrations and protect the openings to maintain the required fire separations. Keep 16-points MSDS of all chemicals in the storage area.<br><br>** As per BNBC, chemical storage room will be Type-1 construction. | Within 2 month | |

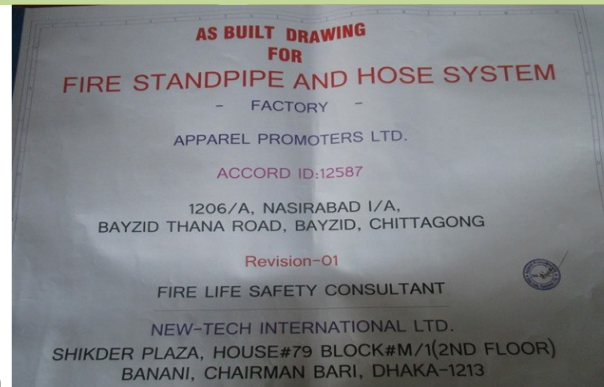
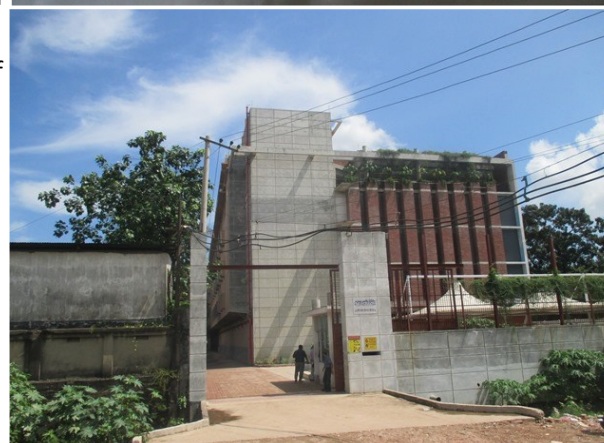
| Sl No. | Category | Findings | Required Action | Remediation Time Frame | Pictorial Evidence |
|---|---|---|---|---|---|
| 6 | Fire Protection | The existing factory building with an occupiable floor greater than 10 m (33 ft.) above the finished grade is not protected with an approved standpipe system. | Submit the as-built design of standpipe system throughout the building in accordance with NFPA 14. | Within 06 Months (Design review & Modification of the system) | |

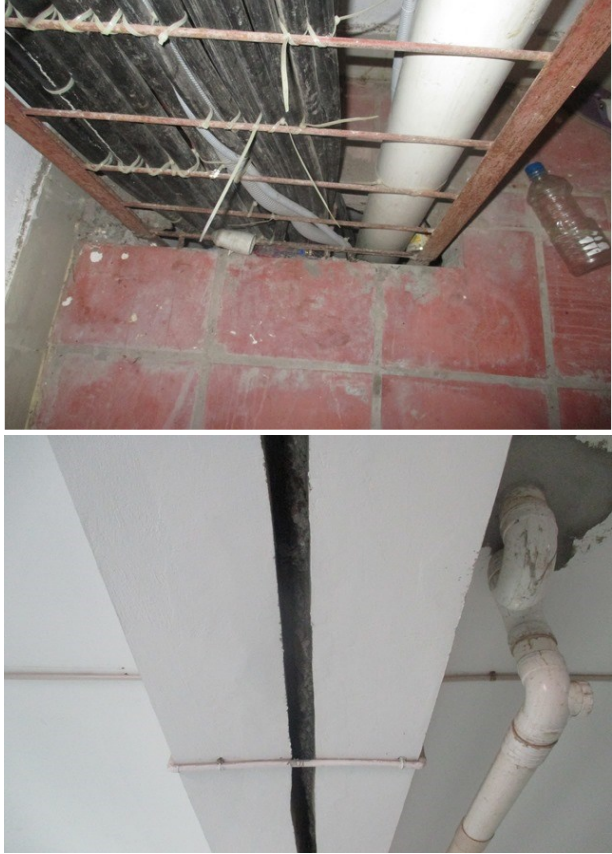
| Sl No. | Category | Findings | Required Action | Remediation Time Frame | Pictorial Evidence |
|---|---|---|---|---|---|
| 10 | Opening/Penetration through Floor/Ceiling | Unsealed Penetrations through floor/ceiling assemblies are observed. Location(s): Inside the production floor near East side and expansion joint of main building. | Provide a minimum 2-hr fire rated shaft to separate the utility risers from each floor if required. Or Seal all penetrations and openings in floor/ceiling (full thickness of the floor/ceiling) assemblies by fire rated materials to maintain the fire resistance rating. | Within 2 months | |
