# Nafa Apparels Ltd

Hijalhati, Bariopara, Kaliakoir, Gazipur, Dhaka  
(+24.026926N, +90.239586E)

13 April 2014

# Observations

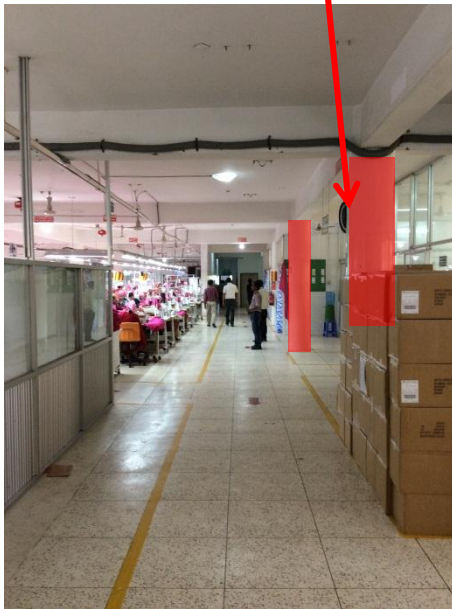
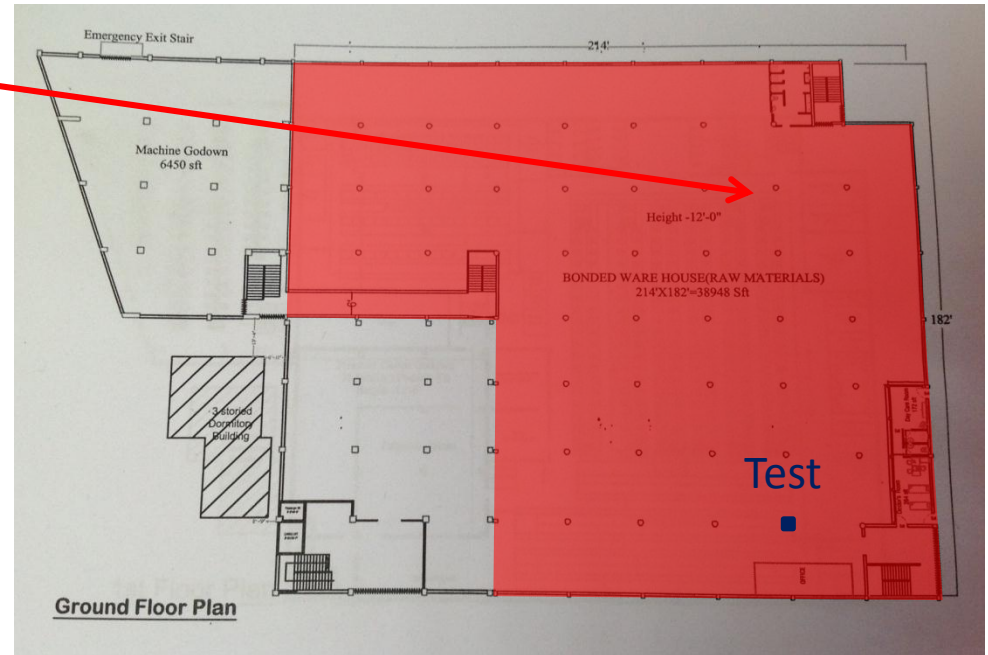
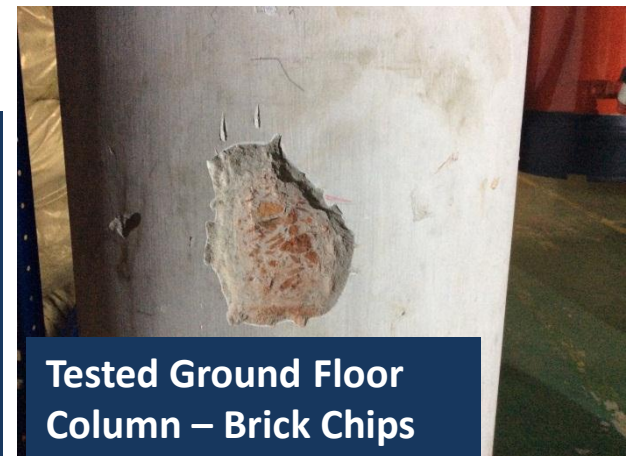
## **3 Storey Factory – Column Stresses**

**Columns, within the 3 storey Factory Building  
appear to be stressed in excess of normal  
design limits**

**Cursory calculations indicate that columns are stressed in excess of normal design limits**

**Tested Ground Floor Column – Brick Chips**

**Specific design check to be carried out on columns in 3 storey Factory**

**Building Engineer is to perform detailed calculations and concrete tests to prove column size and (if required):**

- Reduce loads by vacating floors
- Reinforce columns

| Item No. | Observation | Recommended Action Plan | Recommended Timeline |
|---|---|---|---|
| 1 | Columns within the 3 storey Factory Building appear to be stressed in excess of normal design limits | Building Engineer to review design, loads and column stresses in area identified above | 6-weeks |
| 2 | Columns within the 3 storey Factory Building appear to be stressed in excess of normal design limits | Verify insitu concrete strength either by 100mm diameter cores or existing cylinder strength data for cores from 4 columns | 6-weeks |
| 3 | Columns within the 3 storey Factory Building appear to be stressed in excess of normal design limits | Produce and actively manage a loading plan for all floor plates within the factory giving consideration to floor capacity and column capacity. | 6-months |

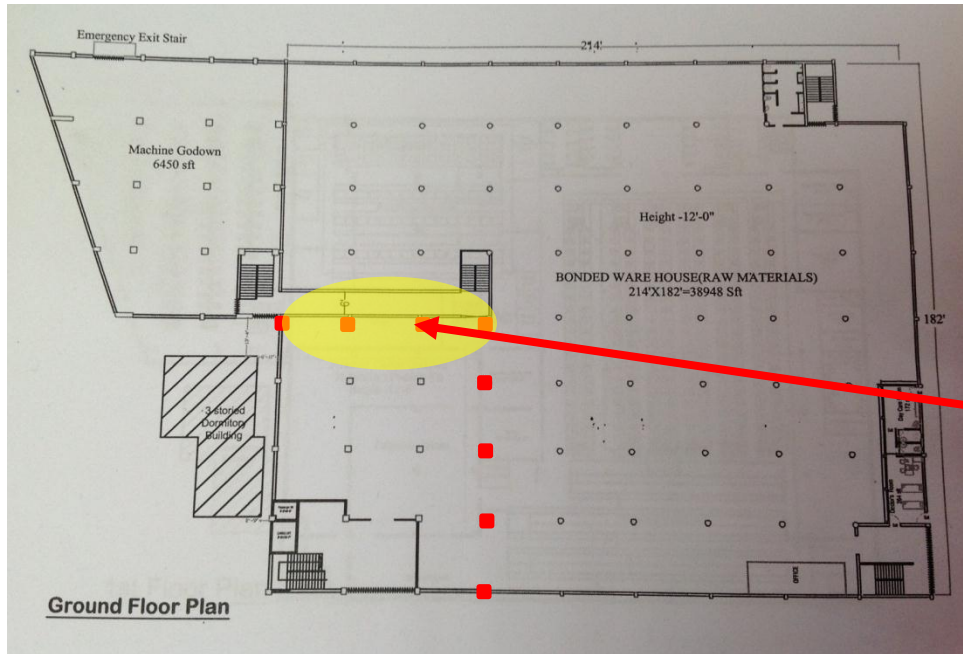
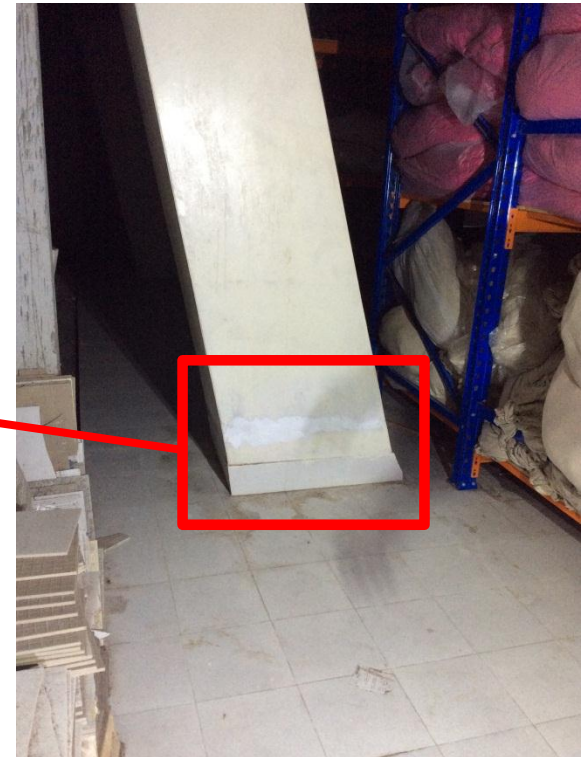
# **Evidence of repairs at base of inclined columns at ground floor west side of Block A**

**Evidence of repairs to base of inclined columns was noted in the highlighted area. Building Engineer to monitor and if cracks reappear – checks should be completed on the design and, if required, remedial measures should be carried out.**

**Evidence of repairs to inclined columns at ground floor west side of Block A**

| Item No. | Observation | Recommended Action Plan | Recommended Timeline |
|---|---|---|---|
| 4 | Evidence of repairs at base of inclined columns at ground floor west side of Block A | Building Engineer to review area of repairs on an on-going basis and propose further remedial works , if required. Structural design check to be carried out if cracking reoccurs | 6-weeks |
| 5 | Evidence of repairs at base of inclined columns at ground floor west side of Block A | Continuous monitoring for evidence of cracking at the base of the inclined columns is advised due to the fact that these columns are key structural elements | 6-months |

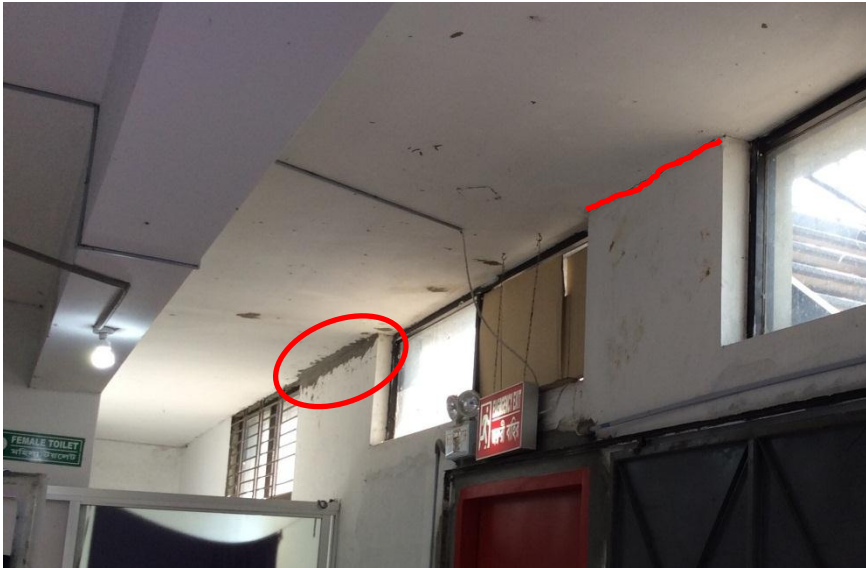
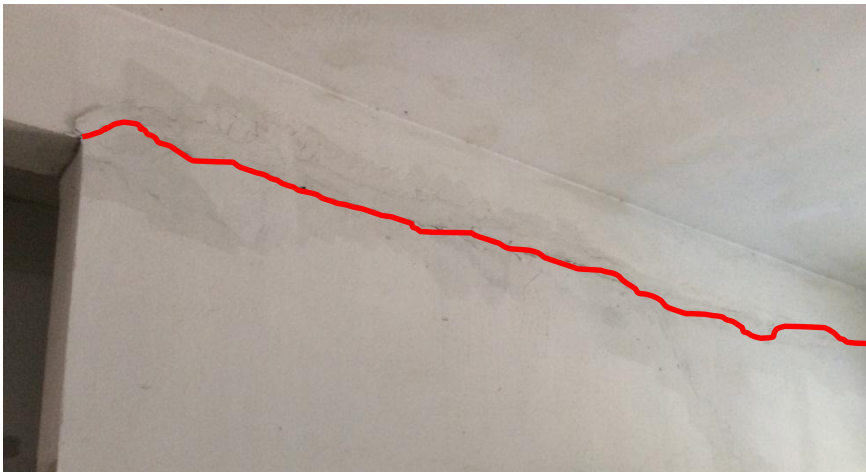
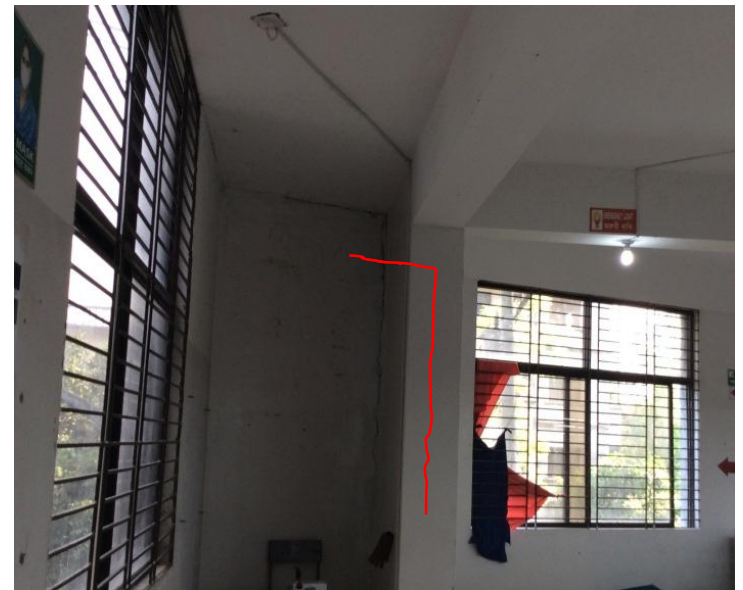
# **Cracking in RC beams, soffit of floor slabs and brick walls**

**Cracking in RC beams, soffit of floor slabs and brick walls**

**Cracks to be reviewed by Building Engineer and remedial measures carried out as required**

| Item No. | Observation | Recommended Action Plan | Recommended Timeline |
|---|---|---|---|
| 6 | Cracking in RC beams, soffit of floor slabs and brick walls | Building Engineer to review cracking on an on-going basis and propose further remedial works , if required | 6-weeks |
| 7 | Cracking in RC beams, soffit of floor slabs and brick walls | Building Engineer to continue to monitor cracks | 6-months |

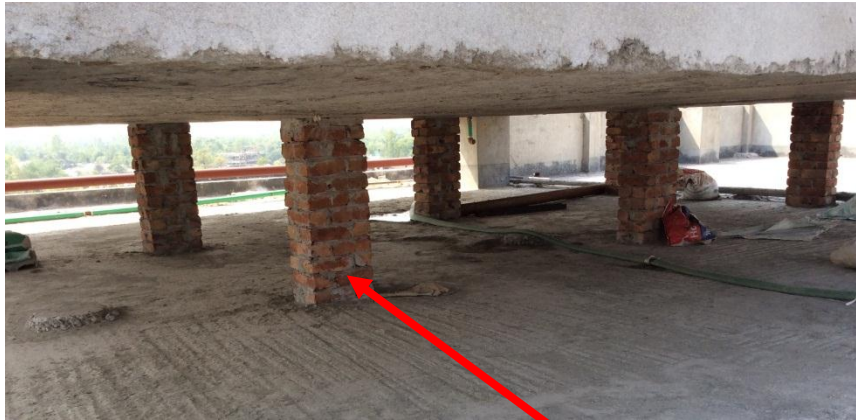
## **Block B - Roof Level**

**Redundant water tank  
support plinth –  
approx 700mm high**

| Item No. | Observation | Recommended Action Plan | Recommended Timeline |
|---|---|---|---|
| 9 | Brick supports to water tank and redundant concrete plinths at roof level to Block B | Circular water tank support plinths to be removed from northern end of roof to Block B. | 6-weeks |

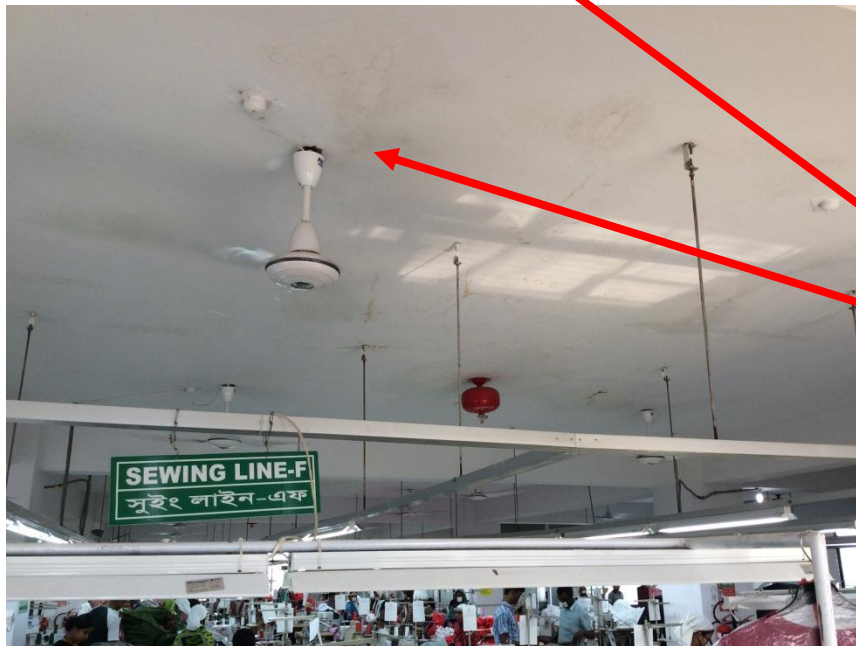
**Brick piers support concrete water  
tank – applying point loads to roof  
slab. Building Engineer to review  
and if piers are not consistent  
with the building design they  
should be removed. Evidence of  
previous water damage noted on  
underside of roof slab**

| Item No. | Observation | Recommended Action Plan | Recommended Timeline |
|---|---|---|---|
| 8 | Brick supports to water tank and redundant concrete plinths at roof level to Block B | Building Engineer to confirm that brick piers to water tank are non structural and that they may be removed to avoid providing an alternative support point to the water tank above which will not have been allowed for by the building designer. | 6-weeks |
| 10 | Brick supports to water tank and redundant concrete plinths at roof level to Block B | Following confirmation by the Building Engineer, brick support piers to concrete water tank to be removed | 6-months |

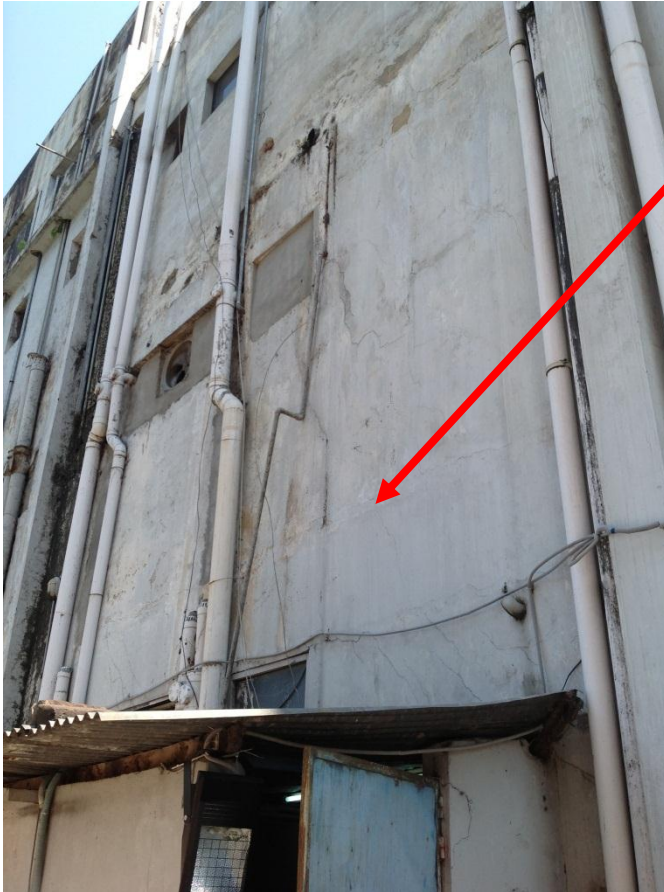
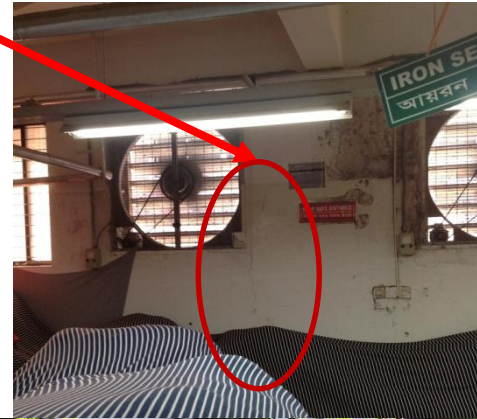
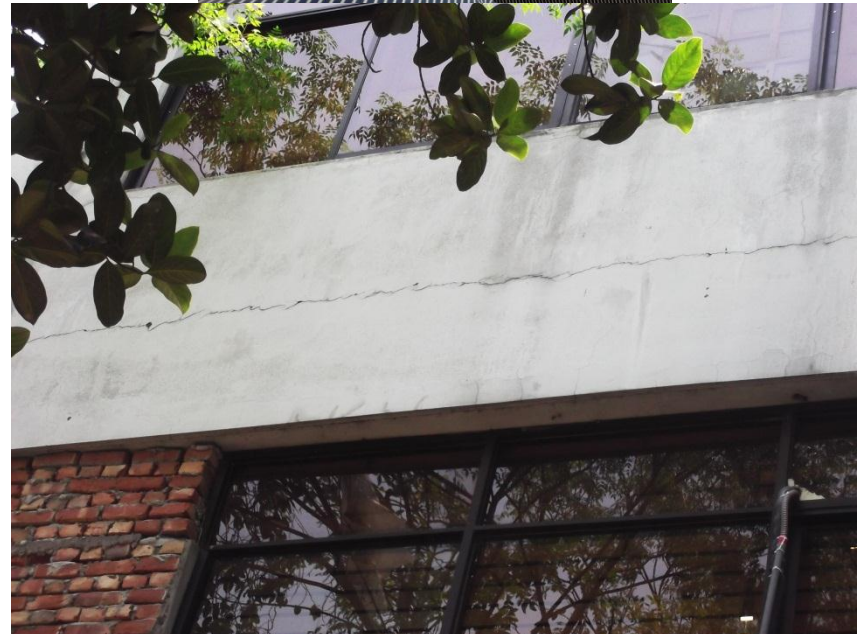
**Cracking of façade was evident. These cracks should be inspected and repaired as necessary, especially if they penetrate through the entire façade thickness**

**Cracks to building façade**

| Item No. | Observation | Recommended Action Plan | Recommended Timeline |
|---|---|---|---|
| 12 | Cracks to building façade | Inspect façade to locate through thickness cracks. Repair cracks on both sides to avoid damp from penetrating the building | 6-months |

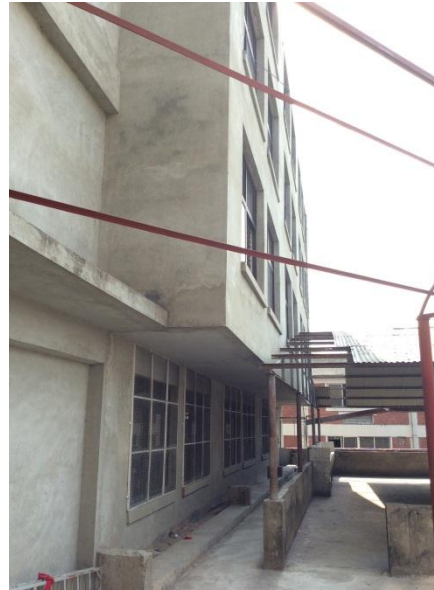
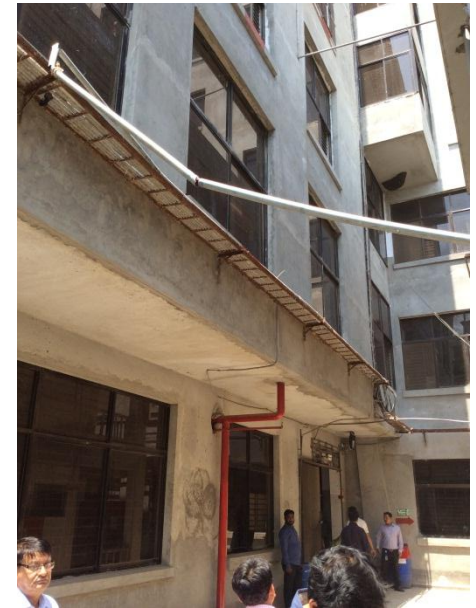
**Structural Drawings**

# **Inconsistencies between structural drawings and the as-constructed arrangement of the factory**

**Full extent of  
cantilever to be  
shown on structural  
drawings.**

**Details of roof steel  
frame to be shown on  
structural drawings**

| Item No. | Observation | Recommended Action Plan | Recommended Timeline |
|---|---|---|---|
| 13 | Inconsistencies between structural drawings and the as-constructed arrangement of the factory | Building Engineer to survey as constructed building. Updated drawings to be prepared showing the correct as constructed layout – in particular cantilever slabs and structural steel. | 6-months |
| 14 | Inconsistencies between structural drawings and the as-constructed arrangement of the factory | Prepare/update calculations showing the structural adequacy of the building structure taking into account the factory design imposed loading and the as built structure. | 6-months |

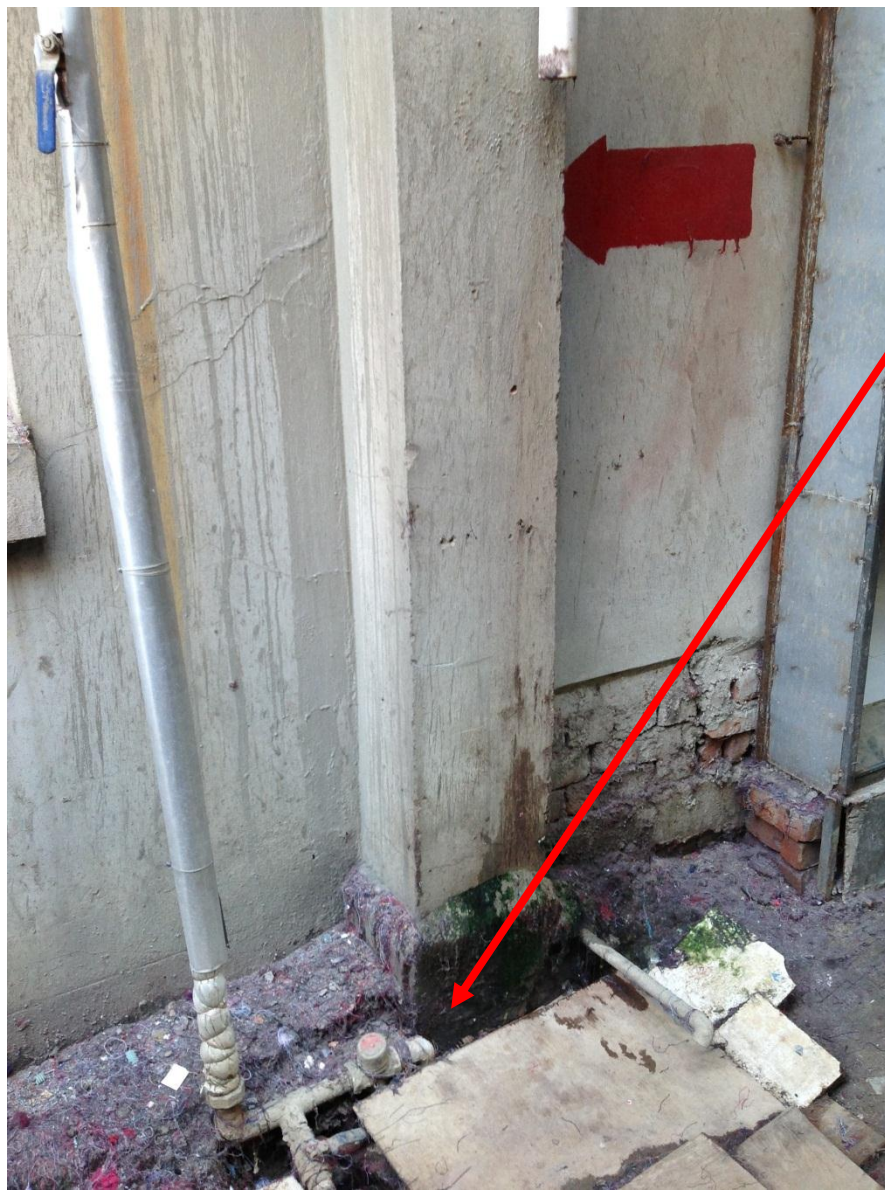
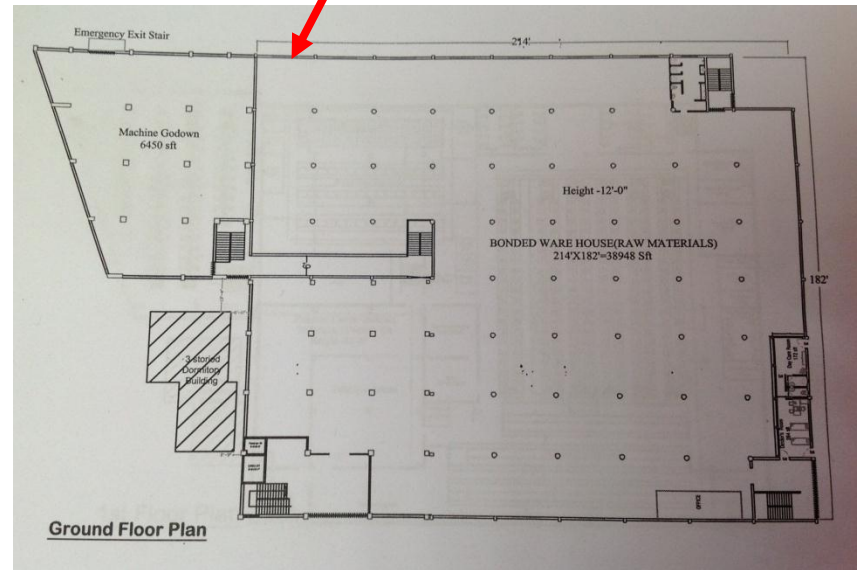
Steam outlet and open water drain at the base of a structural column. These should be diverted away from the building structure to avoid degradation over time.

Steam and water at base of column

| Item No. | Observation | Recommended Action Plan | Recommended Timeline |
|---|---|---|---|
| 16 | Steam and water drain at base of structural column | Divert steam outlet away from structural column | 6-months |
| 17 | Steam and water drain at base of structural column | Divert drainage away from structural column | 6-months |
