# Deluxe Fashions Ltd

178/179 Baizid Bostami Road, Nazirabad Area, Chittagong  
(22.39048N, 91.81110E)

18 March 2014

# Observations

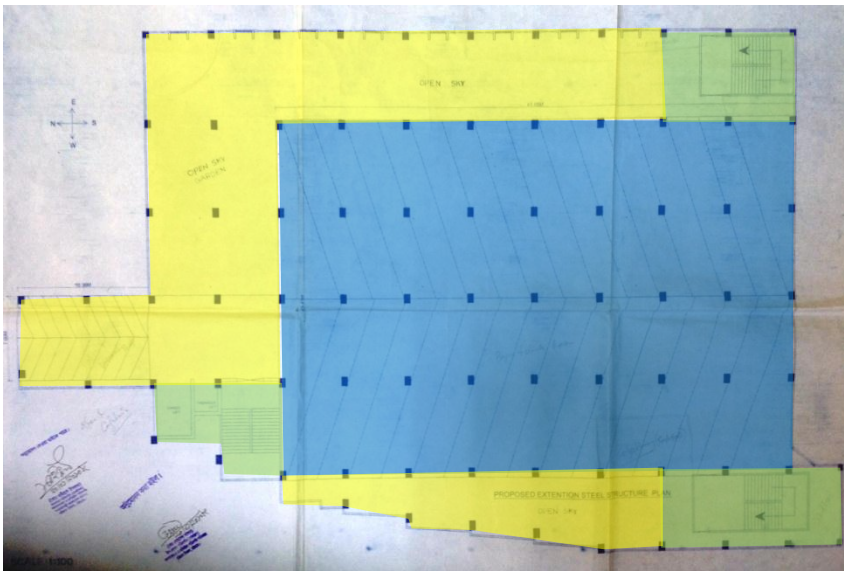
Typical column layout  
& Water Tank Layout

**Columns at the building corners and columns which support the concrete water tanks appear to be stressed in excess of normal design limits**

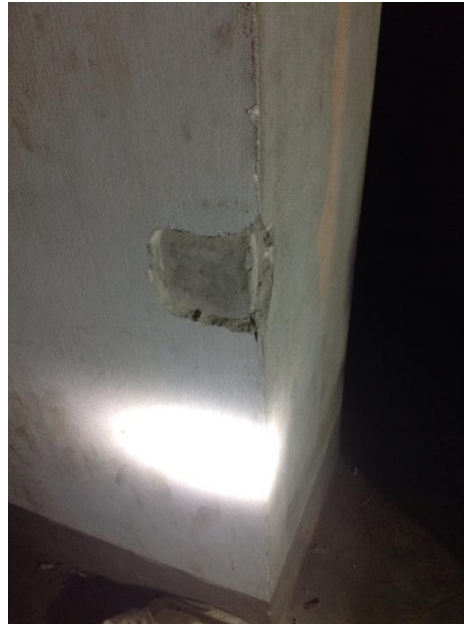
Tested Basement Column – Stone Chips

Cursory calculations indicate column working stress is in excess of normal design limits – for columns at the building corners and columns which support the concrete water tanks

Building Engineer is to perform detailed calculations and concrete tests to prove column size and (if required):

- Reduce loads by vacating floors
- Reinforce columns

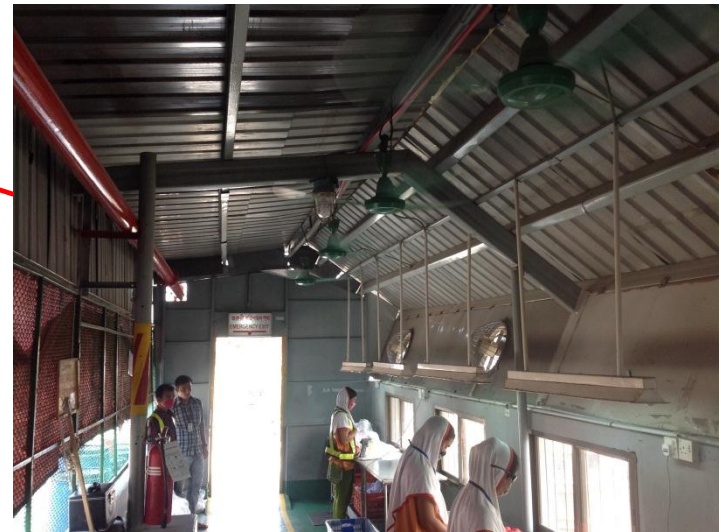
Lean-to structure on 6th Floor

Steel structure used for dining on the roof does not appear to have any vertical bracing. Also, lean-to structure appears to be non-engineered. Building Engineer to review both issues.

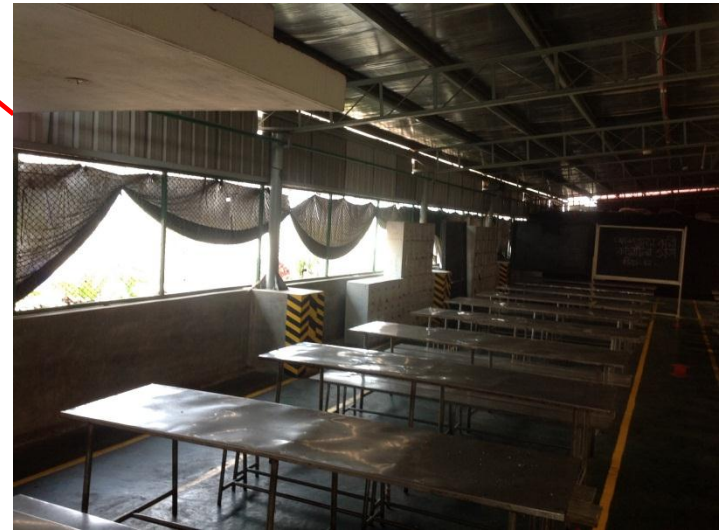
Steel structure on 6th Floor with no vertical bracing

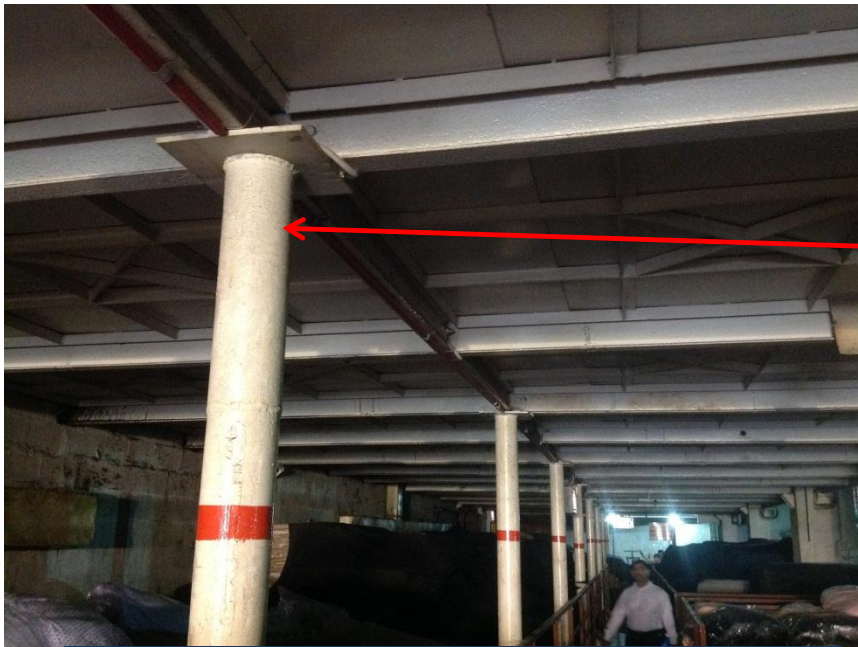
Mezzanine support column applies point load to Ground Floor suspended slab – which also supports heavy storage loads. Building Engineer to review design of ground floor slab.

Mezzanine structure not shown on structural drawings.

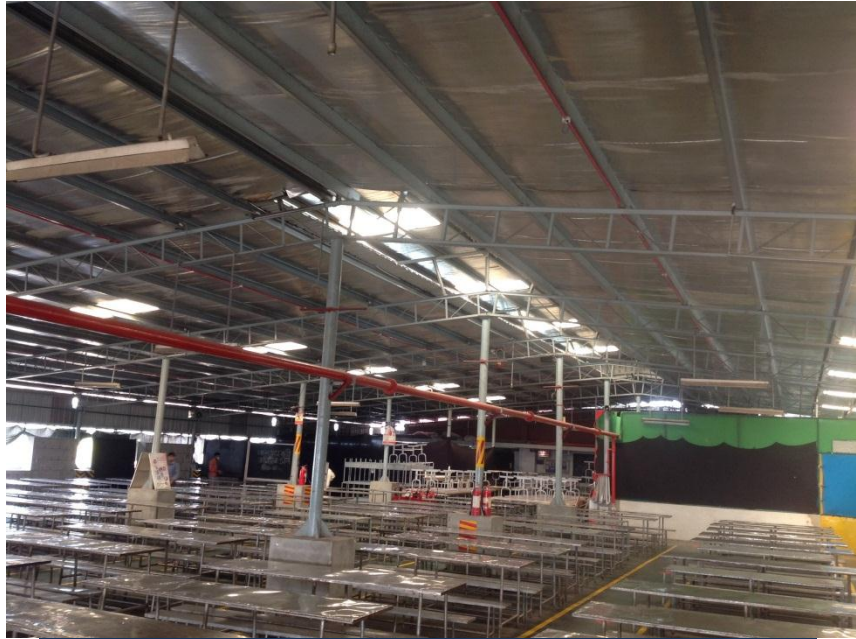
Steel structure at roof level not shown on structural drawings.

Building Engineer to survey as-built structure and update drawings including verification of steel structure at roof level and mezzanine level.

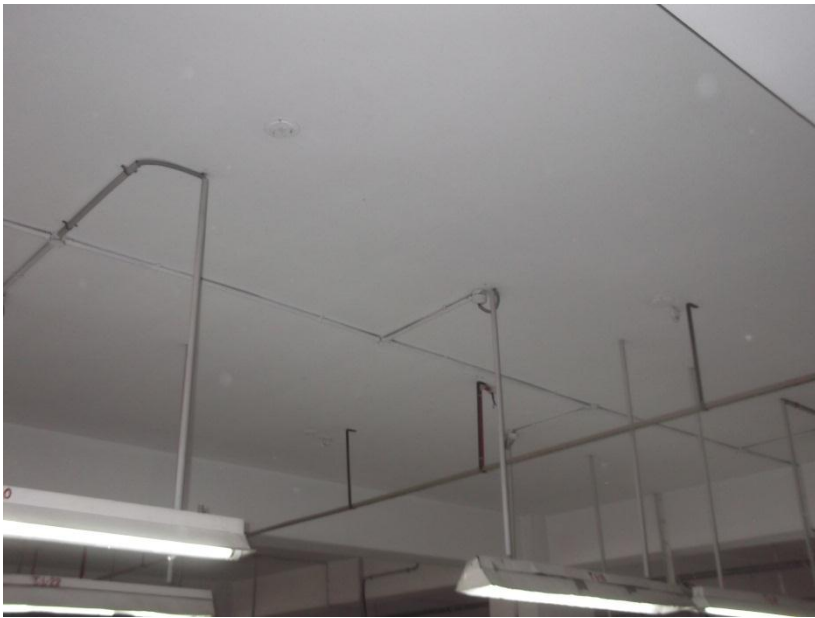
While they are shown on the structural drawing, there are no secondary beams at soffit of 6<sup>th</sup> floor slab.

**Building Engineer to survey as-built structure and update drawings.**

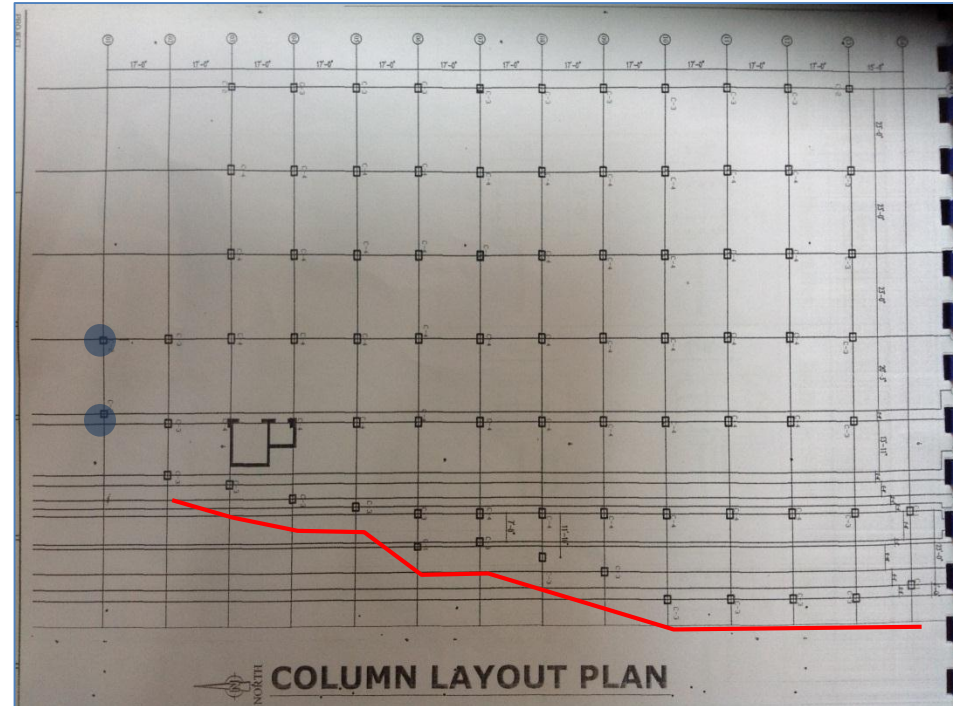
The columns at the front of the retail units are not shown on any drawings and there are no details of the foundations to these columns. Approximate line of these columns is shown in red. Columns highlighted in blue are circular and not rectangular as shown on the drawings.
