Aman Sweaters Ltd.

Rajaghat, Rajfulbaria, Savar, Dhaka
(23.8122779, 90.260986)

19 MARCH 2014

Observations Made

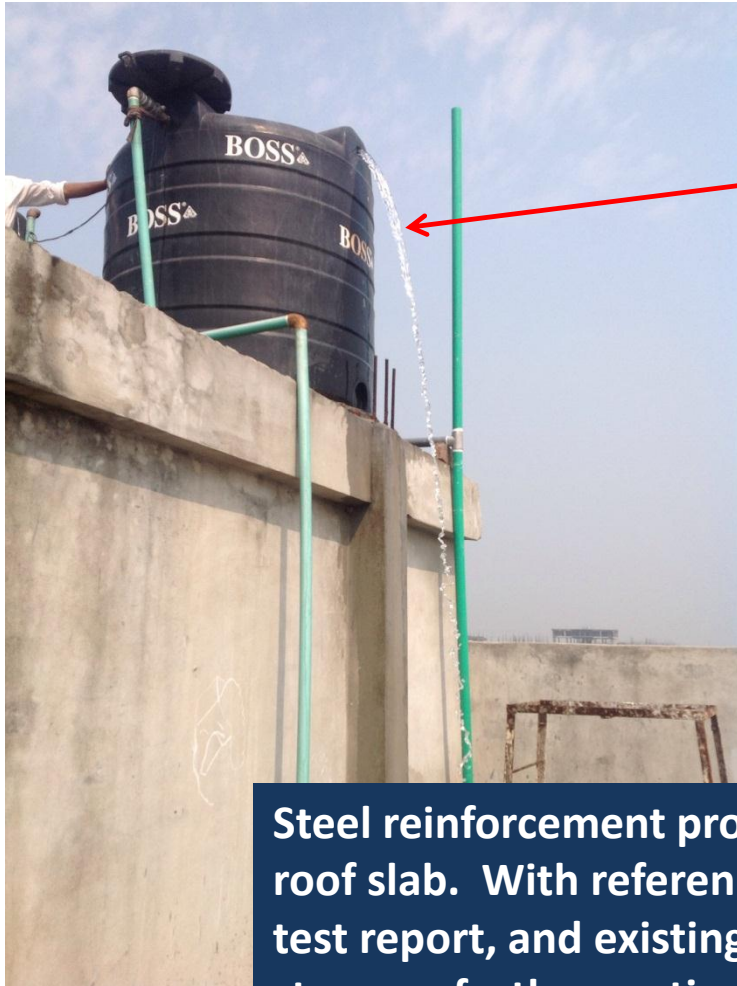
Column reinforcement projecting from roof

Overflow from water tank is uncontrolled and lands on top of reinforcement projecting from column forming stair enclosure. If not addressed this will lead to corrosion of reinforcement.

Steel reinforcement projects from roof slab. With reference to soil test report, and existing column stresses, further vertical extension is not permitted.

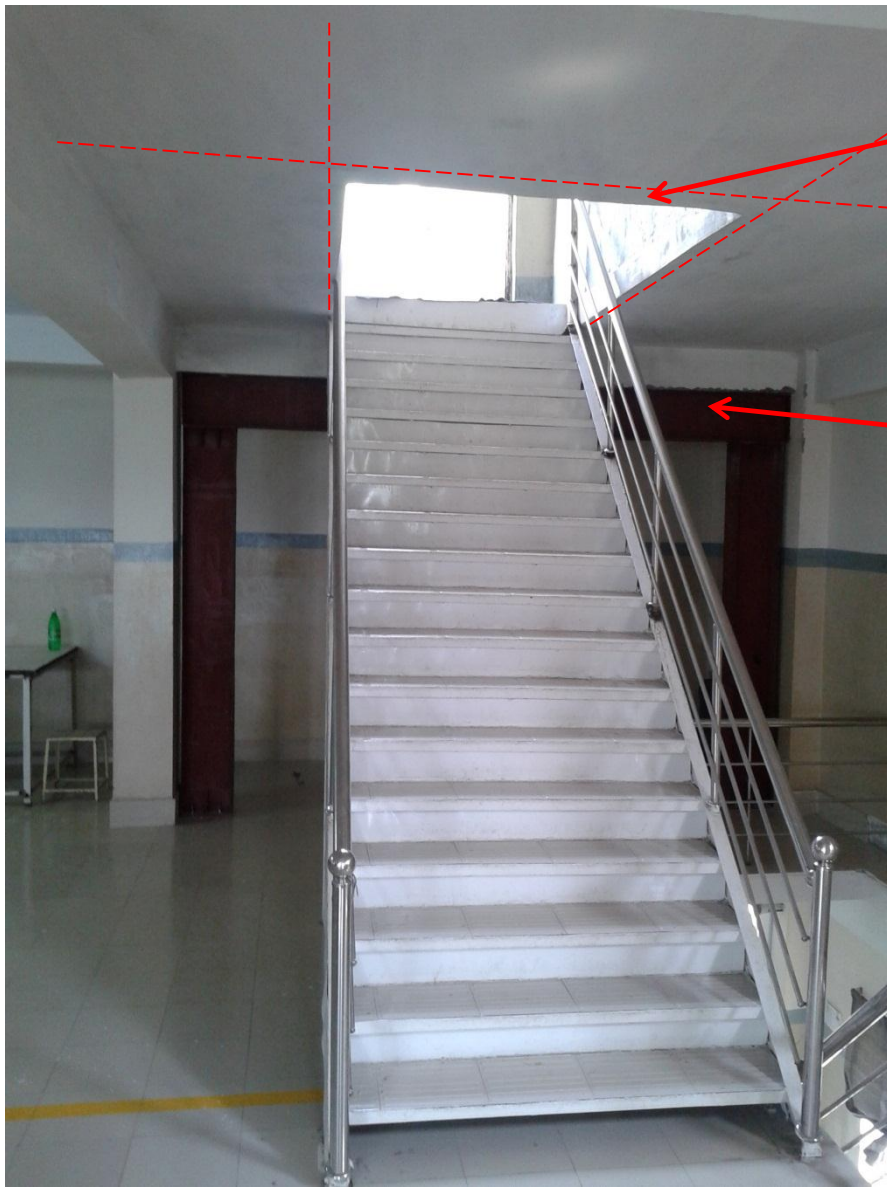
Opening through slab, believed to be an alteration after the slab was formed. Previous structural survey in August 2013 highlighted lack of edge beam to opening

Steel frame added following previous structural survey. Frame added is ineffective stiffening slab opening edge (see dotted lines for more appropriate locations)

Item No.	Observation	Recommended Action Plan	Priority
6	No framing around openings in slabs for stairs in 5 storey section of Building 1	Ensure structural bay with slab opening is not used for storage (i.e. heavy loading to be kept away from edge of opening).	6-weeks
7	No framing around openings in slabs for stairs in 5 storey section of Building 1	Building engineer to check design of slab where edge of opening is not supported (i.e. where there is not an existing concrete beam), giving consideration to reinforcement quantity and loading. Engineer to design strengthening if required.	6-weeks
8	Column stresses in building 2	Construction of an additional storey shall not commence without adequate structural design and approval where Factory Engineer review design, loads and columns stresses .	6-months
9	Column stresses in building 2	Verify insitu concrete stresses either by cores or existing cylinder strength data for the identified columns.	6-months

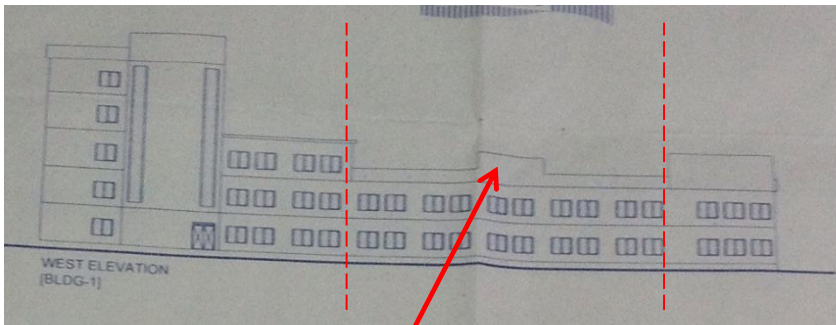
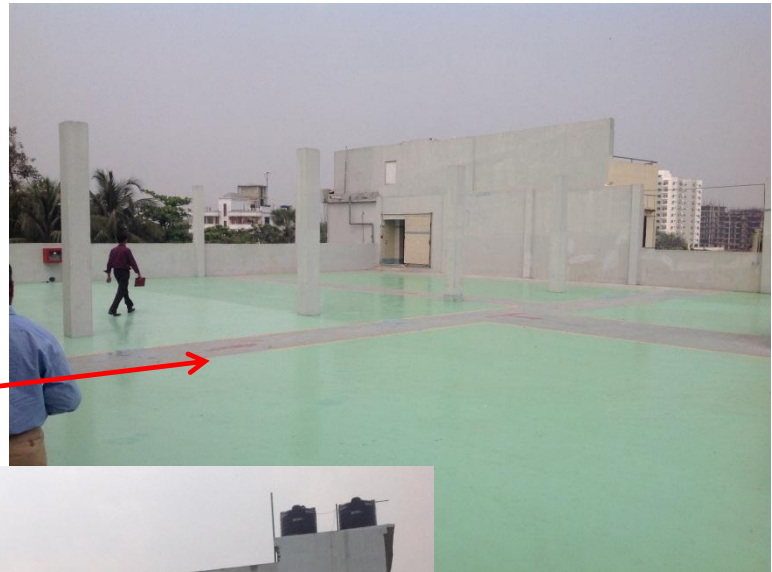
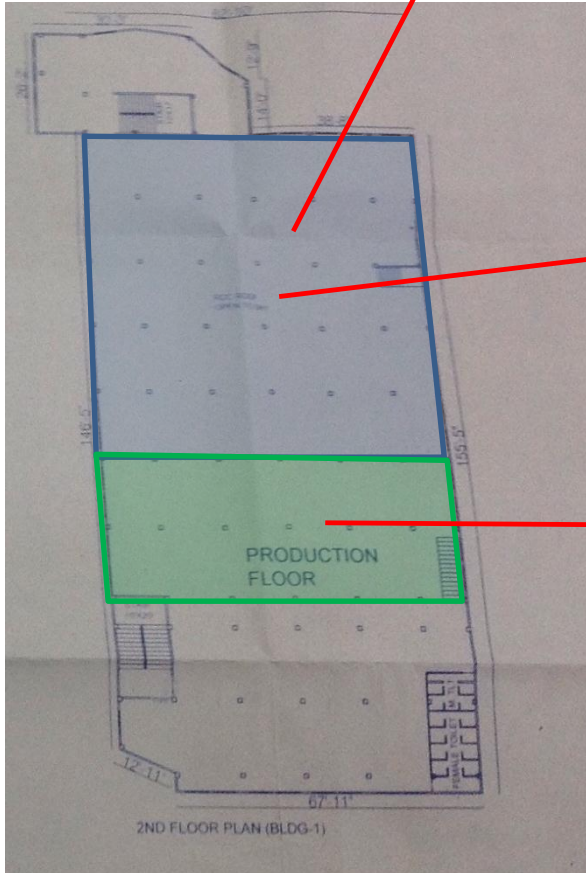
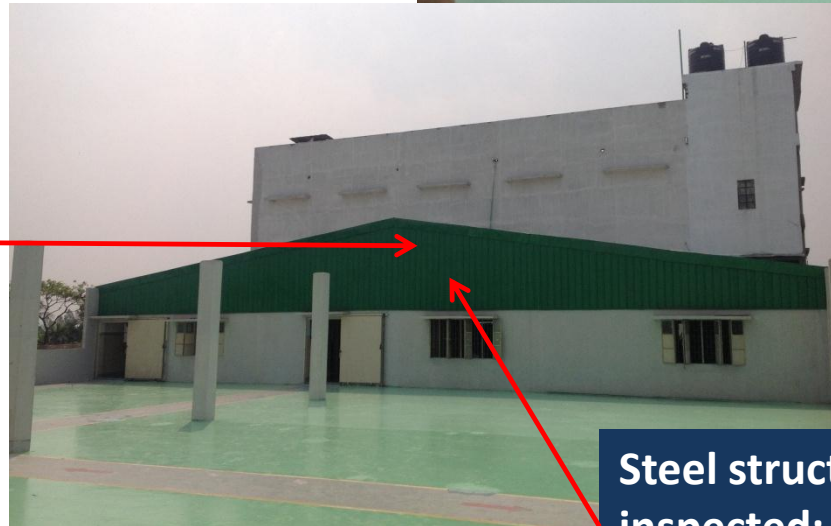
Removal of steel roof

Steel roof structure was removed last year following a BGMEA inspection.

Steel structure not inspected; not visible due to suspended ceiling

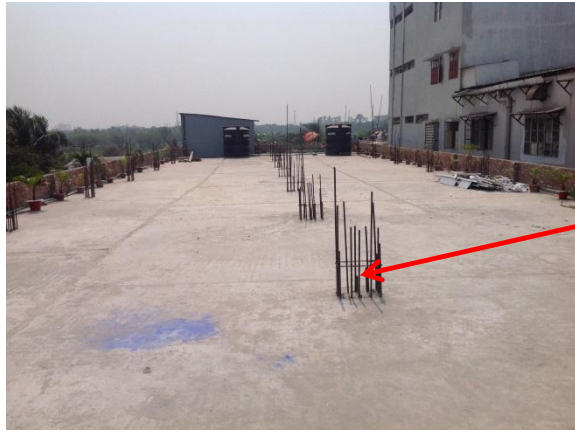
Starter bars extended above the roof of Building 2 for another storey to be added in the future.

Floor with heaviest load requirement should be placed on the ground floor where practical. Building Engineer to confirm capacity of floor slabs and columns.

No vertical extension of the building should commence without the correct engineering and permit approvals.

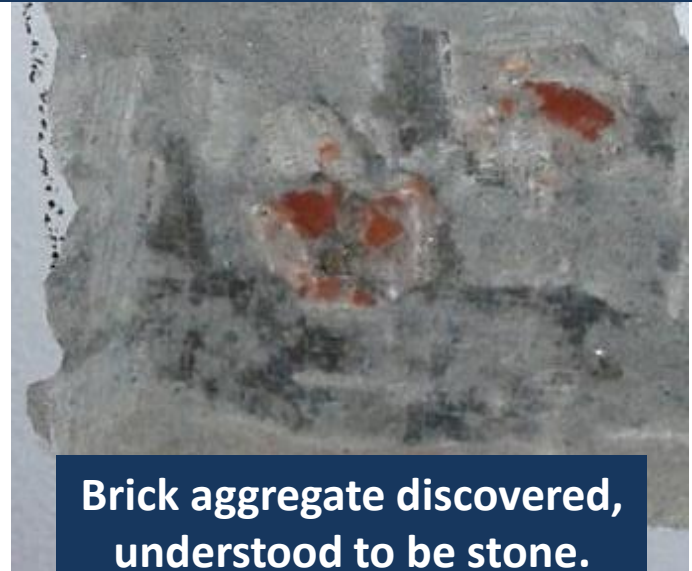
Brick aggregate discovered, understood to be stone.

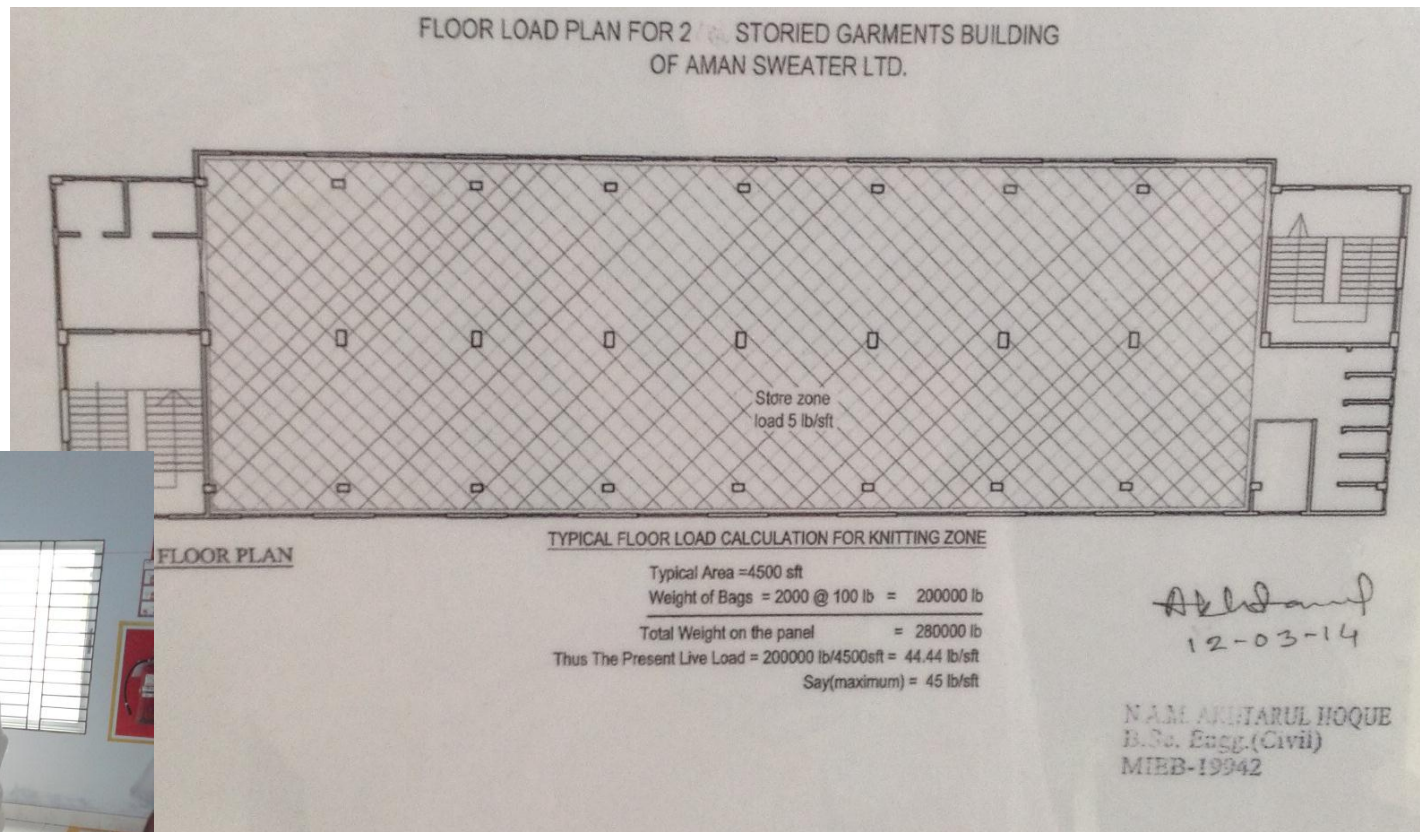
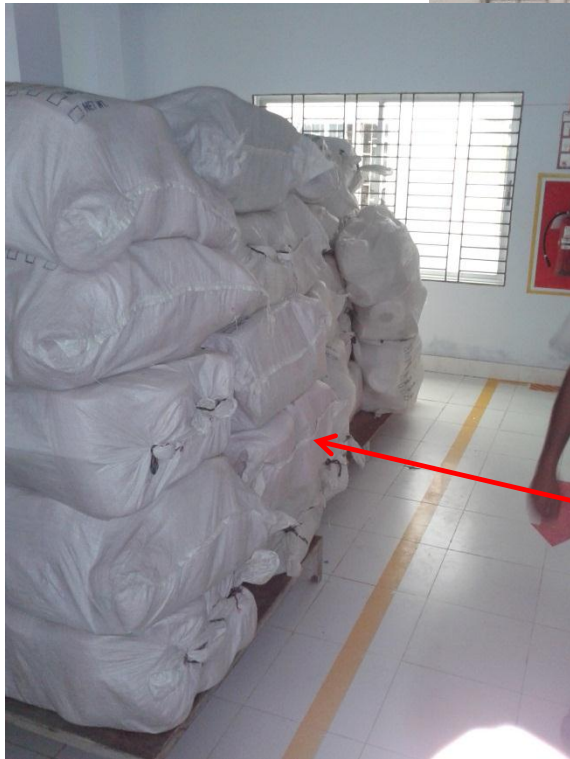
Aggregate type and planned increases in column loads

Loading plans consider full floor area. An individual column may experience higher loading

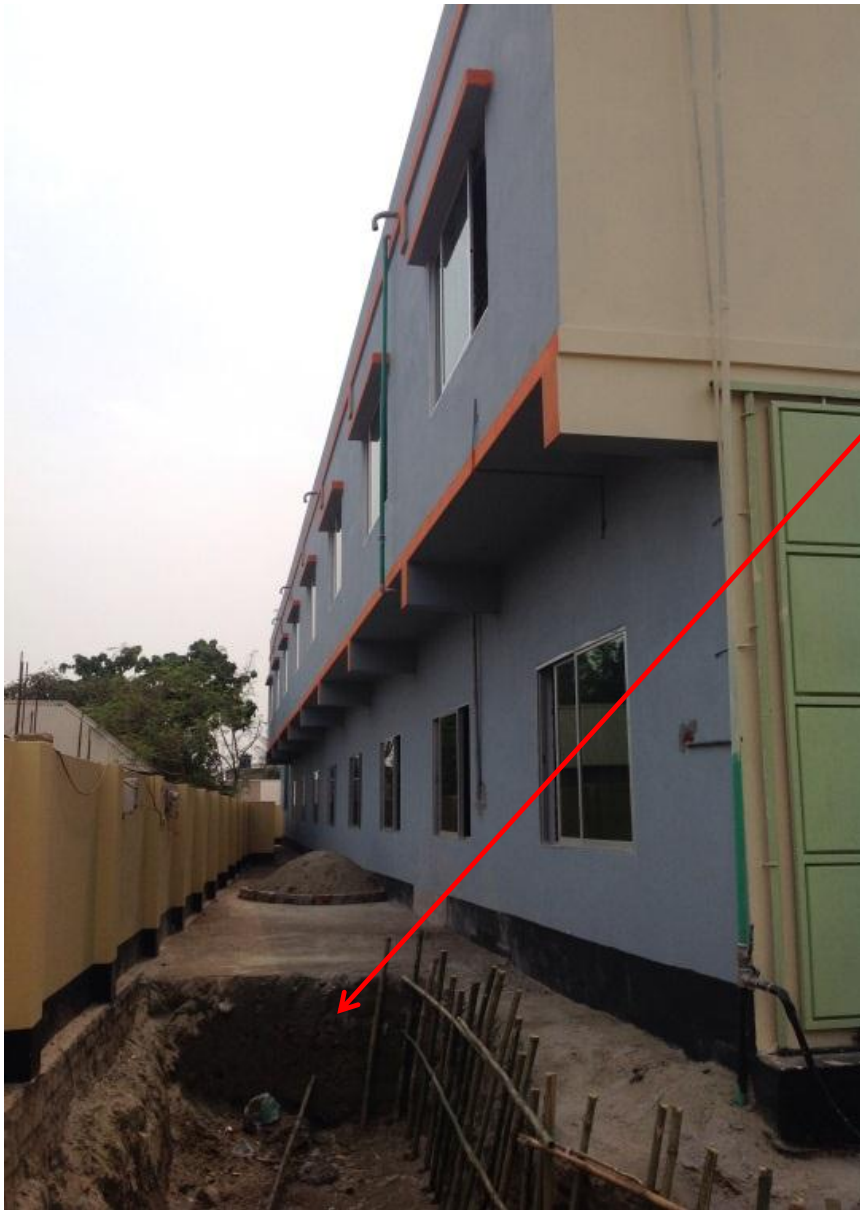
Open excavation near building

Unprotected excavation located nearby foundations of Building 2.

Engineering drawings indicate foundations extend 10 ft (3m) below ground level thus excavation does not undermine building structure.
