# A Plus Sweater LTD.

Sarifpur Road,(Maleker Bari) P.O. National University, Gazipur Sadar, Gazipur  
(23.966094N,90.377113E)  
22<sup>th</sup> September 2016

# Observation

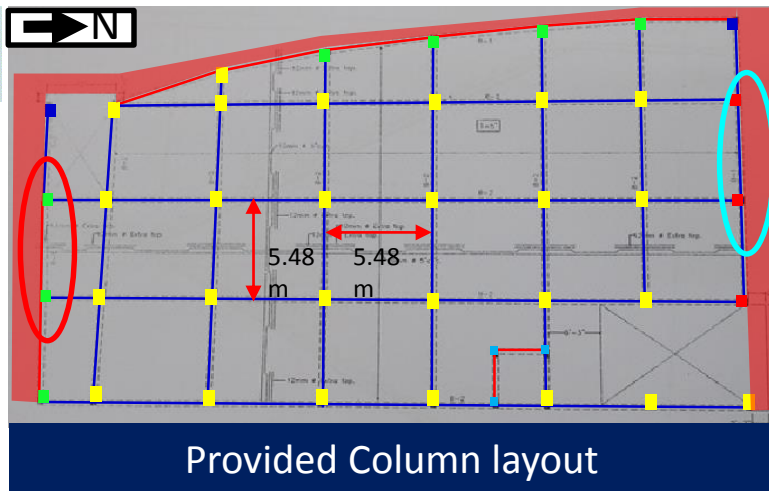
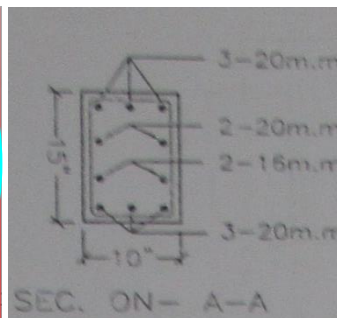
Provided Column layout

Column schedule for "Red" colour circle column

Column reinforcement did not match with schedule for the marked column

| Item No. | Observation | Recommended Action Plan | Recommended Timeline |
|---|---|---|---|
| 1 | Discrepancies between provided drawing and as built condition | Factory Engineer to update the drawings to “as-constructed” status. | 6-weeks |

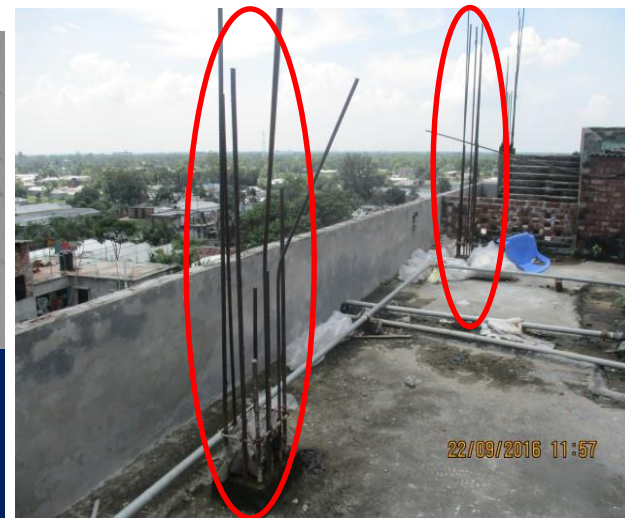
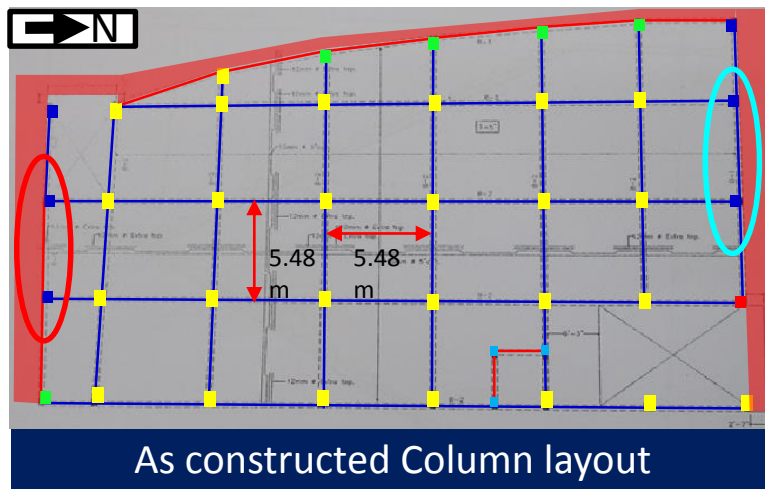
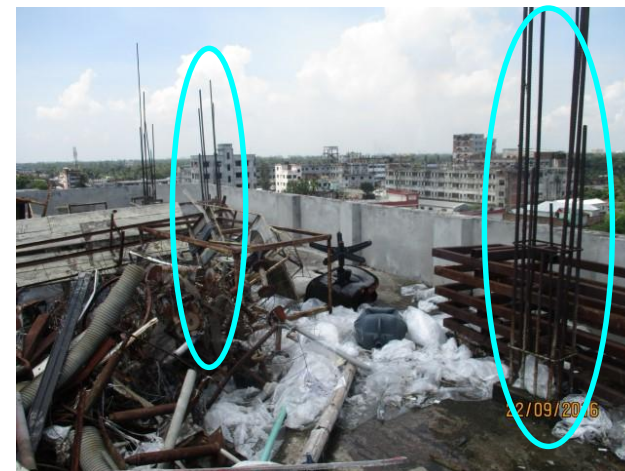
As constructed Column layout

Column schedule for "Aqua" colour circle column

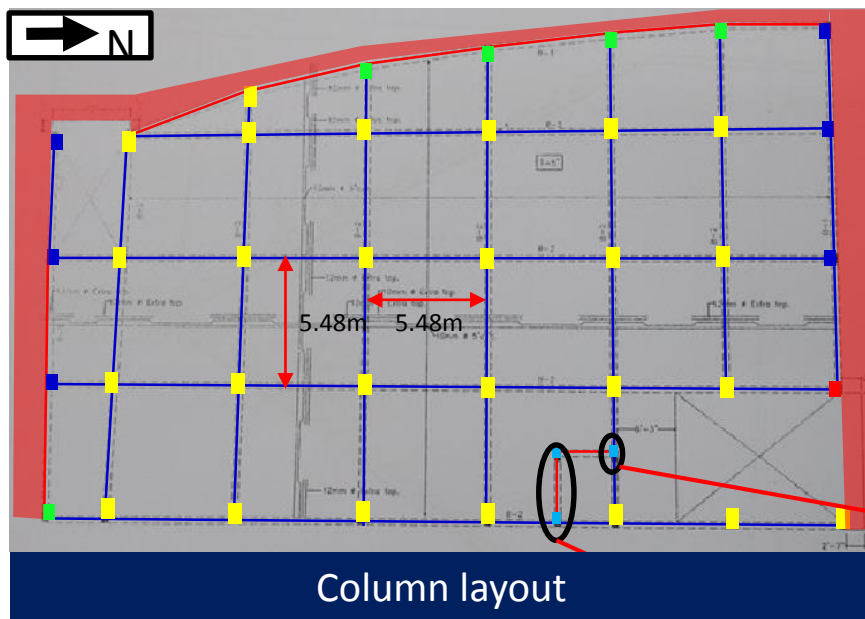
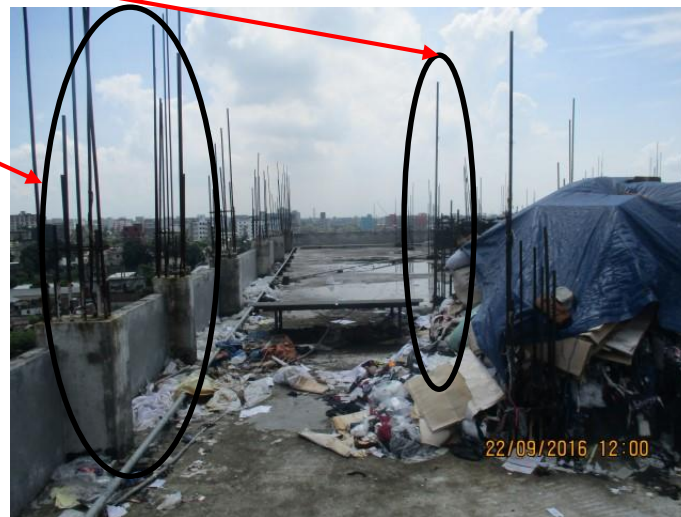
In structural drawing, no column or beam schedule were present for the marked column and beam. Also the cantilever was absent in provided drawing.

| Item No. | Observation | Recommended Action Plan | Recommended Timeline |
|---|---|---|---|
| 2 | Discrepancies between provided drawing and as built condition | Building engineer to investigate the whole building and Conduct Engineering Assessment (EA ) especially for foundation. | 6-weeks |

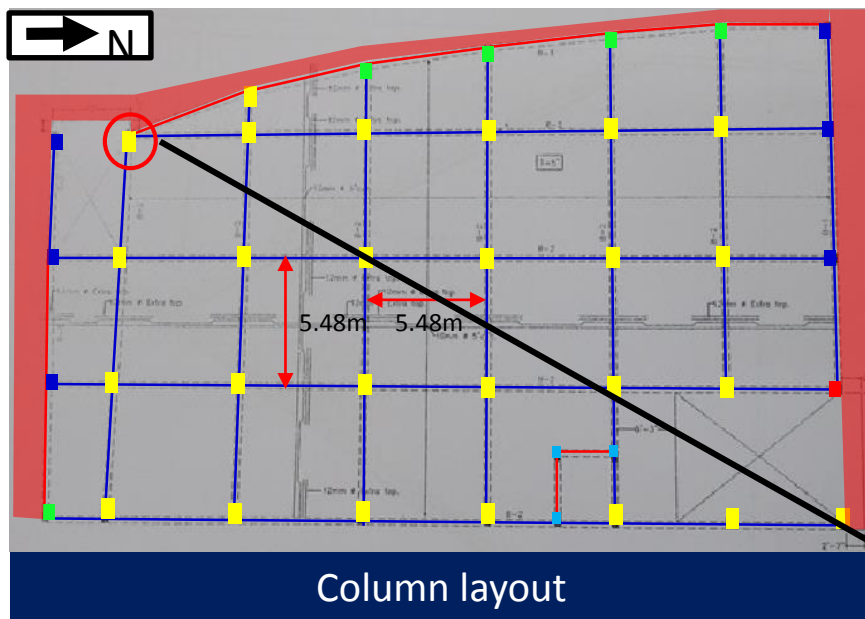
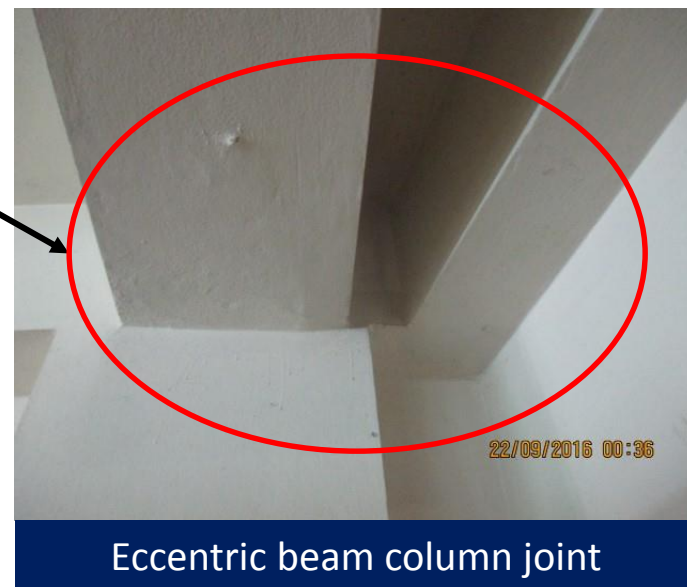
Eccentric beam column joint found adjacent with south stair side

| Item No. | Observation | Recommended Action Plan | Recommended Timeline |
|---|---|---|---|
| 3 | Discrepancies between provided drawing and as built condition | Implement remedial work if necessary. | 6-months |

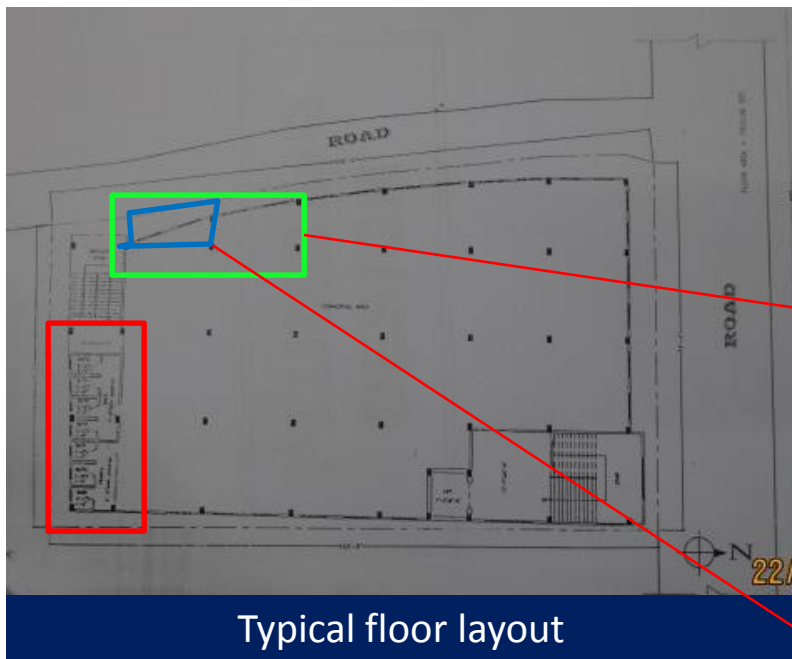
Typical floor layout

In floor layout plan, the toilet area did not match with provided drawing, also a small mezzanine floor was found over ground floor just beside the south side stair case

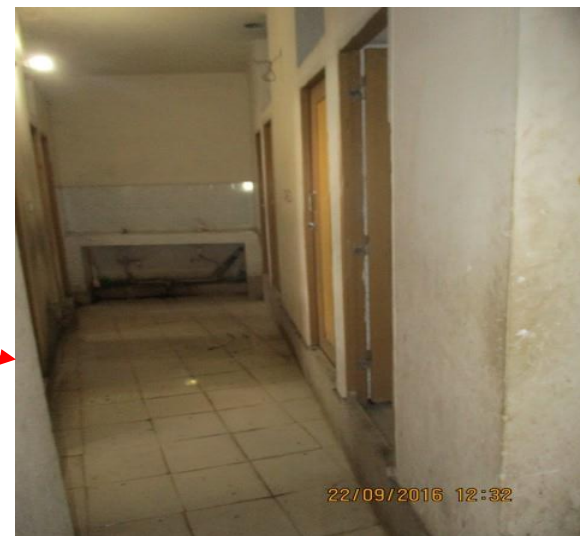
Toilet area on 3<sup>rd</sup> floor

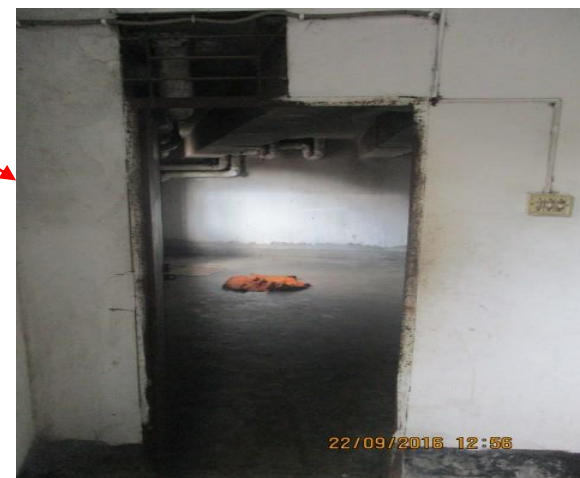
Mezzanine floor beside south stair case

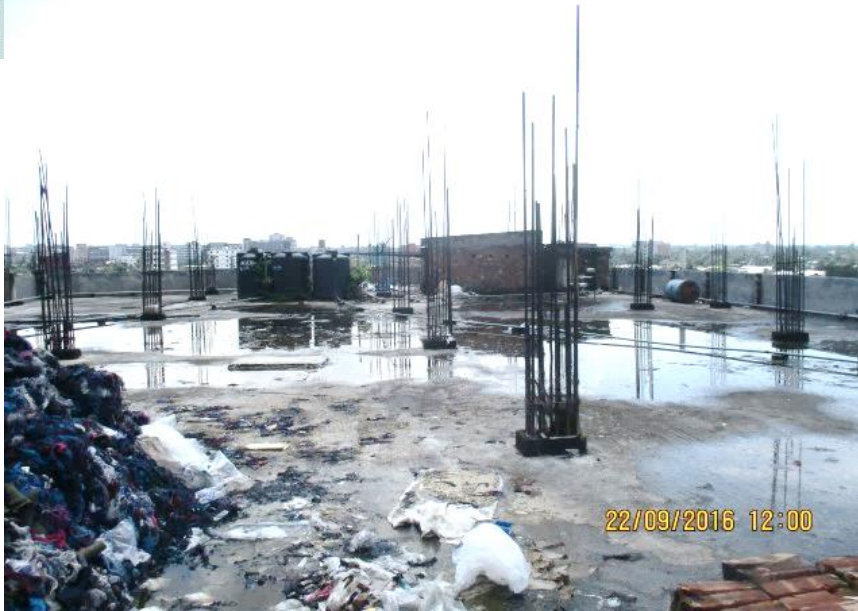
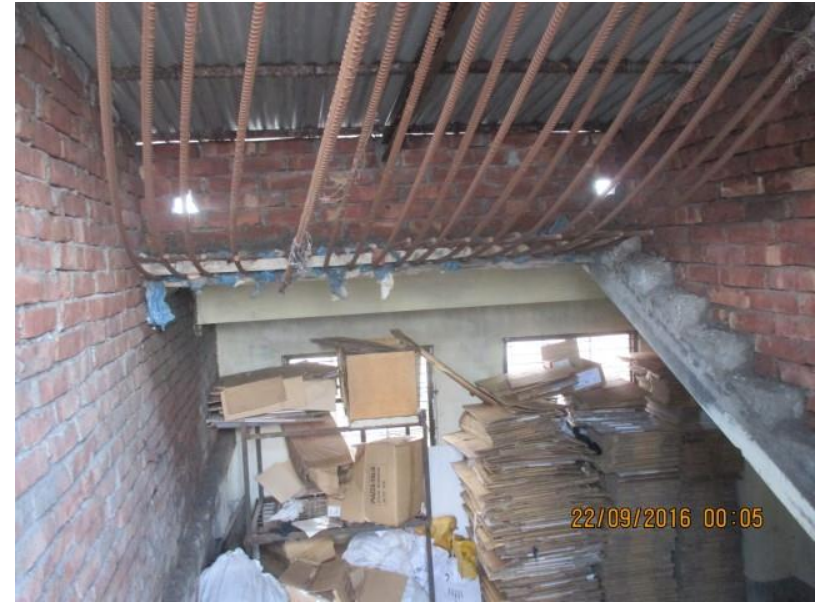
# **Excessive column stresses in fully completed building (6 storeys)**

Exposed reinforcement on roof top and building permission for 6 storey indicate a sign of further extension of the building. For any future extension it may cause a significant increase in column stresses which would be required to be carried out Detail Engineering assessment.

| Item No. | Observation | Recommended Action Plan | Recommended Timeline |
|---|---|---|---|
| 4 | Excessive column stresses in fully completed building (6 storeys) | Any extensions or modifications of the existing building needs to be carryout Details Engineering assessment by a Structural Engineer and in full compliance with the BNBC provision. | 6-months |

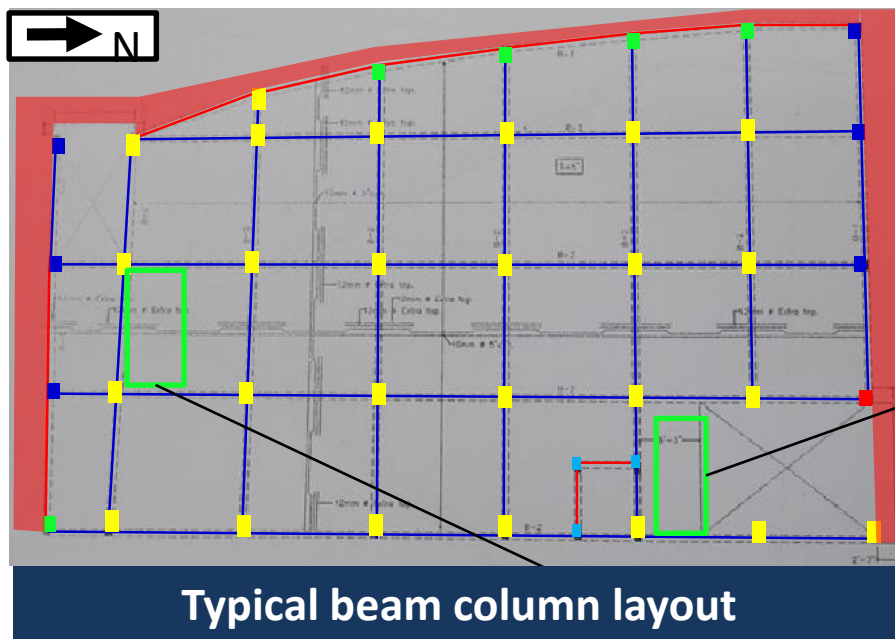
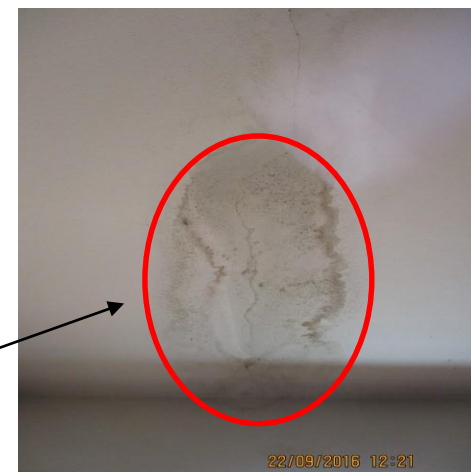
## Cracks on 3<sup>rd</sup> floor Slab

Cracks under the slab  
beside north side  
stair case

| Item No. | Observation | Recommended Action Plan | Recommended Timeline |
|---|---|---|---|
| 5 | Cracks on 3rd floor slab | Building engineer to check the crack and analyze the slab capacity considering the crack. | 6-weeks |
| 6 | Cracks on 3rd floor slab | Carry out remedial works resulting from engineering assessment . | 6-months |

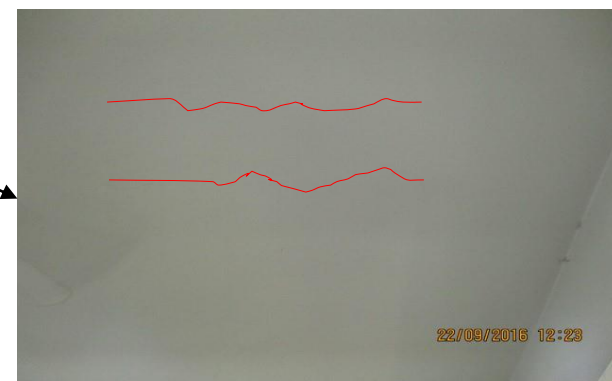
Cracks on slab below the  
water tank

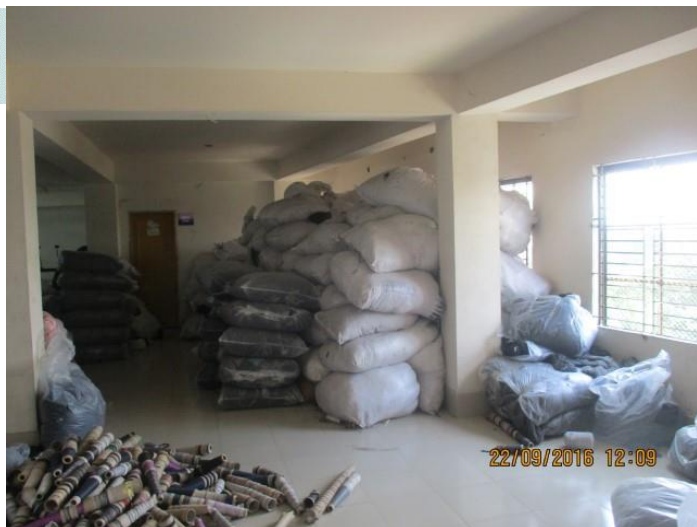
Over loaded area on 4<sup>th</sup> floor

| Item No. | Observation | Recommended Action Plan | Recommended Timeline |
|---|---|---|---|
| 7 | Overloaded storage areas | The quantity of the stored materials must be reduced up to 2KPa. | 6-weeks |
| 8 | Overloaded storage areas | Building Engineer to prepare a Load Plan for each level | 6-weeks |
| 9 | Overloaded storage areas | Reduce loading to the recommendations of the loading plans | 6-months |

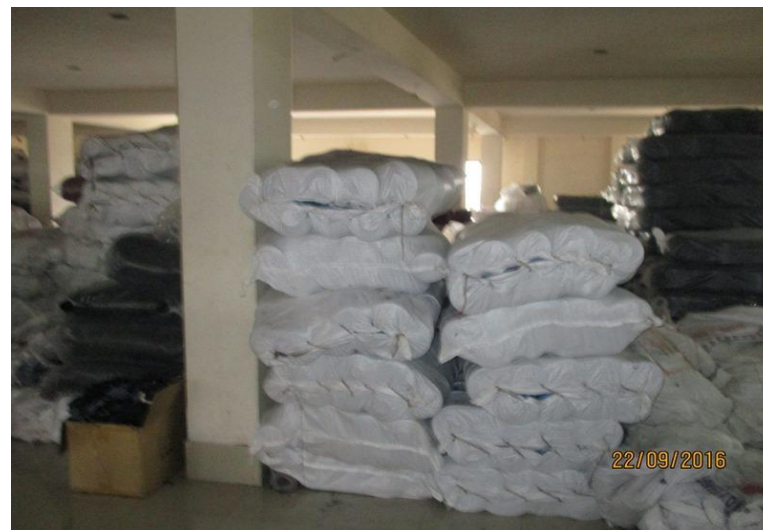
Over loaded area on 2<sup>nd</sup> floor

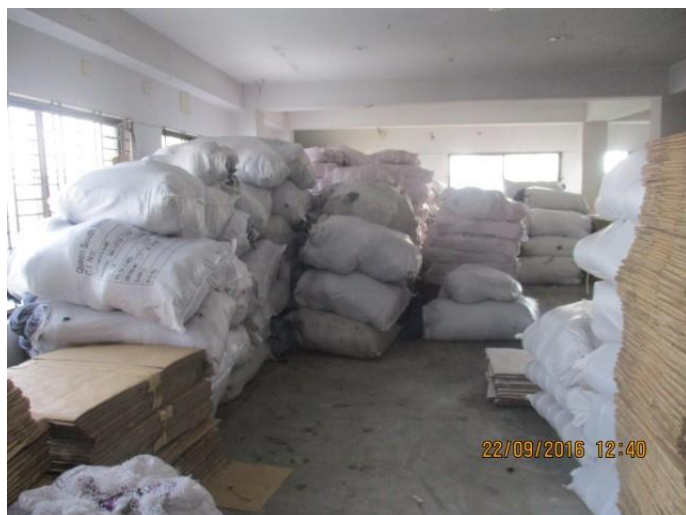
Over loaded area on 2<sup>nd</sup> floor

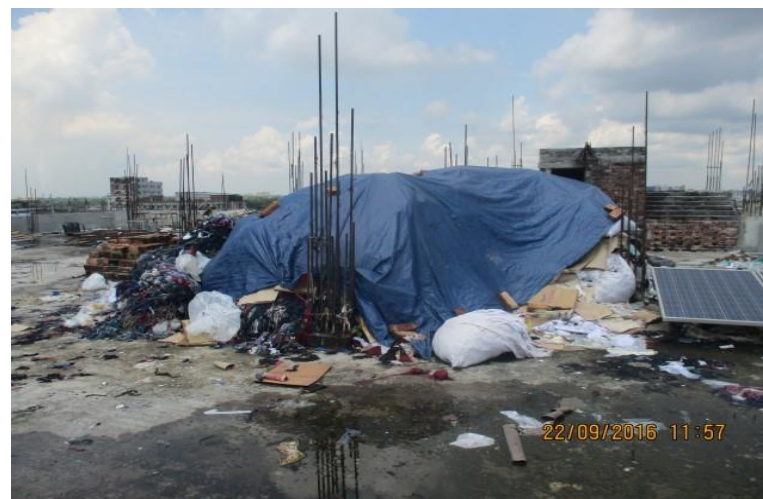
Over loaded area on roof top

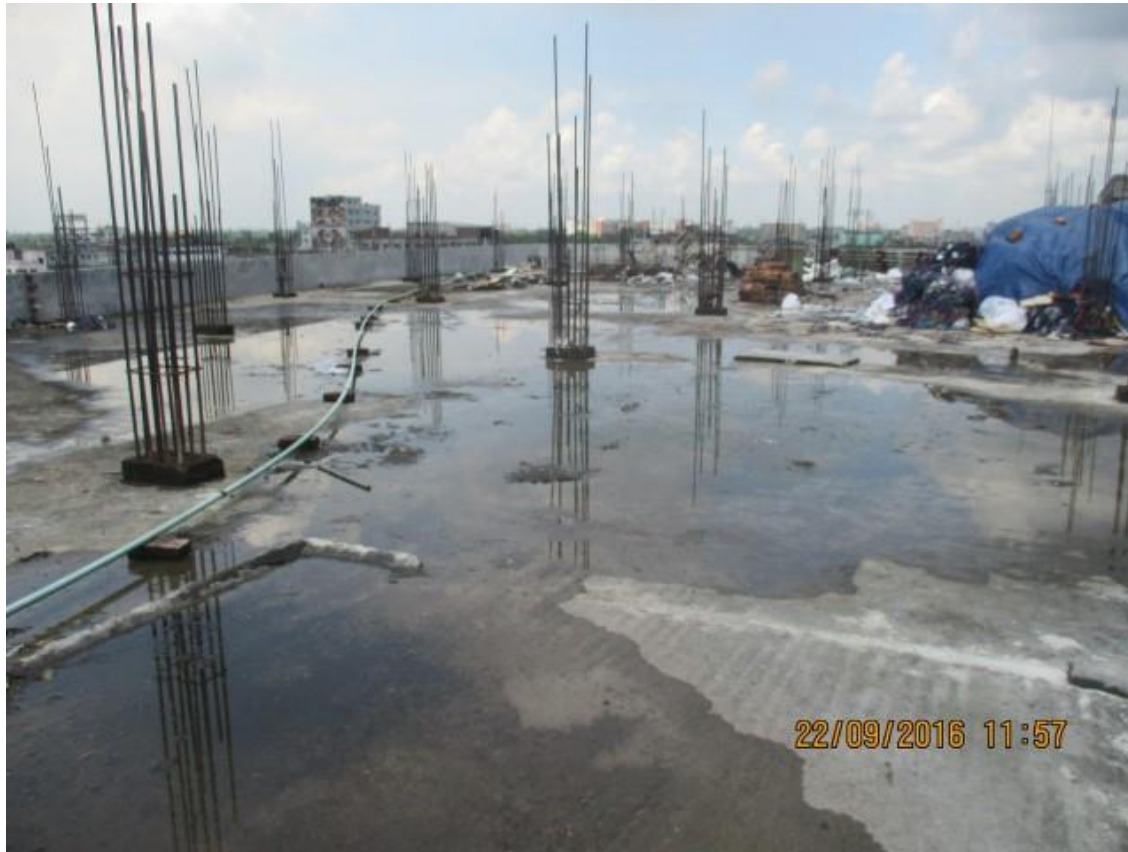
# Water ponding on roof slab

Water ponding was found in almost all over the roof area

| Item No. | Observation | Recommended Action Plan | Recommended Timeline |
|---|---|---|---|
| 10 | Water ponding on roof slab | Provide proper drainage and water proofing layer with appropriate water proofing materials | 6-weeks |

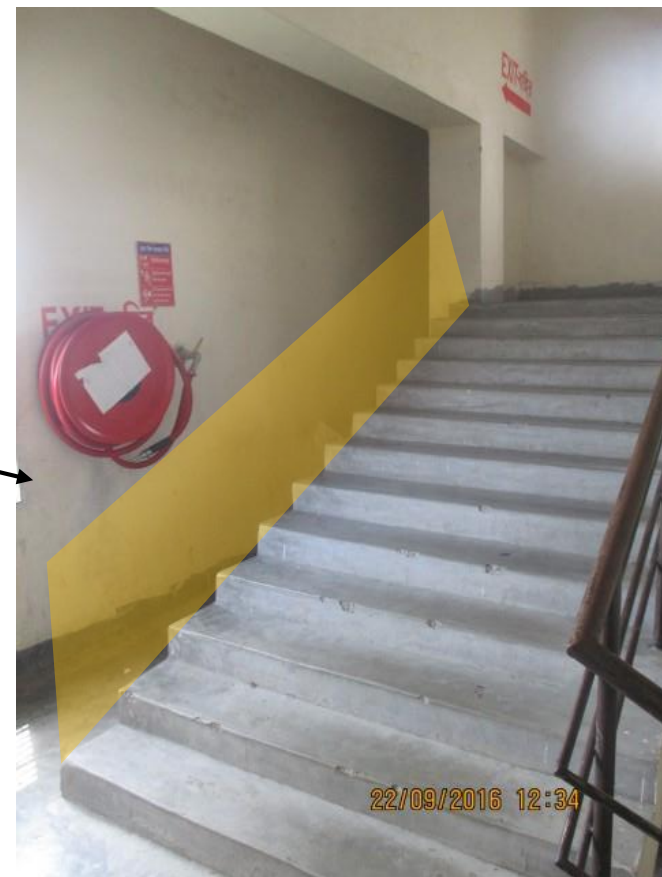
# Lack of edge protection of Stair Case

No edge protection was found on south side stair case

| Item No. | Observation | Recommended Action Plan | Recommended Timeline |
|---|---|---|---|
| 11 | Lack of edge protection at roof level | Provide edge protection as per suggestion of building engineer | 6-weeks |

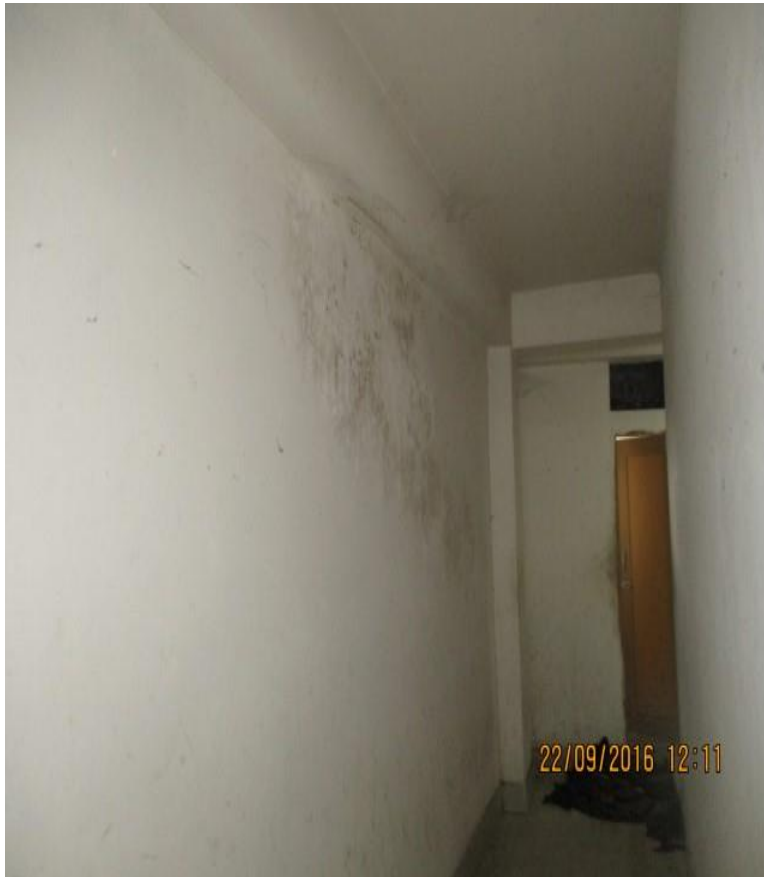
Side wall of south side stair case

# Dampness and water ingress through slab and walls

| Item No. | Observation | Recommended Action Plan | Recommended Timeline |
|---|---|---|---|
| 12 | Dampness and water ingress through slab and walls | Factory Engineer to inspect water damaged structures and repair with a suitable methods. | 6-months |

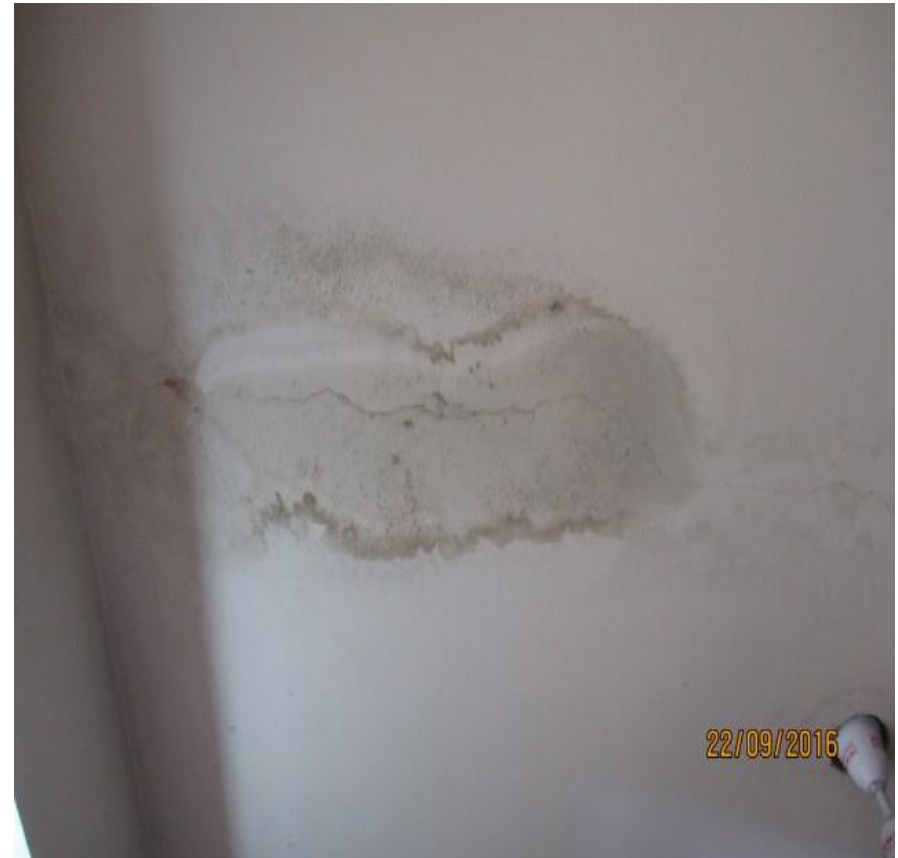
Water ingress through the crack of slab  
beside the north side stair case on 4<sup>th</sup>  
floor.
