# **FIRE SAFETY INSPECTION REPORT**

**HYDROXIDE KNITWEAR LTD.**

**ACCORD**  
on Fire and Building Safety in Bangladesh

March 12, 2014

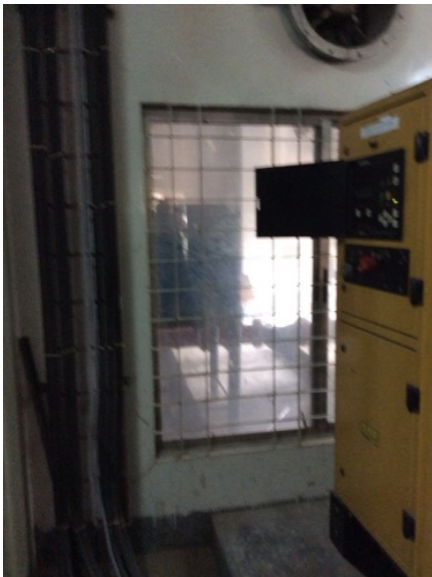
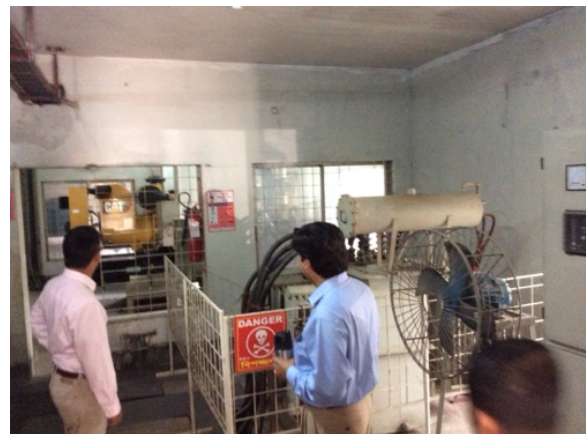
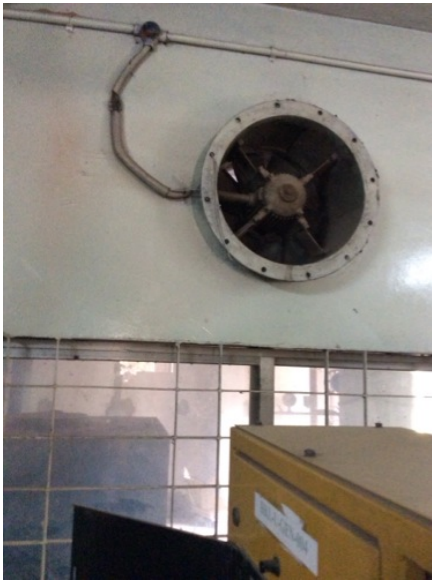
| No. | Category | Finding | Recommendation | Remediation Timeframe |
|---|---|---|---|---|
| F-2 | Fire Rated Construction | The generator room is not separated by fire-rated construction due to openings and penetrations. The room also contains transformers. | Separate the generator room by a minimum 2-hr fire-rated construction. Seal and/or protected all openings to maintain the required fire separations | Within 3 months |

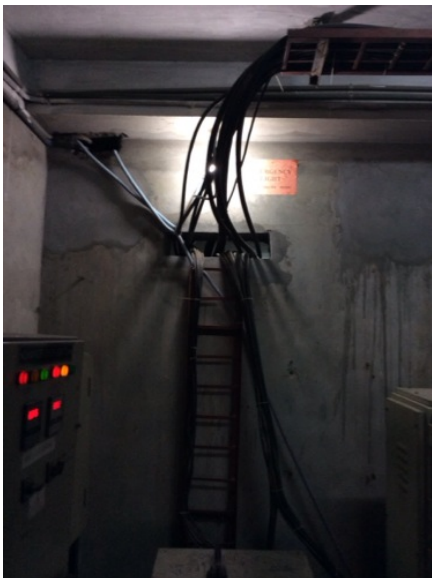
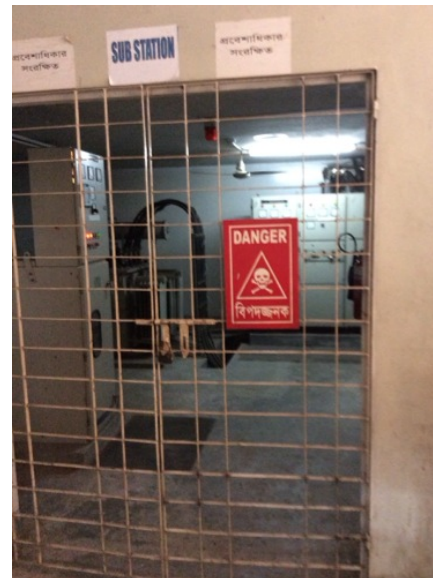
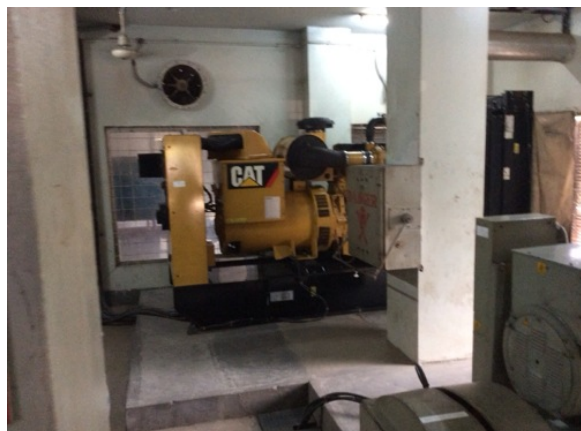
| F-3 | Fire Rated Construction | The transformer room is not separated by fire-rated construction openings and penetrations. The room also contains generators. | Separate the transformer room by a minimum 2-hr fire-rated construction. Seal and/or protected all openings to maintain the required fire separations | Within 3 months |

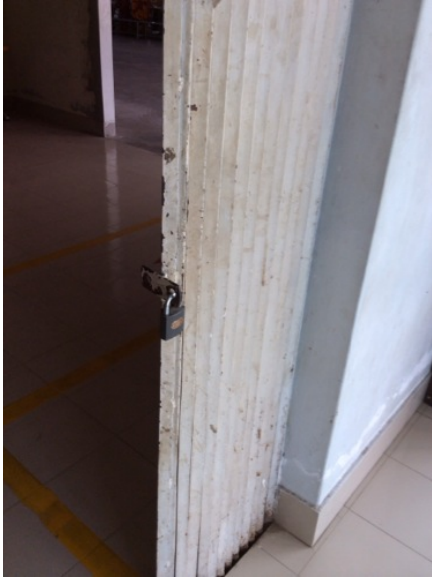
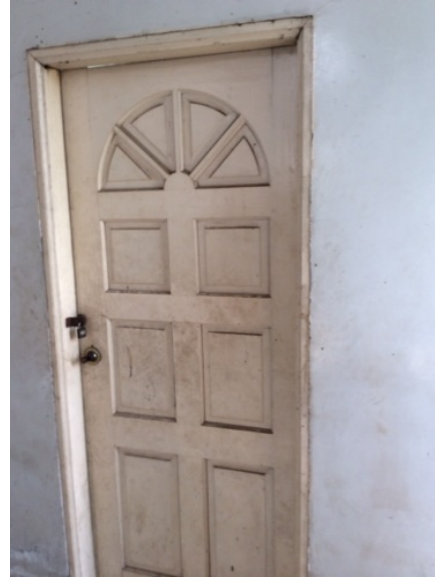
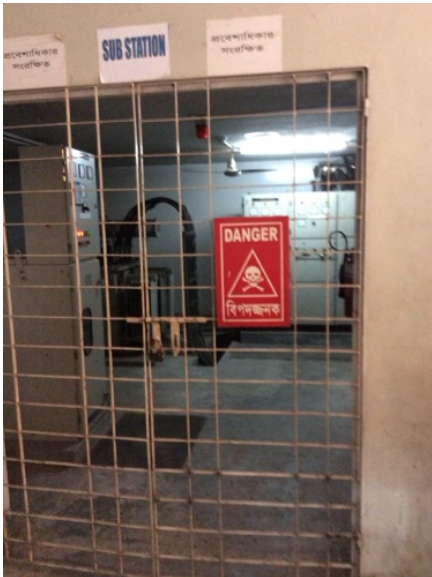
| F-5 | Egress | Egress doors and gates with locking features are provided at building exits, exit stairs, and along egress routes. | <p>Remove locking features from all egress doors and gates.</p> <p>If locks are required for security reasons, utilize special door locking features complying with NFPA 101.</p> | Immediate |

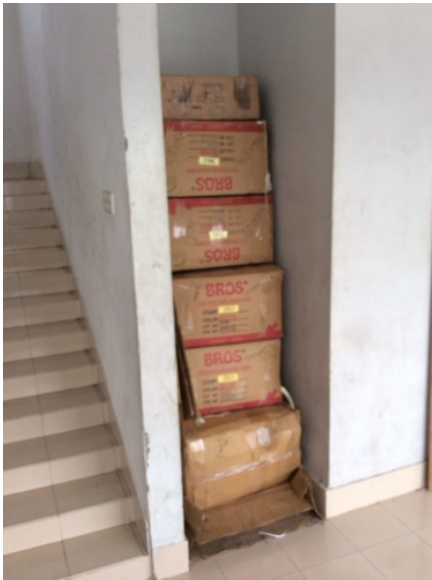
| F-6 | Egress | Storage was located in the northeast exit stair. | Remove all storage from exit stairs and egress paths. | Immediate |

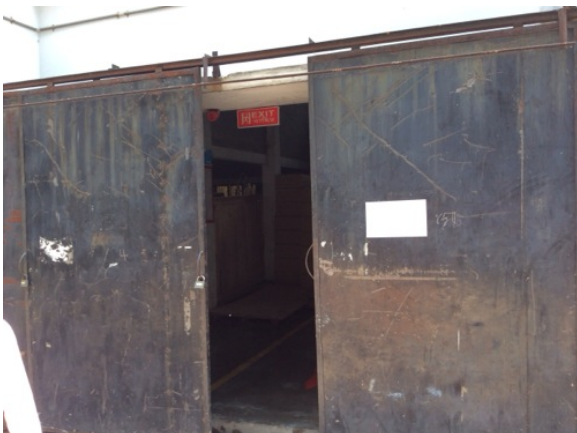
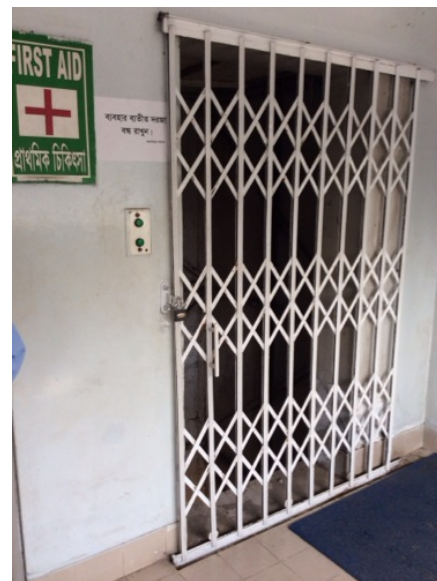
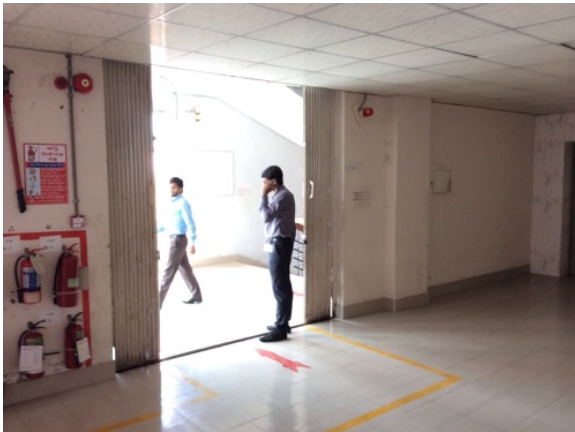
| F-7 | Egress | Collapsible gates are provided at building exits and exit stairs. | Replace all gates along the means of egress with side-hinged, swinging egress doors. | Within 1 month |

| | | | If locks are required for security reasons, utilize special door locking features complying with NFPA 101. | |
