FIRE SAFETY INSPECTION REPORT

**IRIS FABRICS LIMITED
ZIRANI BAZAR, KASHIMPUR, GAZIPUR**

ACCORD
on Fire and Building Safety in Bangladesh

July 1, 2014

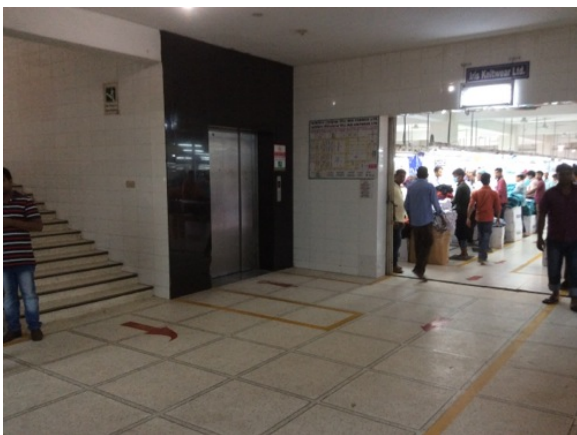
No.	Category	Finding	Recommendation	Remediation Timeframe
F-1	Fire Rated Construction	The exit stairs are not separated from work areas, and other spaces on each floor by fire-rated construction. This was reflected throughout the building on all floors.	<p>Provide minimum 1.5-hr fire rated doors and seal all unprotected openings to separate the exit stairs from work areas and other building spaces on all floor levels. Ensure that the fire doors are self-closing and positive latching and that they are provided with fire exit (panic) hardware where serving production floors.</p> <p>If fire doors are required to be held open for functional reasons, provide automatic-closing devices tied to the fire alarm system.</p>	Within 3 months

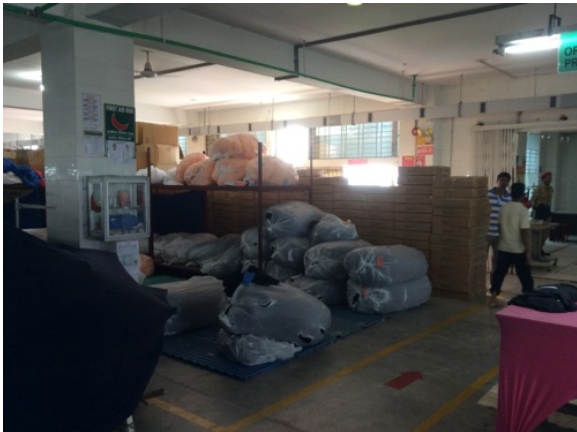
F-2	Fire Rated Construction	Areas used for combustible storage are not separated by fire-rated construction. This was reflected throughout the building on the first, third, fourth, sixth, and seventh floors.	Provide dedicated storage rooms separated by minimum 1-hr fire-rated construction. Where separate storage rooms are not feasible, provide defined storage areas and limit the storage arrangement as follows: - Maximum height of 2.4m and maximum area of 23m ² - If sprinkler protected: maximum height of 3.66m and maximum area of 93m ² Separate areas of unenclosed combustible storage by a minimum clear distance of 3m.	Within 3 months
-----	-------------------------	---	--	-----------------

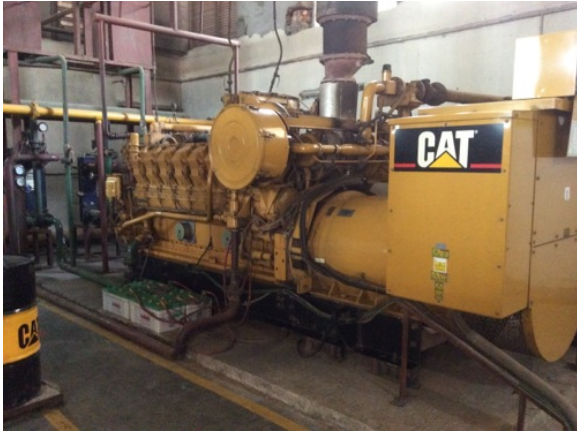
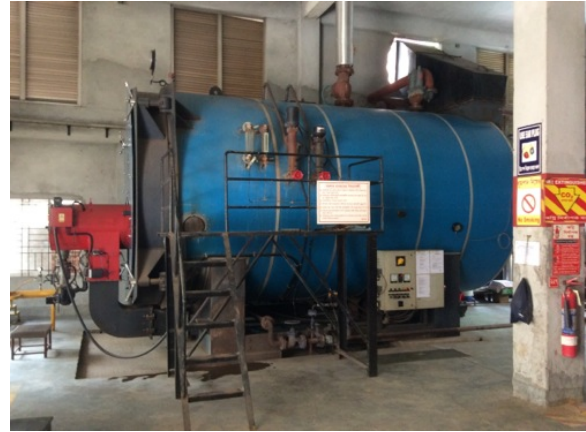
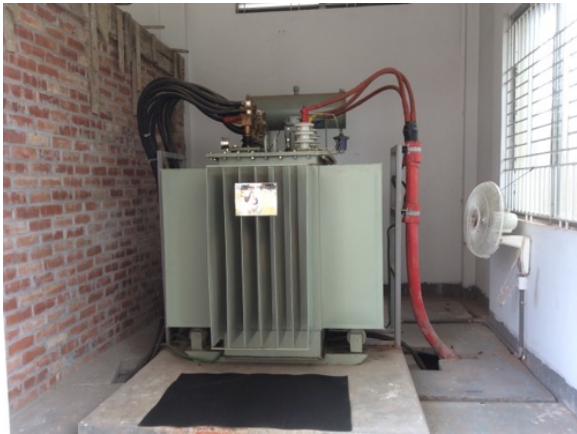
F-3	Fire Rated Construction	The boiler, generator, and transformer room located in a separate building 03, is not separated by fire-rated construction, openings, non-rated doors, and penetrations.	Separate the boiler, generator, and transformer room by a minimum 2-hr fire-rated construction. Seal and/or protected all openings to maintain the required fire separations	Within 3 months
-----	-------------------------	--	--	-----------------

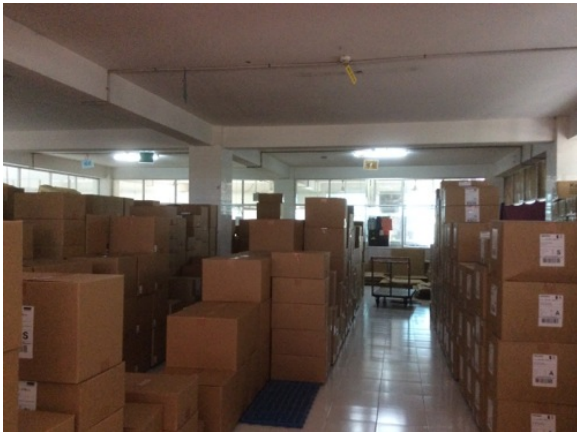
F-4	Fire Rated Construction	Storage rooms used for combustible storage are not separated by fire-rated construction. This was reflected throughout the building on the first, third, fourth, sixth, and seventh floors.	Provide dedicated storage rooms separated by minimum 1-hr fire-rated construction.	Within 3 months
-----	-------------------------	---	--	-----------------

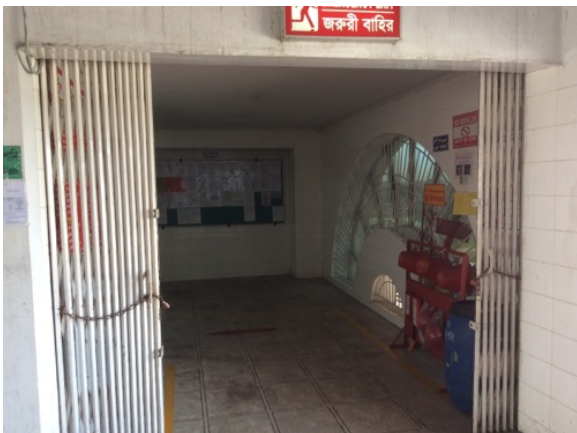
F-5	Egress	Egress doors / gates with locking features are provided at building exits, exit stairs, along egress routes, and exit discharge. This was reflected throughout the building on all floors.	Remove locking features from all egress doors / gates. If locks are required for security reasons, utilize special door locking features complying with NFPA 101.	Immediate
-----	--------	--	--	-----------

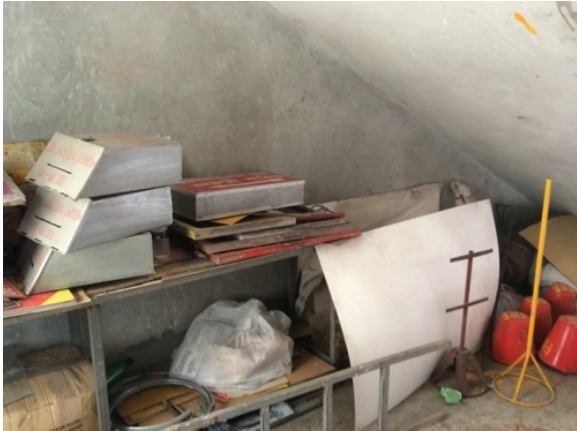
F-6	Egress	Storage areas were located in all exit stairwells on the ground floor, underneath the stairs.	Remove all storage from exit stairs and egress paths.	Immediate
-----	--------	---	---	-----------

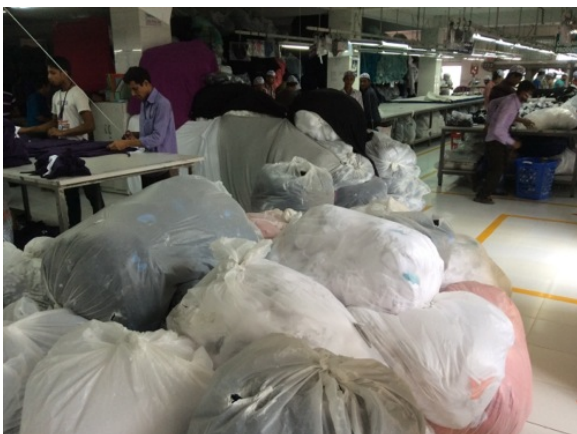
F-7	Egress	There was storage located in egress paths throughout the first through seventh floors.	Keep egress paths and stairs clear of storage.	Immediate
-----	--------	--	--	-----------

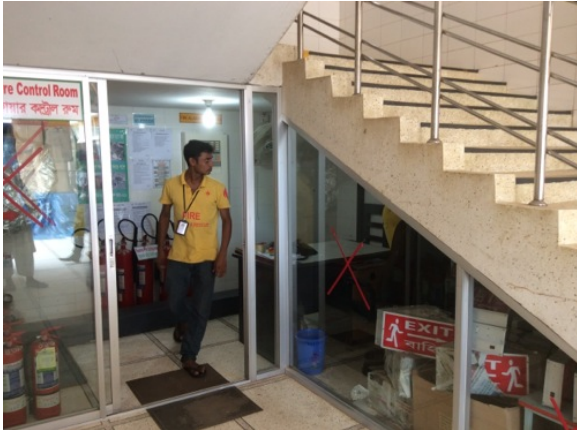
F-8	Egress	The fire command room is located underneath the west exit stairwell on ground floor.	Remove all storage / rooms from exit stairs and egress paths.	Immediate
-----	--------	--	---	-----------

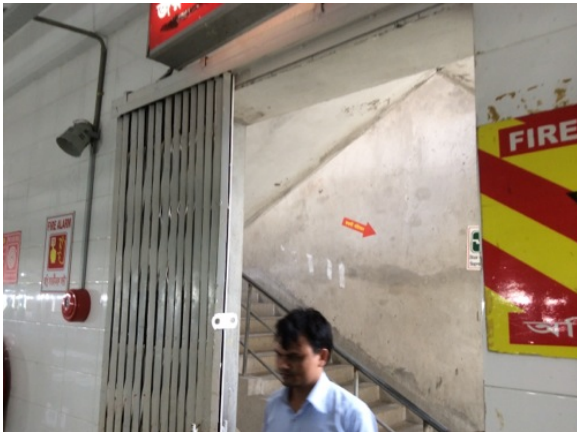
F-9	Egress	Collapsible gates / sliding doors are provided at building exits, exit stairs, along egress routes, and exit discharge. This was reflected throughout the building on all floors.	Replace all gates / sliding doors along the means of egress with side-hinged, swinging egress doors. If locks are required for security reasons, utilize special door locking features complying with NFPA 101.	Within 1 month
-----	--------	---	--	----------------

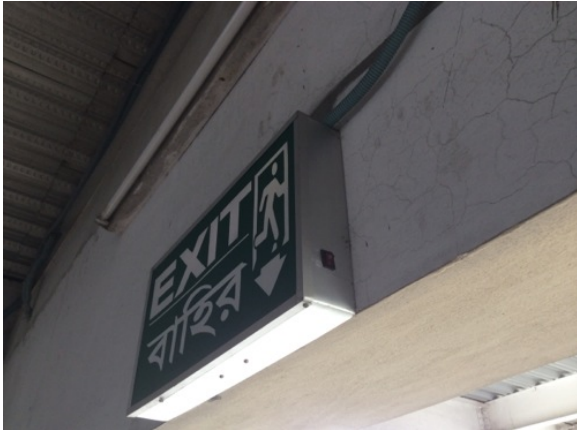
F-10	Fire Protection	The high-rise building has an occupied floor greater than 23m (75 ft) and is not provided with automatic sprinkler protection. The large occupant loads, heavy fuel loading, and anticipated extended egress times warrant sprinkler protection.	Provide automatic sprinkler protection throughout the building in accordance with NFPA 13.	Design within 6 months, install within 12 months
F-11	Fire Protection	Inspection, testing, and maintenance records for the fire alarm system was not in accordance with NFPA 72.	Inspect, test and maintain the fire alarm system, and keep written records on-site, in accordance with NFPA 72.	Within 3 months
F-12	Egress Lighting	Manual on-off switch is provided for emergency lighting units. This was reflected throughout the building in various locations.	Remove manual on/off switches from emergency lighting units to prevent them from being switched off.	Within 1 month

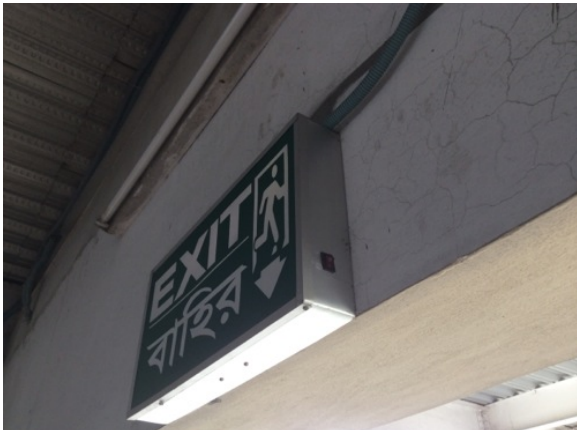
F-13	Egress Lighting	Exit signage not illuminated (burned out, broken, etc.). This was reflected throughout the building on various floors.	Regularly inspect all exit signage and replace/install lights as needed to illuminate signs.	Within 1 month
------	-----------------	--	--	----------------
