# MAAA APPARELS Ltd.

Plot # 1187, 1214-15, Gacha Maddhapara, Gazipur Sadar  
(23.936233, 90.376661)

30<sup>th</sup> August 2016

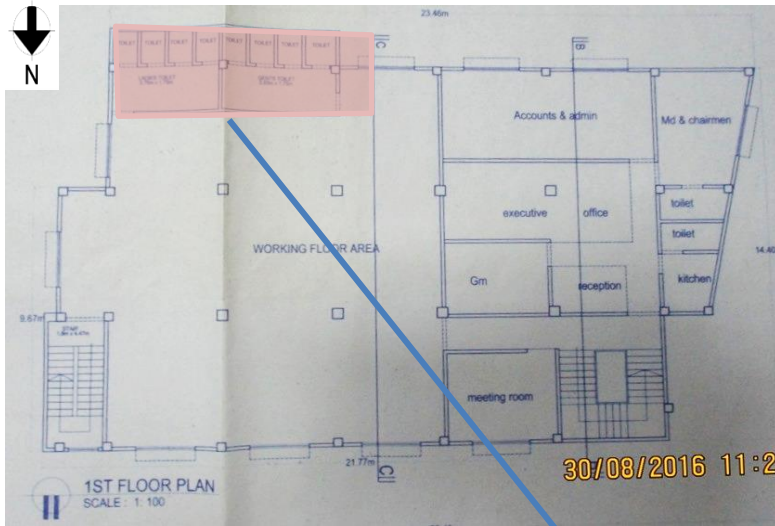
Cursory calculations indicate that the working stresses to the Ground Floor and First floor columns are at a high level. Building Engineer to review design, loads and columns stresses.

Column sizes in provided schedule are bigger than on-site condition.

Toilet partition wall and build-up observed at south-east cantilever .

Item No.	Observation	Recommended Action Plan	Recommended Timeline
1	High Stress Column	Limit Live Load to 2.0kN/m <sup>2</sup> on all floors immediately.	<b>Immediate - Now</b>
2	High Stress Column	Verify in-situ concrete strength and aggregate type by taken min. 4 nos. 100mm dia. core samples from columns.	<b>6-weeks</b>
3	High Stress Column	The Detailed Engineering Assessment to be completed.	<b>6-weeks</b>
4	High Stress Column	Produce and actively manage a loading plan for all floor plates within the factory, giving consideration to floor capacity and column capacity.	<b>6-weeks</b>
5	High Stress Column	Complete implementation of any remedial works deemed necessary by the DEA.	<b>6-months</b>
6	High Stress Column	Continue to implement loading plan.	<b>6-months</b>
7	Discrepancies between Structural drawings and site observations	Building Engineer to survey as-built structure and prepare accurate as-built survey information, including all columns, beams and slabs as part of DEA.	<b>6-weeks</b>

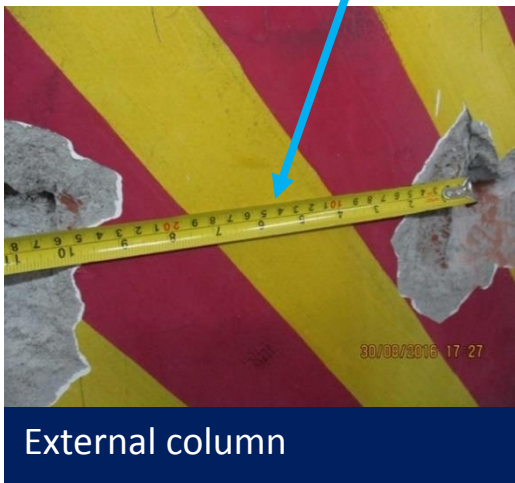
External column

External columns are measured 10x10 inch but in column schedule it is shown as 10x15 inch. Some brick columns are found which is marked as red colour on column layout plan.

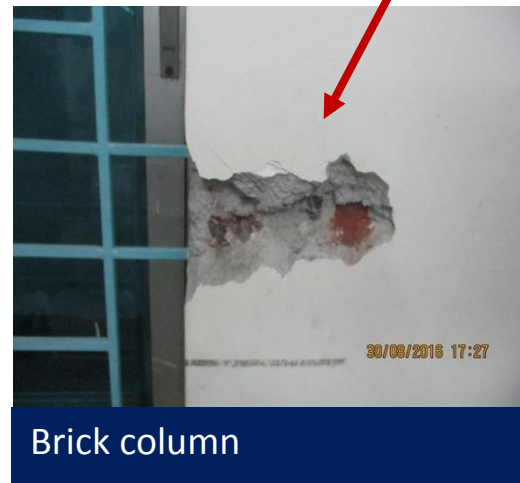
Brick column

This column is not shown in column schedule. On site measurement the column size was 10x10 inch and 4 nos. of rebar observed by Ferro scanner.

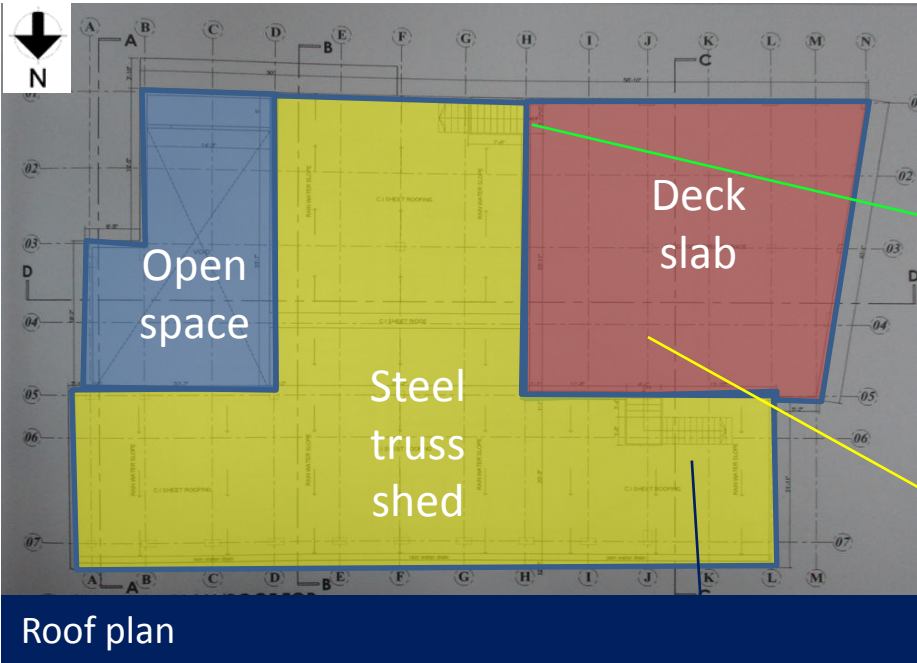
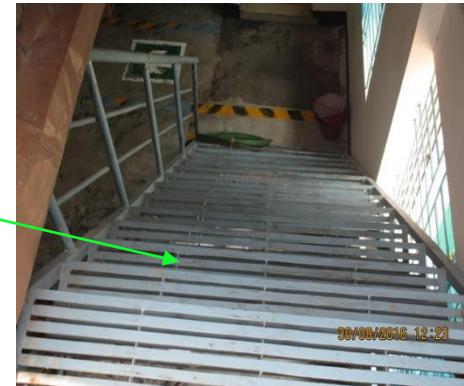
Steel stair at south poorly connected with I beam of deck slab

8	No structural drawings of roof shed, steel deck and steel stair were found	Building Engineer to survey as-built structure and prepare accurate as-built drawings as part of DEA.	<b>6-weeks</b>

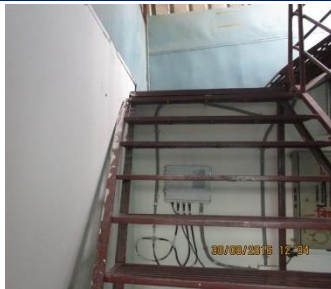
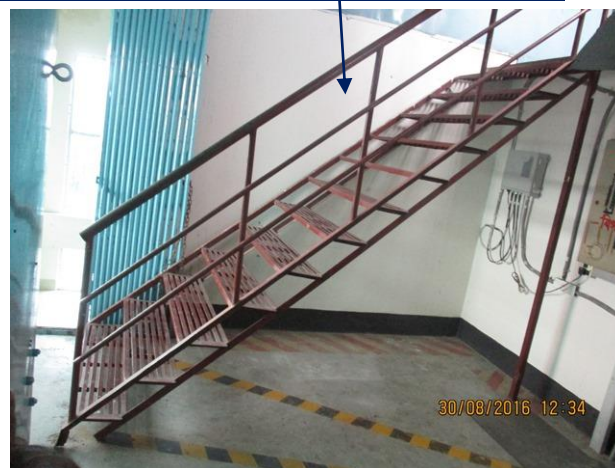
Steel stair poorly connected with partition wall and floor.

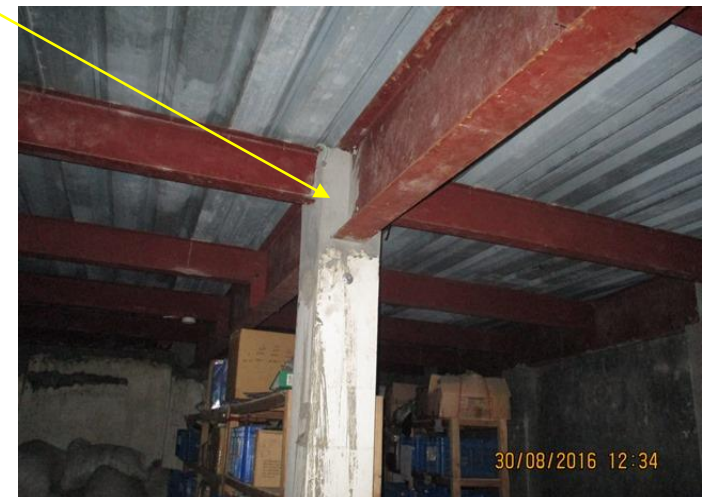
Connection with column is not clear. No details drawings was found for connection.

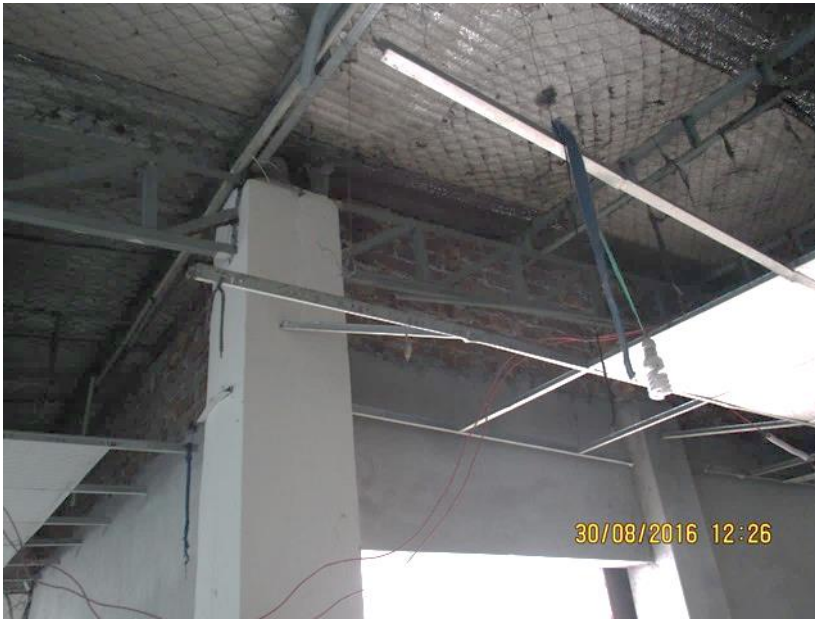
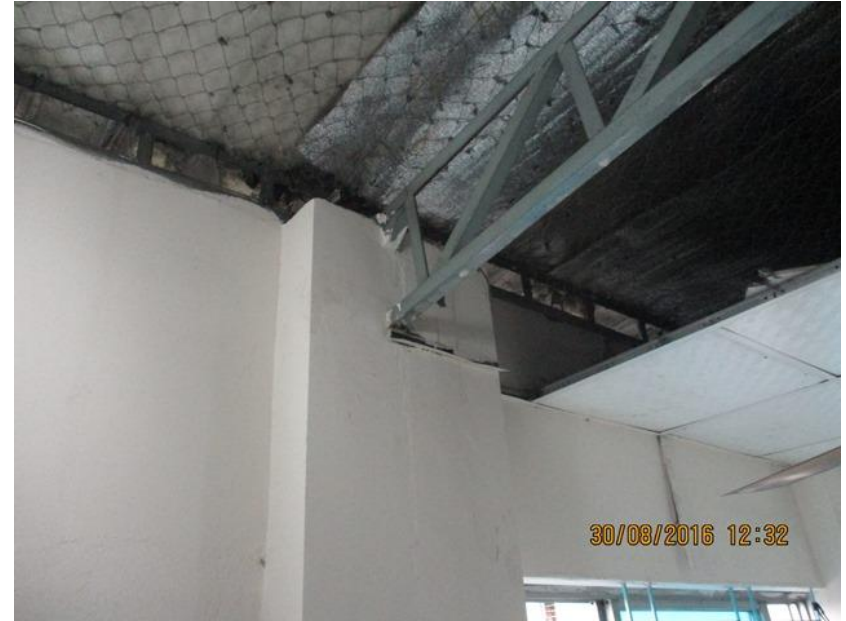
Apparently non engineered steel shed at roof. Steel truss rest on RC column. No drawing was found during inspection.

Item No.	Observation	Recommended Action Plan	Recommended Timeline
9	Apparently non-engineered roof shed and steel stair	A Detailed Engineering Assessment to be conducted in order to determine the adequacy of steel stair & rooftop truss arrangement.	6-weeks
10	Apparently non-engineered roof shed and steel stair	Engage a qualified structural engineer to confirm satisfactory structural performance of the steel shed under wind loading as part of DEA.	6-weeks
11	Apparently non-engineered roof shed and steel stair	Carry out any remedial measures recommended by above mentioned detailed engineering assessment	6-months
12	Discrepancies between Structural drawings and site observations	Building Engineer to survey as-built structure and prepare accurate as-built drawing including all columns, beams and slabs as part of engineering assessment.	6-weeks
13	Discrepancies between Structural drawings and site observations	Verify in-situ concrete strength and aggregate type by taken min. 4 nos. 100mm dia. core samples from columns.	6-weeks

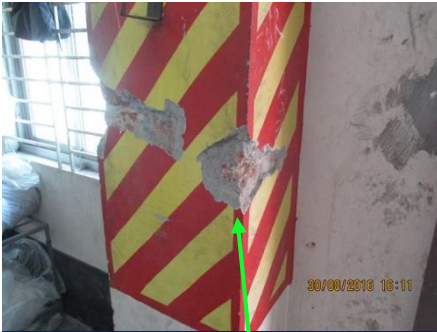
10x15 in size

Column sizes are not matched with column schedule. One external column was found 10x15 inch shown in purple. On site measurement black marked columns were found 10x10 inch which is not shown in column schedule.

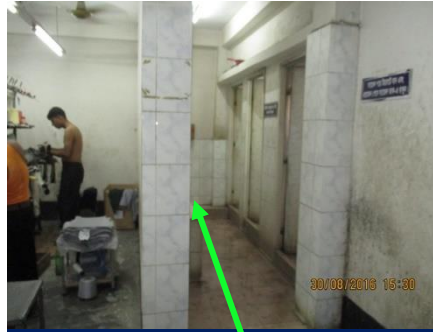
Brick column

One brick column was found at GF & 1<sup>st</sup> floor marked as red in column layout plan which does exist at upper floor.

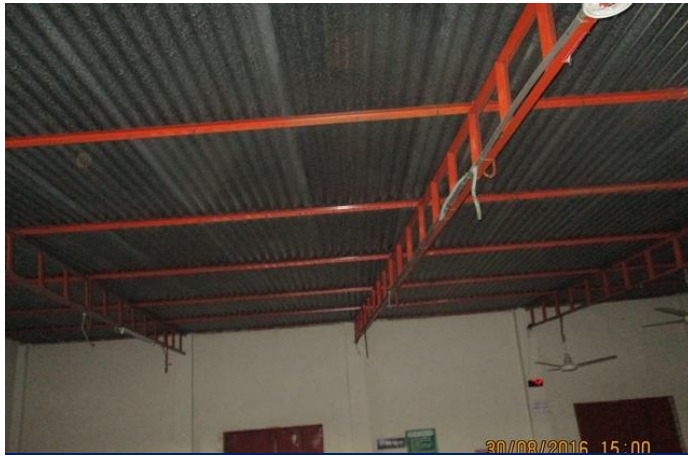
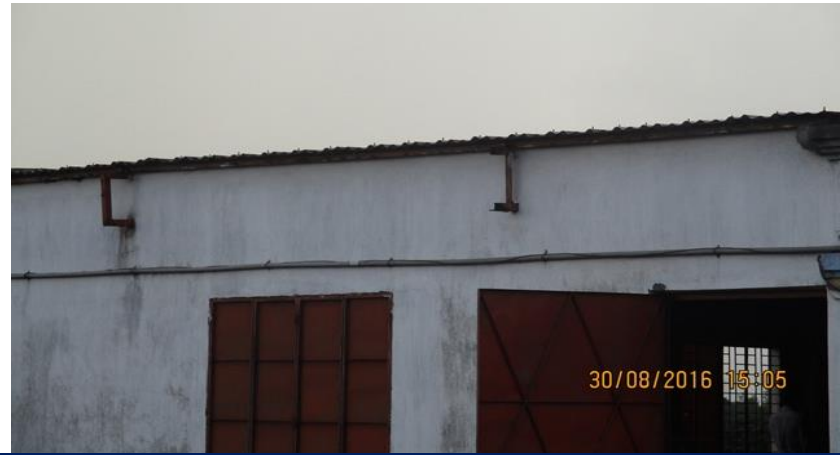
Steel truss are connected with brick column and periphery wall.

Item No.	Observation	Recommended Action Plan	Recommended Timeline
17	Apparently non-engineered steel roof and steel stair	Engage a qualified structural engineer to confirm satisfactory structural performance of the steel shed under wind loading.	6-weeks
18	Apparently non-engineered steel roof and steel stair	Carry out any remedial measures recommended in assessment report.	6-months
19	No drawings was found for both sheds	Building Engineer to survey as-built structure and prepare accurate as-built drawings.	6-weeks
20	Stability of sheds against lateral load	Engage a qualified structural engineer to confirm satisfactory structural performance of the buildings under wind loading.	6-weeks
21	Stability of sheds against lateral load	Carry out any remedial measures recommended in assessment report.	6-months

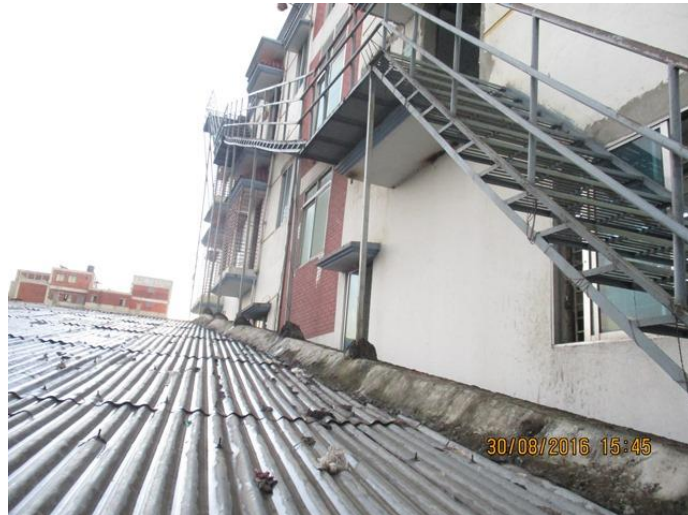
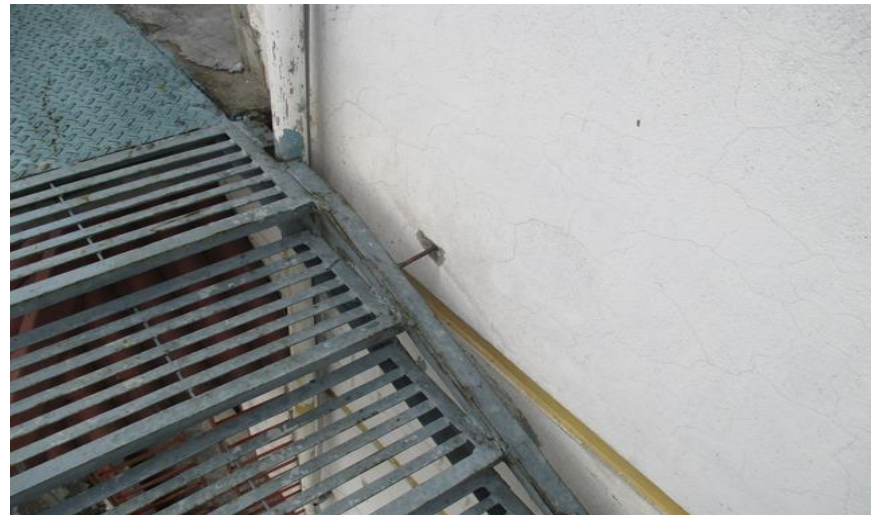
Apparently non-engineered steel stair poorly connected with north façade

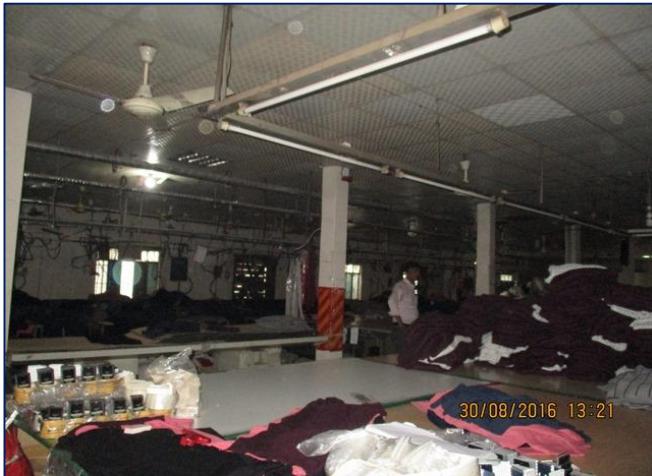
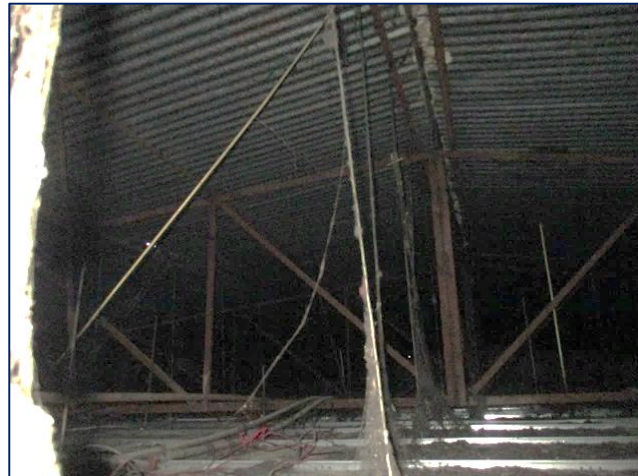
Shed-1

Drawings were not found during inspection. Factory engineer required to be prepared the as-built drawings.

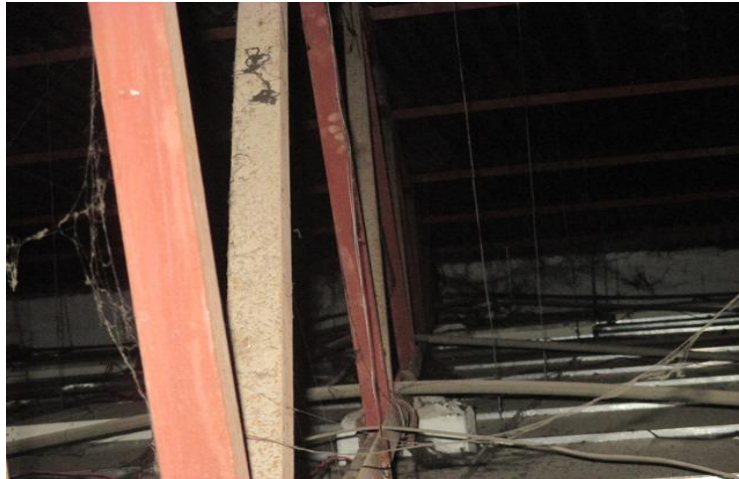
Shed-1

Steel truss are poorly connected with column. No roof bracing was observed in both shed. Factory engineer required to check the connection and overall stability of both sheds.

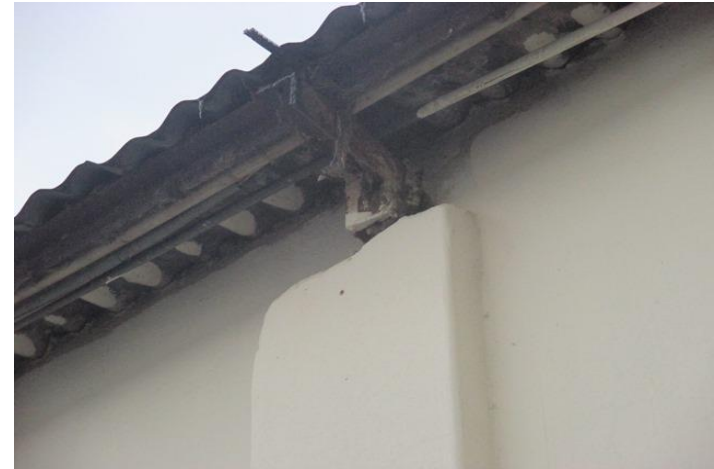
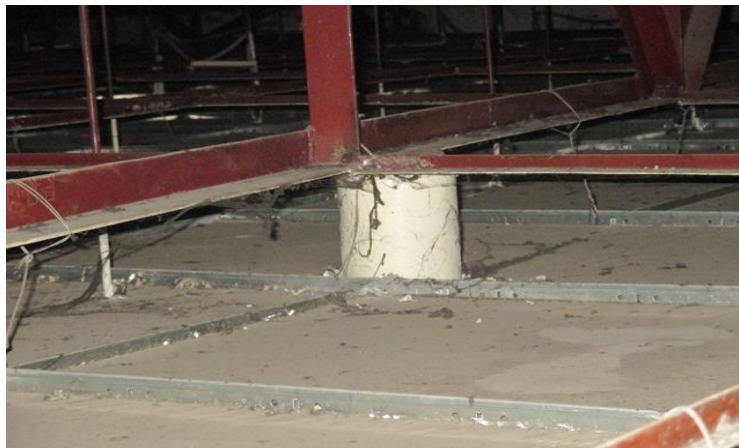
Steel pipe to truss connection for shed-2
