# APPAREL PROMOTERS LTD.

Nasirabad, Rubi gate, Baizid Bostami Road, Chittagong, Bangladesh  
(22.377522N, 91.815487E)

02<sup>nd</sup> Oct 2016

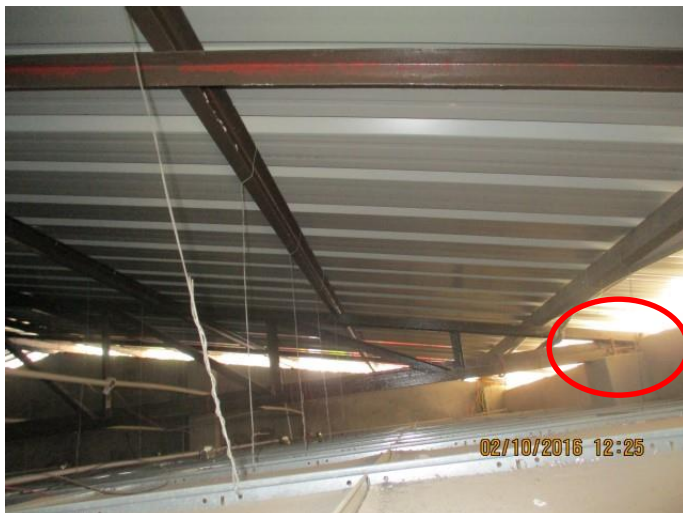
**Weak connection between column & truss**

**Lack of lateral stability due to poor connection detail and lack of bracing. The sheds are required to analysis of their stability system.**

| Item No. | Observation | Recommended Action Plan | Recommended Timeline |
|---|---|---|---|
| 1 | Lack of lateral stability of single storey steel sheds | Building engineer to check the lateral stability of single storey steel sheds. | 6-weeks |
| 2 | Lack of lateral stability of single storey steel sheds | Carry out remedial works resulting from Engineering Assessment. | 6-months |

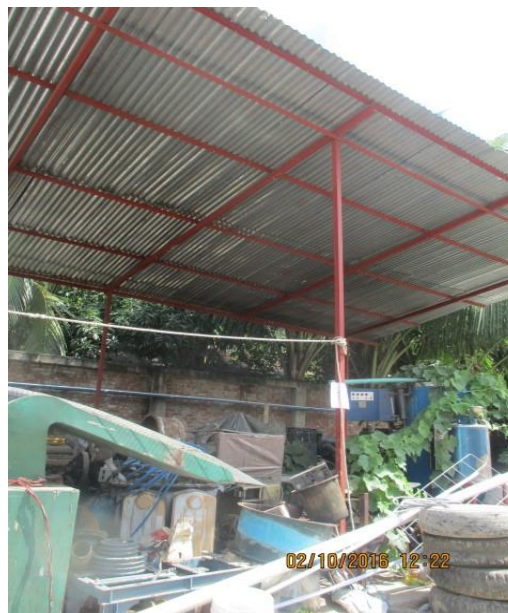
**Poor construction**

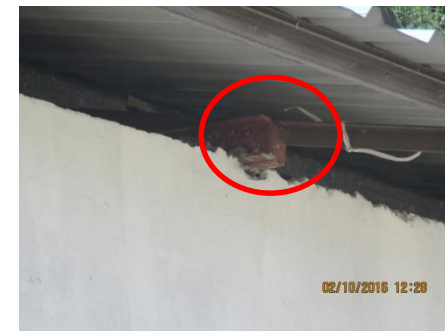
**Weak support of truss**

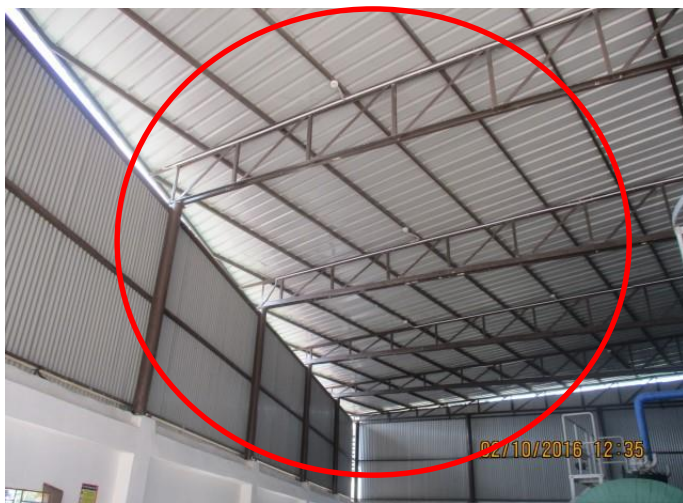
**No bracing observed**

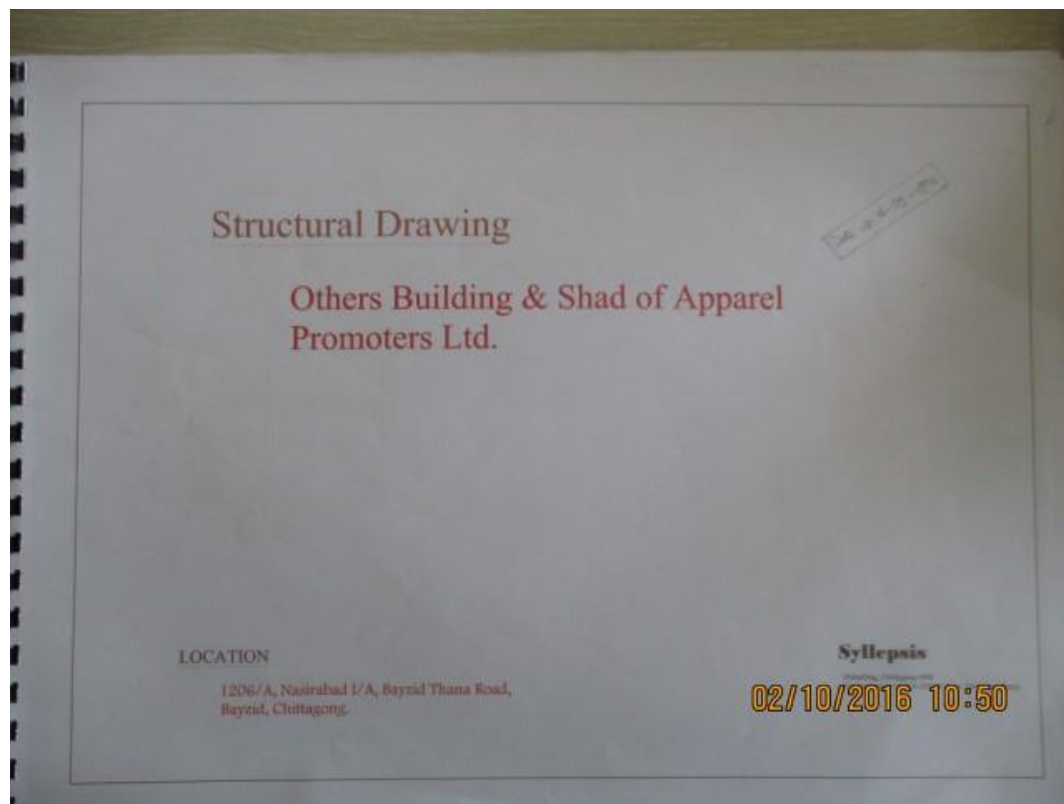
**Factory provided only structural drawing of the single storey building & shed though the drawing was incomplete . Also no architectural drawing was available.**

| Item No. | Observation | Recommended Action Plan | Recommended Timeline |
|---|---|---|---|
| 3 | Lack of as-built documents of all Single storey buildings and sheds | Building engineer to produce as built drawing for the Single storey buildings and Sheds. | 6-weeks |

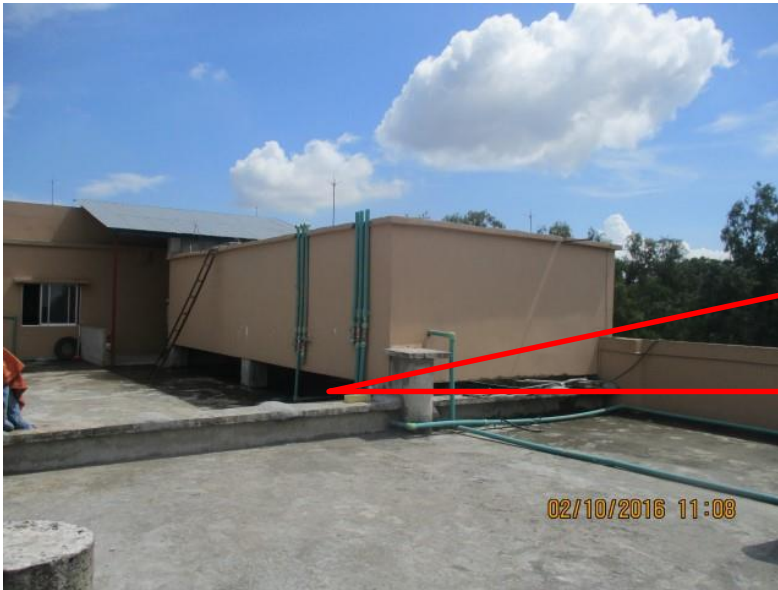
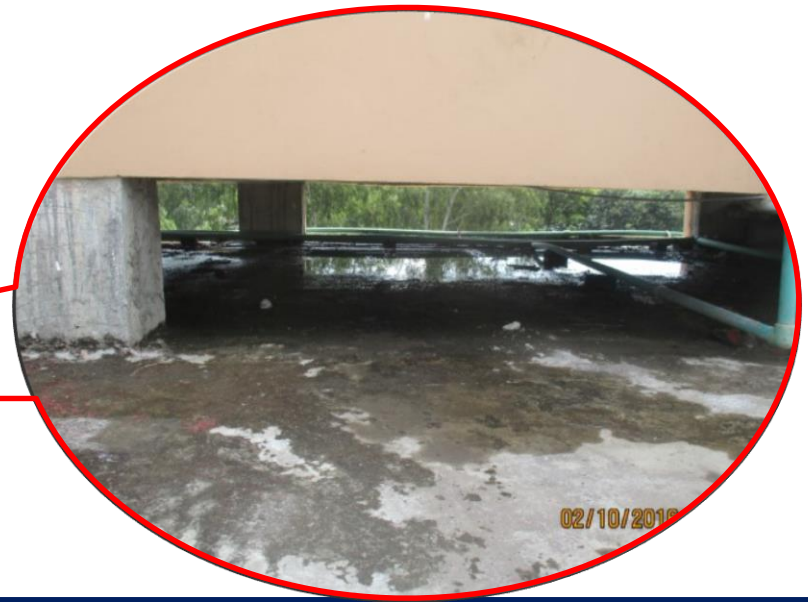
**Water ponding observed under water tank on Main building roof top.**

| Item No. | Observation | Recommended Action Plan | Recommended Timeline |
|---|---|---|---|
| 4 | Water ponding on roof level of Main building & Building-2 | Provide proper drainage and water proofing layer with appropriate water proofing materials. | 6-weeks |

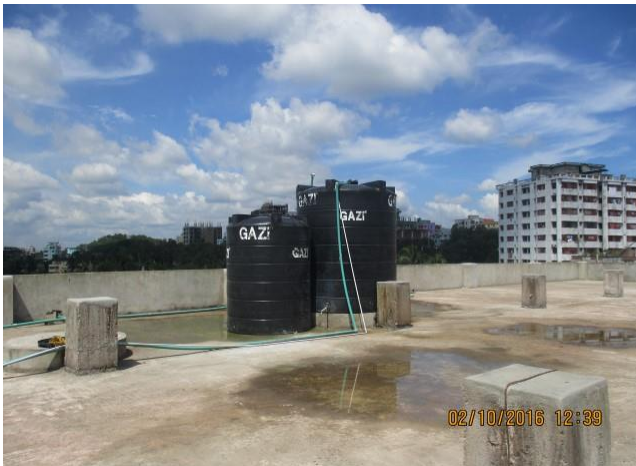
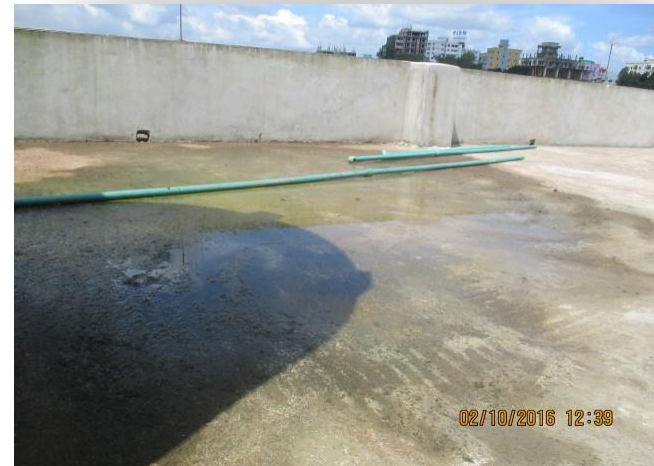
**Water ponding also observed on roof top of Building-2 .**

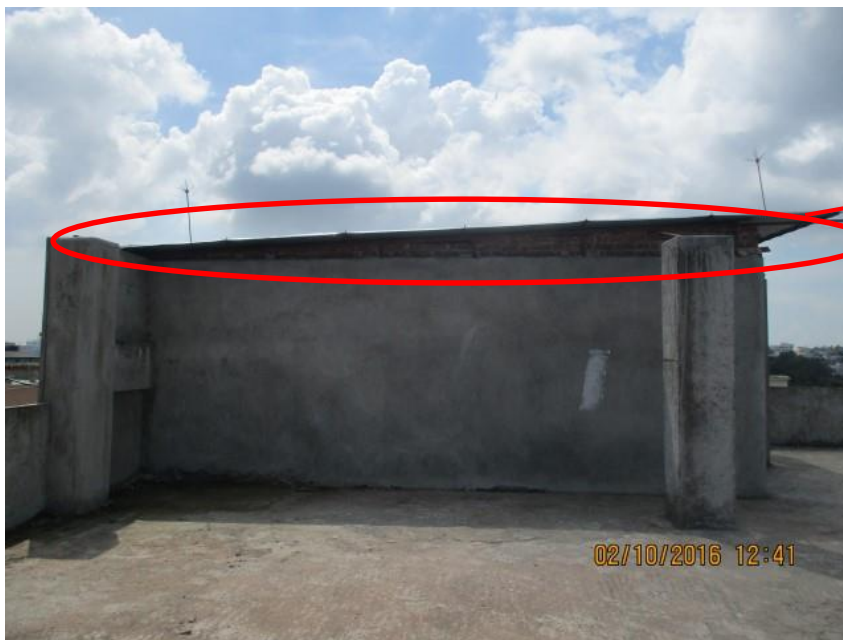
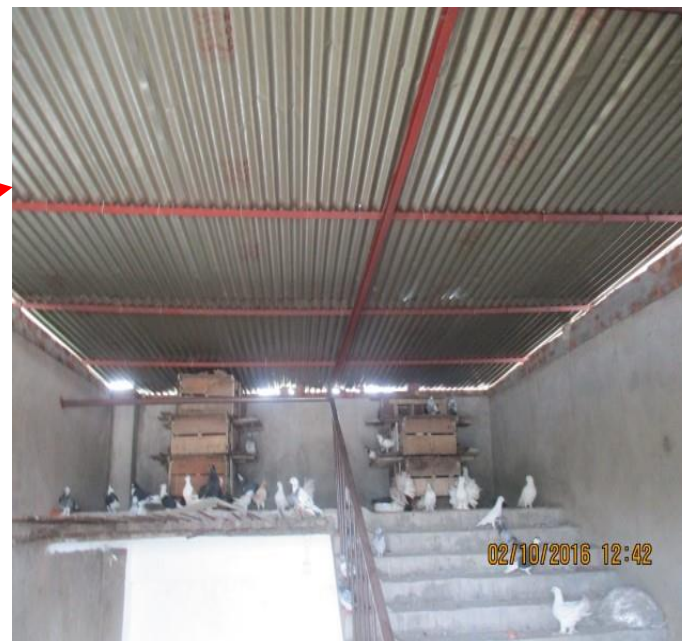
**Apparently non engineered steel shed on stair case. The support connection is not cleared.**

| Item No. | Observation | Recommended Action Plan | Recommended Timeline |
|---|---|---|---|
| 5 | Non engineered steel shed on roof top of Building -2 | Building engineer to check the lateral stability of single storey steel sheds. | 6-weeks |
| 6 | Non engineered steel shed on roof top of Building -2 | Carry out remedial works resulting from Engineering Assessment. | 6-months |
