# Pandora Sweaters Ltd.

Gilar Chala, Master Bari, Shreepur, Gazipur.  
(24.187444, 90.424696)  
19<sup>th</sup> April 2014

# Observations

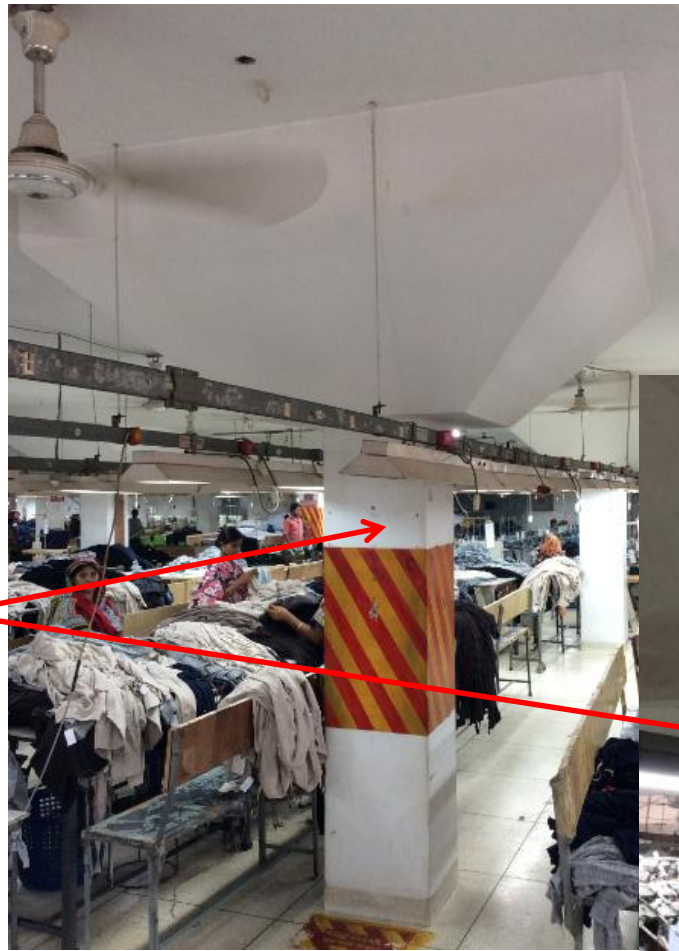
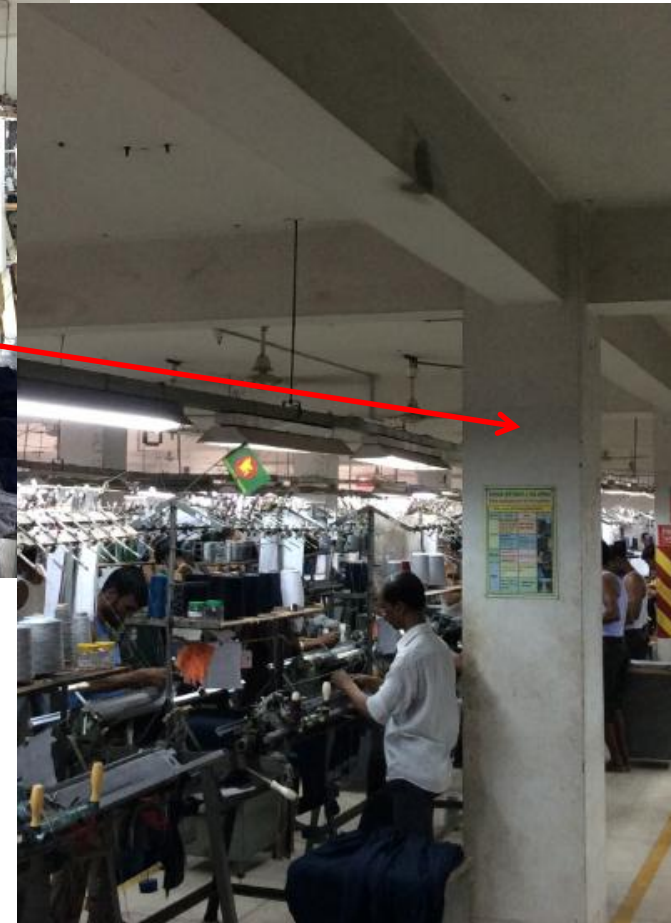
# High stress in columns in the two main production buildings

Cursory calculations indicate that internal and external column's working stress is at a high level in the two main production RC buildings.

High stress in columns

In-situ concrete strengths to be confirmed by Building Engineer.

Item No.	Observation	Recommended Action Plan	Recommended Timeline
1	High stress in columns in the two main production buildings.	Factory Engineer to review columns stresses at the ground floor in the 4-storey and 6-storey main production buildings.	6-weeks
2	High stress in columns in the two main production buildings.	Verify in-situ concrete strength either by cores or utilising existing cylinder strength data for the columns in the buildings.	6-weeks
3	High stress in columns in the two main production buildings.	Prepare Loading Management Plans for each floor showing allowable loadings in each area.	6-weeks
4	High stress in columns in the two main production buildings.	Continue to actively manage the loading plans for all floor plates within the factory giving consideration to floor capacity and column capacity.	6-months
5	Cracking in Beams in 6-Storey Building at 3rd Floor to be investigated by the Building Engineer.	Sections of plaster finish to beams on 3rd floor of 6 storey building to be removed to investigate if cracks are reflected in the building structure.	6-weeks

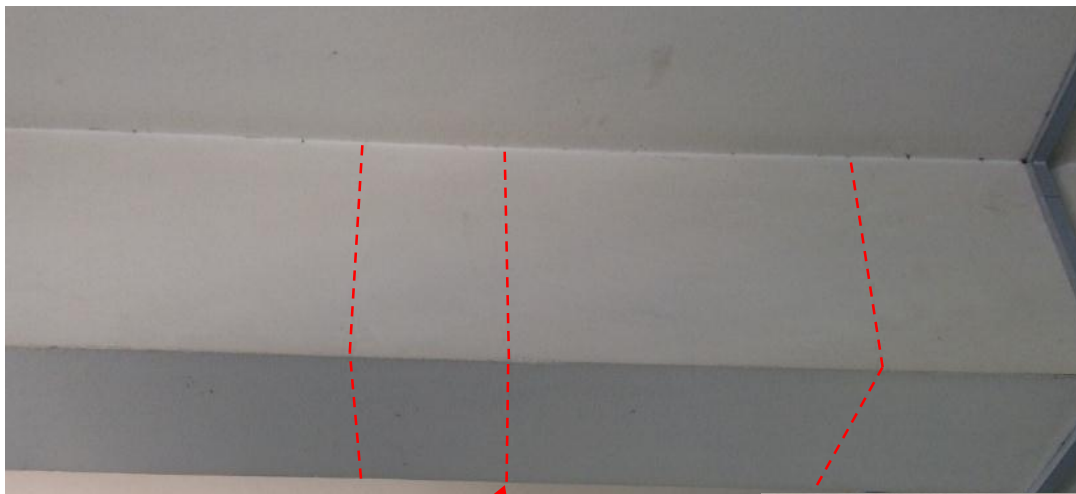
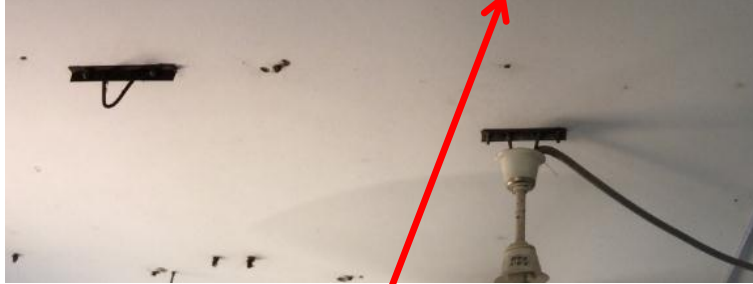
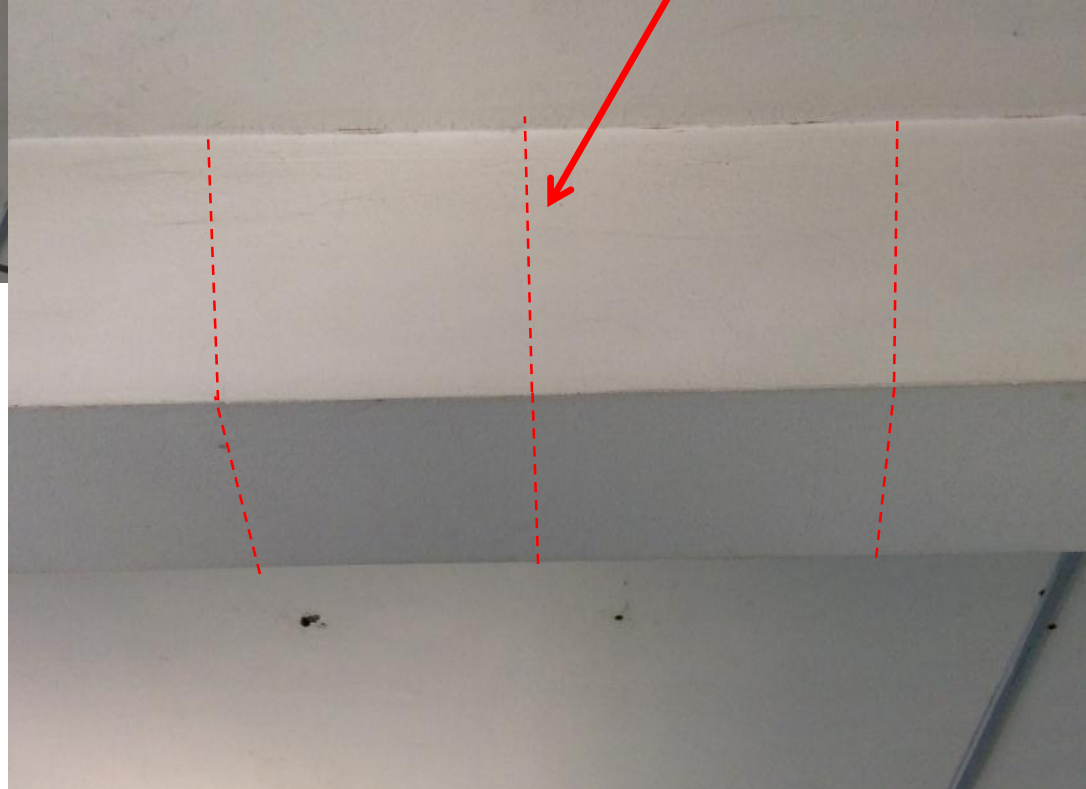
## Cracking in Beams

Hairline cracks to the beams at mid-span occur on the 3<sup>rd</sup> Floor of the 6-storey building.

Building engineer to confirm cracks are typical of normal structural behaviour, and to ensure the load on the 4<sup>th</sup> floor does not increase.

6	Cracking in Beams in 6-Storey Building at 3rd Floor to be investigated by the Building Engineer.	Building Engineer to carry out design check on beams to confirm that these cracks are within allowable structural behaviour.	6-months
7	Cracking in Beams in 6-Storey Building at 3rd Floor to be investigated by the Building Engineer.	Building Engineer to prepare Allowable Floor Loading Plans. (See also Item 1)	6-months

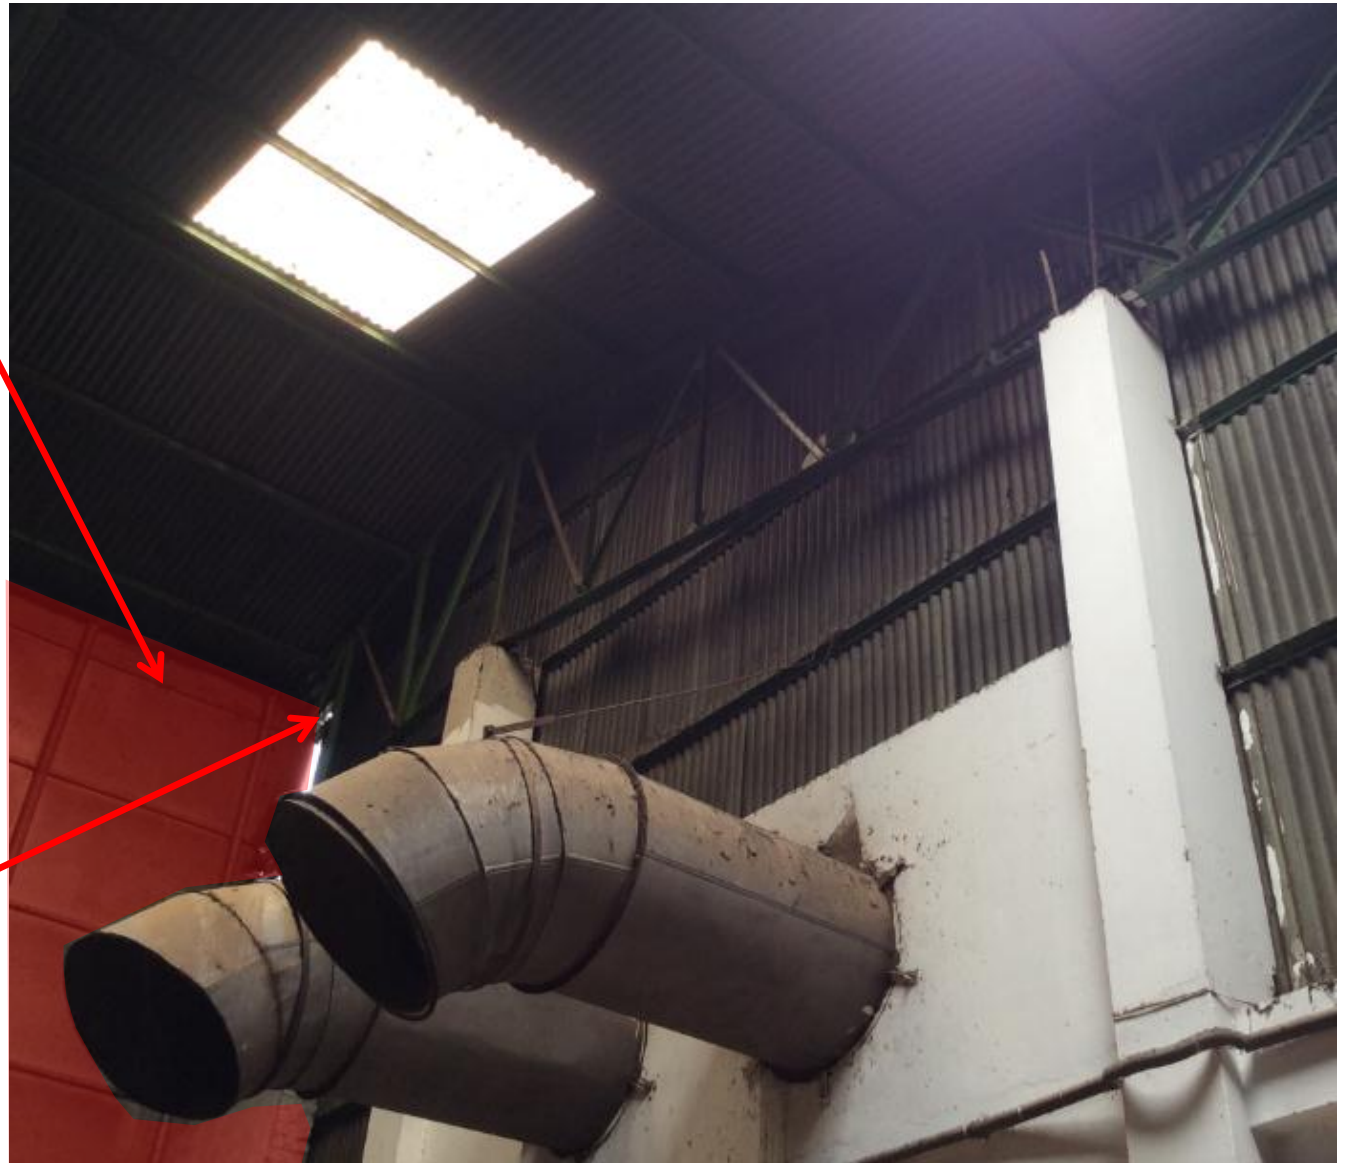
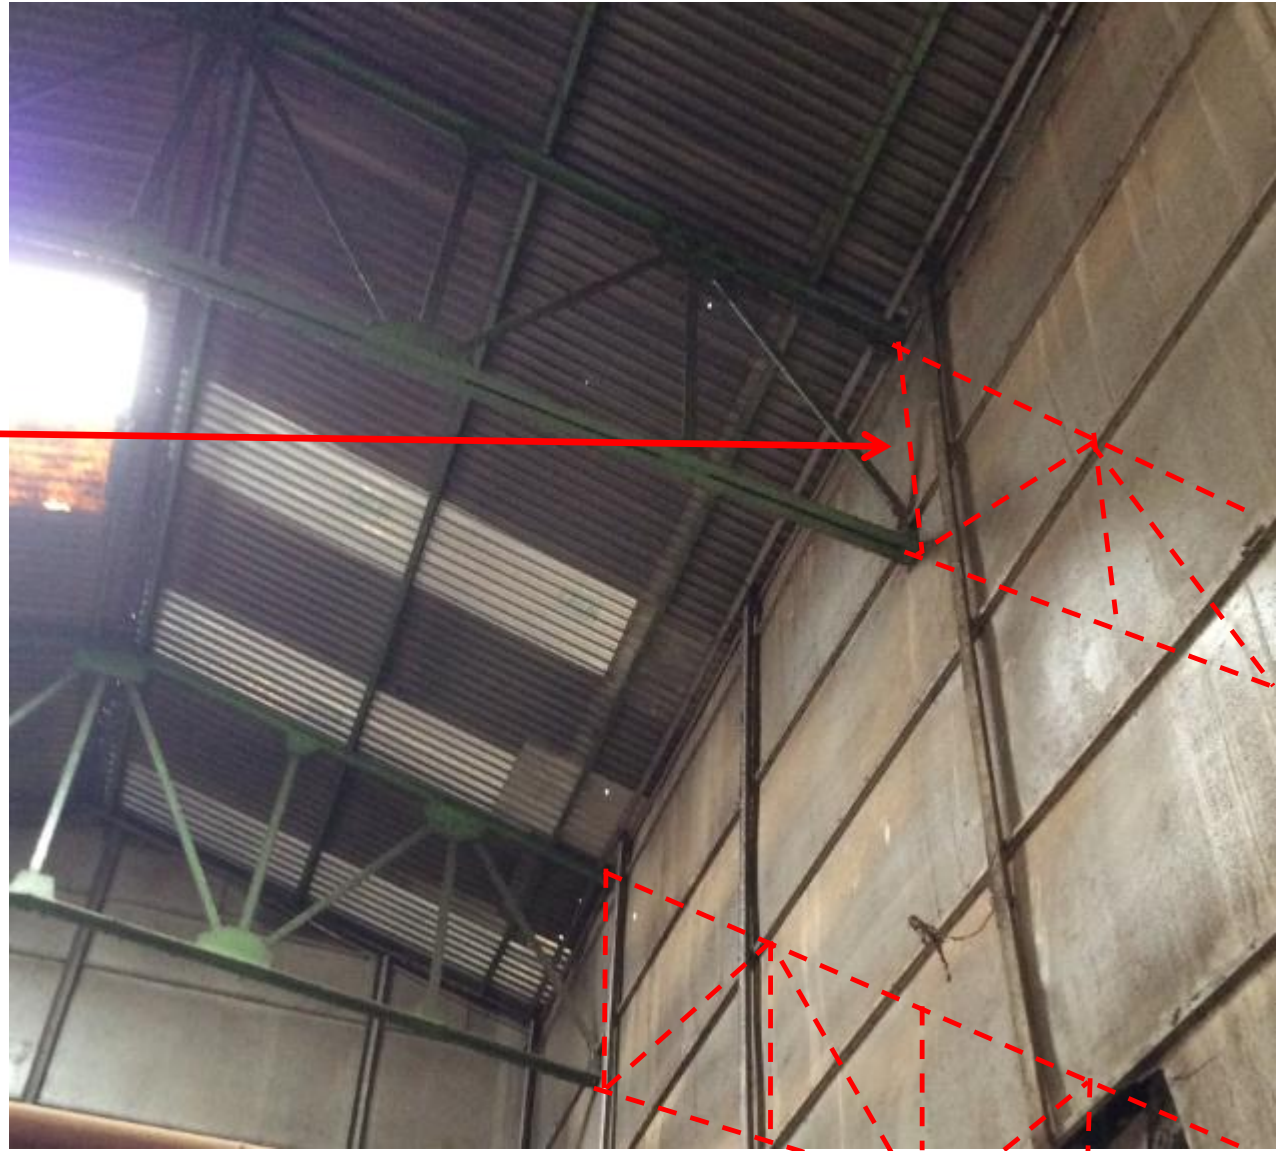
**New 6 Storey building impinged on existing boiler and generator building.**

**Part of the existing steel truss has been cut to allow for the new building (see also next slide).**

Part of the existing steel truss has been cut to allow for the new production building. New connection into brickwork wall and vertical tie in truss missing at the support.

Building Engineer to investigate adequacy of truss support at wall

<b>Item No.</b>	<b>Observation</b>	<b>Recommended Action Plan</b>	<b>Recommended Timeline</b>
8	Modified truss sections in Boiler/Generator Building need investigation	Building Engineer to check the steel truss configuration and design strengthening as required, particularly at the supports	<b>6-weeks</b>
9	Modified truss sections in Boiler/Generator Building need investigation	Implement strengthening measures as required.	<b>6-months</b>
10	Steel canopy at entrance of ad-hoc construction	Building engineer to check the design of the canopy roof and propose strengthening to the existing structure or recommend a new structure.	<b>6-weeks</b>
11	Steel canopy at entrance of ad-hoc construction	Construct strengthening or replacement structure.	<b>6-months</b>
12	Roof over Single-storey Storage Area to rear	Building engineer to check the design of the storage room roof and recommend strengthening measures, if required.	<b>6-weeks</b>

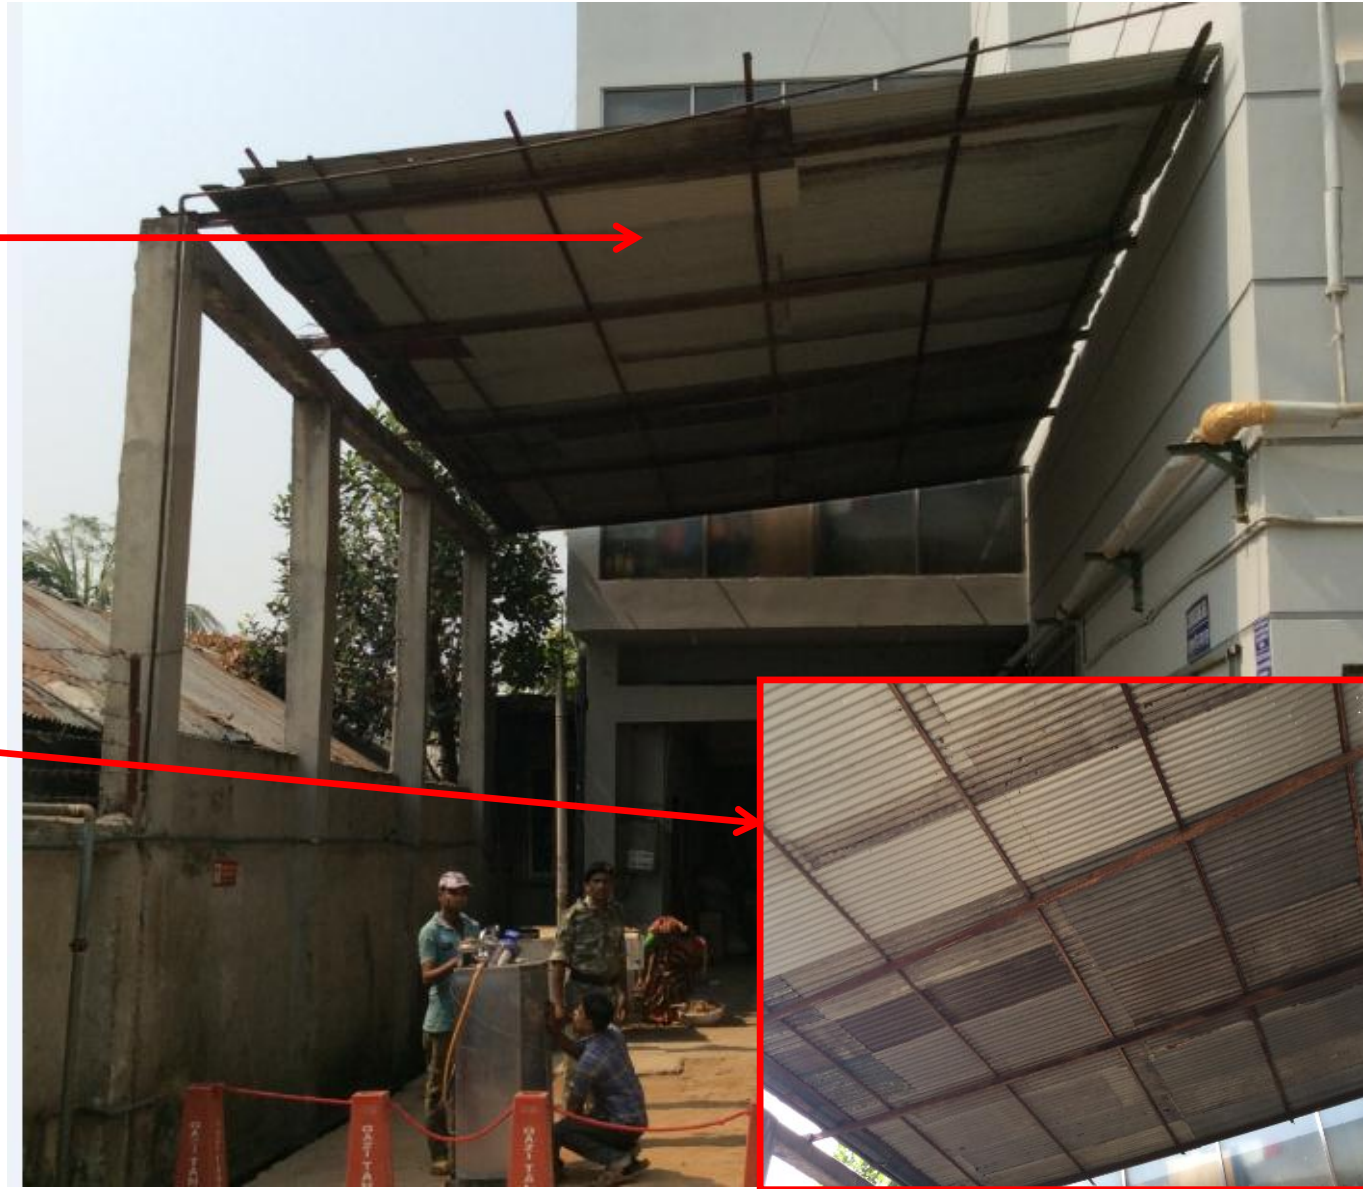
**Steel canopy at entrance**

**Steel canopy  
entrance of ad-hoc  
construction with  
substantial  
deflection.**

**Purlins appear  
inadequate to  
support 7.0m span.  
Building Engineer to  
recommend new  
canopy structure.**

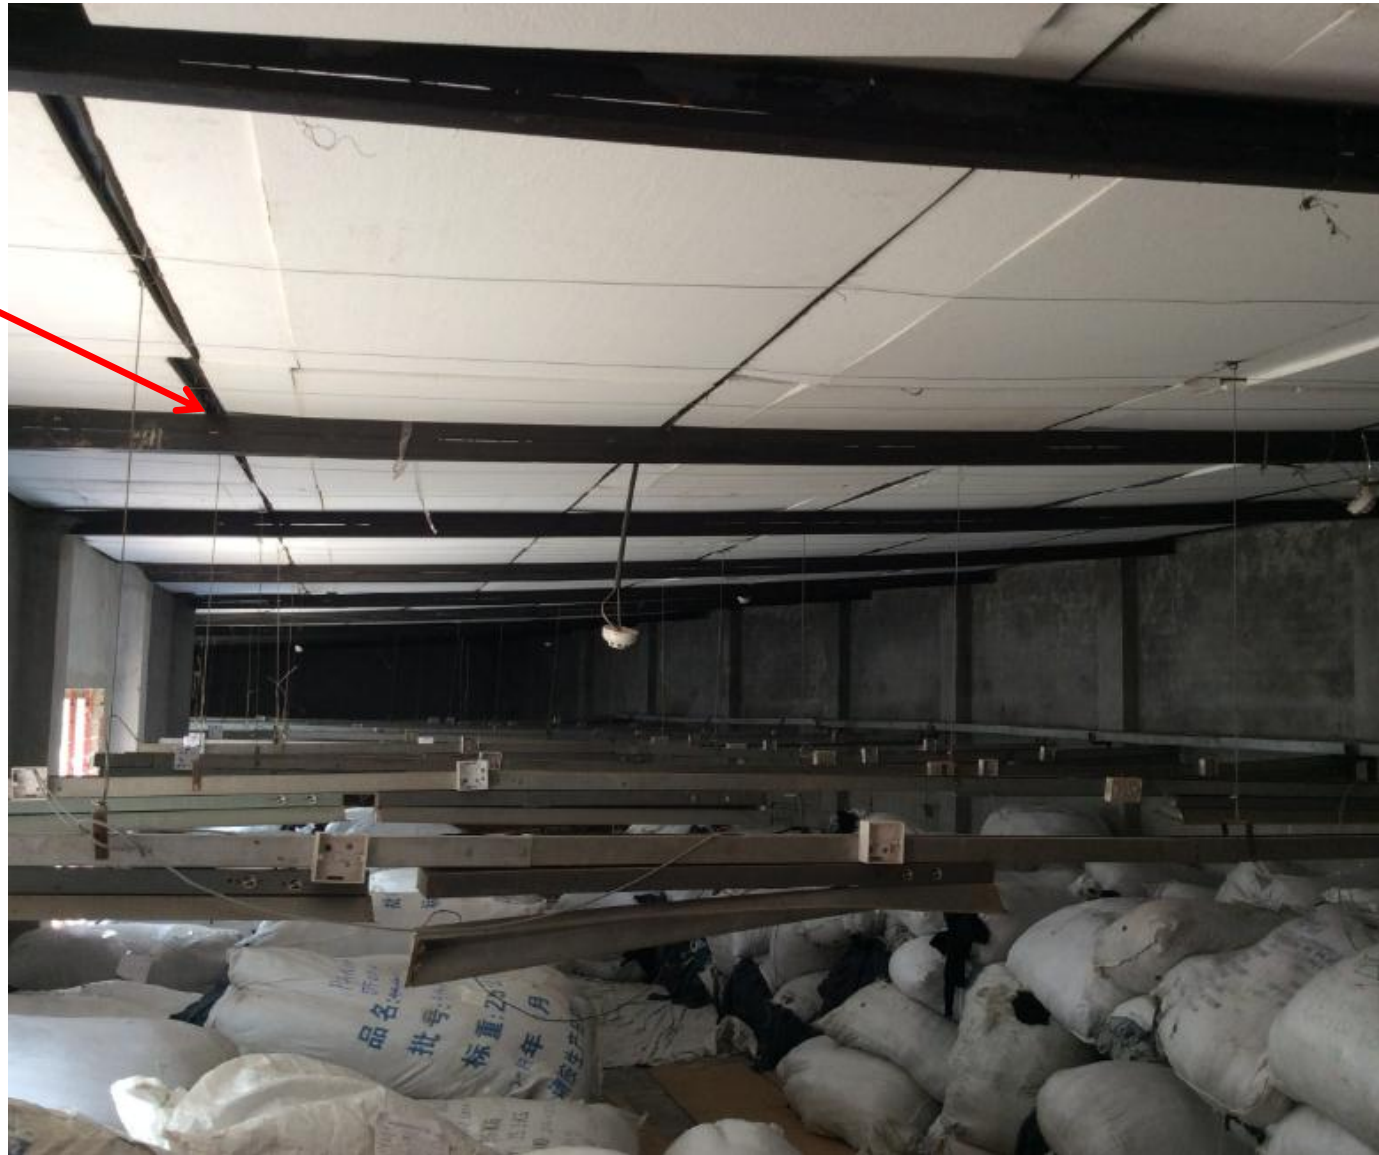
## Roof over storage Area

Roof to storage area at rear is made from angled sections tack welded together to create a channel section. These appear to be deflecting over the large span.

Sections appear inadequate to support the roof. Building Engineer to design strengthening or replacement structure for roof.

13	Roof over Single-storey Storage Area to rear	Implement strengthening measures where required.	<b>6-months</b>
