FIRE SAFETY INSPECTION REPORT

**4A YARN DYEING LTD.
KAICHABARI, SAVAR**

ACCORD
on Fire and Building Safety in Bangladesh

March 24, 2014

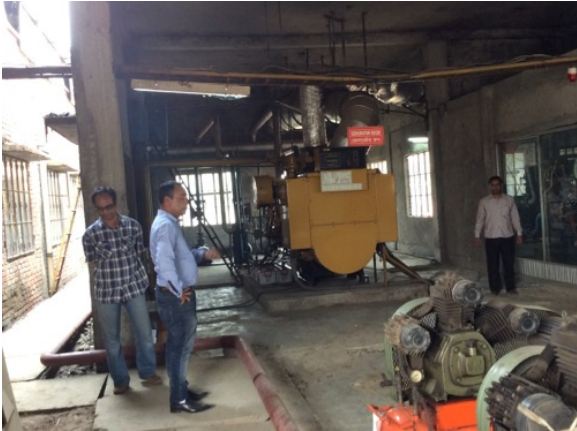
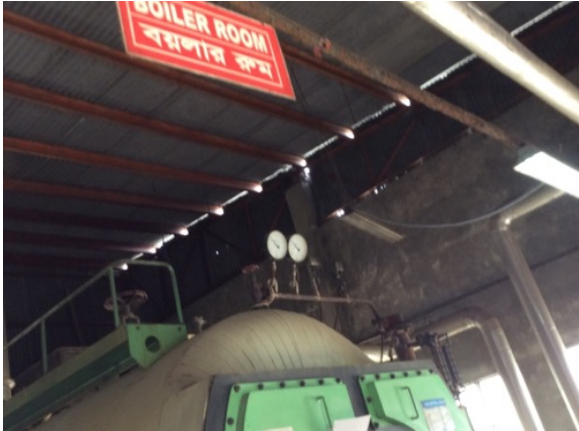
No.	Category	Finding	Recommendation	Remediation Timeframe
F-1	Fire Rated Construction	The boiler & generator shared the same room, and we're not separated from each other by fire rated construction.	Separate the boiler & generator rooms by a minimum 2-hr fire-rated construction. Seal and/or protected all openings to maintain the required fire separations	Within 3 months
<div style="display: flex; justify-content: space-around;">

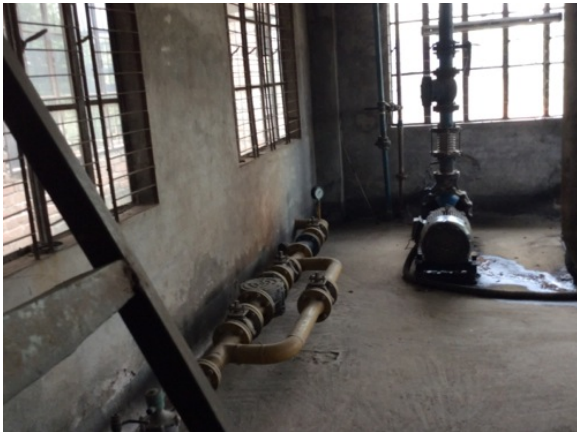
</div>				
F-2	Fire Rated Construction	The generator room had unprotected window openings facing another (non-factory) building approximately 5 feet away.	Separate the generator room by a minimum 2-hr fire-rated construction. Seal and/or protected all openings to maintain the required fire separations	Within 3 months

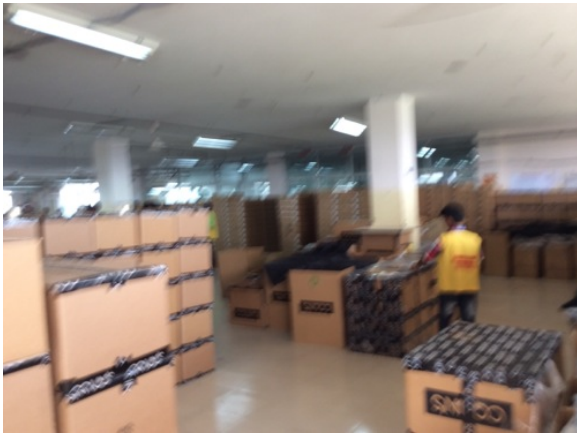
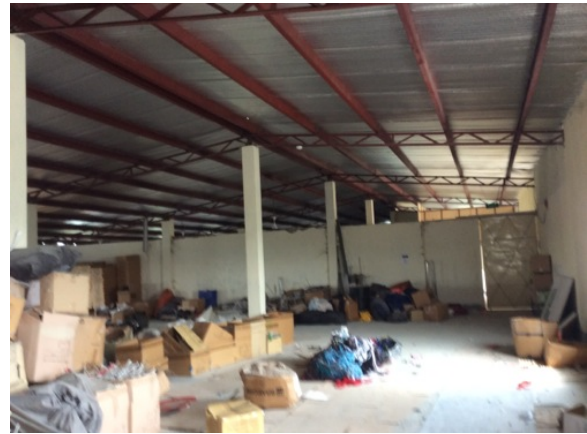
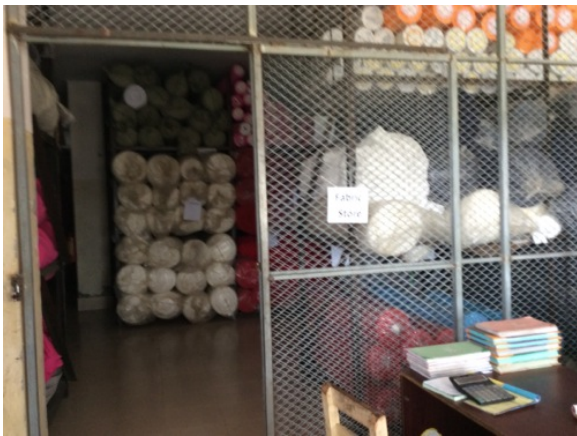
F-3	Fire Rated Construction	Areas used for combustible storage are not separated by fire-rated construction.	Provide dedicated storage rooms separated by minimum 1-hr fire-rated construction.	Within 3 months
		Fabric Store room, Packing Section, 4th floor waste store room.	<p>Where separate storage rooms are not feasible, provide defined storage areas and limit the storage arrangement as follows:</p> <ul style="list-style-type: none"> - Maximum height of 2.4m and maximum area of 23m² - If sprinkler protected: maximum height of 3.66m and maximum area of 93m² <p>Separate areas of unenclosed combustible storage by a minimum clear distance of 3m.</p>

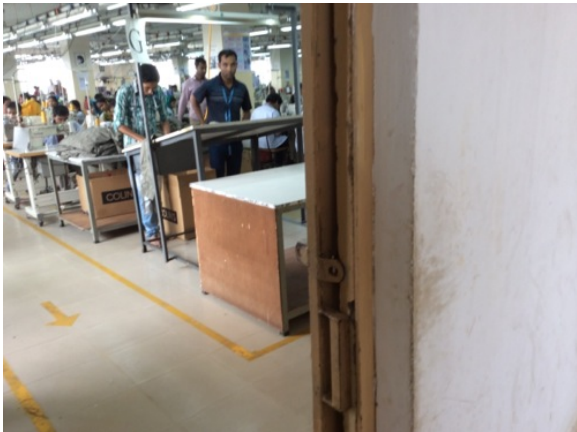
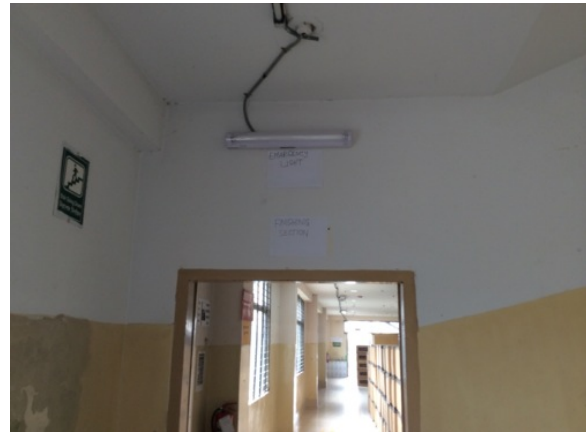
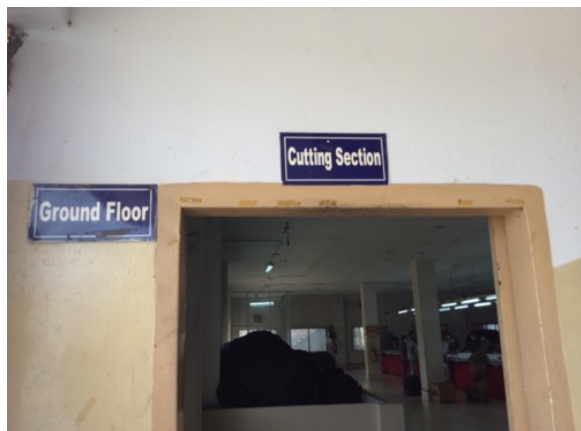
F-4	Fire Rated Construction	The exit stairs are not separated from work areas or other spaces on each floor by fire-rated construction.	Provide minimum 1.5-hr fire rated doors and seal all unprotected openings to separate the exit stairs from work areas and other building spaces on all floor levels. Ensure that the fire doors are self-closing and positive latching and that they are provided with fire exit (panic) hardware where serving production floors.	Within 3 months
		If fire doors are required to be held open for functional reasons, provide automatic-closing devices tied to the fire alarm system.

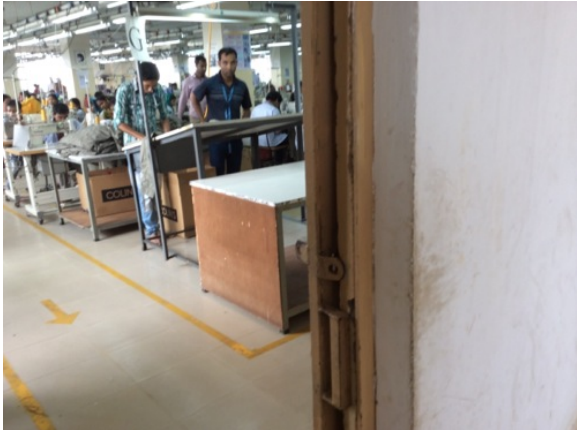
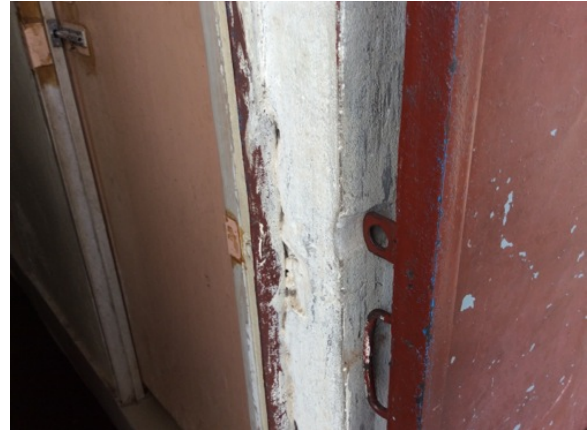
F-5	Egress	Exit capacity is not adequate for the occupant load on 3rd floor.	Reduce the occupant load on the 3rd floor immediately. In the future provide adequate egress width by either: - Addition of an exit stair or - Upgrade of the existing North exit stair to provide sufficient combined width for the occupants of 3rd floor.	Immediate
F-6	Egress	Egress doors / gates with locking features are provided at all exit stair openings and central stair discharge.	Remove locking features from all egress doors / gates. If locks are required for security reasons, utilize special door locking features complying with NFPA 101.	Immediate

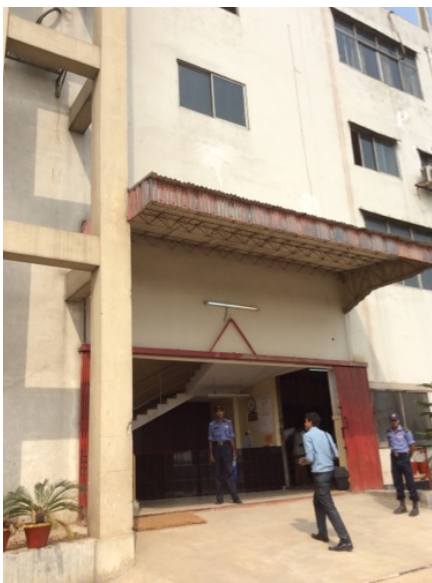
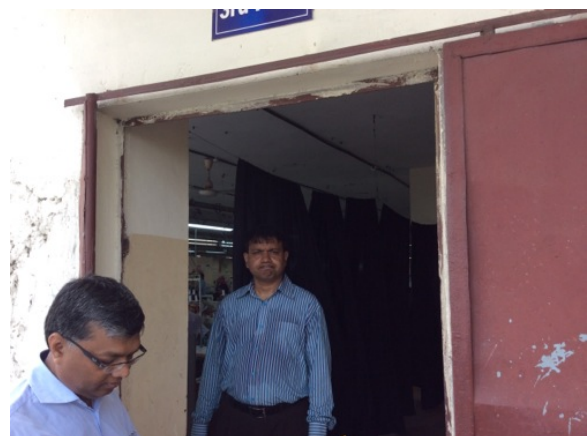
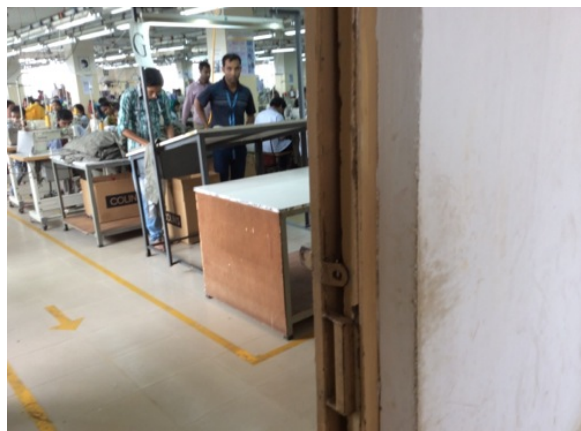
F-7 Egress

Sliding doors are provided at all exit stair doors and central stair discharge.

Replace all gates / sliding doors along the means of egress with side-hinged, swinging egress doors.

If locks are required for security reasons, utilize special door locking features complying with NFPA 101.

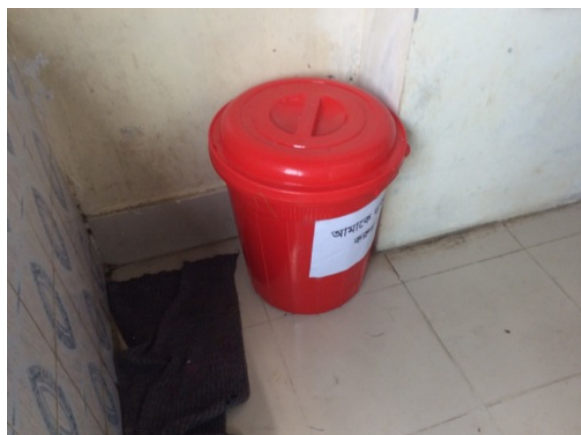
F-8	Egress	Waste bins were located in the central exit stair.	Remove all storage from exit stairs and egress paths.	Within 3 months
-----	--------	--	---	-----------------

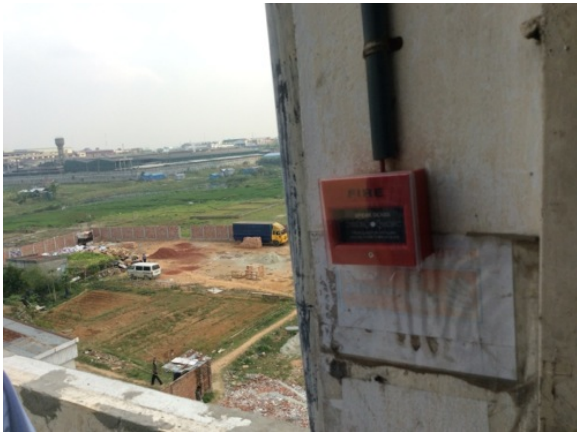
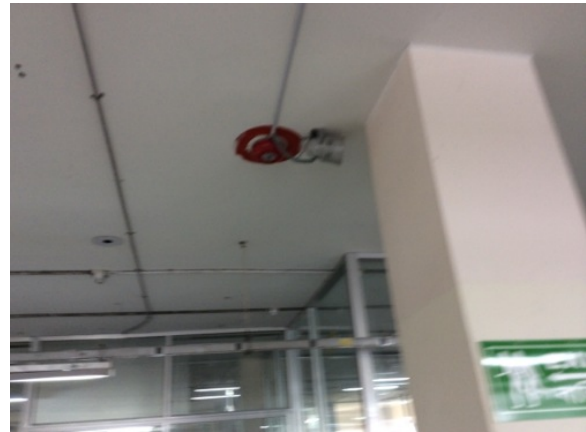
F-9	Fire Protection	The fire alarm system is antiquated, not a listed system, and does not provide alarm and notification features consistent with acceptable standards.	Replace the fire alarm system with a new, listed addressable fire alarm system in accordance with NFPA 72.	Design within 4 months, install within 9 months
-----	-----------------	--	--	---

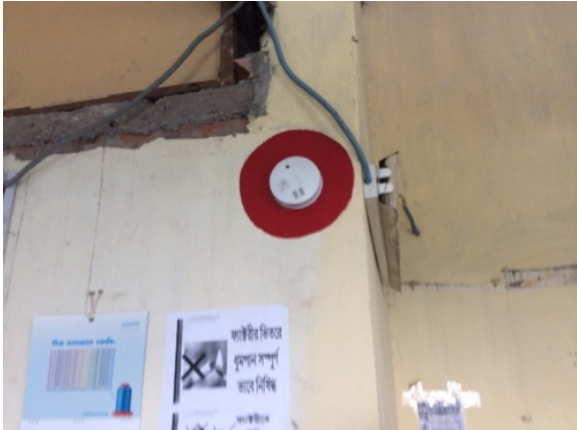
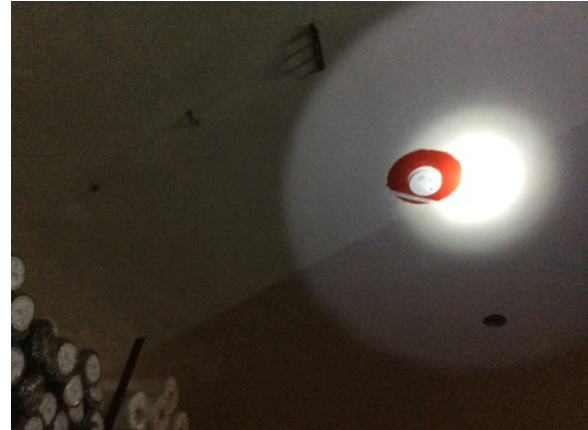
F-10	Fire Protection	Inspection, testing, and maintenance for the fire alarm system were not in accordance with NFPA 72.	Inspect, test and maintain the fire alarm system, and keep written records on-site, in accordance with NFPA 72.	Within 3 months
F-11	Fire Protection	The building is equipped with single-station smoke alarms. Smoke alarm activation sounds only a local alarm and does not provide automatic fire alarm notification of occupants.	Replace the single-station smoke alarms with automatic smoke detectors tied into the fire alarm system. Configure the fire alarm system to initiate occupant notification upon activation of any two smoke detectors in addition to the manual fire alarm stations.	Within 6 months

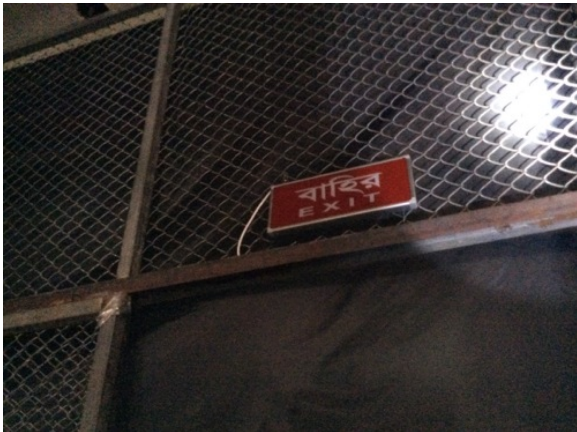
F-12 Egress Lighting

Exit signage not illuminated within fabric store was not working.

Regularly inspect all exit signage and replace/install lights as needed to illuminate signs.
