Euro Knitwear Limited

Chowdhury Bari, Vogra, Gazipur, Bangladesh.

23rd August, 2016

Observations

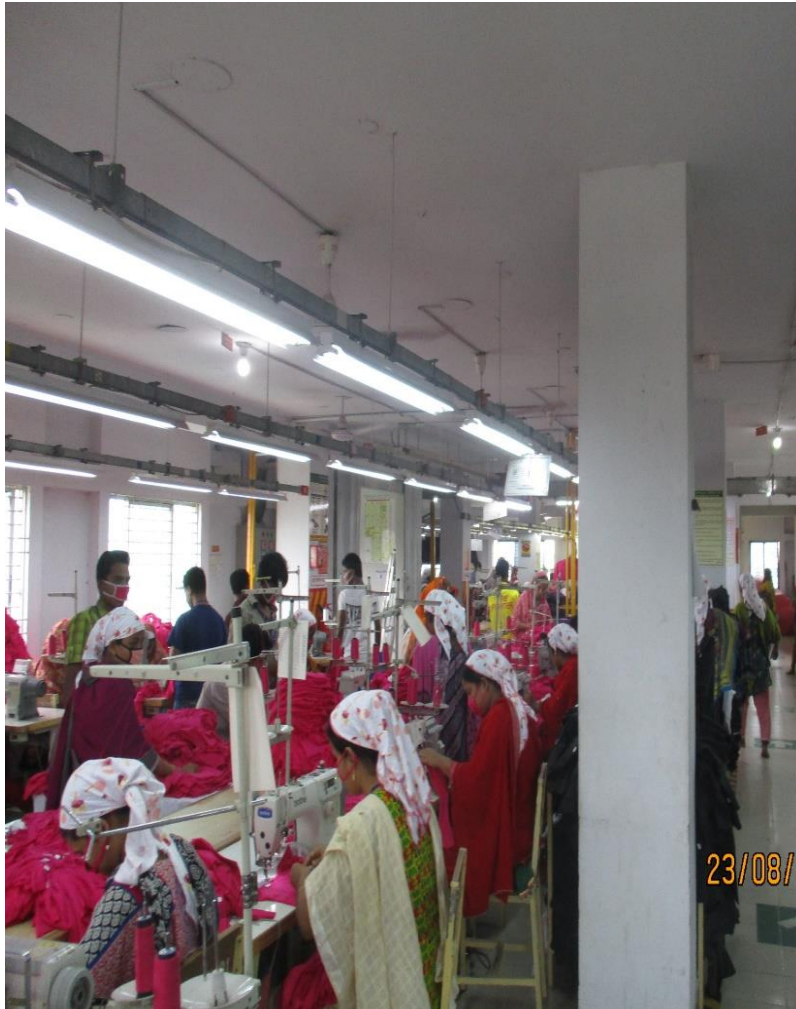
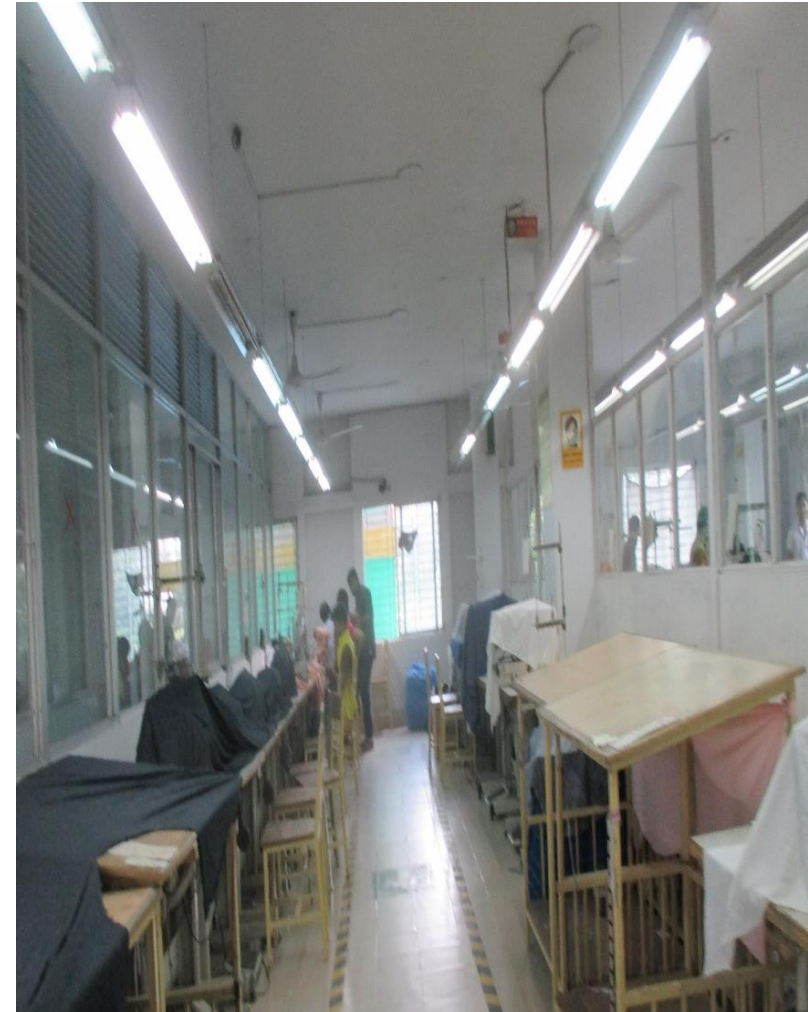
Flat slab vulnerable to punching shear

Internal columns have large tributary area but small slab thickness. Loading limit of 42 psf should be maintained until further investigation.

Item No.	Observation	Recommended Action Plan	Recommended Timeline
1	Flat slab vulnerable to punching shear	Reduce loading to 2 kPa (42psf) on all span of all floors pending the outcome of assessment.	Immediate - Now
2	Flat slab vulnerable to punching shear	Factory Engineer to review the safe load limit and carry out punching shear checks. Allowable floor loading plans to be prepared to establish where storage loads may be placed.	6-weeks
3	Flat slab vulnerable to punching shear	Implement remedial measures which will be the outcome of assessment	6-months
4	Flat slab vulnerable to punching shear	Regular inspection of load management	6-months
5	Localized areas of high loading	Reduce loading to 2 kPa (42psf) on all span of all floors pending the outcome of assessment.	Immediate - Now
6	Localized areas of high loading	Produce and actively manage a loading plan for all floor plates within the factory giving consideration to floor capacity and column capacity.	6-weeks

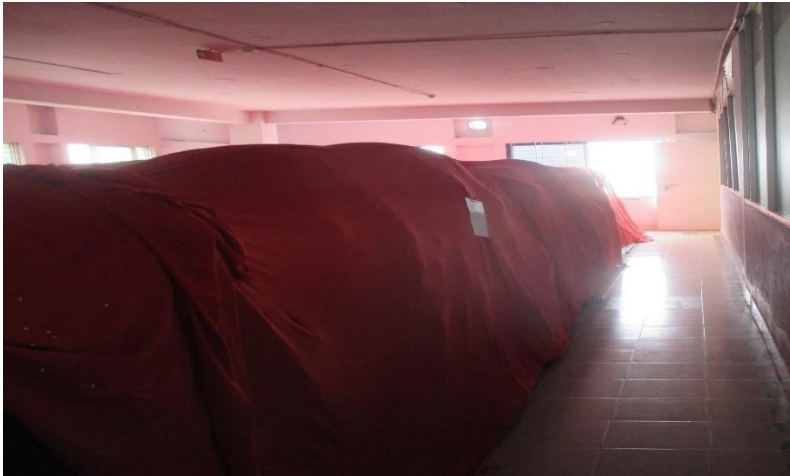
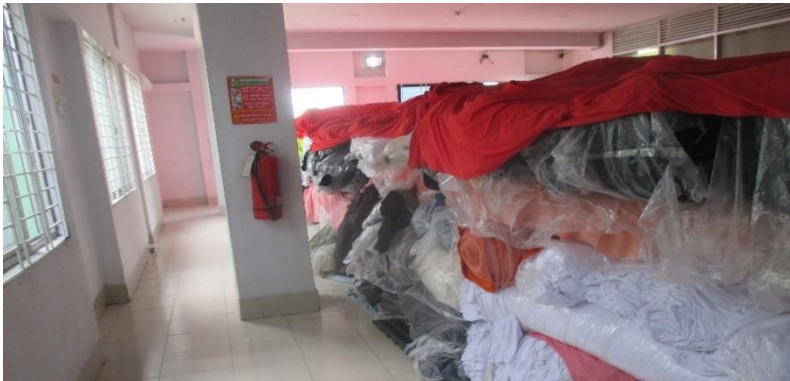
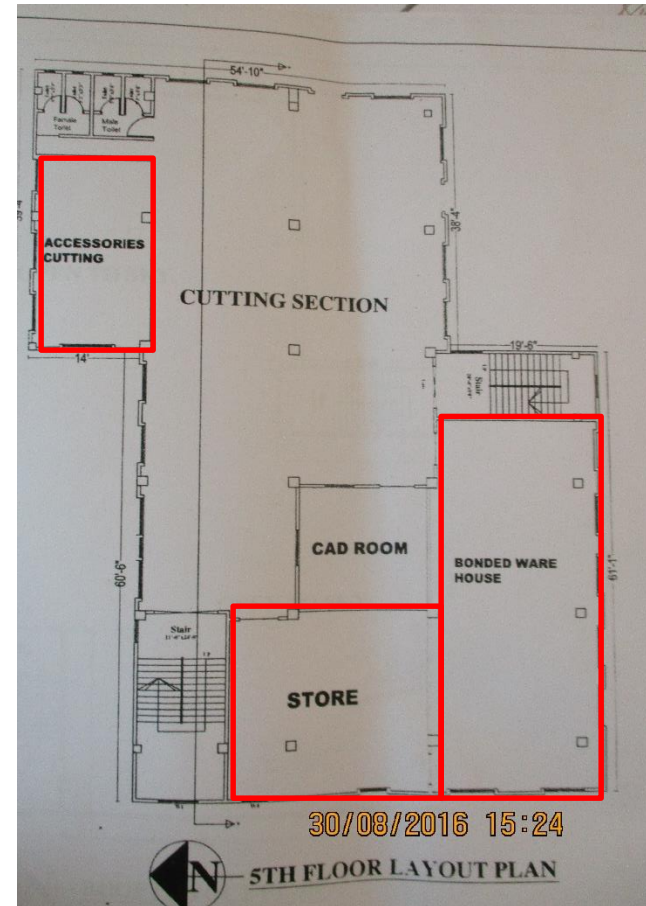
Localized areas of High Loading

We observed loading was more than 42 psf on storage areas at 5th floor . No load management system was visible.

7	Localized areas of high loading	Post load plans on all floors	6-weeks
8	Localized areas of high loading	Provide load markings on all storage areas	6-weeks
9	Localized areas of high loading	Continue to implement load plan.	6-months

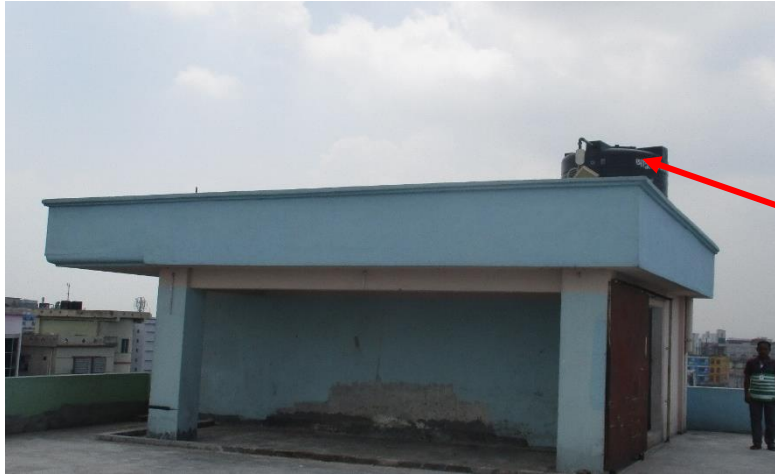
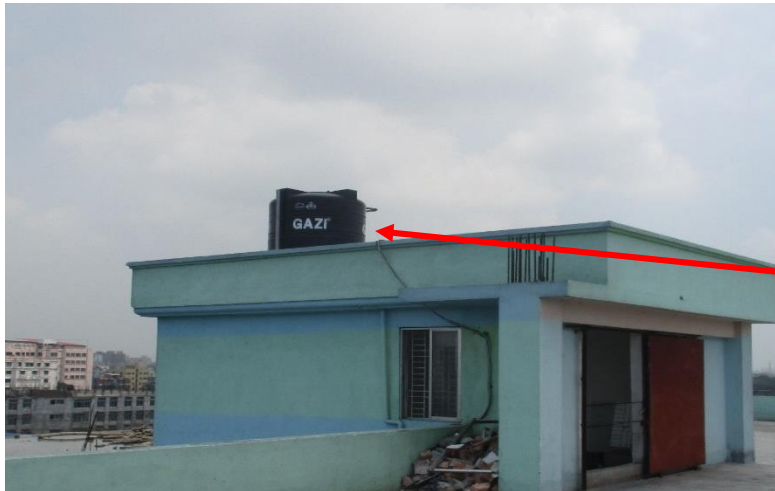
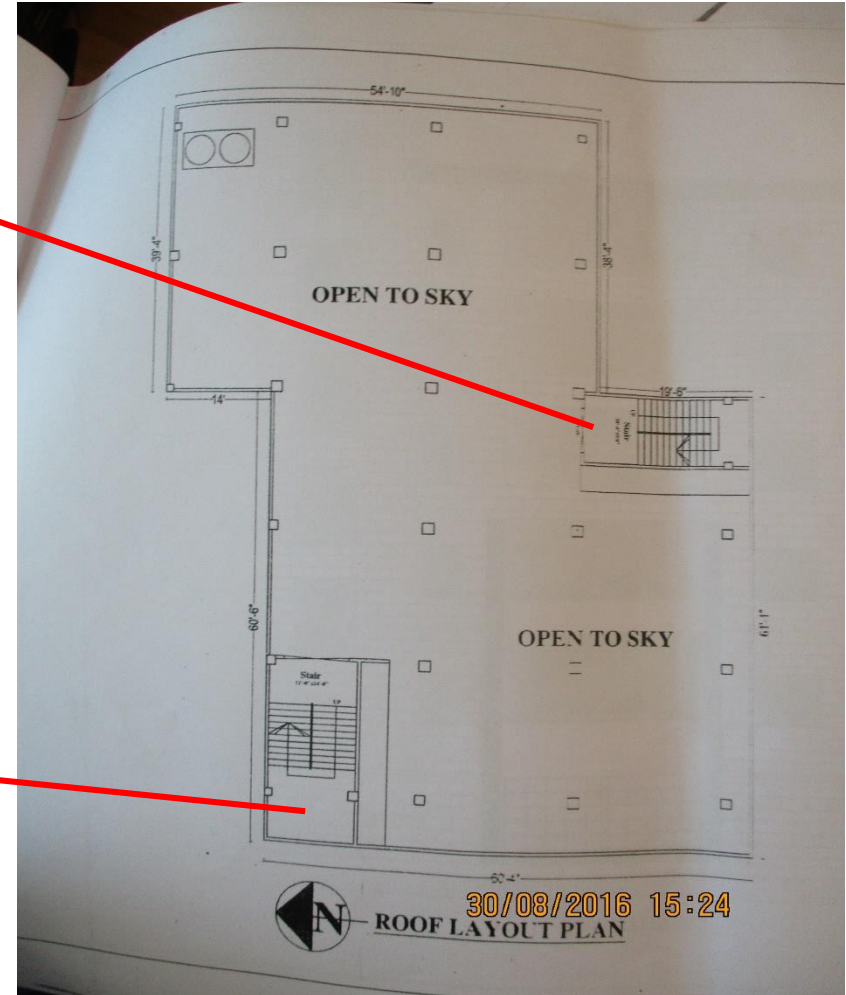
2 plastic water tanks were found on the staircase slab (not shown in the drawings). Factory engineer to verify that the slabs are adequate to carry these point loads.

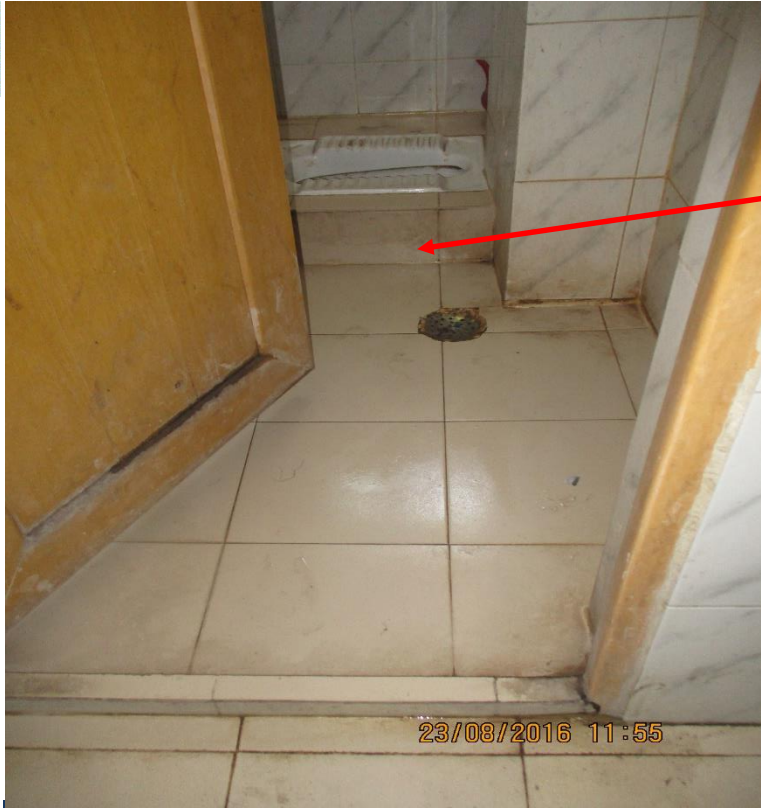
Toilet build up (all floors)

12cm high floor build-up in toilet area supported by concrete slab.
Building Engineer to check that the slab has been adequately designed to carry floor build-up loads

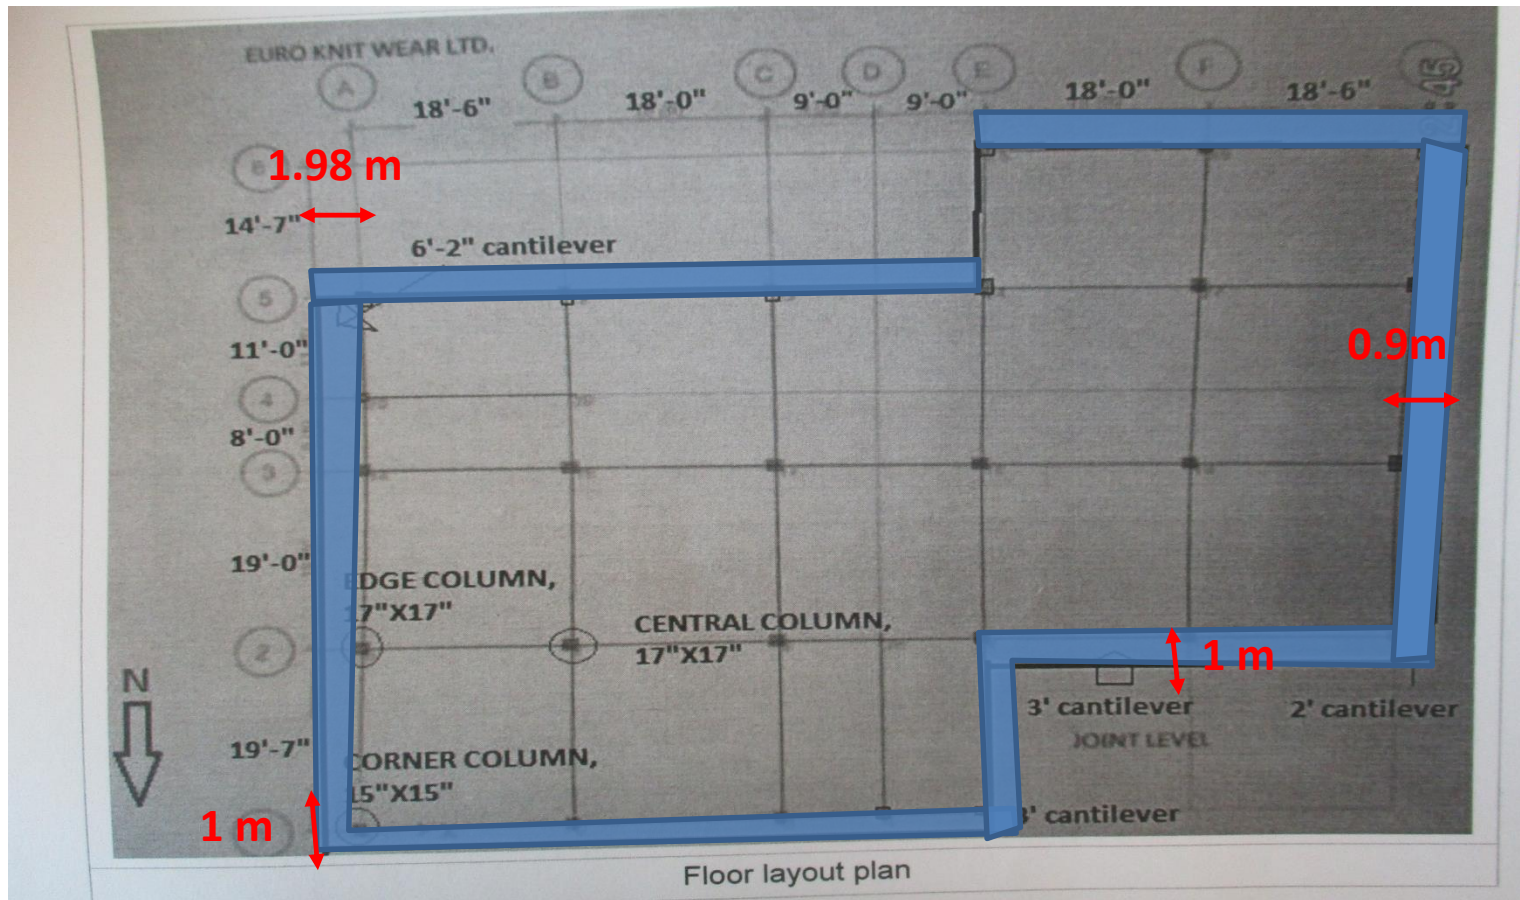
Cantilever portion

Cantilever portions were located along the perimeter of the building.

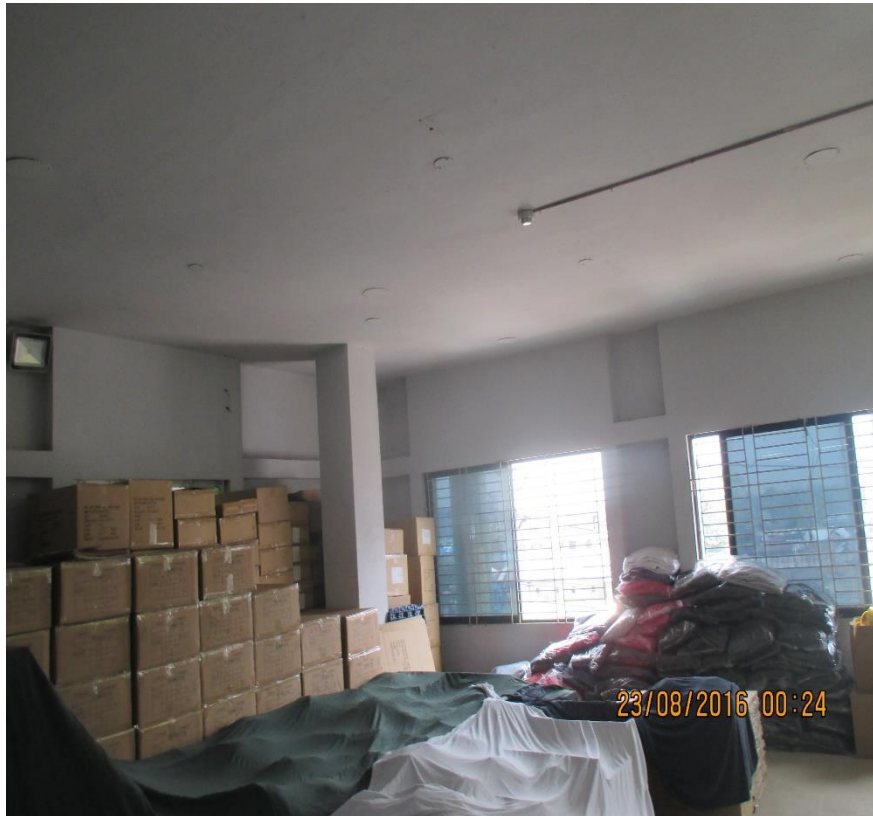
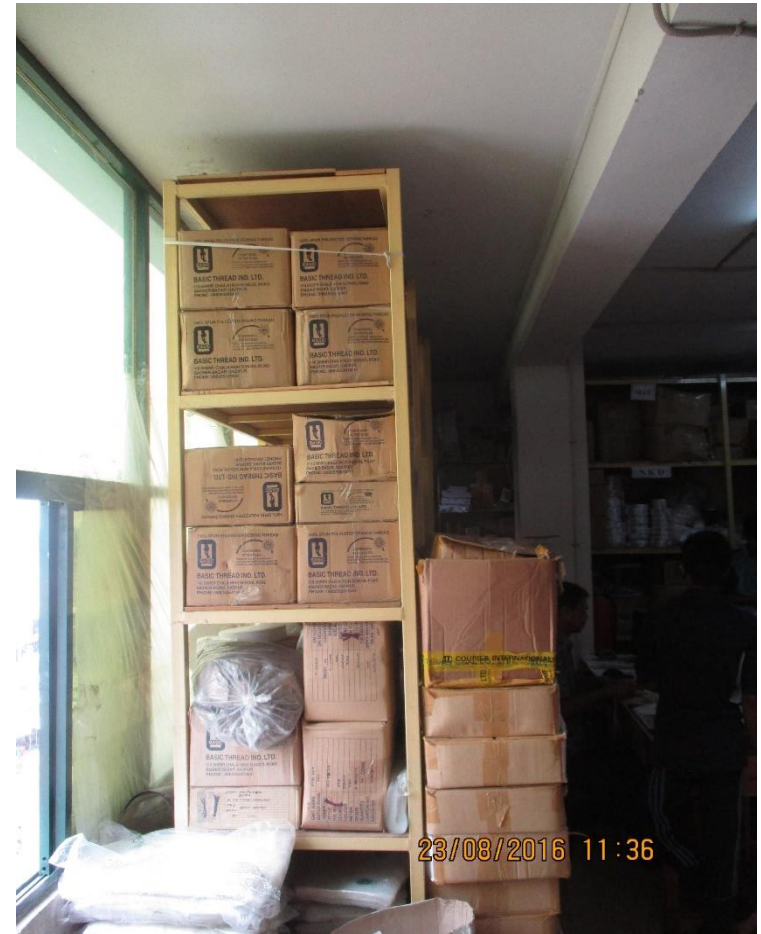
Storage was observed in cantilever portions. Cursory calculations indicate these regions are prone to excessive deflection. Loading limit of 1 kPa should be until further assessment.

Item No.	Observation	Recommended Action Plan	Recommended Timeline
10	Limit density of loading in cantilever areas	Limit loading on cantilever portions to 1 kPa (21 psf) pending the outcome of assessment.	Immediate - Now
11	Limit density of loading in cantilever areas	Factory engineer to assess the capacity of cantilever slabs and check whether the deflection is within the limit.	6-weeks
12	Limit density of loading in cantilever areas	Produce and actively manage a loading plan for all cantilever areas.	6-weeks
13	Limit density of loading in cantilever areas	Carry out remedial works suggested in the assessment report.	6-months
14	Limit density of loading in cantilever areas	Continue to implement load plan.	6-months
15	Lateral stability system to be verified	Factory Engineer to check the overall structural system under lateral loads to verify structural safety as part of the assessment report.	6-weeks

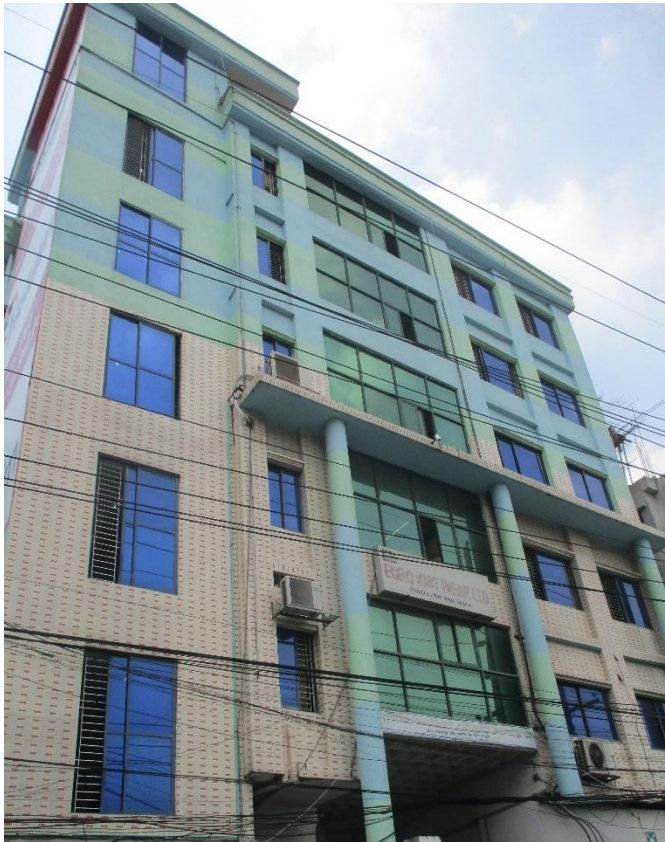
Lateral stability system to be verified

The overall structural arrangement appears not to have any rational form of lateral stability system to resist lateral loads. A lateral load analysis is required to be carried out.

16	Lateral stability system to be verified	Depending on the outcome of the EA report, consider strengthening or modification works.	6-months
17	No Water proofing membrane was provided	Provide the waterproofing layer or provide proper slope so that water do not stand on roof.	6-months

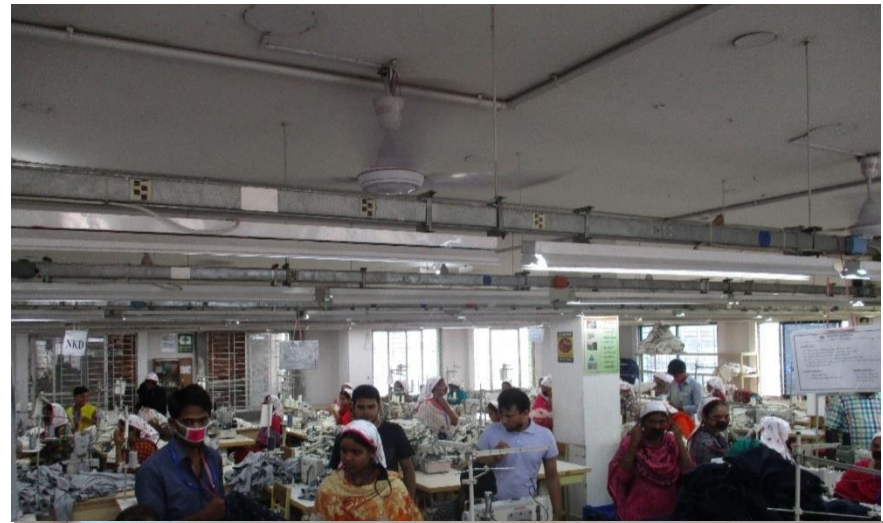
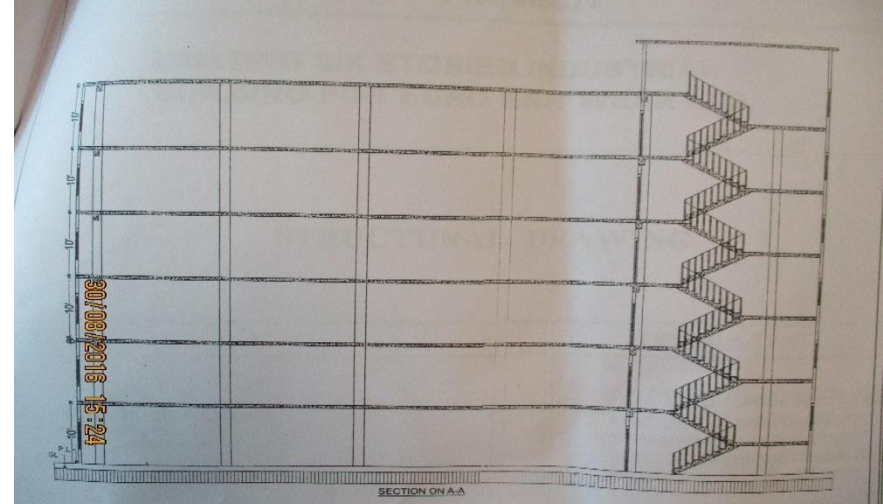
The increase of shear stress to the flat slabs due to these lateral loads also needs to be assessed.

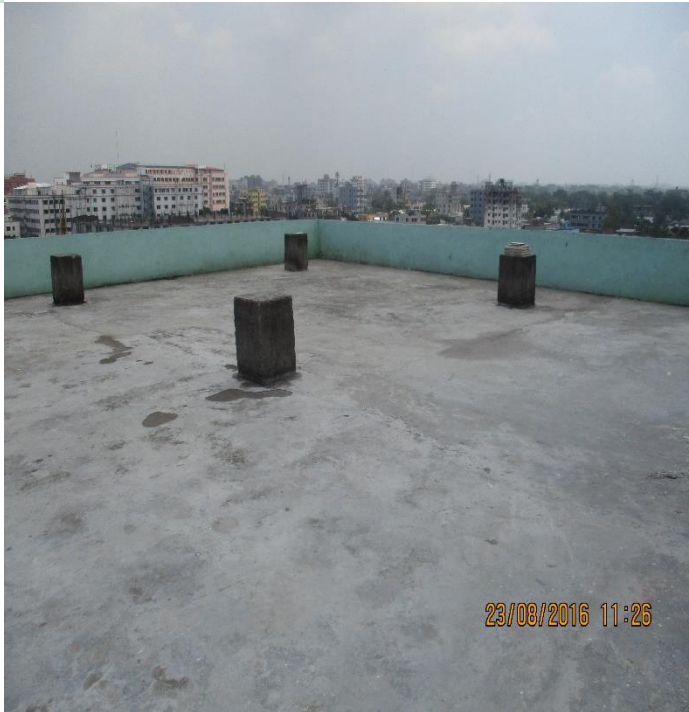
No Water proofing membrane was provided

No water proofing membrane on roof top

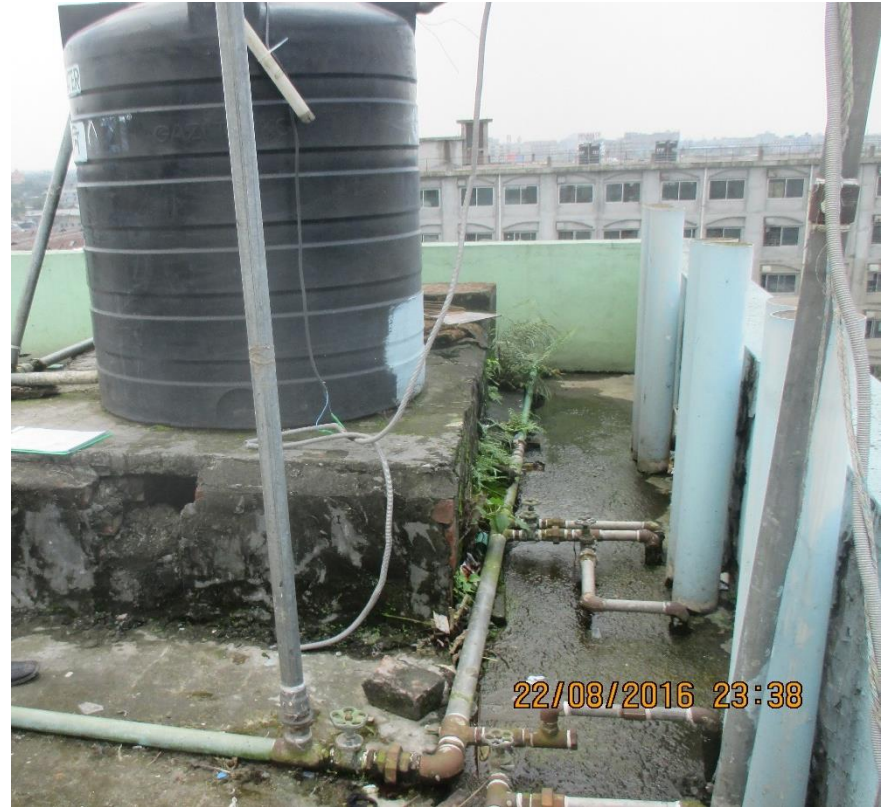
Sign of standing water was visible
