# Farseeing Knit Composite Ltd

Faridpur, Telihati, Sreepur, Gazipur.  
(24.264389, 90.401611)

7<sup>th</sup> May 2014

# Observations

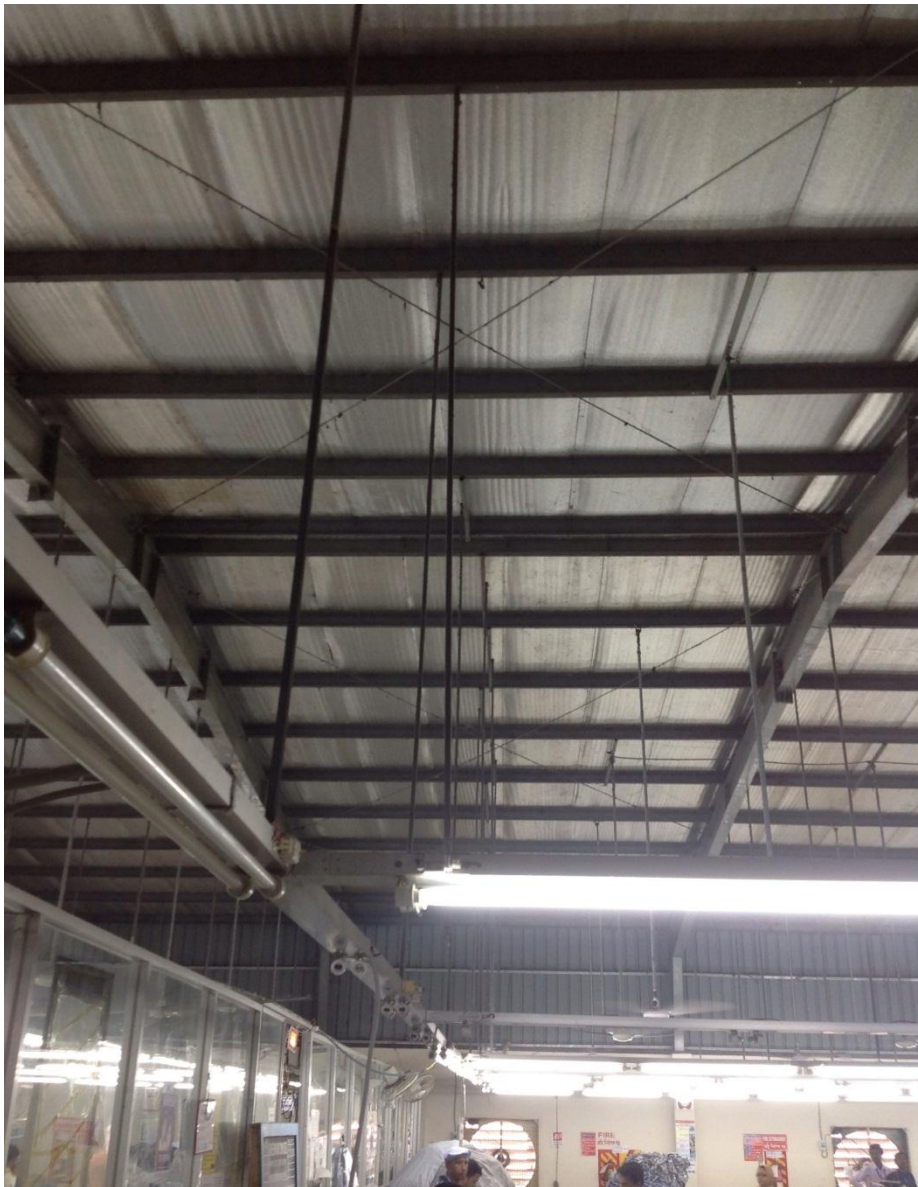
The lateral stability system to the Main Production structural steel shed is unclear – vertical bracing and eaves beams have not been provided. Note that provision for lateral stability is not shown in the as-built drawings. Building Engineer to carry out a lateral stability analysis of the shed and specify the necessary remedial works. Furthermore, Building Engineer to review the design of the cantilevered columns to ensure they can adequately resist the horizontal loads imposed by the portal frame.

Vertical bracing system missing to Main Building

Building Engineer to review the design of the portal frame with regard to lateral stability. The Building Engineer should provide guidance on the requirement or otherwise for vertical bracing and eaves beams in the external wall to enable the horizontal wind loads to be transferred down to foundation level. Furthermore the Building Engineer is to review the design of the cantilevered concrete columns to ensure that they are adequate to resist the horizontal loads imposed by the steel portal frame.

Carry out any remedial works as determined by the Building Engineer

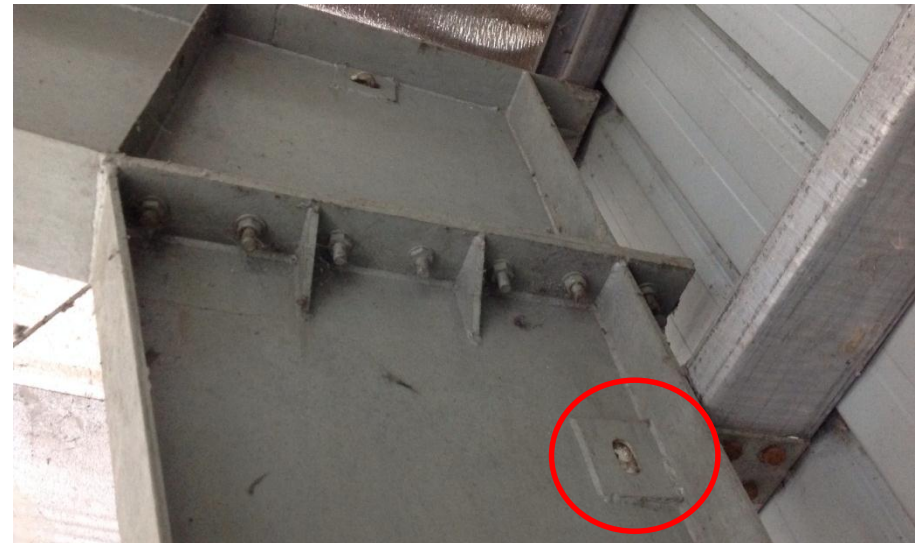
Bracing connection detail for horizontal bracing is provided to stanchion but not used. Eaves beam missing.

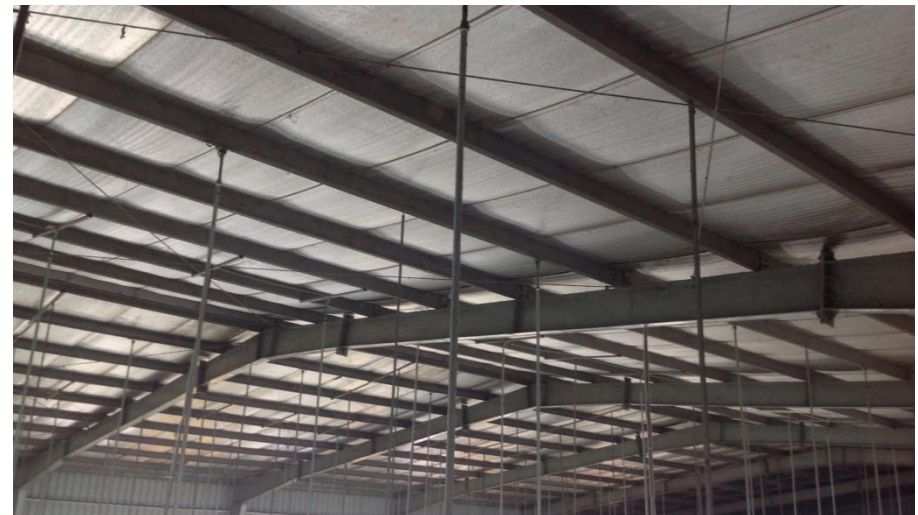
Only Horizontal Bracing provided to Main Building

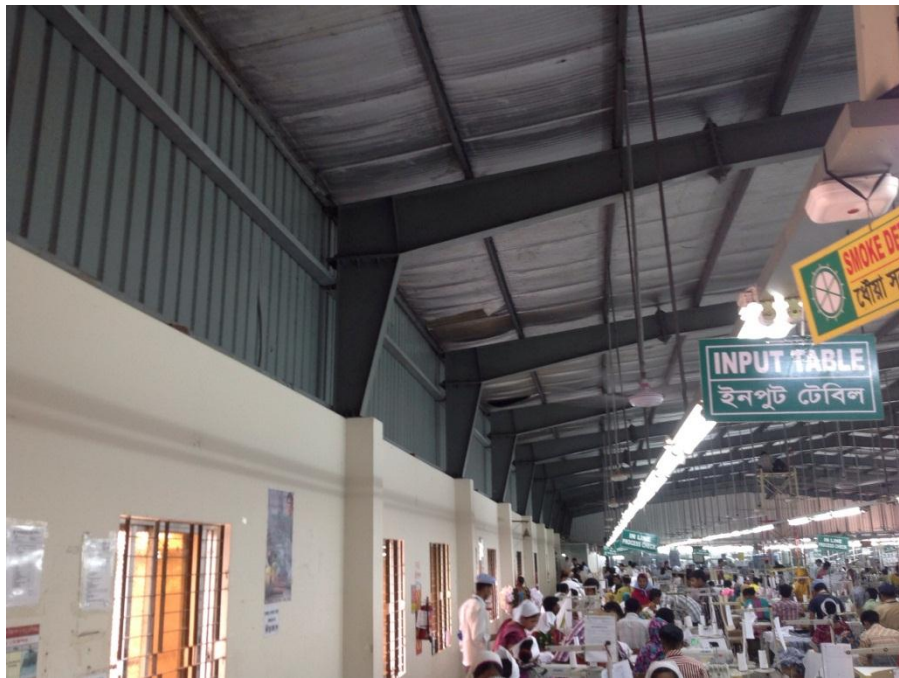
Eaves beams missing to Main Production Building

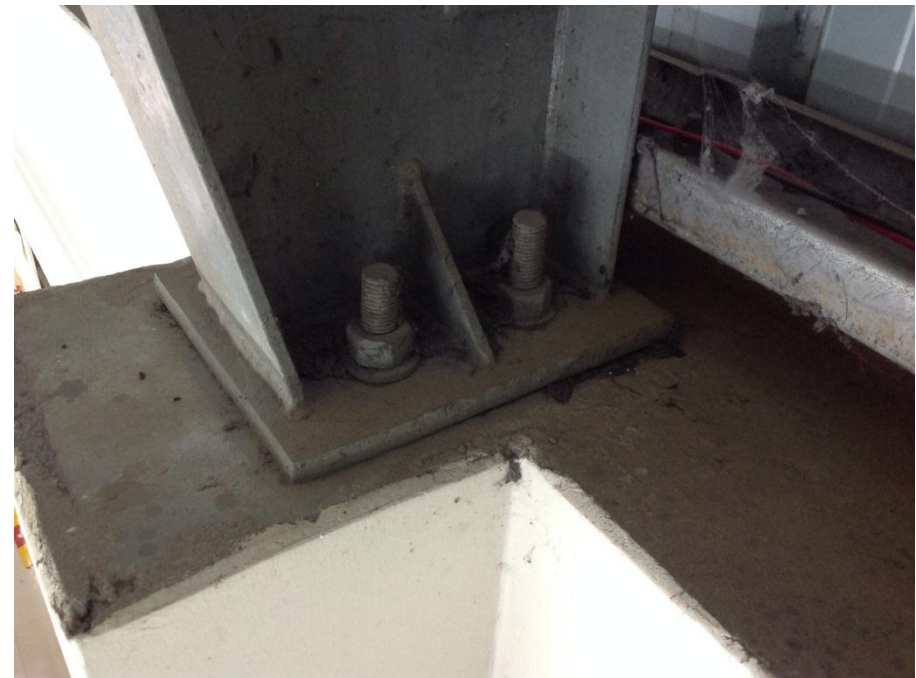
Pin connection between portal frame and cantilevering RC columns – The horizontal force transferred into the top of the columns will need to be transferred into the foundation through cantilever action

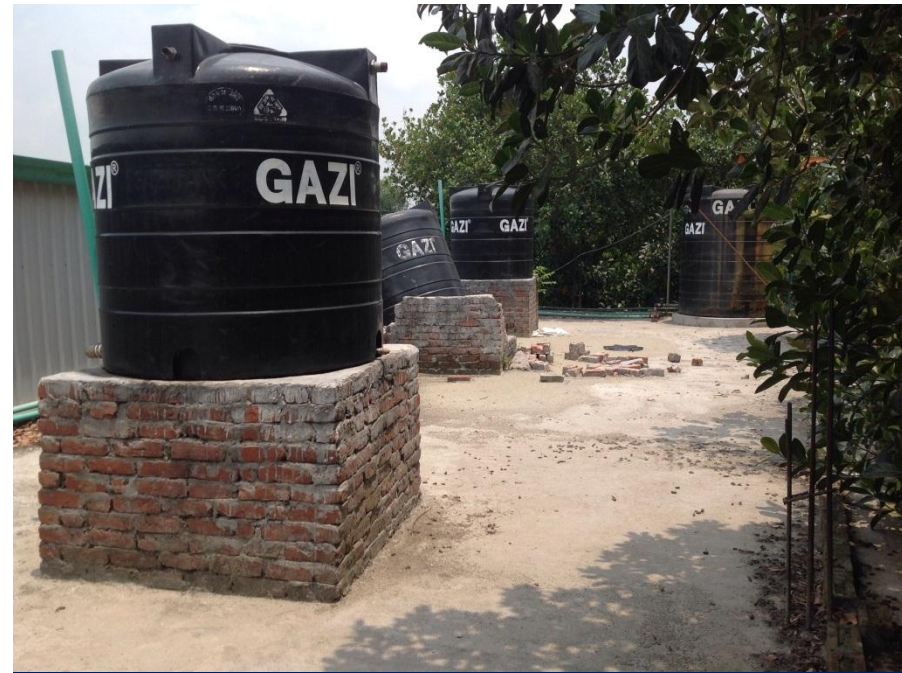
Water Tanks to Roof

An area of high loading was observed above the toilet area to the South of the main Production / Office building where there are four plastic water tanks located at Roof level. There is one 5000L capacity tank on a 160mm plinth, two 2000L capacity tanks on 900mm plinths, and one 2000L capacity tank that is damaged and appears to be out of use. Building Engineer to check that the roof structure has been adequately designed to accommodate this loading.

Damaged 2000L water tank on damaged plinth at Roof Level

Building Engineer to be appointed to review the design of the roof slab over the male toilets to ensure that the structure as-built is adequate to carry the applied loads. Carry out strengthening works if required.

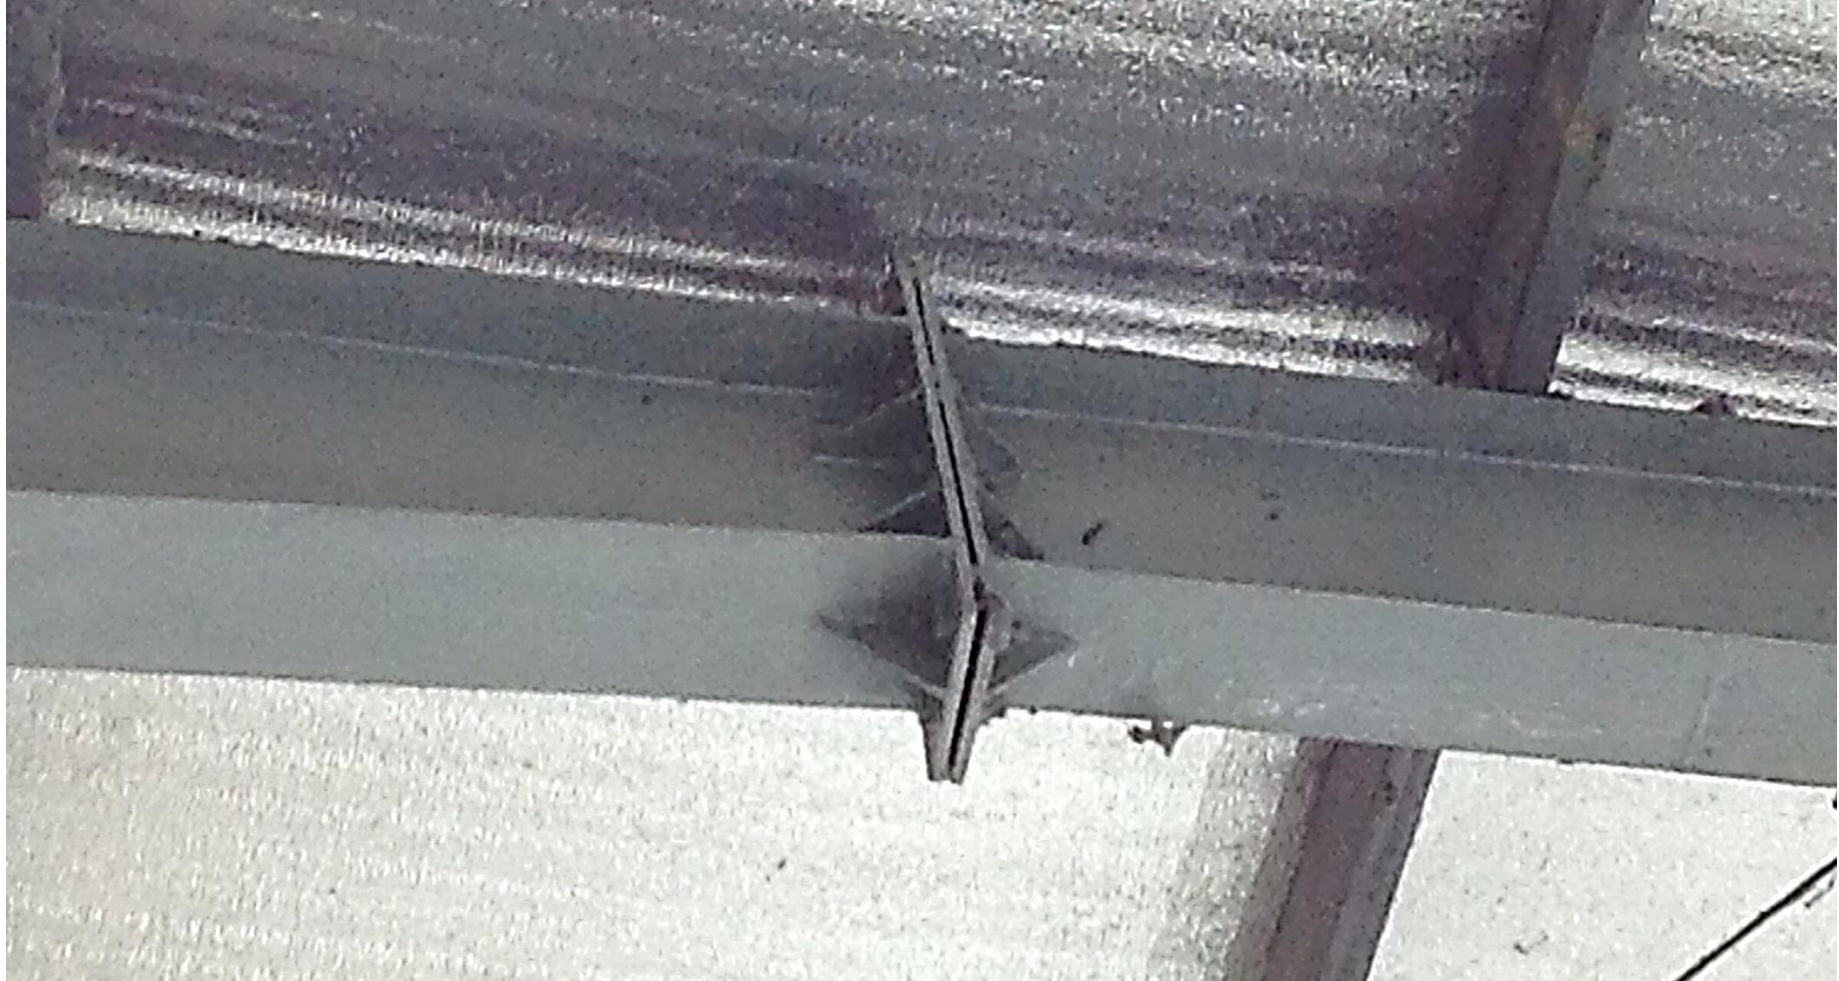
Splice Detail to Rafters in the Main Production / Office Building

There appears to be inadequate bearing of the endplates in a number of splice connections to the rafters in the Main Production / Office Building. Building Engineer to review connections, and direct remedial works to the structure as required.

Building Engineer to check the design and capacity of the splice connection details and make any necessary alterations.

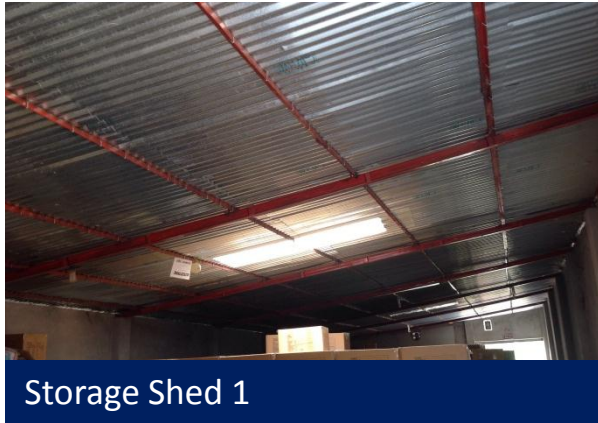
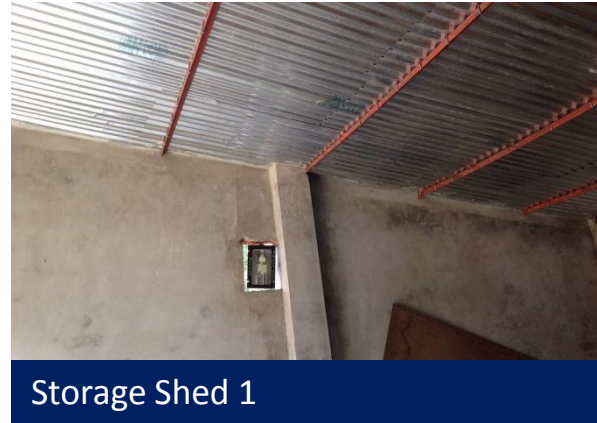
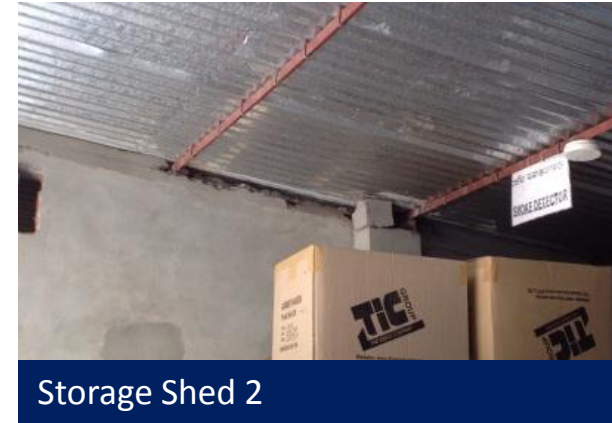
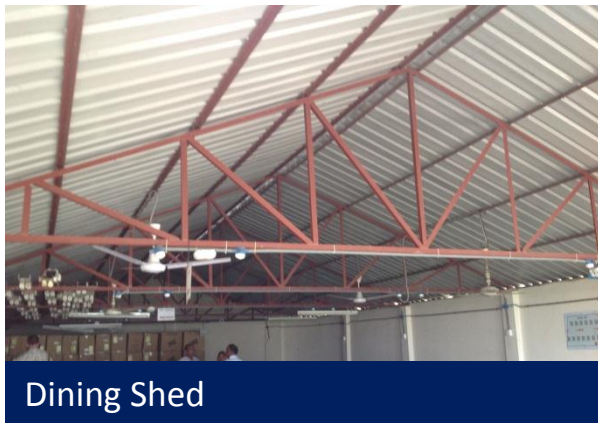
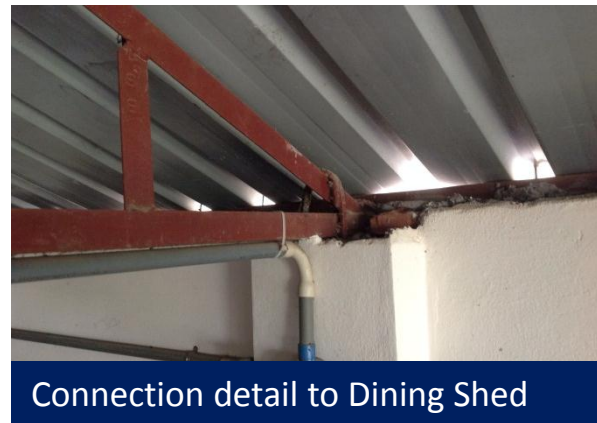
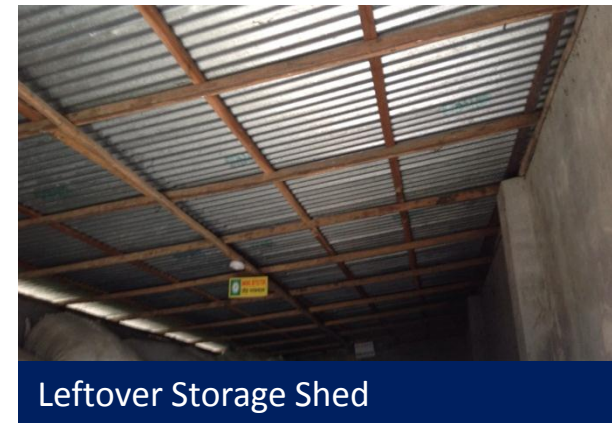
The factory compound comprises a number of ancillary buildings with lightweight roof structures, namely Storage Sheds 1 & 2, the Dining Area and the Leftover Storage Shed. These roof structures, which are typically supported on concrete piers, do not appear to be engineered. Building Engineer to review the design of these structures, with special emphasis on connections and bracing, and to implement any upgrade works as required.

Additional structures to be design checked to ensure adequacy for code vertical and wind loads by the Building Engineer.  
Undertake strengthening if required.  
Building Engineer to produce appropriate documentation and as built drawings.
