Apparel 21 Ltd.

Shirir Chala, Bagher Bazer Gagipur Shadar, Gazipur, Bangladesh
(24.171452N, 90.415817E)

3rd May 2014

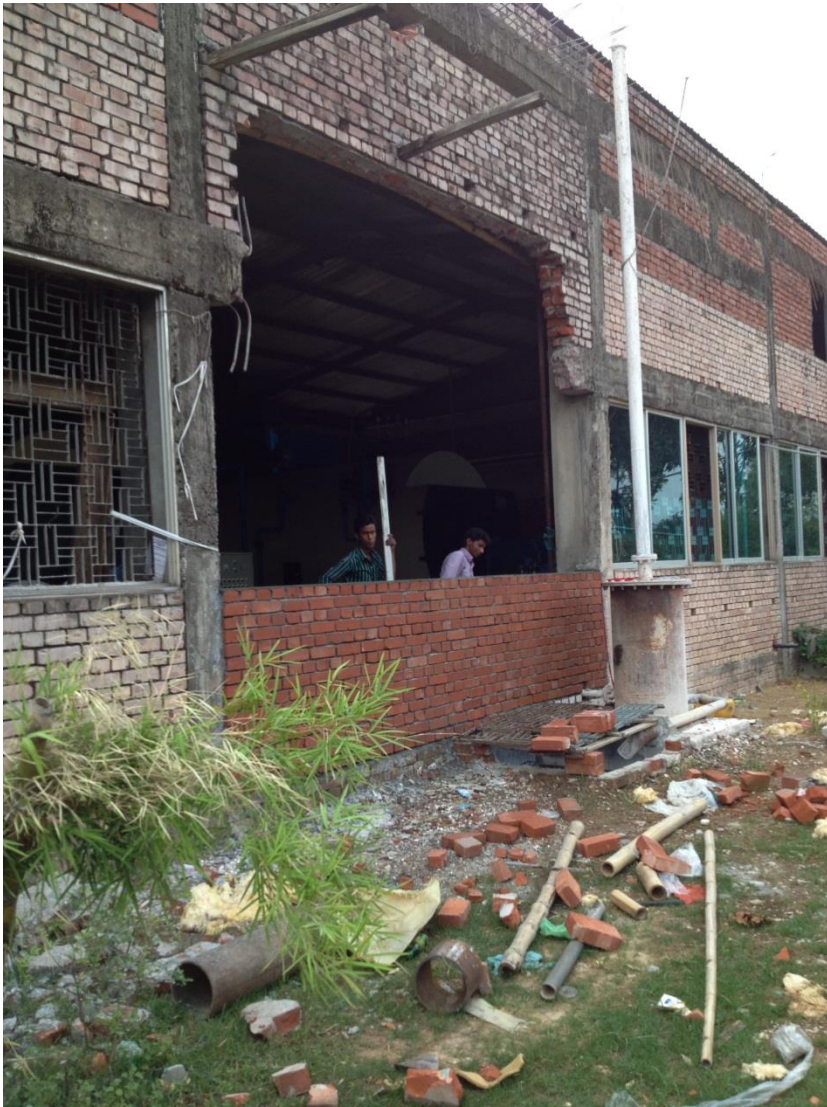
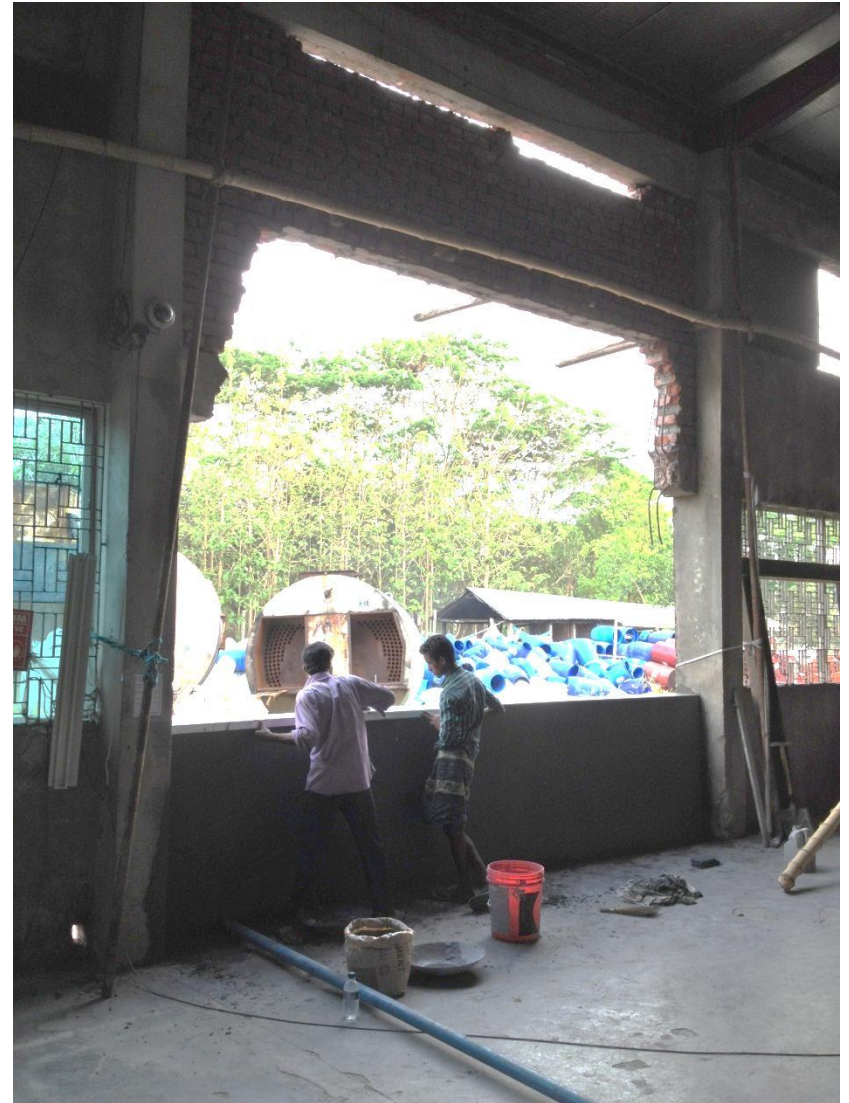
Opening without propping – Boiler building

Temporary opening formed in Boiler building without propping

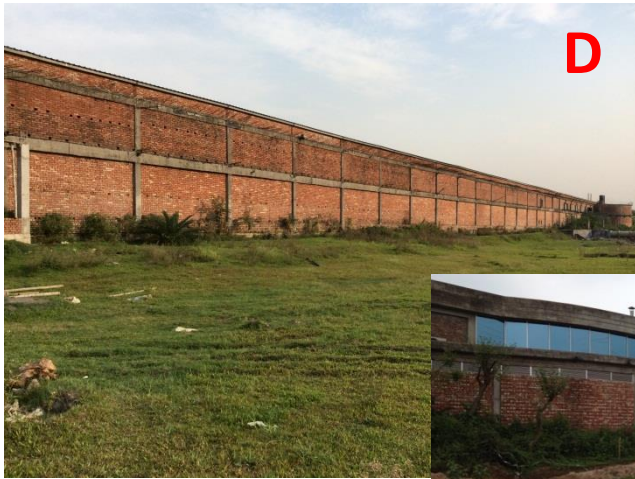
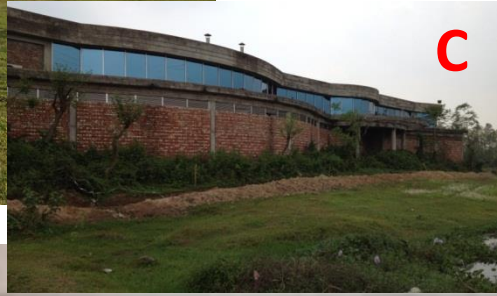
Lateral stability of Building 1 in E-W direction

- Lateral stability East-West relies on façade columns (A) cantilevering from small pad foundations (B).
- At the southern end of the building the curved structure along the W elevation (C) buttresses the columns, but most of this structure (D) has yet to be built.

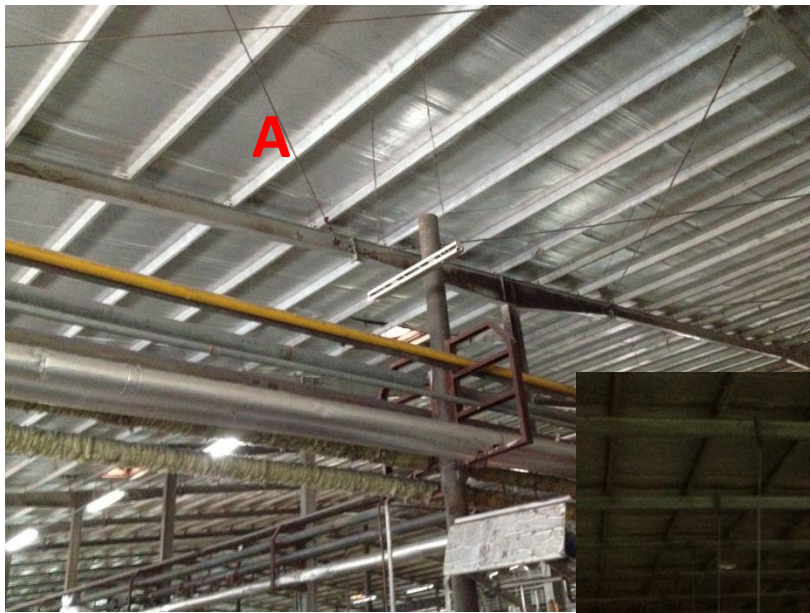
Lateral stability of Building 1 in N-S direction

- In the North-South direction (36 bays), there is bracing across the width of the building (A) in bays 6 and 15 only.
- Vertical bracing missing – stabilised partially on West side.

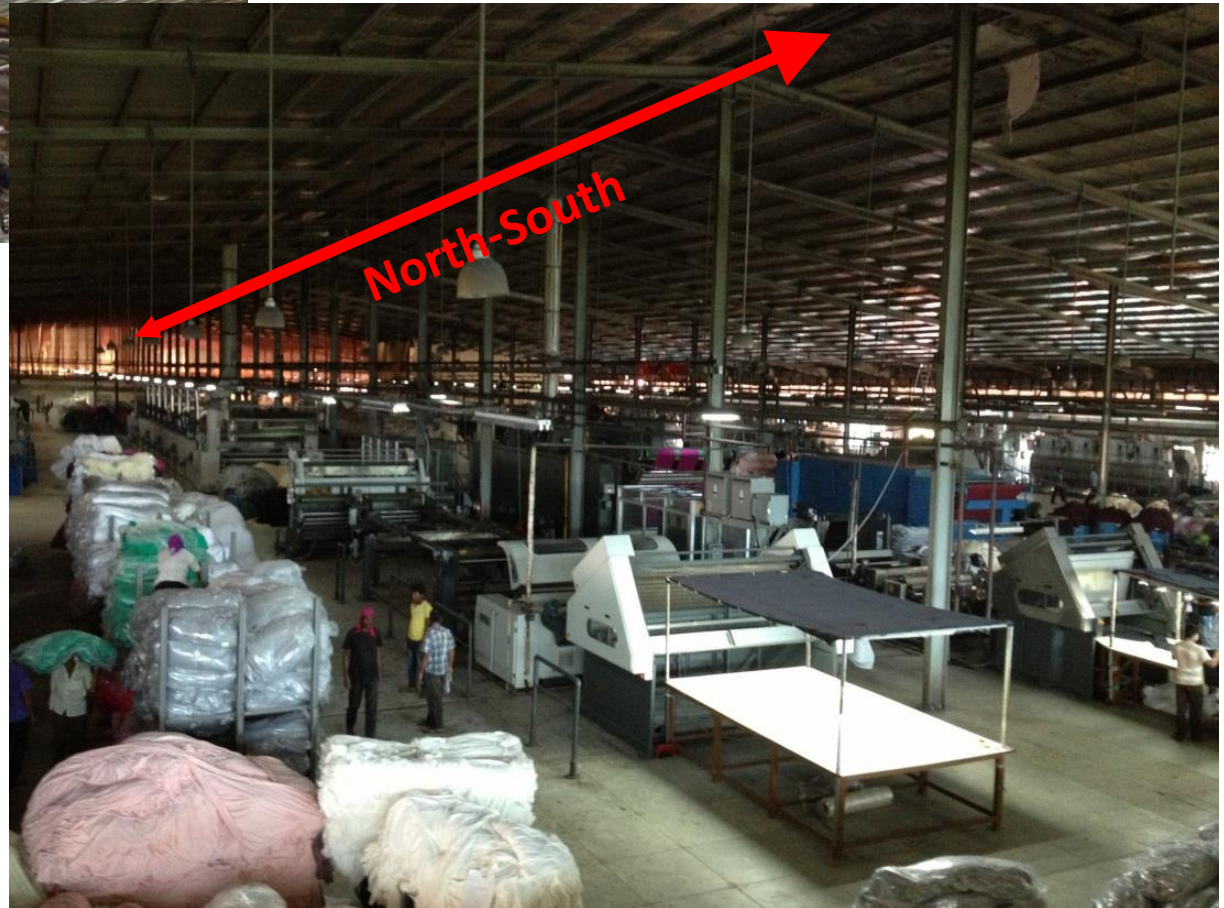
Lateral stability of North gable of Building 1

- Wind load on north gable is resisted by columns cantilevering from small pad foundations, as the mezzanine which buttresses the columns is not yet constructed.

7	Wind load on gable walls of Building 1 and Boiler building	Building Engineer to advise on measures to stabilise gable columns and walls if required.	6-months

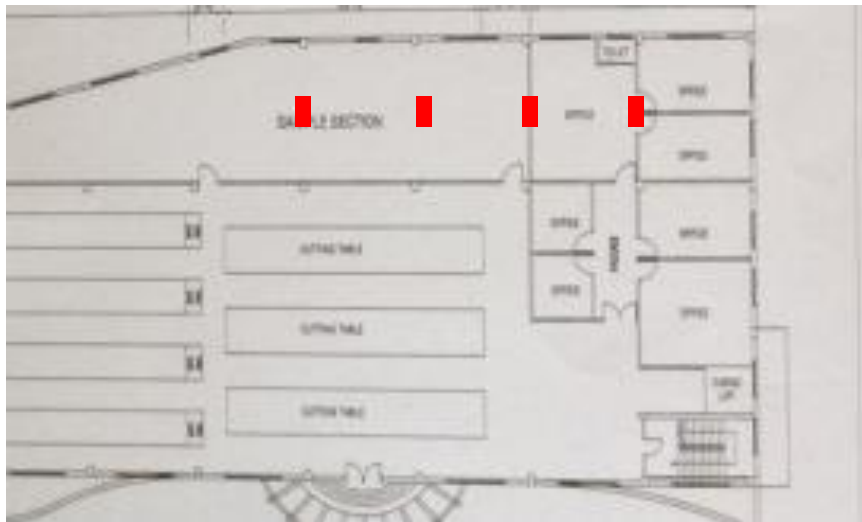
Propped beams in Finish Fabric area of Building 2 (under 1st Floor Sample section)

- 4 Beams display a very small sag and flexural cracking towards mid-span.
- 4 brick props (A) have been installed at ground floor and 3 at first floor.
- Brick props appear to be built directly off ground slab with no other foundation .

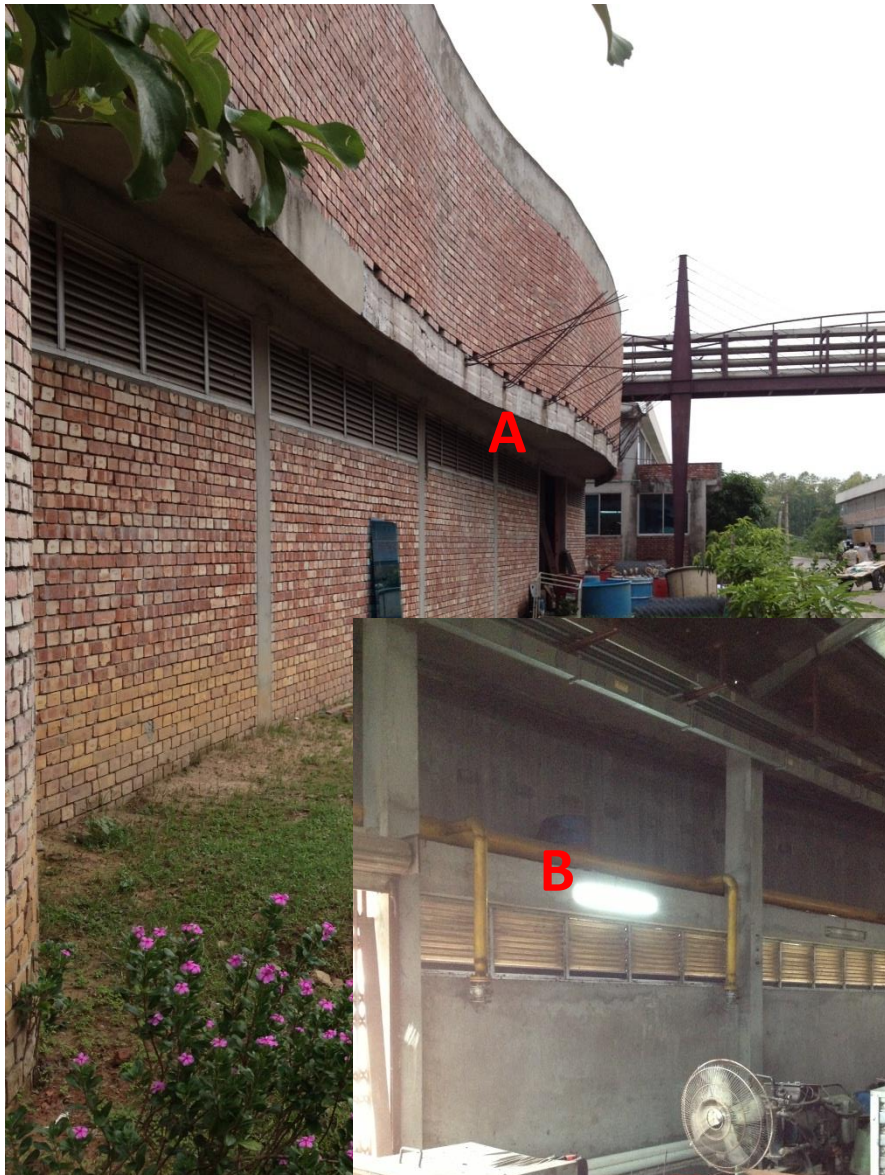
First floor cantilever to Generator building

- First floor cantilever (A) supporting brick façade does not have a backspan (B).
- Drawing suggests that this cantilever slab was actually intended to span between two lines of columns (C), but the outer line has not been constructed.
- Columns cantilever from small pads (D).

Item No.	Observation	Recommended Action Plan	Recommended Timeline
8	Edge cantilever of Generator building	Building Engineer to check ability of facade columns and edge beams to resist bending and torsion from the first floor edge cantilever.	6-weeks
9	Edge cantilever of Generator building	Building Engineer to advise on remedial measures for cantilever slab structure if required.	6-months
10	Monitor performance of propped beams in Building 2	Building engineer to monitor behaviour of propped beams in Finish Fabric area (S-E side) of Building 2, and record any settlement of brick props or further deflection of beams.	6-weeks
11	Monitor performance of propped beams in Building 2	Building Engineer to provide remedial works to ensure effective propping of beams if required.	6-months

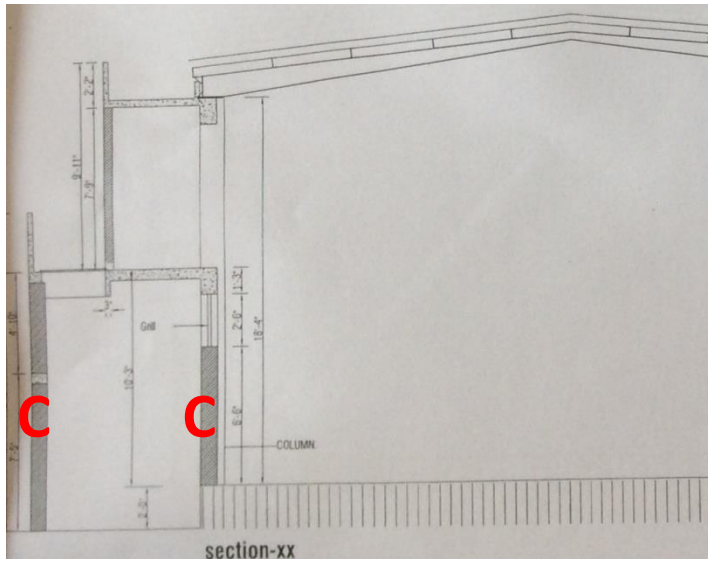
Stability of South gable of Boiler building

- Wind on gable will bend column (A) about its weak axis
