INITIAL STRUCTURAL INTEGRITY ASSESSMENT REPORT (SIAR)

Factory Name: **Delta Fashions Ltd**

Assessor: **Walter P. Moore**

Date: **28 May 2014**

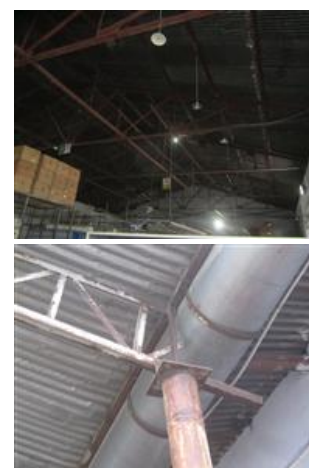
Question:	Are structural steel members free of corrosion, physical damage or other types of deterioration?
Priority Level:	Medium
Non-Compliance Level:	2
Description:	Structural Steel members as observed on roof of storage shed and entrance canopy were noted to be unpainted and indicating signs of corrosion.
Source of Findings:	
Suggested Plan of Action:	Complete further testing on areas of deterioration and have a qualified engineer develop a remediation plan along with periodic maintenance of all such members by providing anti-corrosive paints etc.
Suggested Deadline Date:	15 Oct 2014
Standard:	Alliance Standard Part 8 Section 8.26
