Delicate Garments Ltd

Rajaghat, Rajfulbaria, Savar, Dhaka, Bangladesh.

10th May 2014

Observations

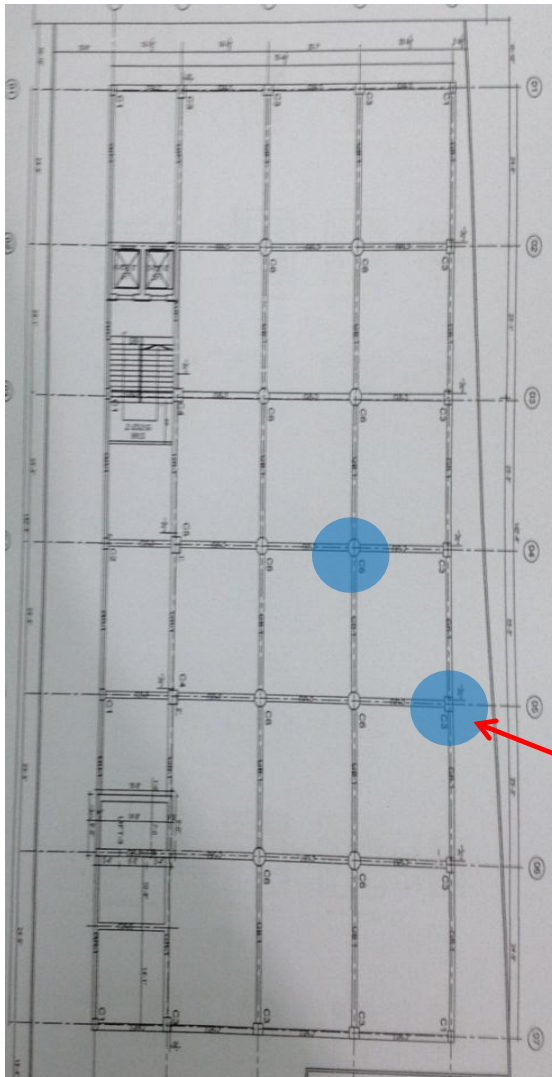
Schmidt Hammer and Ferros scanner testing on highlighted columns

Column investigations indicated stone aggregate.

Reinforcement was investigated using a ferros scanner.

Arrangement noted on site corresponded to structural drawings provided.

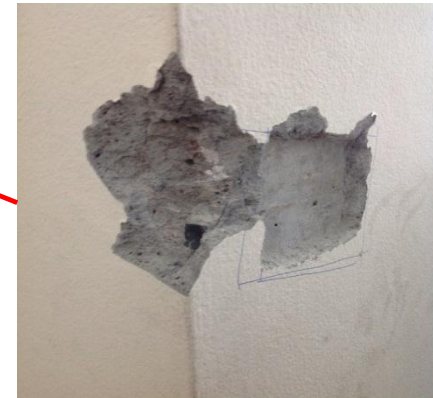
Column showing stone aggregate.

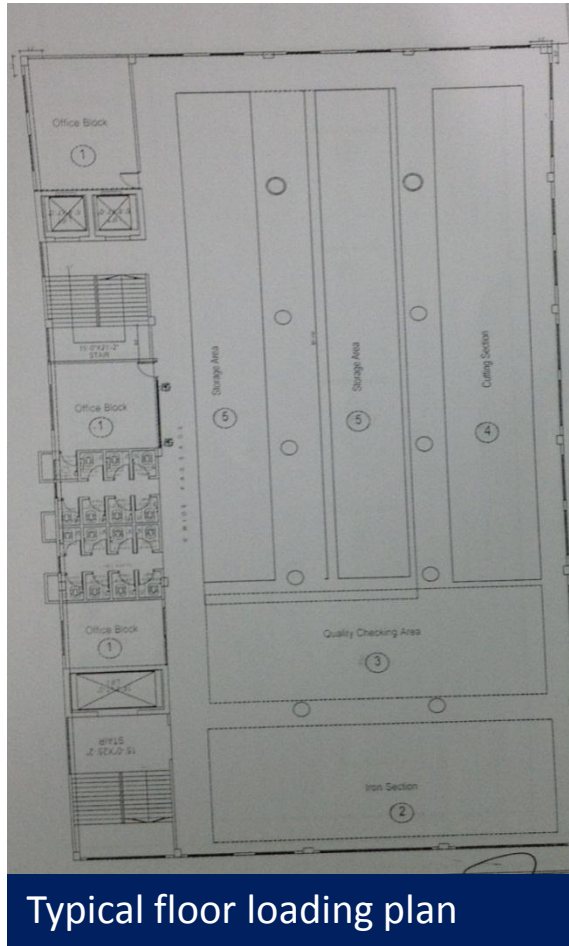
Typical floor loading plan

Allowable loading shown on Loading Plans is very high.

An allowable imposed load of 250 psf (12kPa) shown in all areas of all floors.

Existing loads are very significantly lighter.

- Factory Engineer to revise allowable loading document to include maximum allowable load of 5kPa and check capacity of slabs and beams under this loading.

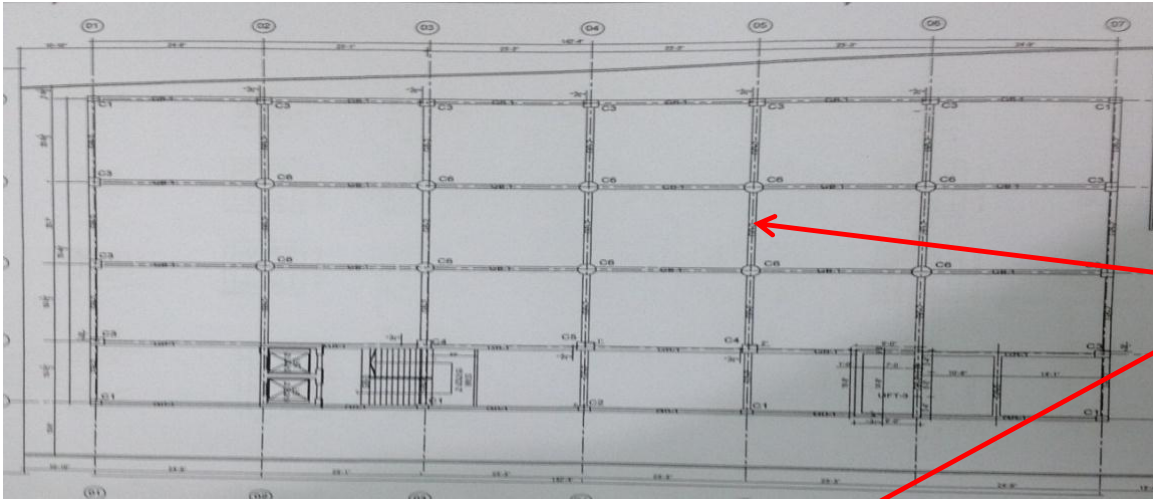
Cracks along line of ground beams may be the result of settlement of the filling under the floor slab. Cracking is visible in areas without floor finish.

- Factory Engineer to monitor settlement of the ground floor slab and note if any settlement occurs in foundations to the main structural elements.

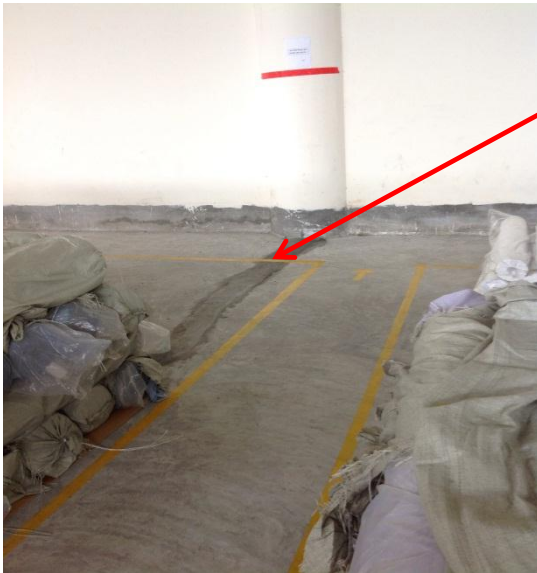
Extent of cracking

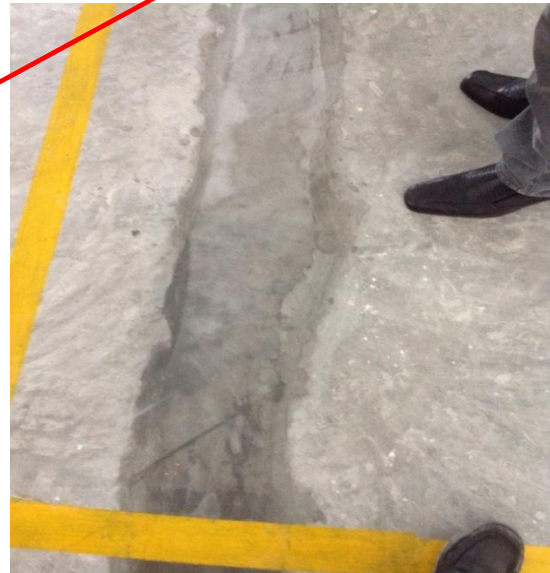
Crack over ground tie beams
