# Cotton Dyeing & Finishing Mills Ltd

10 No. Habirbari PO, Seed Store Bazzar Thana, Valuka, Mymensing, Dhaka  
(+24.315N, 90.38389E)

10 May 2014

# Observations Garments Building

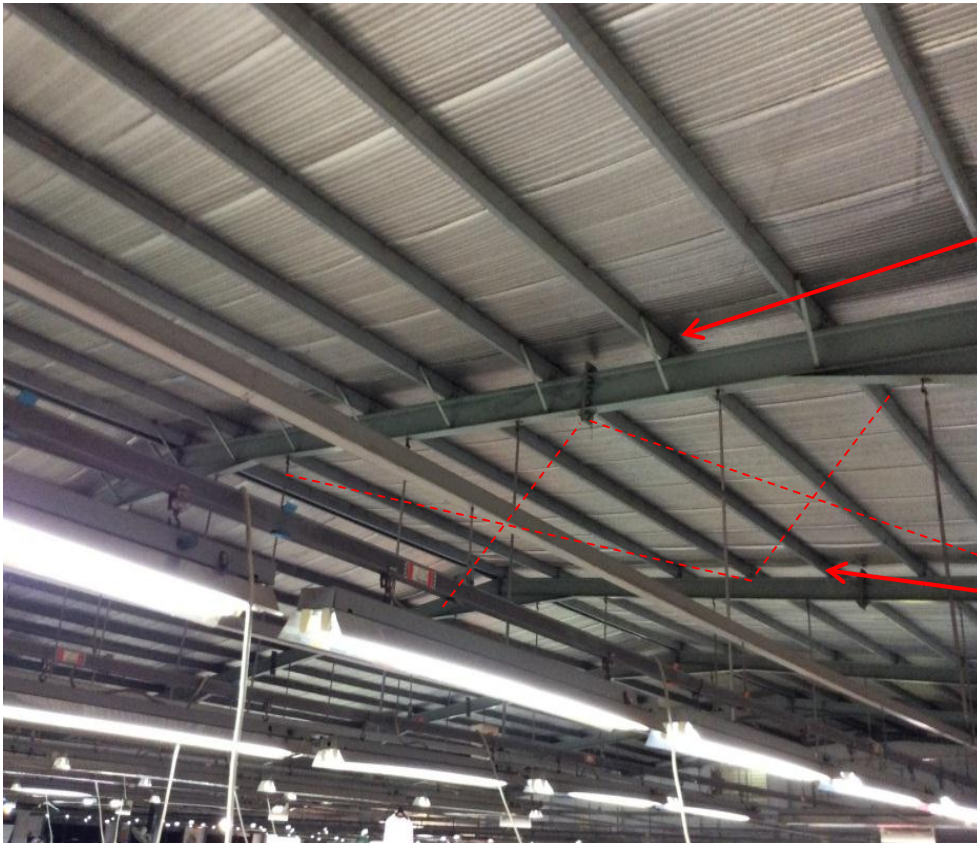
## **Incomplete bracing and inconsistent restraint detail to steel rafter**

**Compression flange restraints for roof rafter steel are provided at a limited number of locations.**

**Roof horizontal bracing for lateral stability of steel roof structure is incomplete. Building Engineer to review horizontal and vertical bracing.**

**Structural steel columns do not correspond with sizes shown on building section drawing. Building Engineer to review adequacy of steel roof structure.**

**Building Engineer to review and confirm that these are provided in accordance with the design.**

- The design of the steel roof should be checked by the Building Engineer and, if required, upgraded to support code vertical and wind loads. Specifically the provision of roof bracing (horizontal and vertical) and compression flange restraints should be reviewed.

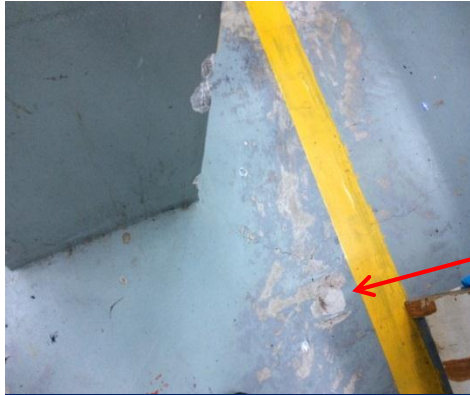
**Cracks in 1<sup>st</sup> floor slab**

**Building Engineer to prepare controlled loading plans, based on floor slab and column capacity, for all floors which will designate allowable storage density and where storage may be placed. Crack repairs to be carried out as necessary.**

- Produce and actively manage a loading plan for all floor plates within the factory giving consideration to floor capacity and column capacity.
- Building Engineer to review typical floor finish cracks at ground and 1<sup>st</sup> floors and confirm that cracking is in finishes only. Where required, remedial works to be carried out.

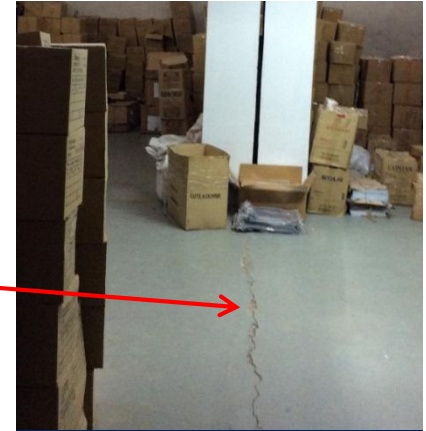
**Cracks in Ground floor slab**

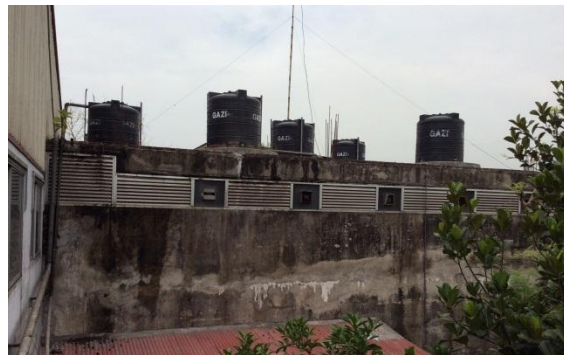
**8 No. 2000 litre water tanks above the East extension**

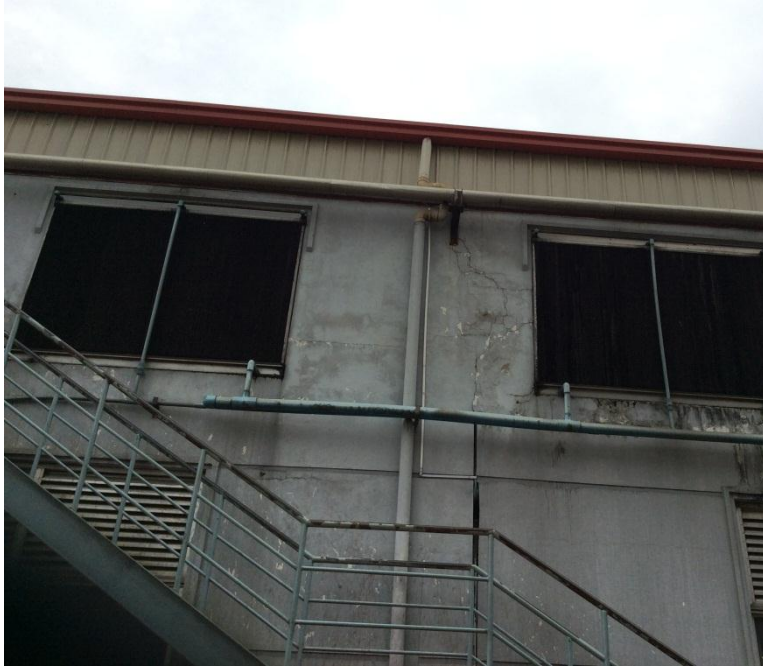
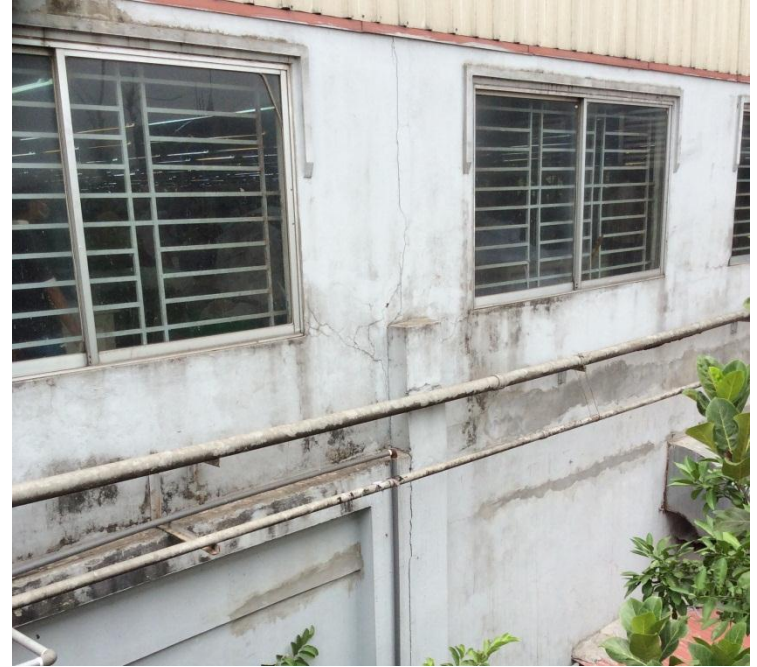
**Façade cracks visible on elevations of the Garments Building.**

**Building Engineer to conduct routine inspection and issue maintenance schedule for façade brick walls**

- Building Engineer to inspect area where cracking has occurred and propose a suitable repair to ensure that rainwater does not penetrate the building fabric.
- Building Engineer to provide a method statement for the on-going maintenance of the external facades.

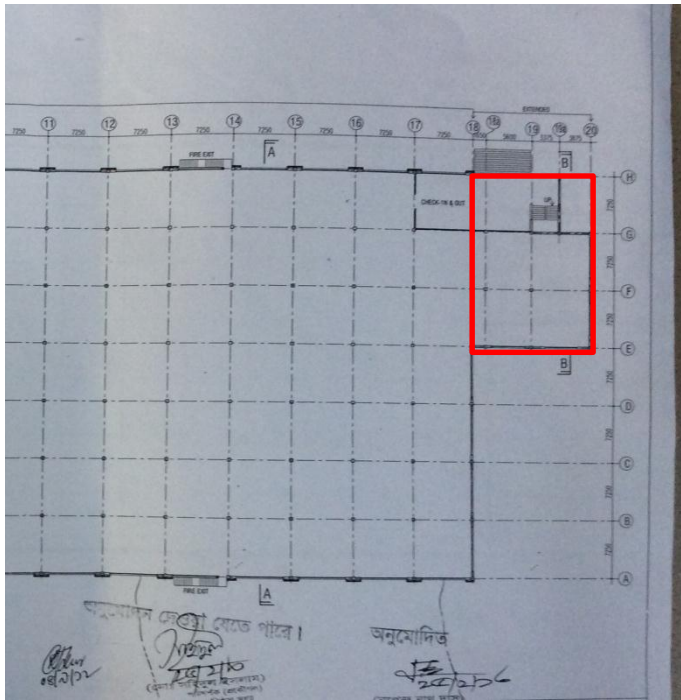
As constructed Eastern extension is rectangular on plan – this differs to layout shown on drawing

Building Engineer to check all drawings and update to match as constructed building.

- Building Engineer to survey as constructed building. Updated drawings to be prepared showing the correct as constructed layout including the steel frame structure.
- Update controlled loading plans for all floors designating allowable storage density and where storage may be placed.

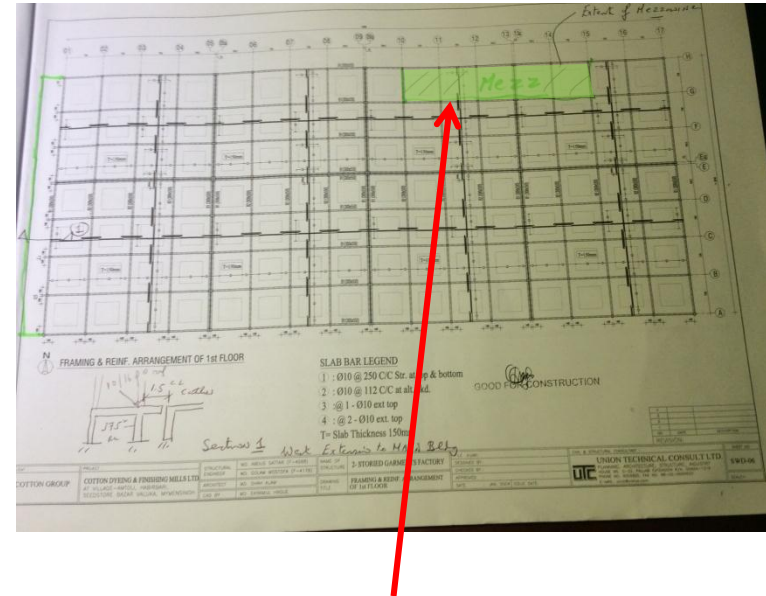
Missing drawings for the Mezzanine floor of the Garments Building

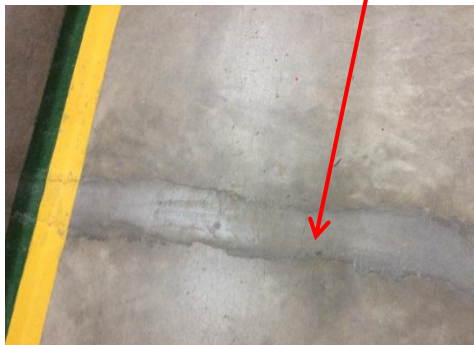
**1<sup>st</sup> floor slab**

**Building Engineer to prepare controlled loading plans, based on floor slab and column capacity, for all floors which will designate allowable storage density and where storage may be placed. Crack repairs to be carried out as necessary.**

- Produce and actively manage a loading plan for all floor plates within the factory giving consideration to floor capacity and column capacity.
- Building Engineer to review typical floor finish cracks and confirm that cracking is in finishes only. Where required, remedial works to be carried out.

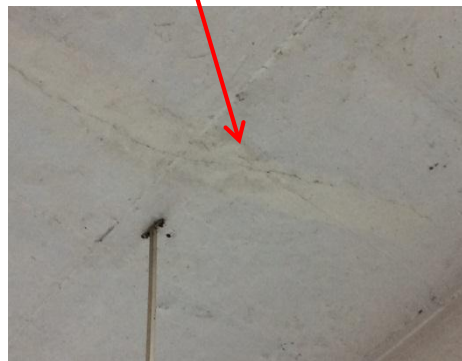
**2<sup>nd</sup> floor slab soffit**

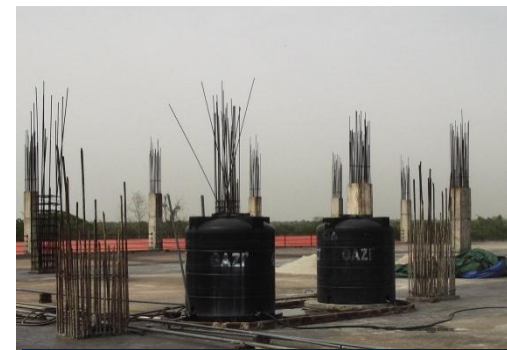
**Water tanks loads**

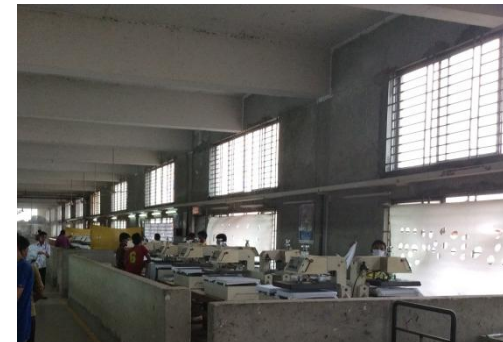
**Equipment loads**

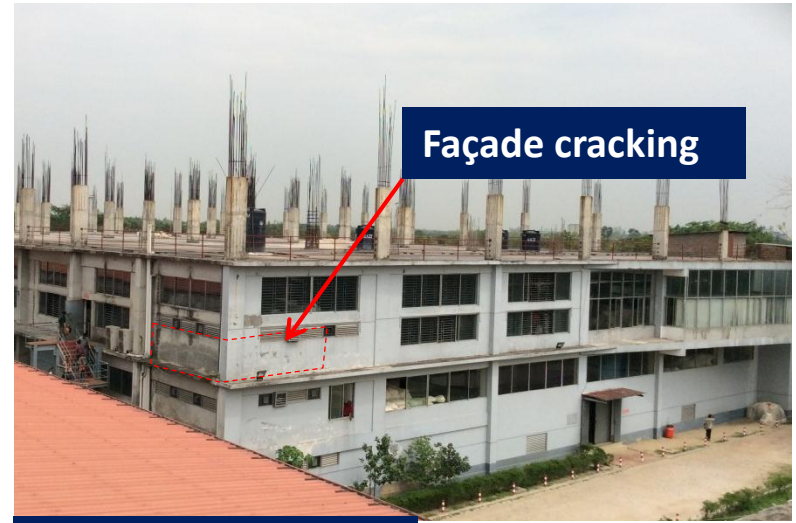
**Façade cracking**

- Building Engineer to inspect area where cracking has occurred and propose a suitable repair to ensure that rainwater does not penetrate the building fabric and cantilever slab.
- Building Engineer to provide a method statement for the on-going maintenance of the external facades.

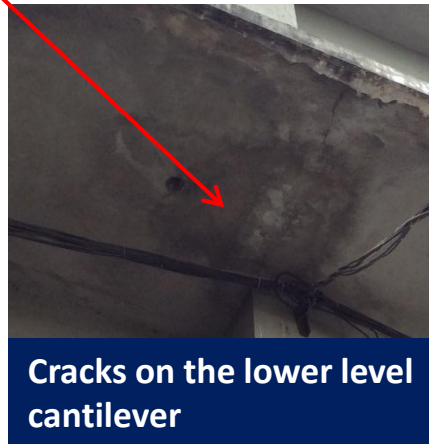
**Cracks on the lower level cantilever**

**Cracks on the upper and lower cantilevers propagating from the column towards the tip of the cantilevers**

**Building Engineer to investigate reasons for cracking and implement repairs as necessary**

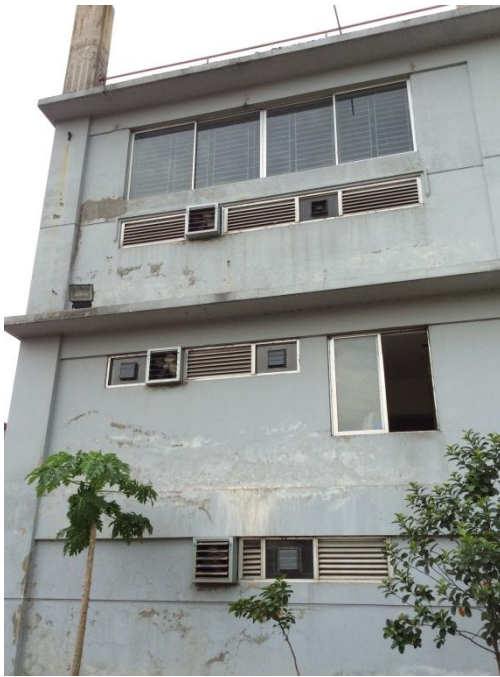
**Façade cracks visible on elevations of the Knitting and Dyeing building.**

**Building Engineer to conduct routine inspection and issue maintenance schedule for façade brick walls**

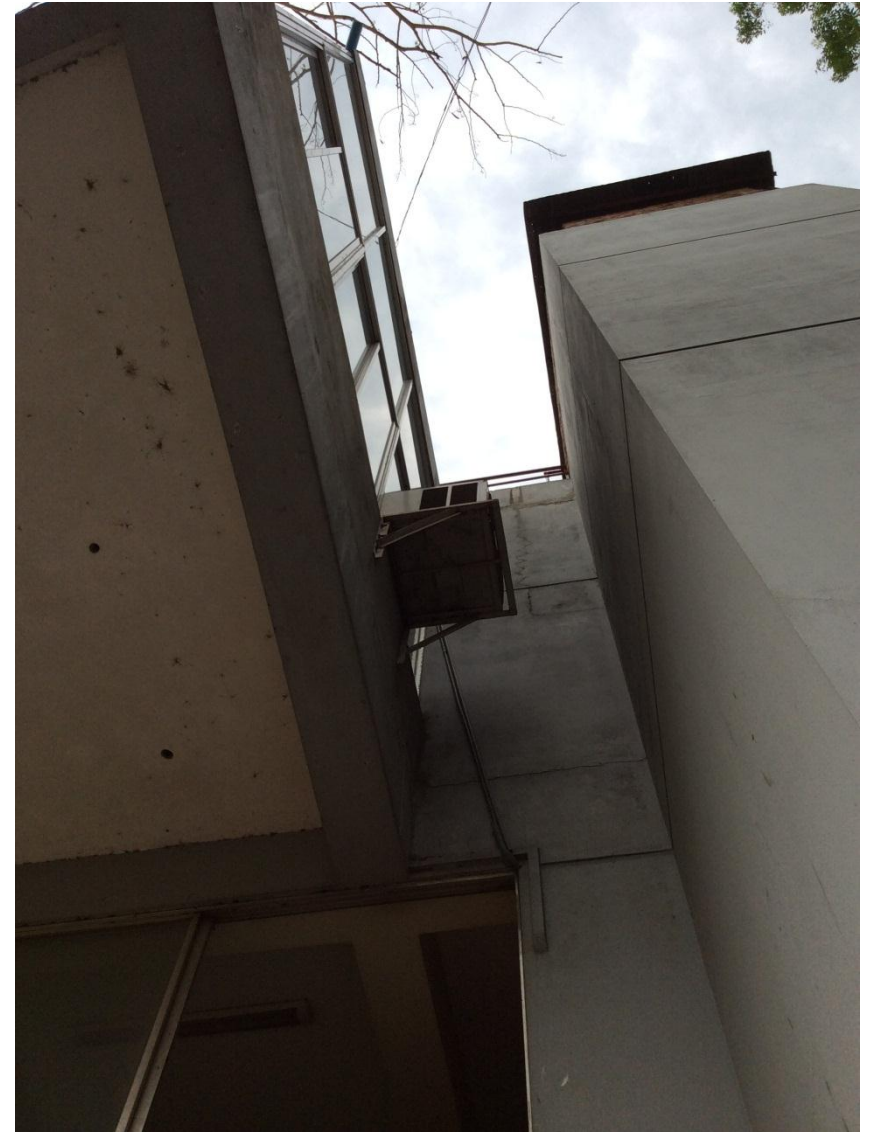
**Cracks on façade brickwork walls**

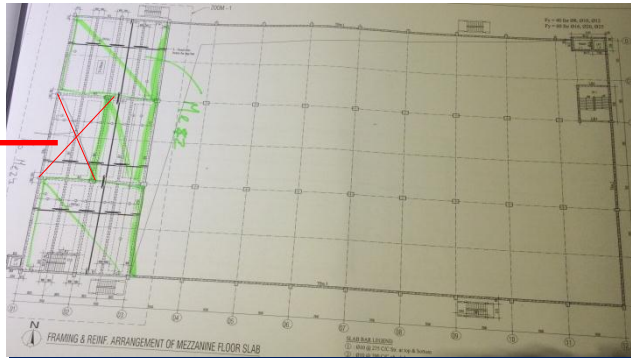
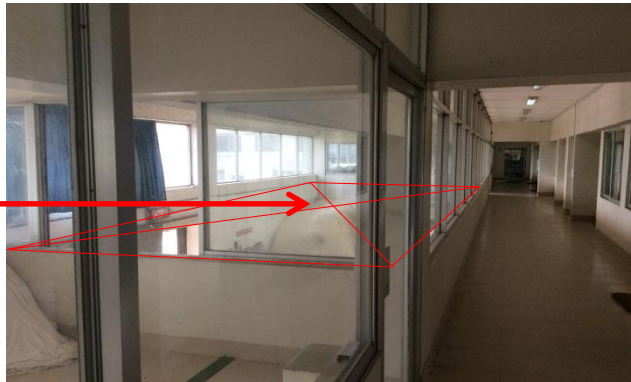
**Mezzanine RC drawing**

**Mezzanine as constructed**

Mezzanine is shown covering 2 full bays at the west end of the building on the RC drawing. As constructed it only covers 1 bay at the middle section of the mezzanine.

**Building Engineer to check all drawings and update as constructed.**

- Building Engineer to survey as constructed building. Updated drawings to be prepared showing the correct as constructed layout.
- Update controlled loading plans for all floors designating allowable storage density and where storage may be placed.

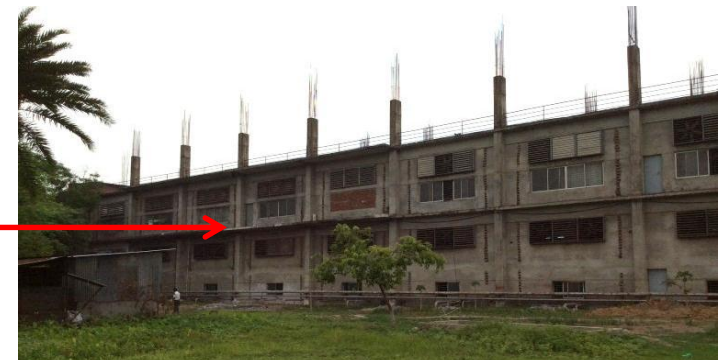
**Cantilever slabs as constructed – not shown on drawings**

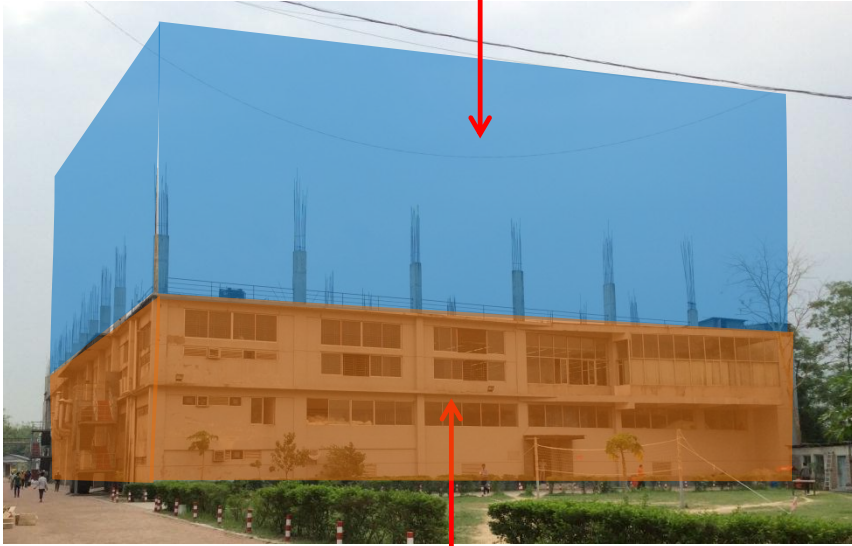
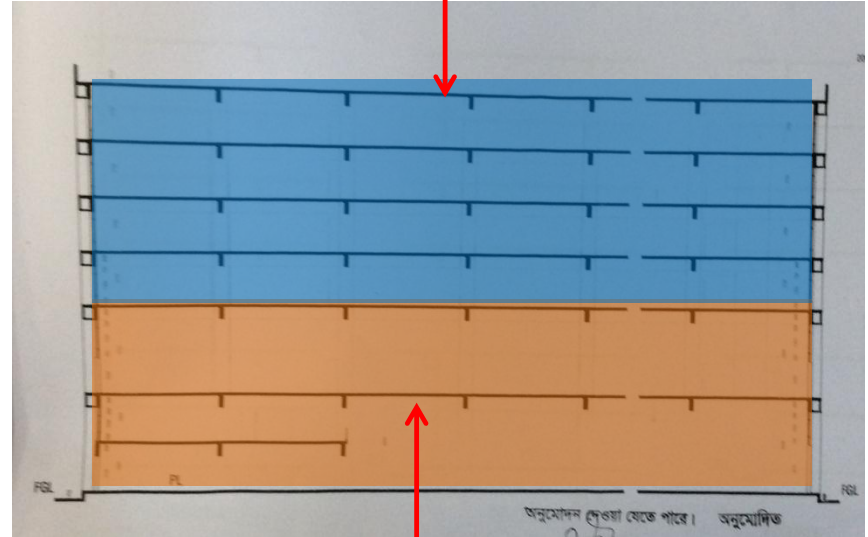
Permit for 4 more storeys

Existing structure – 2 storeys

2 storeys currently constructed, permit drawings allow for 6 storeys. Building Engineer to review structural design and concrete strength within existing columns prior to commencing construction of any further building extension above the existing 2 storeys.

**Any proposed additions to the existing building structure, including additional storeys, should be reviewed by the Building Engineer**

- If any additions to the building structure are proposed, the Building Engineer shall provide calculations showing the structural adequacy of all columns taking into account any additions to the existing structure, the loading plans and as built structure, including insitu concrete strength testing.
