# INITIAL STRUCTURAL INTEGRITY ASSESSMENT REPORT (SIAR)

Factory Name: **Glory Fashionwear Ltd**

Assessor: **Emkay Enterprises LTD**

Date: **26 Feb 2014**

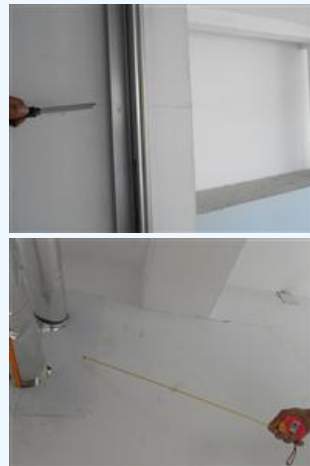
| Description: | Horizontal crack at 5" brick wall at Brick-Lintel Joint in the reception area. In the Cantilever portion, between interface of beam and wall, crack in plaster have been found in all levels above grade except top level. (Grid Location → between (I), (J) and (3), (2); (C), (B) and west to (1). (Canti.) (B), (C); (3) | |
| Source of Findings: | Photograph: Horizontal crack in Brick wall Brick-Lintel interface Horizontal crack in beam-wall interface | |

| Suggested Plan of Action: | Have a qualified structural engineer provide further testing and analysis of distress, settlement, shifting, or cracking in columns or walls and provide a remediation plan to correct noted issues. | |
