INITIAL STRUCTURAL INTEGRITY ASSESSMENT REPORT (SIAR)

Factory Name: **Silver Composite Textile Mills**
Address: **B.K. Bari, Taltoli, Moniur, Mirzaur Bazar, Gazipur
Gazipur Dhaka Bangladesh**
Assessor: **Emkay Enterprises LTD**
Date: **27 Jun 2015**

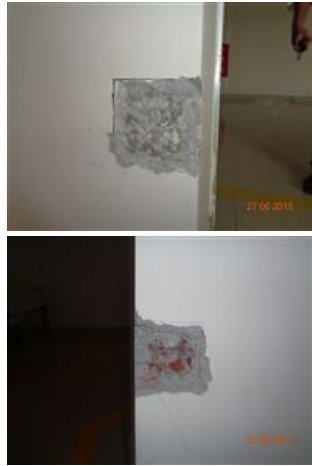
Priority Level:	High	
Non-Compliance Level:	2	
Description:	<p>Main Production Building: The building was designed for 7 stories but approved and constructed up to 6 storied. FoS calculations were completed assuming an average live load of 42 psf for working area; 80psf for stair area and also considering over head water tank(OHWT) as per design for the current 6-story configuration. A concrete compressive strength of 2370 psi was assumed based on the Alliance Standard minimum for SCAC (observed on-site). A 60 ksi reinforcing steel strength was assumed according to design documents. Column FoS results, current 6-story building configuration: Central column= 2.34; Corner column at stair= 2.08; Corner column at expansion joint= 2.07; Edge column= 2.25; Edge column at expansion= 2.16; Edge column at expansion below OHWT= 1.80; Edge column at stair= 1.95; Edge column at stair below OHWT= 1.68. Residence & Medical Building: The building was designed and constructed for 5 storied. FoS calculations were completed assuming an average live load of 42 psf for working area and 80psf for stair area for the current 5-story configuration. A concrete compressive strength of 2045psi was assumed based on the Alliance Standard minimum for MCAC (observed on-site). A 60 ksi reinforcing steel strength was assumed according to design documents. Column FoS results, current 5-story building configuration: Central column= 3.15; Central column at stair= 2.36; Corner column= 3.68; Corner column at stair= 4.19; Edge column= 4.82. FoS results for the Main Production Building warrant validation of in-situ concrete compressive strength via coring.</p>

Source of Findings:	Uploaded Document: 1. FoS calculation of Main Production Building; 2. FoS calculation of Residence & Medical Building.	
Suggested Plan of Action:	The in-situ concrete compressive strength in the Main Production Building should be verified via core testing conducted under the guidance of a qualified structural engineer.	
Suggested Deadline Date:	31 Aug 2015	
Standard:	Provide results of preliminary calculations in space provided. a) column capacity; FoS > 1.86 - Safe b) column capacity; FoS 1.5 -1.86 - Needs Evaluation c) Column capacity; FoS 1.25-1.5 - Needs Evaluation d) Column capacity; FoS <1.25 - Unsafe In case of a critically low FoS (<1.25), consider Immediate Escalation Protocol
