# **FIRE SAFETY INSPECTION REPORT**

**Factory Name: Dekko Designs Ltd. (New Building)**

**ACCORD ID: 12523**

**Date: 25th August' 2016**

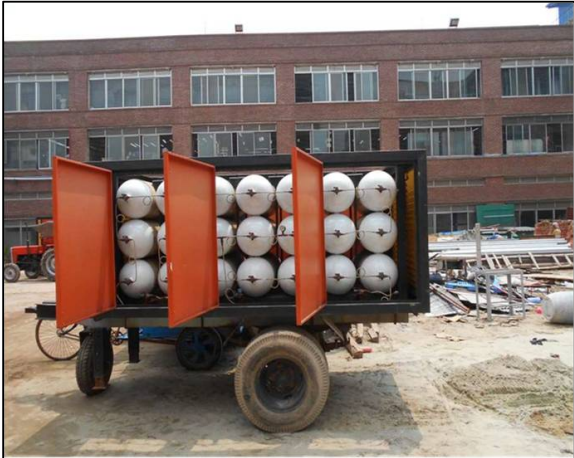
| SI No. | Category | Findings | Required Action | Remediation Time Frame | Pictorial Evidence |
|---|---|---|---|---|---|
| 1 | <b>Fire rated construction</b> | The factory is using/storing liquified gas cylinders without proper separations. | Remove them from the factory building.<br>or<br>Provide 2-hr rated room for using/storing liquified gas cylinders and ensure proper ventilation of that room. Source of fire such as electrical connection is prohibited. | Within 1 month | |

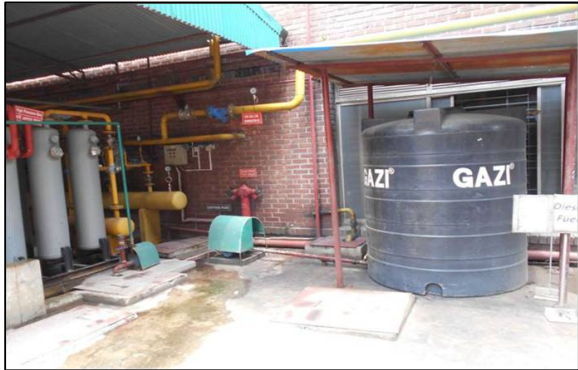
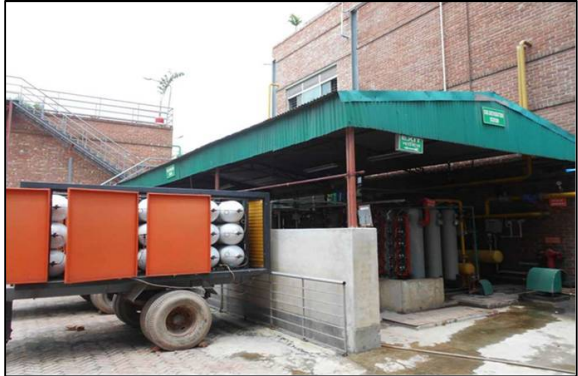
| SI No. | Category | Findings | Required Action | Remediation Time Frame | Pictorial Evidence |
|---|---|---|---|---|---|
| 2 | <b>Fire rated construction</b> | The CNG distribution station is not seperated from the surrounding occupancies by fire rated construction. | Provide 2-hr rated seperation and ensure proper ventilation of that room. Source of fire such as electrical connection is prohibited. | Within 3 months | |

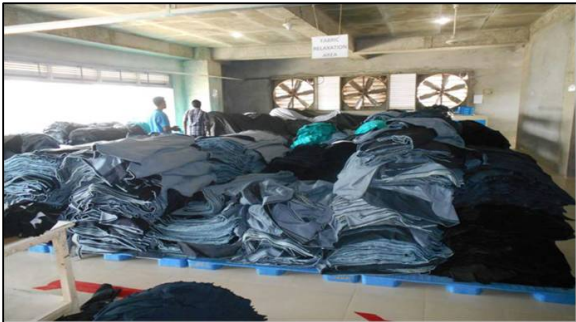
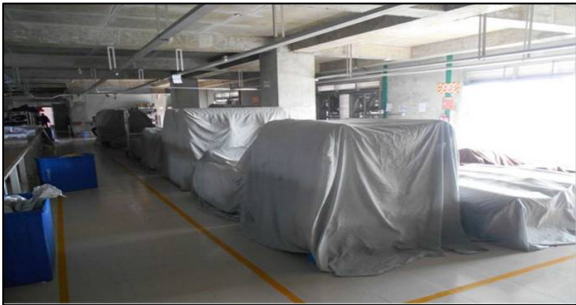
| SI No. | Category | Findings | Required Action | Remediation Time Frame | Pictorial Evidence |
|---|---|---|---|---|---|
| 3 | Fire rated construction | Areas used for in-process storage of combustible materials are open to the surrounding occupancy. <b>(2nd and 3rd floor, cutting section)</b> | <p>Provide defined storage areas and limit the storage arrangement as follows:-</p> <ol style="list-style-type: none"> <li>1. General Condition: Maximum height of 2.4m and maximum area of 23m<sup>2</sup>. Separate areas of unenclosed combustible storage by a minimum clear distance of 3m.</li> <li>or</li> <li>2. Enclose the storage area from the surrounding occupancy with a minimum 1 hour construction.</li> </ol> | Within 3 months | |

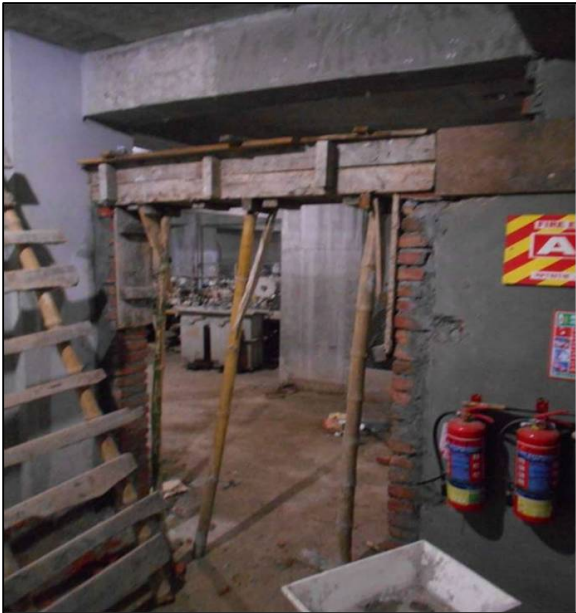
| SI No. | Category | Findings | Required Action | Remediation Time Frame | Pictorial Evidence |
|---|---|---|---|---|---|
| 4 | Fire rated construction | The south-west exit stair is not separated from basement by fire-rated construction. <b>(Basement floor)</b> | <p>Stair shall be enclosed with a minimum 2-hr fire-rated construction. Seal all unprotected openings and provide minimum 1.5-hr fire rated doors to separate the exit stairs from work areas and other building spaces on all floor levels. Ensure that the fire doors are self-closing, positive latching and that they are provided with fire exit (panic) hardware where serving production floors.</p> <p>If fire doors are required to be held open for functional reasons, provide automatic-closing devices tied to the fire alarm system.</p> | Within 3 months | |

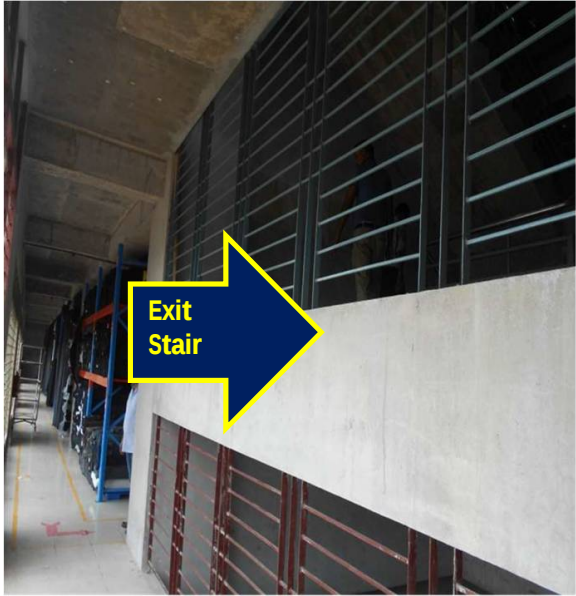
| SI No. | Category | Findings | Required Action | Remediation Time Frame | Pictorial Evidence |
|---|---|---|---|---|---|
| 5 | Fire rated construction | Unsealed penetrations and openings are located in North-East exit stair enclosures. <b>(All floors)</b> | Seal all penetrations and openings in the wall of exit enclosure walls (full thickness of the wall) by fire rated materials to maintain the fire resistance rating. | Within 3 months | |

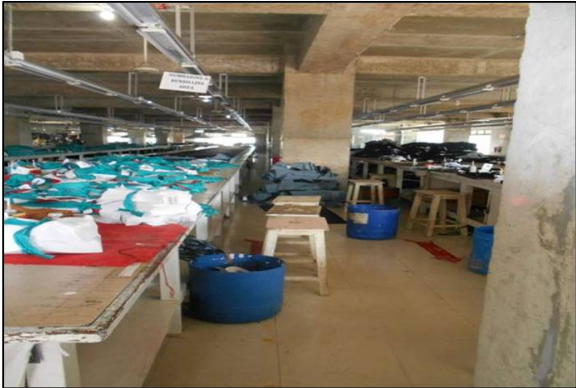
| SI No. | Category | Findings | Required Action | Remediation Time Frame | Pictorial Evidence |
|---|---|---|---|---|---|
| 6 | Egress | Width of aisles is less than 0.9m (36-in.). <b>(2nd floor)</b> | Aisles shall be provided with a minimum unobstructed clear-width of 0.9 m (36 in.). | Within 3 months | |

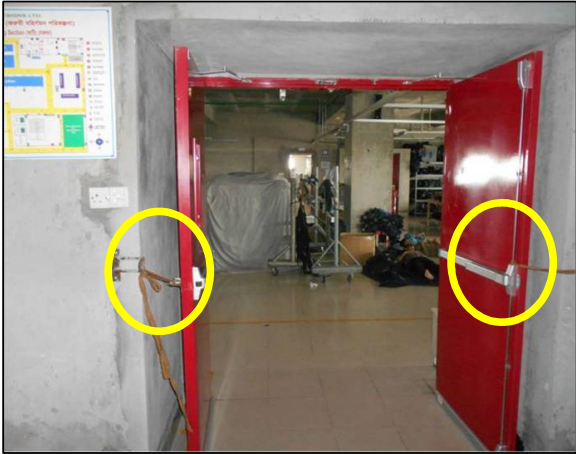
| SI No. | Category | Findings | Required Action | Remediation Time Frame | Pictorial Evidence |
|---|---|---|---|---|---|
| 7 | Egress | Fire door has been installed in most of the exits at production and store floors. Doors were found forcibly opened for functional purpose by non-mechanical means. <b>(All floors)</b> | If fire doors are required to be held open for functional reasons, provide automatic-closing devices interfaced with the fire alarm system. | Within 3 months | |

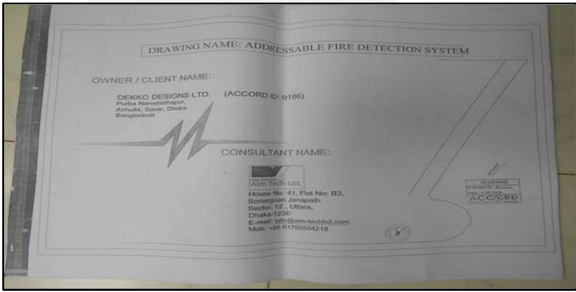
| SI No. | Category | Findings | Required Action | Remediation Time Frame | Pictorial Evidence |
|---|---|---|---|---|---|
| 8 | Fire Protection | Currently no Fire alarm system is operating. An addressible fire alarm system installation is on-going. Drawing for the fire alarm system has been reviewed by Accord. | Complete installation of fire alarm system as per NFPA-72. | Within 4 months | |

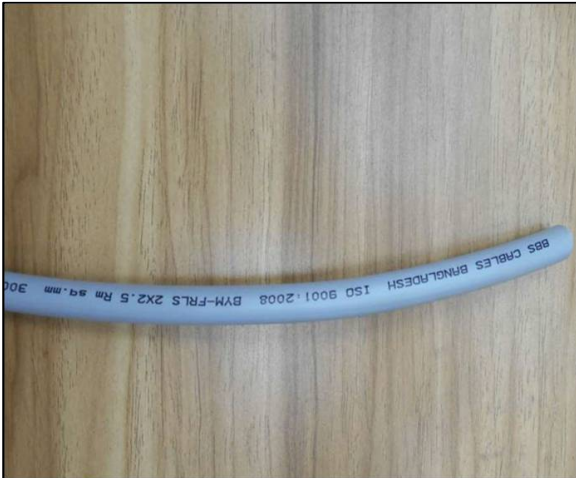
| SI No. | Category | Findings | Required Action | Remediation Time Frame | Pictorial Evidence |
|---|---|---|---|---|---|
| 9 | Fire Protection | Cables used for fire alarm system did not have any third party certification. | Factory have to prove whether the installed fire alarm cable has been certified by any third party or not. | Within 1 month | |

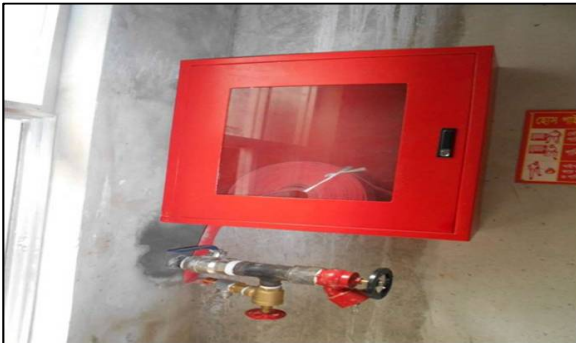
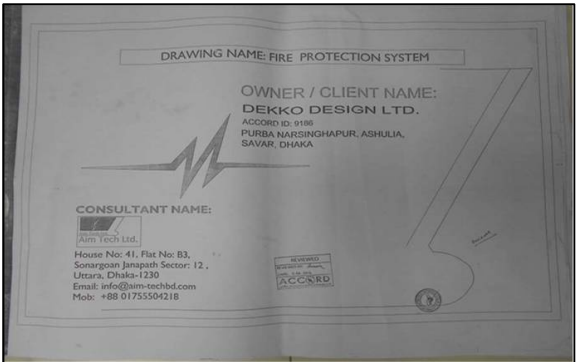
| SI No. | Category | Findings | Required Action | Remediation Time Frame | Pictorial Evidence |
|---|---|---|---|---|---|
| 11 | Fire Protection | The building has an occupied floor greater than 10 meter (33 feet) and a class (III) stand-pipe system installation has not been completed yet. Accord reviewed drawing was present on site. | Provide standpipe and hose system as per NFPA 14 & 20. | Within 4 months | |

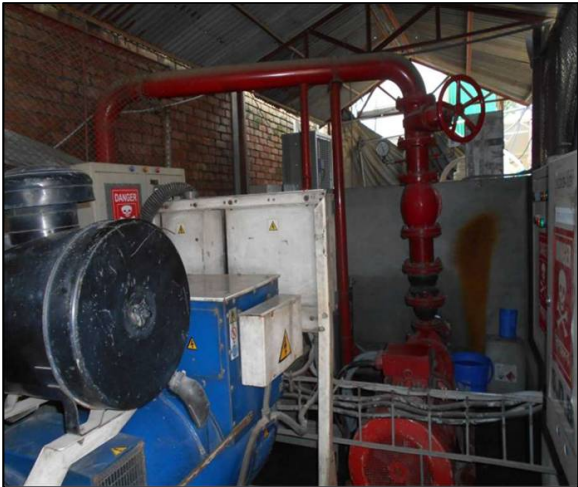
| SI No. | Category | Findings | Required Action | Remediation Time Frame | Pictorial Evidence |
|---|---|---|---|---|---|
| 12 | Fire Protection | Installed Fire pump used for the stand-pipe system is not as per NFPA-20. | Install dedicated fire pump following the requirements of NFPA-20. | Within 4 months | |

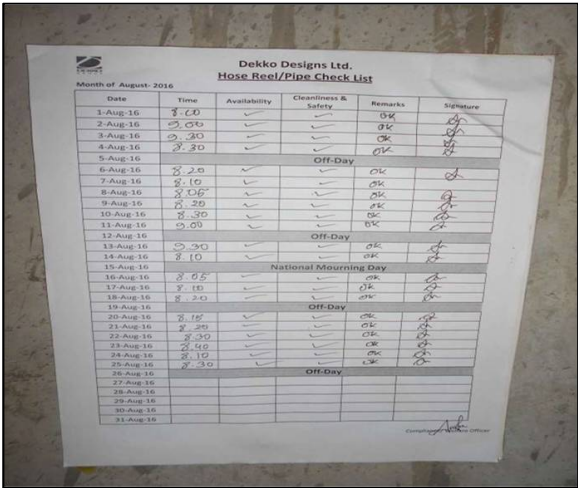
| SI No. | Category | Findings | Required Action | Remediation Time Frame | Pictorial Evidence |
|---|---|---|---|---|---|
| 13 | Fire Protection | Inspection, testing, and maintenance of the standpipe system is not in accordance with NFPA 25 or as per Accord standard. | Inspect, test and maintain the standpipe system and keep written records on-site, in accordance with NFPA 25 or as per Accord standard. | Within 3 months | |

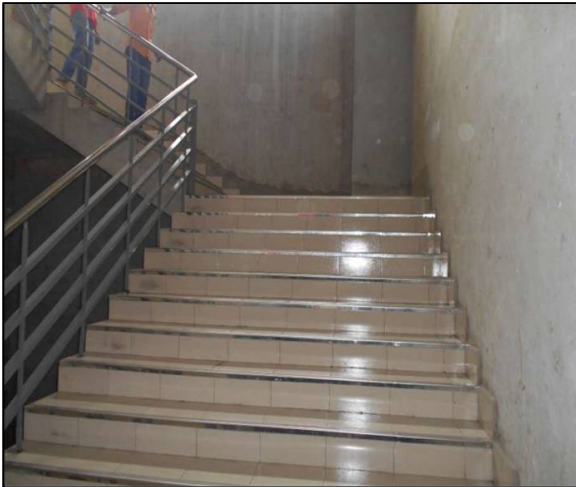
| SI No. | Category | Findings | Required Action | Remediation Time Frame | Pictorial Evidence |
|---|---|---|---|---|---|
| 16 | Egress | Width of exit stairs are more than 1.2 meter and not provided with handrails on both side. | Provide handrails on both side of exit stair having a minimum height 34 in. | Within 3 months | |

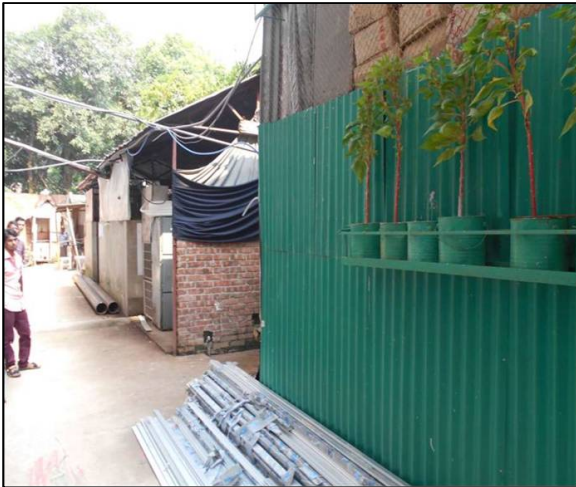
| SI No. | Category | Findings | Required Action | Remediation Time Frame | Pictorial Evidence |
|---|---|---|---|---|---|
| 18 | <b>Fire rated construction</b> | Fire pump room is not separated from other occupancies by fire rated construction. | Provide 2-hr fire rated separation for fire pump room<br>or<br>Relocate it 15.3m (50 ft.) away from any occupancies exposing the fire pump room. | Within 3 months | |

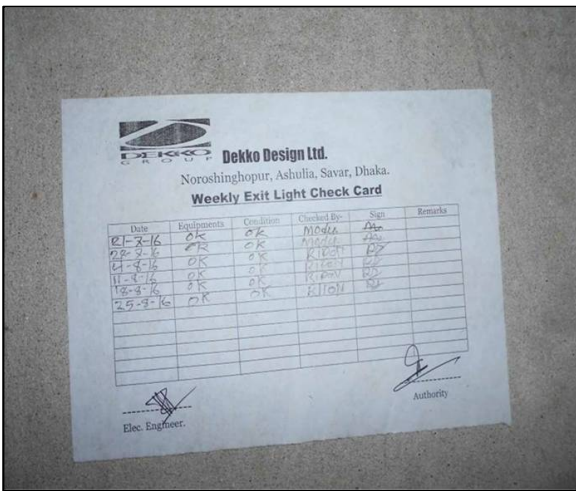
| SI No. | Category | Findings | Required Action | Remediation Time Frame | Pictorial Evidence |
|---|---|---|---|---|---|
| 19 | <b>Egress Lighting</b> | Inspection, testing, and maintenance for the exit sign and emergency lighting system was not in accordance with The ACCORD standard. | Inspect, test and maintain the exit sign and emergency lighting system in the accordance with The ACCORD standard. Keep written records on-site. | Within 3 months | |
