# MB Knit Fashion Ltd.

B/164-166, B/185-187 BSCIC, Fatullah, Narayanganj, Bangladesh.

6<sup>th</sup> September, 2016

# Observations

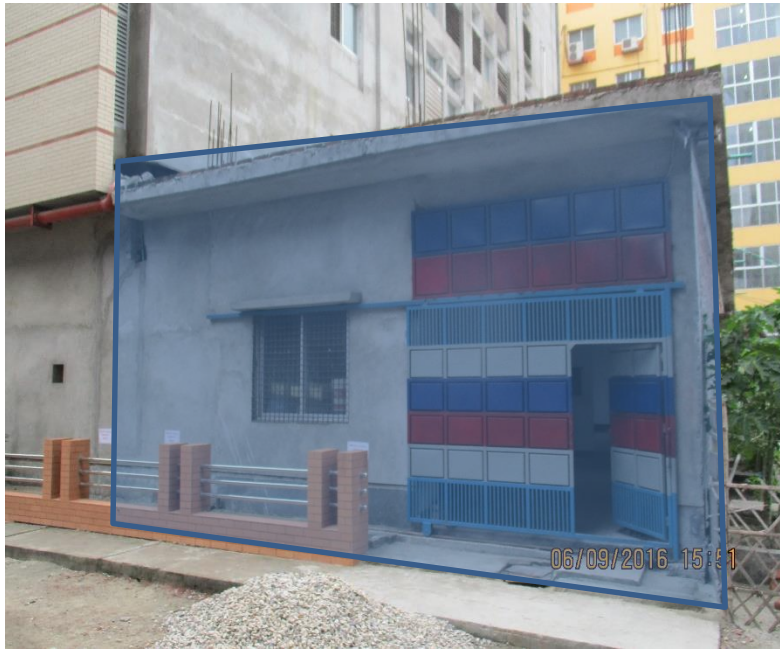
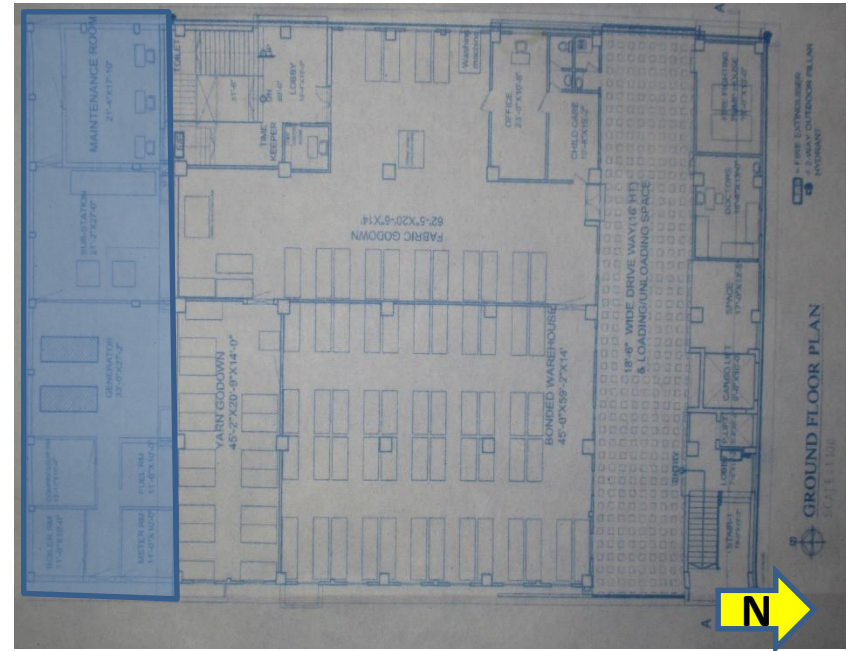
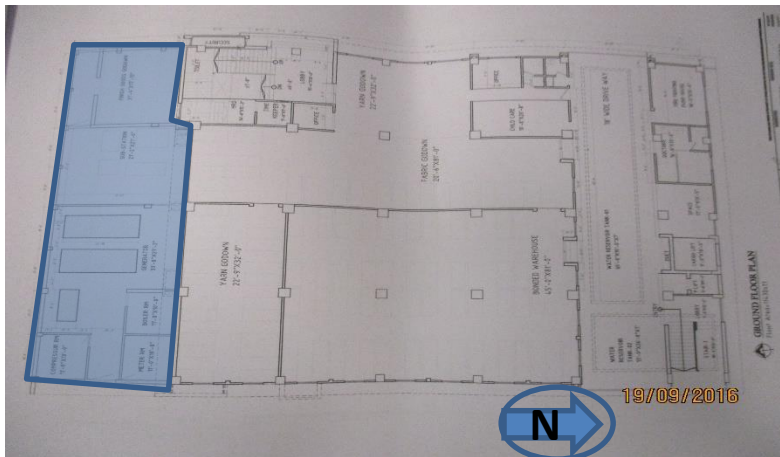
**As- Built Drawing of Generator Building was  
not available**

No detail drawing(As build structural)  
was found during inspection.

As- Built Drawing of Generator Building was not  
available

**Item 1:** Incompletion of As-Built Drawing of generator building

| Item No. | Observation | Recommended Action Plan | Recommended Timeline |
|---|---|---|---|
| 1 | Incompletion of As-Built Drawing of generator building | Building Engineer to produce a set of As Built drawing (Architectural & Structural) of generator building. | 6-weeks |

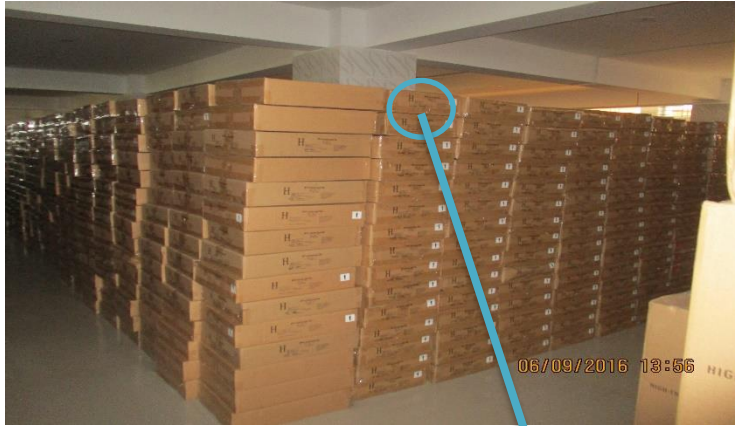
High Loading observed on 6<sup>th</sup> Floor

| Item No. | Observation | Recommended Action Plan | Recommended Timeline |
|---|---|---|---|
| 2 | Uncontrolled loading on floor area | Reduce floor loading down to 2Kpa. | Immediate - Now |
| 4 | Uncontrolled loading on floor area | Produce and actively manage a loading plan for all floor plates within the factory giving consideration to floor capacity and column capacity. | 6-weeks |

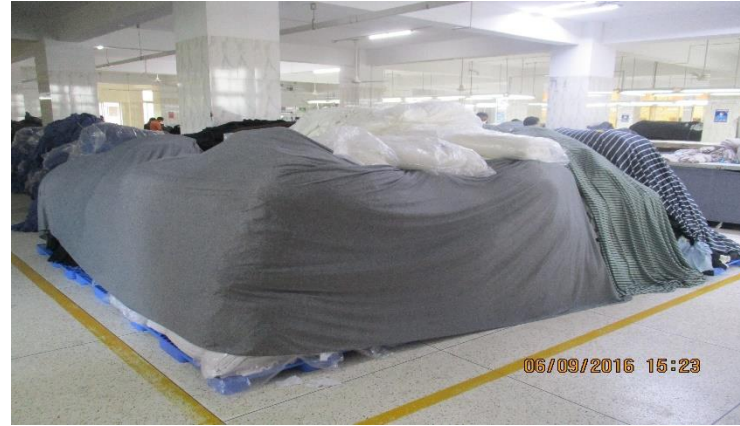
High Loading observed on 2<sup>nd</sup> Floor

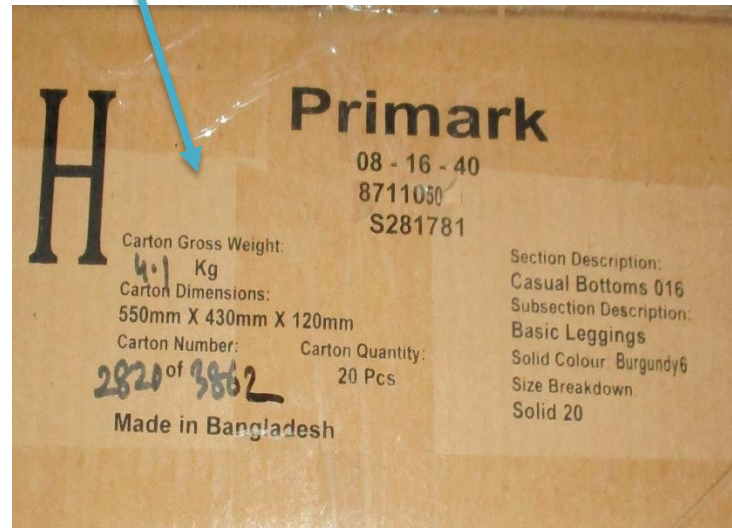
Uncontrolled loading on floor area

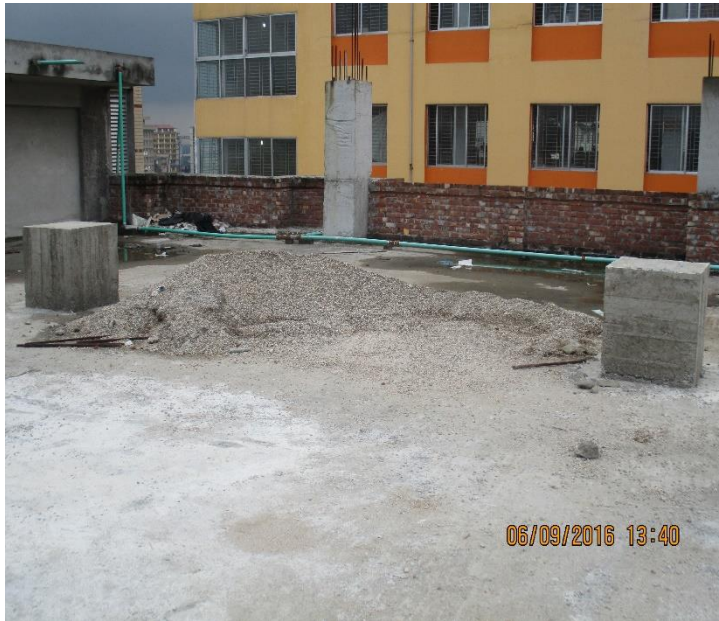
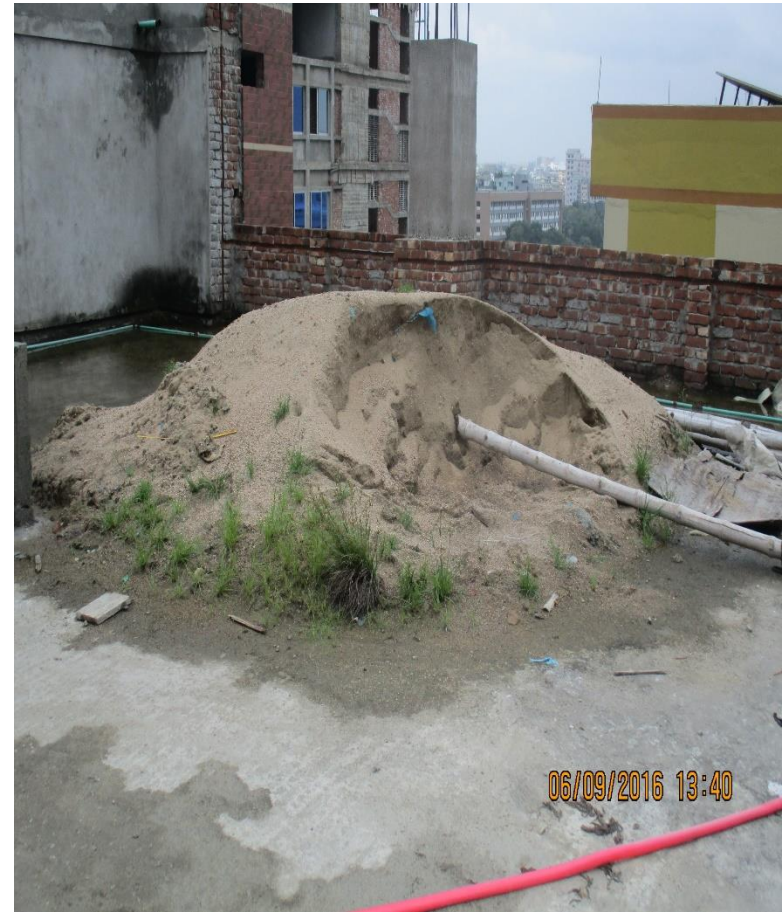
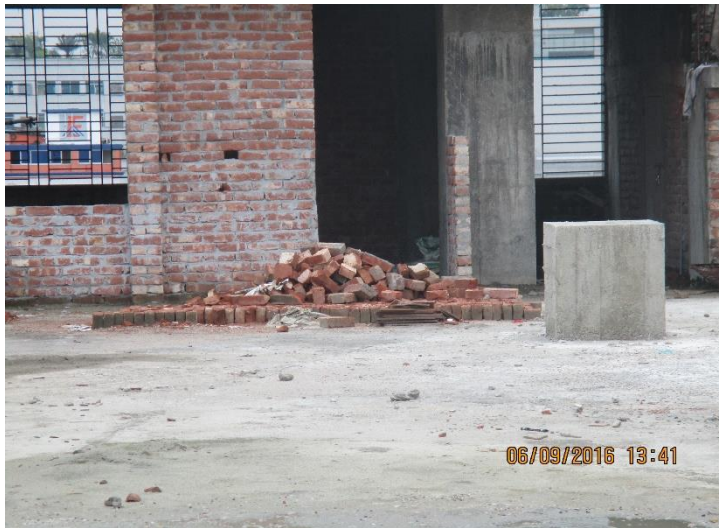
Construction Material observed on  
roof

**Uncontrolled loading on floor area**

| Item No. | Observation | Recommended Action Plan | Recommended Timeline |
|---|---|---|---|
| 3 | Uncontrolled loading on floor area | Remove all construction materials from roof | Immediate - Now |

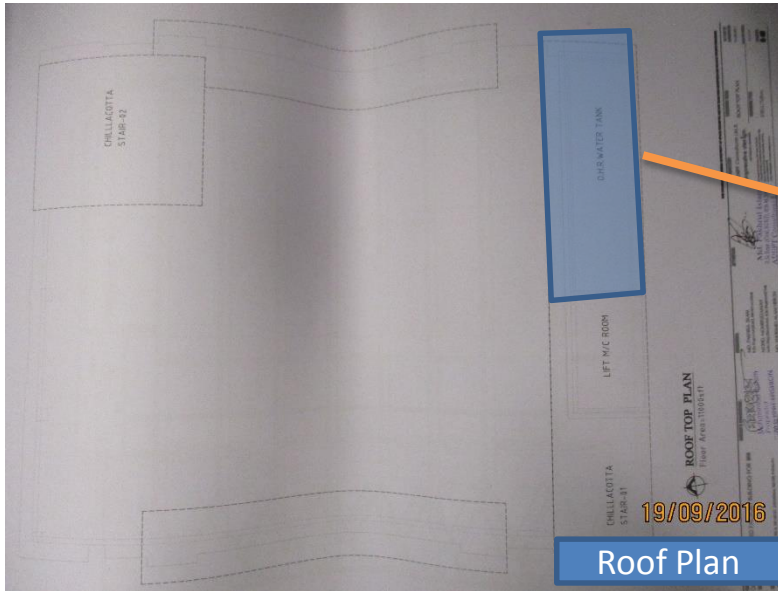
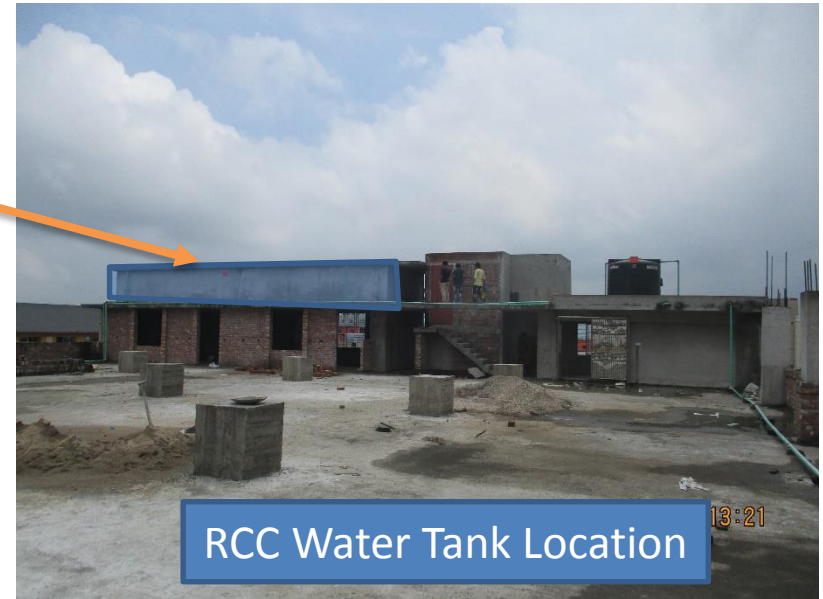
RCC Water Tank Location

## **Dampness found on the bottom slab of RCC water tank**

| Item No. | Observation | Recommended Action Plan | Recommended Timeline |
|---|---|---|---|
| 6 | Dampness found on the bottom slab of RCC water Tank | Building Engineer to investigate the extent of dampness and recommend the suitable repair on it | 6-weeks |
| 7 | Dampness found on the bottom slab of RCC water Tank | Take remedial action as per investigation | 6-months |

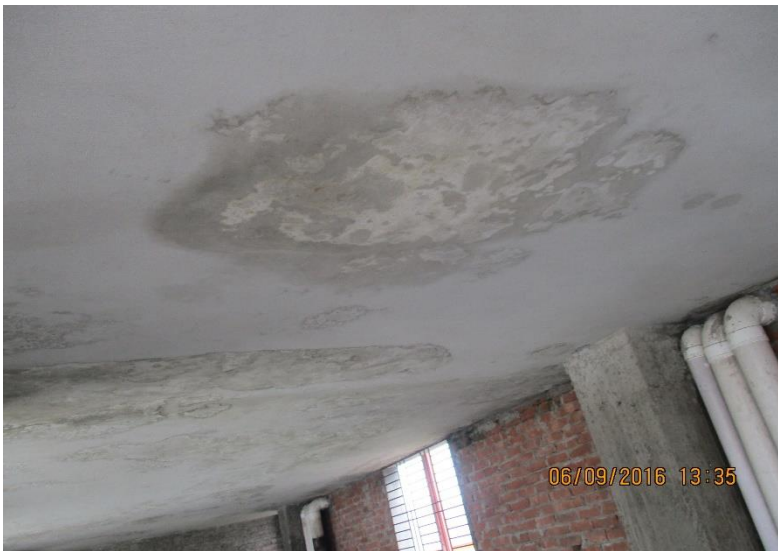
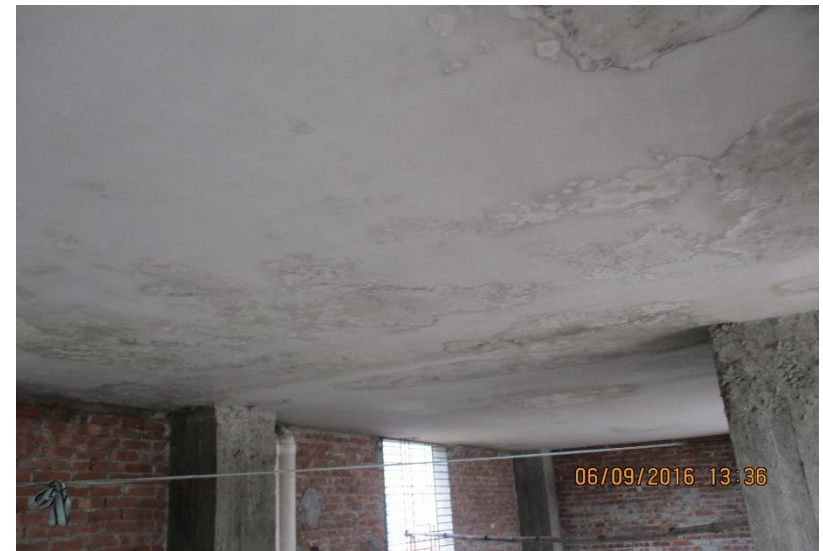
Dampness found on the bottom slab of RCC water Tank

**Item 3:** Dampness found on the bottom slab's soffit of RCC water Tank

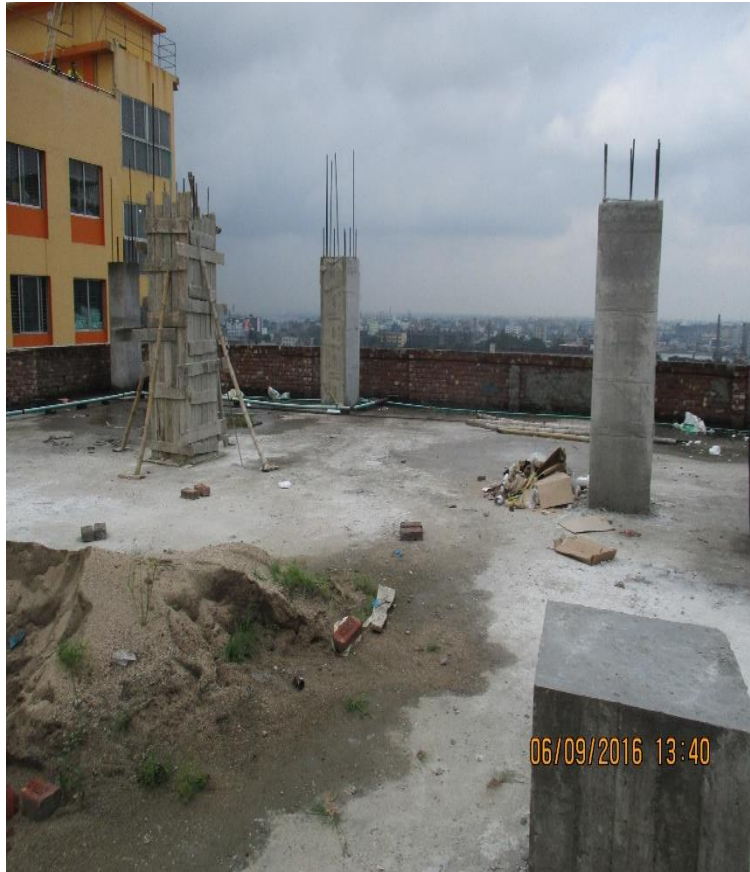
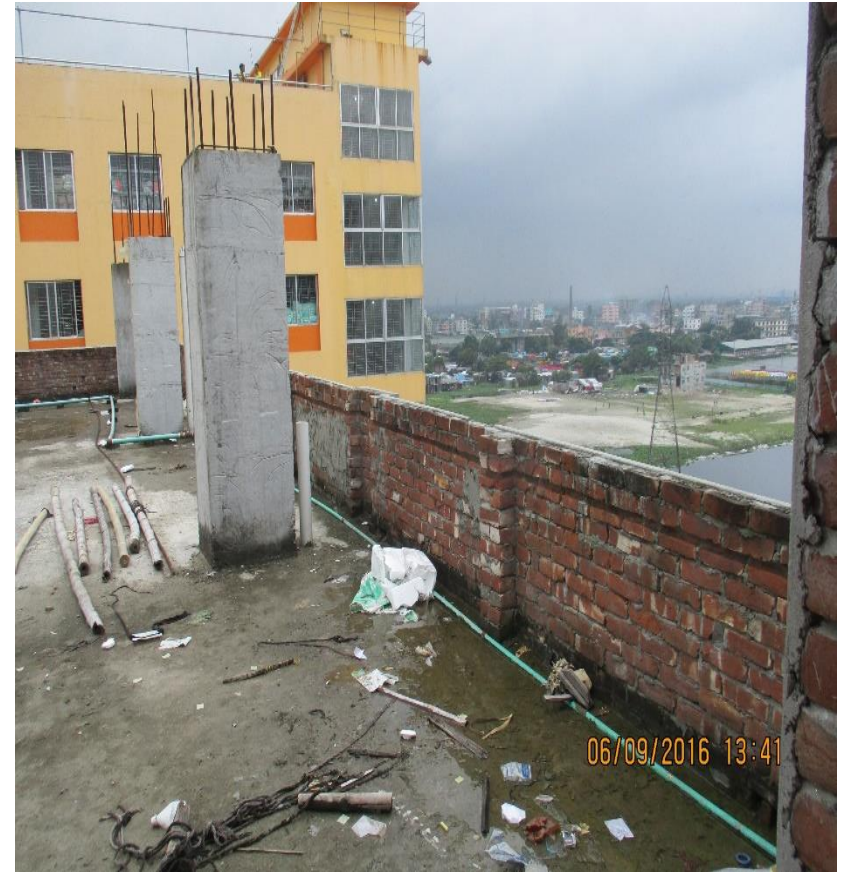
The building was permitted as 8-Storeyed building from local authority. During inspection, it was observed that the column was extending which seemed to be further vertical extension in future

**Item 4:** Possible vertical Extension

| Item No. | Observation | Recommended Action Plan | Recommended Timeline |
|---|---|---|---|
| 8 | Provision for future vertical Extension | If vertical extension is intended, to conduct its feasibility conduct DEA for the factory building following BNBC. | 6-weeks |
| 9 | Provision for future vertical Extension | Implement necessary remedial actions recommended in DEA. | 6-months |
