# **FIRE SAFETY INSPECTION REPORT**

## **W APPARELS**

**295/JA/4, RAYER BAZAR**

March 23, 2014

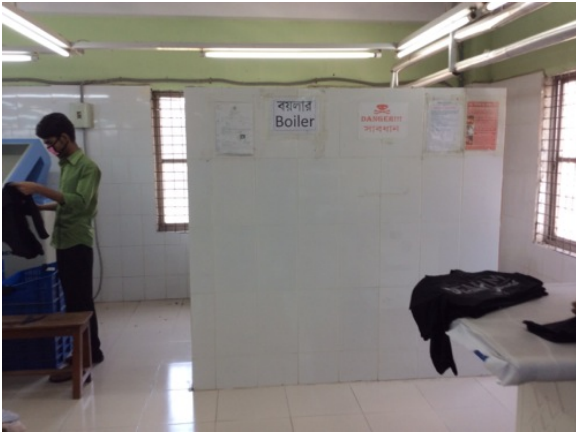
| No. | Category | Finding | Recommendation | Remediation Timeframe |
|---|---|---|---|---|
| F-1 | Fire Rated Construction | The boiler room on the 2nd floor is not separated from the factory floor by fire-rated construction. | Separate the boiler room by a minimum 2-hr fire-rated construction. Seal and/or protected all openings to maintain the required fire separations | Within 3 months |

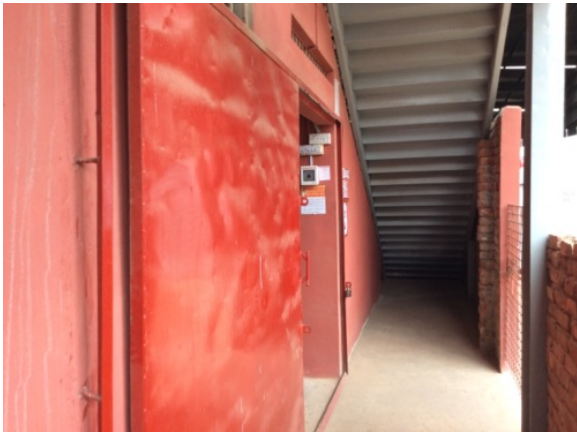
| No. | Category | Finding | Recommendation | Remediation Timeframe |
|---|---|---|---|---|
| F-2 | Fire Rated Construction | The transformer room is not separated by fire-rated construction. Currently it opens underneath the southeast emergency exit stairs without a fire-rated door or any other kind of protection for the stair. | Separate the transformer room by a minimum 2-hr fire-rated construction. Seal and/or protected all openings to maintain the required fire separations | Within 3 months |

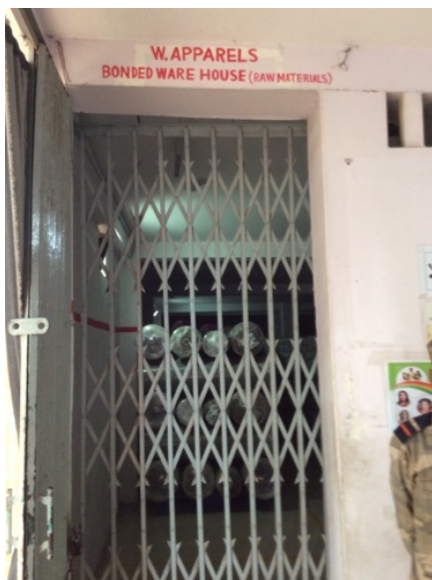
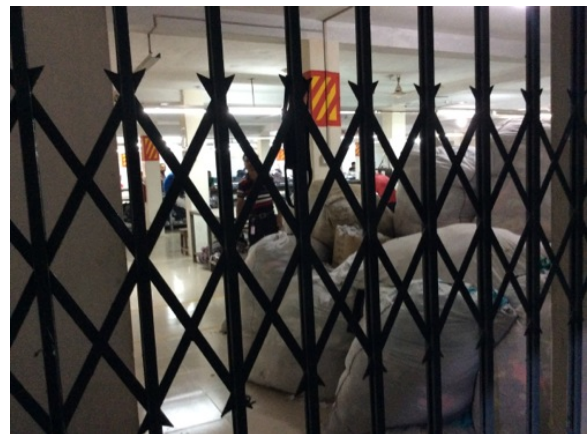
| F-3 | Fire Rated Construction | Areas used for combustible storage are not separated by fire-rated construction. | Provide dedicated storage rooms separated by minimum 1-hr fire-rated construction. | Within 3 months |

The Bonded Warehouse currently opens onto the exit discharge with an unprotected opening, and has unprotected openings to the Cutting Section and the west end of the exit stair.

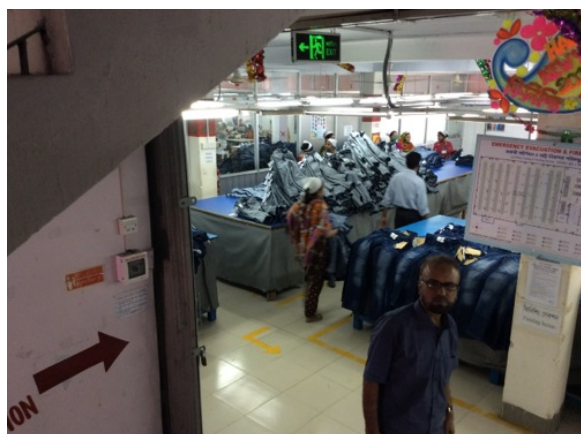
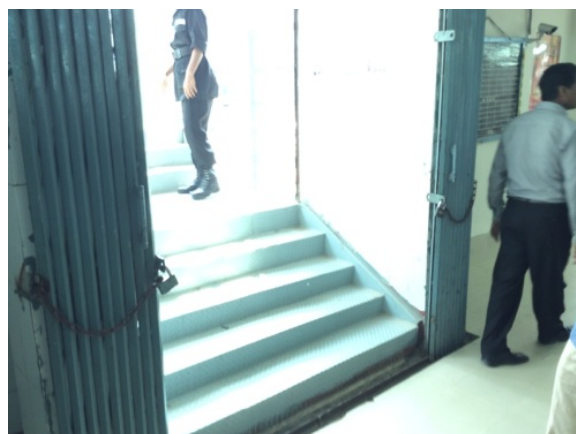
| F-4 | Fire Rated Construction | The exit stairs are not separated from work areas and other spaces on each floor by fire-rated construction. | Provide minimum 1.5-hr fire rated doors and seal all unprotected openings to separate the exit stairs from work areas and other building spaces on all floor levels. Ensure that the fire doors are self-closing and positive latching and that they are provided with fire exit (panic) hardware where serving production floors.<br><br>If fire doors are required to be held open for functional reasons, provide automatic-closing devices tied to the fire alarm system. | Within 3 months |

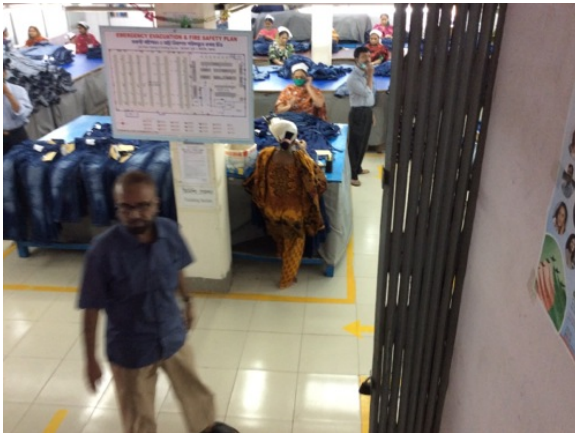
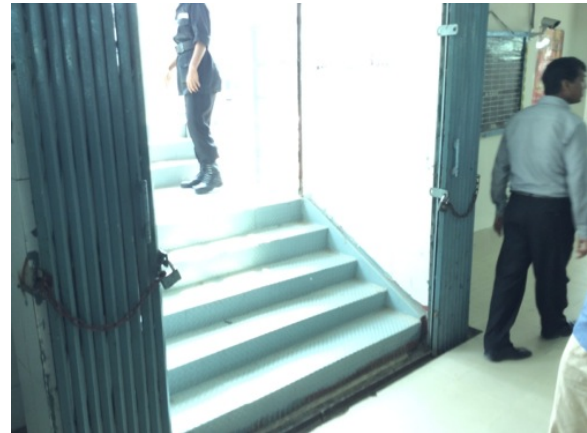
| F-6 | Egress | Egress doors / gates with locking features are provided at all stair openings on 1st-3rd floors, and exit discharge. | Remove locking features from all egress doors / gates.<br><br>If locks are required for security reasons, utilize special door locking features complying with NFPA 101. | Immediate |

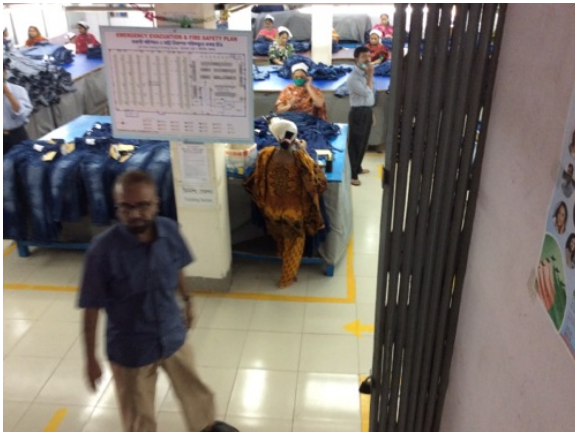
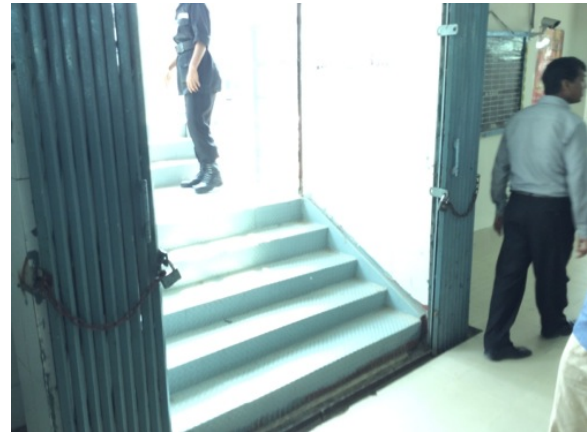
| F-7 | Egress | Collapsible gates / sliding doors are provided at all stair openings on 1st-3rd floors, and Bonded Warehouse exits. | Replace all gates / sliding doors along the means of egress with side-hinged, swinging egress doors.<br><br>If locks are required for security reasons, utilize special door locking features complying with NFPA 101. | Within 1 month |

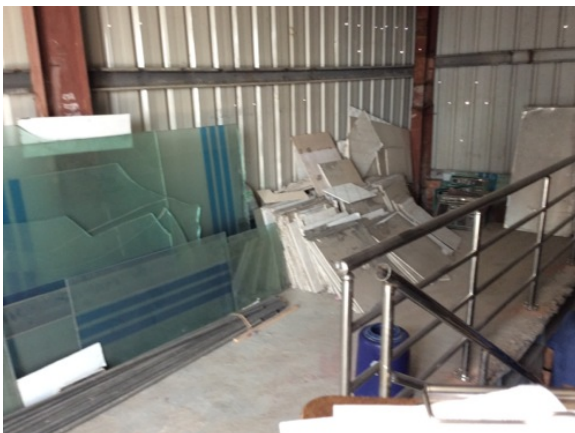
| F-8 | Egress | Construction storage was located in the top of the southeast exit stair. | Remove all storage from exit stairs and egress paths. | Within 3 months |

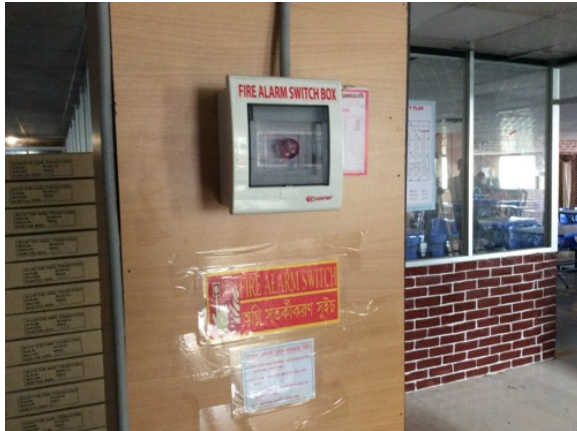
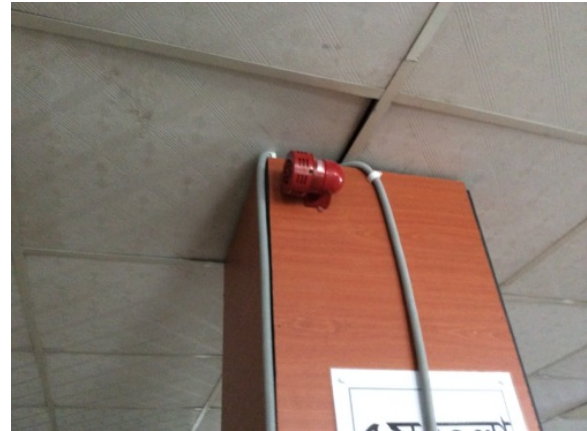
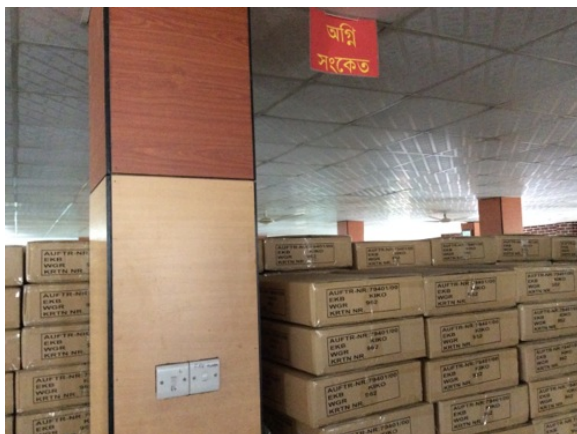
| F-10 | Fire Protection | The fire alarm system is antiquated, not a listed system, and does not provide alarm and notification features consistent with acceptable standards. | Replace the fire alarm system with a new, listed addressable fire alarm system in accordance with NFPA 72. | Design within 4 months, install within 9 months |

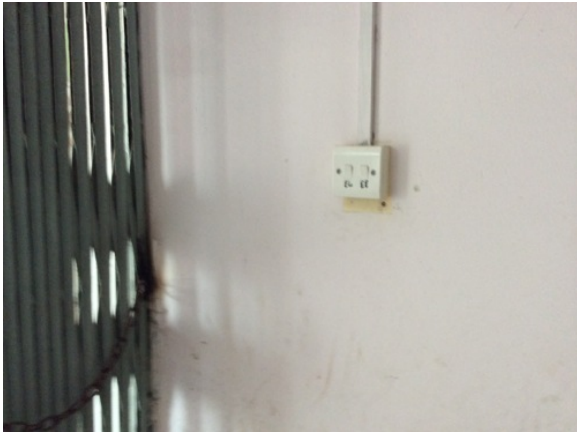
| F-12 | Egress Lighting | Manual on-off switch is provided for emergency lighting & exit signage units in the stairwell. | Remove manual on/off switches from emergency lighting & exit signage units to prevent them from being switched off. | Within 1 month |
