FIRE SAFETY INSPECTION REPORT

**STERLING CREATIONS LTD.
BARON, EARPUR UNION,ASHULIA, SAVER**

ACCORD
on Fire and Building Safety in Bangladesh

July 10, 2014

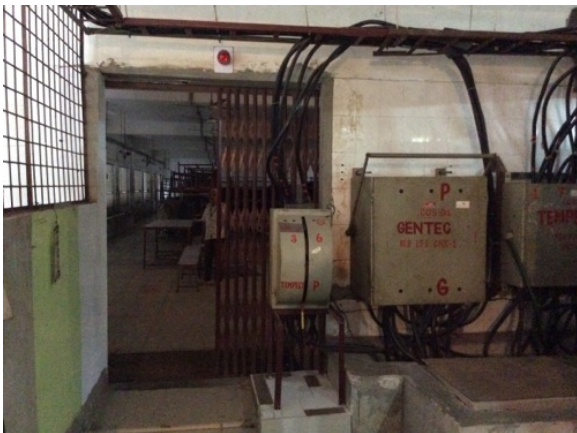
No.	Category	Finding	Recommendation	Remediation Timeframe
F-1	Fire Rated Construction	The generator and transformer rooms are not separated by fire-rated construction.	Separate the generator and transformer rooms by a minimum 2-hr fire-rated construction. Seal and/or protected all openings to maintain the required fire separations	Within 3 months

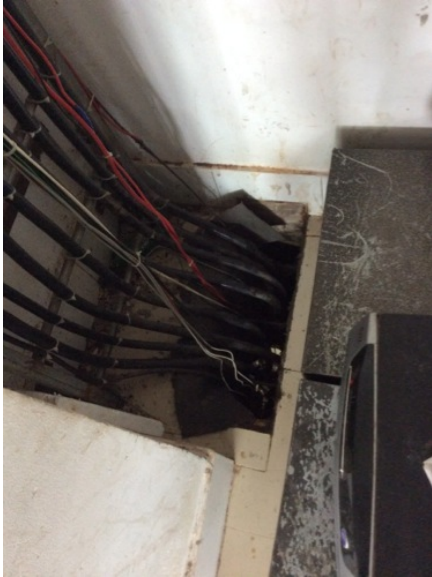
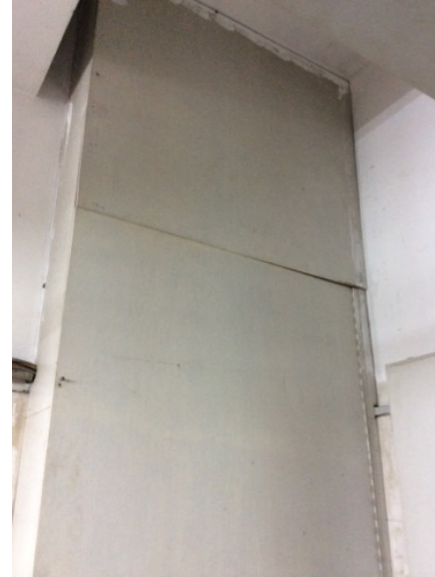
F-2	Fire Rated Construction	Unsealed penetrations and openings are located in the fire-rated floor/ceiling assemblies, specifically the electrical penetrations/ plywood shaft.	Provide a minimum 2-hr fire-rated shaft to separate the utility risers from each floor level.	Within 3 months
-----	-------------------------	---	---	-----------------

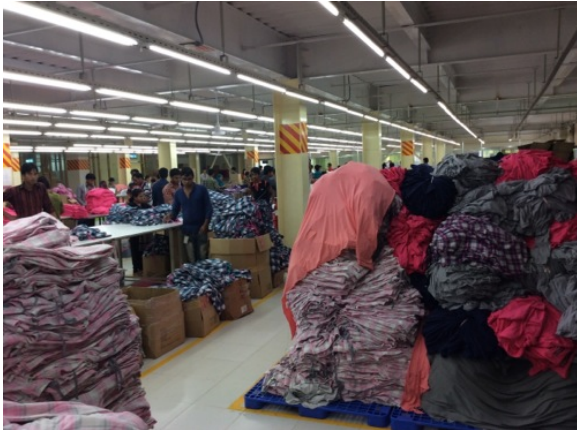
F-3	Fire Rated Construction	<p>Areas used for combustible storage on floors 2, 4, 5, and 6 are not separated by fire-rated construction.</p> <p>Rooms used for combustible storage on floor 1 are not separated by fire-rated construction.</p>	<p>Provide dedicated storage rooms separated by minimum 1-hr fire-rated construction.</p> <p>Where separate storage rooms are not feasible, provide defined storage areas and limit the storage arrangement as follows:</p> <ul style="list-style-type: none">- Maximum height of 2.4m and maximum area of 23m²- If sprinkler protected: maximum height of 3.66m and maximum area of 93m² <p>Separate areas of unenclosed combustible storage by a minimum clear distance of 3m.</p>	Within 3 months
-----	-------------------------	---	---	-----------------

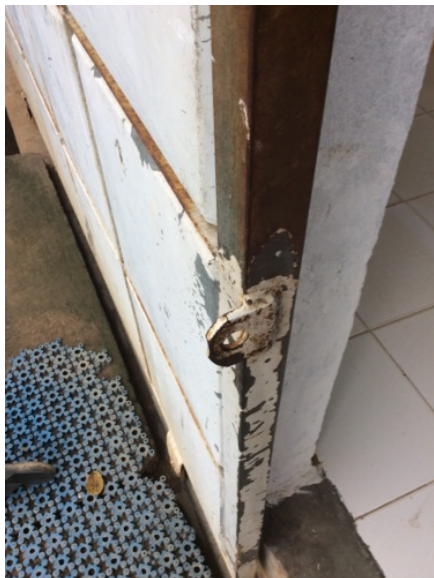
F-4	Egress	Egress gates and sliding doors with locking features are provided at building exits, exit stairs, and exit discharges.	Remove locking features from all egress gates and doors. If locks are required for security reasons, utilize special door locking features complying with NFPA 101.	Immediate
-----	--------	--	--	-----------

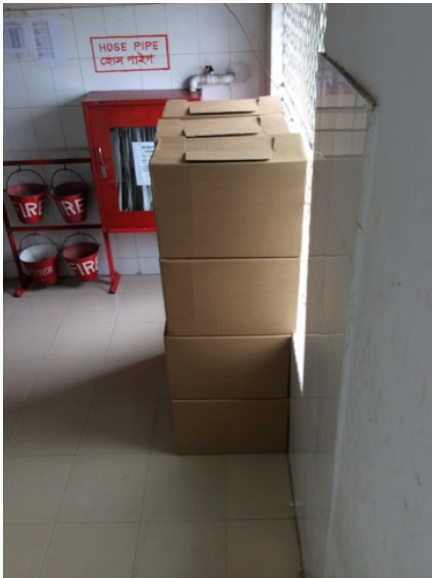
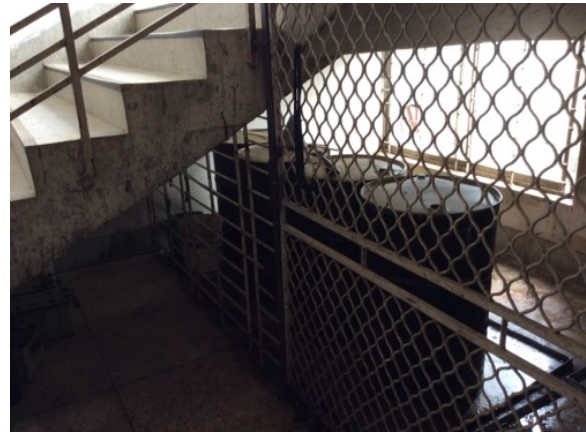
F-5	Egress	Storage was located in the South exit stair on floor 6.	Remove all storage from exit stairs and egress paths.	Immediate
-----	--------	---	---	-----------

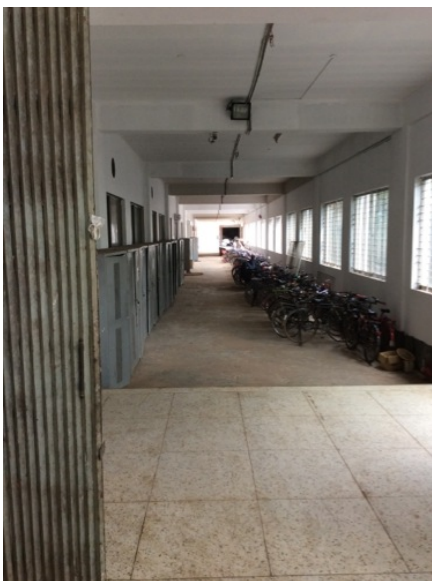
F-6	Egress	Collapsible gates and sliding doors are provided at building exits, exit stairs, and exit discharges.	Replace all gates and sliding doors along the means of egress with side-hinged, swinging egress doors. If locks are required for security reasons, utilize special door locking features complying with NFPA 101.	Within 1 month
-----	--------	---	--	----------------

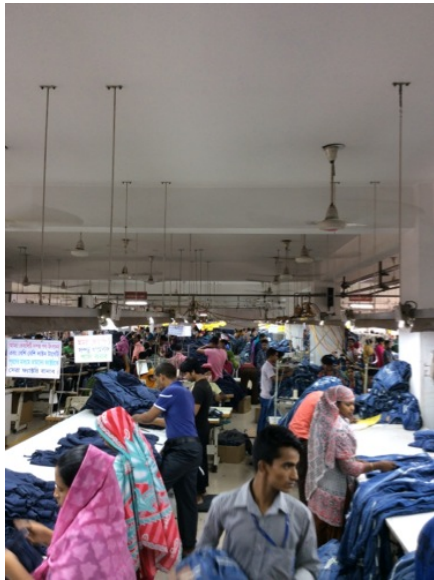
F-7	Egress	The width of egress aisles on floors 2, 4, and 6 is less than 36-in.	Provide minimum aisle widths of 36-in.	Within 3 months
-----	--------	--	--	-----------------

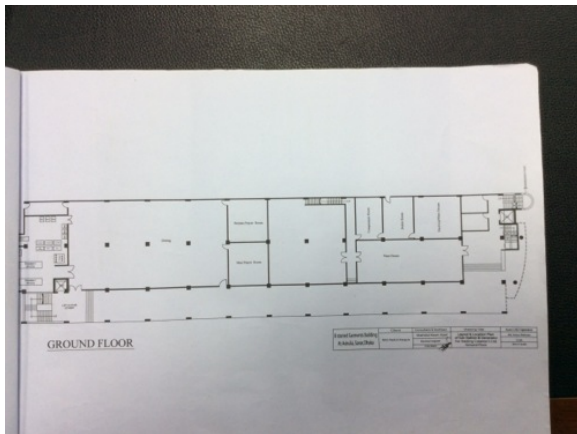
F-8	Egress	Common path of egress travel exceeds 30 m. from women's prayer room.	Reconfigure the egress arrangement to reduce the maximum common path of travel to not more than 30 m.	Within 3 months
-----	--------	--	---	-----------------

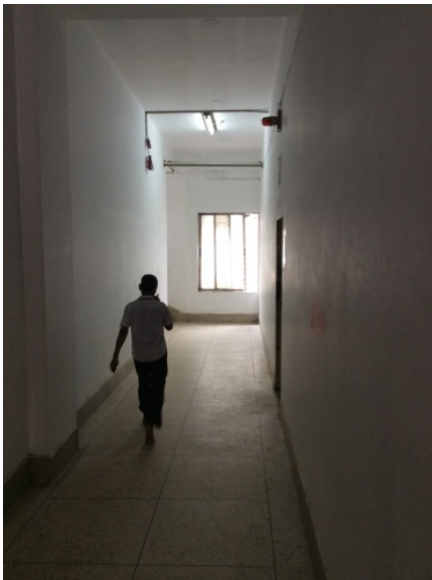
F-9	Egress	Exit stairs discharge inside the building to an interior hall with unprotected openings to storage.	Provide 2-hr fire-rated exit passageway leading directly outside (vestibules to separate any storage areas). OR Provide sprinkler protection for discharge floor in accordance with NFPA 13.	Within 6 months
-----	--------	---	--	-----------------

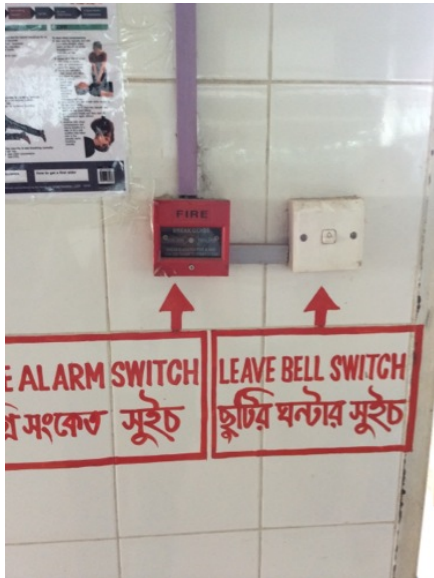
F-10	Fire Protection	The fire alarm system is antiquated, not a listed system, and does not provide alarm and notification features consistent with acceptable standards.	Replace the fire alarm system with a new, listed addressable fire alarm system in accordance with NFPA 72.	Design within 4 months, install within 9 months
------	-----------------	--	--	---

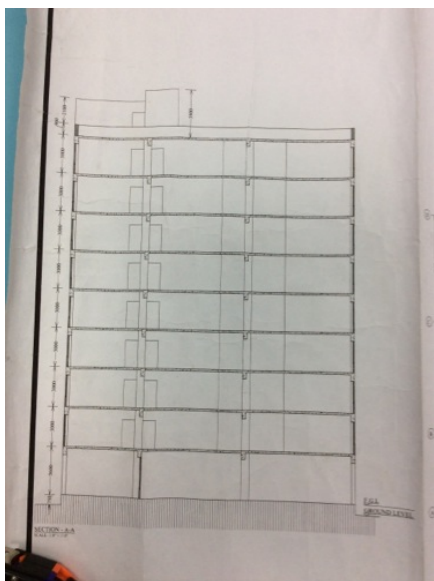
F-11	Fire Protection	The high-rise building has an occupied floor greater than 23m (75 ft) and is not provided with automatic sprinkler protection. The large occupant loads, heavy fuel loading, and anticipated extended egress times warrant sprinkler protection.	Provide automatic sprinkler protection throughout the building in accordance with NFPA 13.	Design within 6 months, install within 12 months
------	-----------------	--	--	--

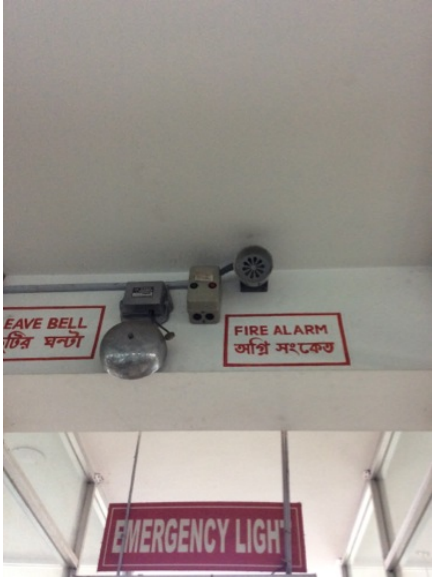
F-12	Fire Protection	Inspection, testing, and maintenance of the fire alarm system is not in accordance with NFPA 72.	Inspect, test and maintain the fire alarm system, and keep written records on-site, in accordance with NFPA 72.	Within 3 months
------	-----------------	--	---	-----------------

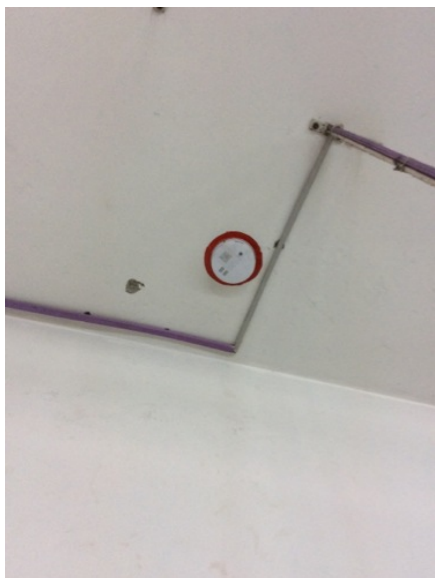
F-13	Fire Protection	The building is equipped with single-station smoke alarms. Smoke alarm activation sounds only a local alarm and does not provide automatic fire alarm notification of occupants.	Remove single-station smoke alarms. Provide automatic smoke detection throughout the building, tied into the fire alarm system, in accordance with NFPA 72.	Within 6 months
------	-----------------	--	---	-----------------

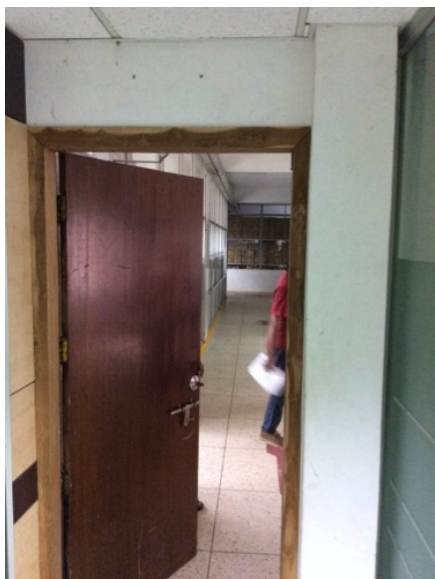
F-14	Egress Lighting	Exit sign not provided at exit from office on floor 1.	Provide exit signs above all exits to the exterior and all doors to the exit stairs.	Within 1 month
------	-----------------	--	--	----------------

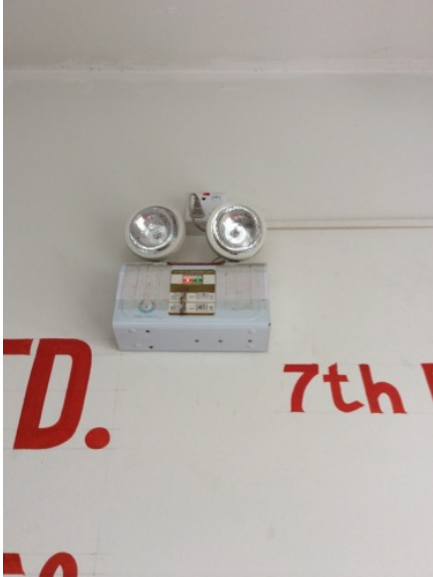
F-15	Egress Lighting	Inspection, testing, and maintenance for the emergency lighting system was not in accordance with The ACCORD standard.	Inspect, test and maintain the emergency lighting system in accordance with The ACCORD standard. Keep written records on-site.	Within 3 months
------	-----------------	--	--	-----------------
