FIRE SAFETY INSPECTION REPORT

Amir Shirts Ltd (23.301720, 91.290824)

ACCORD ID: 12586

Date: 30th October, 2016

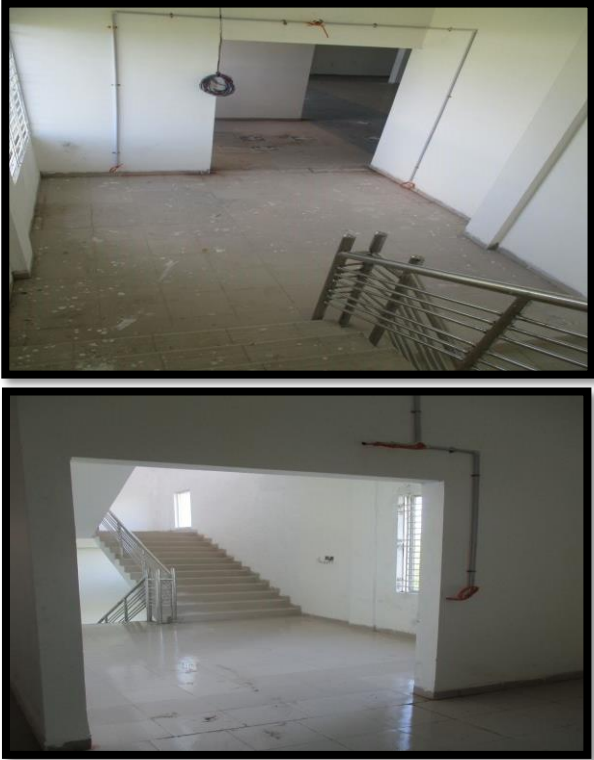
SI No.	Category	Findings	Required Action	Remediation Time Frame	Pictorial Evidence
1	Fire Rated Construction	<p>Unit-1: The exit stairs are not separated on each floor by fire-rated construction. In ground floor stairs are discharging without proper separation.</p>	<p>Provide minimum 1.5-hr fire rated doors and seal all unprotected openings to separate the exit stairs from work areas and other building spaces on all floor levels. Ensure that the fire rated doors are self-closing and positive latching and that they are provided with fire exit (panic) hardware where serving production floors.</p> <p>If fire rated doors are required to be held open for functional reasons, provide automatic closing devices tied to the fire alarm system.</p>	Within 3 months

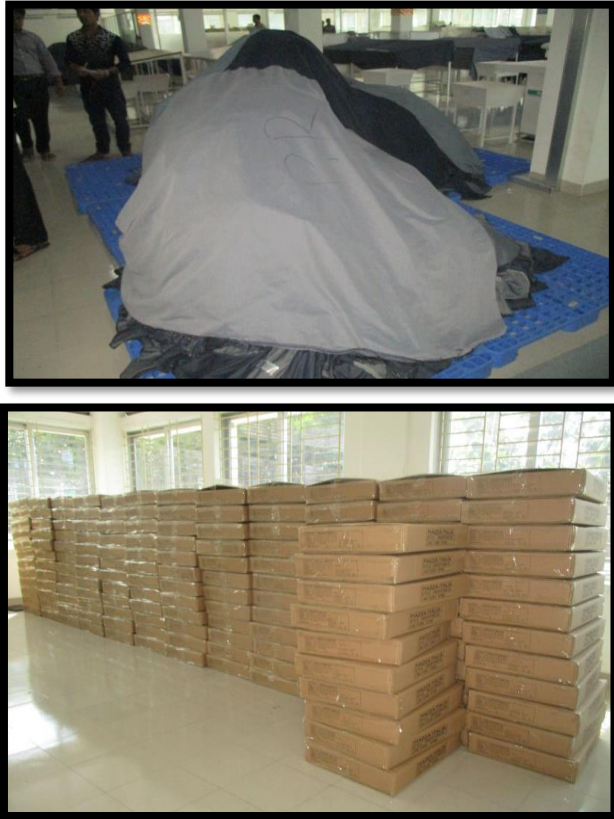
SI No.	Category	Findings	Required Action	Remediation Time Frame	Pictorial Evidence
2	Fire Rated Construction	Unit-1: Areas used for in-process storage of combustible materials are open to the surrounding occupancy. Location: Ground floor	<p>Provide defined storage areas and limit the storage arrangement as follows:-</p> <ol style="list-style-type: none"> 1. General Condition: Maximum height of 2.4m and maximum area of 23m². Separate areas of unenclosed combustible storage by a minimum clear distance of 3m. 2. If sprinkler protected: maximum height of 3.66m and maximum area of 93m². Separate areas of unenclosed combustible storage by a minimum clear distance of 3m. or 3. Enclose the storage area from the surrounding occupancy with a minimum 1 hour construction. 	Within 3 months

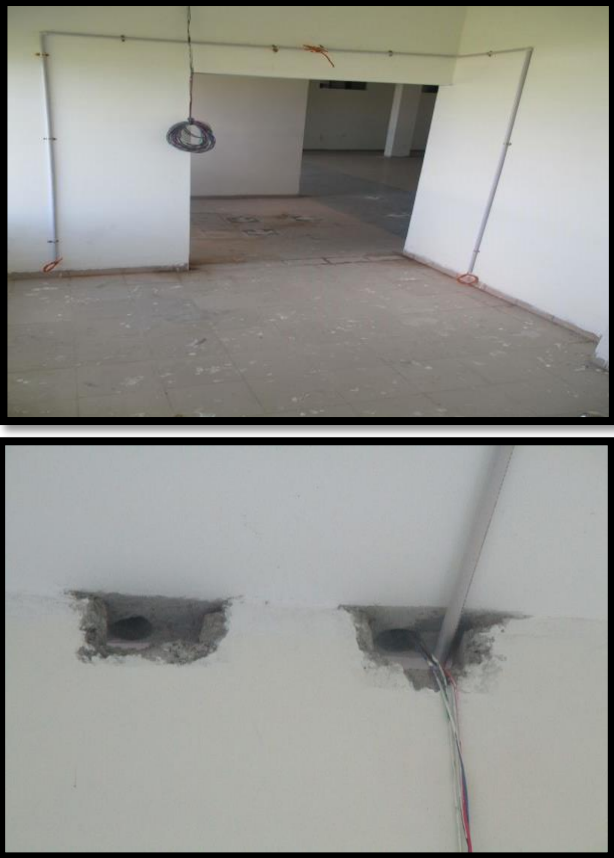
SI No.	Category	Findings	Required Action	Remediation Time Frame	Pictorial Evidence
3	Unsealed Stair Penetrations	Unit-1: Unsealed penetrations and openings are located in the exit stair enclosures	Seal all penetrations and openings in exit stair enclosure walls to maintain the fire separations.	Within 3 months

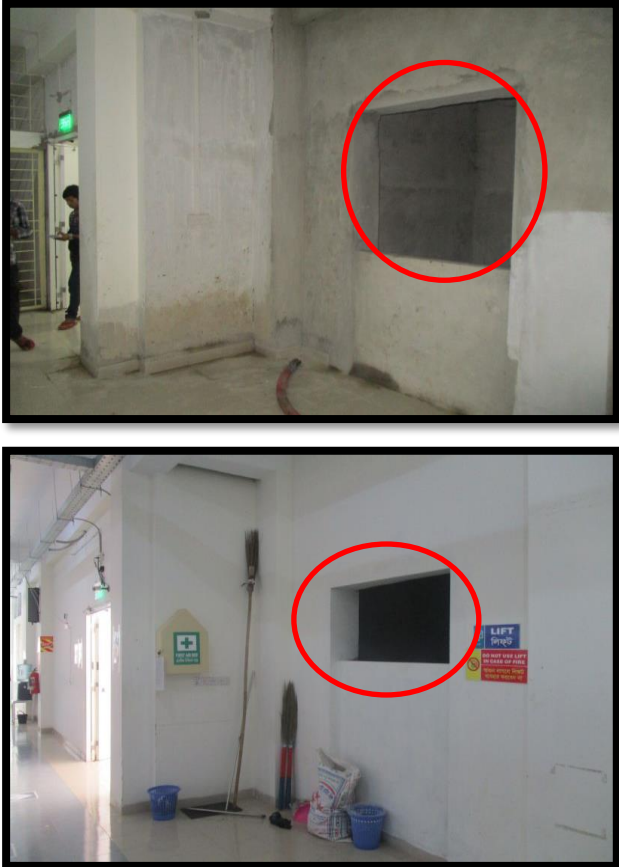
SI No.	Category	Findings	Required Action	Remediation Time Frame	Pictorial Evidence
4	Unsealed/non rated Elevator Shaft	Unit-1: The elevator [on all the floors] discharges inside the production floor. [Unsealed penetrations & openings]	Provide a minimum 2-hr fire rated construction to separate the elevator shaft from each floor level. Seal all penetrations and openings in floors/ceiling assemblies to maintain the fire separation.	Within 3 months

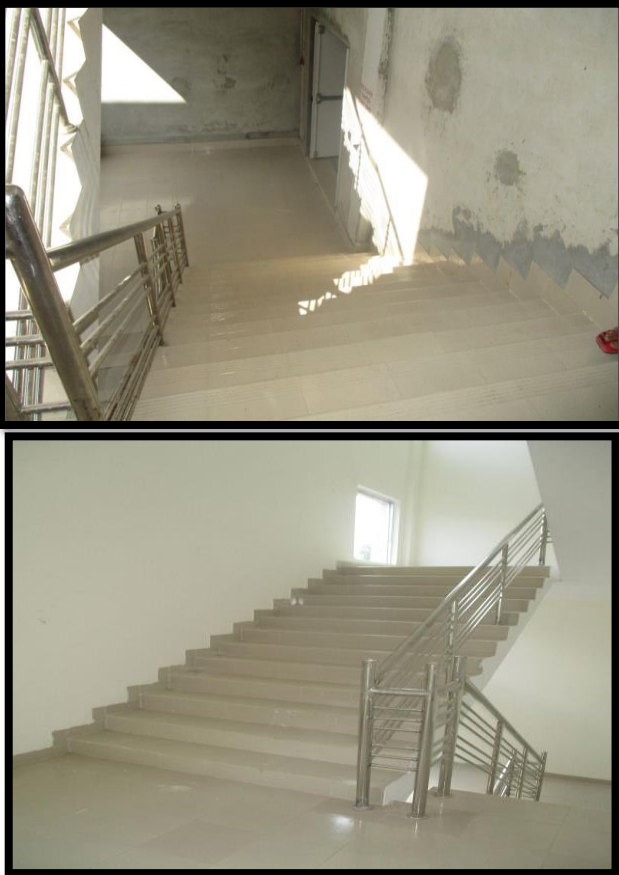
SI No.	Category	Findings	Required Action	Remediation Time Frame	Pictorial Evidence
5	No Handrails	Handrails are not provided on both sides of each exit stairs on all floors. Having handrails on one side of said staircase, may pose as a falling hazard during evacuation. Location: For both unit-1 and unit-2.	Provide handrails on both sides of the exit stair. New handrails shall have a minimum height of 865 mm (34 in.) and a maximum height of 965 mm (38 in.) as measured from the leading edge of the tread. Intermediate handrails shall be provided when the stair width exceeds 2.2 m (87 in.	Within 3 months

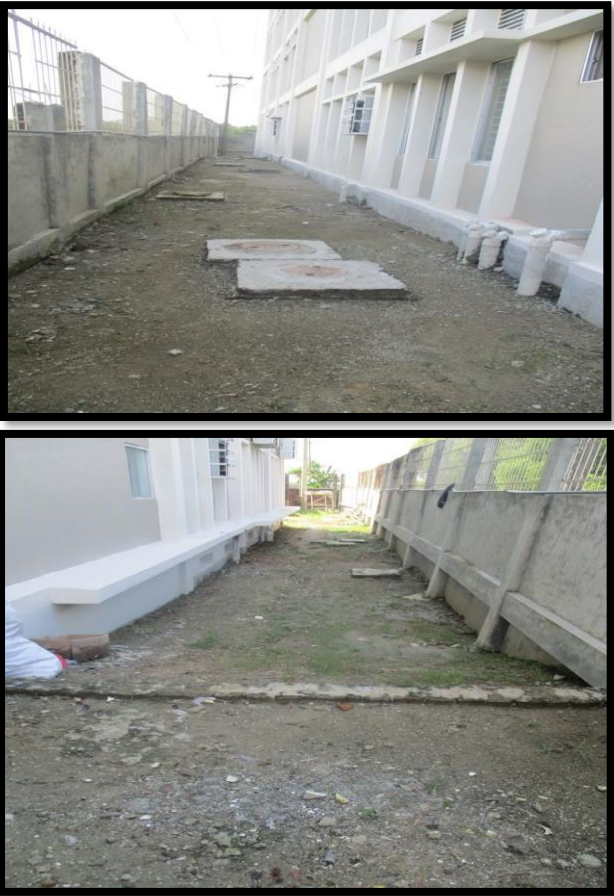
SI No.	Category	Findings	Required Action	Remediation Time Frame	Pictorial Evidence
6	Discharge path	Unit-1: Uneven walking surface and tripping hazards were found on the exit discharge path of stair-3 and 4	Make a road / egress path for smooth discharge of occupants. Means of egress shall be maintained continuously free and clear of all obstructions.	Within 3 months

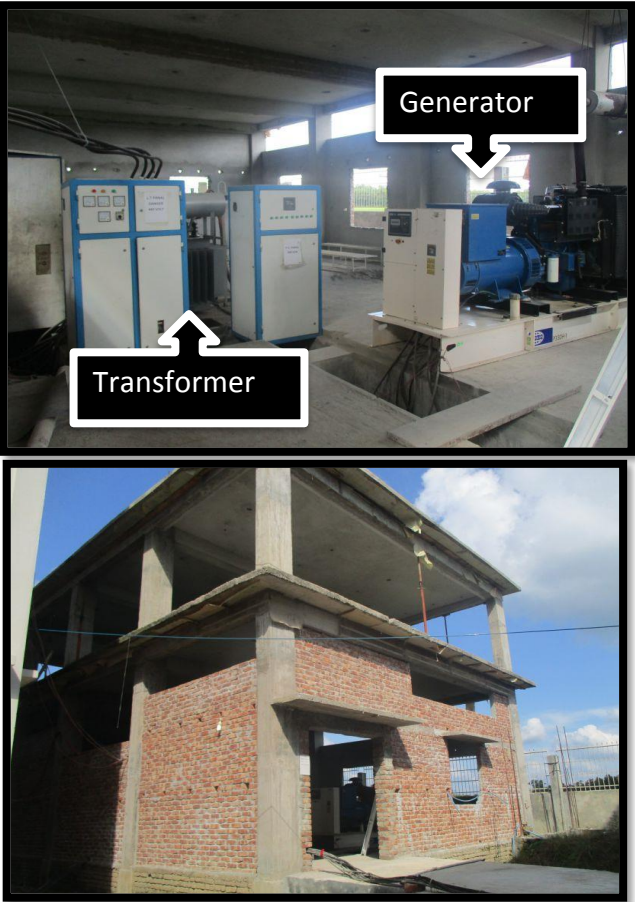
SI No.	Category	Findings	Required Action	Remediation Time Frame	Pictorial Evidence
7	Service Room Separation	Utility Building: Generator and transformer room is not separated by fire rated construction (openings, non-rated doors, penetrations).	Separate the generator and transformer room by a minimum 2-hr fire rated construction. Seal and/or protected all openings to maintain fire separations.	Within 3 months

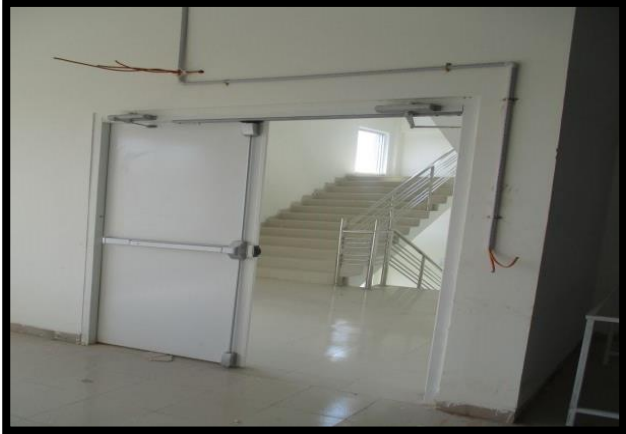
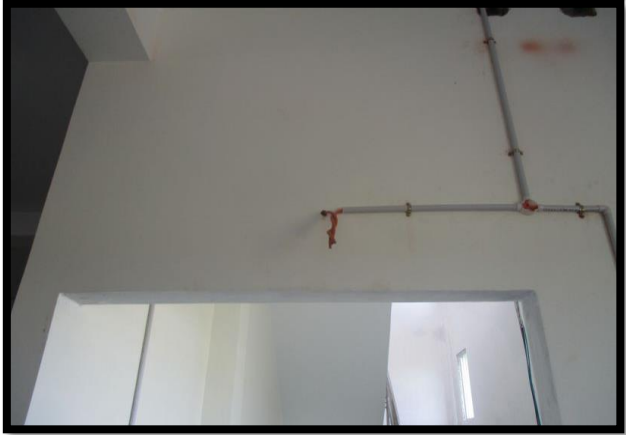
SI No.	Category	Findings	Required Action	Remediation Time Frame	Pictorial Evidence
8	Misplaced Exit Sign	Unit-1: Exit sign not provided at exit. Location: Unit-1 building.	Provide exit signs above all exits to the exterior and all doors to the exit stair.	Within 1 month

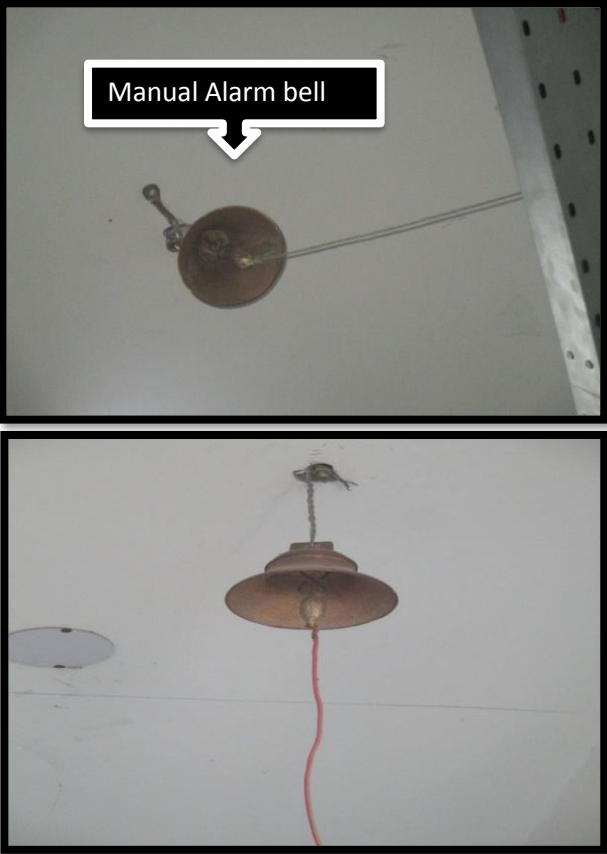
SI No.	Category	Findings	Required Action	Remediation Time Frame	Pictorial Evidence
9	Antiquated Fire Detection System	Unit-1: The fire detection system is antiquated, not a listed system, and does not provide alarm and notification features consistent with acceptable standards.	Replace the fire detection system with a new, listed addressable fire detection system in accordance with NFPA 72. Submit the design to ACCORD for review.	Design within 3 months, Install within 9 months

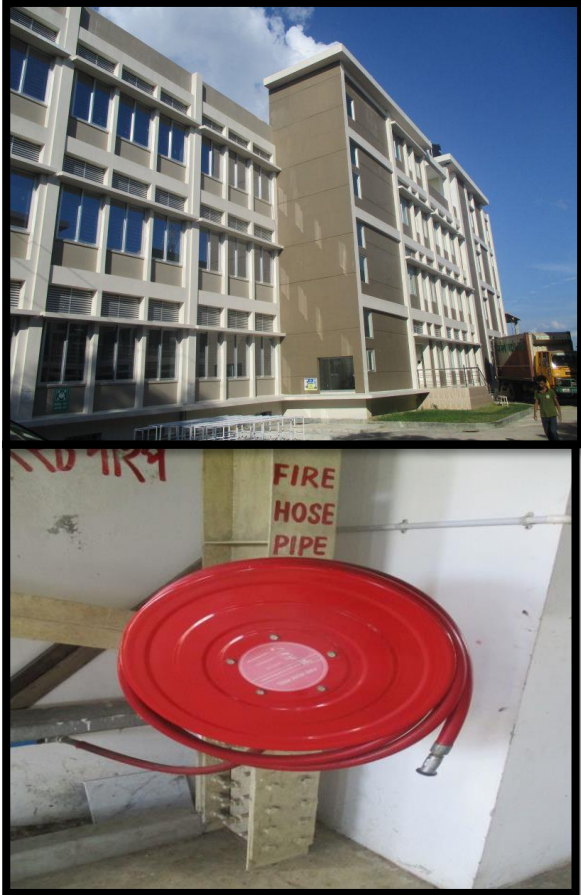
SI No.	Category	Findings	Required Action	Remediation Time Frame	Pictorial Evidence
11	Standpipe System	Unit-1: The existing building has an occupied floor greater than 10 meter (33 feet) and is not provided with standpipe protection. For unit-1 production building	Install a new class III standpipe system & fire department connection in accordance with NFPA 14. A class I system shall be permitted in buildings protected throughout by an automatic sprinkler system.	Design within 3 months, Install within 6 months

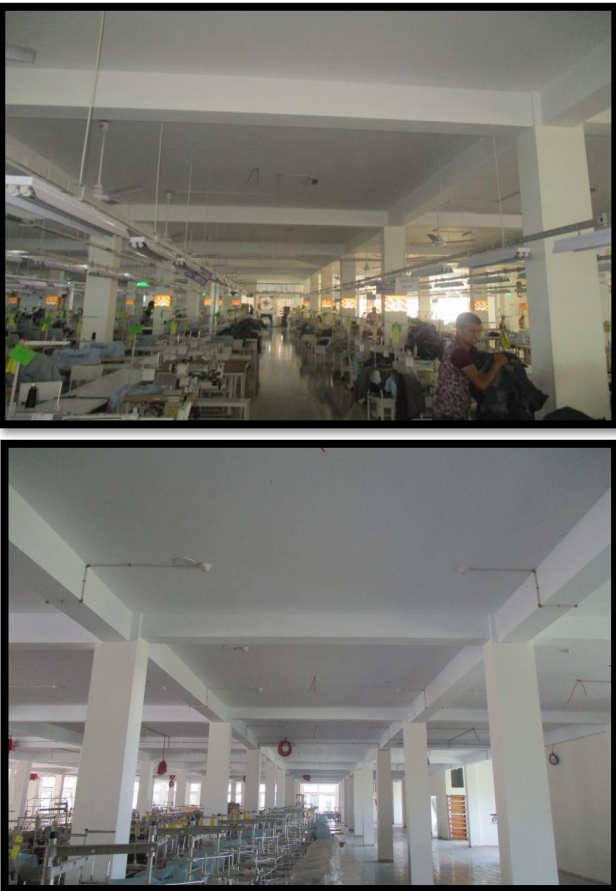
SI No.	Category	Findings	Required Action	Remediation Time Frame	Pictorial Evidence
13	Inadequate Lighting	Unit-1: Based on the number and location of emergency lights observed, adequate illumination levels are not anticipated along egress routes.	Test the emergency lighting system on each floor and provide additional emergency fixtures to provide adequate illumination along the means of egress. Provide a minimum illumination of 10 lux at the floor level within exit stairs and exit discharge paths and minimum 2.5 lux along exit access aisles.	Within 3 months

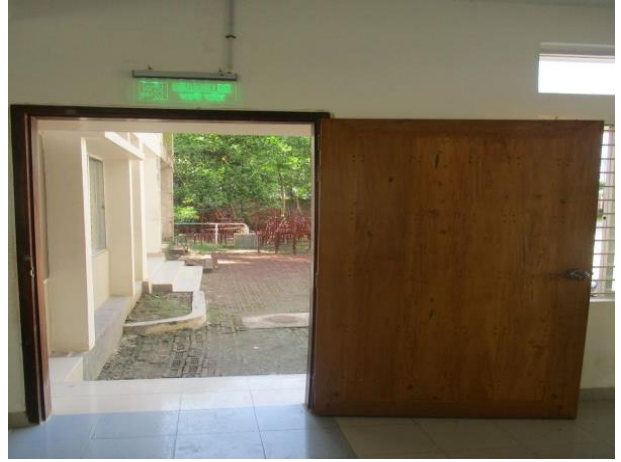
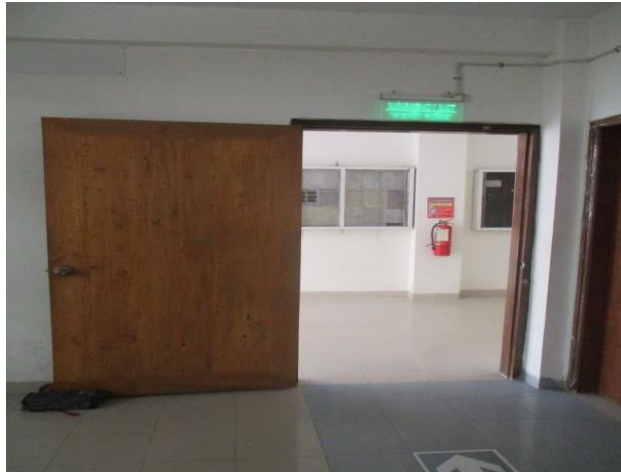
SI No.	Category	Findings	Required Action	Remediation Time Frame	Pictorial Evidence
15	Door Swing Direction	Office Building: Exit stair door/egress door serving 50 or more occupants does not swing in the direction of egress travel. Location: Dining area at office building.	Modify the egress door to swing in the direction of egress travel.	Within 1 month

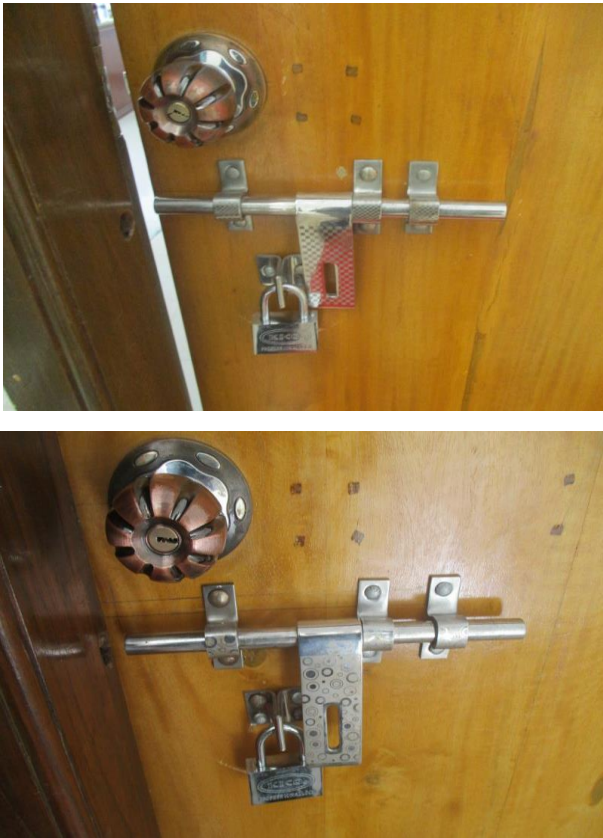
SI No.	Category	Findings	Required Action	Remediation Time Frame	Pictorial Evidence
16	Lockage Egress Doors	Office Building: Egress doors/gates with locking features not complying with NFPA101 are provided at [building exits, exit stairs, along egress routes, exit discharge]	Remove locking features from all egress doors/gates. If locks are required for security reasons, utilize specialized door locking features complying with NFPA101.	Immediate

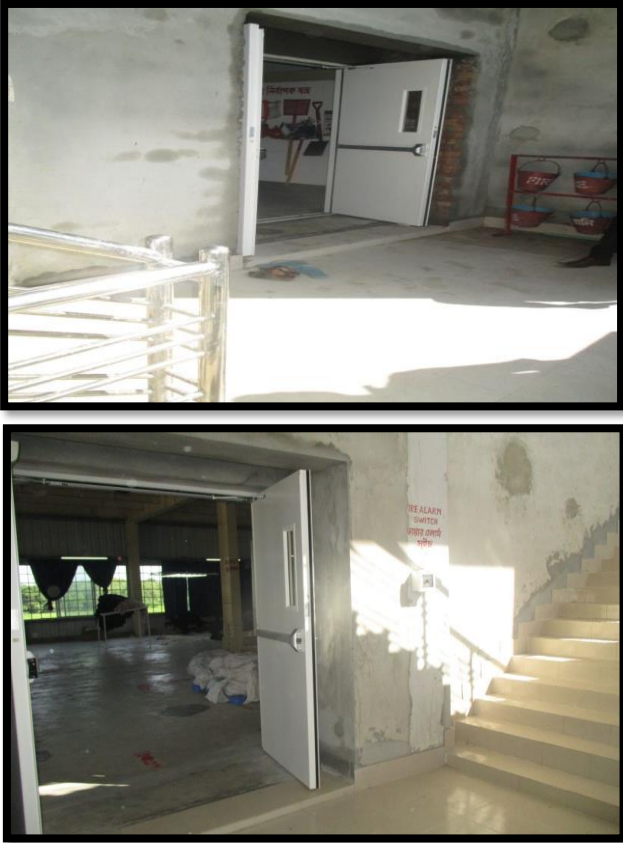
SI No.	Category	Findings	Required Action	Remediation Time Frame	Pictorial Evidence
17	Fire Rated Construction	Unit-2: The exit stairs are not separated on each floor by fire-rated construction. In ground floor stairs are discharging without proper separation.	<p>Stair shall be enclosed with a minimum 2-hr fire-rated construction. Seal all unprotected openings and provide minimum 1.5-hr fire rated doors to separate the exit stairs from work areas and other building spaces on all floor levels. Ensure that the fire doors are self-closing, positive latching and that they are provided with fire exit (panic) hardware where serving production floors.</p> <p>If fire doors are required to be held open for functional reasons, provide automatic-closing devices tied to the fire alarm system.</p>	Within 3 months

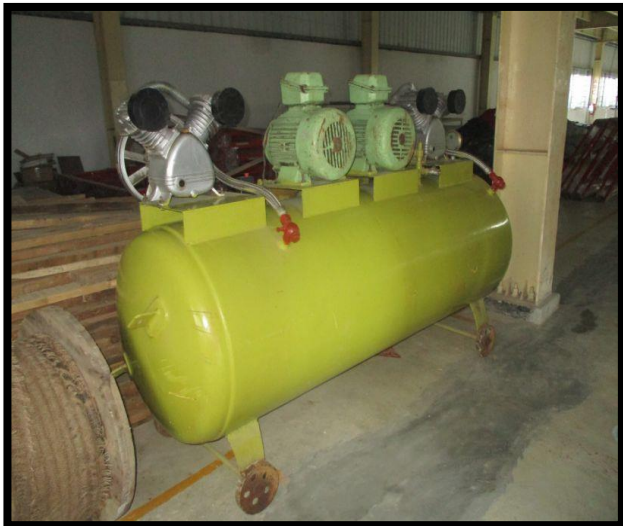
SI No.	Category	Findings	Required Action	Remediation Time Frame	Pictorial Evidence
18	Service Room Separation	Unit-2: Compressor is not separated by fire rated construction (openings, non-rated doors, penetrations)	Separate the compressor by a minimum 2-hr fire rated construction. Seal and/or protected all openings to maintain fire separations.	Within 3 months

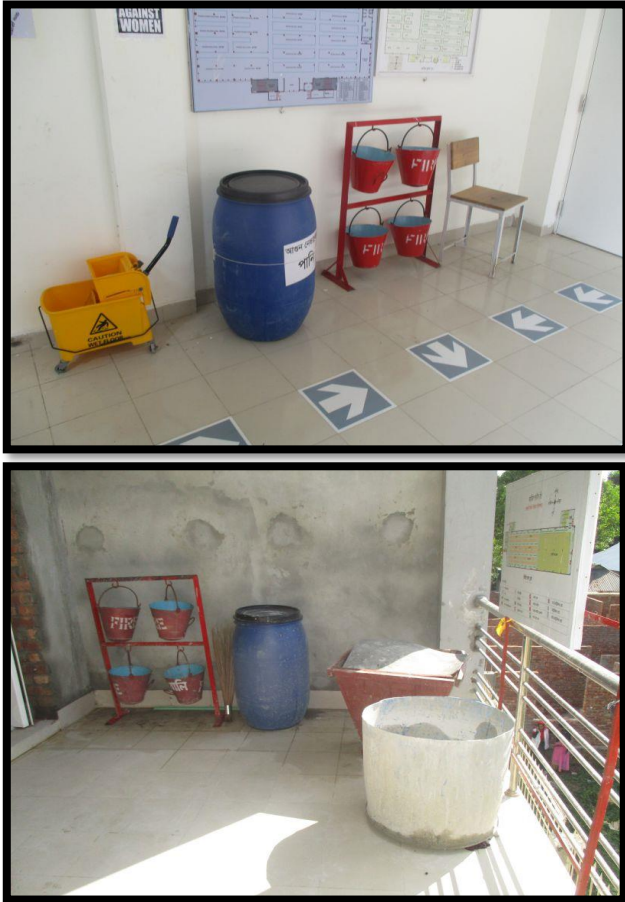
SI No.	Category	Findings	Required Action	Remediation Time Frame	Pictorial Evidence
19	Storage in Egress Path	Unit-2: Storage was located in the egress path.	Keep egress path and stair clear of storage.	Immediate

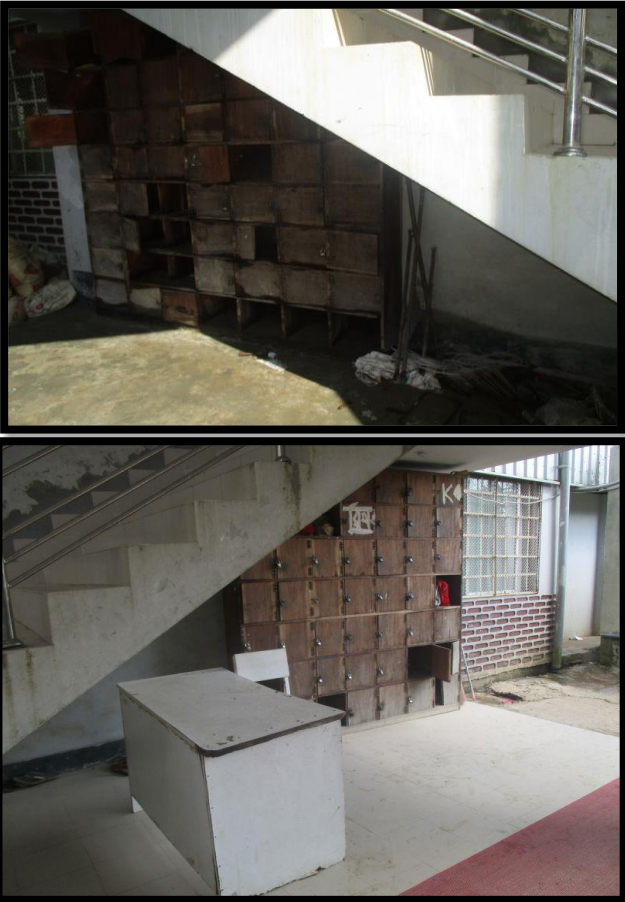
SI No.	Category	Findings	Required Action	Remediation Time Frame	Pictorial Evidence
20	Storage in Exit Stair	Unit-2: Storage was located under exit stair.	Remove storage from the exit stairs and egress path	Immediate

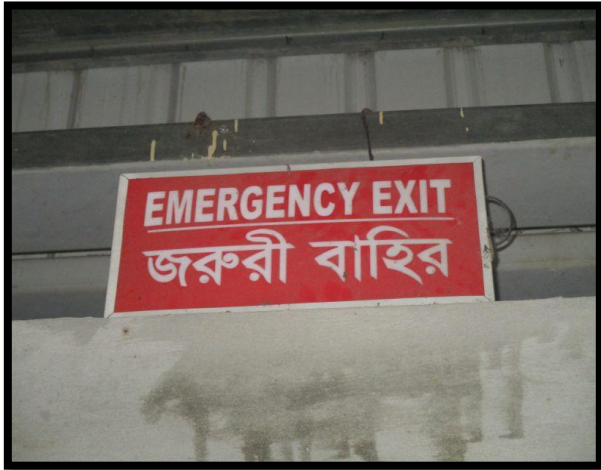
SI No.	Category	Findings	Required Action	Remediation Time Frame	Pictorial Evidence
21	Non-Working Exit Signs	Unit-2: Exit signage not illuminated (burned out, broken, etc.). Location: Unit-2 building.	Regularly inspect all exit signage and replace/install lights as needed to illuminate signs	Within 1 month

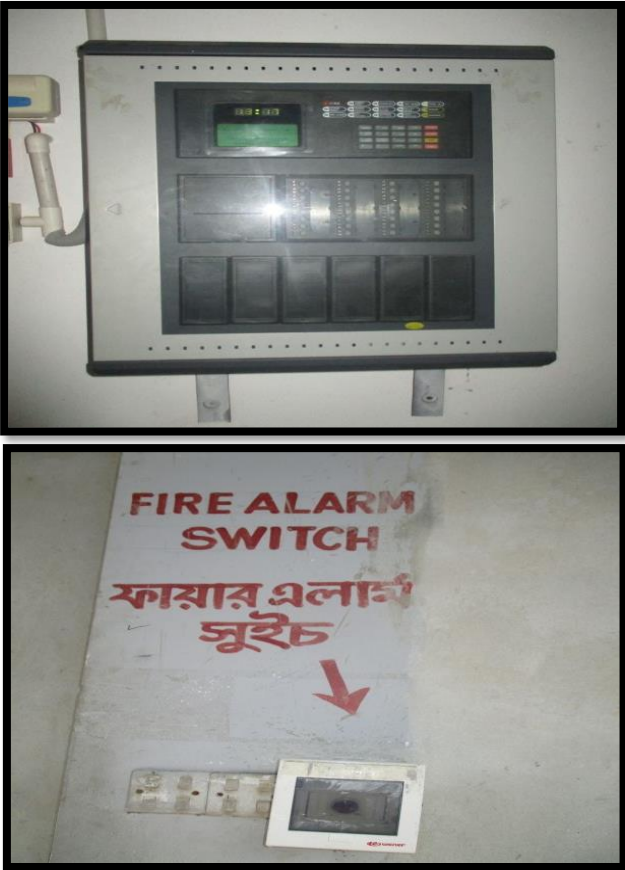
SI No.	Category	Findings	Required Action	Remediation Time Frame	Pictorial Evidence
22	As Built Fire Detection System	Unit-2: Fire detection system installation requires detailed review to confirm compliance with NFPA 72 and ACCORD standards	Submit as-built drawings, testing records, equipment certification and other relevant documentation to the ACCORD for review and approval	Design within 1 month; Modification within 6 months

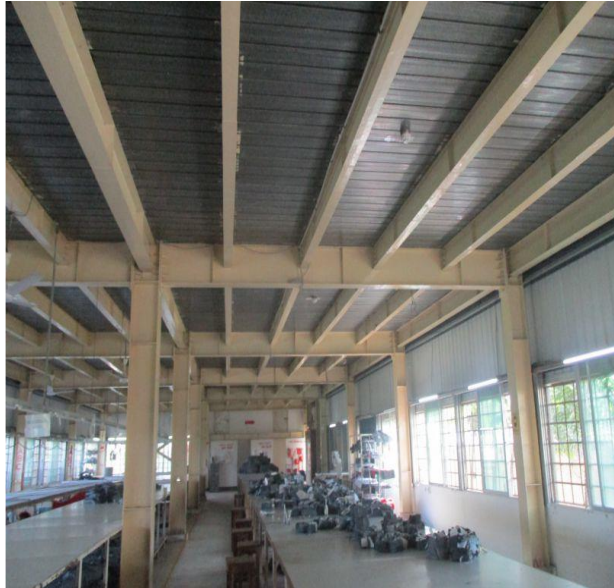
SI No.	Category	Findings	Required Action	Remediation Time Frame	Pictorial Evidence
23	Inadequate Lighting	Unit-2: Based on the number and location of emergency lights observed, adequate illumination levels are not anticipated along egress routes.	Test the emergency lighting system on each floor and provide additional emergency fixtures to provide adequate illumination along the means of egress. Provide a minimum illumination of 10 lux at the floor level within exit stairs and exit discharge paths and minimum 2.5 lux along exit access aisles.	Within 3 months

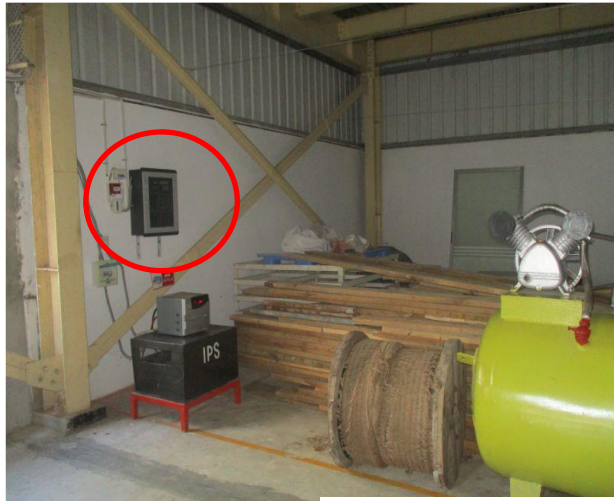
24	FACP location	Unit-2: Fire alarm control panel is located in an unsafe location. Location: Ground floor, unit-2	Relocate the FACP to a safe place from where it can be easily monitored with an easy and safe access.	Within 1 month
