Cordial Design TMS Fashion Ltd

25/2 Shah Alibagh, Mirpur-1, Dhaka
(+23.7952N, 90.358E)

16 September 2013

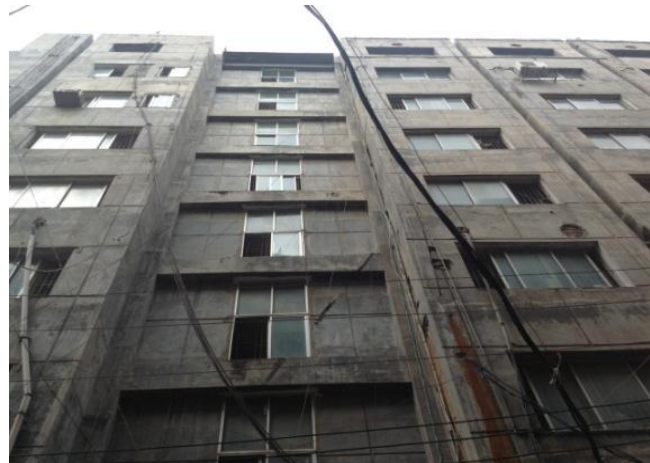
Check on column loads and design required

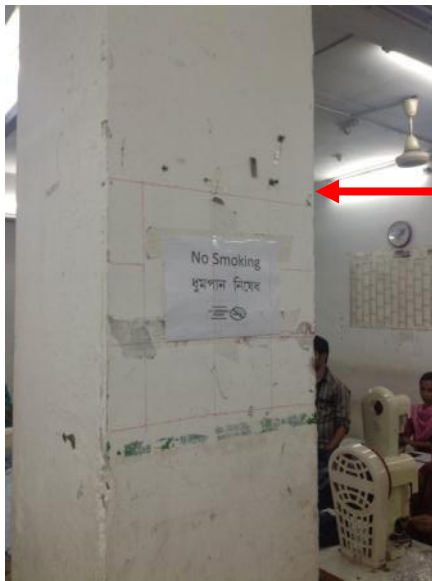
Column investigation shows columns have not been increased in size for the extra floor(s)

Permit Drawing indicates vertical and horizontal addition to the building, but is not accurate as to which floors were added. We believe one slab was added (current roof slab)

ITEM 1: Historic addition of a floor has resulted in heavily loaded columns, As-Built drawings do not match the actual columns.

Building Engineer to revisit As-Built Drawings, Design Check required for all columns in the original Southern building

Item No.	Observation	Recommended Action Plan	Recommended Timeline
1	Historic addition of a floor has resulted in heavily loaded columns, As-Built drawings do not match the actual columns	Design check all columns South of the joint between the original and extension buildings. Revise As-Built drawings showing actual column sizes. Propose strengthening as required	6-weeks
2	Historic addition of a floor has resulted in heavily loaded columns, As-Built drawings do not match the actual columns	Verify insitu concrete stresses either by cores or existing cylinder strength data for South of the joint between the original and extension	6-weeks
3	Historic addition of a floor has resulted in heavily loaded columns, As-Built drawings do not match the actual columns	Produce and actively manage a loading plan for all floor plates within the factory giving consideration to floor capacity and column capacity.	6-months

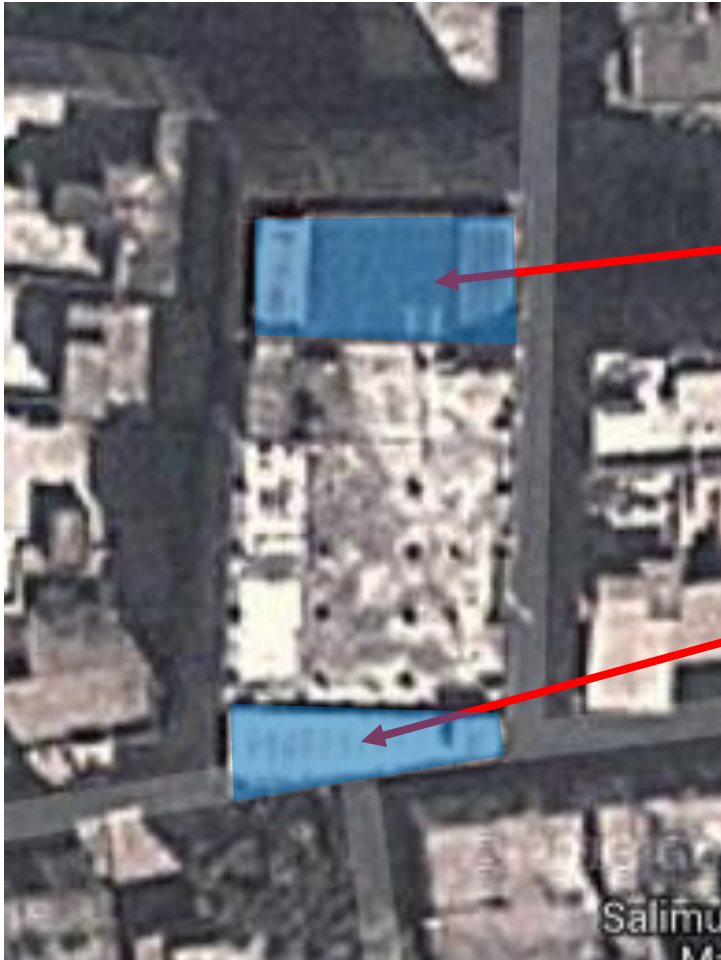
Northern roof structures built beyond the height shown in the design drawings, built of masonry and a lightweight steel roof

South Set-Back roof structure addition

ITEM 2: Lightweight steel roof additions do not appear to be strong enough for severe wind events or access loading

Check on roof additions required

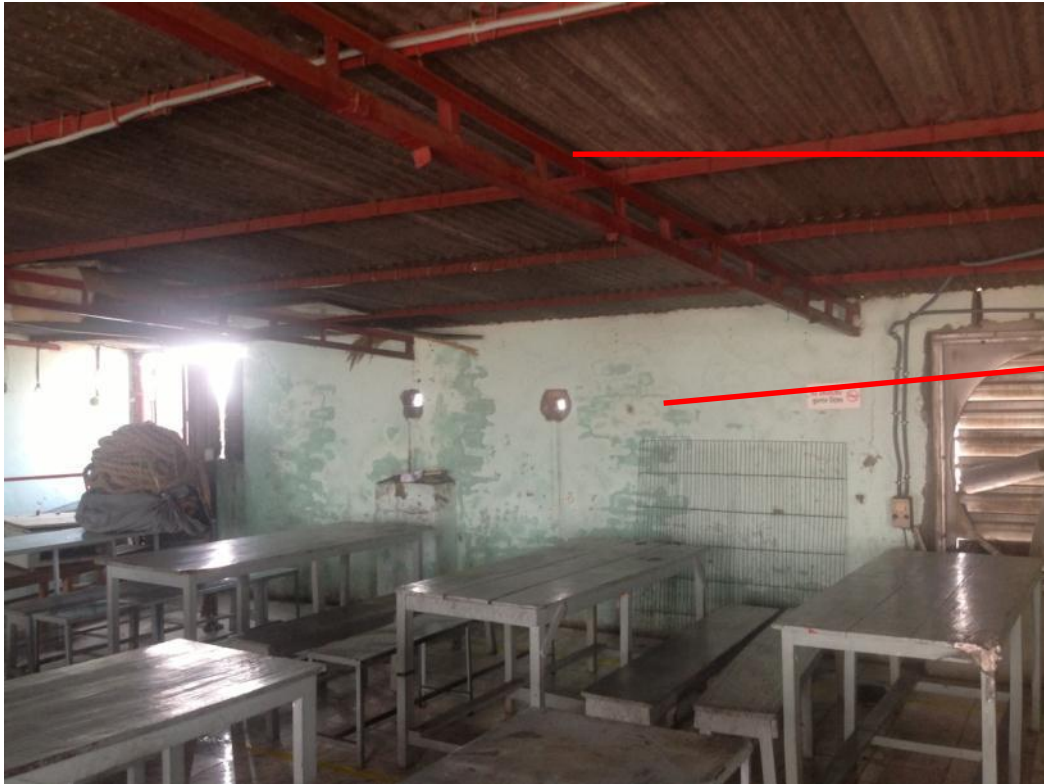
Lightweight steel roof

Masonry Walls

**Check on roof additions
required**

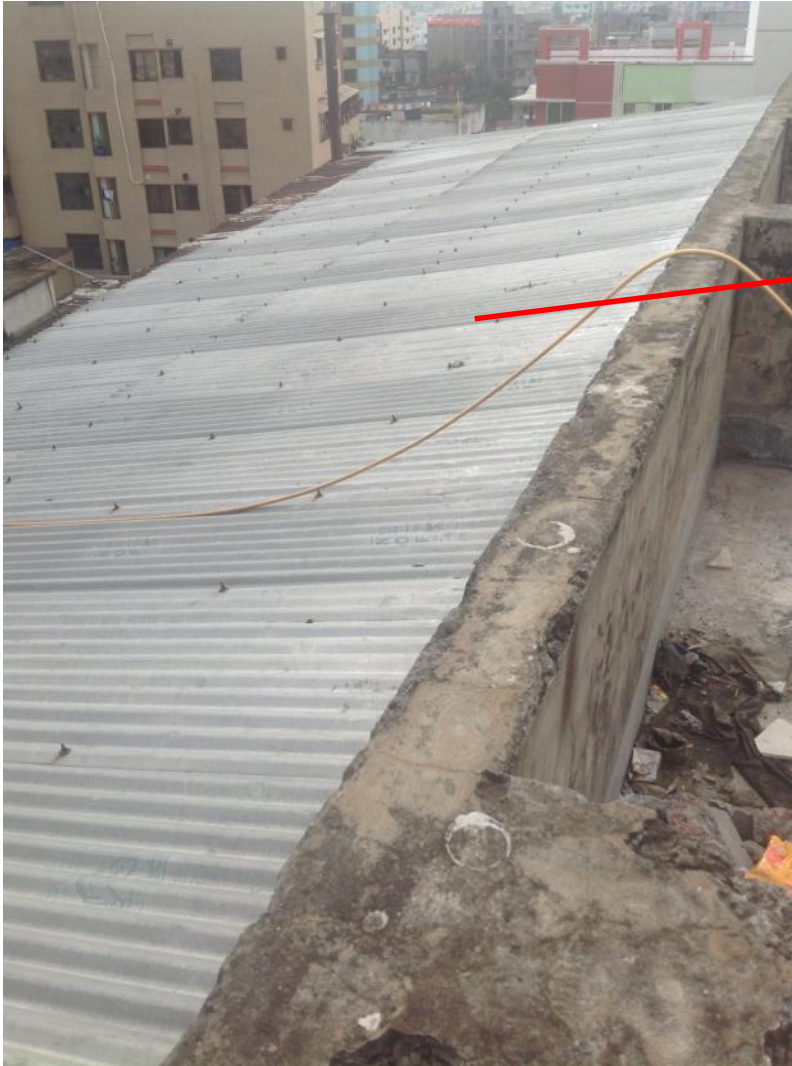
**Lightweight steel roof built
Over original roof set-back
on South side**

**These structures should be
Designed and upgraded to
support code vertical and wind
loads by the building Engineer,
or they should be vacated and
removed.**

4	Lightweight steel roof additions do not appear to be strong enough for severe wind events or access loading	Addition structures should be Designed and upgraded to support code vertical and wind loads by the building Engineer, or they should be vacated and removed.	6-months
5	One ground level column in the South-West corner has corroded	Engineer to inspect propose a suitable repair	6-months
6	The original lift shaft has been filled-in with a lightweight steel floor, which does not appear to be strong enough for heavier storage loads	Do not place storage on the lift shaft area	Immediate - Now
7	The original lift shaft has been filled-in with a lightweight steel floor, which does not appear to be strong enough for heavier storage loads	The building Engineer should verify this can carry code floor load, or design and construct a retrofit	6-months

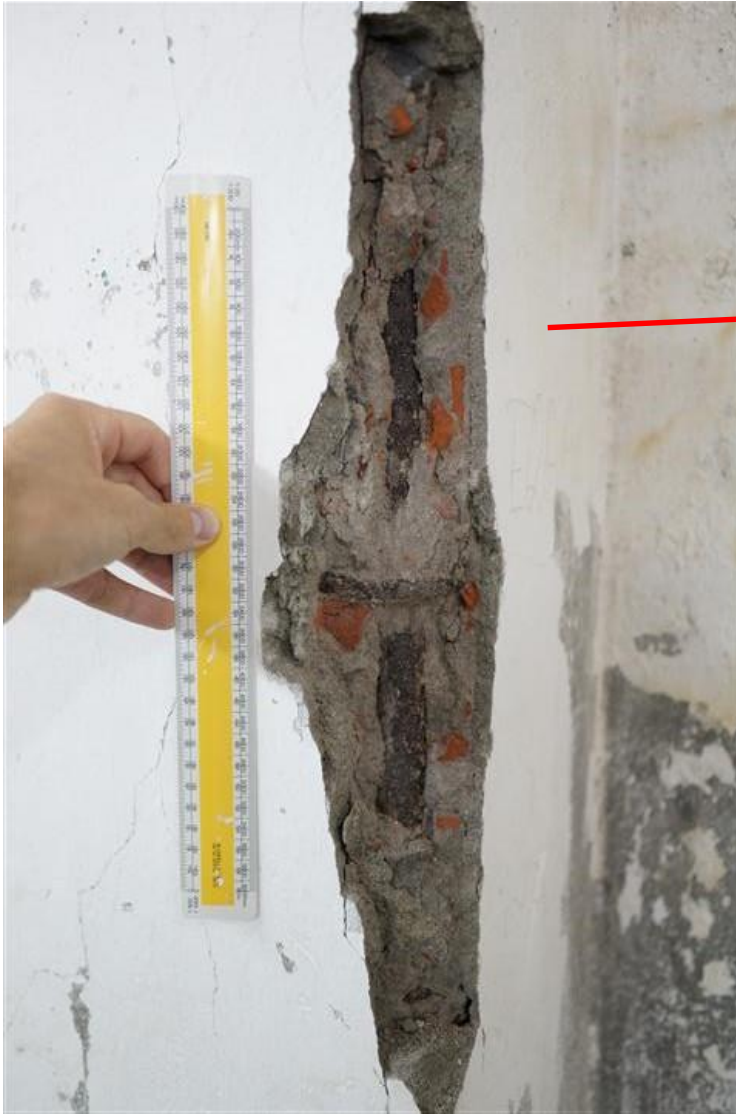
Water damage has rusted steel reinforcement, causing spalling of concrete.

ITEM 3: One ground level column in the South-West corner has corroded.

Engineer to inspect propose a suitable repair
