# **A.G. Dresses Ltd, Pinaki Garments Ltd, Pinaki Seha Industries Ltd, Seha International Bangladesh Ltd.**

Plot-9 Block-C Tongi Industrial Area, Haimardighi, Tongi Gazipur  
(23.899N, 90.405E)

1st March 2014

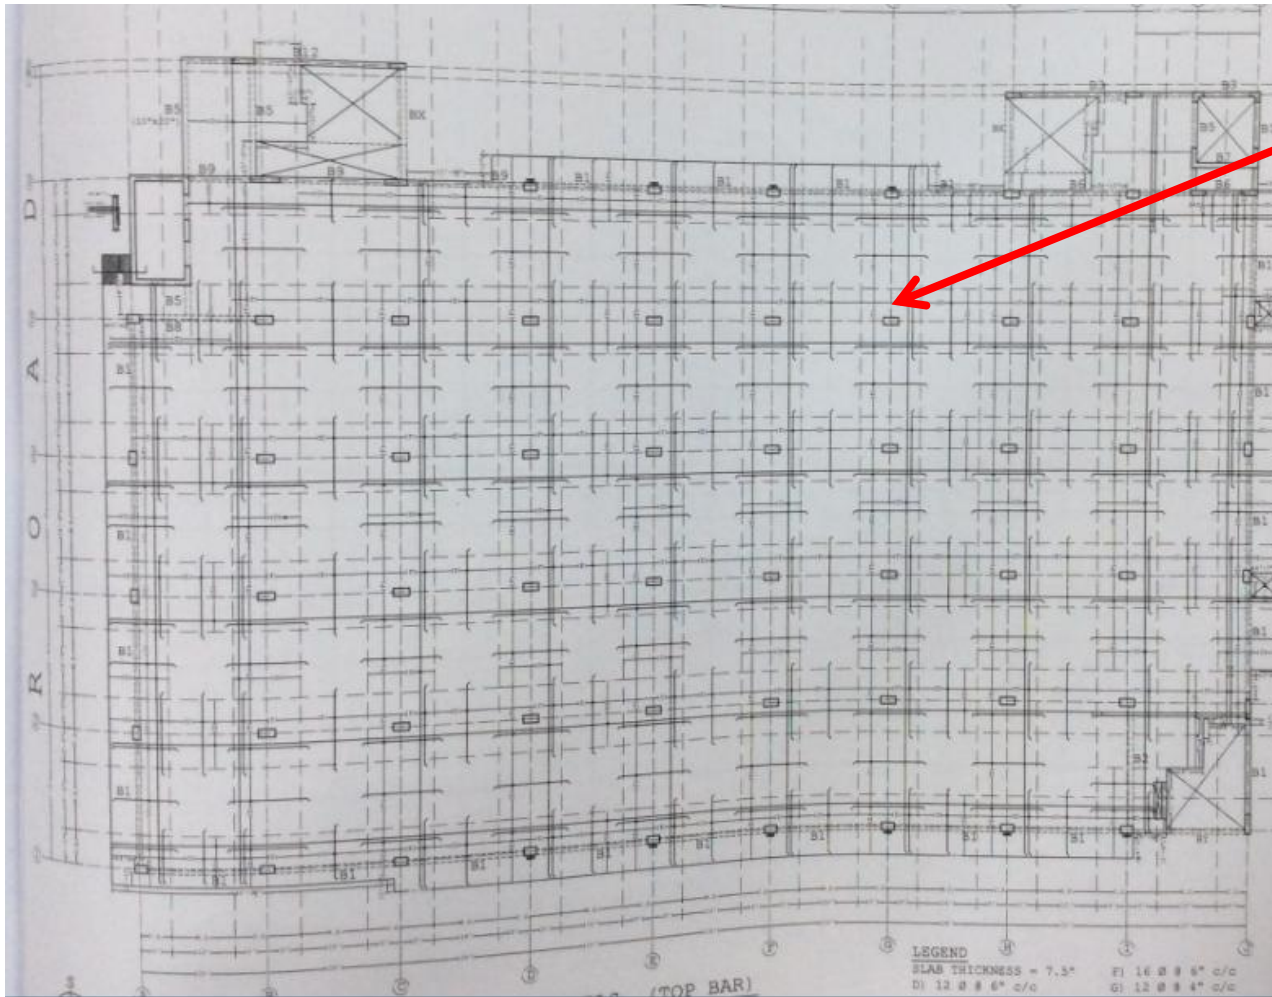
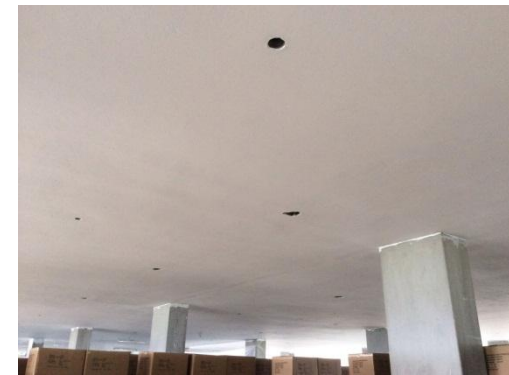
Cursory Calculations indicate high shear stress at column heads.

Shear reinforcement not indicated on the drawings presented for inspection.

Building Engineer to check punching shear for the slab at all levels

| Item No. | Observation | Recommended Action Plan | Recommended Timeline |
|---|---|---|---|
| 1 | Flat slab design | Engineer to carry out punching shear calculation check on the building floor slabs. | 6-weeks |

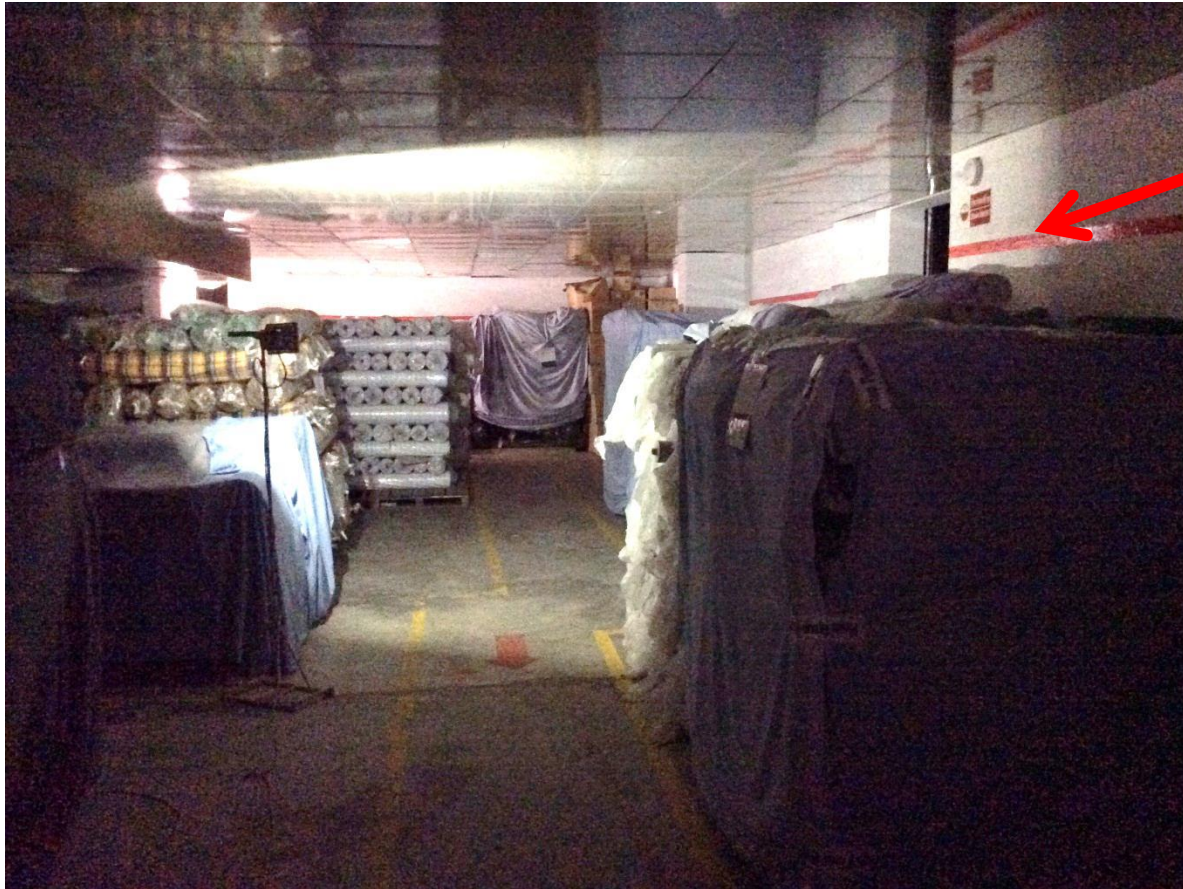
Material stacked to to approx 2m in height in mezzanine area

Storage height restrictions (red line marking) to be checked by building engineer to ensure storage does not exceed the maximum design loading.

| Item No. | Observation | Recommended Action Plan | Recommended Timeline |
|---|---|---|---|
| 3 | Storage loading | Storage height restrictions (red line marking) to be checked by building engineer , with consideration to the density of material being stored, to ensure storage does not exceed the maximum design loading | 6-weeks |
| 4 | Storage loading | Building Engineer to create controlled loading plans for all floors. | 6-months |

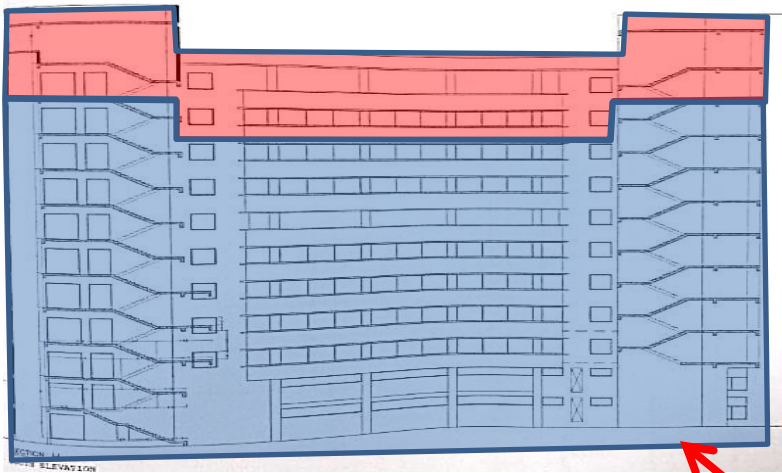
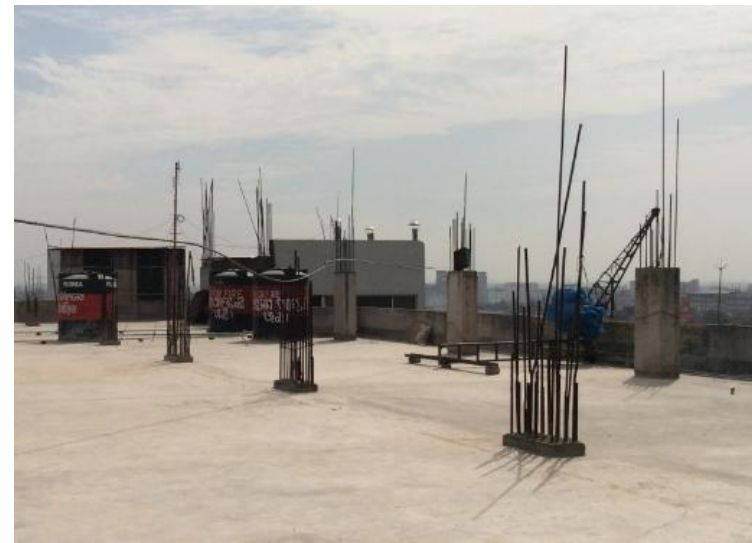
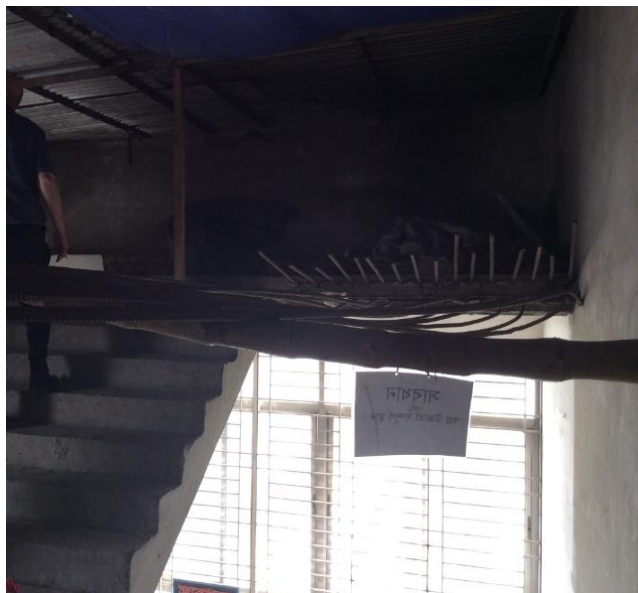
The Building is currently 8 storeys. Stub column reinforcement at roof level and continuity reinforcement in stair cores indicate that there is potential for future vertical extension of the building.

Further extension of the building should not be carried out without a detailed engineering assessment and testing of the concrete in the vertical load bearing elements

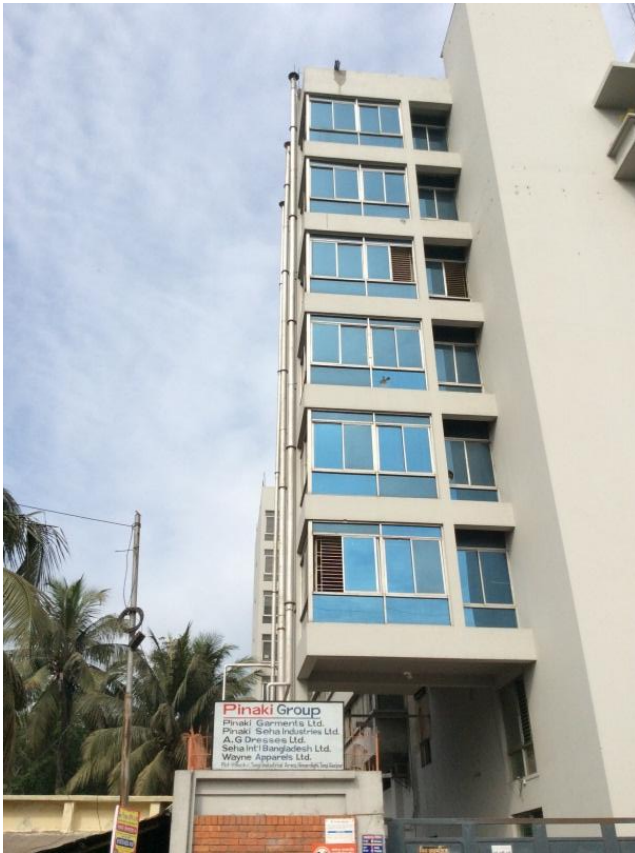
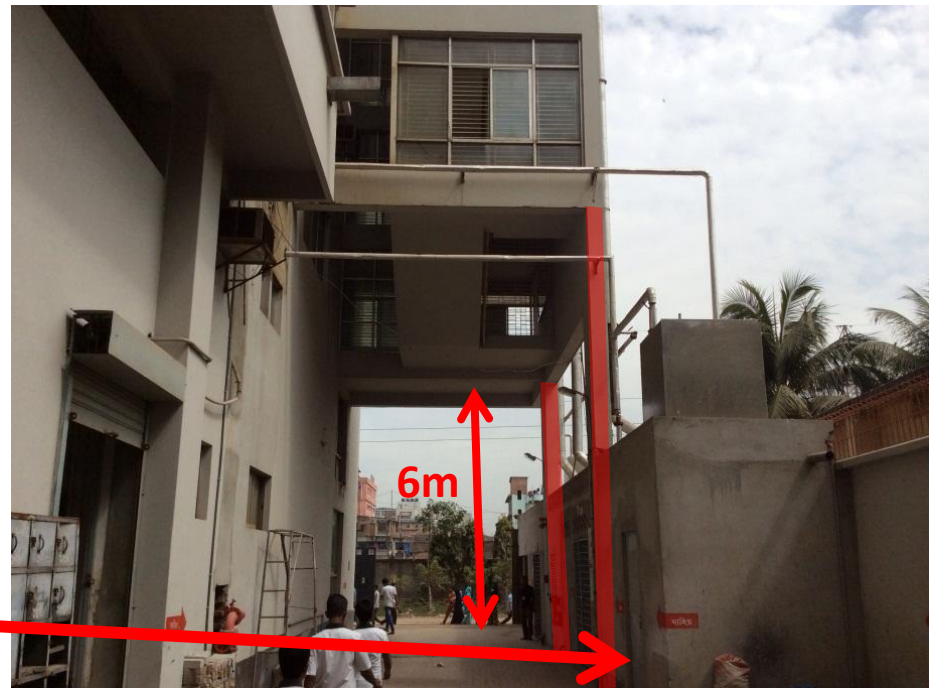
The columns supporting the stair core to the south east corner of the building appear to be very slender.

Column size: 1000 x 240 mm

Span: Approximately 6 m (gr. floor to level 2)

Column unrestrained by shed building at ground level

Risk of accidental damage from potential vehicle impact

| Item No. | Observation | Recommended Action Plan | Recommended Timeline |
|---|---|---|---|
| 8 | Slender columns under Stair core | Design check of 2 external columns supporting stair core to be carried out by the building engineer. | 6-months |
| 9 | Slender columns under Stair core | Additional protection measures such as a barrier to be installed to reduce accidental impact risk | 6-months |

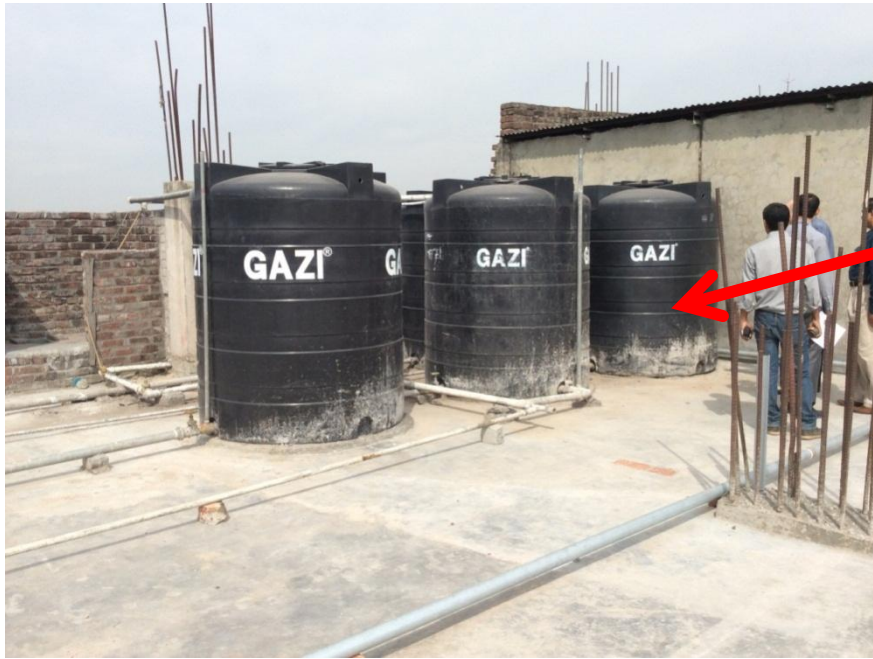
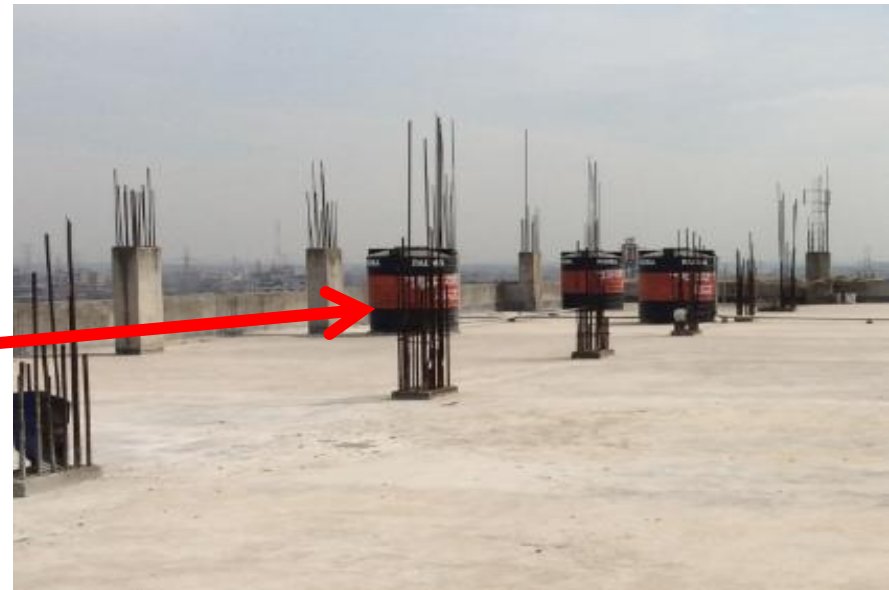
3000 litre Fire water tanks

Building Engineer to check that beam and slab have been designed to accommodate loads.

| Item No. | Observation | Recommended Action Plan | Recommended Timeline |
|---|---|---|---|
| 10 | Water tank on roof | Building Engineer to check that slab has sufficient capacity to support fully filled water tanks. Punching shear at column heads to be checked (refer item 1 above) | 6-weeks |
| 11 | Water tank on roof | Relocate tanks if necessary | 6-weeks |

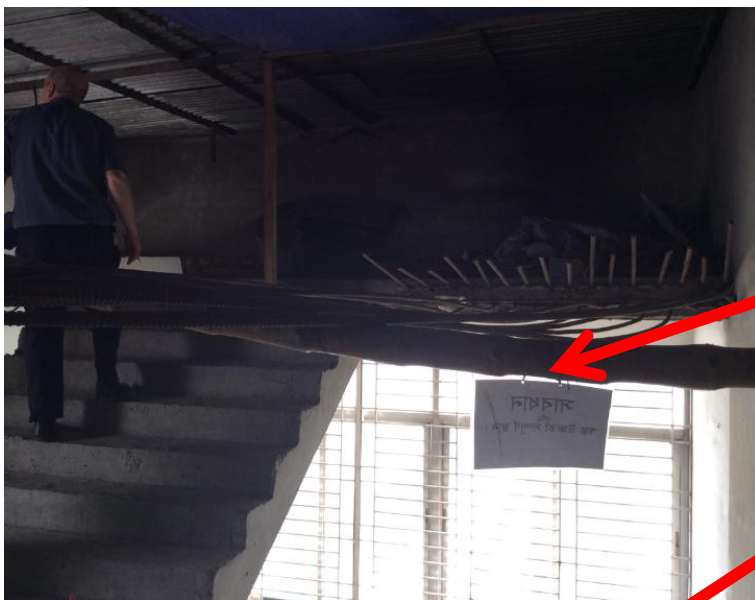
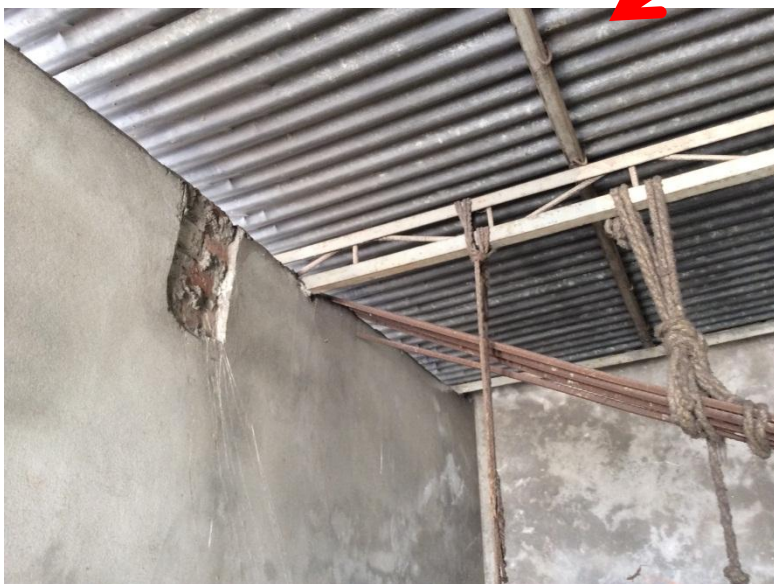
Reinforcement for new staircore beam and stairs for future extension exposed. Inadequate edge protection to stairs

Lightweight temporary roof subject to uplift under heavy wind loading

Area to be made safe and cordoned off for access with handrails installed for safety. Temporary roof to be assessed by Building Engineer and adequate tie downs installed.
