# **FIRE SAFETY INSPECTION REPORT**

**STARLIGHT SWEATERS LTD.  
VOGRA NATIONAL UNIVERSITY, GAZIPUR, SADAR**

**ACCORD**  
on Fire and Building Safety in Bangladesh

March 22, 2014

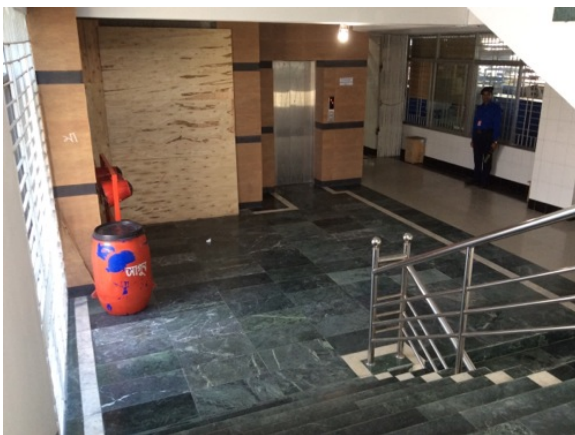
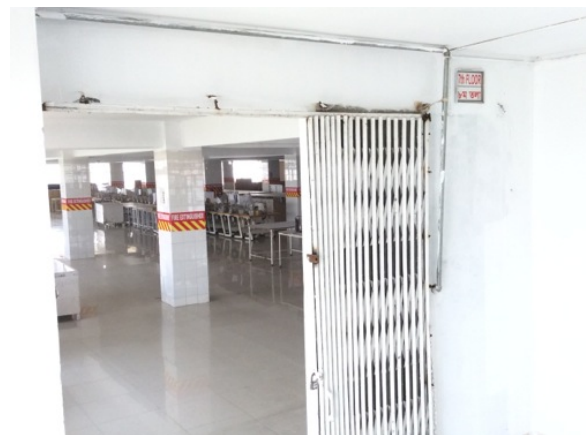
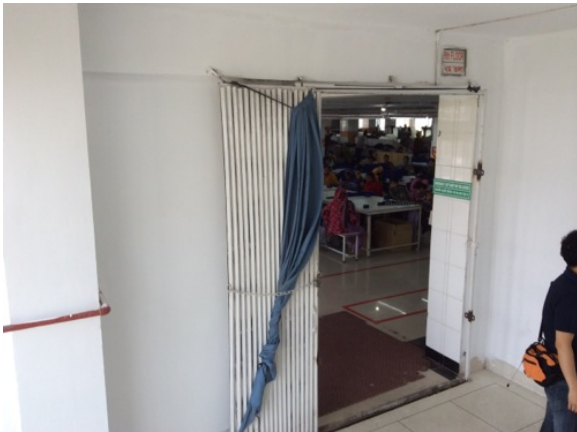
| No. | Category | Finding | Recommendation | Remediation Timeframe |
|---|---|---|---|---|
| F-1 | Fire Rated Construction | <p>The exit stairs are not separated from work areas, other spaces on each floor by fire-rated construction.</p> <p>No fire rated doors installed throughout the stairwells.</p> | <p>Provide minimum 1.5-hr fire rated doors and seal all unprotected openings to separate the exit stairs from work areas and other building spaces on all floor levels.</p> <p>Ensure that the fire doors are self-closing and positive latching and that they are provided with fire exit (panic) hardware where serving production floors.</p> <p>If fire doors are required to be held open for functional reasons, provide automatic-closing devices tied to the fire alarm system.</p> | Within 3 months |

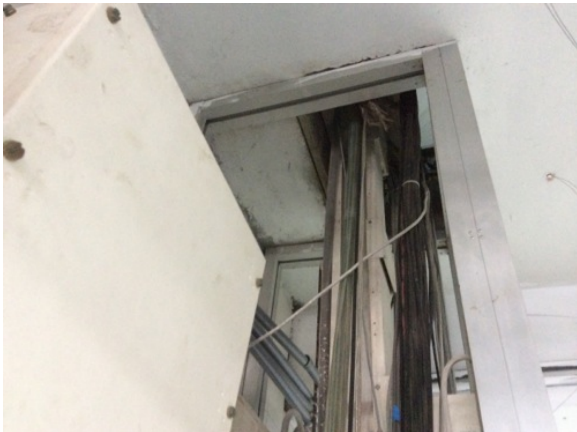
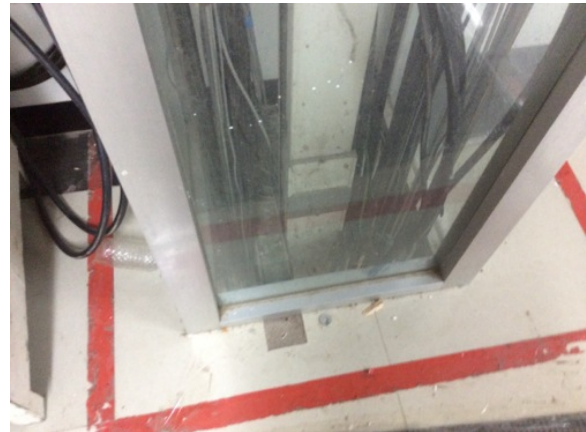
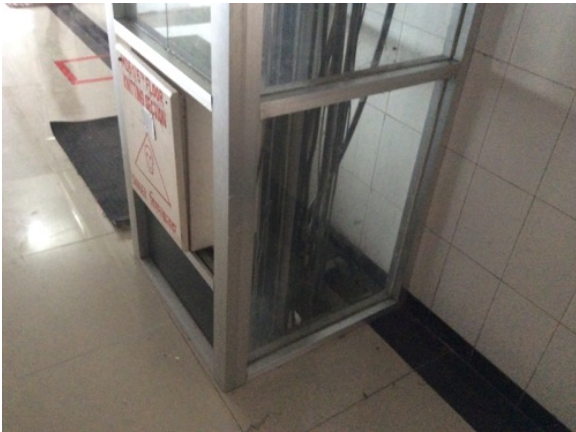
| F-2 | Fire Rated Construction | Unsealed penetrations and openings are located in the fire-rated floor/ceiling assemblies throughout the building. (electrical shafts). | Provide a minimum 2-hr fire-rated shaft to separate the utility risers from each floor level. | Within 3 months |

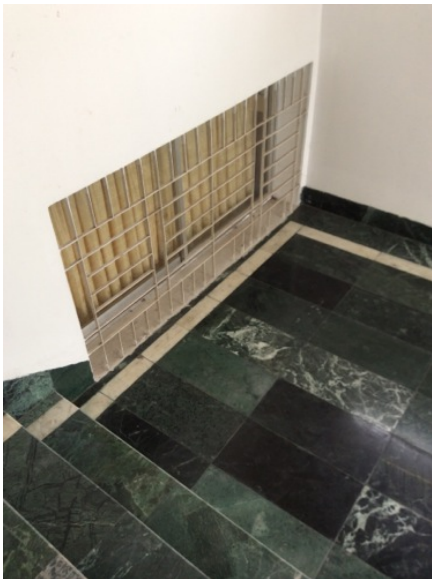
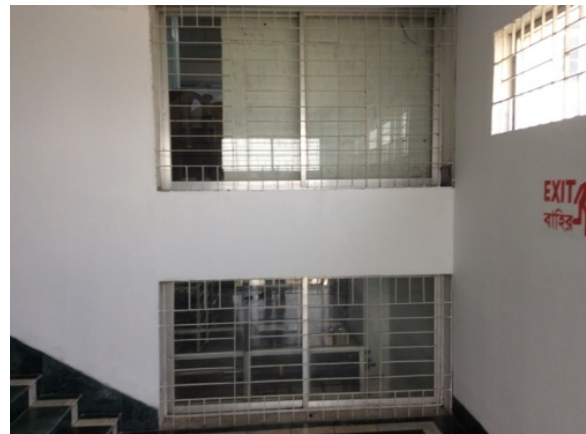
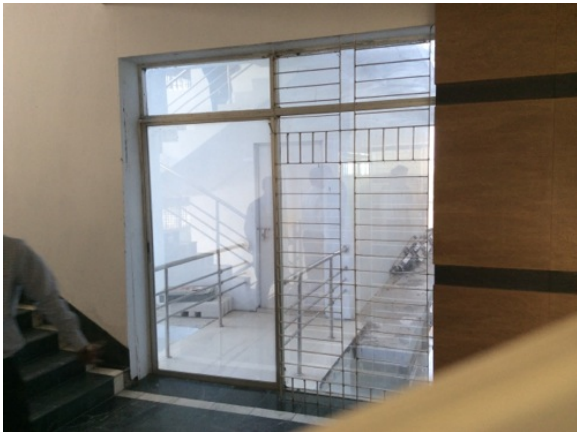
| F-3 | Fire Rated Construction | Unsealed penetrations and unprotected openings are located in north exit stairwells enclosures. | Seal all penetrations and openings in exit stair enclosure walls to maintain the fire separation. | Within 3 months |

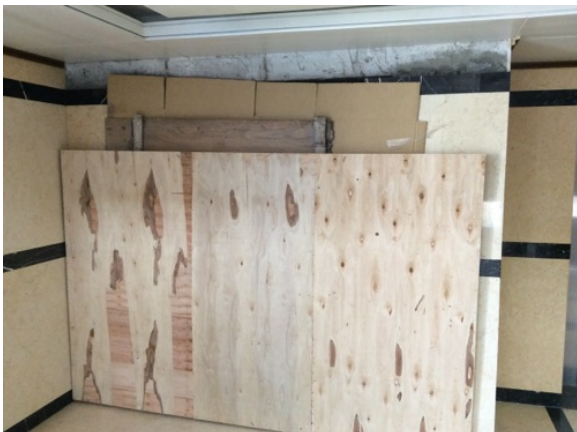
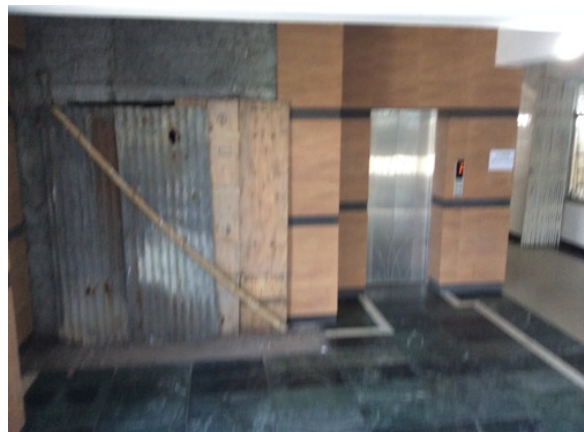
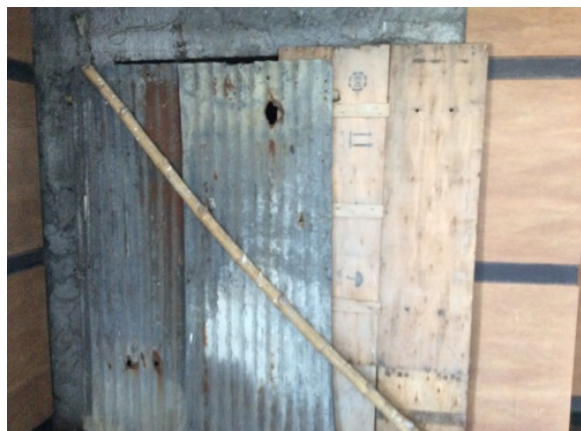
| F-4 | Fire Rated Construction | The elevator shaft are not separated from work areas on each floor by fire-rated construction due to elevator opening. | Provide minimum 1.5-hr fire rated doors and seal all unprotected openings to separate the elevator shaft from work areas and other building spaces on all floor levels. | Within 3 months |

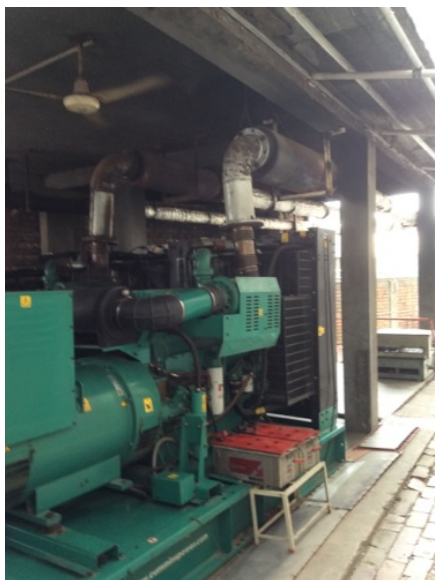
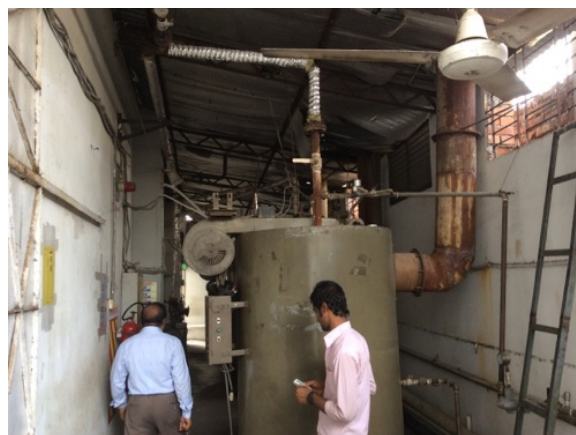
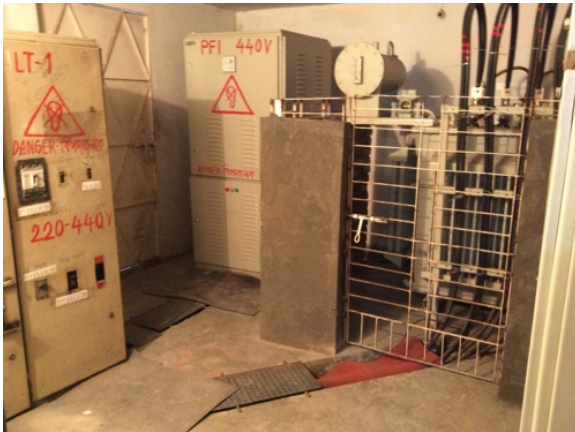
| F-5 | Fire Rated Construction | The boiler, generator and transformer room on the ground floor is not separated by fire-rated construction (openings, non-rated doors, penetrations). | Separate the boiler, generator and transformer room by a minimum 2-hr fire-rated construction. Seal and/or protected all openings to maintain the required fire separations | Within 3 months |

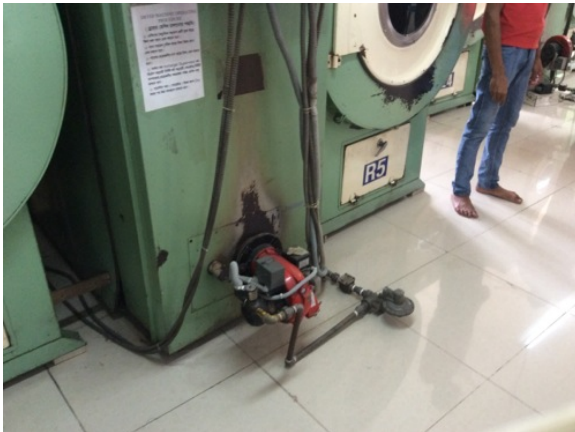
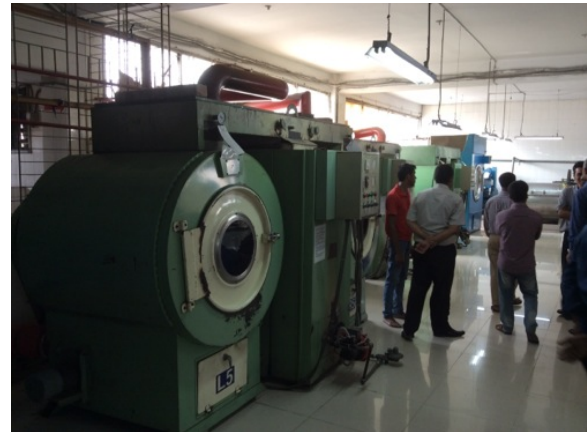
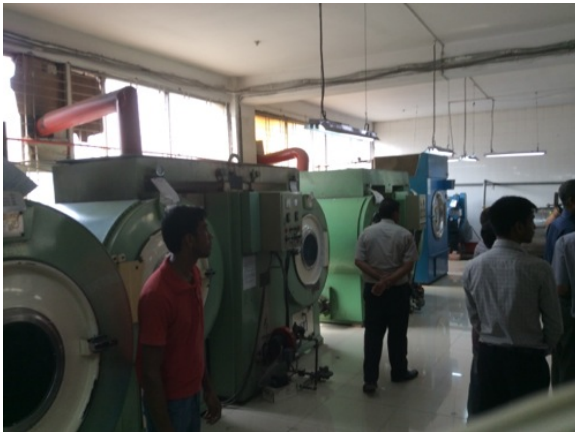
| F-6 | Fire Rated Construction | Gas fired dryer is not separated from the factory. | Separate the gas fired dryers by a minimum 2-hr fire-rated construction. Seal or protected all openings to maintain the required fire separations | Within 3 months |

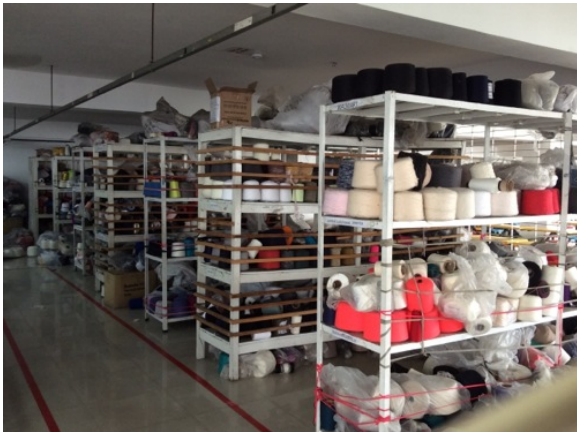
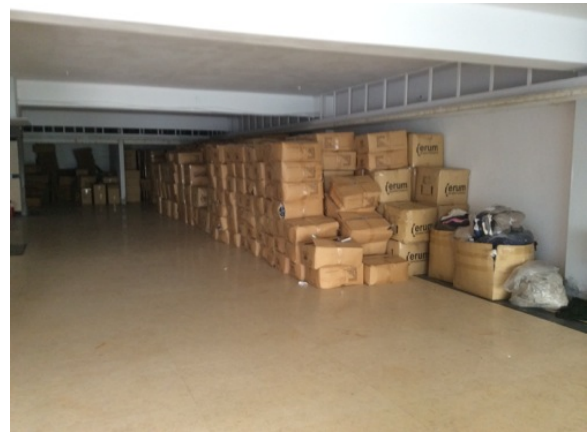
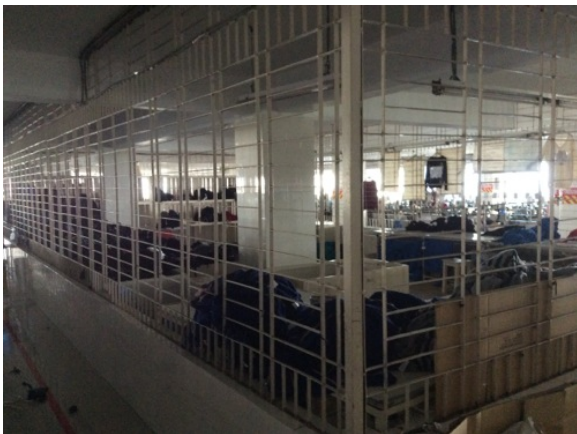
| F-7 | Fire Rated Construction | <p>Areas used for combustible storage in several location are not separated by fire-rated construction.</p> <p>Locations; 9th, 8th, 6th, 4th, ground floor.</p> | <p>Provide dedicated storage rooms separated by minimum 1-hr fire-rated construction.</p> <p>Where separate storage rooms are not feasible, provide defined storage areas and limit the storage arrangement as follows:</p> <ul style="list-style-type: none"> <li>- Maximum height of 2.4m and maximum area of 23m<sup>2</sup></li> <li>- If sprinkler protected: maximum height of 3.66m and maximum area of 93m<sup>2</sup></li> </ul> <p>Separate areas of unenclosed combustible storage by a minimum clear distance of 3m.</p> | Within 3 months |

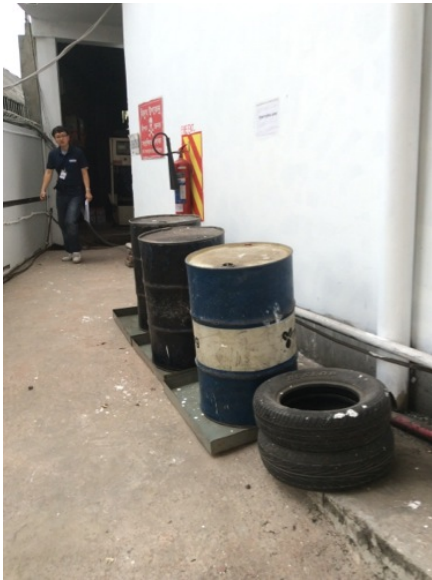
| F-8 | Fire Rated Construction | Diesel storage area is not separated by fire-rated construction. | Separate the diesel storage by a minimum 2-hr fire-rated construction. Seal and/or protected all openings to maintain the required fire separations. | Within 3 months |

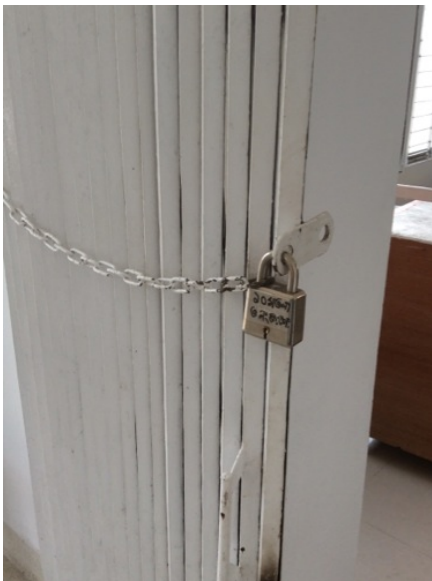
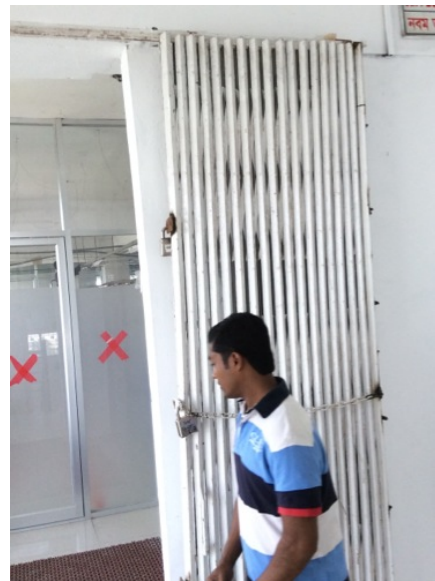
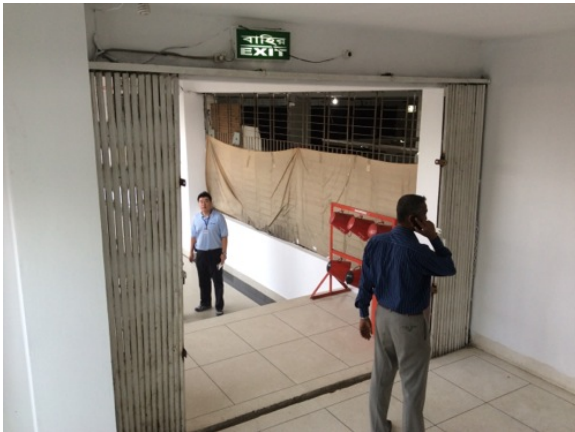
| F-9 | Egress | <p>Egress doors, exit stair doors, gates with locking features are provided throughout the building.</p> <p>During the inspection all gates and doors are open and unlocked.</p> | <p>Remove locking features from all egress doors / gates.</p> <p>If locks are required for security reasons, utilize special door locking features complying with NFPA 101.</p> | Immediate |

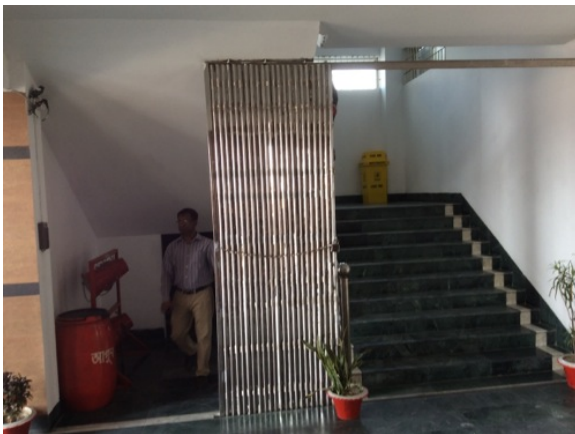
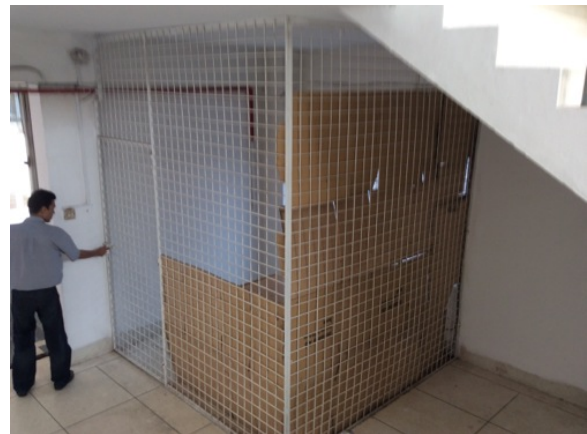
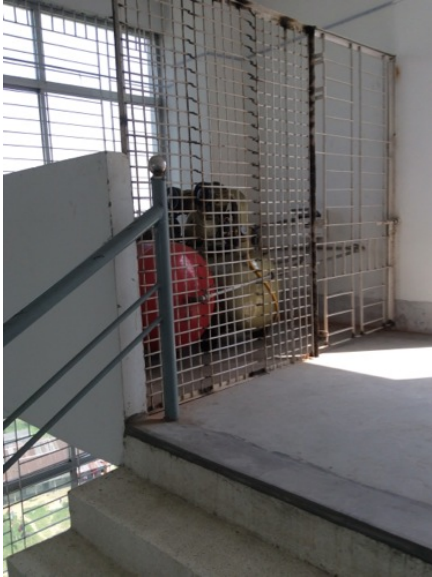
| F-10 | Egress | Storage is located in all exit stair. | Remove all storage from exit stairs and egress paths. | Immediate |

| | | | Provide fire separation and fire rated doors. | |

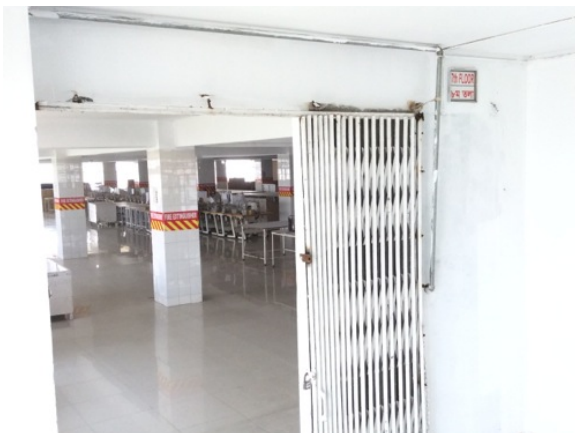
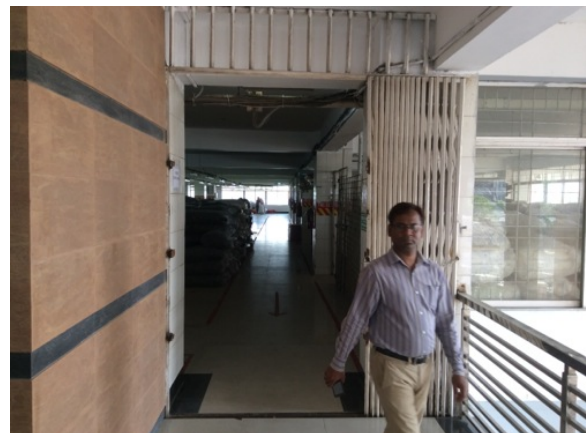
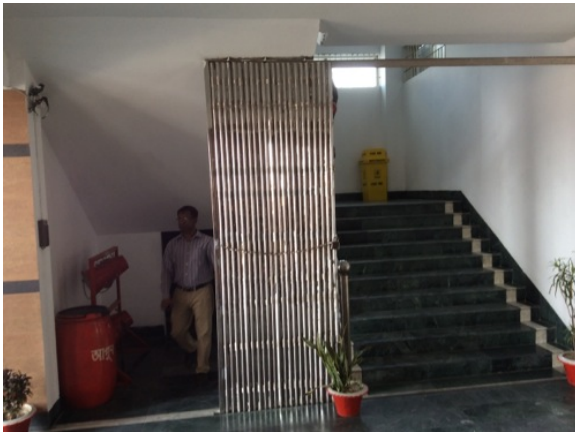
| F-11 | Egress | Sliding gates / doors are provided throughout the stairwells, building exits, along egress routes, exit discharge. | Replace all gates / sliding doors along the means of egress with side-hinged, swinging egress doors. | Within 1 month |

| | | | If locks are required for security reasons, utilize special door locking features complying with NFPA 101. | |

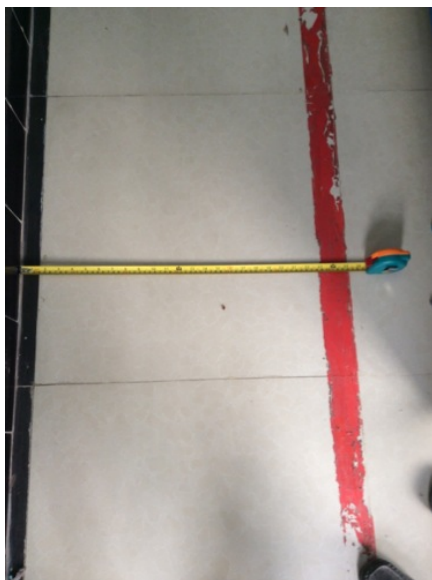
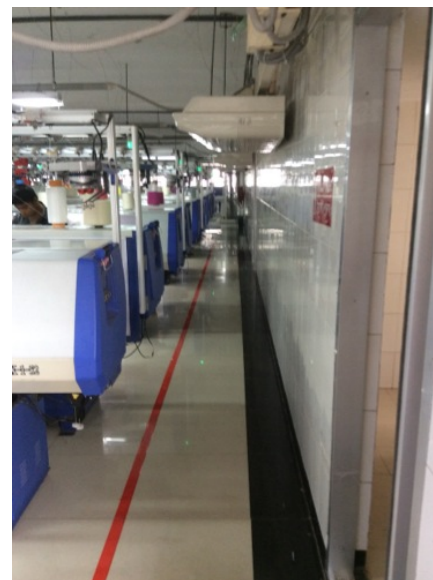
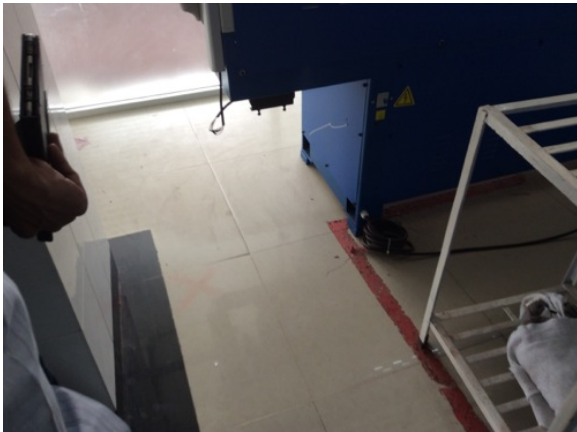
| F-12 | Egress | The width of egress aisles in the 8th floor production area is less than 36-in. Headroom is lower than 60-in. due to indoor AC. | Provide minimum aisle widths of 36-in. and arranges aisle away from indoor AC. | Within 3 months |

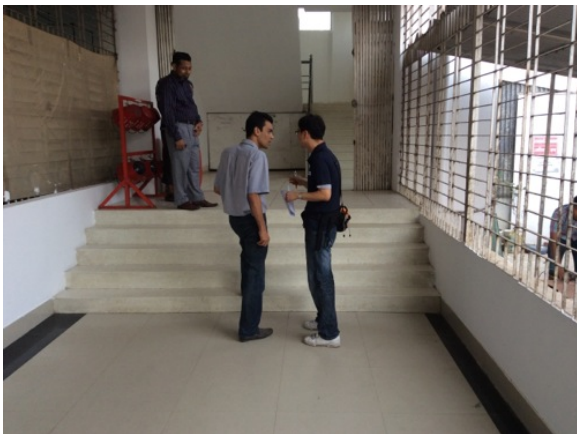
| F-13 | Egress | Handrails are not provided in the exit stair. | Provide handrails on at least one side of exit stair. | Within 3 months |
| | | Location- NW landing stairwell. | | |

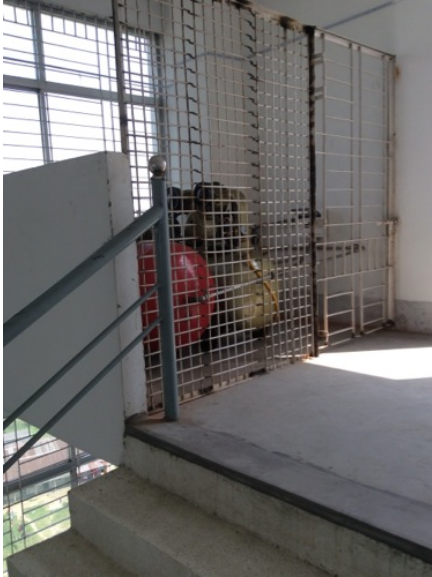
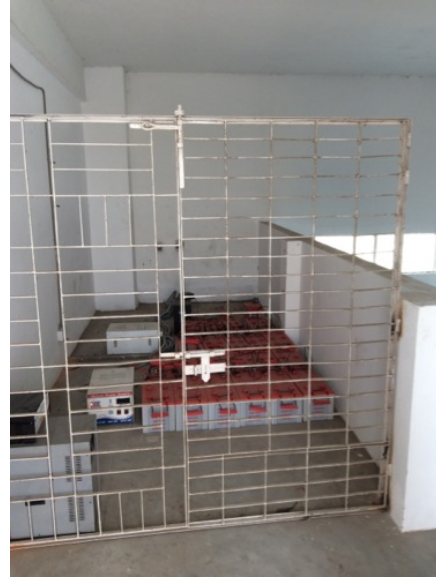
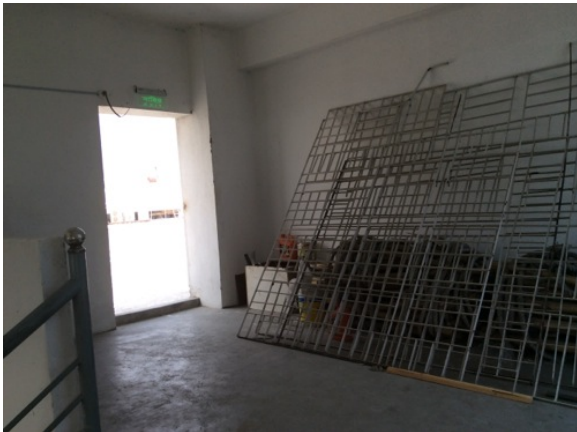
| F-14 | Egress | The storages was located at all exit stairs top floors. | Remove all storage from exit stairs and egress paths. | Within 3 months |

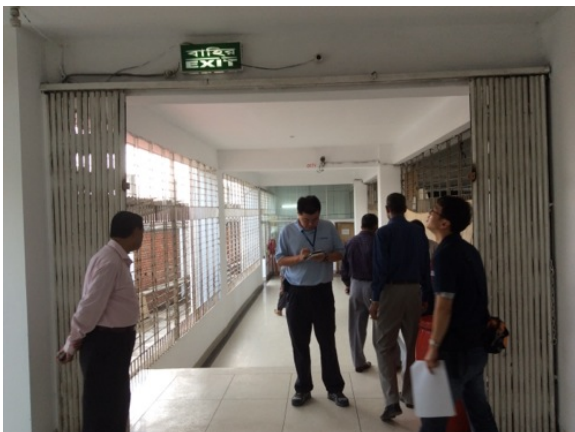
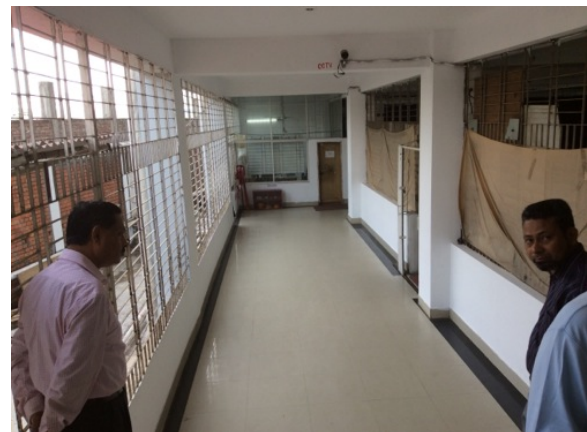
| F-15 | Egress | NW exit stairs discharge inside the building. | <p>- Modify stair to discharge directly outside.</p> <p>Within 6 months</p> <p>or</p> <p>- Provide 2-hr fire-rated exit passageway leading directly outside (vestibules to separate any storage areas).</p> <p>or</p> <p>- Provide sprinkler protection for discharge floor in accordance with NFPA 13.</p> | |

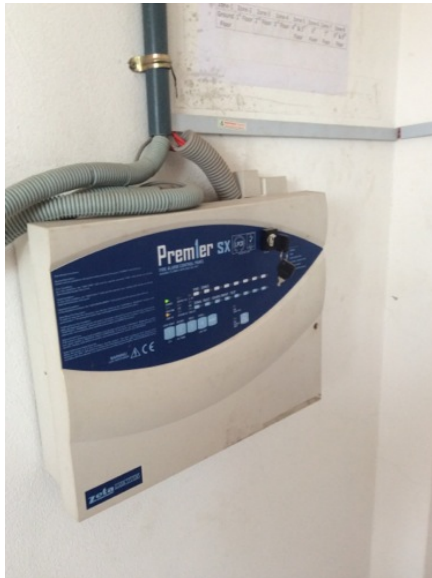
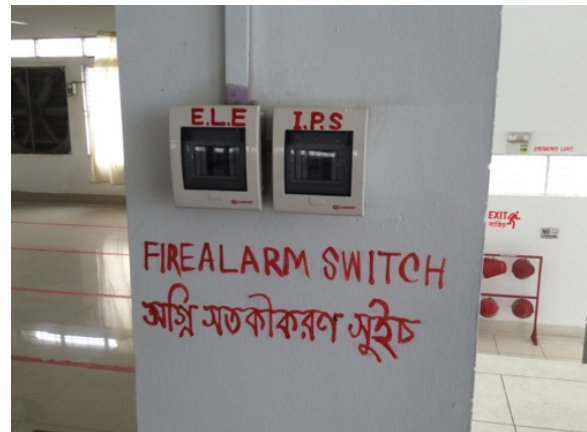
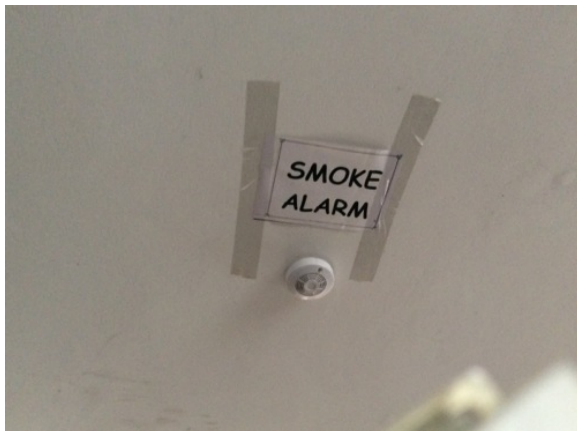
| F-16 | Fire Protection | <p>The fire alarm system is antiquated, not a listed system, and does not provide alarm and notification features consistent with acceptable standards.</p> <p>Automatic smoke detection coverage is incomplete.</p> | <p>Replace the fire alarm system with a new, listed addressable fire alarm system in accordance with NFPA 72.</p> | <p>Design within 4 months, install within 9 months</p> |

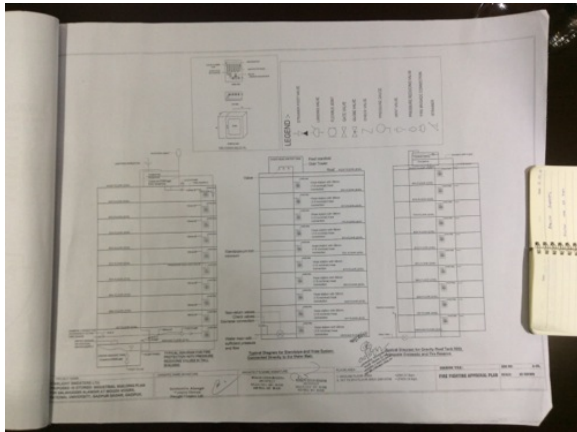
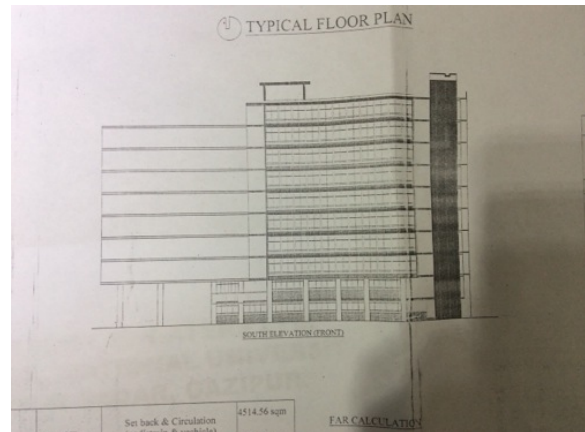
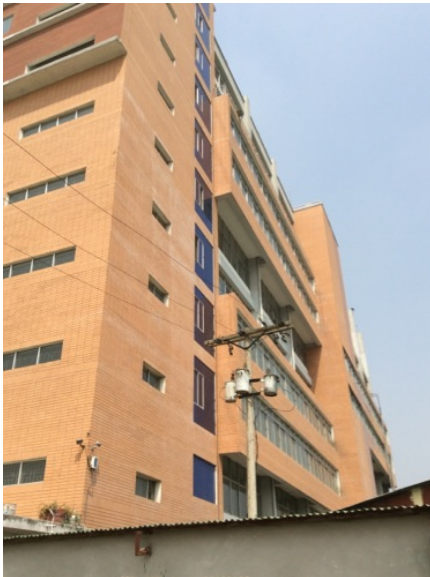
| F-17 | Fire Protection | The high-rise building has an occupied floor greater than 23m (75 ft) and is not provided with automatic sprinkler protection. The large occupant loads, heavy fuel loading, and anticipated extended egress times warrant sprinkler protection. | Provide automatic sprinkler protection throughout the building in accordance with NFPA 13. | Design within 6 months, install within 12 months |

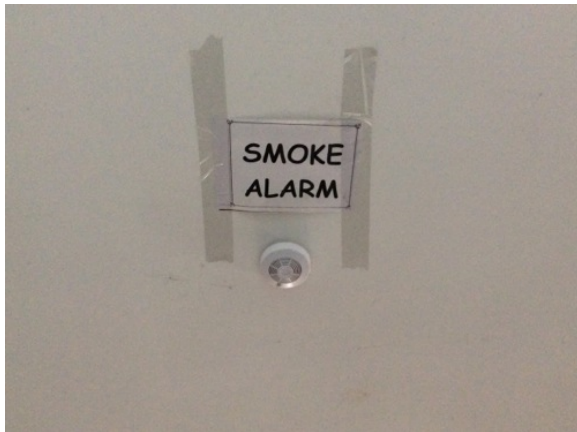
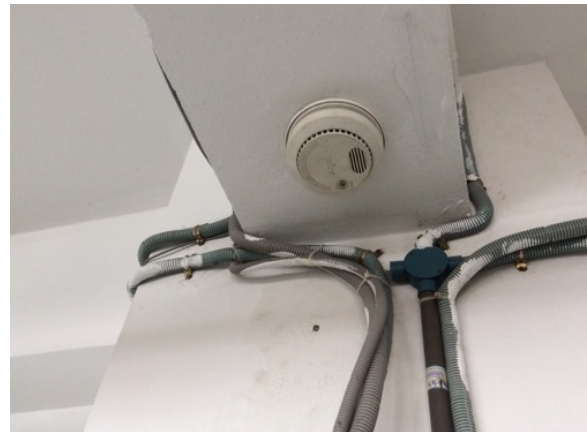
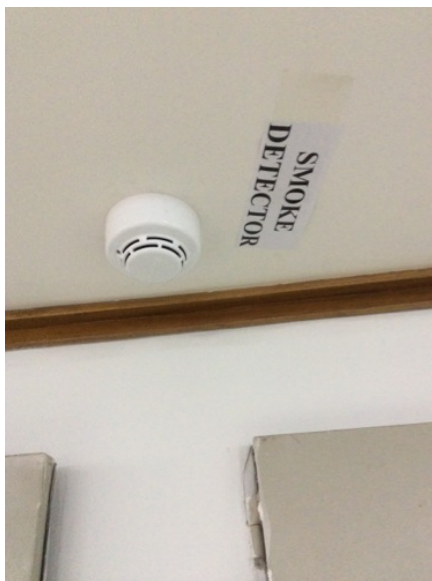
| F-19 | Fire Protection | The building is equipped with single-station smoke alarms. Smoke alarm activation sounds only a local alarm and does not provide automatic fire alarm notification of occupants. | Replace the single-station smoke alarms with automatic smoke detectors tied into the fire alarm system. Configure the fire alarm system to initiate occupant notification upon activation of any two smoke detectors in addition to the manual fire alarm stations. | Within 6 months |

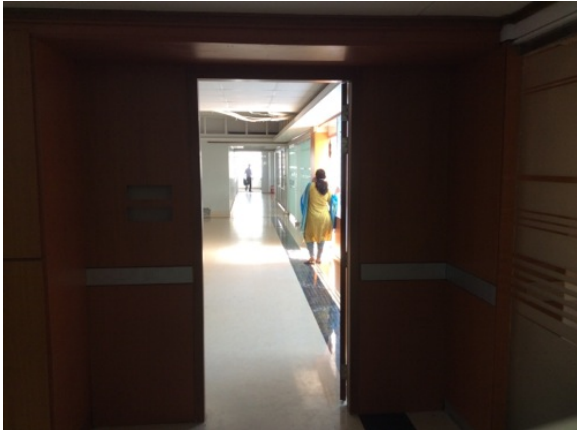
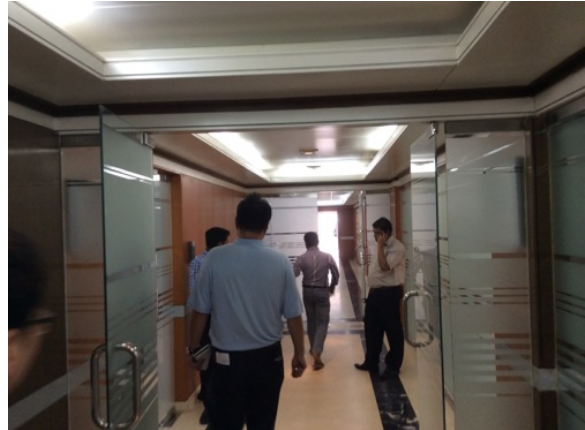
| F-20 | Egress Lighting | The 9th floor office do not have exit sign on both exit doors. | Provide exit signs above all exits. | Within 3 months |

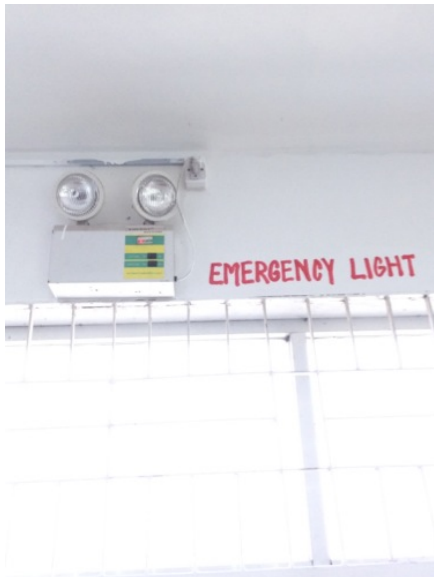
| F-21 | Egress Lighting | The emergency lighting at the 7th floor NW stair did not function during testing. | Regularly test the emergency lighting system on each floor and replace/repair lights as needed. | Within 3 months |
