# **FIRE SAFETY INSPECTION REPORT**

**TEXTOWN LIMITED (NEW BUILDING)**

**ACCORD ID: 12527**

**Date: 22 November, 2016**

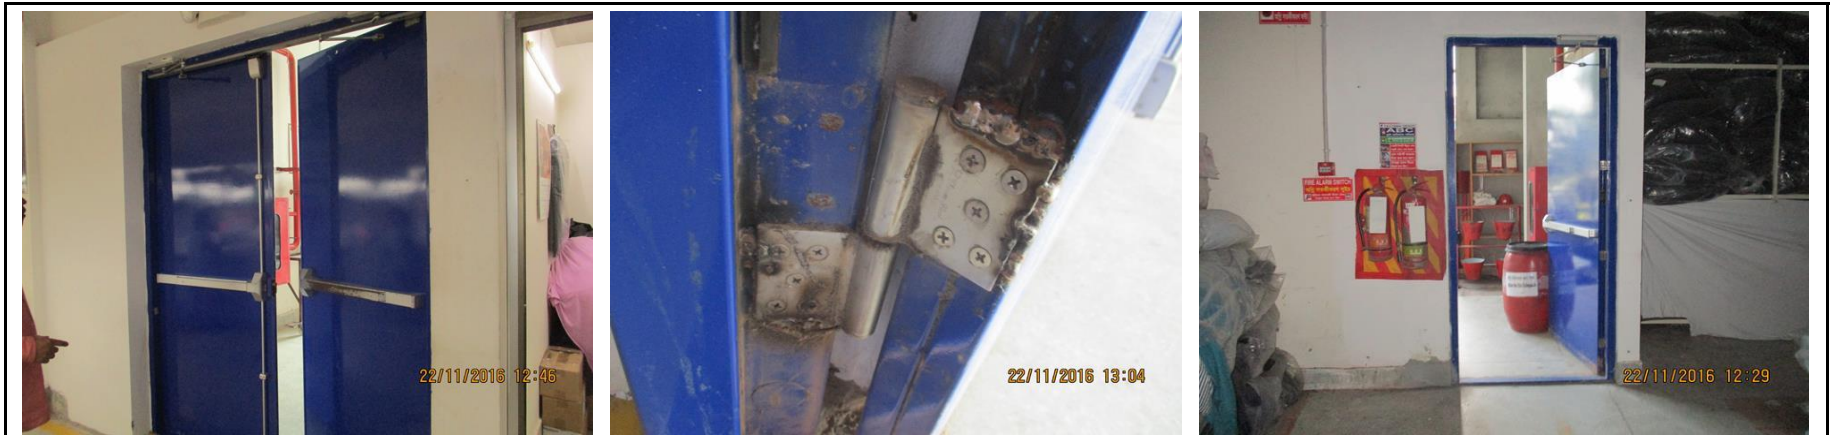
SI No.	Category	Findings	Required Action	Remediation Time Frame
1	Fire Rated Construction	<p>The exit stair enclosures are not separated from work areas and other spaces on each floor by fire rated construction.</p> <p><b>Note:</b> Door accessories were not properly functional in all fire rated door. Fire rated doors of stair-3 were not interfaced with installed fire alarm system (The fire rated doors were open during inspection for which factory used bricks, drums etc.). Moreover some unprotected openings and penetrations observed on all three stairs.</p>	<p>Provide minimum 1-hr rated doors for buildings with 3 or fewer stories and 1.5-hr fire rated doors for buildings that are 4 or more stories. Seal all unprotected openings to separate the exit stairs from work areas and other building spaces on all floor levels. Ensure that the fire doors are self-closing and positive latching and that they are provided with fire exit (panic) hardware where serving production floors. If fire doors are required to be held open for functional reasons, provide automatic closing devices tied to the fire alarm system. Once fire doors are installed, every door in a stair enclosure serving more than 5 stories shall be provided with re-entry unless it meets.</p>	Within 3 months

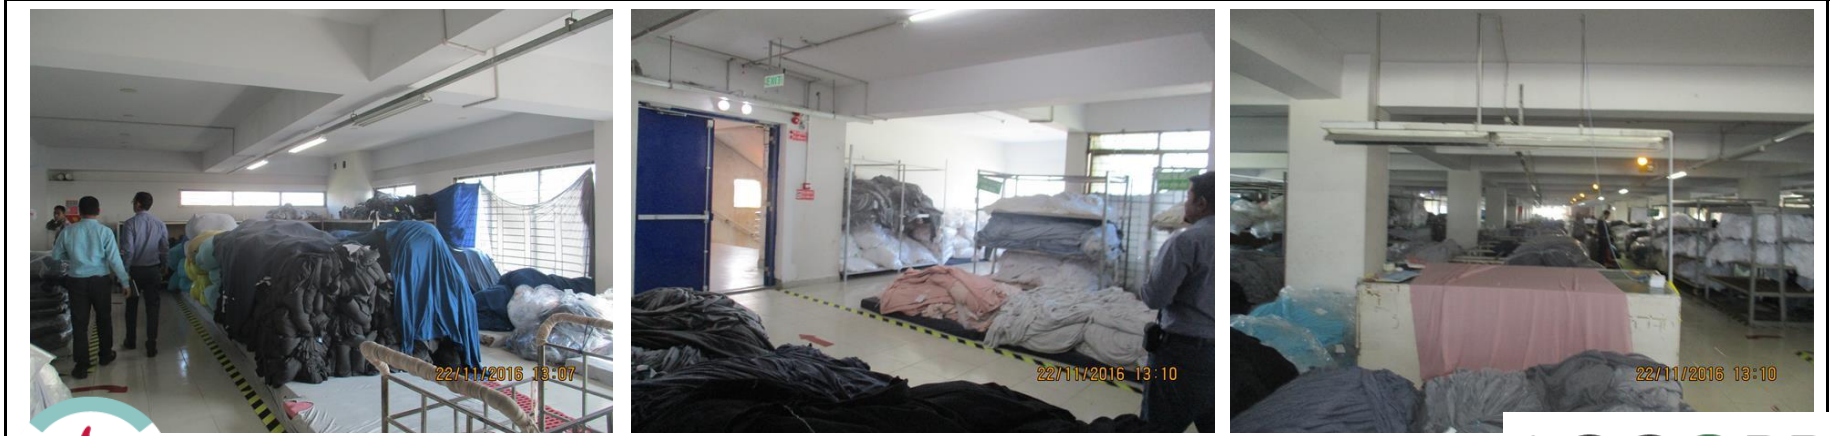
2	Fire Rated Construction	Areas used for combustible storage open to the factory are not separated by fire rated construction on 3rd floor's cutting area.	<p>Provide defined storage areas and limit the storage arrangement as follows:</p> <ul style="list-style-type: none"> <li>- Maximum height of 2.45m (8ft.) and maximum area of 23m<sup>2</sup> (250 ft<sup>2</sup>) - If sprinkler protected: maximum height of 3.66m (12ft.) and maximum area of 93m<sup>2</sup> (305ft<sup>2</sup>) Separate areas of unenclosed combustible storage by a minimum clear distance of 3m (10ft.).</li> </ul>	Within 3 months
---	-------------------------	--	--	-----------------

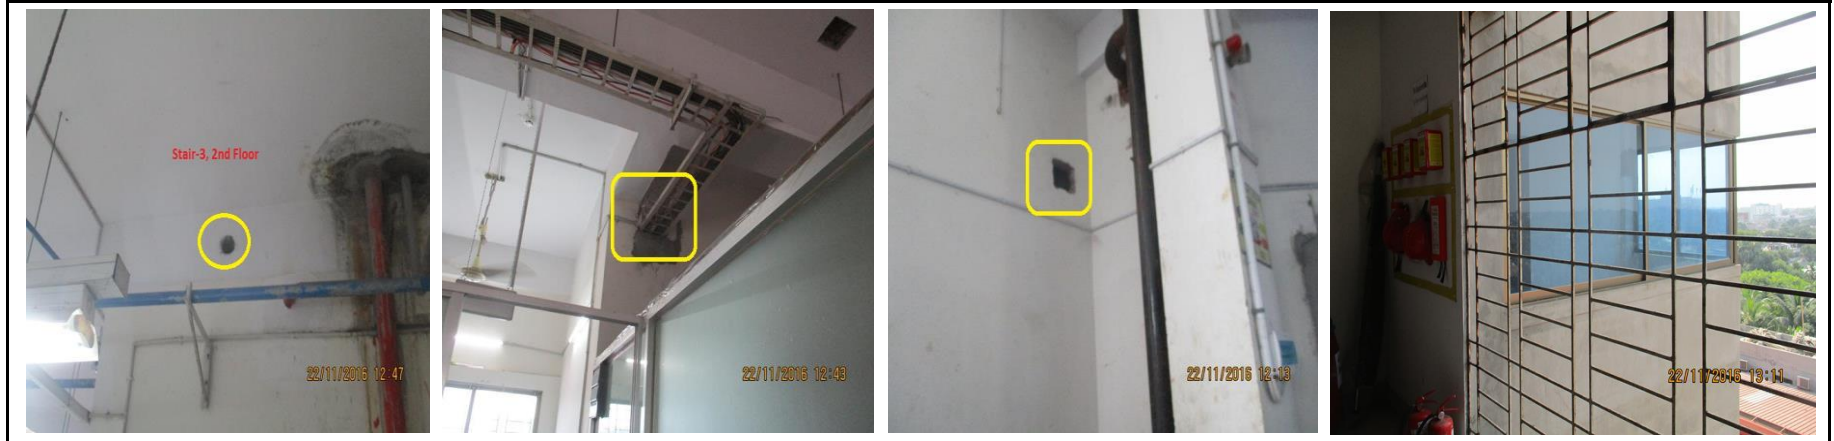
3	Fire Rated Construction	<p>Unsealed penetrations and openings are located in exit stair enclosures and electrical risers on each floor.</p> <p><b>Location:</b> Stair-1 &amp; 2 and north side electrical riser.</p>	<p>Seal all penetrations and openings in exit stair enclosure walls to maintain the fire separation.</p>	<p>Within 3 months</p>
---	-------------------------	--	--	------------------------

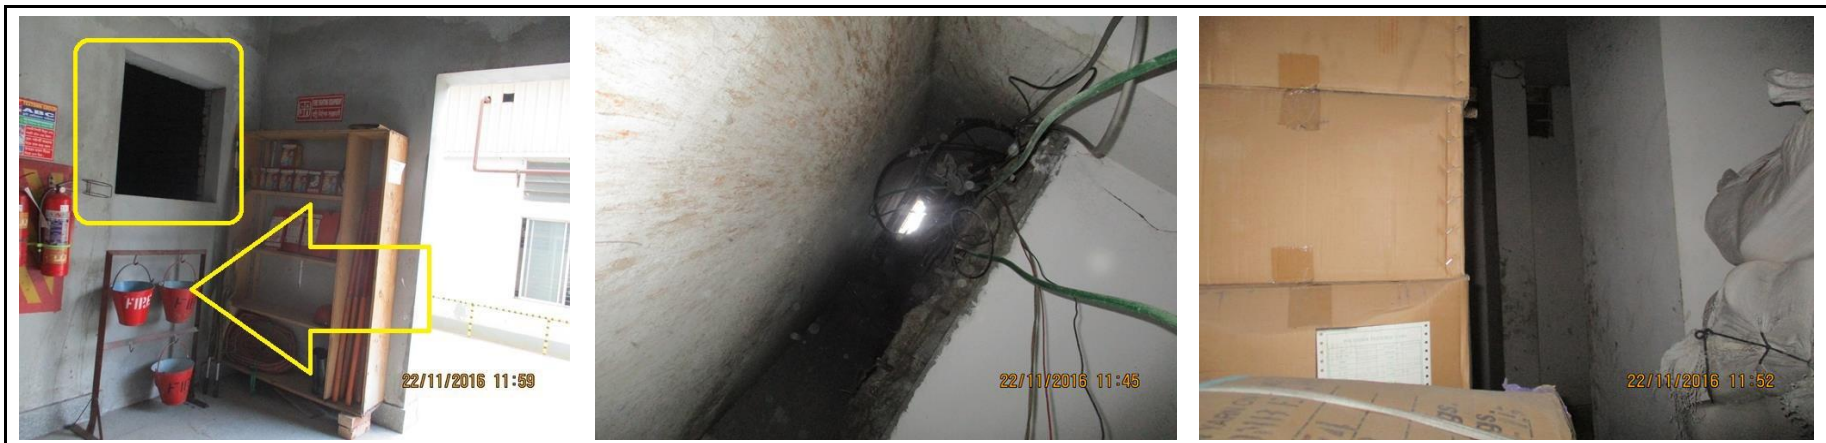
4	Fire Rated Construction	<p>The elevator shafts are not properly fire separated from exit passageway of stair-1 and store room of basement floor by fire rated construction (unprotected openings and penetrations). Location of Elevator Shafts: North and west side of factory building.</p>	<p>Provide 2-hr fire rated construction to separate the shafts with 1.5-hr opening protective assemblies if required.</p>	<p>Within 3 months</p>
---	-------------------------	---	---	------------------------

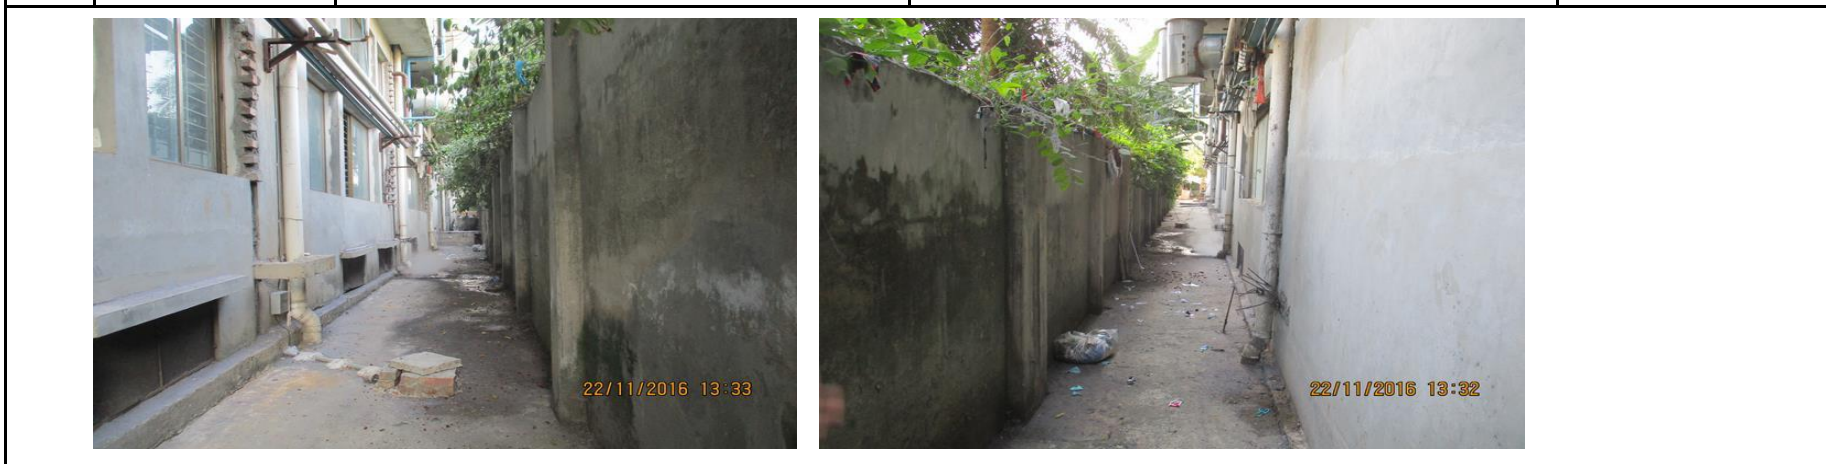
5	Fire Rated Construction	The exit discharge path serving east exit which discharges from stair-3 is less than 10 ft. wide and is not separated from the building interior.	Seal all penetrations and openings to the interior of the building along the discharge path, up to a height of 10 ft. to provide a minimum 2-hr fire separation.	Within 1 month
---	-------------------------	---	--	----------------

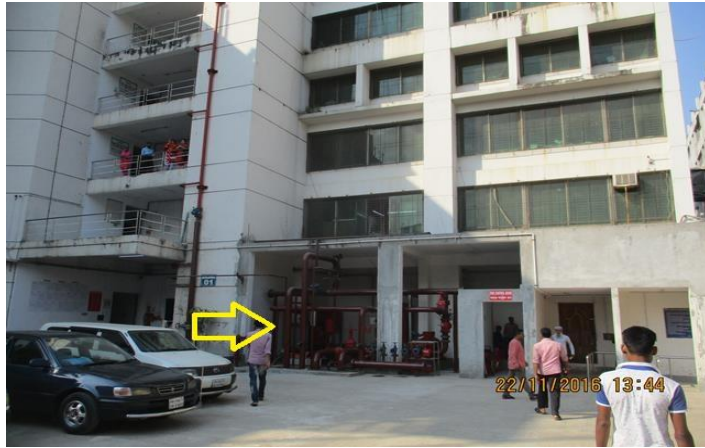
6	Fire Rated Construction	<p>The fire pump room is not provided with adequate fire separation.</p> <p><b>Location:</b> Ground floor of building-1.</p>	<p>Provide fire pump room with 2 hr. rated fire separation when not sprinklered and 1 hr. rated fire separation when provided with automatic sprinklers, in accordance with NFPA 20. If the pump located outside of building then it shall be at least 50 ft away from another occupancy.</p>	Within 3 months
---	-------------------------	--	---	-----------------

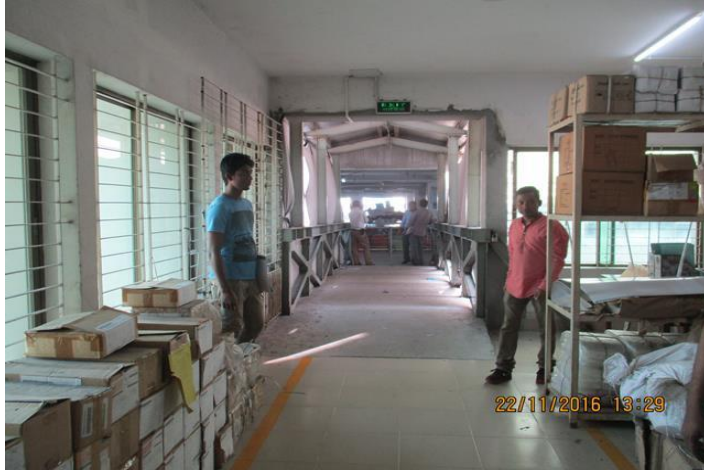
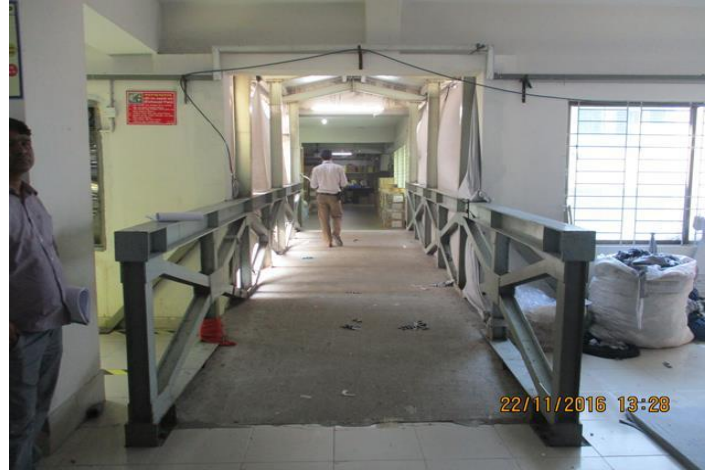
7	Fire Rated Construction	<p>The raised walkway (connecting bridge) is not separated from storage area of building #1 on the 3rd floors by fire-rated construction.</p>	<p>Provide minimum 1.5-hr fire rated doors at least on storage side (building-1) and seal all unprotected openings to separate the connecting bridge from storage areas/work areas and other building spaces on all floor levels.</p> <p>Ensure that the fire doors are self-closing and positive latching and that they are provided with fire exit (panic) hardware where serving production floors.</p> <p>If fire doors are required to be held open for functional reasons, provide automatic closing devices tied to the fire alarm system.</p>	Within 3 months
---	-------------------------	---	---	-----------------

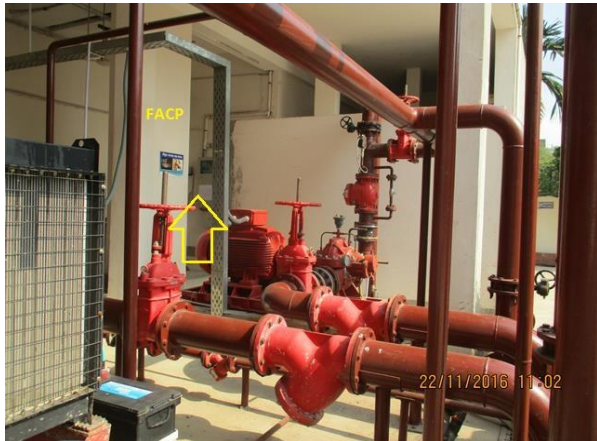
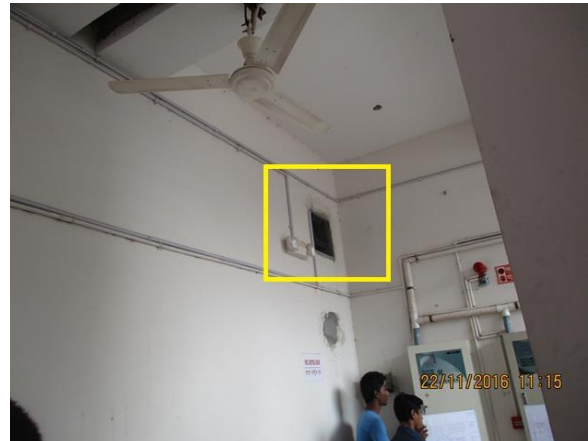
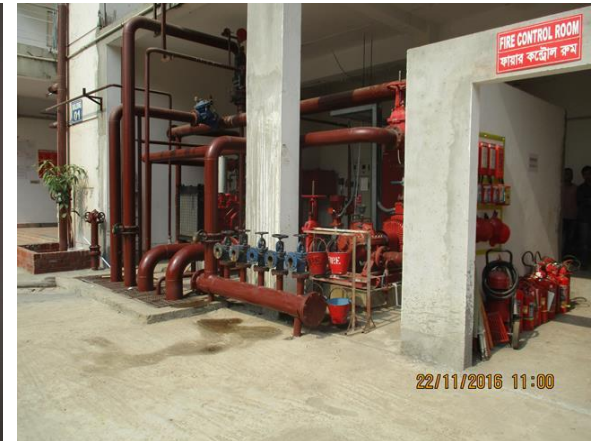
8	Fire Rated Construction	Fire Alarm Control Panel (FACP) room is not separated from adjacent fire pump room by fire rated construction.	Re-locate the FACP into a safe location or provide at least 2-hr fire separation between fire pump room and FACP room.	Within 1 month
---	-------------------------	--	--	----------------

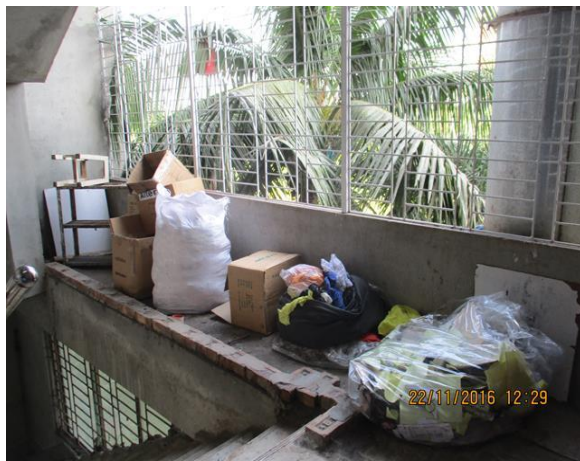
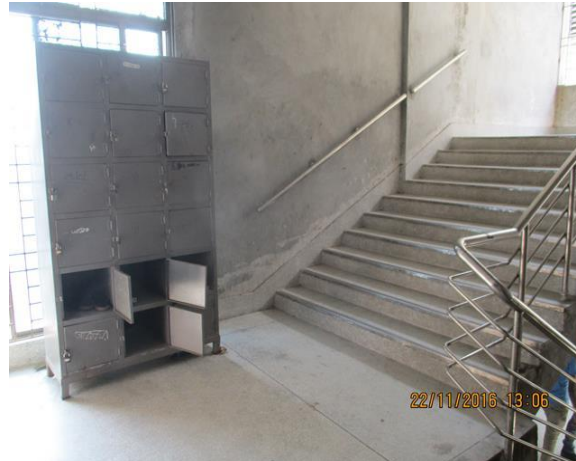
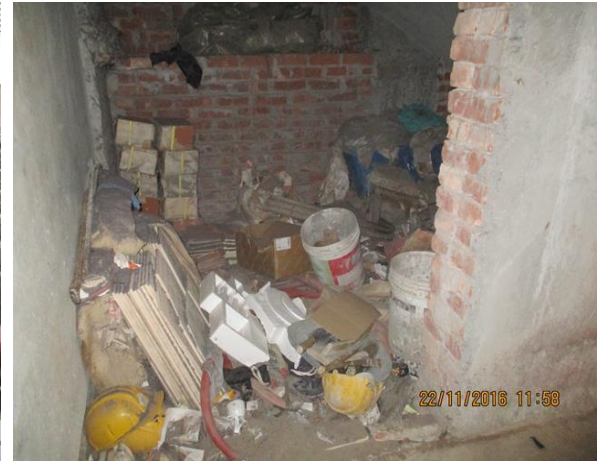
9	Egress	<p>Storage was located in the exit stair.</p> <p><b>Location:</b> Stair-1 (Ground floor), stair-2 (shoe rack on all floor) and Stair-3 (1st Floor).</p>	Remove all storage from exit stairs and egress paths.	Immediate
---	--------	---	---	-----------

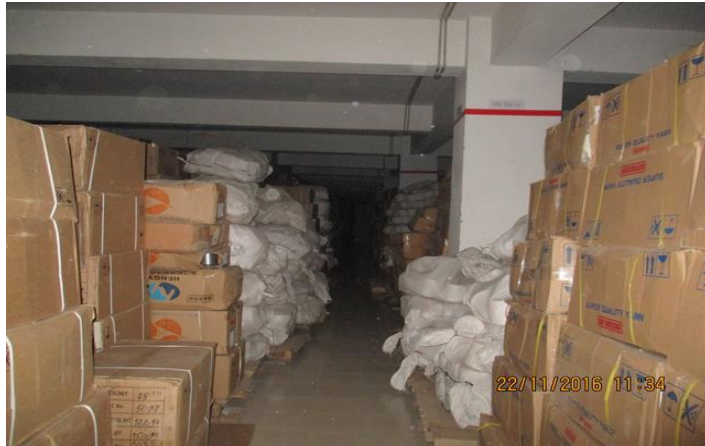
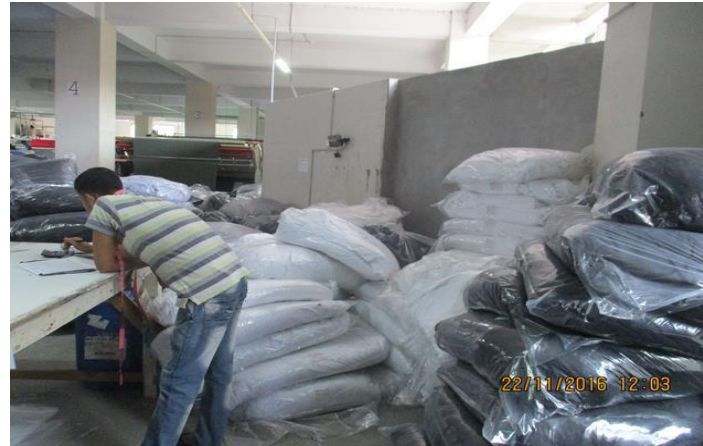
10	Egress	<p>The width of unobstructed egress aisles is less than 36-in.</p> <p><b>Location:</b> Basement and Ground Floor.</p>	Provide minimum unobstructed aisle widths of 36-in.	Immediate
----	--------	---	---	-----------

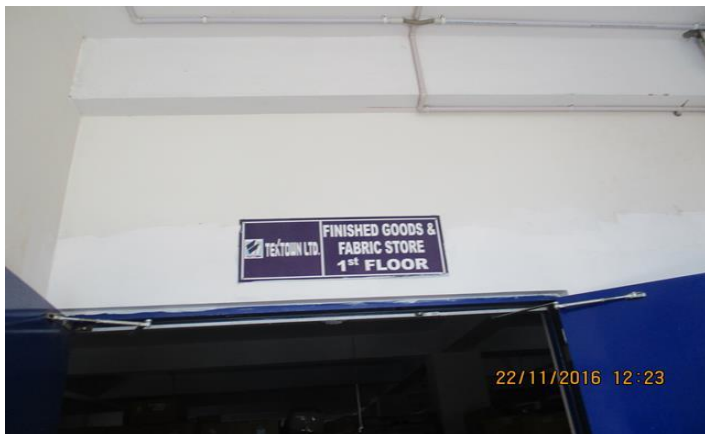
11	Egress	Occupant load and stair designation signage are not provided at all required locations as per ACCORD standard.	Provide Floor, occupant load and stair designation signage as per the ACCORD guideline.	Within 1 month
----	--------	--	---	----------------

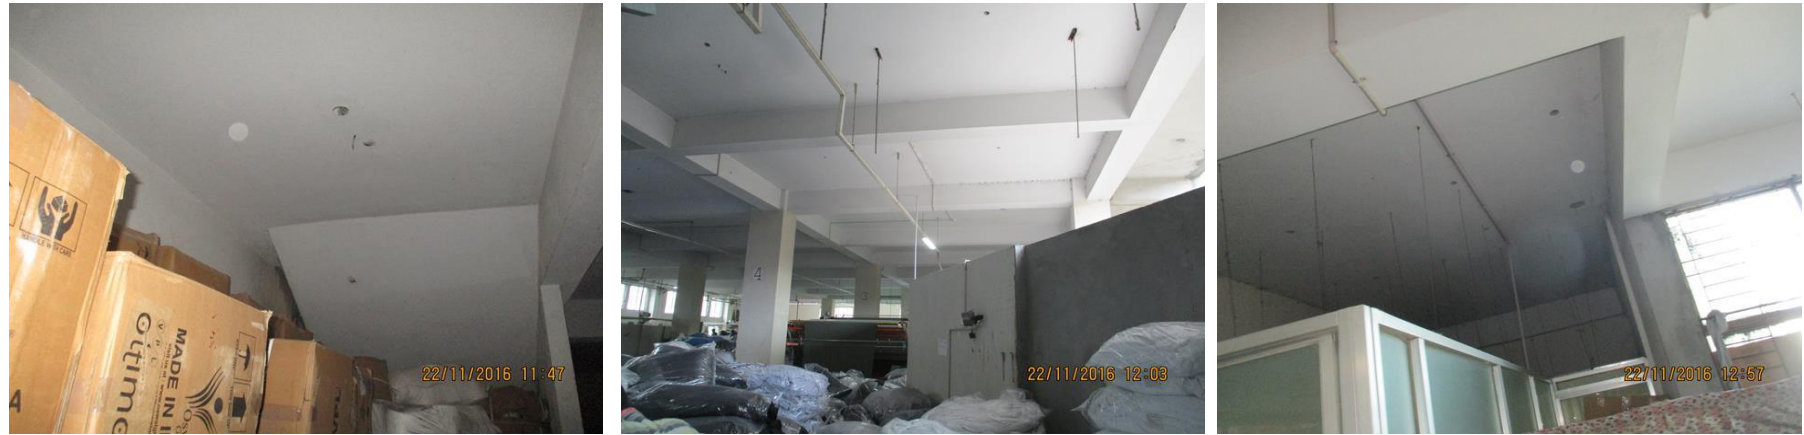
14	Fire Protection	Based on observation and as per actual site condition number of detecting devices observed are inadequate as per NFPA 72 throughout the building.	Provide detecting device in accordance with NFPA-72.	Within 6 months.
----	-----------------	---	--	------------------

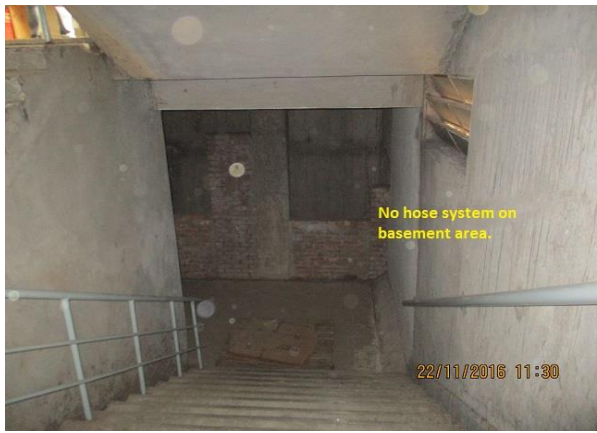
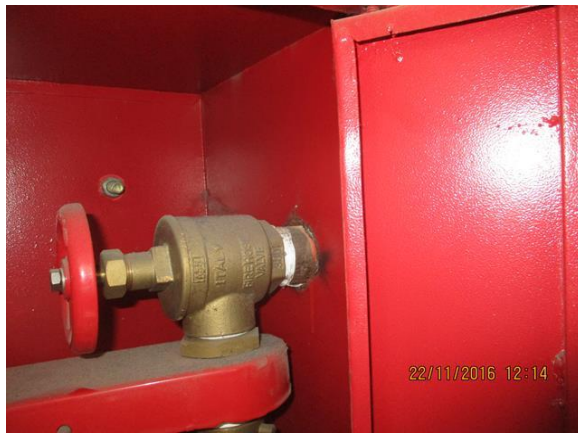
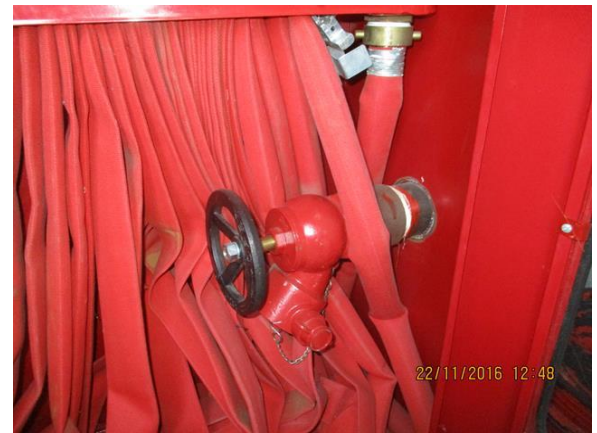
16	Fire Protection	The installed standpipe system is not in accordance with the NFPA 14. Class-III standpipe system is not installed in all required location as well as non listed products observed in several locations.	Install third party certified class-III standpipe system throughout the building in accordance with NFPA-14.	Within 6 months
----	-----------------	--	--	-----------------

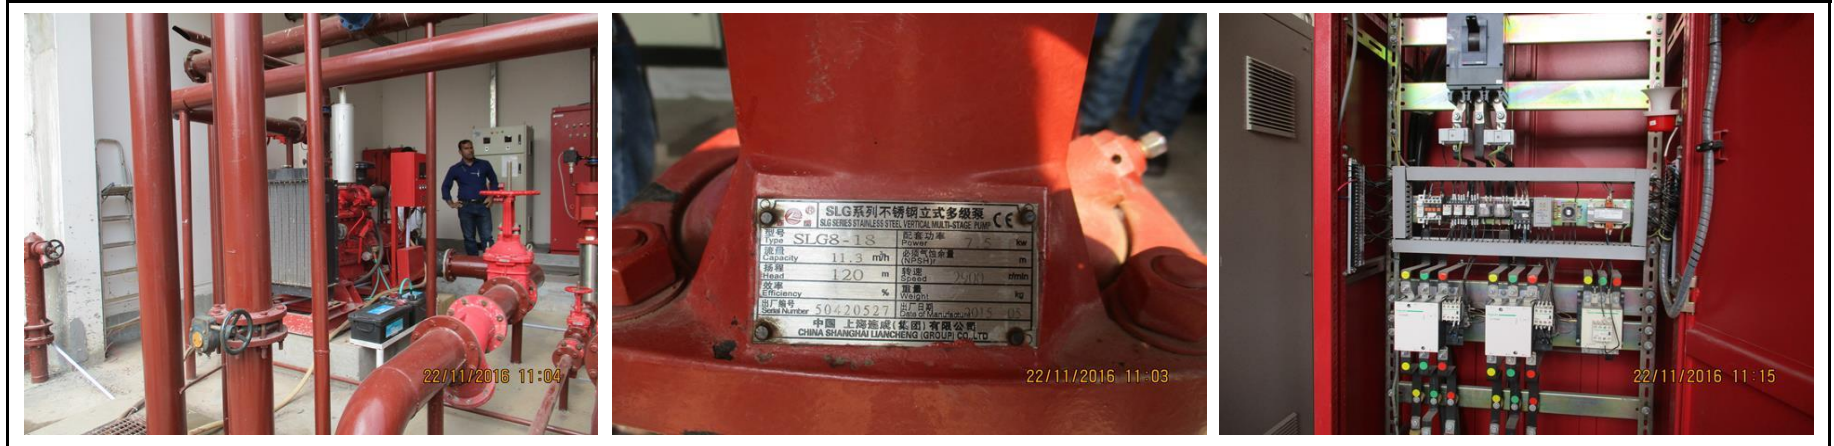
18	Fire Protection	The fire fighting pump set is not installed in accordance with NFPA-20.	Modify the available diesel engine driven fire pump, pump controllers and other required equipment with listed one and in accordance with NFPA-20.	Within 6 months
----	-----------------	---	--	-----------------
