Amir Shirts Ltd.

Sufua, Kalikapur Union, Chauddagam, Comilla, Bangladesh
(23.301700, 91.290802)

30th October 2016

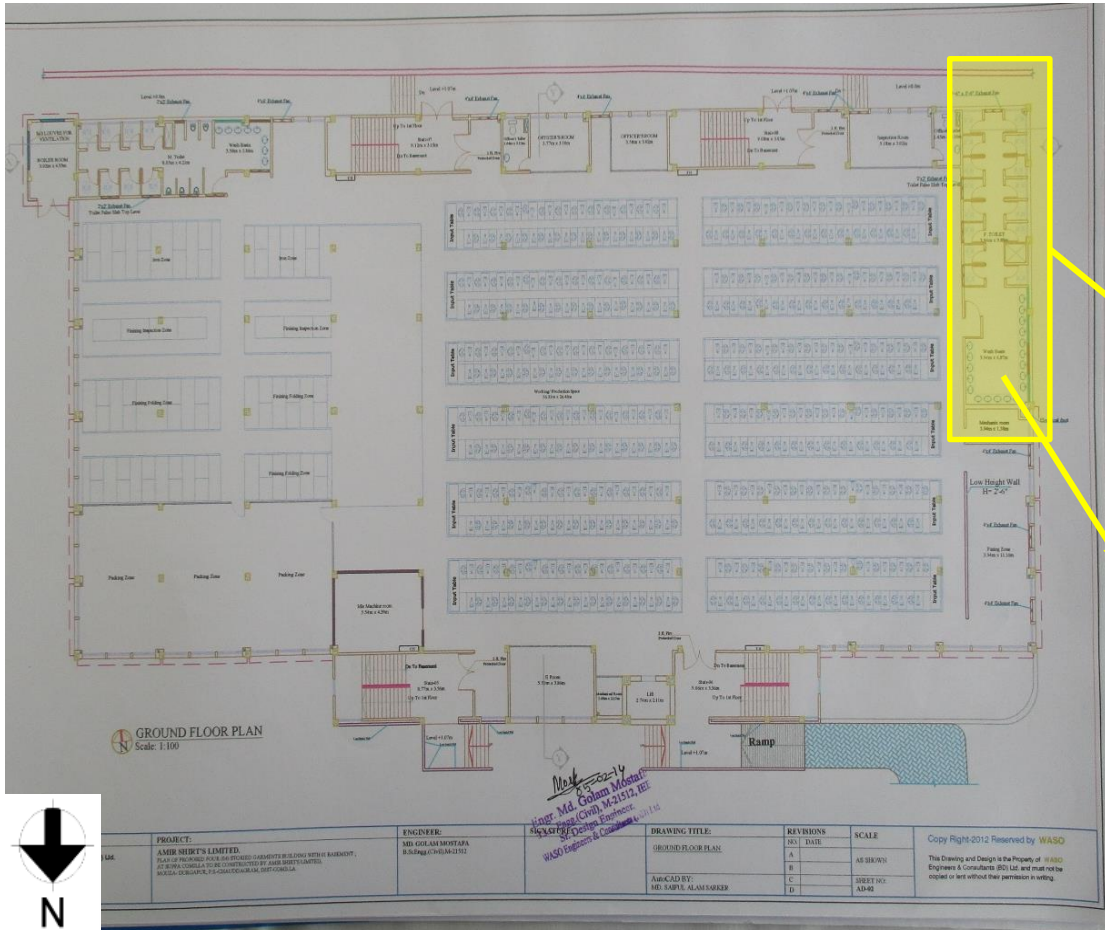
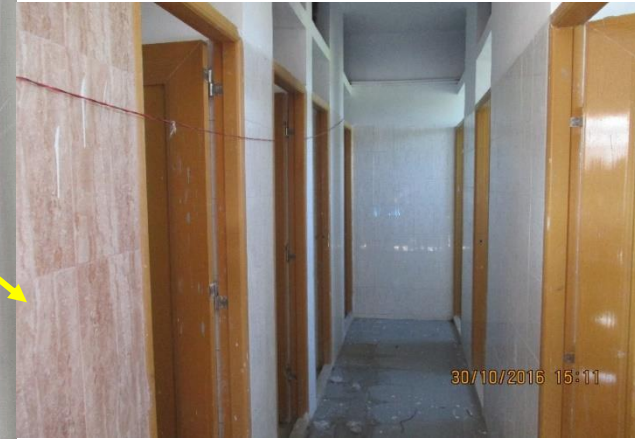
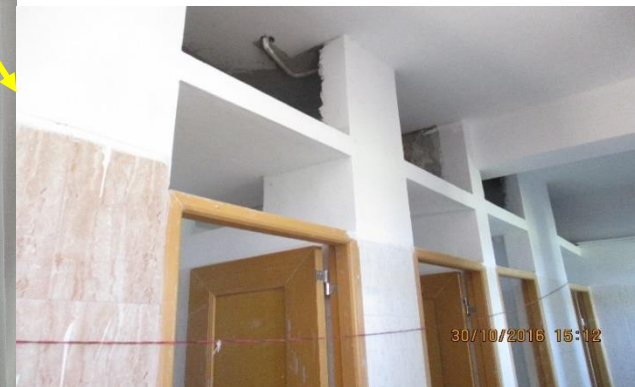
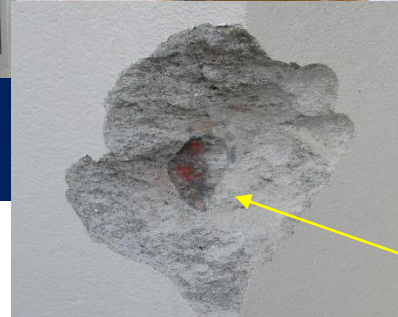
Column to be stressed above normal design limits

Brick Aggregate

Cursory calculation indicates that Columns appears to be stressed above normal design limits

Item No.	Observation	Recommended Action Plan	Recommended Timeline
1	Column to be stressed above normal design limits(Production Building Unit-1)	Factory Engineer to review design, loads and columns stresses.	6-weeks
2	Column to be stressed above normal design limits(Production Building Unit-1)	Verify in-situ concrete stresses by 100mm dia. cores from min. 4 no. column from ground floor level.	6-weeks
3	Column to be stressed above normal design limits(Production Building Unit-1)	Produce and actively manage a loading plan for all floor plates within the factory giving consideration to floor capacity and column capacity.	6-weeks
4	Column to be stressed above normal design limits(Production Building Unit-1)	Make structural alterations if required as advised by Factory Engineer.	6-months
5	Column to be stressed above normal design limits(Production Building Unit-1)	Continue to implement load plan.	6-months

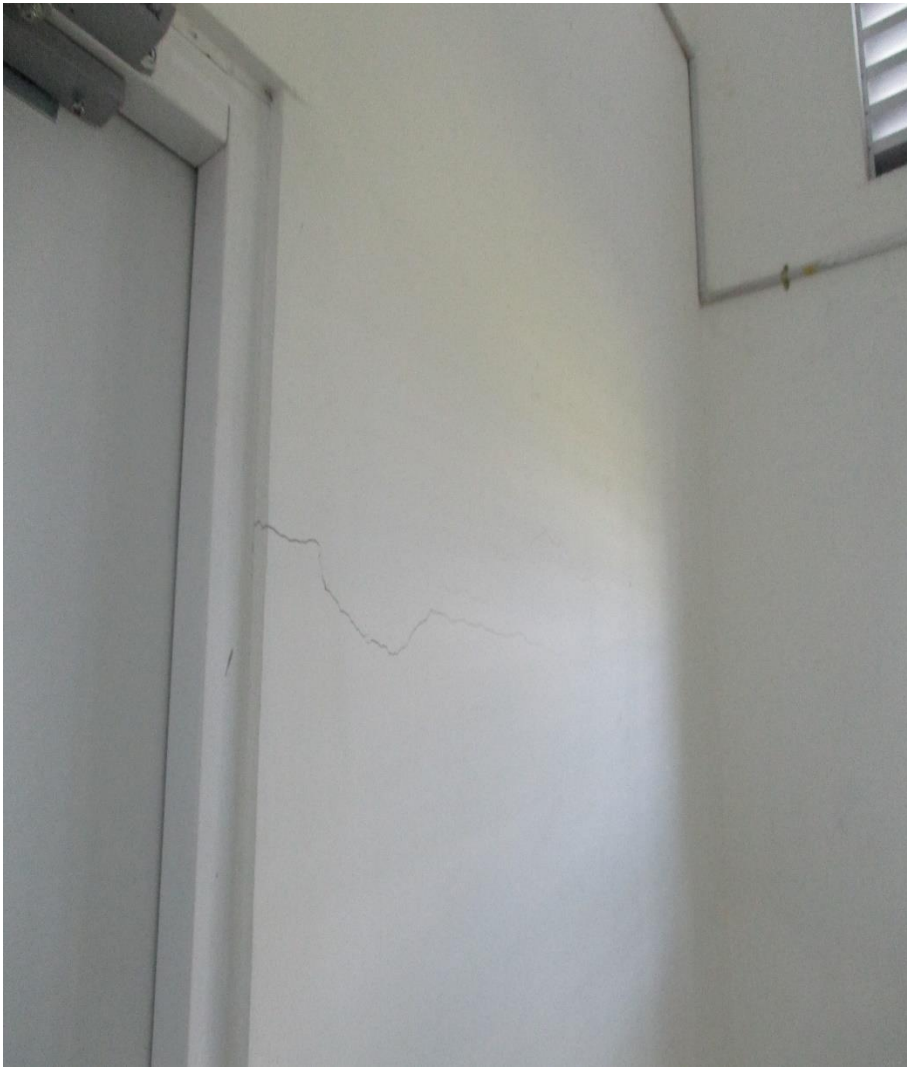
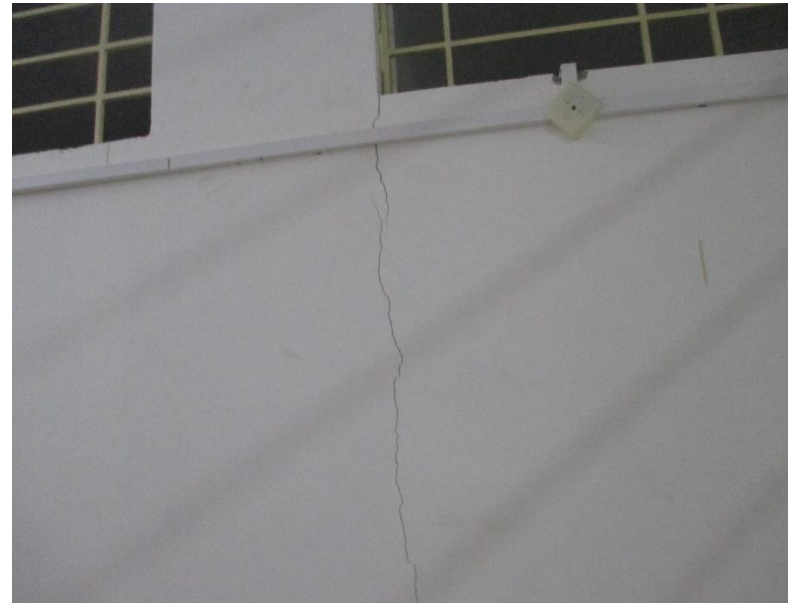
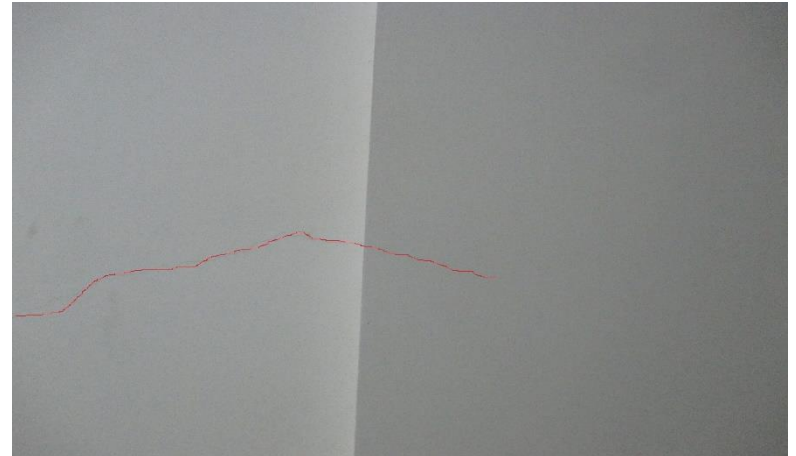
Cracks on basement walls

Cracks have been observed at several basement walls. Considering the location of cracks it is recommended that, building engineer requires to investigate and continuous monitor the cracks.

6	Cracks on basement walls(Production Building Unit-1)	Remove finishes to investigate if cracking extends into structure. Any cracks found should be repaired.	6-weeks
7	Cracks on basement walls(Production Building Unit-1)	Continue to monitor building for signs of cracking on on-going basis and take appropriate action.	6-months

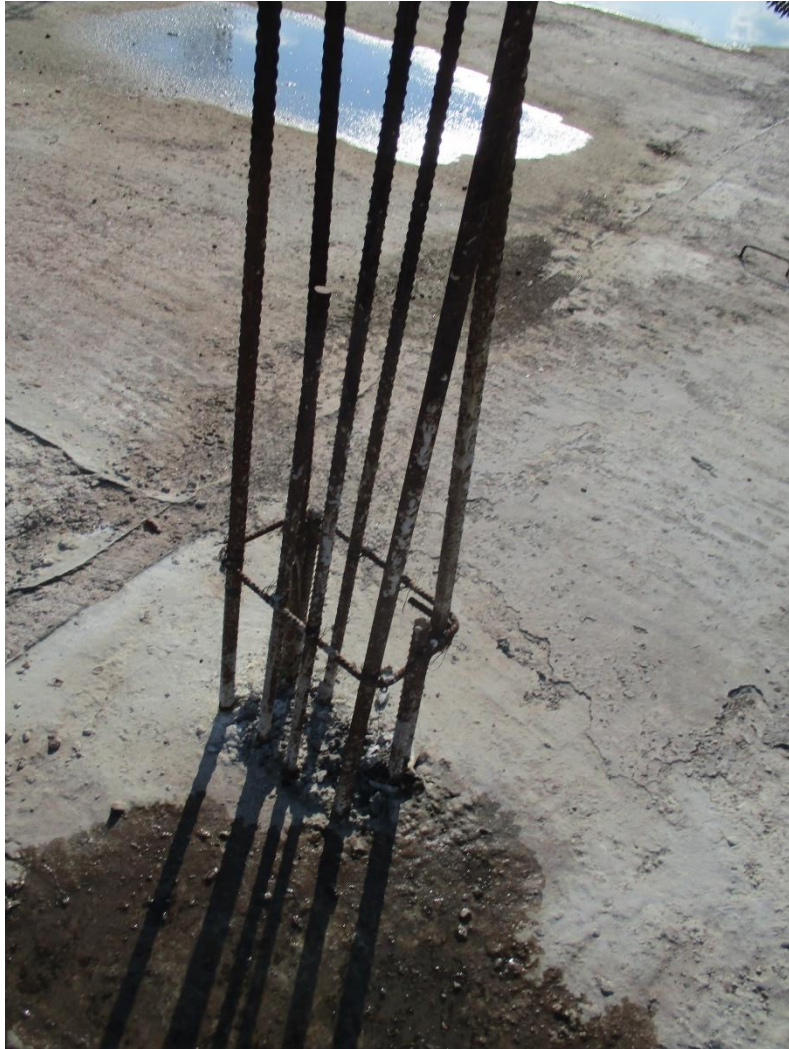
Discrepancies between drawings & on-site observations

Rebar diameter doesn't match with as built drawing.

Item No.	Observation	Recommended Action Plan	Recommended Timeline
8	Discrepancies between drawings & on-site observations(Production Building Unit-1)	Engage a Building Engineer to survey the structure and update a full set of “as-constructed” drawings.	6-weeks
9	Water ponding and rebar corrosion observed at the roof	For both durability and serviceability, rust proof paint or any appropriate method is recommended.	6-weeks
10	Water ponding and rebar corrosion observed at the roof	Waterproofing on the roof slab is to be applied. Moreover the roof slab drainage system should be investigated and improved.	6-months
11	Lack of vertical bracing may effect the overall stability(Production Building Unit-2)	Building Engineer to review stability system for lateral loading as per BNBC. Building Engineer to design and detail structural upgrading work where necessary to ensure adequate stiffness of bracing system.	6-weeks

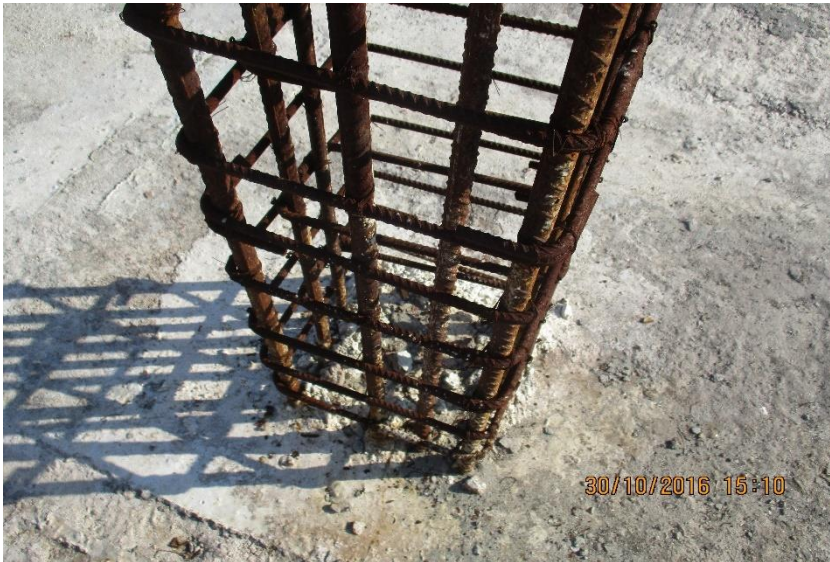
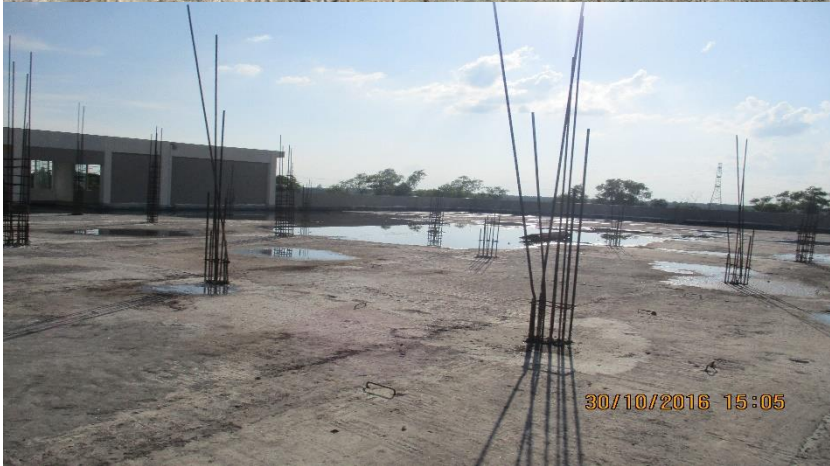
Water ponding and Rebar Corrosion at roof.

Exposed rebar was observed on roof which is suspected to corrosion. No corrosion resisting coating on rebar has found.

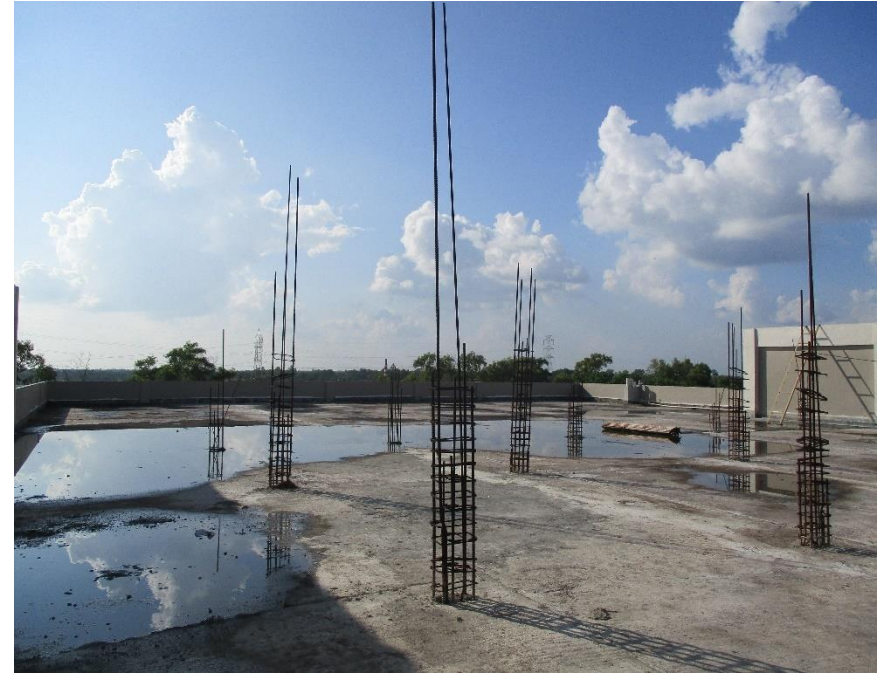
- Water ponding was observed on South-West corner of the roof floor.
- No water proofing layer and proper drainage system has observed on roof.

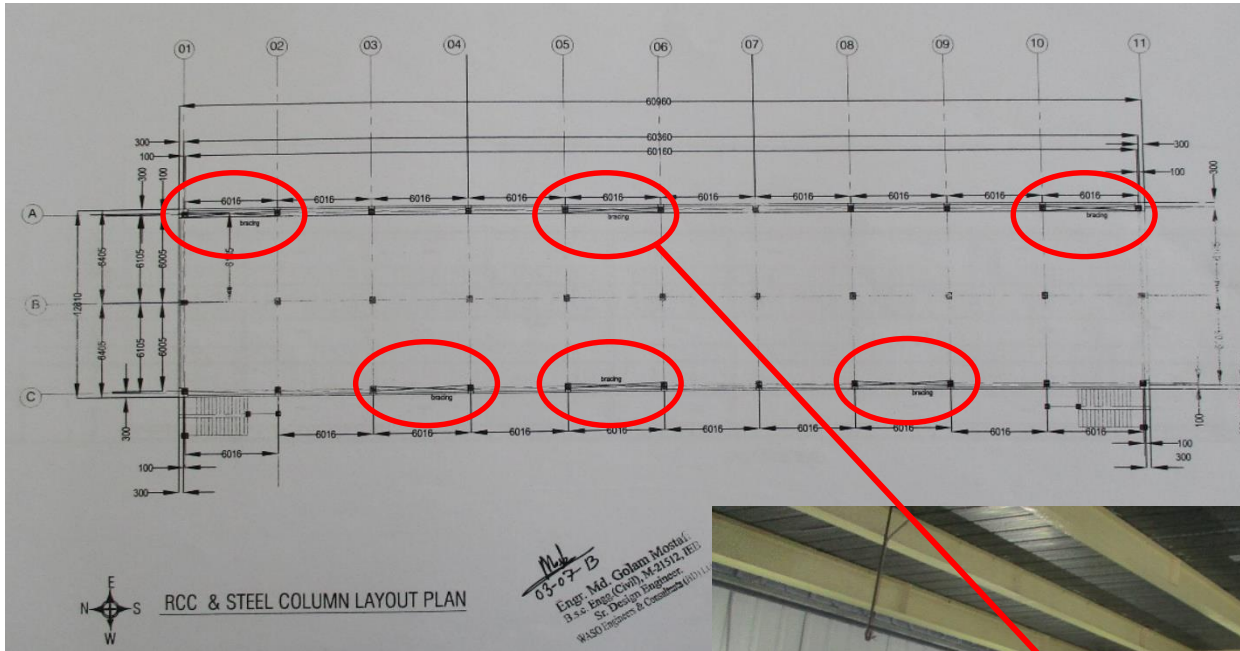
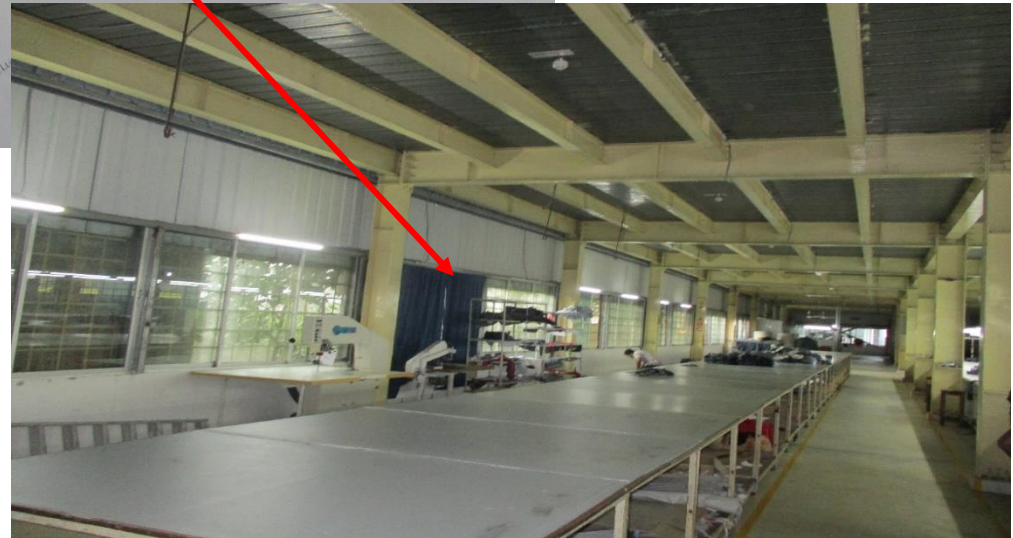
Lack of vertical bracing may effect the overall stability

Bracings has shown on drawing at longitudinal and transverse direction but on site bracings were not installed according to the drawing. Lack of bracing may effect the stability of the building. Building engineer requires to check the stability of the building against lateral loading.

12	Lack of vertical bracing may effect the overall stability(Production Building Unit-2)	Where required, remedial measures to steelwork to be carried out.	6-months

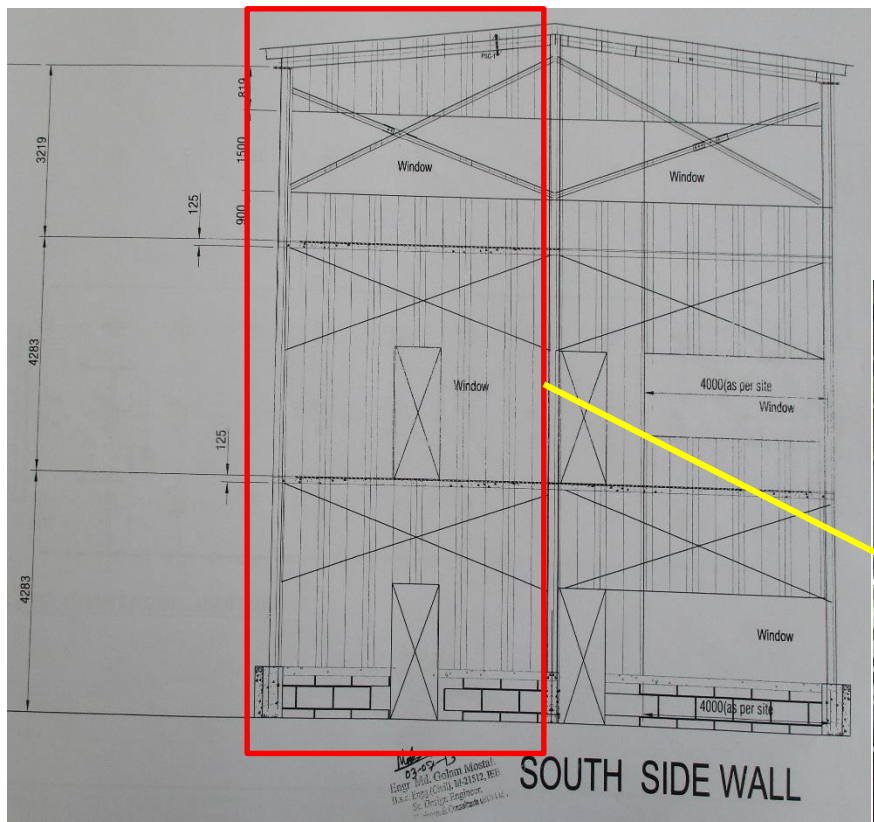
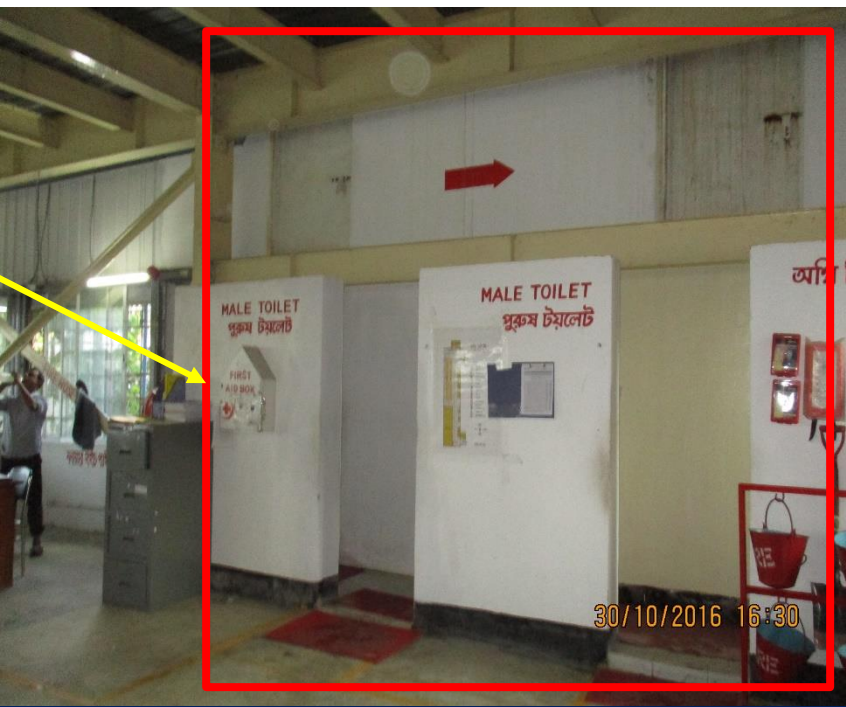
Missing vertical bracing at south side.

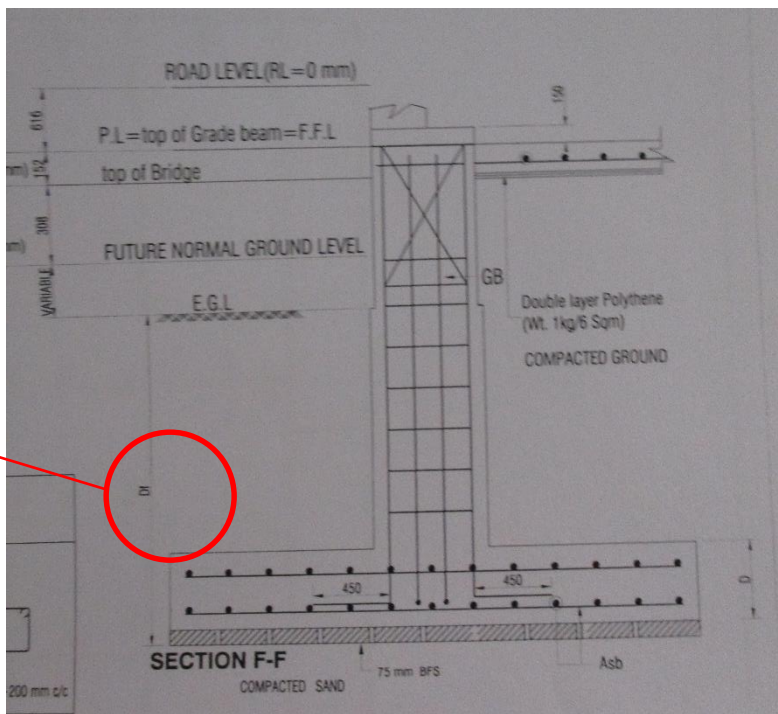
Foundation adequacy requires to be check

As per soil test report, the foundation was supposed to be at a depth of 2400 mm. But foundation depth of 1500 mm is stated in the as-built drawing. Hence, building engineer requires to review and verify bearing capacity and foundation adequacy for the actual site condition.

Item No.	Observation	Recommended Action Plan	Recommended Timeline
13	Foundation adequacy requires to be check(Production Building Unit-2)	Building engineer requires to review the foundation design considering the bearing capacity of the soil and actual depth of footing.	6-weeks
14	Foundation adequacy requires to be check(Production Building Unit-2)	Carry out remedial works if required.	6-months
15	Discrepancies between drawings & on-site observations(Production Building Unit-2)	Engage a Building Engineer to survey the structure and update a full set of “as-constructed” drawings. Also review the design considering existing condition.	6-weeks

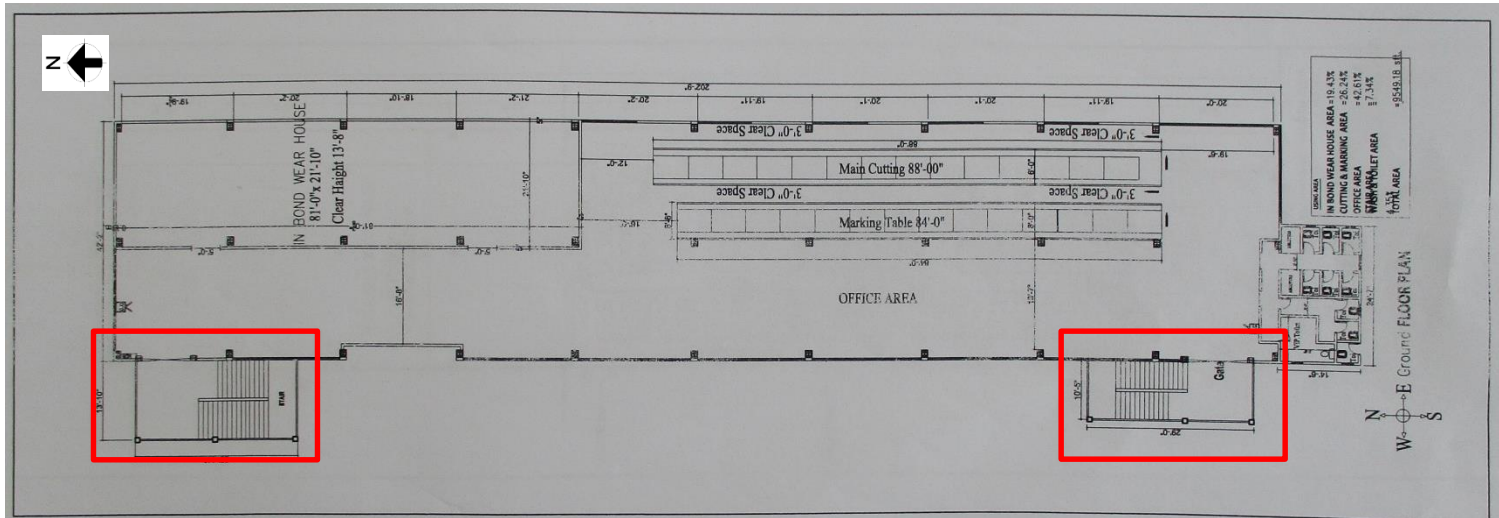
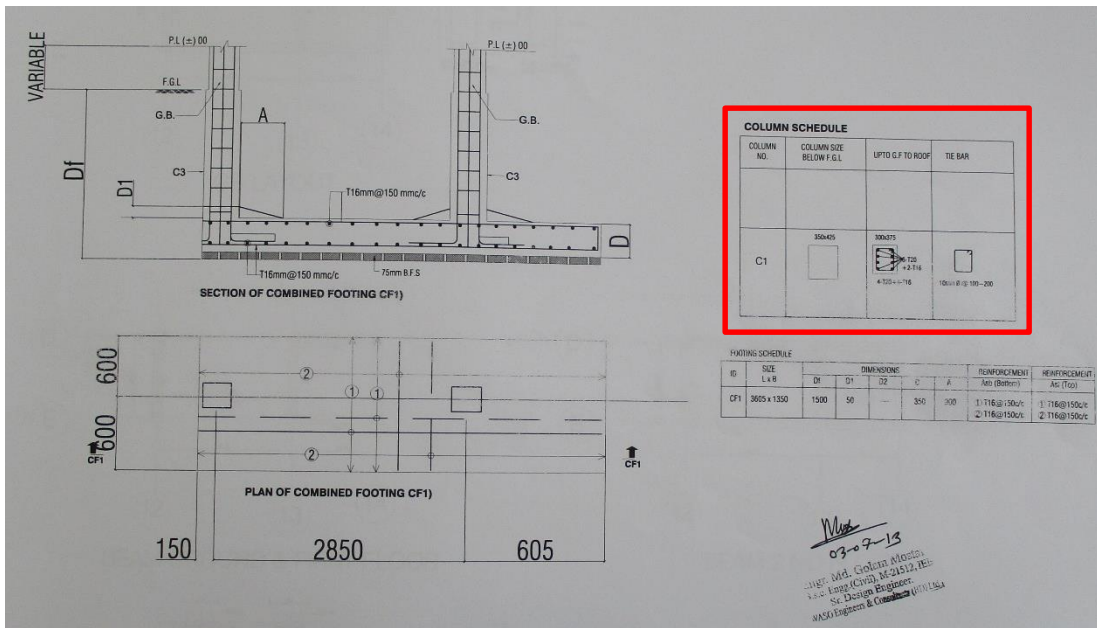
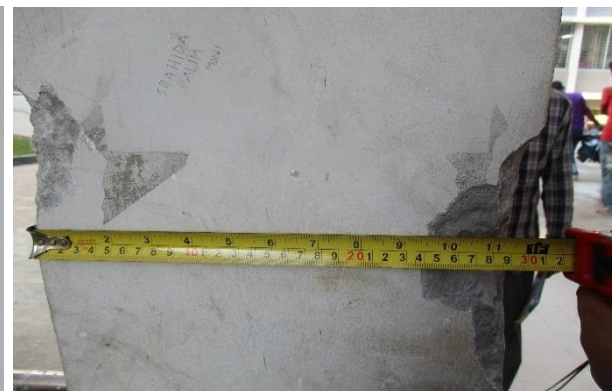
Discrepancies between drawings & on-site observations

No. of rebar and column size doesn't match with drawings on stair. Building engineer requires to review the design considering existing condition.
