# Taqwa Fabrics Ltd. Libas Knitwear

Bohera chala, Gilabereed, Kewa, Shreepur  
(24.195779, 90.407035)

16<sup>th</sup> April 2014

# Observations

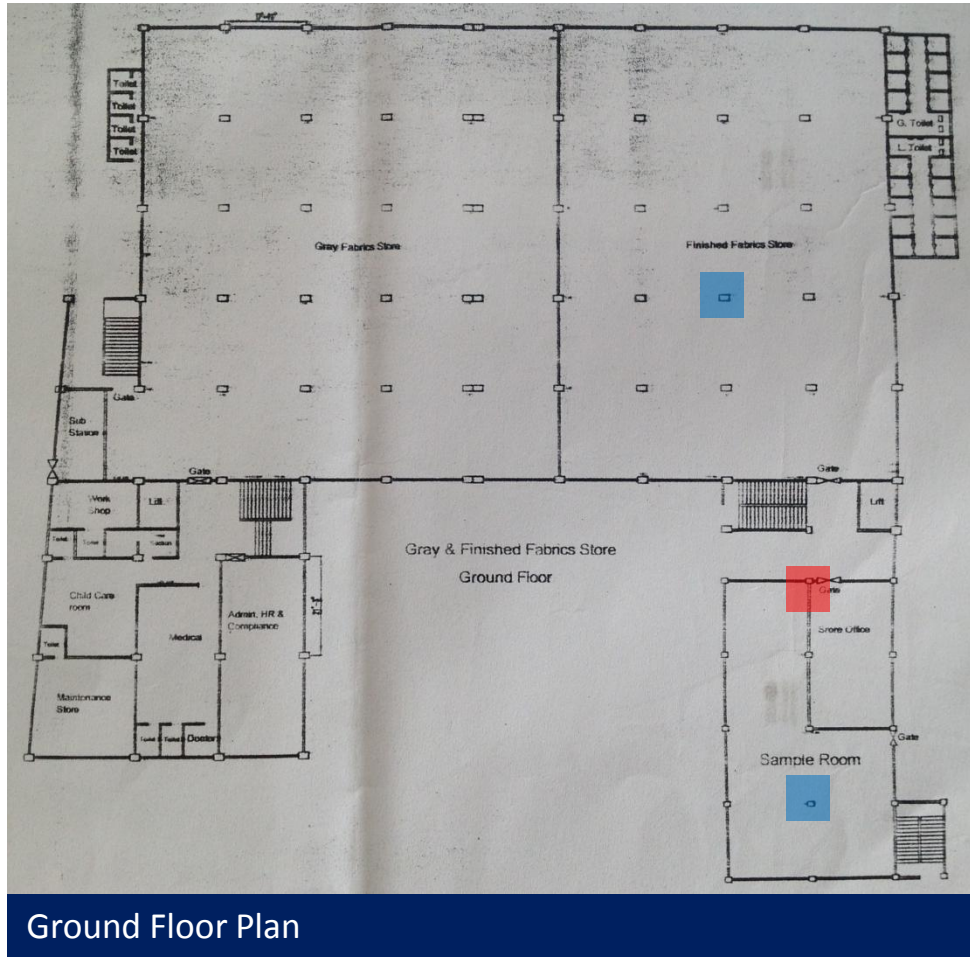
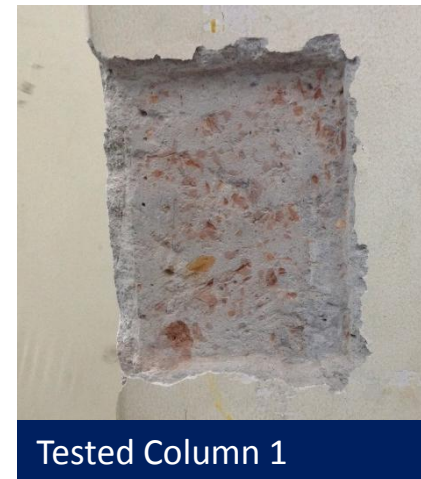
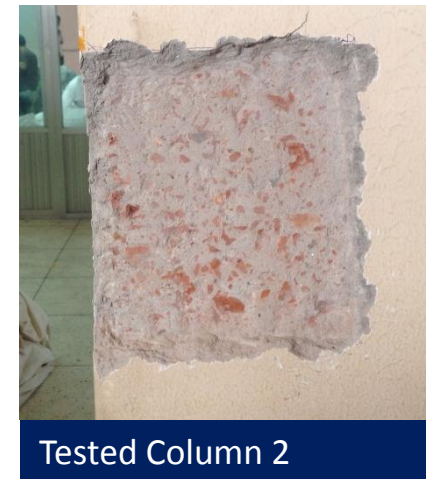
# **Stress levels in columns, with particular reference to internal column beneath 3-storey vertical extension to Packing Section of Main Building**

Cursory calculations indicate that the working stress of the columns at Ground Floor levels of the Main Building are at a high level, particularly at the internal column beneath the 3-storey extension to the Packing Section. Detail Engineering Assessment required.

- Construction of the Main Building began in 2007, with the first two storeys completed in 2009.
- Construction of the 3<sup>rd</sup> to 5<sup>th</sup> storeys commenced in 2010 and was completed in 2012.
- Construction of the 6<sup>th</sup> storey currently ongoing.
- Limited information on the structural drawings, and drawings for the central section of the building only were provided for review.
- Brick aggregate observed in Ground Floor columns and at Roof level.
- Mild steel reinforcement called up on drawings, but high yield steel bars observed at Roof level.

Tested Columns

Critical Column

- Building Engineer to review design, loads and column stresses in structure.
- A **Detail Engineering Assessment** of Packing Section in Main Building is to be commenced – see attached scope.
- Verify insitu concrete stresses by taking 100mm diameter cores from min. 4 columns at ground floor level.

- Produce and actively manage a loading plan for all floor plates within the factory, giving consideration to floor capacity and column capacity.
- Detail Engineering Assessment to be completed.

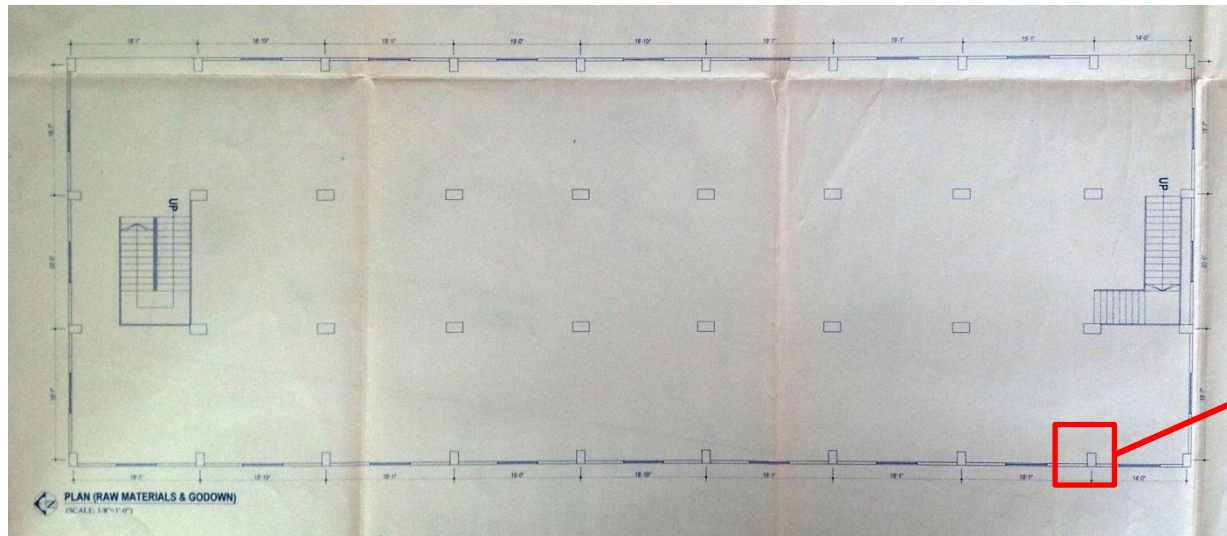
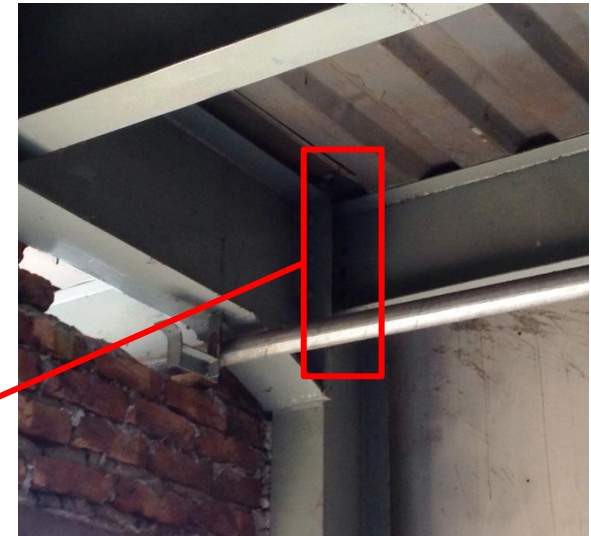
A number of bolts were observed to be missing at connections to the primary steelwork in the two-storey Raw Materials Godown Building. Special emphasis is drawn to the steel edge beam supporting the first floor, as identified below, where **all** bolts are missing at the column connection. It is not clear how the beam is adequately supported. Building Engineer to review all connections as a matter of urgency, and to carry out remedial works to the structure as required.

All bolts are missing at Edge Beam-to-Column Connection

Location of Connection Detail where all bolts are missing

- Provide temporary prop to end of steel beam. Building Engineer to ensure correct connection detail is designed, fabricated and installed on site.

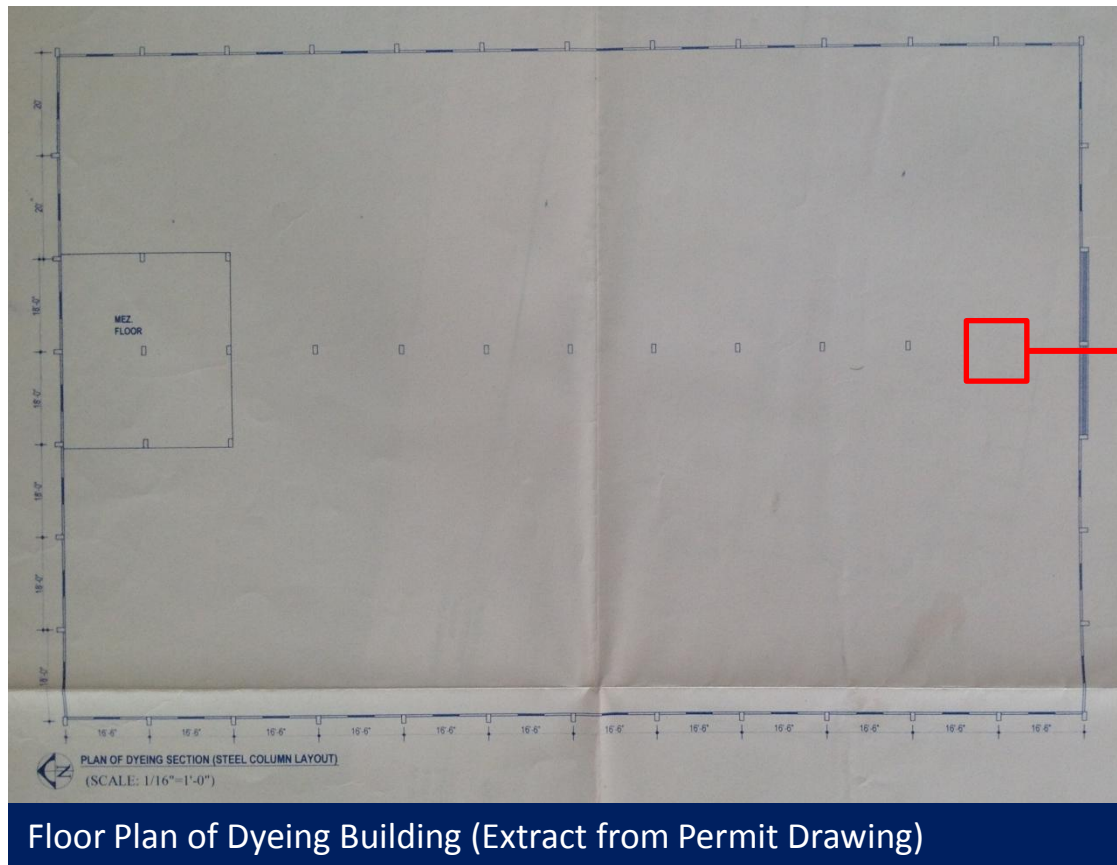
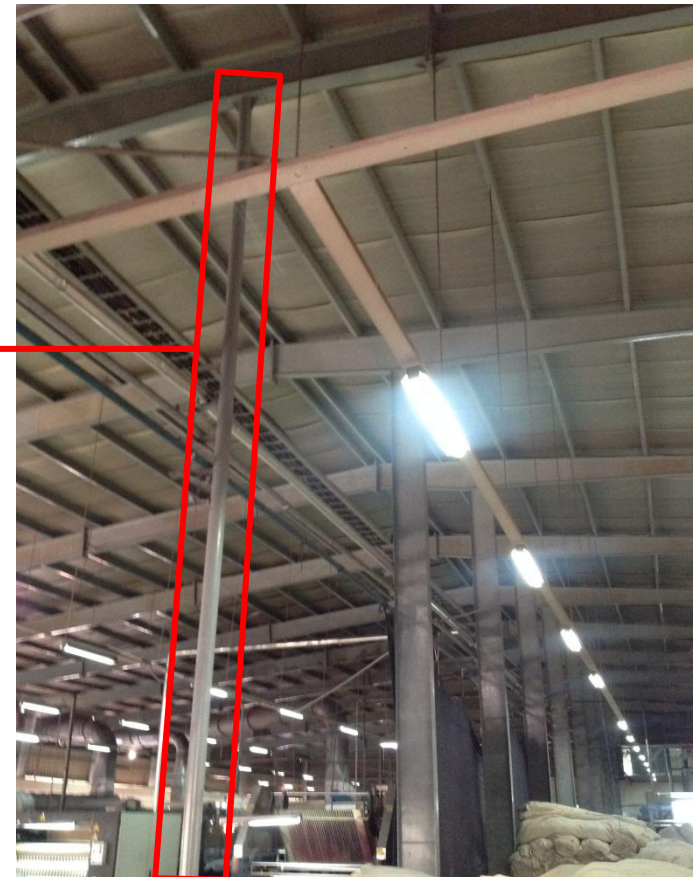
A slender circular hollow section was observed in the Dyeing Building, providing support to the rafter. This is not in accordance with the structural drawings, where a 450x150 I-section is typically shown. It does appear as if the column section is missing from the Sreepur Municipality-approved permit drawing (see below). Building Engineer to review design as a matter of urgency, and to carry out remedial works to the structure as required.

Location of Slender Column

Slender Column

- Building Engineer to check the design and capacity of the slender circular hollow section supporting the steel roof and make any necessary alterations.

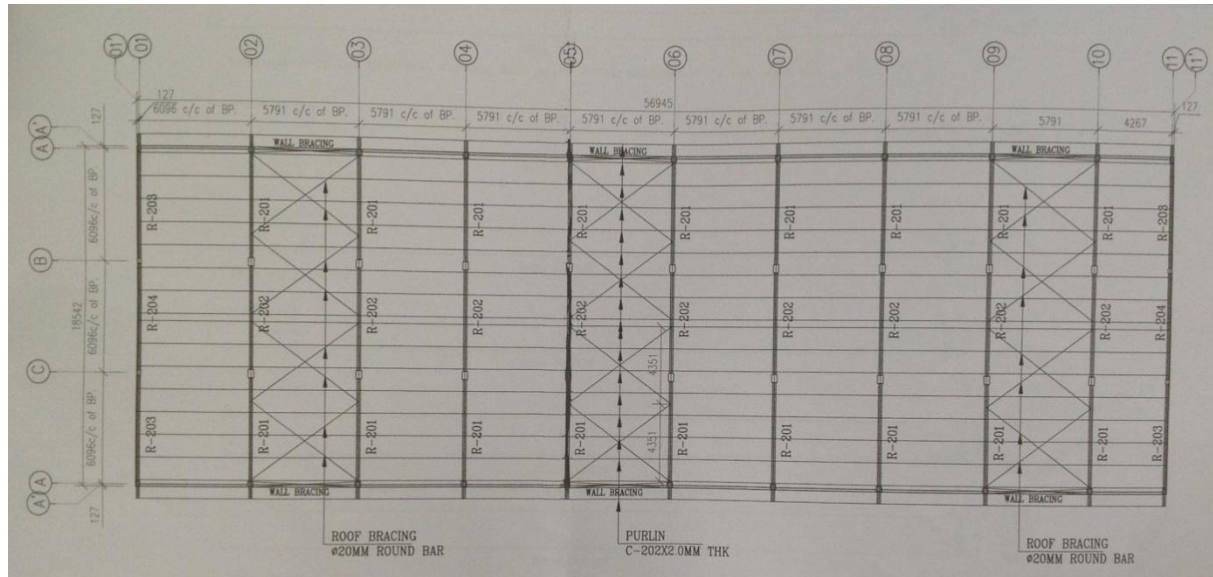
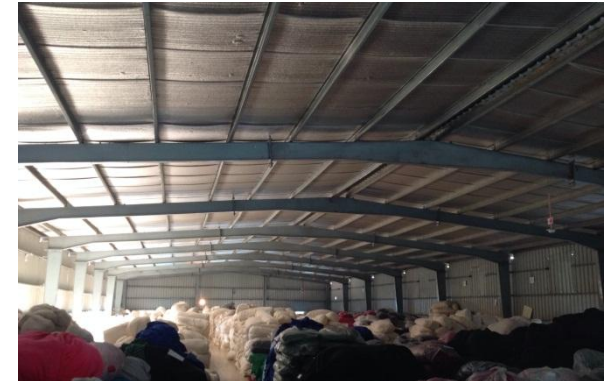
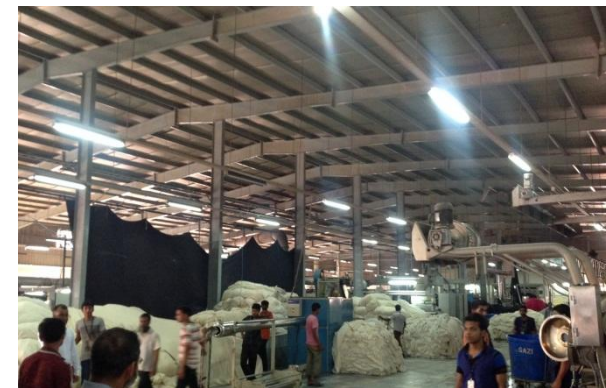
Question stability system to the prefabricated structural steel sheds. Horizontal and vertical bracing has not been provided to the Raw Materials Godown Building and the Dyeing Building. Building engineer to carry out a stability analysis and provide stability system as required.

Horizontal bracing system to Raw Materials Godown Building Roof as shown on extract from Structural Drawings - missing on site.

Bracing system missing from Raw Materials Godown Building

Bracing system missing from Dyeing Building

- Building Engineer to check the design of the building for longitudinal stability and provide roof and wall bracing as necessary.

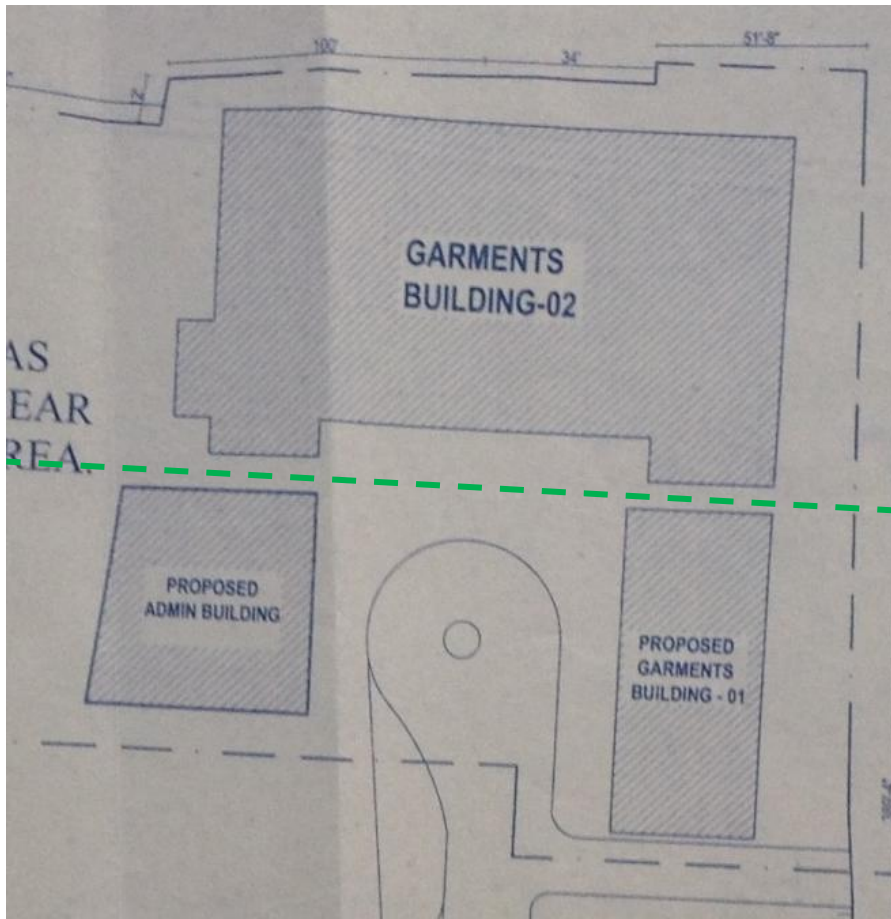
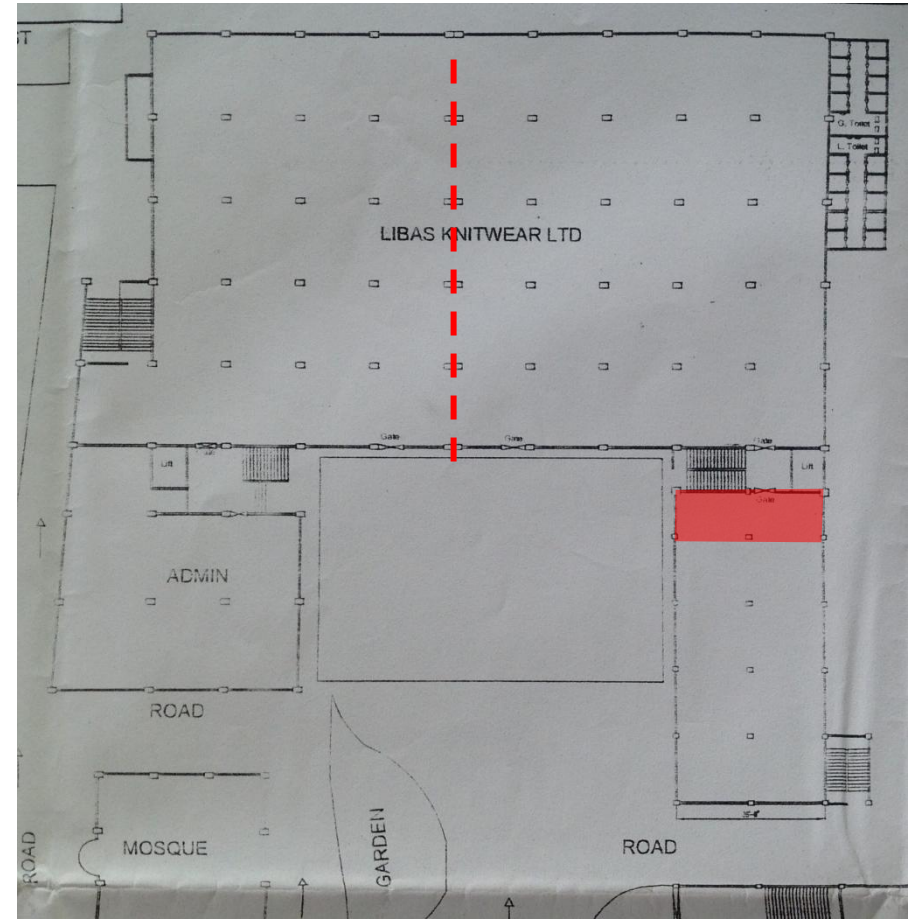
A set of Structural Drawing for the Main building, as well as for the Dyeing Building and the Raw Materials Godown Building, were made available for review on the day of the survey. A Sreepur-approved Building Permit Drawing was also made available for review. The main differences between the drawings and the constructed building include, but are not limited to:

- The permit drawing and structural drawings show the Main Factory Building as three separate units, comprising the Packing Section, the Administration Section and the Central Factory Section. They are actually built as a single unit with a movement joint running through the Central Factory Section.
- A 3 storey extension has been added above the Packing Section of the Main Factory Building. This has not been approved, and the column beneath this extension is proving critical (refer to Item 1).
- The longitudinal bracing for the Raw Materials Godown Building is referenced in the drawings, but is missing on site.
- Inconsistencies in rebar quantities for the Main Building.

Original Location of Movement Joint

Extent of 3-storey vertical extension

Actual Location of Movement Joint

Building Engineer to review and provide clarification.

- Factory Engineer to survey the structure and prepare a full set of “as-constructed” drawings.

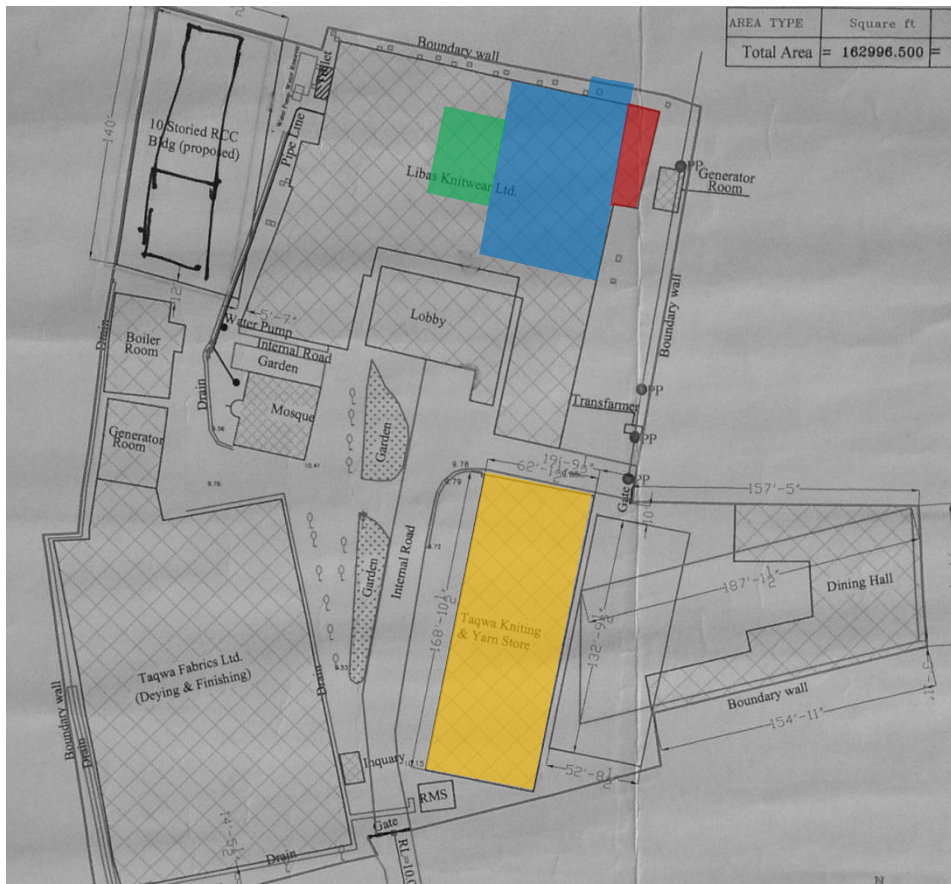
Typical Site Layout

Areas of high loading were noted at the water tanks at roof level, the 1<sup>st</sup> Floor Finished Goods Storage area, and the toilets plinths and suspended ceiling slabs at all floors of the Main Building, and at the yarn storage area in the Knitting & Raw Materials Godown Building at 1<sup>st</sup> Floor level. Building Engineer to check that the different slab constructions have been adequately designed to accommodate this loading, particularly the 1<sup>st</sup> floor cantilever.

- Water Tanks at Roof Level
- 1<sup>st</sup> Floor Finished Goods Storage Area
- Extent of Toilet Plinths & Slabs to all Floors
- Yarn Storage at 1<sup>st</sup> Floor of RMG Building

- Factory Engineer to investigate the loading from water tanks, 1<sup>st</sup> floor storage area and toilet floor build-up (and slabs over) and advise on any necessary alterations taking account of floor capacity and column capacity.

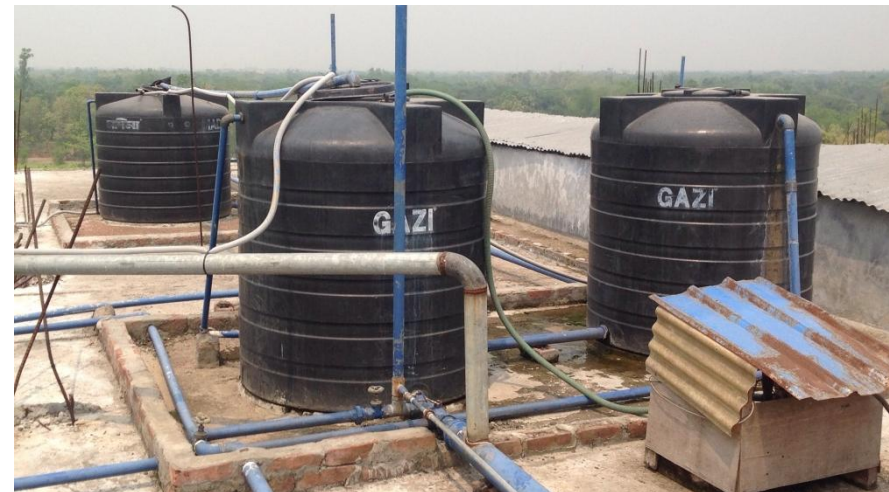
Water Tanks to Roof

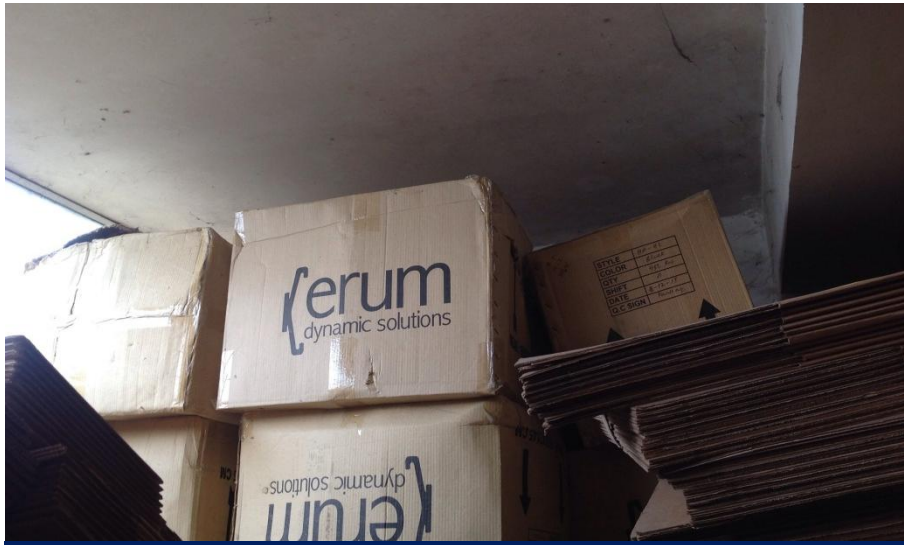
1<sup>st</sup> Floor Finished Goods Storage at Cantilever Location

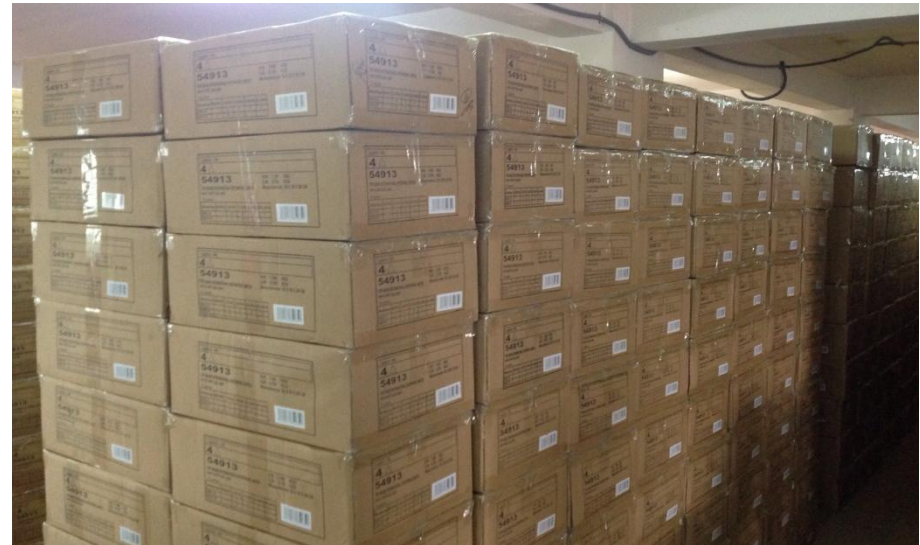
1<sup>st</sup> Floor Finished Goods Storage Area

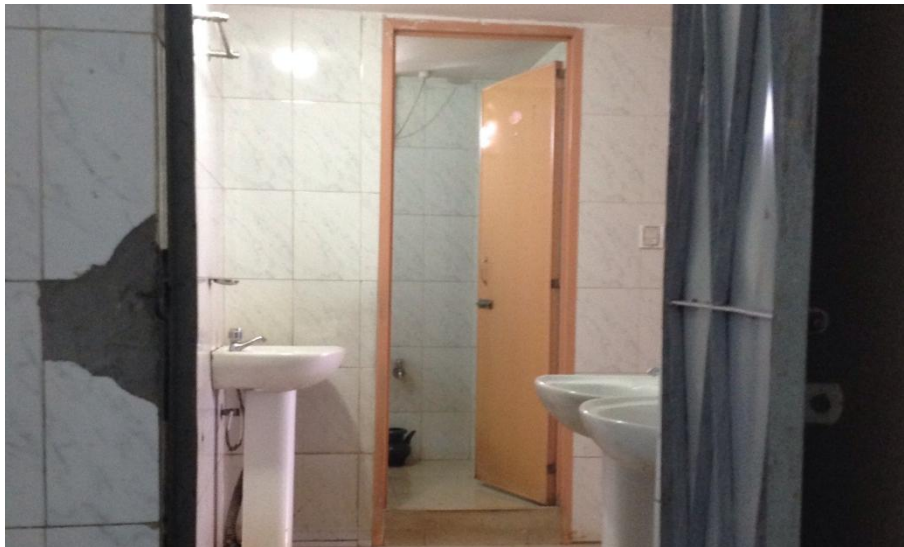
Plinths & Suspended Ceiling Slabs to Toilets (All Floors)

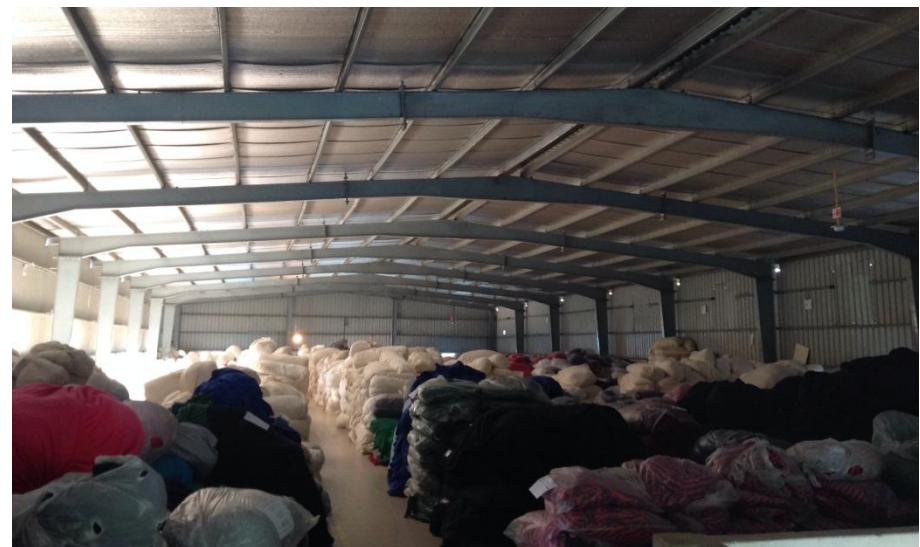
Yarn Storage to Raw Materials Godown Building

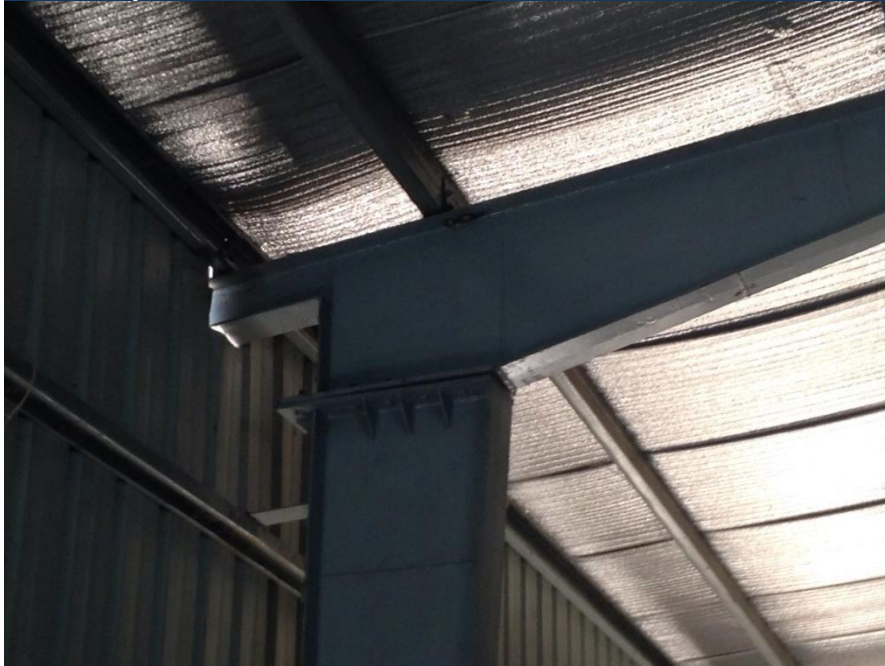
Column-to-Haunch Connection Detail

There appears to be inadequate bearing of the endplates (gaps evident) in a number of splice and column-to-haunch connections in the Knitting & Raw Materials Godown Building. Building Engineer to review connections, and to carry out remedial works to the structure as required.

- Building Engineer to check the design and capacity of the splice connection details and make any necessary alterations.

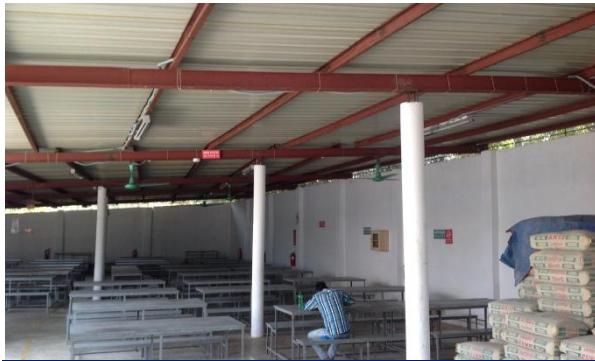
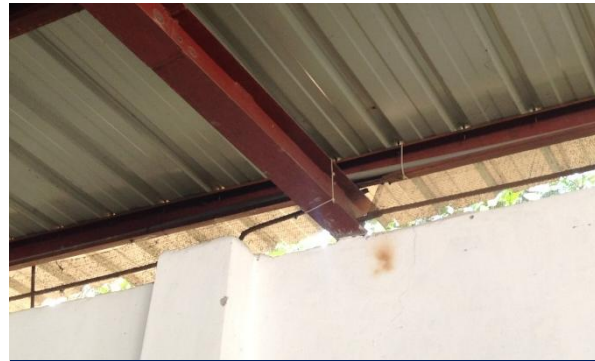
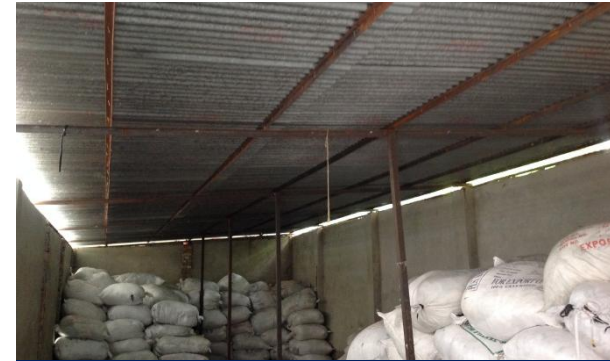
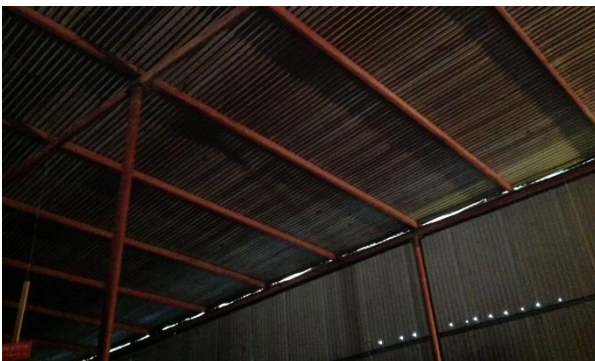
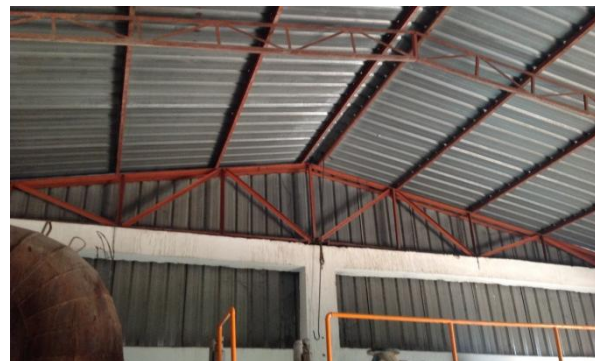
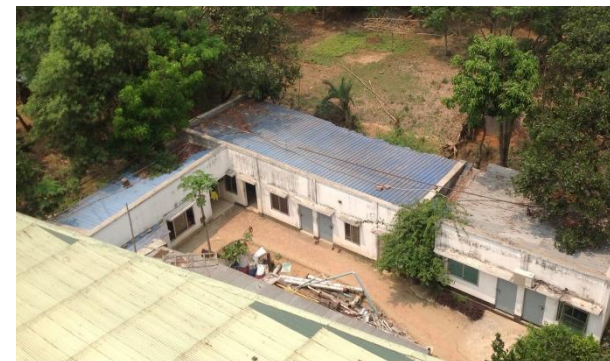
The factory compound includes a number of lightweight structures, namely the Dining Shed, the Leftover Storage Shed, the Staff Compound, the Chemical Storage Shed and the Boiler Room, all of which are outside of the main factory building at ground floor level. These structures, which include lightweight roofs on steel or RC columns, do not appear to be engineered. Building Engineer to review the design of these structures, with special emphasis on connections and bracing, and to implement any upgrade works as required.

Dining Area Shed

Dining Shed Connection Detail

Leftover Storage Shed

Chemical Storage Shed

Boiler Room

Staff Accommodation

- Building Engineer to check the design and capacity of the lightweight roof structures/connection details and make any necessary alterations.

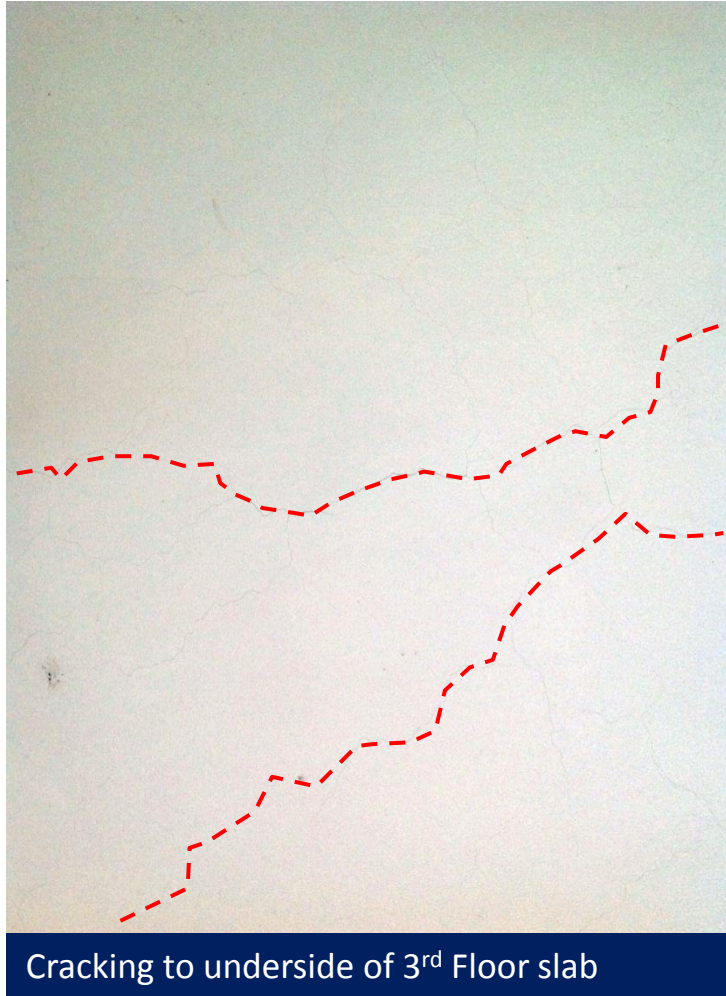
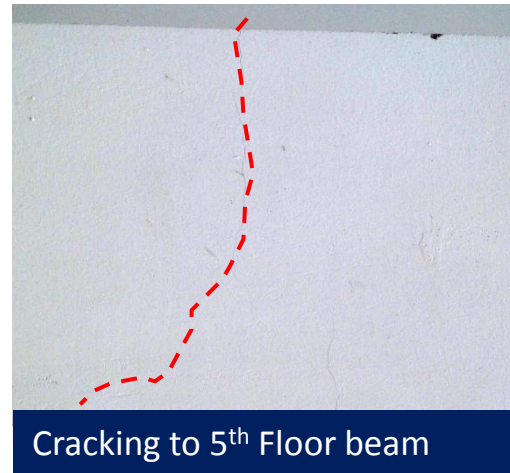
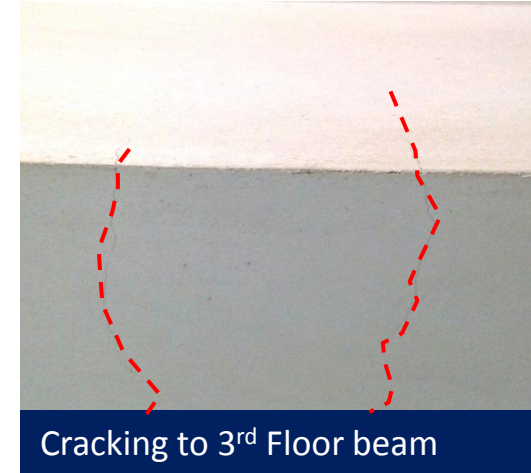
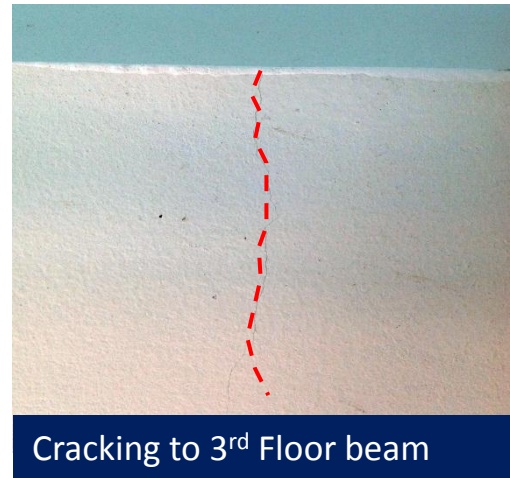
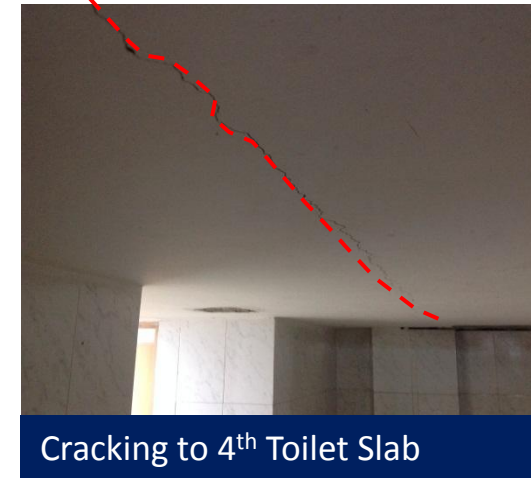
Hairline cracking was observed to the soffit of a number of beams and slabs at 1<sup>st</sup>, 2<sup>nd</sup>, 3<sup>rd</sup>, 4<sup>th</sup> and 5<sup>th</sup> Floor levels. Building Engineer to investigate and carry out remedial works to the structure as required.

- Monitor cracks to beams and slab soffit. Factory Engineer to investigate if cracks are limited to the plastering.
- Factory Engineer to advise on load reduction and repair and strengthening of the slab if required.

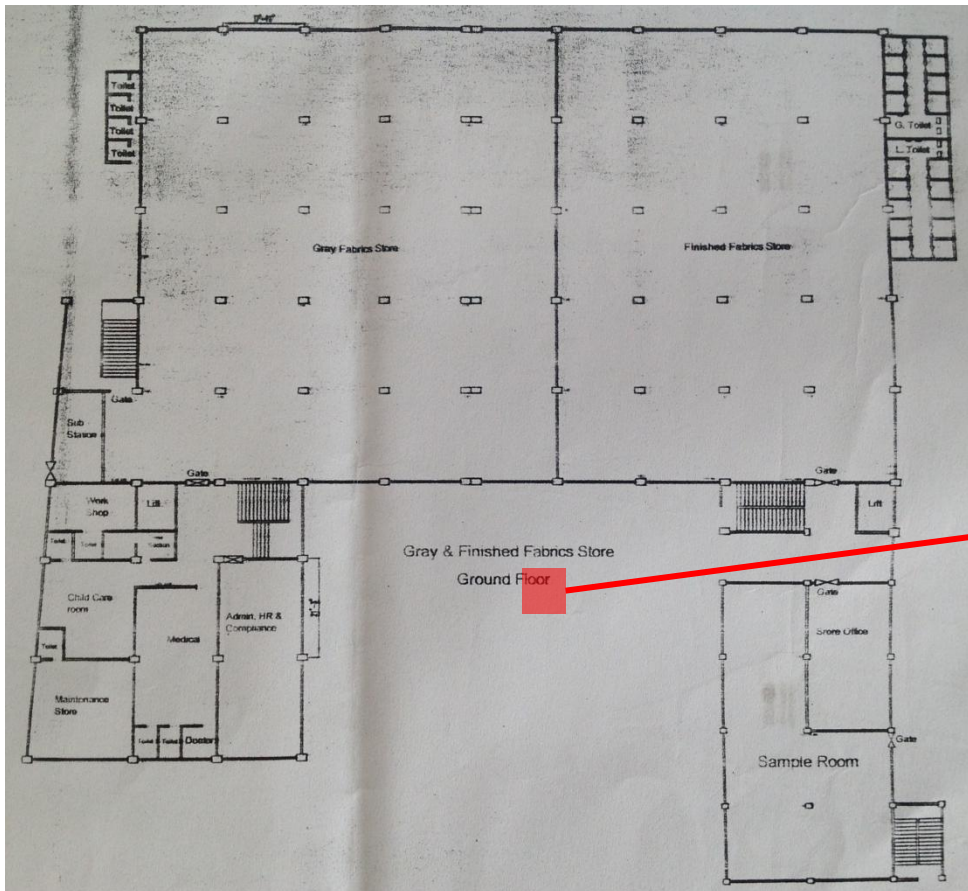
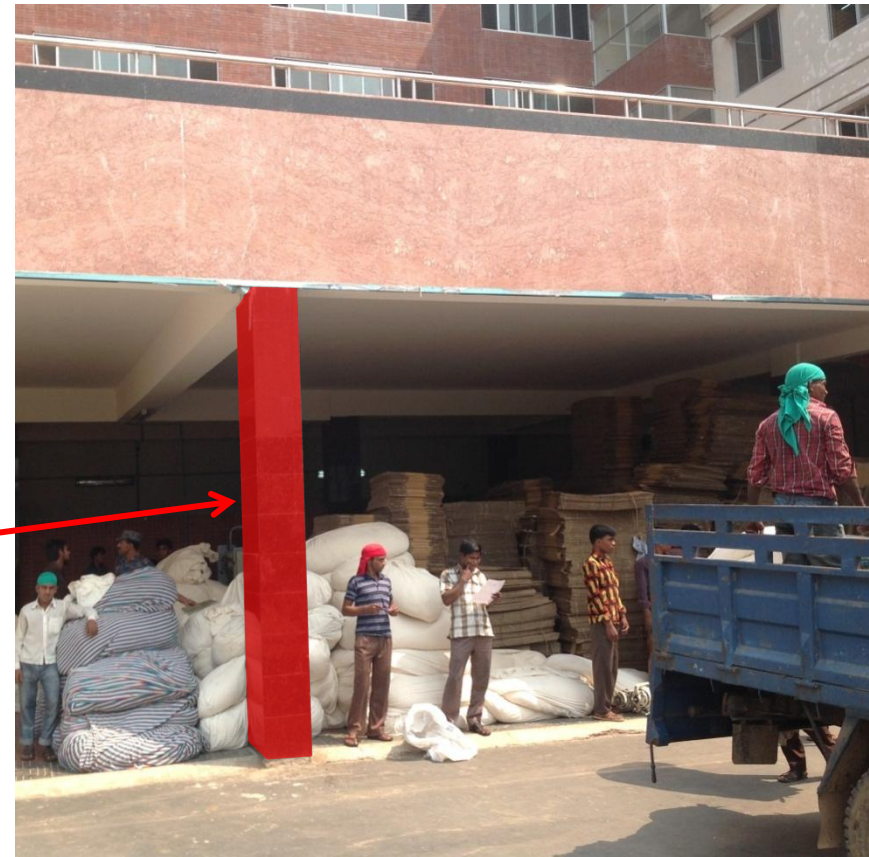
The central column at the delivery entrance to the Main Building is at risk of being accidentally struck by a vehicle. Building Engineer to check that the column has been adequately designed for impact loading, and to ensure that adequate protection is provided.

Delivery Area

Column at risk of impact loading

- Building Engineer to check if the column has been adequately designed for impact loading, and to ensure that adequate protection is provided.

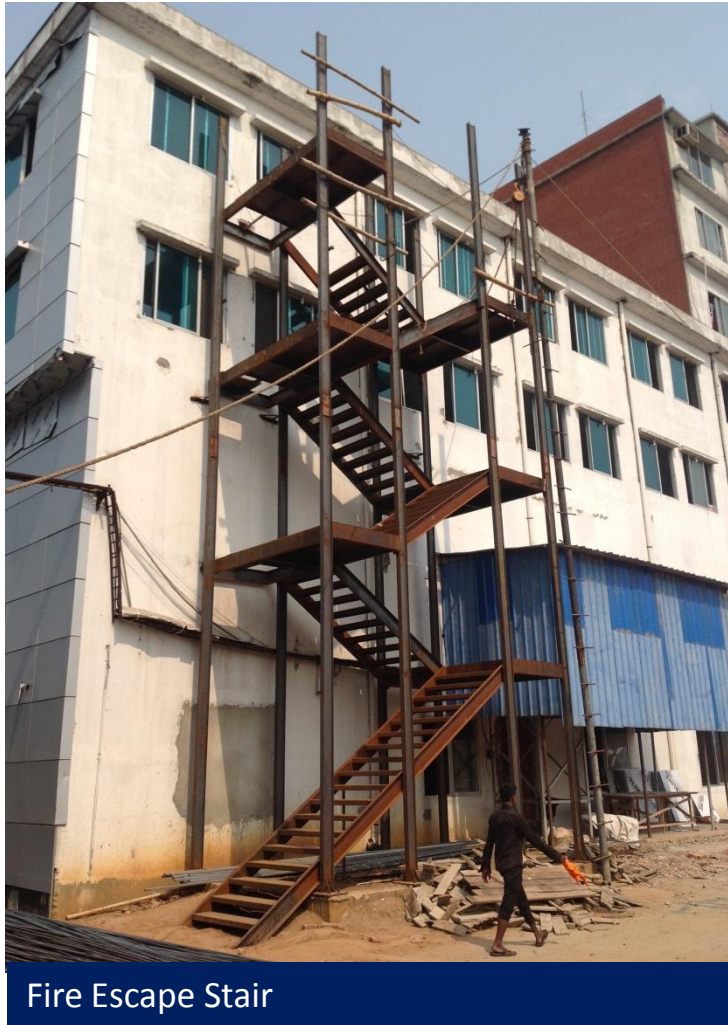
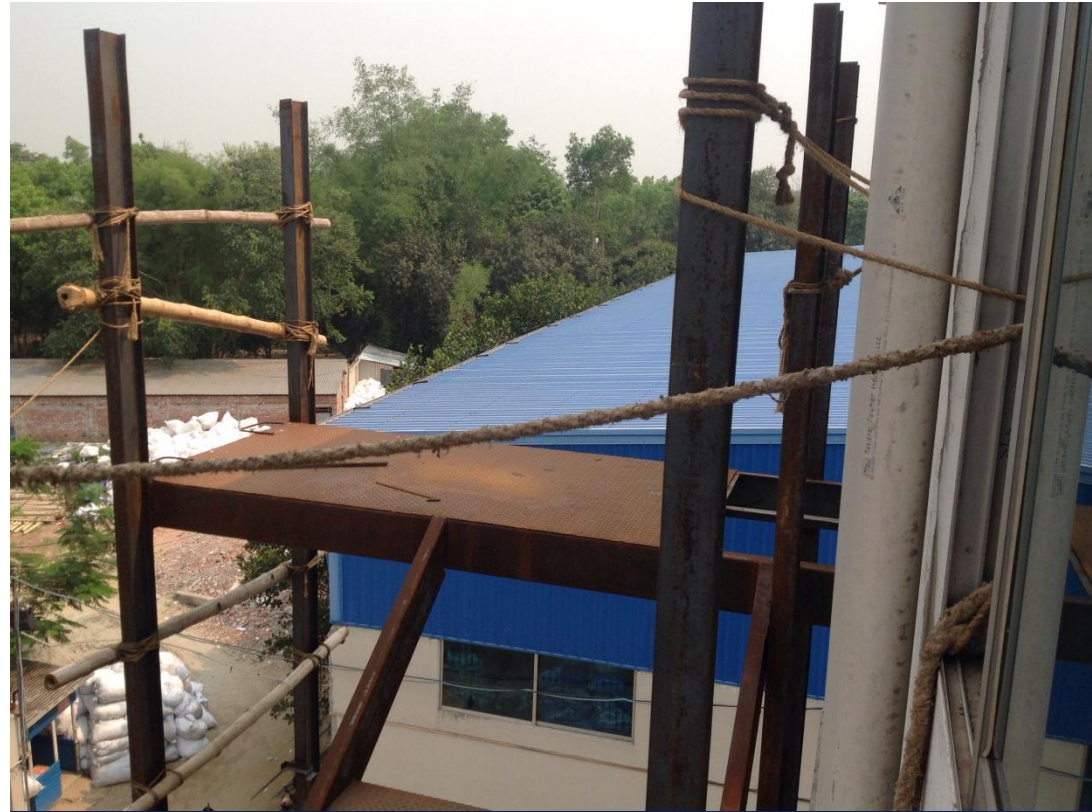
The fire-escape stair to the east of the Main Building was observed to be under construction at the time of the survey. Building engineer to check the suitability of the fire-escape stair.

Fire Escape Stair

Fire Escape Stair to East Elevation of Main Building

- Building Engineer to check the design of the external steel staircase and connection to existing building and make any necessary alterations.

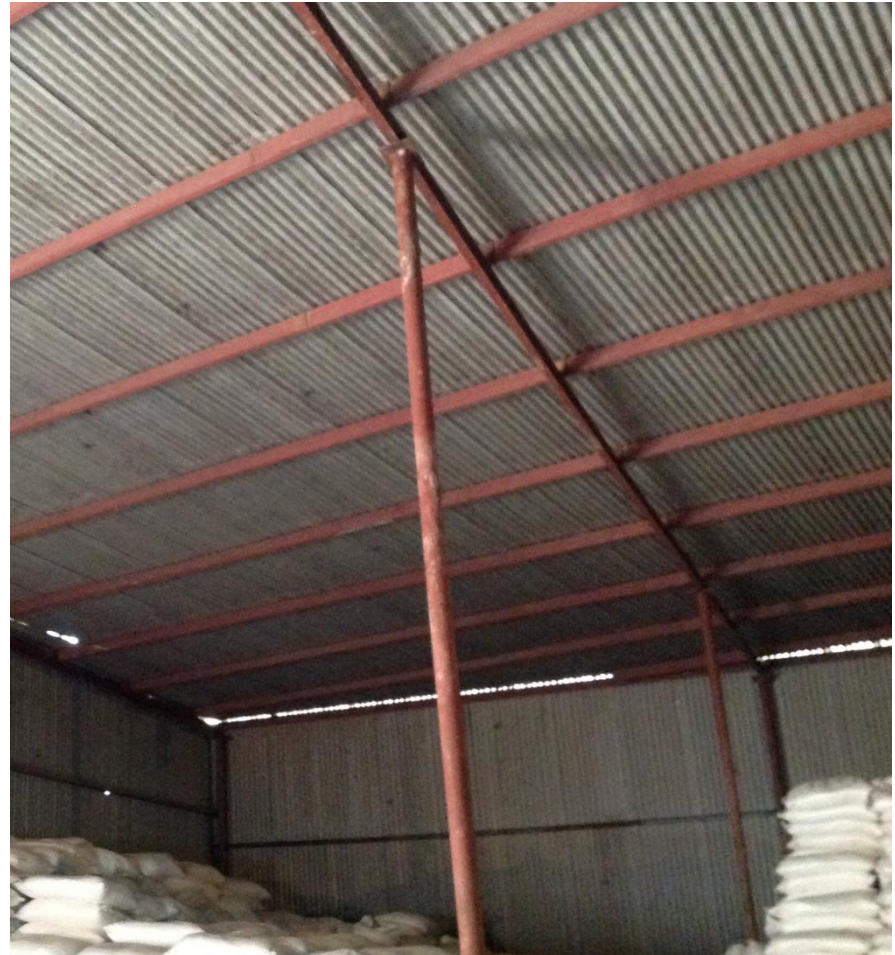
The structural columns in the Chemical Storage Shed are at risk of corrosion by Sodium Hydroxide solutions (caustic soda) currently stored on site immediately adjacent to the columns. Building Engineer to ensure that the columns have adequate protection.

Columns at Risk of Corrosion

- Engage Building Engineer to review storage location and ensure columns are protected from potential corrosive chemical attack.
