Brothers Fashion Ltd

Redwan Tower, Holding-1, , Block-B, Ward-15, Vogra, Gazipur.

16th October, 2016

Observations

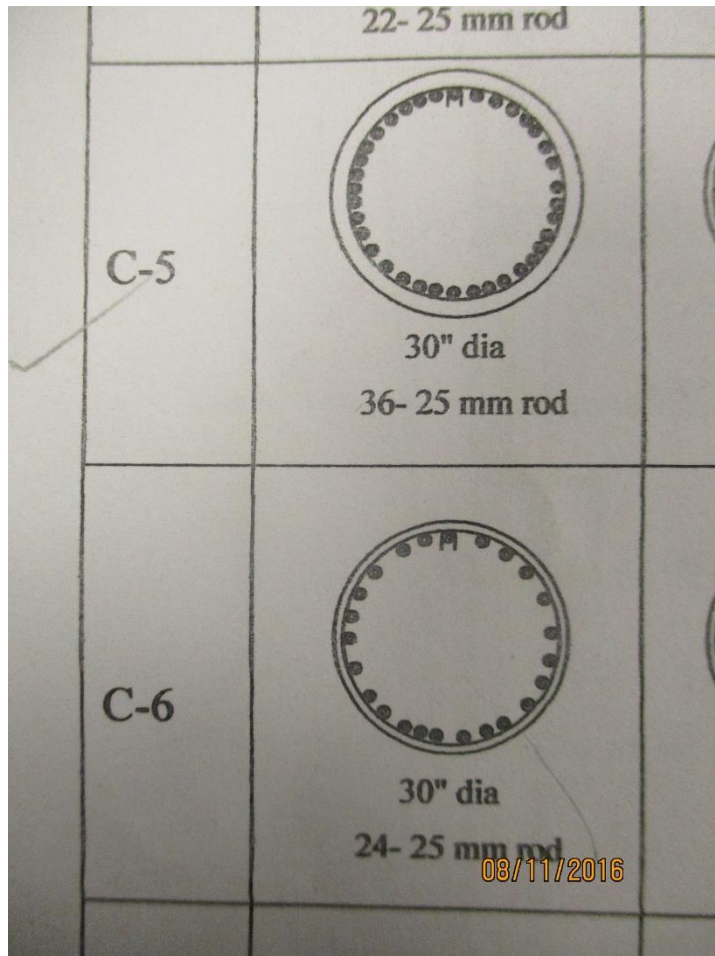
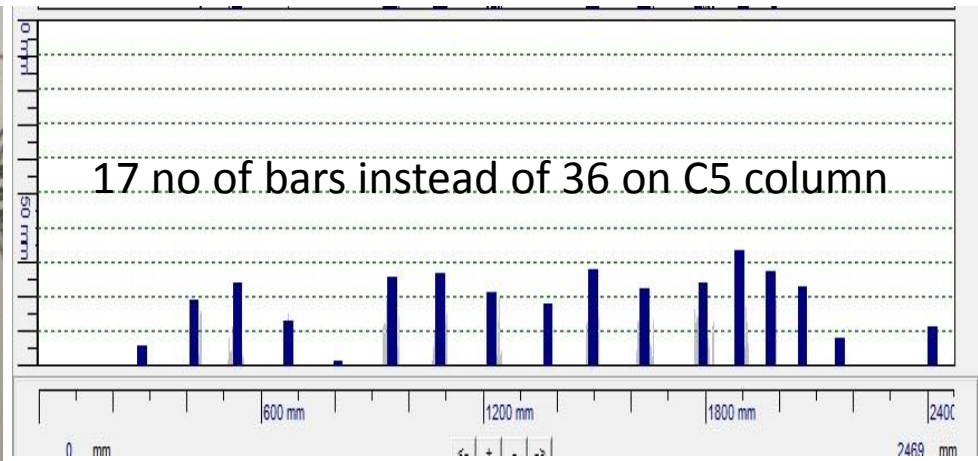
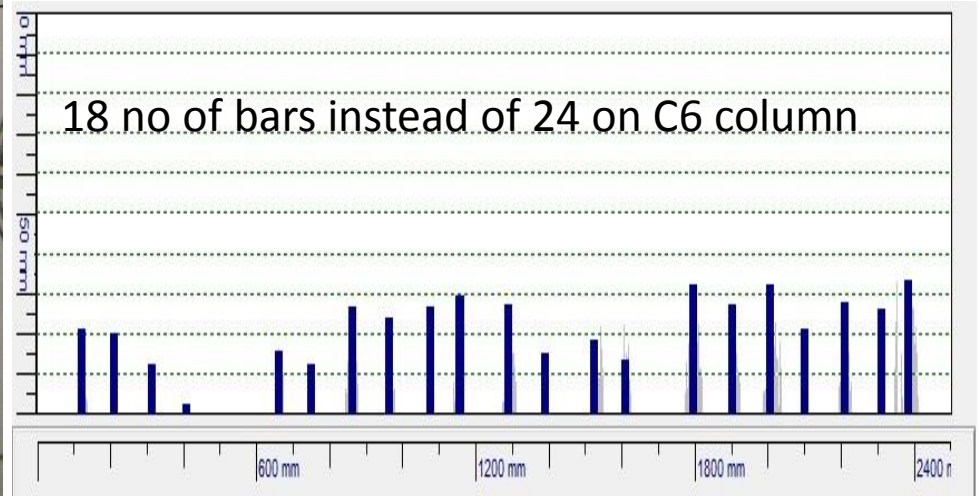
Rebar mismatch on Ground Floor Column

The Ferro scanning image shows that no of rebar doesn't match with the as built structural drawing.

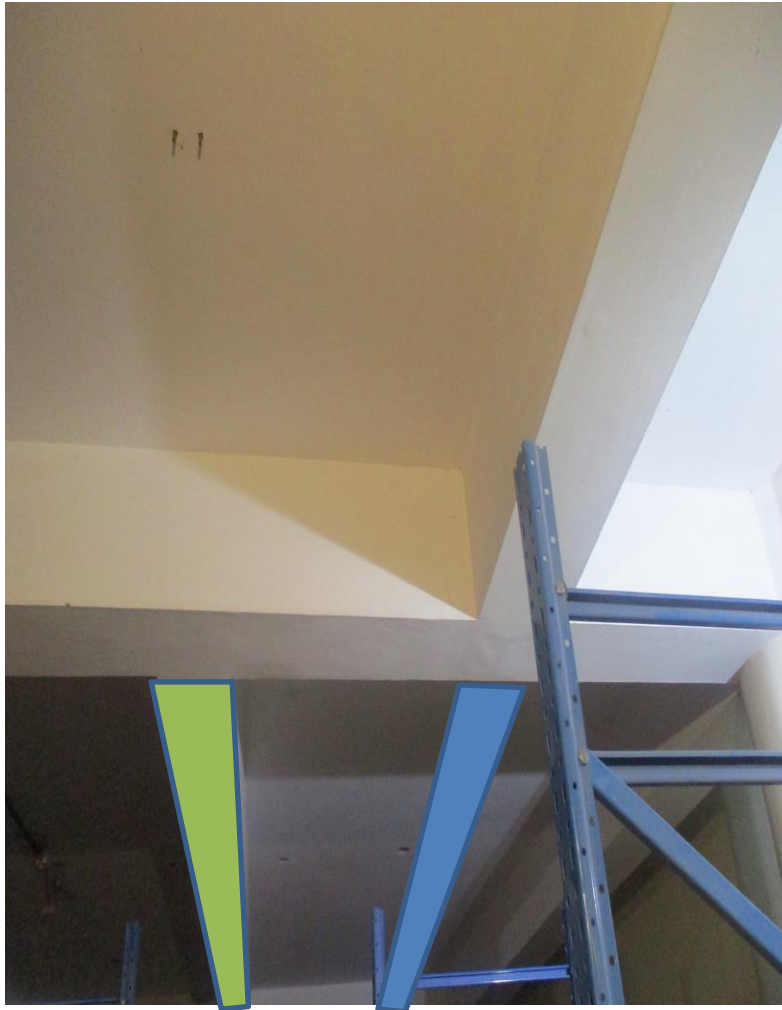
As per As-built drawing

Irregularities in Beam Layout

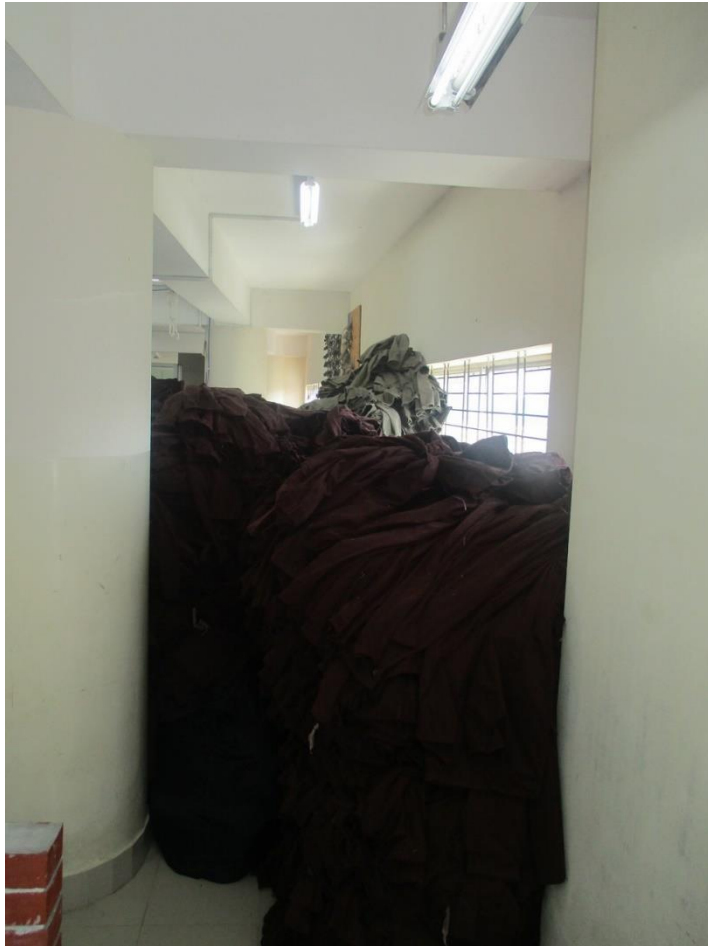
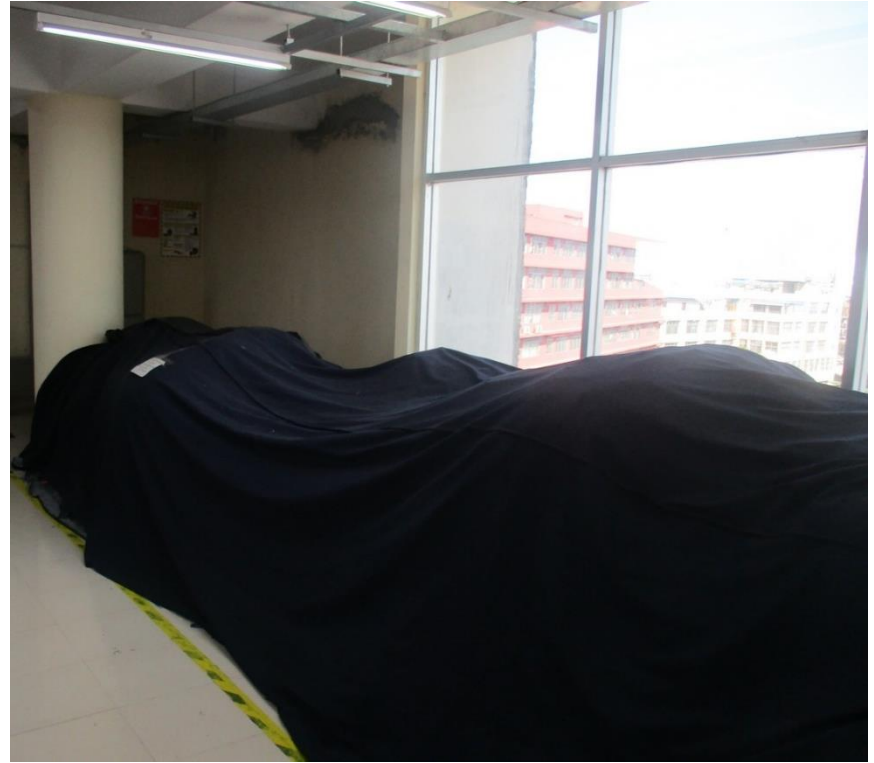
Loads on Cantilever

High Storage of Fabric has been observed on Cantilever Slab

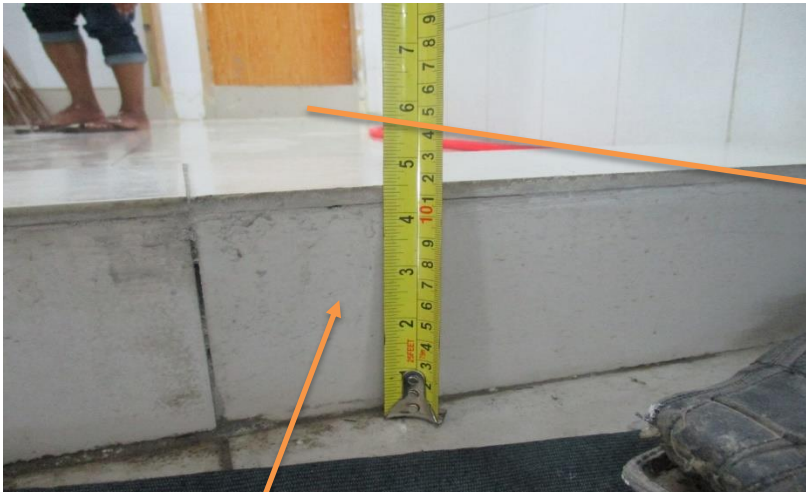
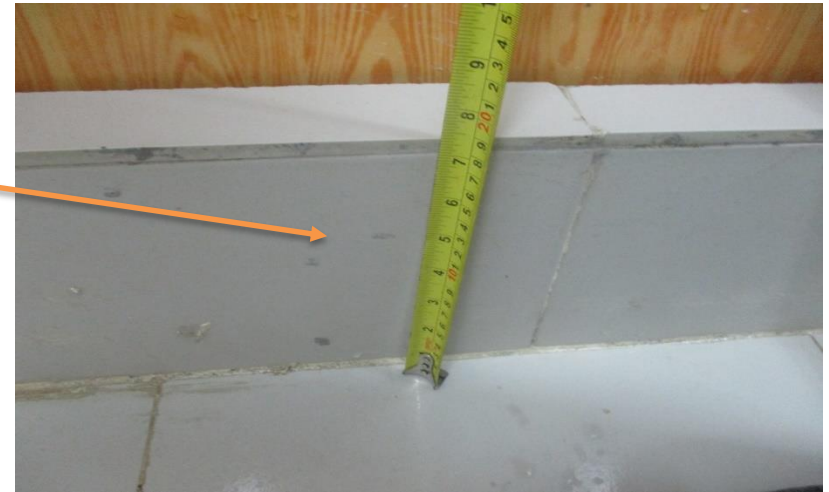
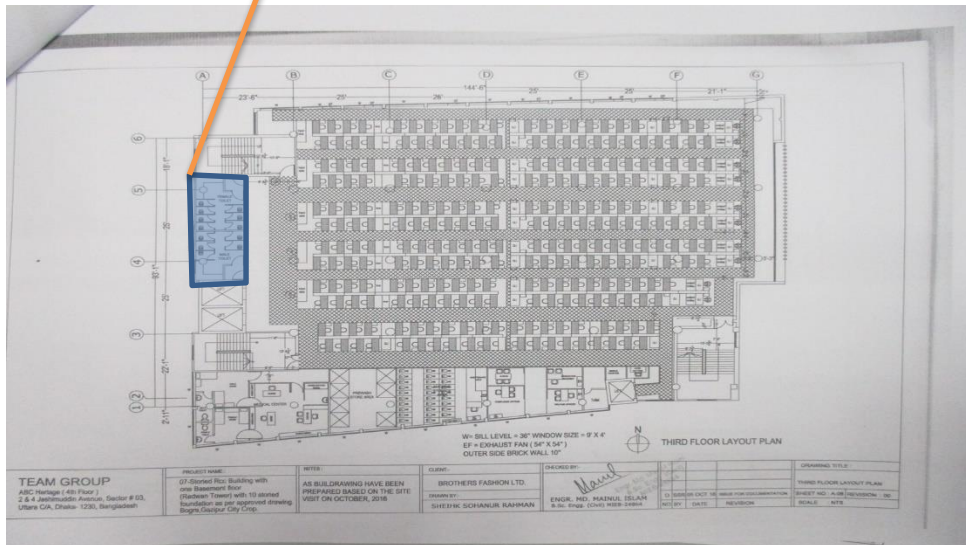
Loads On Cantilever

Total with 150mm build up on cantilever slab

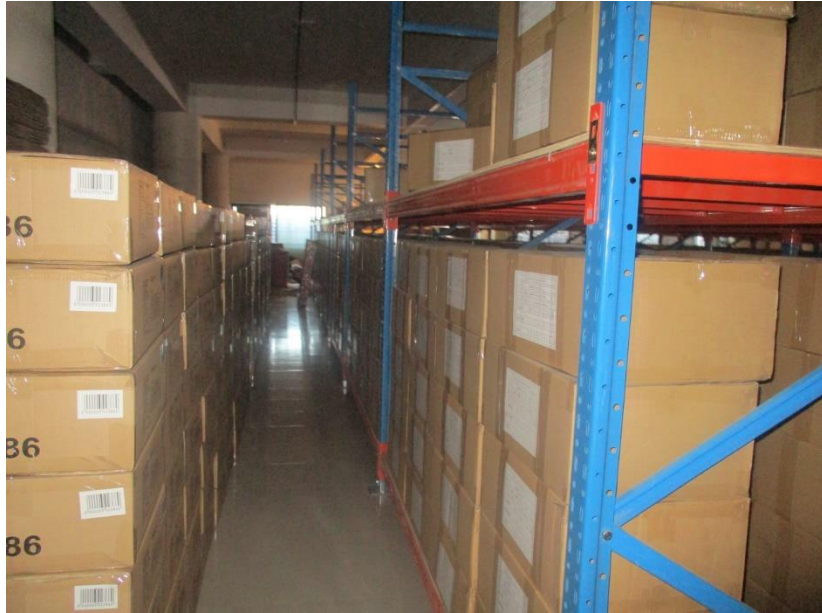
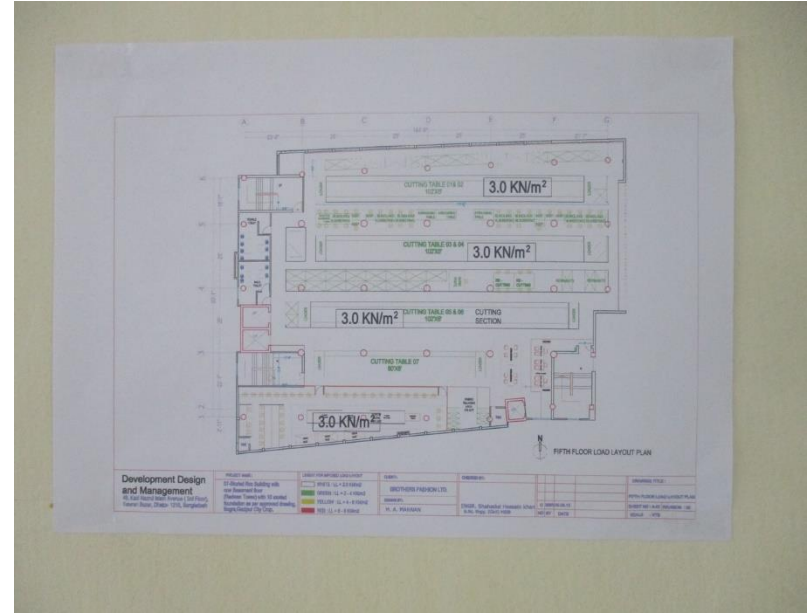
High Storage Load on Ground Floor

The Load Plan Posted on Ground Floor shows that allowable load limit is 3kn/m² but high storage load more than 3kn/m² has been observed on Ground floor

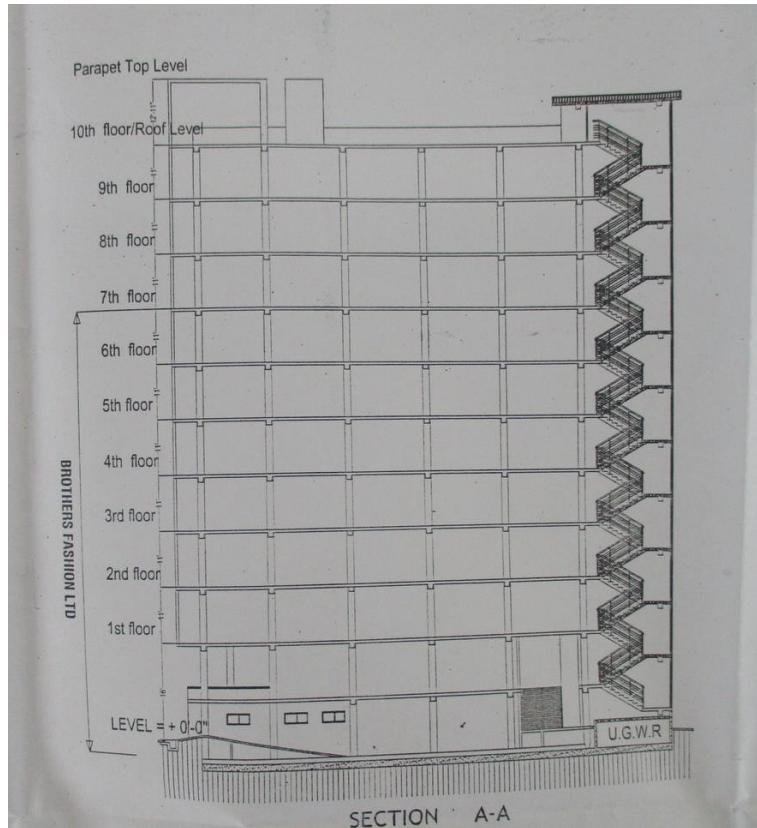
Approved Drawing (10 story)

The building was permitted as 10-Storeyed building from local authority. During inspection, it was observed that the column was extending which shows sign of possible vertical extension in future. This vertical extension will cause high stress on columns.
