# W. Apparels Chancellor Garments Ltd.

295/JA/4 Rayer Bazar, Dhaka  
(23.74143N, 90.36202E)  
08 March 2014

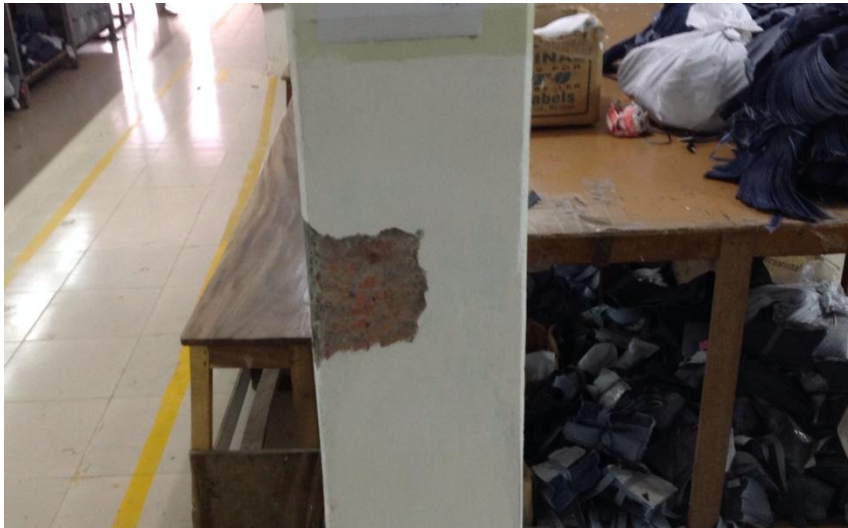
**Columns appear to be stressed in excess of  
normal design limits**

Tested Ground Floor Column – Brick aggregate

Cursory calculations indicate that column working stress is in excess of normal design limits.

Building Engineer is to perform detailed calculations including a Detail Engineering Assessment (See attached scope) and concrete tests to prove column size and (if required):

- Reduce loads by vacating floors
- Reinforce columns

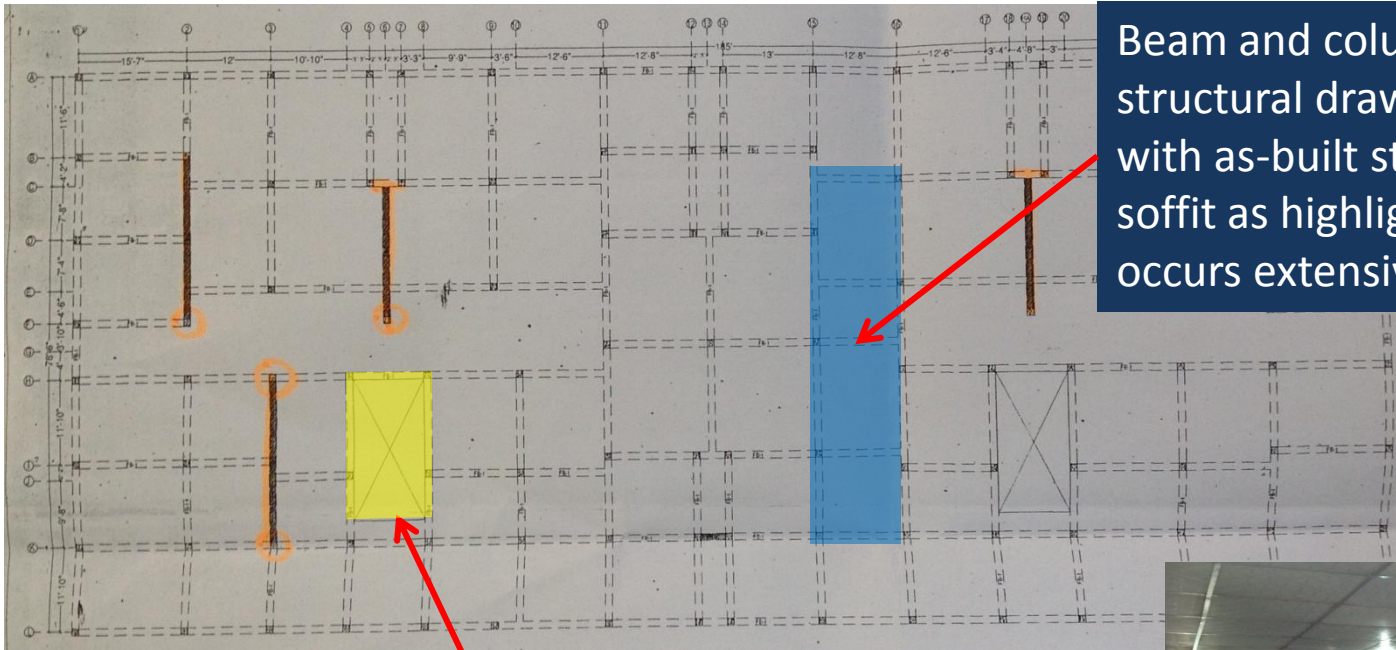
Structural Floor Plan

Beam and column arrangement on structural drawings not consistent with as-built structure on 2<sup>nd</sup> floor soffit as highlighted. Discrepancy also occurs extensively on 1<sup>st</sup> floor soffit.

The building structure should be surveyed and a set of accurate “As-Built” drawings prepared consistent with the current structural arrangement

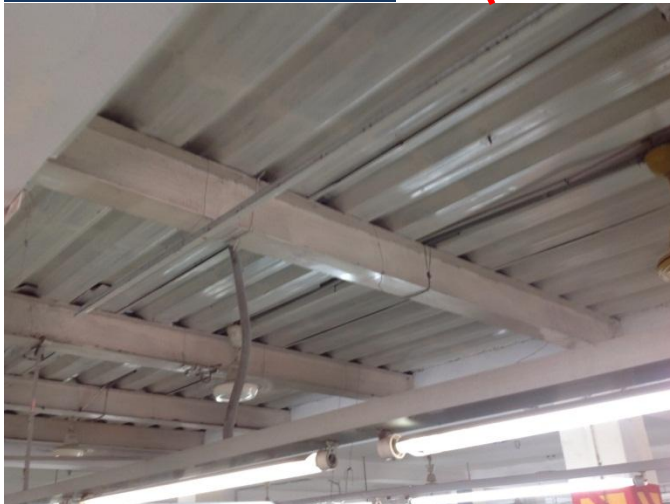
Stair ope in-filled

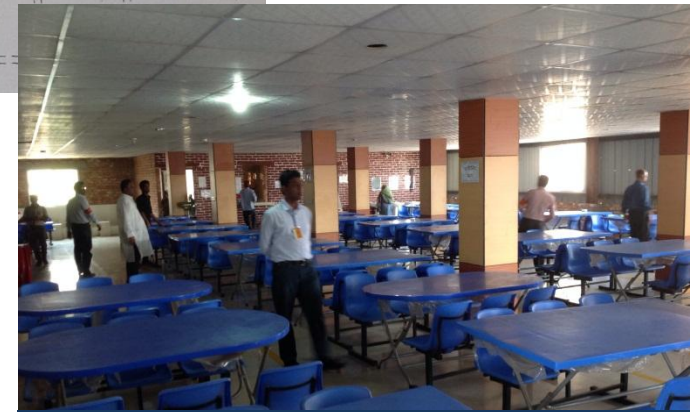
4<sup>th</sup> floor column layout differs from Ground to 3<sup>rd</sup> floor column layout

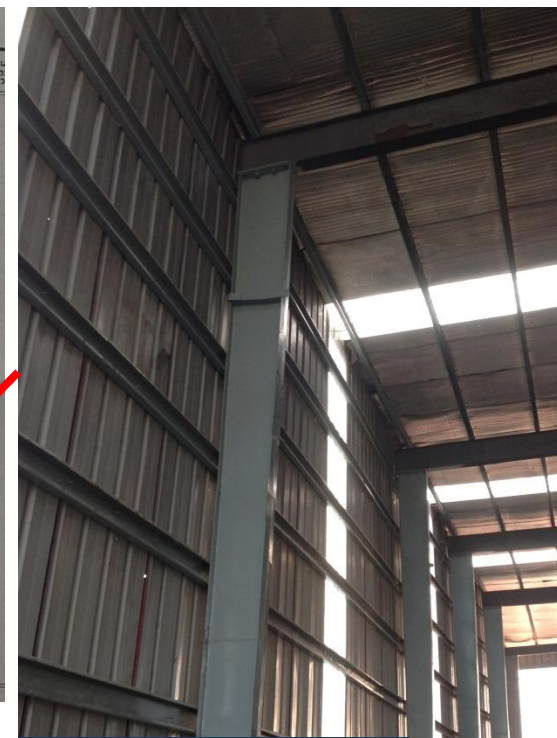
Steel lean-to structure

**Check required to confirm that steel frame to lean-to entrance structure and steel stairs is adequately braced and designed to resist high wind loading and that connections are adequately designed and confirmed to be as-built**

Additional steel stairs and lean-to structure not on structural drawings.

Engineer to check design of steel structures to resist high wind and lateral loads and completeness of connections on site.

| Item No. | Observation | Recommended Action Plan | Priority |
|---|---|---|---|
| 9 | Check required to confirm that steel frame to lean-to entrance structure and steel stairs is adequately braced and designed to resist high wind loading. | Steel roofs to lean-to entrance structure and steel stairs - design should be checked by the Building Engineer to confirm that it includes the provision of a horizontal stability system and, if required, upgraded to support code vertical and wind loads. | 6-weeks |
| 10 | Check required to confirm that steel frame to lean-to entrance structure and steel stairs is adequately braced and designed to resist high wind loading. | Completeness of steelwork connections should be checked on site. | 6-months |

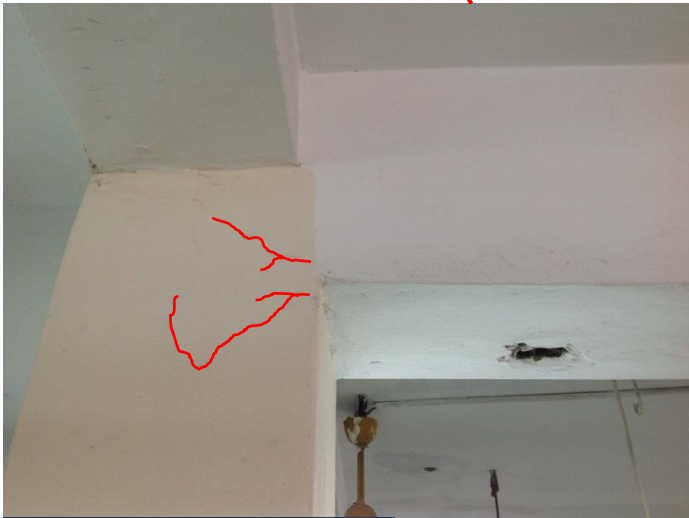
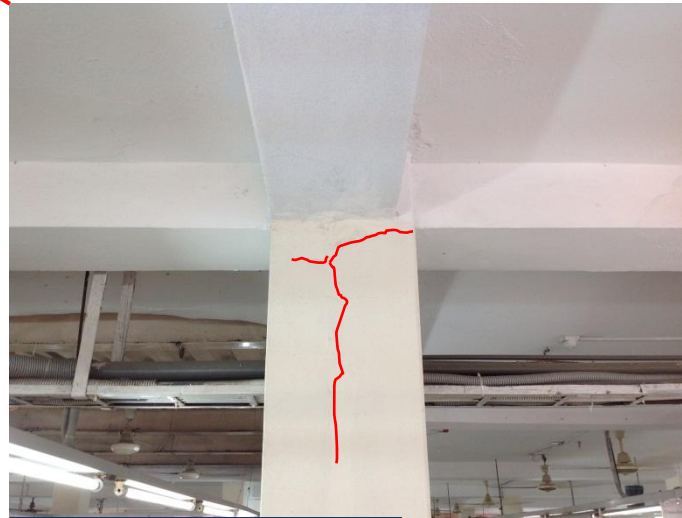
# **Cracking of 2 No columns on 3<sup>rd</sup> floor and cracking on the soffit of 3<sup>rd</sup> and 4<sup>th</sup> floor slabs**

Column cracking

Column cracks to be reviewed by removing plaster to confirm that cracks do not extend into structure.

| Item No. | Observation | Recommended Action Plan | Priority |
|---|---|---|---|
| 11 | Cracking of 2 No columns on 3rd floor and cracking on the soffit of 3rd and 4th floor slabs | Sections of plaster finish to columns and slabs to be removed to investigate if cracks penetrate the building structure. | 6-weeks |
| 12 | Cracking of 2 No columns on 3rd floor and cracking on the soffit of 3rd and 4th floor slabs | Building Engineer to carry out design check on columns and slabs to confirm that these cracks are non-structural. | 6-weeks |

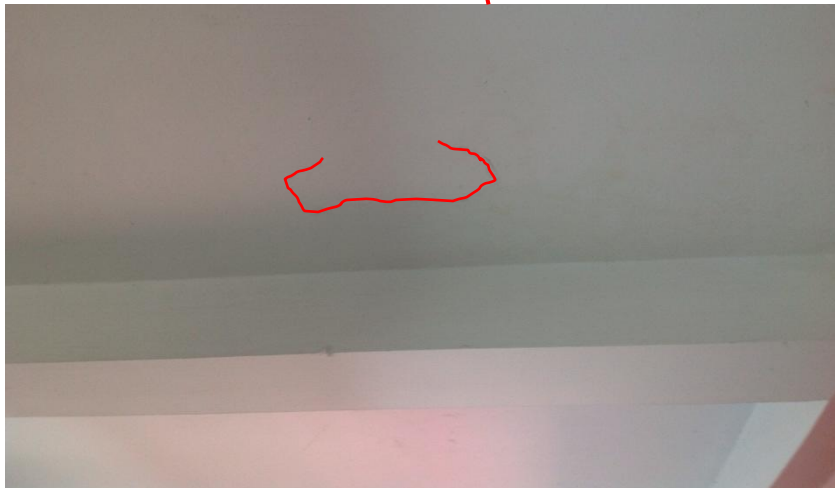
3<sup>rd</sup> Floor crack in slab soffit

Beam and slab cracks to be reviewed by removing plaster to confirm that cracks do not extend into structure.

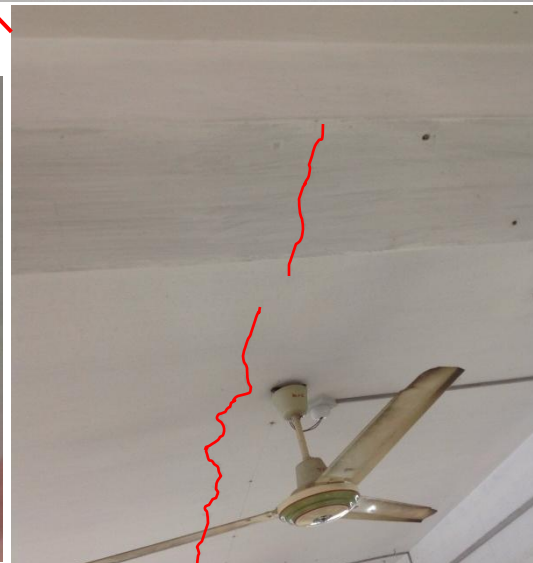
2<sup>nd</sup> Floor crack in slab soffit

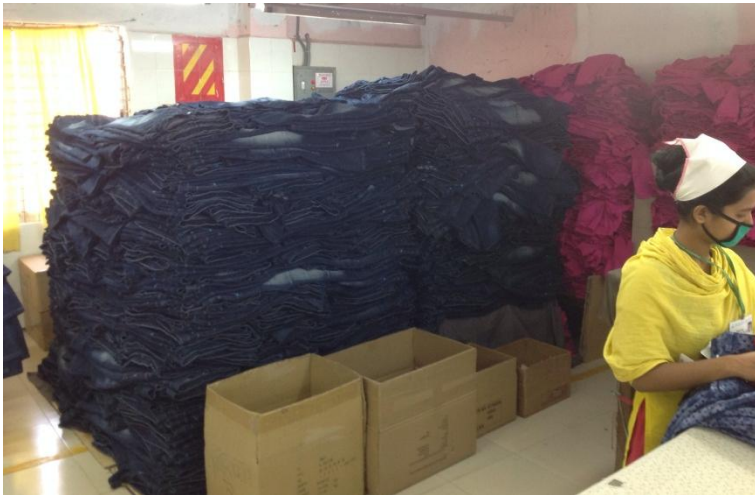
# Management of loads on 3<sup>rd</sup> floor

3<sup>rd</sup> Floor storage area

Building Engineer to create controlled loading plans for all floors which will designate where storage can be placed.

| Item No. | Observation | Recommended Action Plan | Priority |
|---|---|---|---|
| 14 | Management of loads on 3rd floor | Produce and actively manage a loading plan for all floor plates within the factory giving consideration to floor capacity and column capacity. (Refer to Item 1) | 6-weeks |

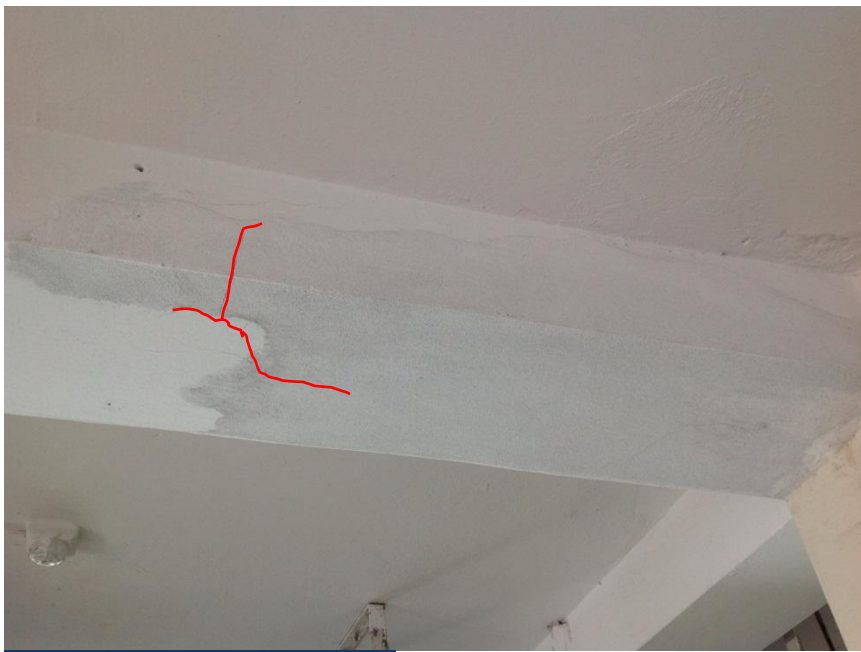
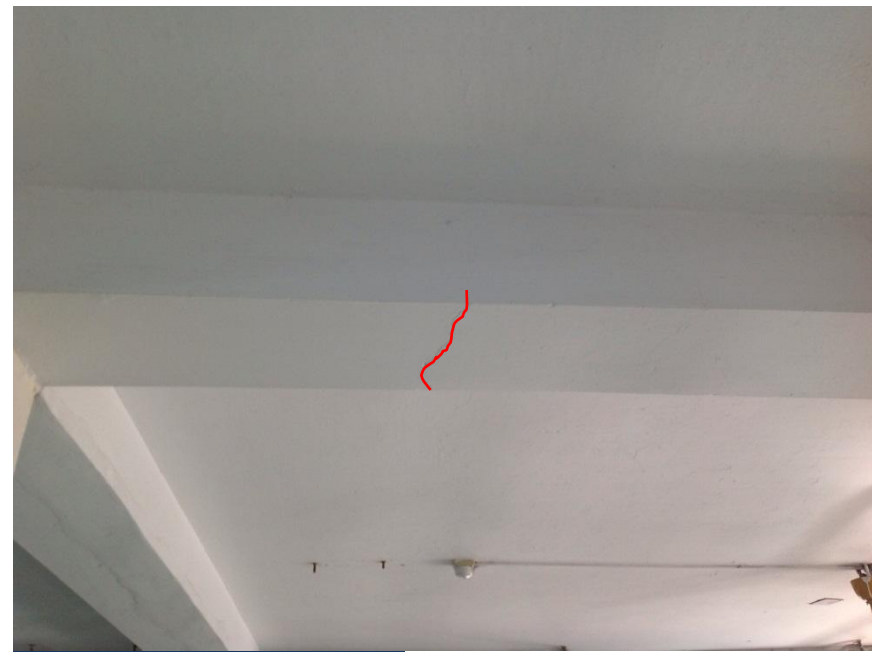
# Cracking of beams on soffit of all floors

Beam cracking

Beam cracks on all floors to be reviewed by removing plaster to confirm that cracks do not extend into structure.

| Item No. | Observation | Recommended Action Plan | Priority |
|---|---|---|---|
| 16 | Cracking of beams on soffit of all floors | Sections of plaster finish to beams to be removed to investigate if cracks penetrate the building structure. | 6-weeks |
| 17 | Cracking of beams on soffit of all floors | Building Engineer to carry out design check on beams to confirm that these cracks are non-structural. | 6-months |

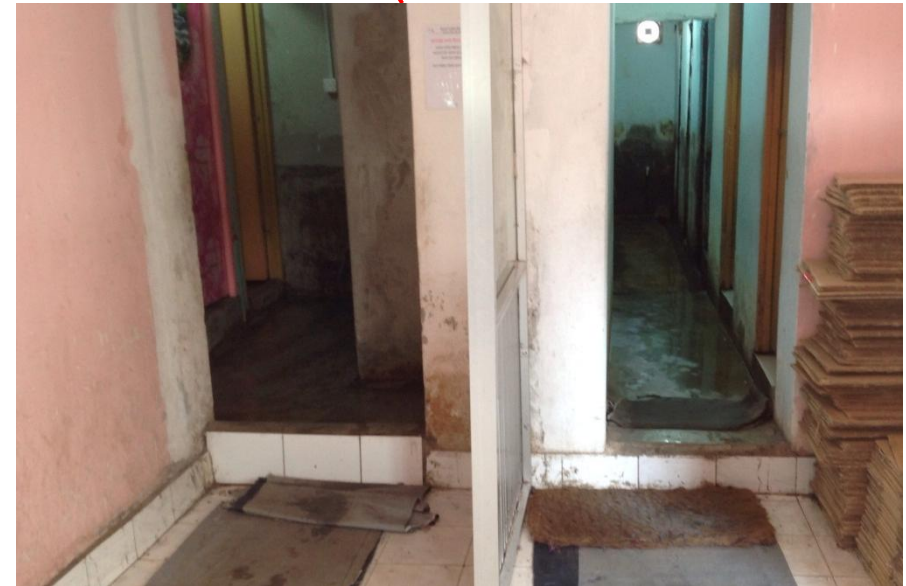
**Design check required for floor build-up in toilet area on 3<sup>rd</sup> floor to confirm floor slab load capacity**

Floor build-up in toilet area

**Building Engineer to review and confirm floor slab load capacity to carry floor build-up loading in toilet area.**

| Item No. | Observation | Recommended Action Plan | Priority |
|---|---|---|---|
| 19 | Design check required for floor build-up in toilet area on 3rd floor to confirm floor slab load capacity | Extent of build-up loading within toilet areas to be surveyed and capacity of floor slab to be assessed to confirm that the floor slab is designed to carry these loads. | 6-weeks |

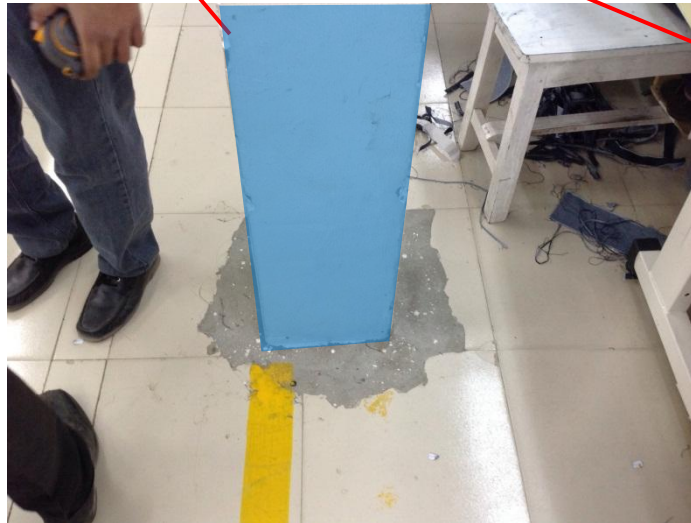
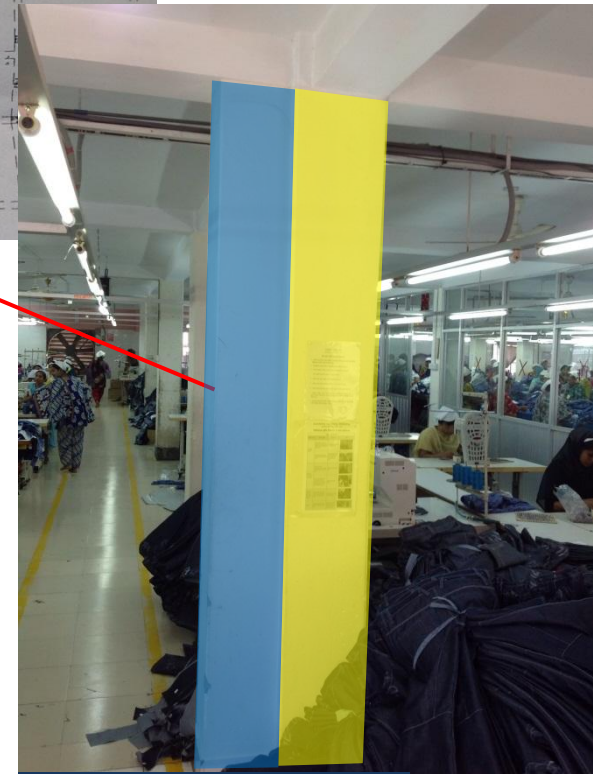
**Redundant brick columns on 3<sup>rd</sup> floor may be supporting beam/slab above**

Brickwork column

**2 No brickwork columns  
(locations shown on plan)  
to be removed**

| Item No. | Observation | Recommended Action Plan | Priority |
|---|---|---|---|
| 22 | Redundant brick columns on 3rd floor may be supporting beam/slab above | Building Engineer to confirm that brick columns are non structural and that they may be removed to avoid providing an alternative support point to the beam above which will not have been allowed for by the building designer. | 6-weeks |
| 23 | Redundant brick columns on 3rd floor may be supporting beam/slab above | Following confirmation by the Building Engineer, two plastered brick columns to be removed. | 6-months |
