# Pawla Knitwear Ltd

Isdair, Fatullah, Narayangong  
(23.633828,90.492207)  
19<sup>th</sup> April 2014

# Executive Summary (continued)

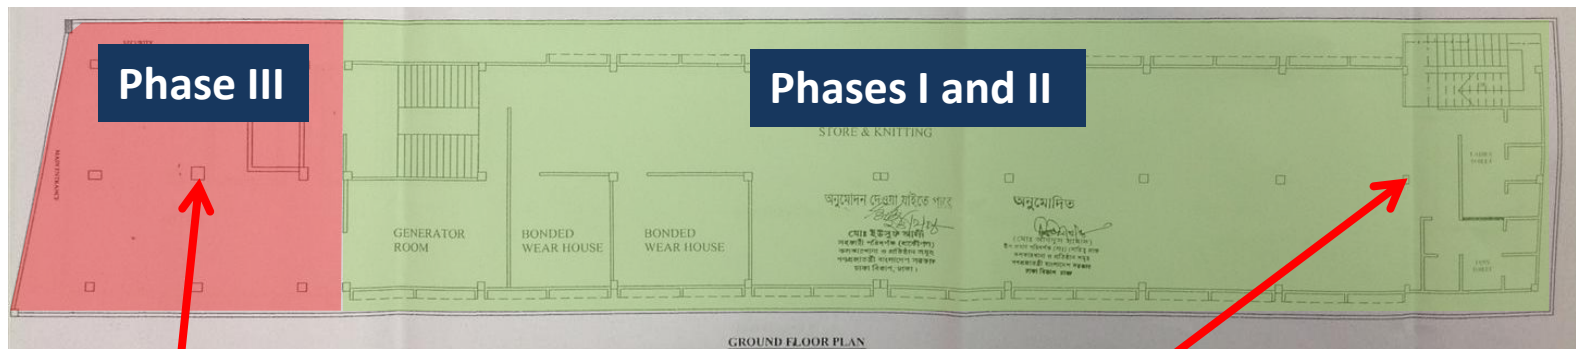
**Typical column layout**

**Preliminary calculations indicate that column working stress is at a high level in all parts of the buildings.**

- The area highlighted above is to be vacated of all storage and personnel at Levels 1 to 7. Personnel access to the toilets is permitted.
- Ensure the live load in all other areas at Levels 1 to 7 is limited to **1.5kPa**.
- Verify insitu concrete stresses by min. 4 no. 100mm dia. cores
- A **Detail Engineering Assessment** of the building to be commenced, see attached Scope

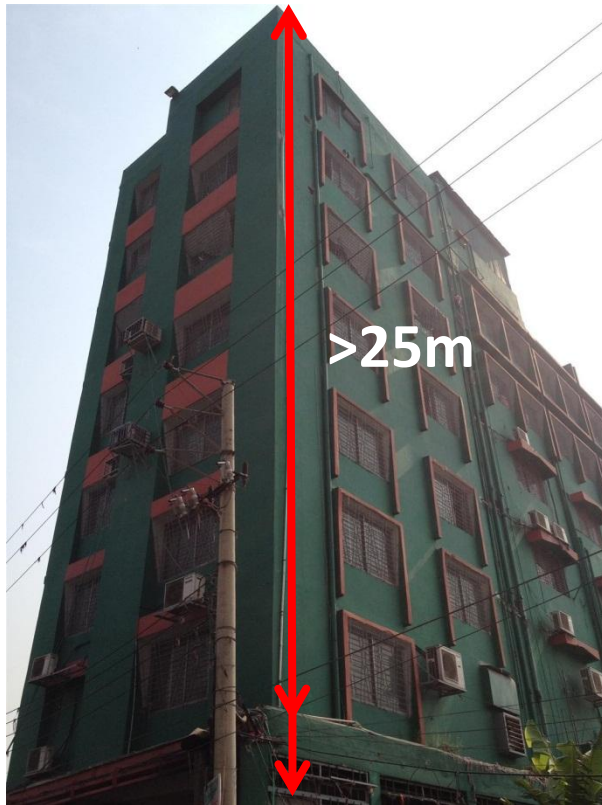
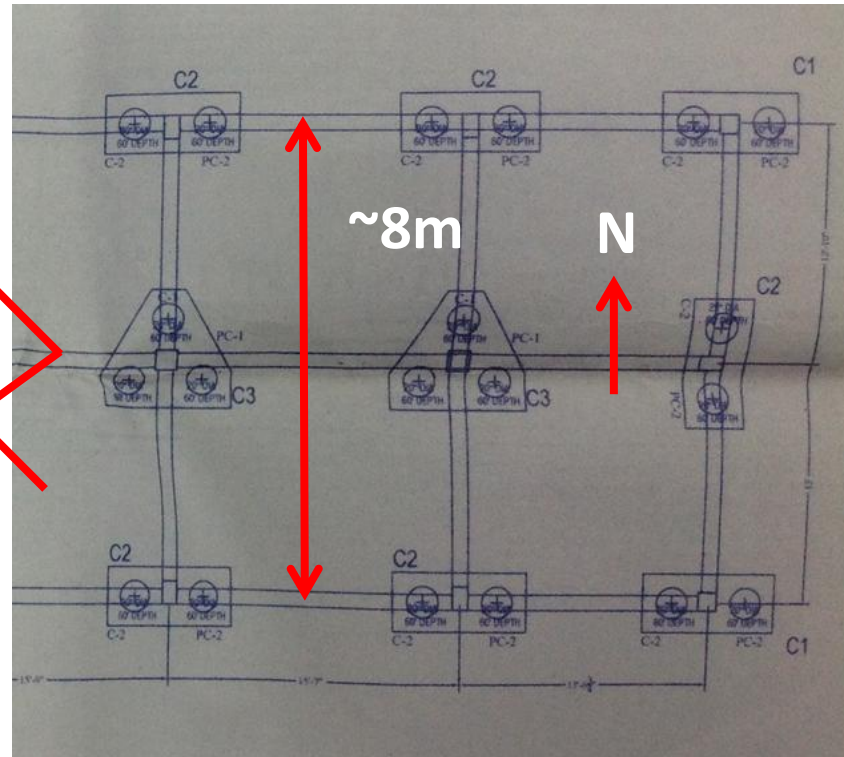
Height to north-south plan width ratio  $> 3$ . Additional vertical load expected in existing highly-stressed columns during an extreme hazard event.

- A **Detail Engineering Assessment** of the building is to be commenced, as Item 1. Ensure that lateral stability forms part of the assessment.

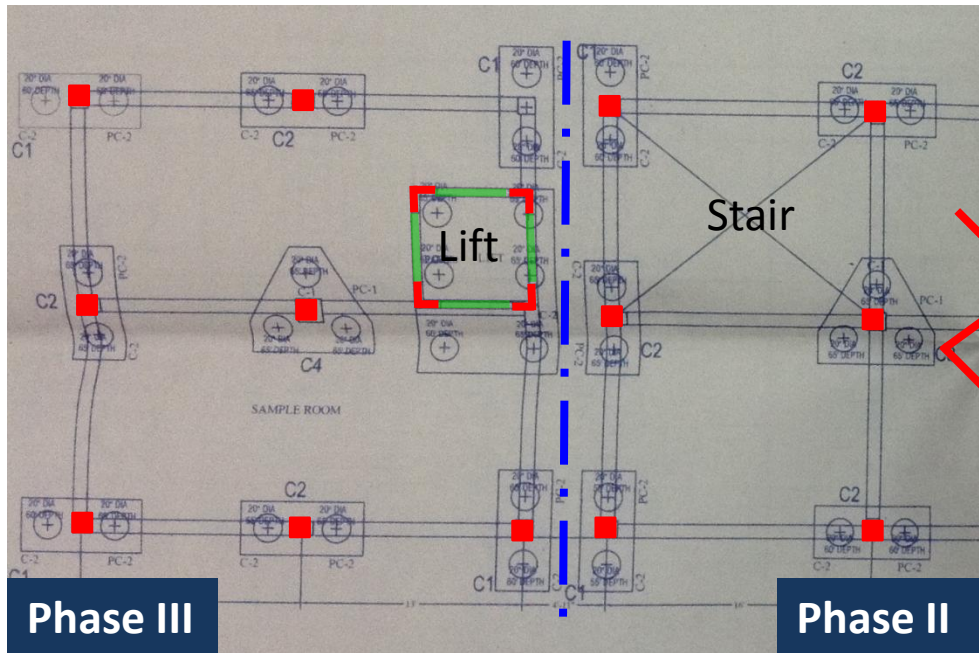
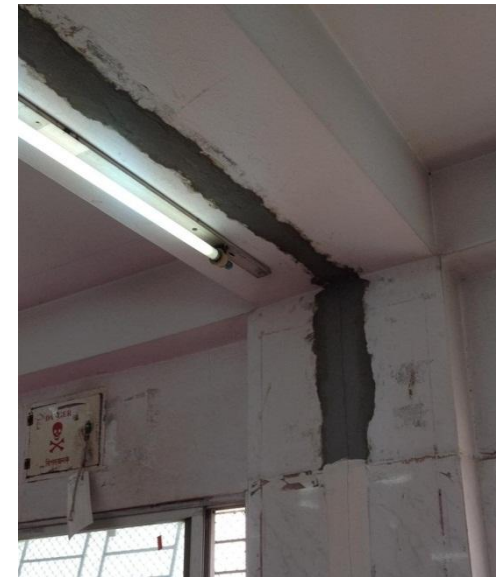
Phases I, II and III are separated by movement joints. It should be noted that:

- Movement joints have been filled with non-structural material.
- Pounding may occur where joints have been filled.
- Movement joints reduce redundancy of complete building structure.

No reinforced concrete shear walls. Limited vertically continuous non-structural masonry infill walls. Primary lateral load path relies on floor column moment frame action.

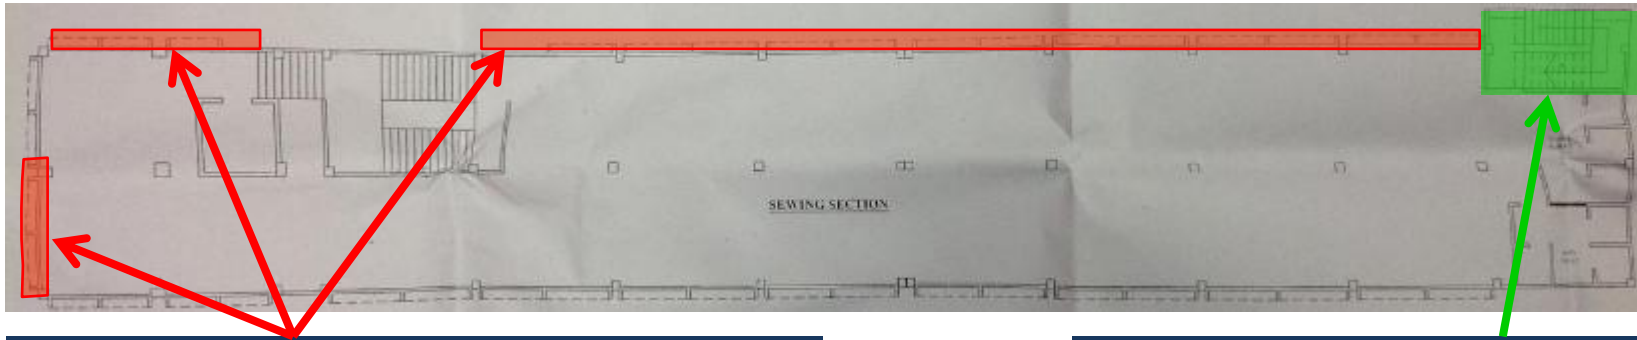
Typical plan showing areas where cantilevers do not appear on the permit / structural drawings on some levels.

- As part of Detail Engineering Assessment (see Item 1), ensure that accurate as-built documentation and drawings are produced.

- Detail Engineering Assessment to be completed, as Item 1.
- Issue accurate as-built documentation and drawings.

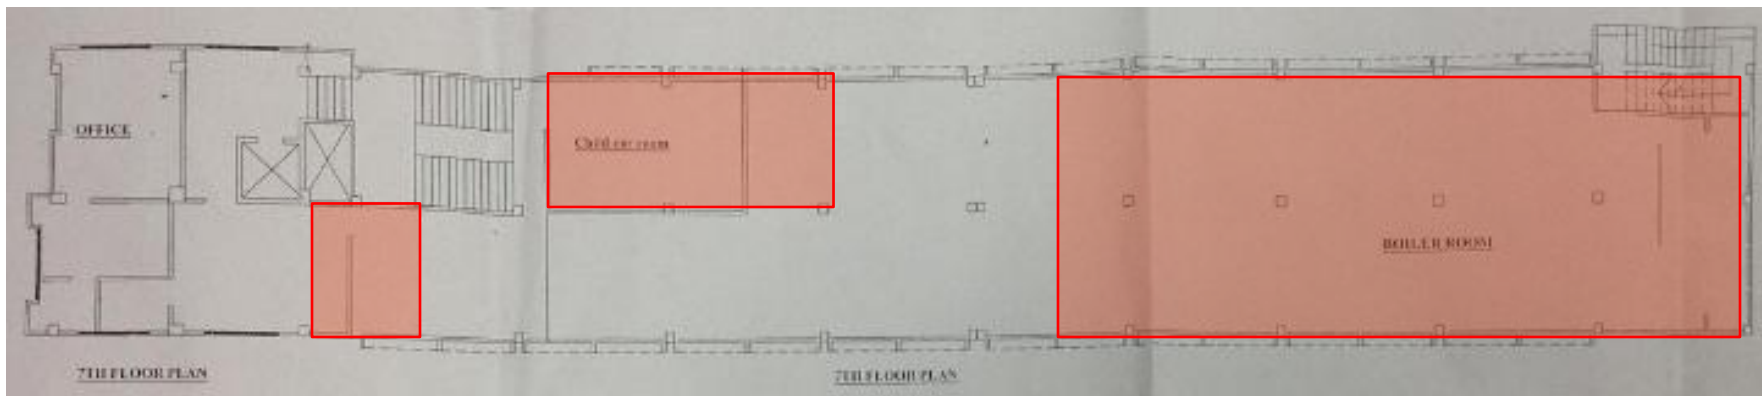
Roof plan showing steel shed locations shaded in red.

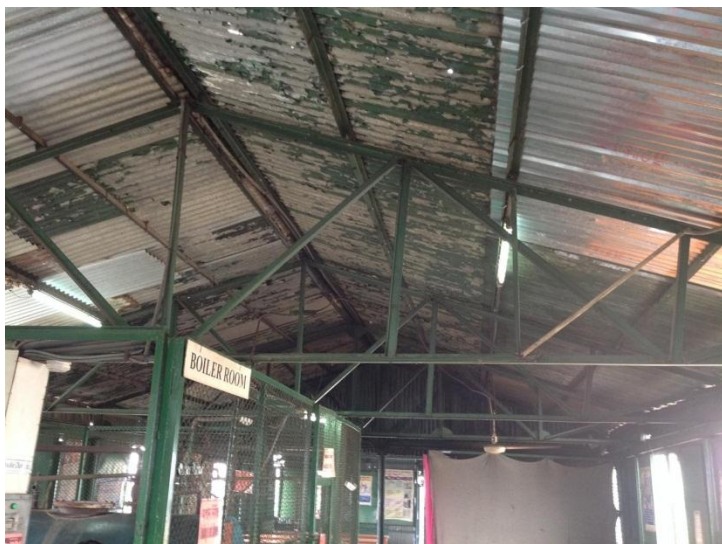
Limited tie down for wind uplift.  
No roof or wall in-plane bracing  
observed.

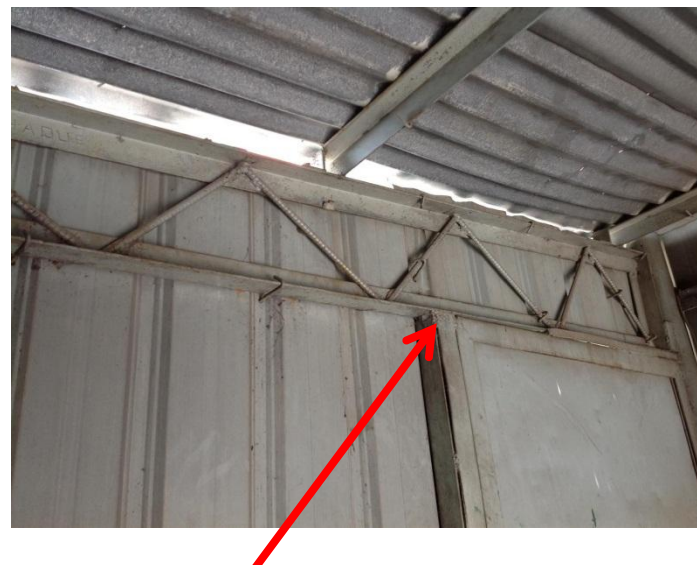
Non-engineered truss.  
Steel columns do not support  
truss at node point.

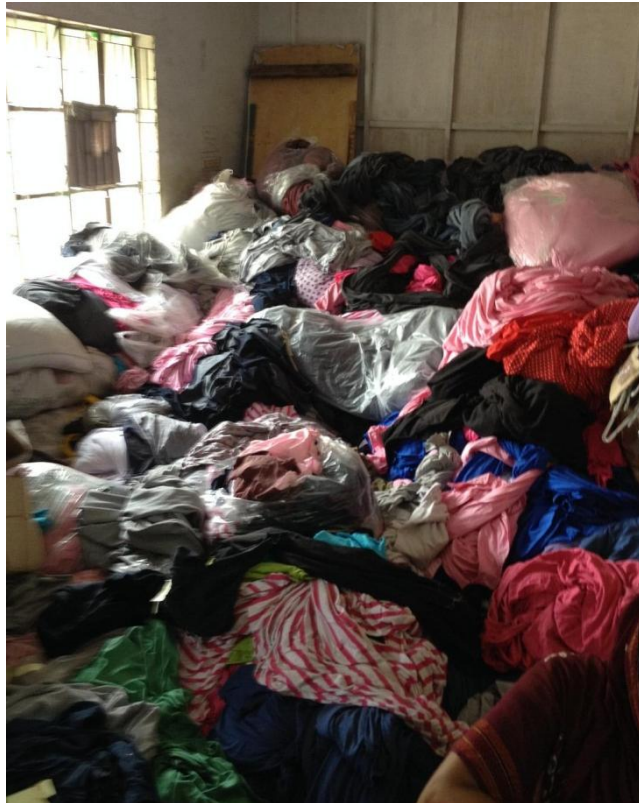
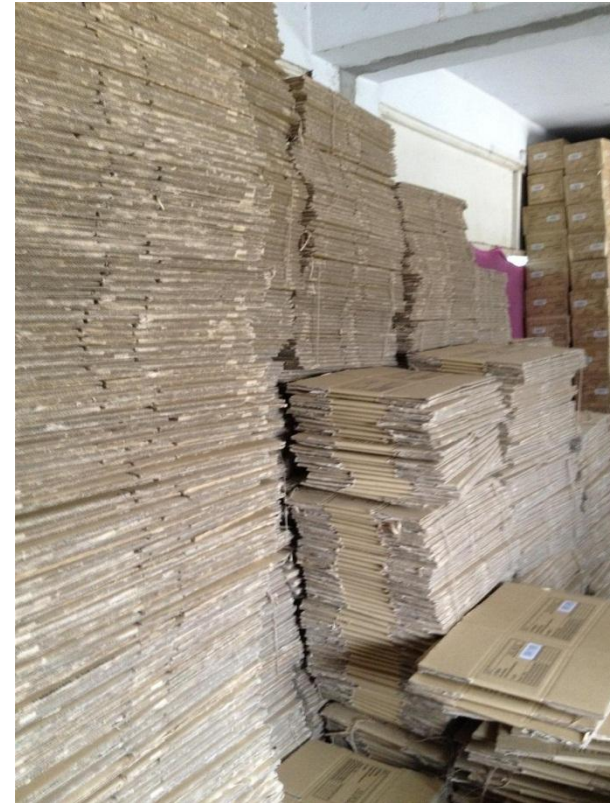
**Floor load management system incomplete as no loading plans were observed at the suspended floors.**

**Localised areas of uncontrolled high storage loading observed.**

**A high density of heavyweight internal brick partitions constructed on Phase III suspended floors.**

- Building engineer to produce loading plans to be displayed at each floor level. Allowable load allowance to be calculated considering existing super-imposed dead loads (e.g. floor finishes and partition walls), live load, floor and column capacity.
- Factory manager to actively manage floor usage in accordance with the loading plan.

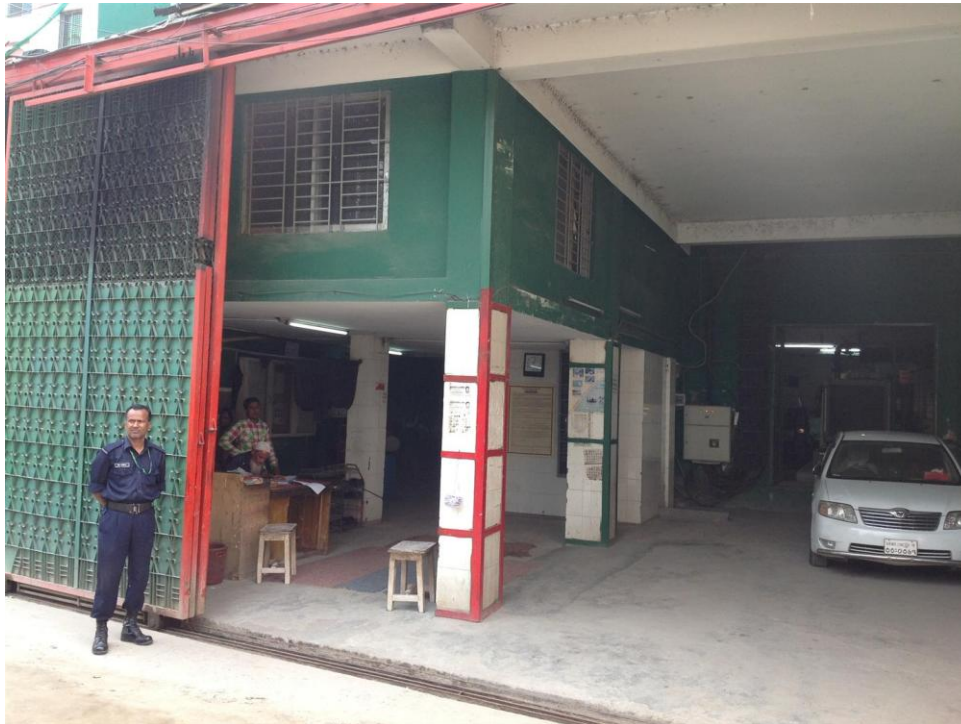
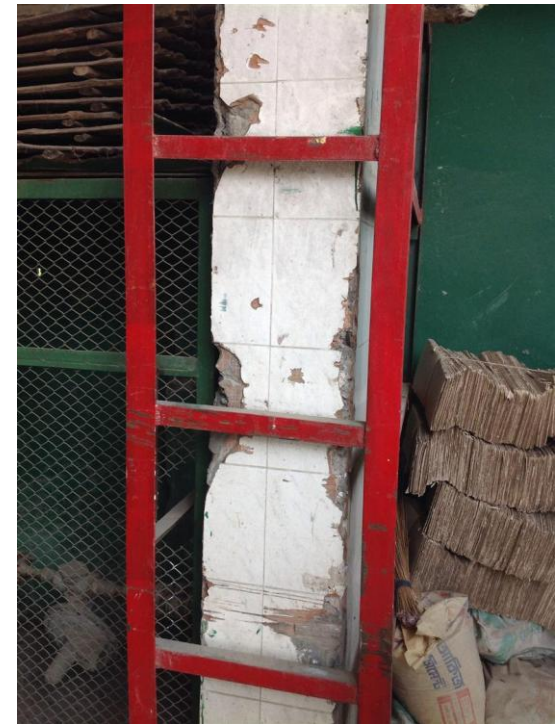
**Columns at ground floor level susceptible to impact loading from vehicles. Existing protection is not robust.**

**Visible damage observed in columns, may have been caused by vehicular impact.**

- Place temporary warning/protection (e.g. traffic cones, sand filled barrels as deemed appropriate by building engineer) at 1m from column faces.

- Building engineer to design appropriate impact protection for columns within loading dock.

- Construct and maintain protection to columns within loading dock and continue to assess likelihood of vehicle impact to critical elements.

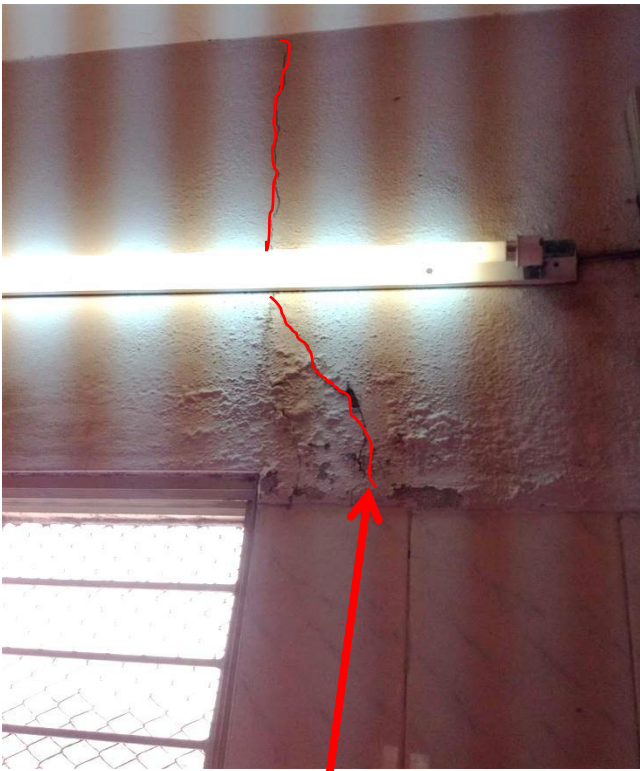
Cracking was evident at a number of positions around the façade particularly near openings for windows.

- Building engineer to review façade and advise if any remediation is necessary to ensure structural sufficiency for the full design life.
- As a minimum, exposed rebar should be protected against further corrosion and area of damaged concrete should be repaired.

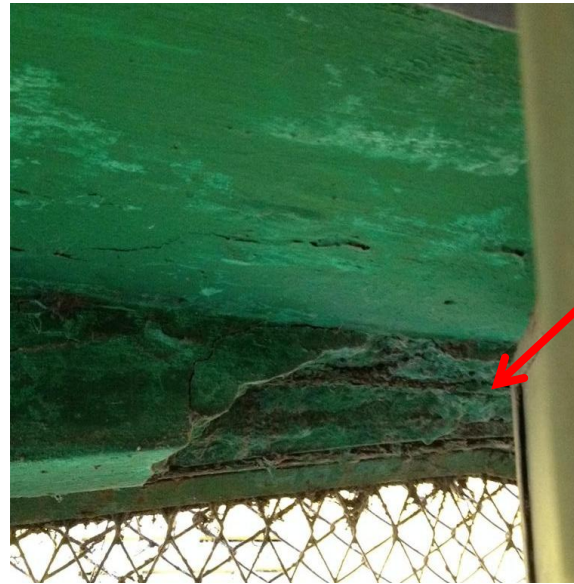
Severe corrosion and concrete spalling was evident with rebar exposed at some locations.

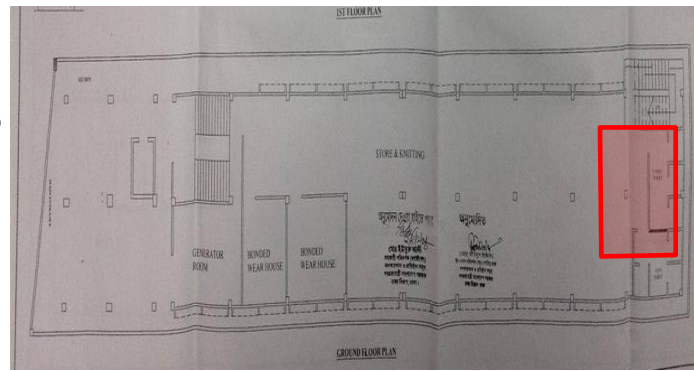
See Page 4 for exact dimensions of restricted zone.
