# P.A. Knit Composite Ltd.

Hobirbari, Jamirdia, Valuka, Mymensingh  
Coordinates: 24.289696, 90.390687

20<sup>th</sup> April 2014

# Observations

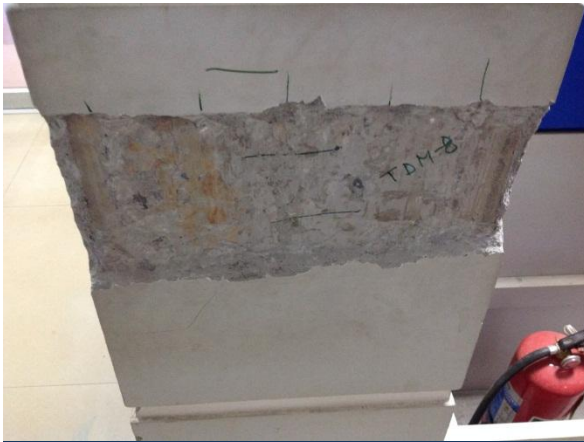
Stone aggregate in columns

Preliminary calculations indicate that column working stress is above that recommended by the code for the given materials and loading

| Item No. | Observation | Recommended Action Plan | Recommended Timeline |
|---|---|---|---|
| 1 | Concrete stress levels in columns in Main Building | A Detail Engineering Assessment of Factory is to be commenced – see attached scope | Immediate - Now |
| 3 | Concrete stress levels in columns in Main Building | Building Engineer to review design, loads and column stresses in structure. | Immediate - Now |
| 4 | Concrete stress levels in columns in Main Building | Verify insitu concrete stresses by taking 100mm diameter cores from min. 4 columns at ground floor level. | Immediate - Now |
| 5 | Concrete stress levels in columns in Main Building | Verify number and diameter of reinforcement bars in ground floor columns. | Immediate - Now |

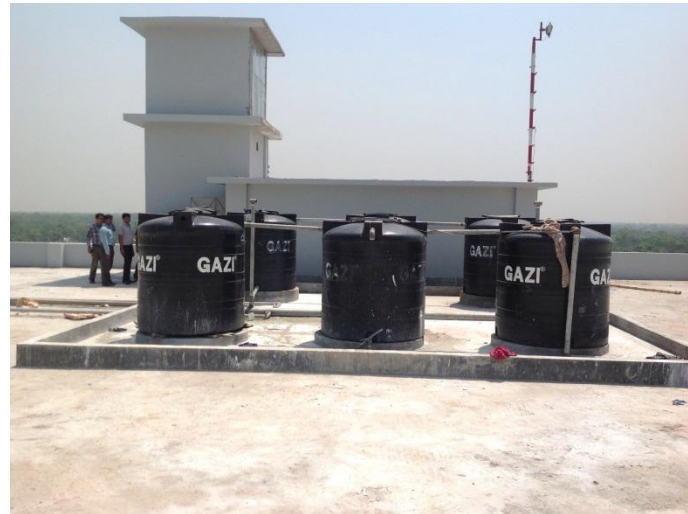
6 no. 2000 litre water tanks at roof level

| Item No. | Observation | Recommended Action Plan | Recommended Timeline |
|---|---|---|---|
| 6 | Concrete stress levels in columns in Main Building | Produce and actively manage a loading plan for all floor plates within the factory giving consideration to floor capacity and column capacity. | 6-weeks |

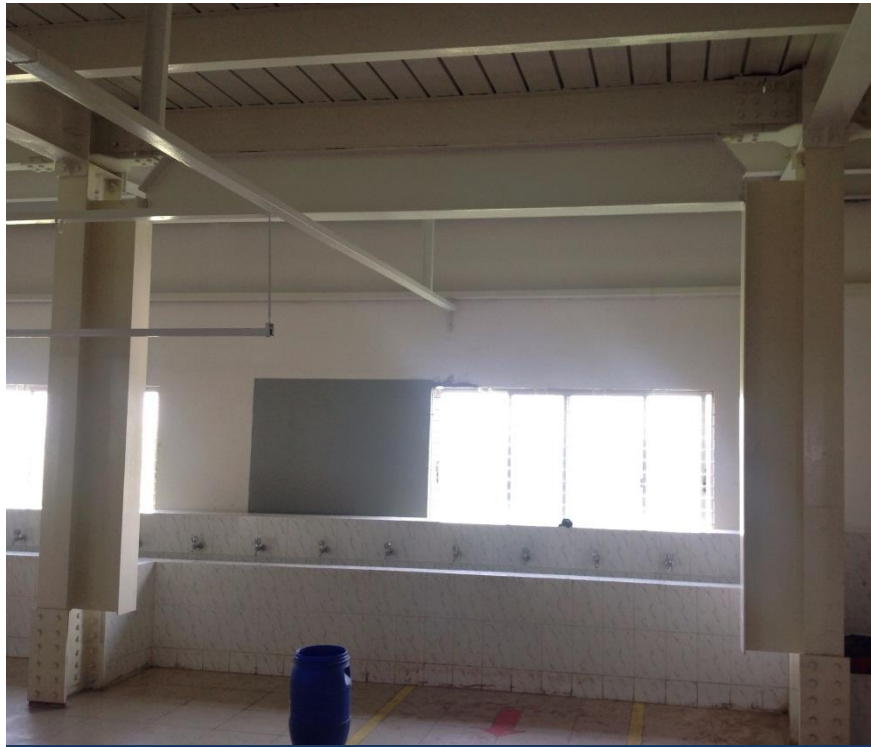
Typical portal brace – 3<sup>rd</sup> to 5<sup>th</sup> floors

Lateral stability to steel frame appears to be reliant on portal braces at locations shown. These are provided in one direction only. Connections of braces to main structure and ability to act as lateral frame to be reviewed

| Item No. | Observation | Recommended Action Plan | Recommended Timeline |
|---|---|---|---|
| 8 | Main Building Steel structure – 3rd floor to roof. | Building Engineer to review the design and construction of the main building steelwork as part of the required Detail Engineering Assessment (see Item 1) and ensure frame stability is addressed. | Immediate - Now |

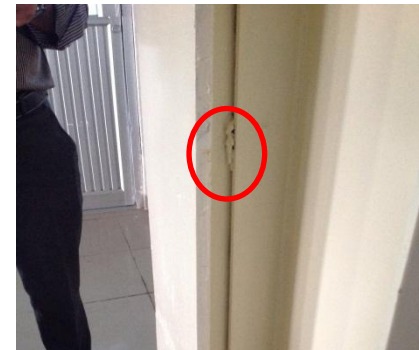
Weld quality appears poor and should be reviewed

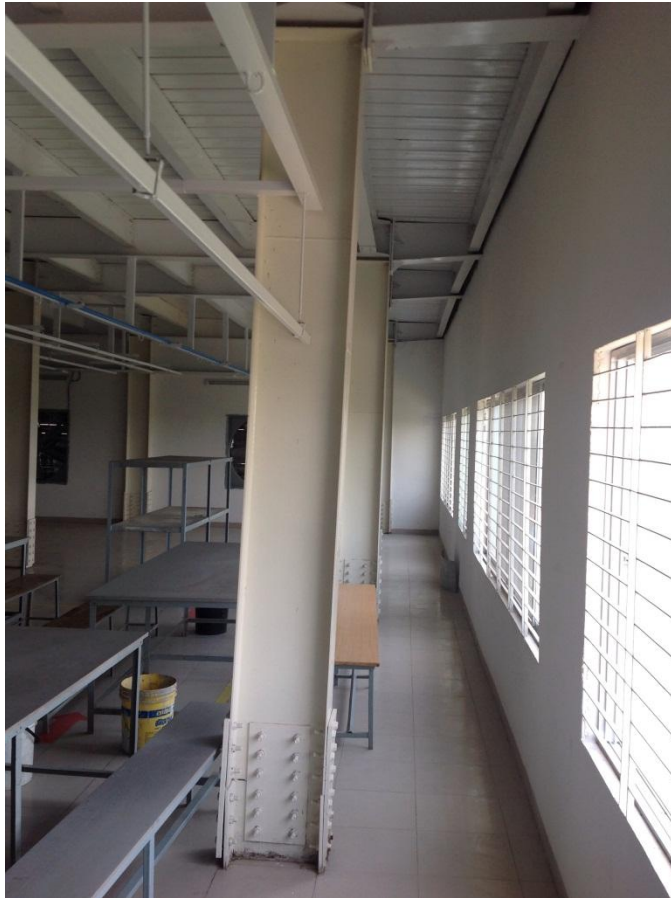
Columns out of plumb at 5<sup>th</sup> floor

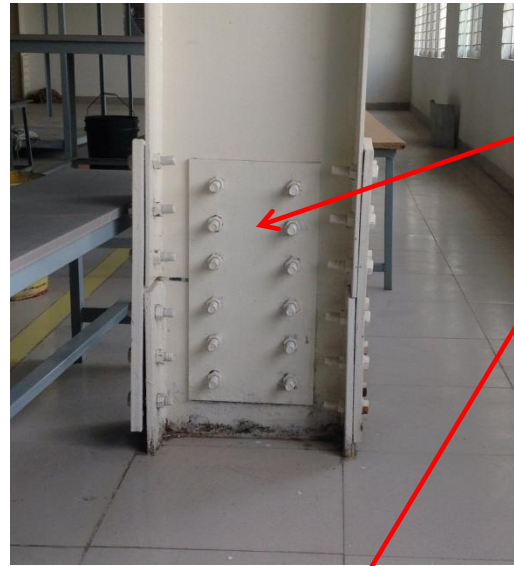
General lack of fit of connections in steel frame

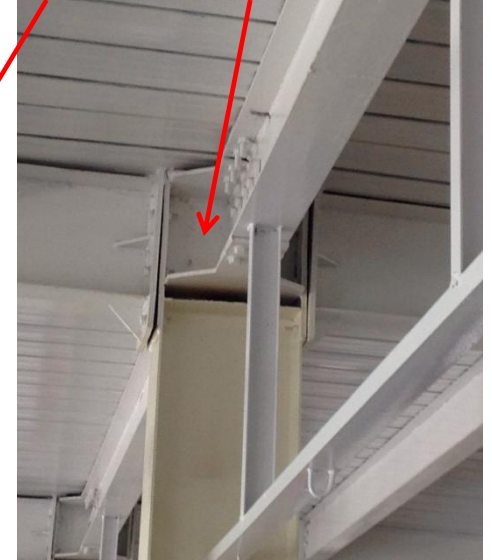
Site modifications to bracing members

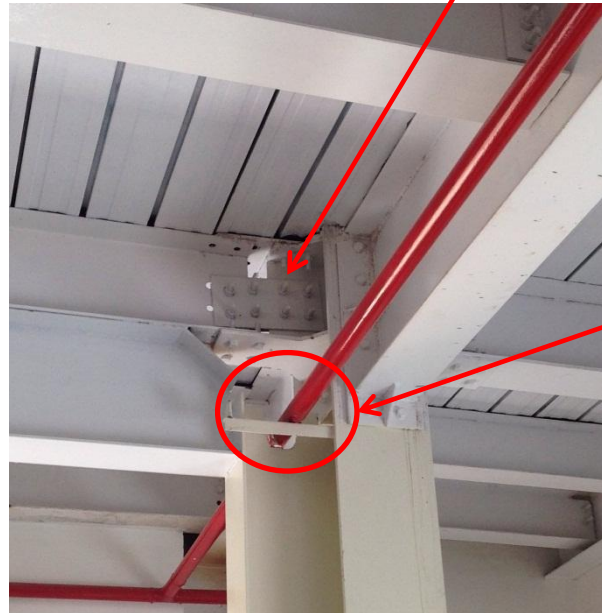
**As-built drawings do not match as-built structure**

| Item No. | Observation | Recommended Action Plan | Recommended Timeline |
|---|---|---|---|
| 11 | The “as-built” drawings for the Main Building do not match the as-built structure. | Building Engineer to survey the structure and prepare a full set of “as-constructed” drawings as part of Detail Engineering Assessment (see Item 1). | 6-months |

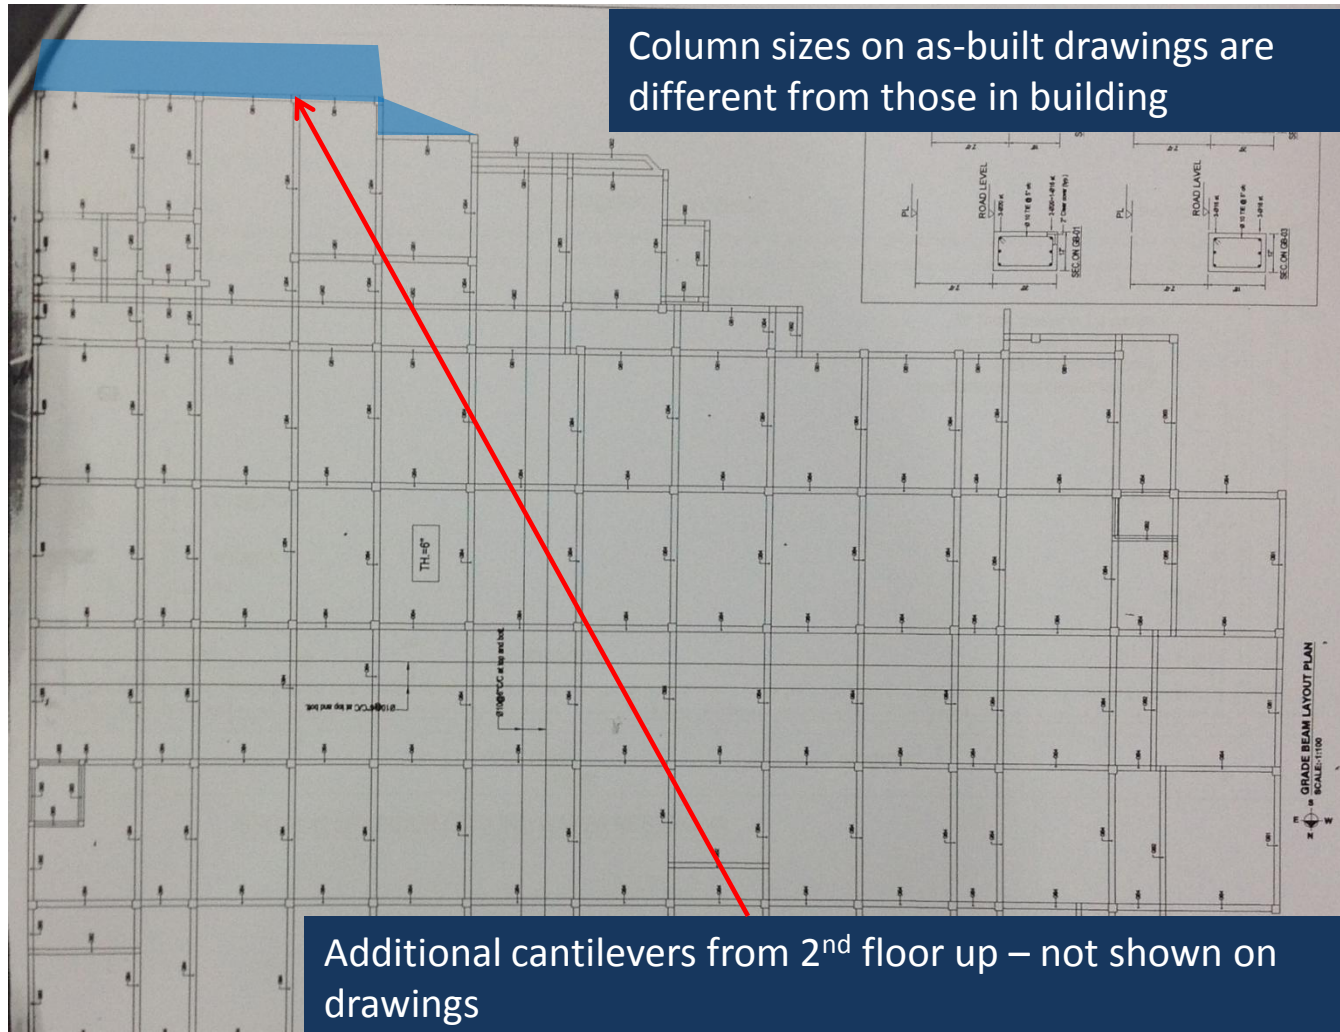
**As-built drawings not accurate**

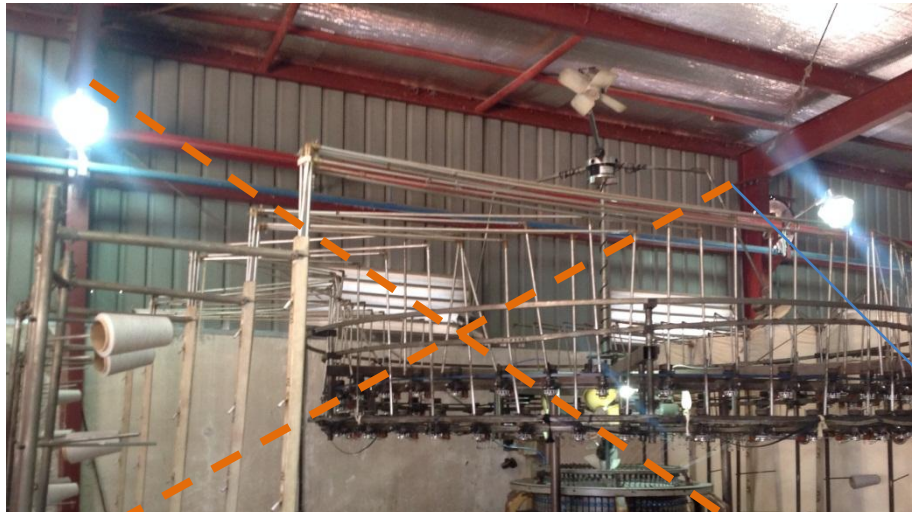
Knitting Shed – vertical bracing missing or disconnected in two locations

| Item No. | Observation | Recommended Action Plan | Recommended Timeline |
|---|---|---|---|
| 14 | External shed buildings – engineering checks required. | Building Engineer to check the design and capacity of the lightweight roof structures, including stability and connections details, and make any necessary alterations. | 6-weeks |

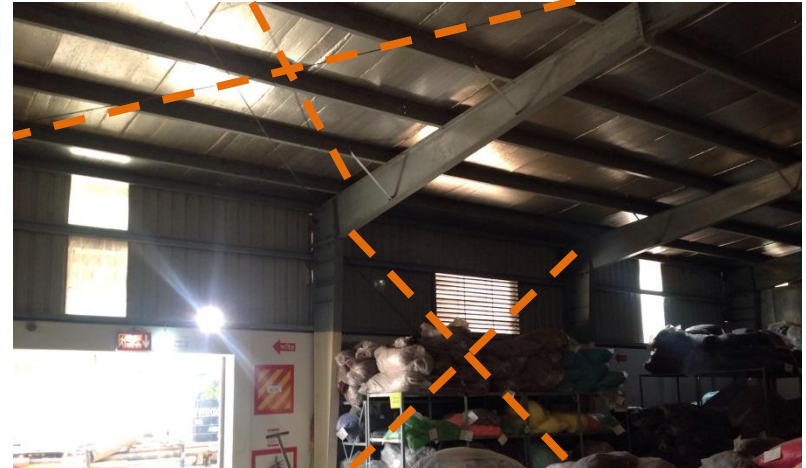
Godown Shed – discontinuity of vertical and roof bracing with no apparent eaves beam to transfer loads

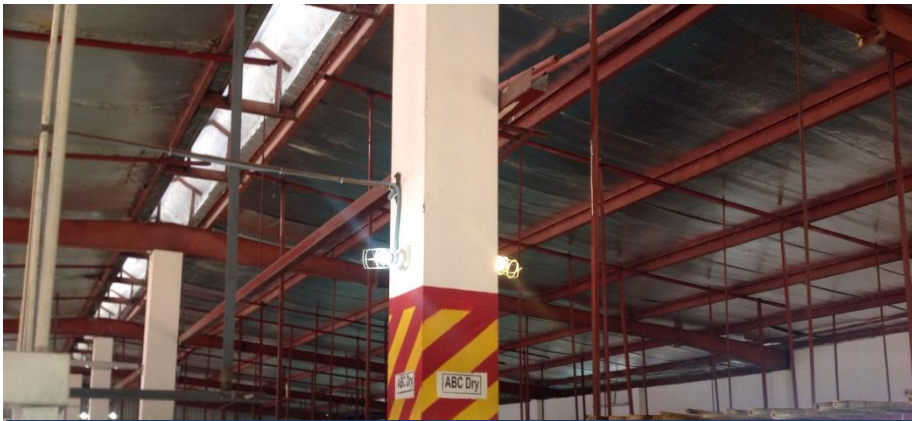
Printing Shed – no roof bracing
