Radial International Ltd. Array International Ltd.

Zirani Bazar, Kashmirpur, Gazipur Sadar.
(23.997823, 90.254950)
20th April 2014

Observations

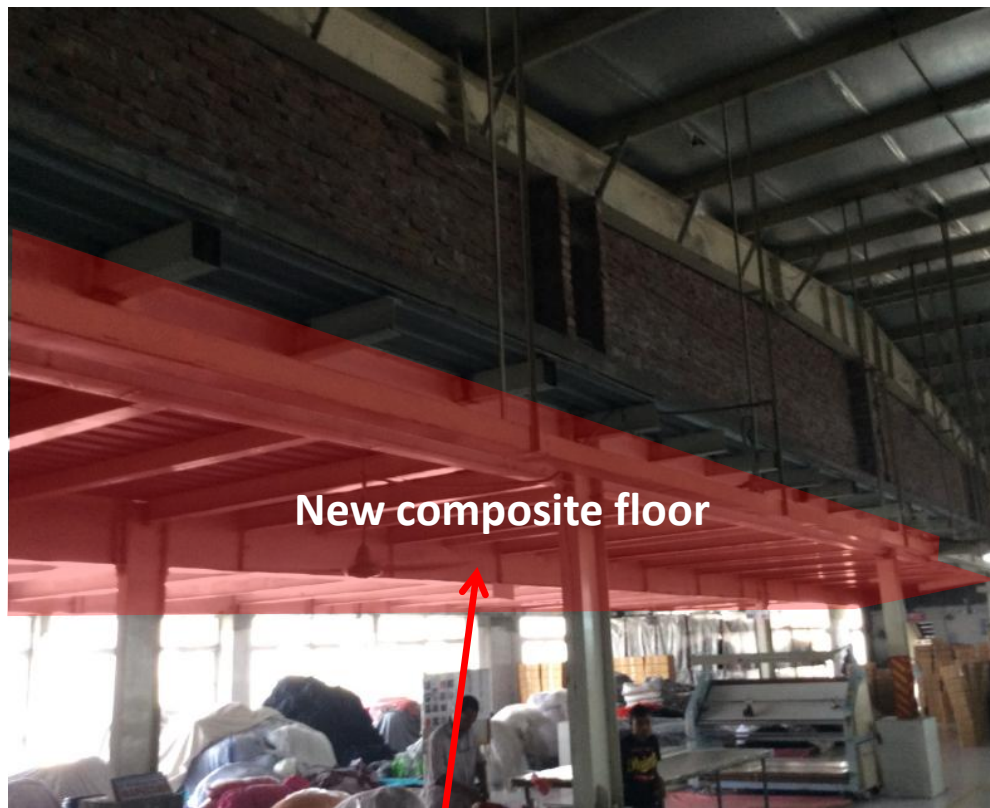
New composite floor

Changes have been made to the structure with part of the portal frame removed and replaced with a composite deck for fire safety reasons. This modification has removed an entire bay of roof bracing.

Some bracing elements are slack and should be tightened to ensure they are functioning properly.

Item No.	Observation	Recommended Action Plan	Recommended Timeline
1	Main Building Steel Roof Structures over Fifth Floor	Full structural survey and analysis of existing steel roof structures to be carried out by Factory Building Engineer	Immediate - Now
2	Main Building Steel Roof Structures over Fifth Floor	Lateral stability of roof to be assessed	Immediate - Now
3	Main Building Steel Roof Structures over Fifth Floor	Support bearings and connections to be assessed	Immediate - Now
4	Main Building Steel Roof Structures over Fifth Floor	Slight sagging in beams under new concrete roof (West side) to be assessed	Immediate - Now
5	Main Building Steel Roof Structures over Fifth Floor	Strengthening measures to be designed where required by Building Engineer	Immediate - Now
6	Main Building Steel Roof Structures over Fifth Floor	Diagonal bracing, removed to construct new concrete flat roof, to be replaced	6-weeks

7	Main Building Steel Roof Structures over Fifth Floor	Missing diagonal bracing (walls and roof) to be installed	6-weeks
8	Main Building Steel Roof Structures over Fifth Floor	Tension in all cross-bracing to be restored	6-weeks
9	Main Building Steel Roof Structures over Fifth Floor	Strengthen bearings, connections, support brackets and structural sections where required by the Building Engineering Structural analysis	6-months
10	Main Building Steel Roof Structures over Fifth Floor	Implement other Building Engineer's recommendations.	6-months

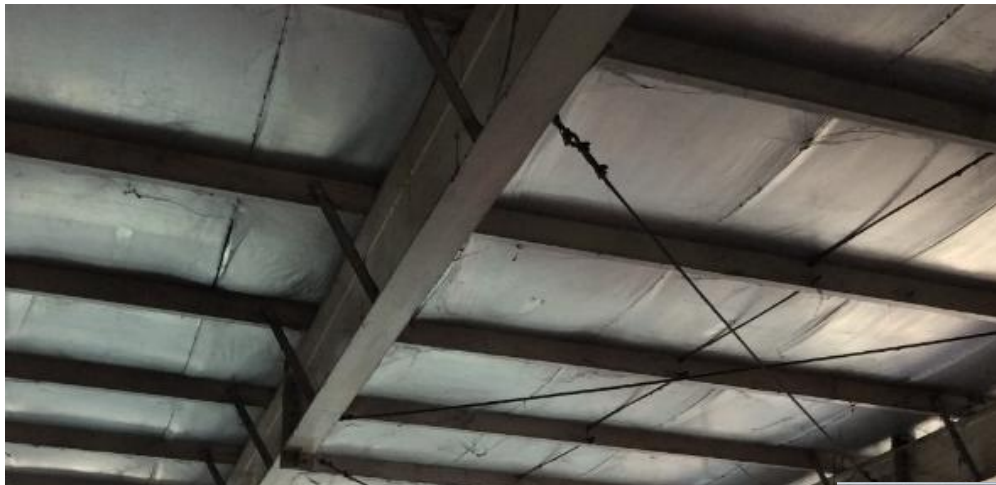
Bracing elements missing on elevation both sides (north and south).

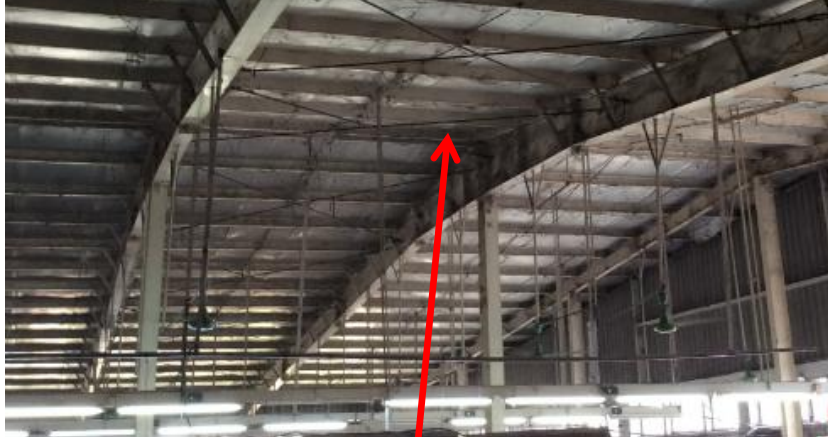
Bracing in steel roof for lateral restraint.

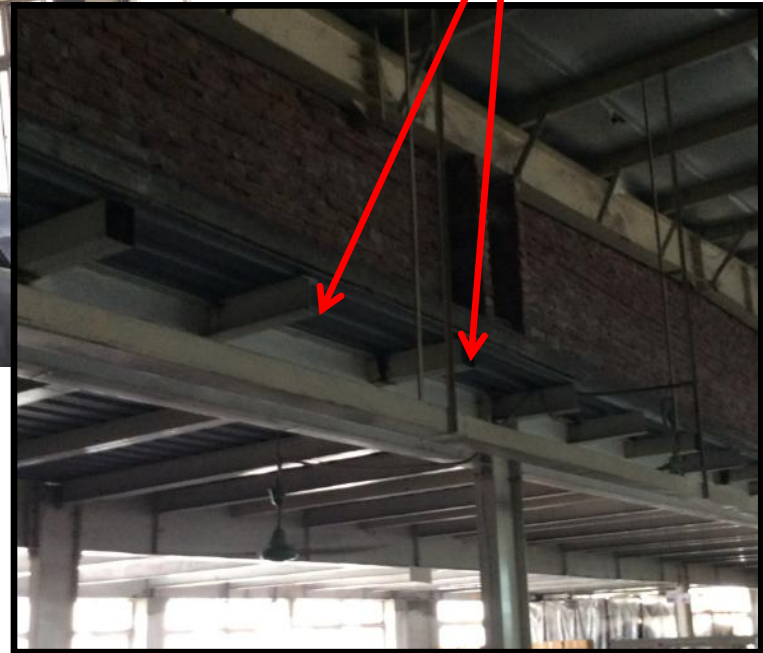
Composite Deck

New composite deck above the 5th Floor appears to be deflecting slightly.

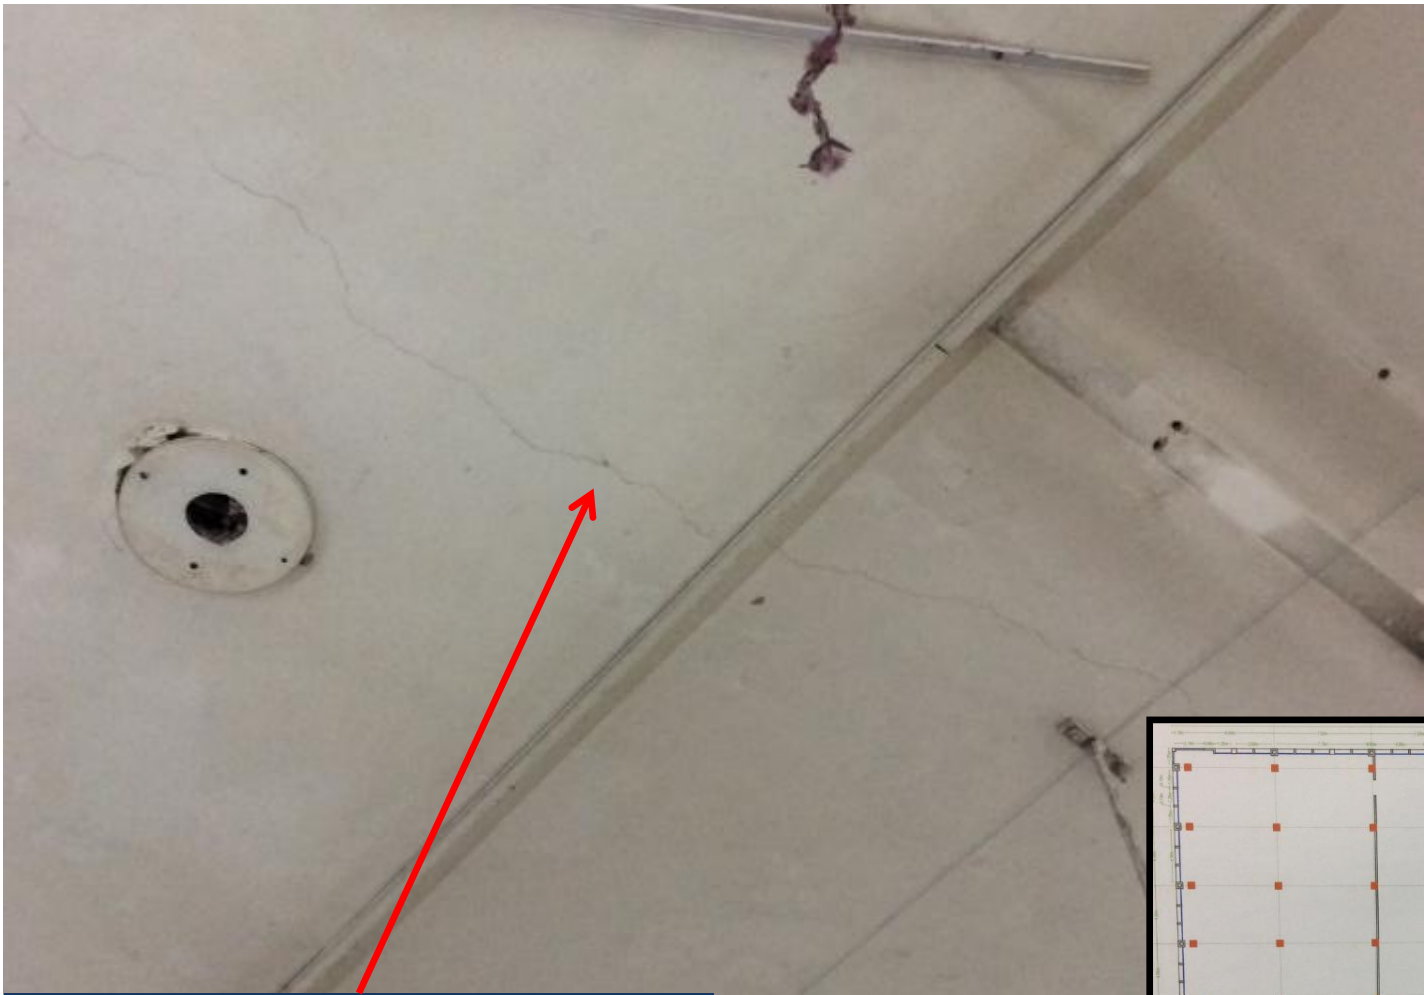
Crack in the soffit of the 1st Floor

Item No.	Observation	Recommended Action Plan	Recommended Timeline
11	Cracking to the soffit of 1st Floor in Main Production Building	Sections of plaster finish to the soffit of the 1st floor of the Main Production Building to be removed to investigate if cracks are reflected in the building structure.	6-weeks
12	Cracking to the soffit of 1st Floor in Main Production Building	Building Engineer to carry out design check on the slab to confirm that these cracks are within normal structural behaviour	6-weeks
13	Cracking to the soffit of 1st Floor in Main Production Building	Strengthening measures installed if required.	6-months
14	Drainage to flat roof of Main Production Building.	Clear all rubbish and building materials from roof area	Immediate - Now
15	Drainage to flat roof of Main Production Building.	Monitor storm water flows during rainy periods	6-weeks
16	Drainage to flat roof of Main Production Building.	Install additional rainwater outlets from roof to ensure no build-up of water is possible, which could potentially overload the structure	6-weeks

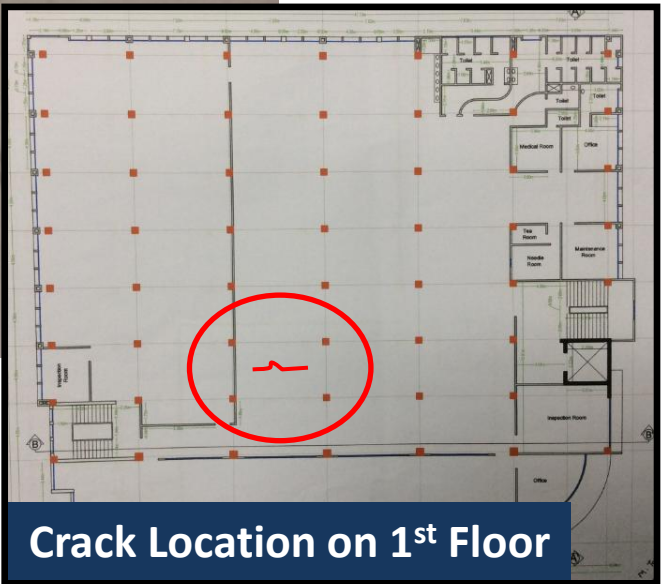
Crack Location on 1st Floor

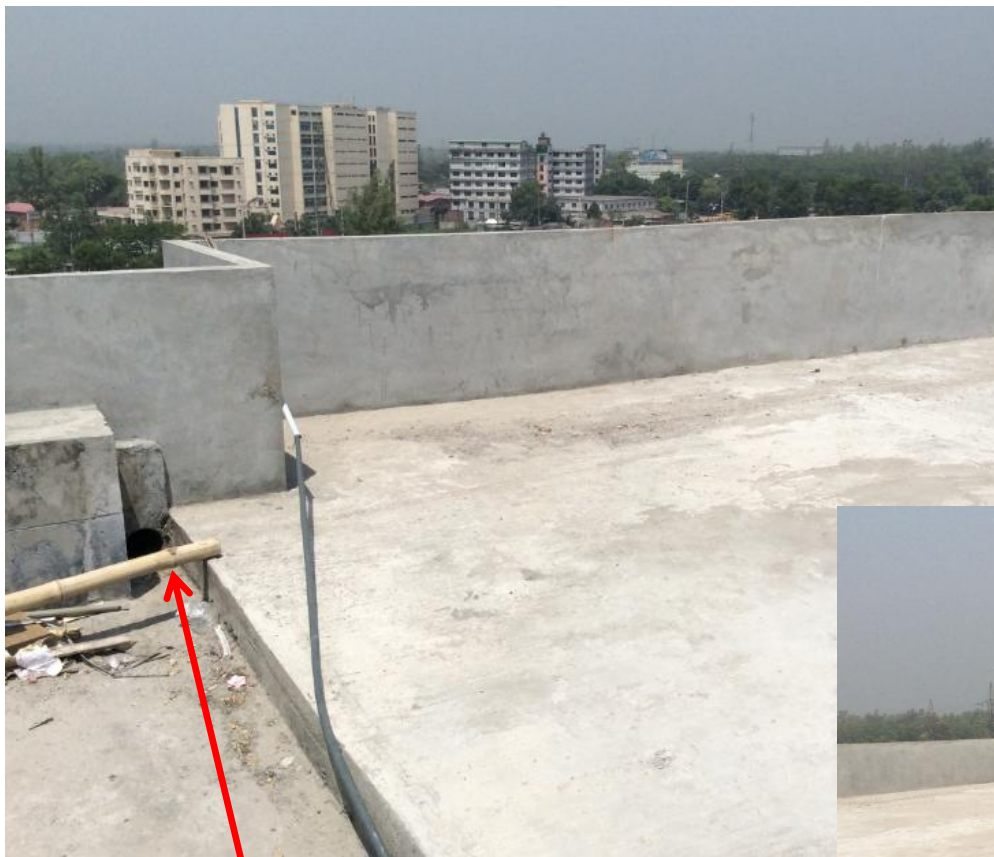
Only one drainage route on the roof to let water escape. Surrounding debris can block this one route and can cause an accumulation of water in a severe weather event.

No other drainage routes provided to the roof. New concrete parapet walls.

17	Drainage to flat roof of Main Production Building.	Continue to ensure no debris can block drainage routes	6-months

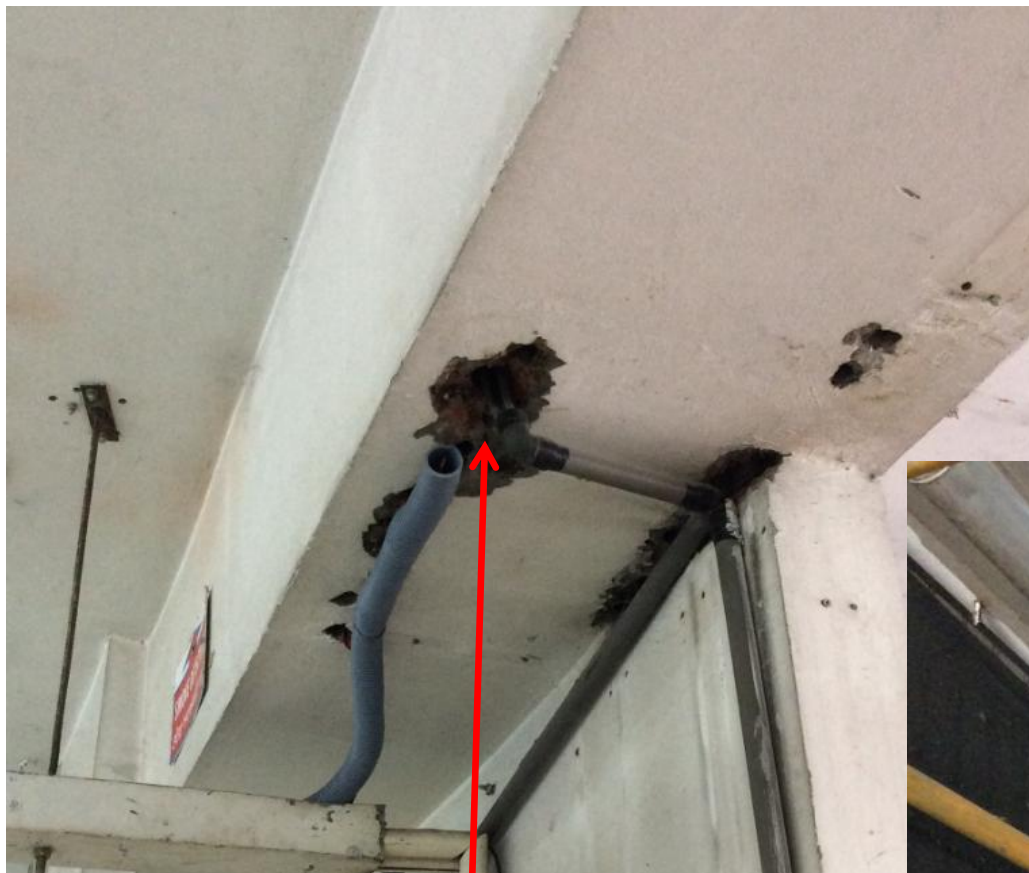
New service opening broken in slab at toilet block to allow for pipes to pass through. Not good practice but has not compromised strength here.

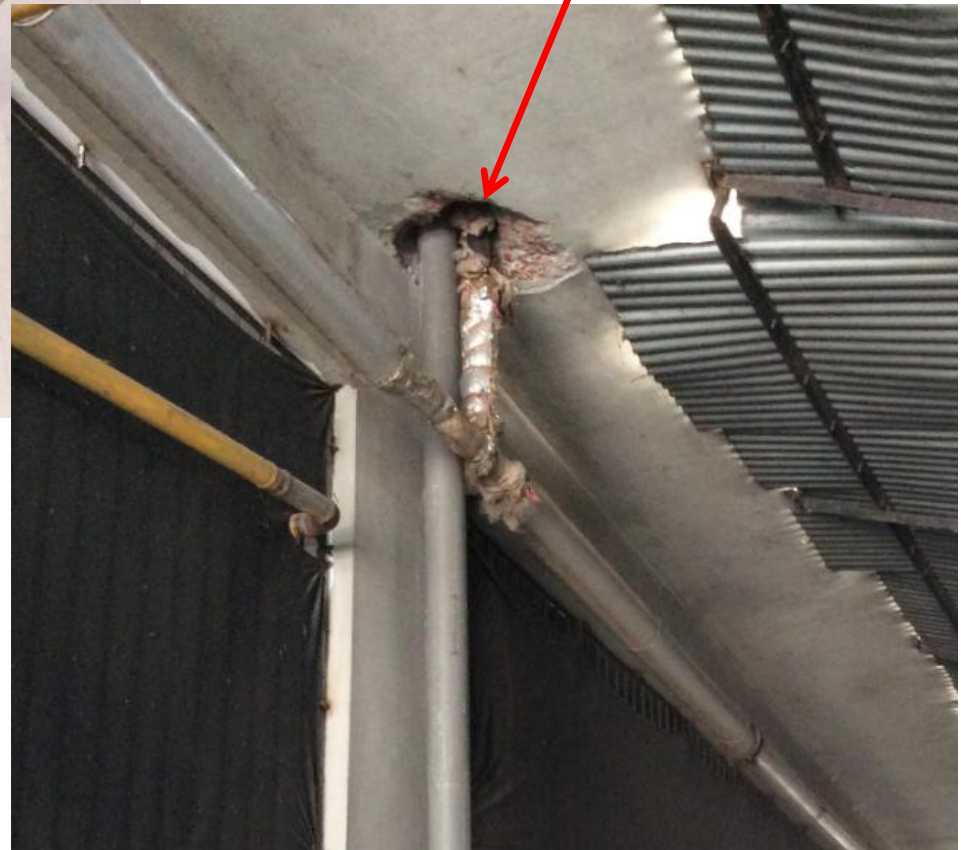
New service openings broken/drilled in beams to allow electric cables to pass through. Not good practice but has not compromised strength here.

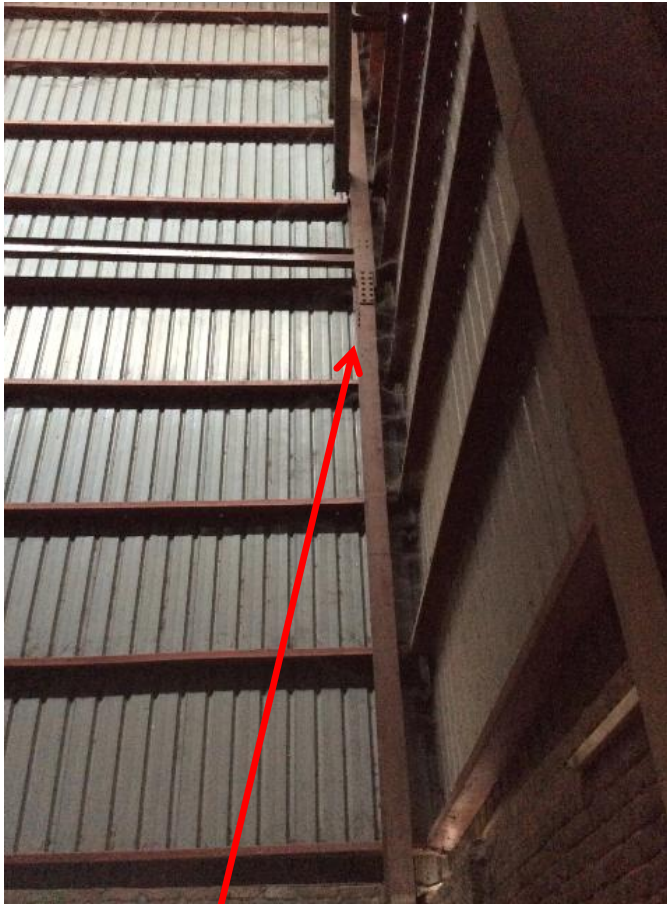
Boiler house columns are larger section at higher levels than at lower levels. Bolted connection at mid-height is poorly aligned.

Boiler house steel structure is tall without the benefit of floors or effective bracing.

Item No.	Observation	Recommended Action Plan	Recommended Timeline
18	Single-Storey Buildings: Boiler House Steelwork	Full survey and structural analysis of the Boiler House steel structure to be carried out by the Factory Building Engineer to assess section sizes, connection details and lateral stability.	Immediate - Now
19	Single-Storey Buildings: Boiler House Steelwork	Additional steelwork and strengthening measures to be designed by the Factory Building Engineer.	6-weeks
20	Single-Storey Buildings: Boiler House Steelwork	Strengthening works to be implemented before the cyclone season to ensure the building is laterally stable against wind loads.	6-months
21	Single-Storey Buildings: Dyeing Shed Steelwork Roof	Full survey and structural analysis of the Dyeing Shed roof steel structures to be carried out by the Factory Building Engineer to assess section sizes, connection details and lateral stability.	Immediate - Now

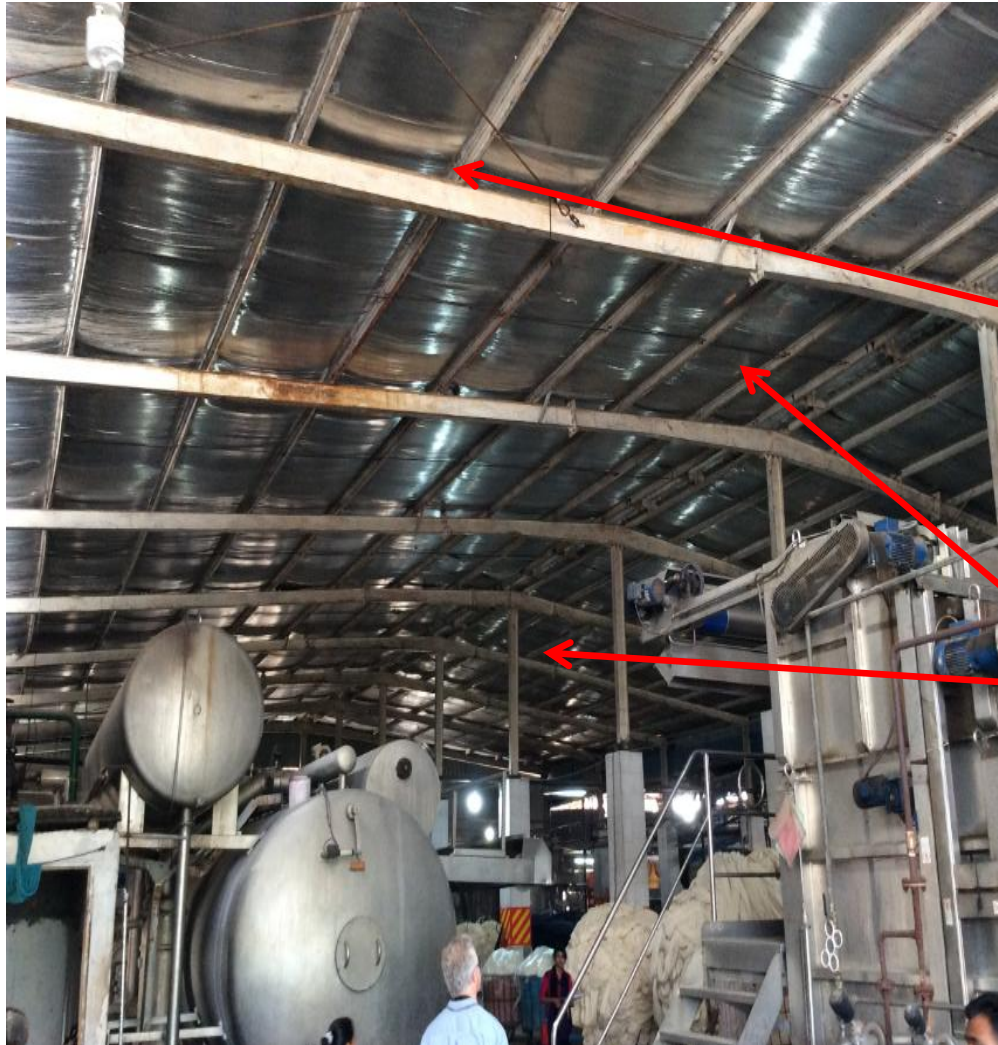
The steel sections in the portal frame in the dyeing shed appear extremely lightweight for the large span.

No lateral stability cross-bracing observed in roof structure of the portal frame in Dyeing shed.

22	Single-Storey Buildings: Dyeing Shed Steelwork Roof	Additional steelwork, support bearings and strengthening measures to be designed by the Factory Building Engineer.	6-weeks
23	Single-Storey Buildings: Dyeing Shed Steelwork Roof	Additional lateral stability elements to be designed by the Factory Building Engineer.	6-weeks
24	Single-Storey Buildings: Dyeing Shed Steelwork Roof	Strengthening works to be implemented before the cyclone season to ensure the building is laterally stable against wind loads and structurally complete to take normal design loads.	6-months

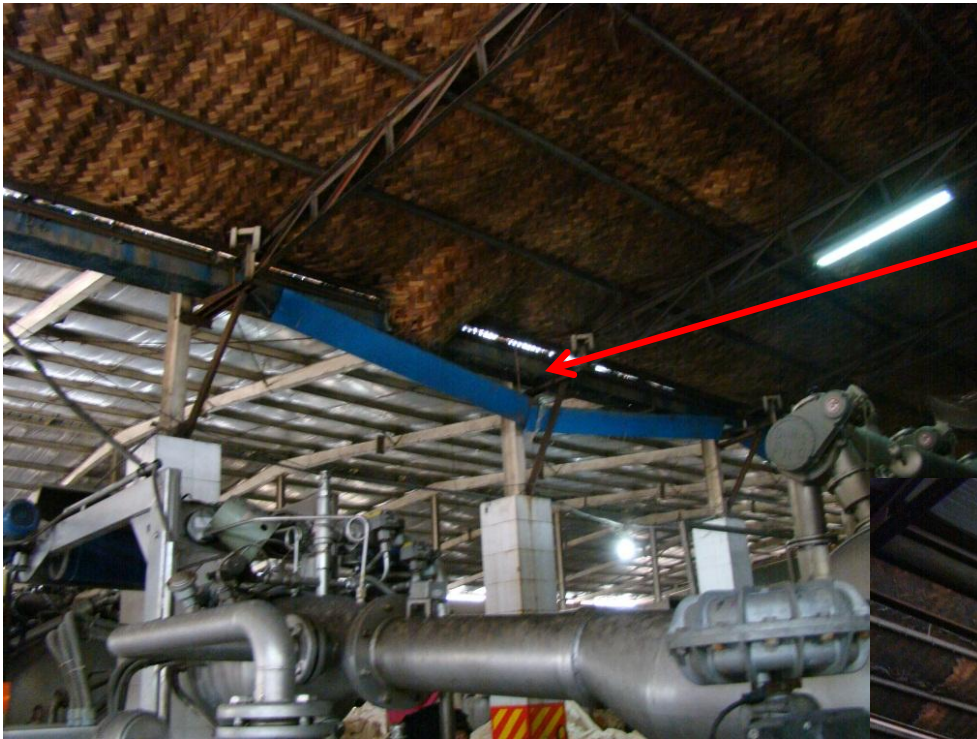
Gutter and part roof collapse –
Dyeing Shed

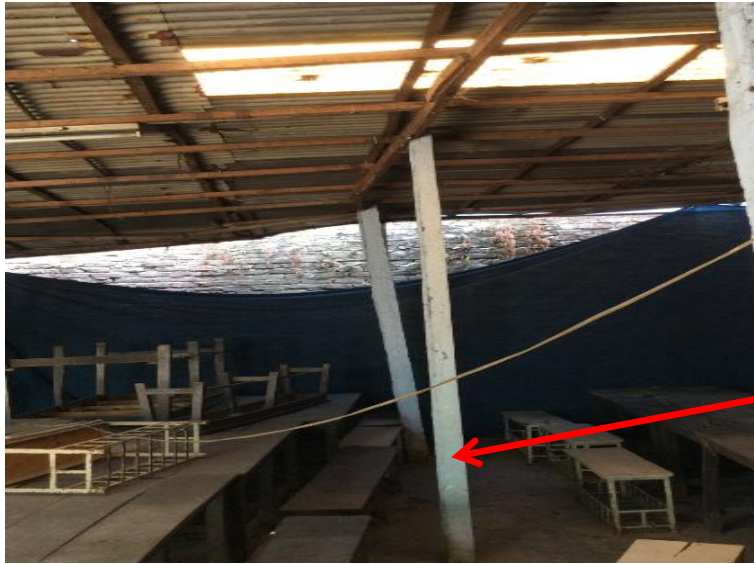
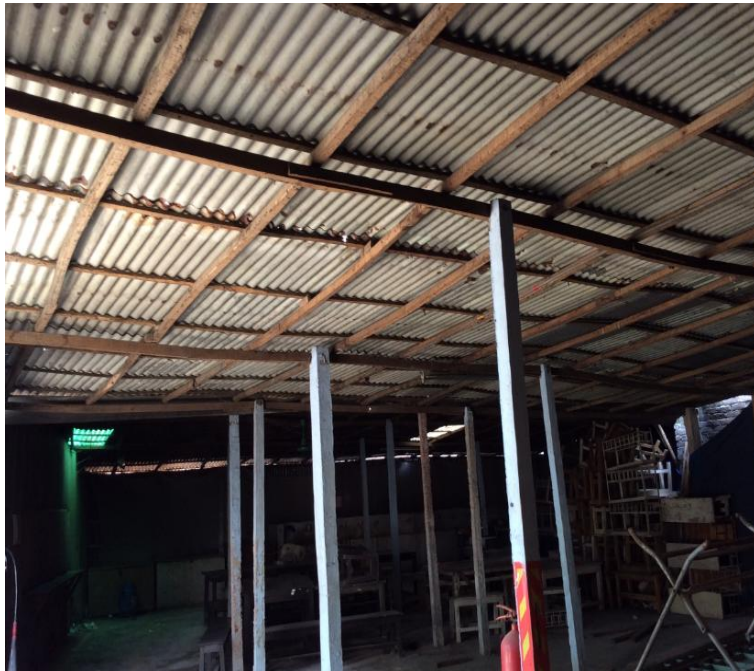
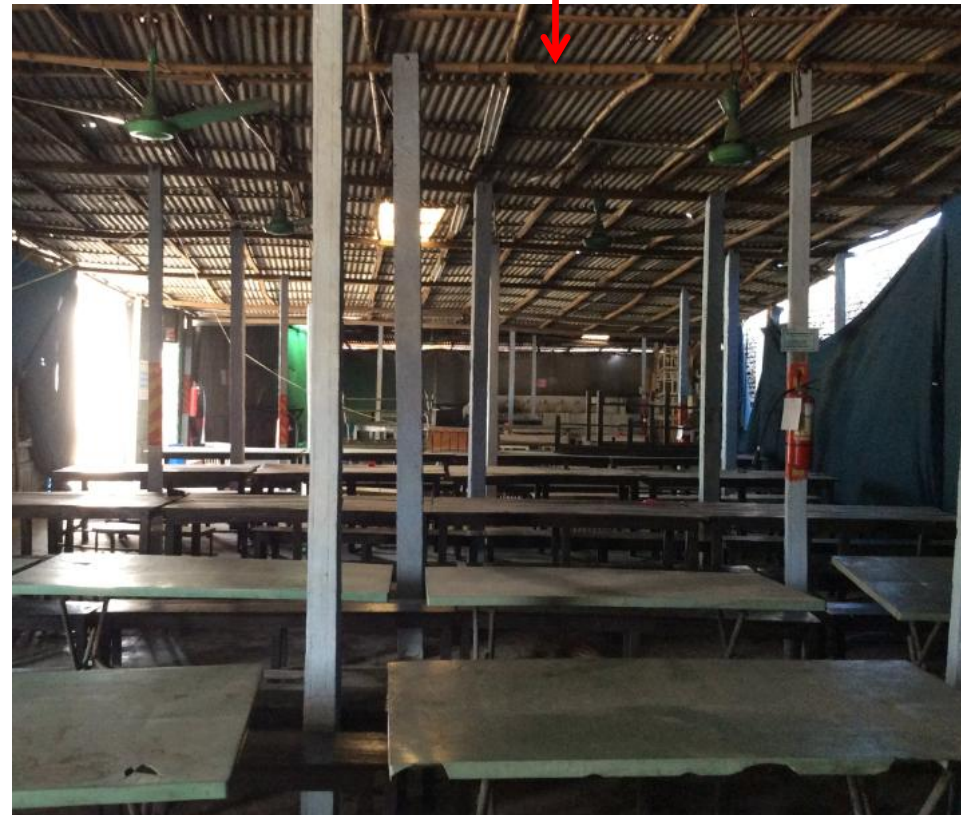
Ad-hoc
bamboo/timber/steel roof
on concrete posts arranged
haphazardly over canteen
area used by approx. 300
workers.

Item No.	Observation	Recommended Action Plan	Recommended Timeline
25	Single-Storey Buildings: Dining Area Shed	Provide alternative dining accommodation which is safe and structurally sound until the existing roof structure is properly strengthened or replaced	Immediate - Now
26	Single-Storey Buildings: Dining Area Shed	Provide a safe and structurally sound Dining Area for employees	6-weeks
27	Single-Storey Buildings: Ancillary Ad-hoc Structures	Carry out an assessment for current building requirements to cater for the miscellaneous other uses required on the site.	Immediate - Now
28	Single-Storey Buildings: Ancillary Ad-hoc Structures	Factory Building Engineer to design warehouse structures which comply with Bangladesh building standards and meet the required site demands into the future.	6-weeks
29	Single-Storey Buildings: Ancillary Ad-hoc Structures	Demolish existing ad-hoc structures	6-months

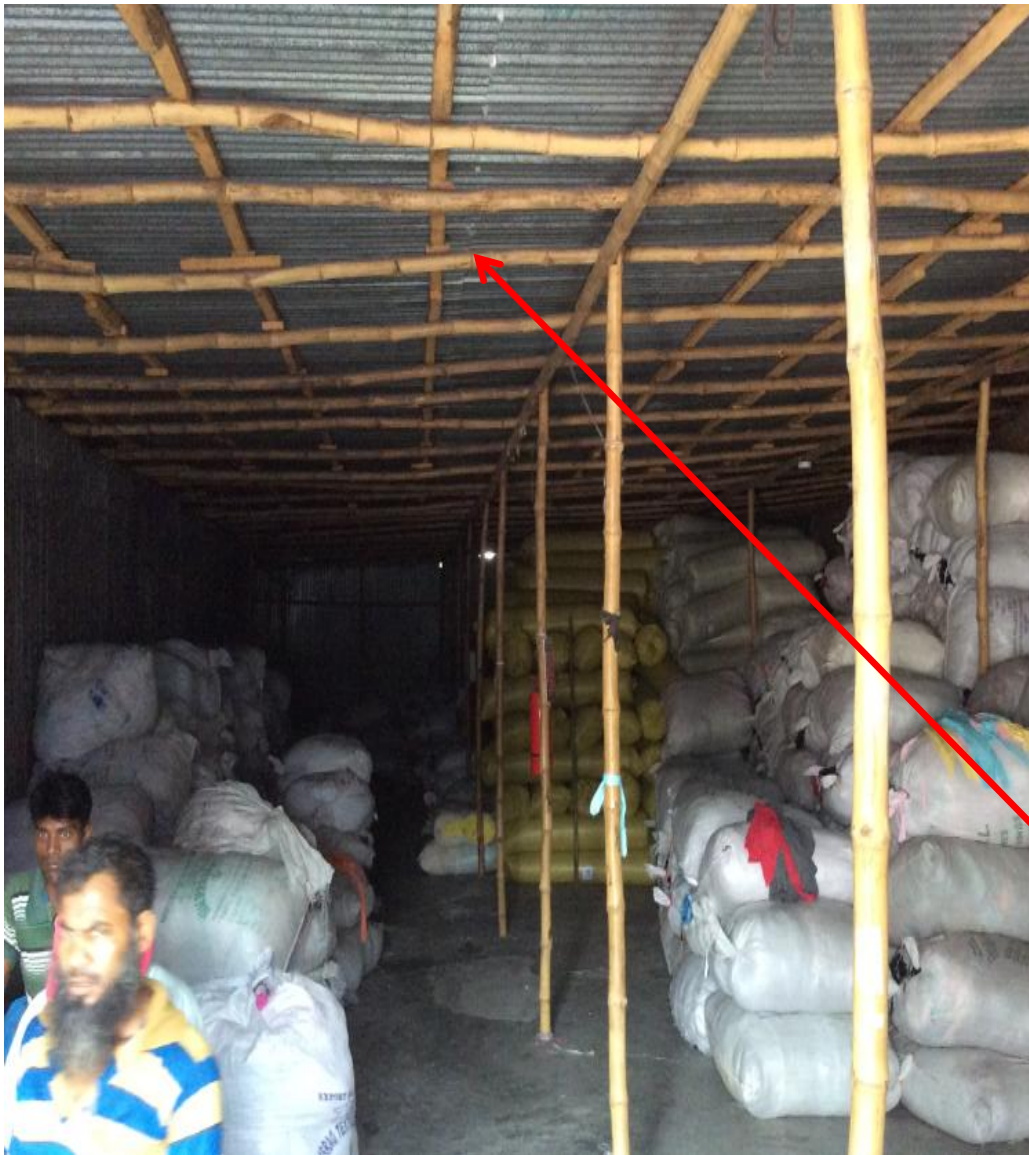
Bamboo/timber/steel/concrete used randomly and ad-hoc in single-storey miscellaneous structures. Stability of structures very questionable.

30	Single-Storey Buildings: Ancillary Ad-hoc Structures	Construct new warehousing as required.	6-months

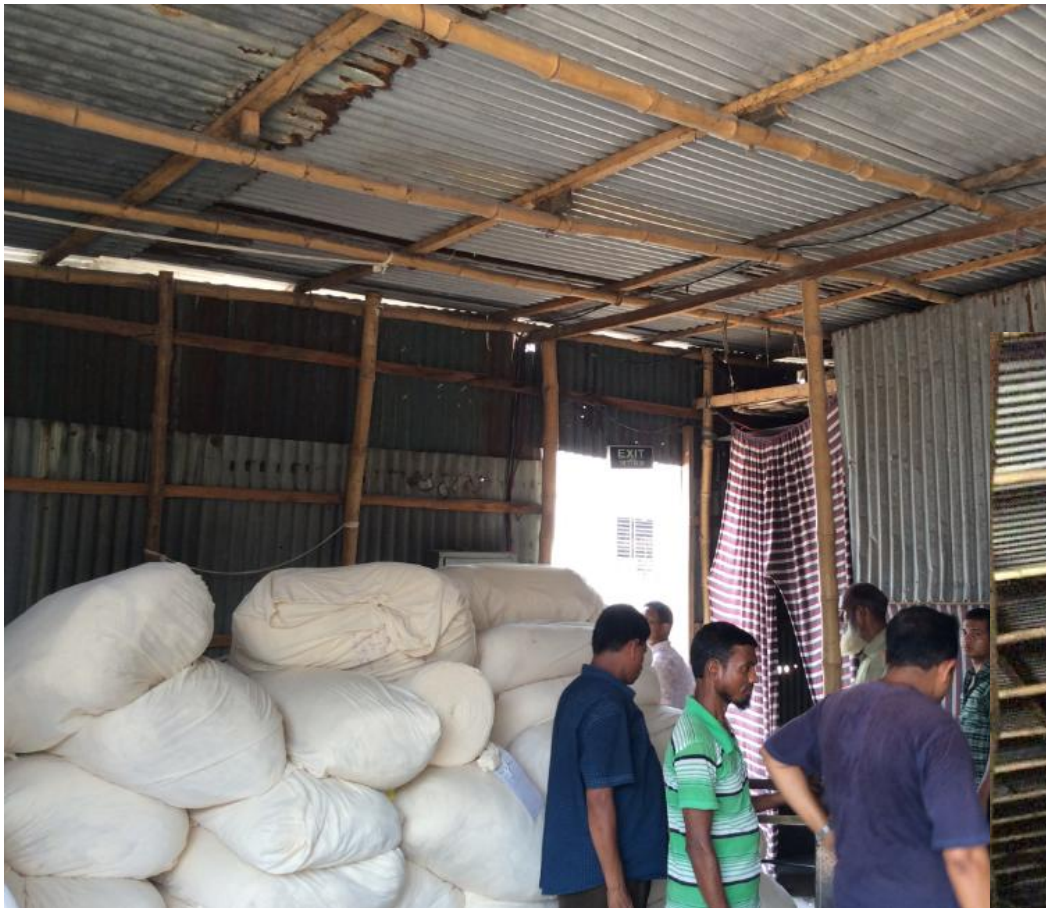
No lateral stability in the second raw material storage shed.

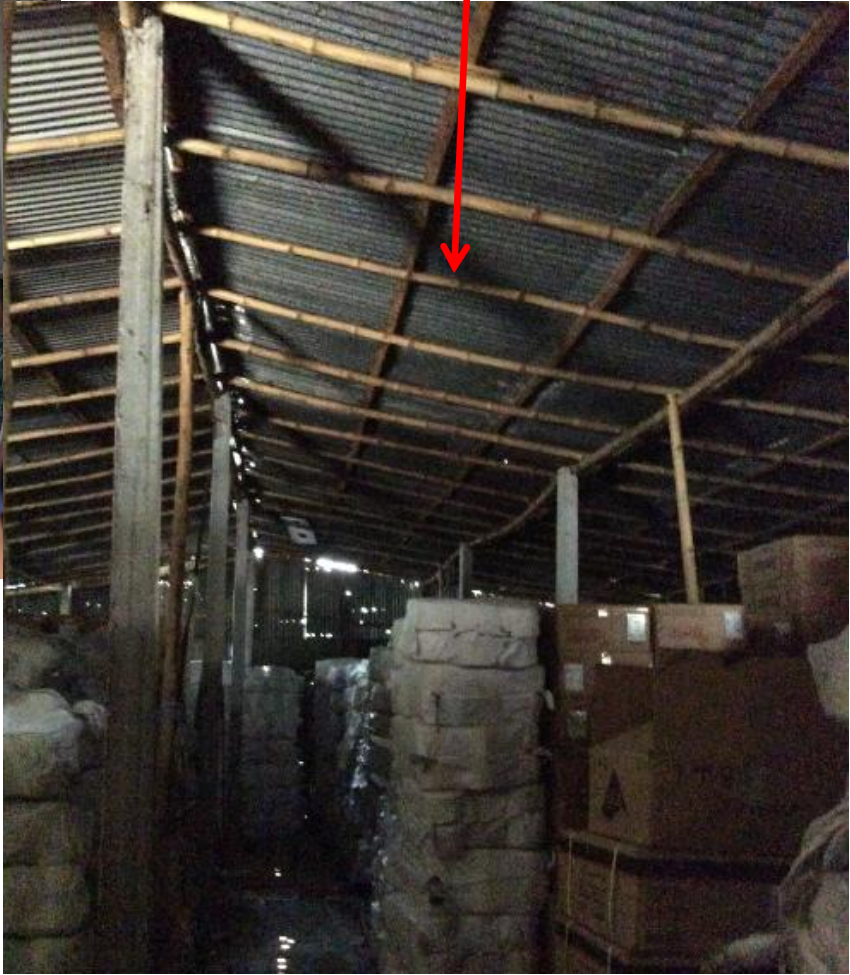
No lateral stability in both directions is a common issue across all non-engineered single-storey structures.

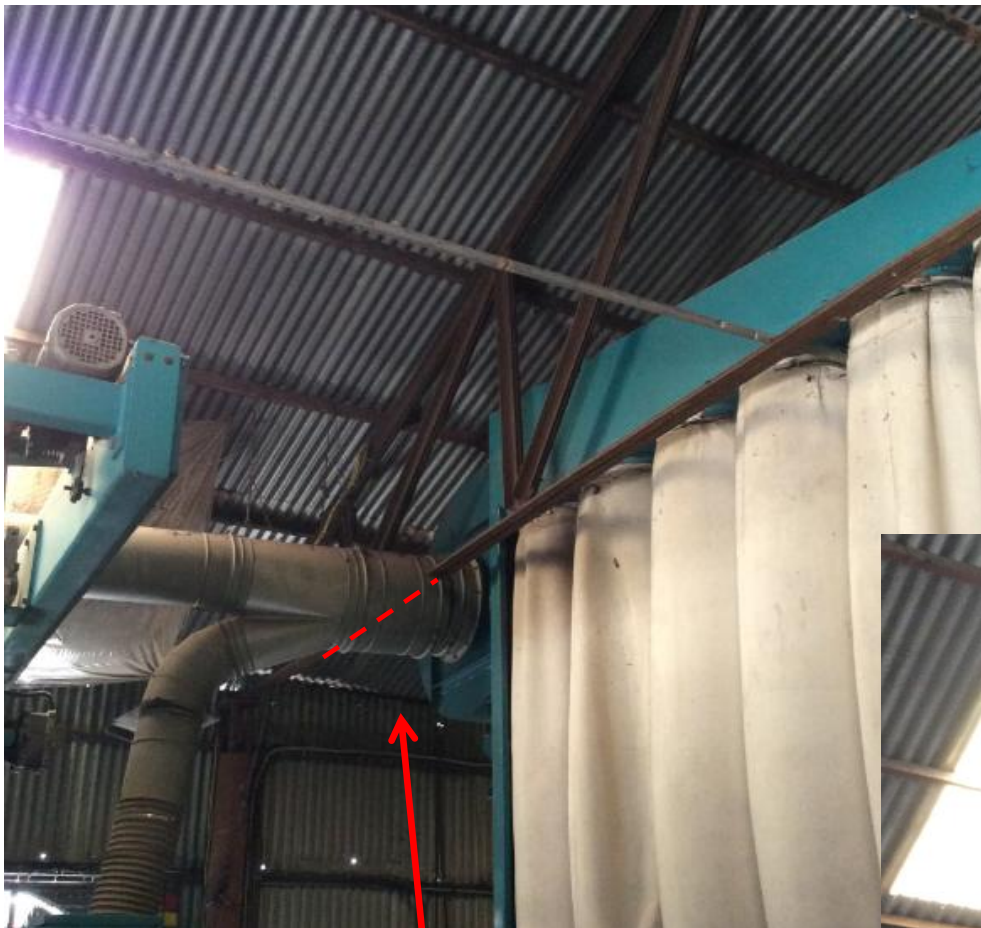
Bottom section of truss removed to make way for machinery piping.

Bottom section of the truss has either been removed or has failed locally. Bamboo currently in place to support section.

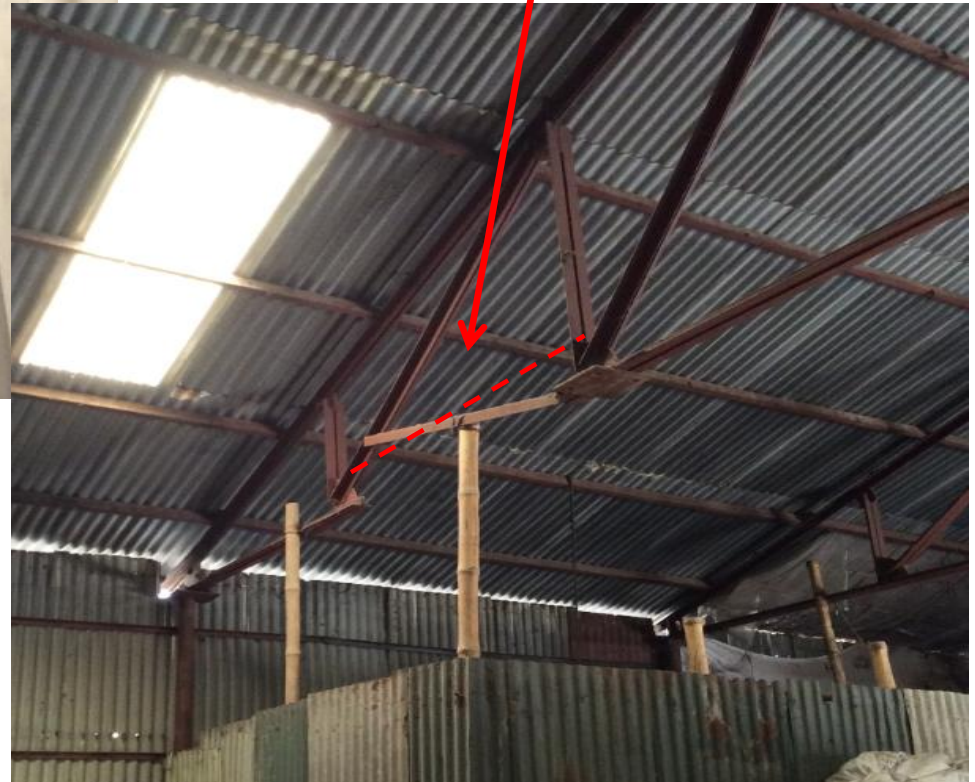
Angle section supporting roof has either buckled or has been hit by a vehicle

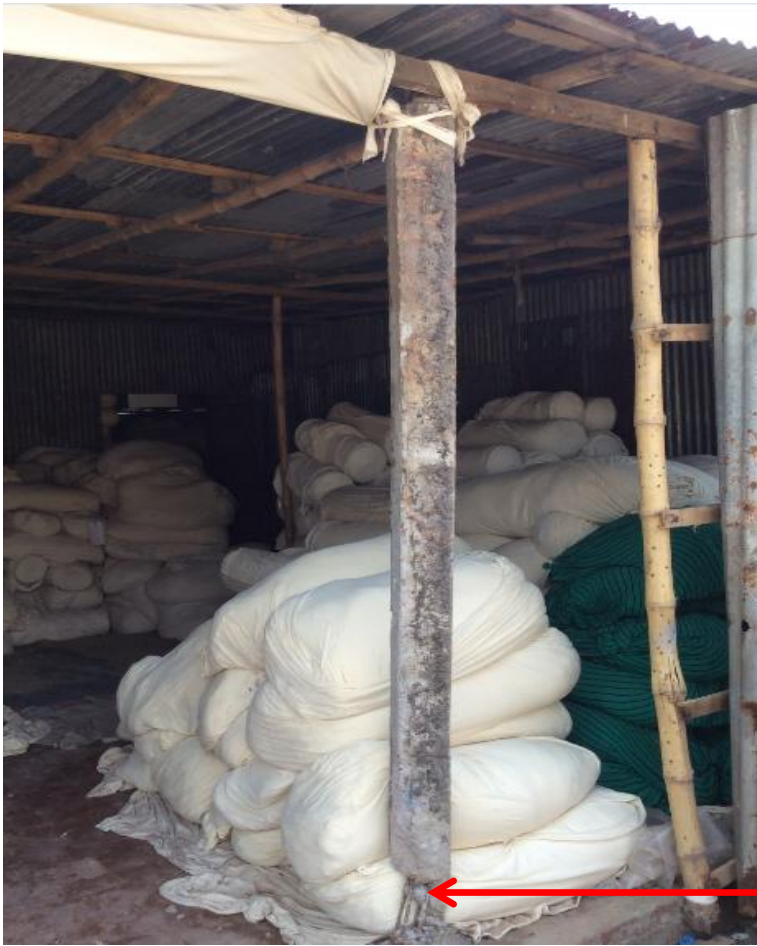
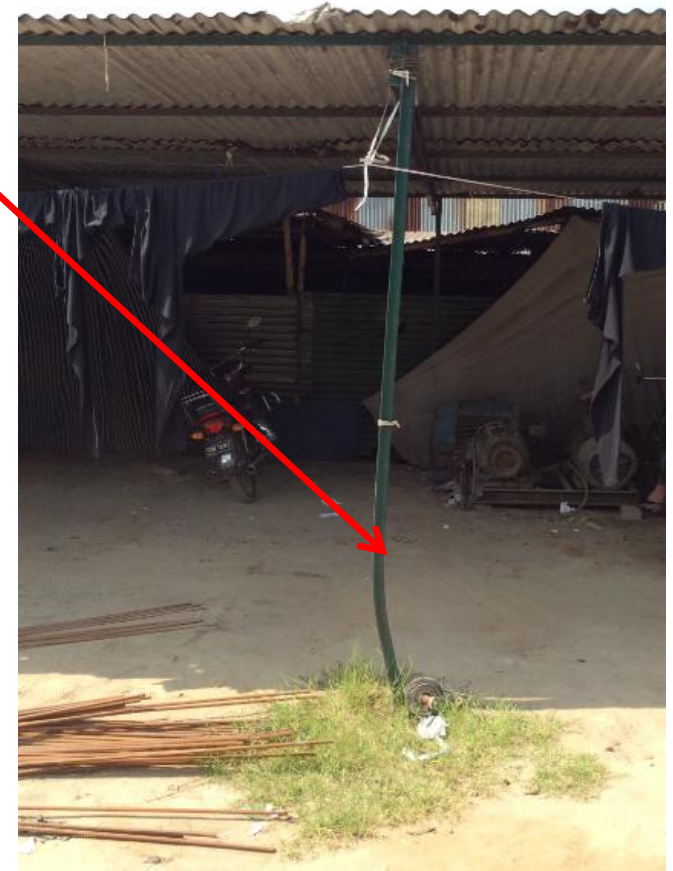
Concrete removed at base and column base and is in danger of collapse.
