Ettade Jeans Limited

1670/2091, West Sholashahar, Building #3, Aturer Depot, Chittagong
(22.382352N, 91.827703E)
20 April 2014

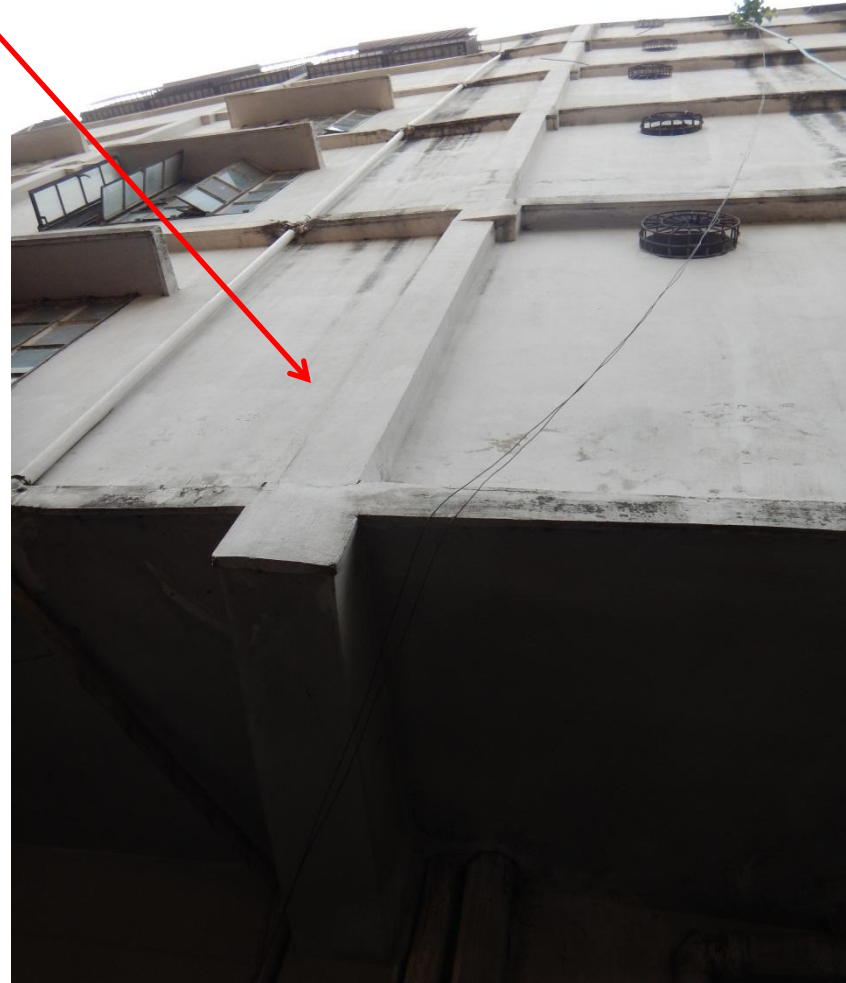
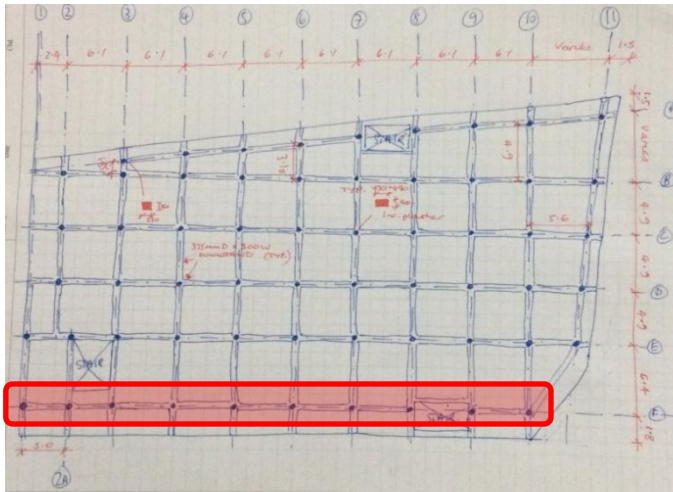
High stress in columns

Columns support a cantilever of 1.8m carrying a brick façade.

Cursory calculations at ground floor level indicate that edge column's working stresses are at a high level.

Some columns extend below.

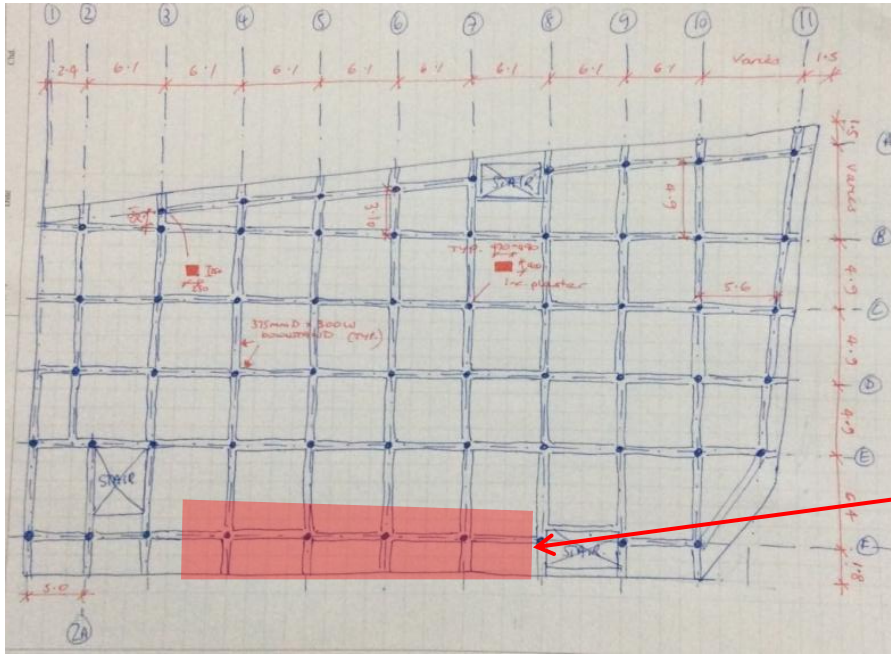
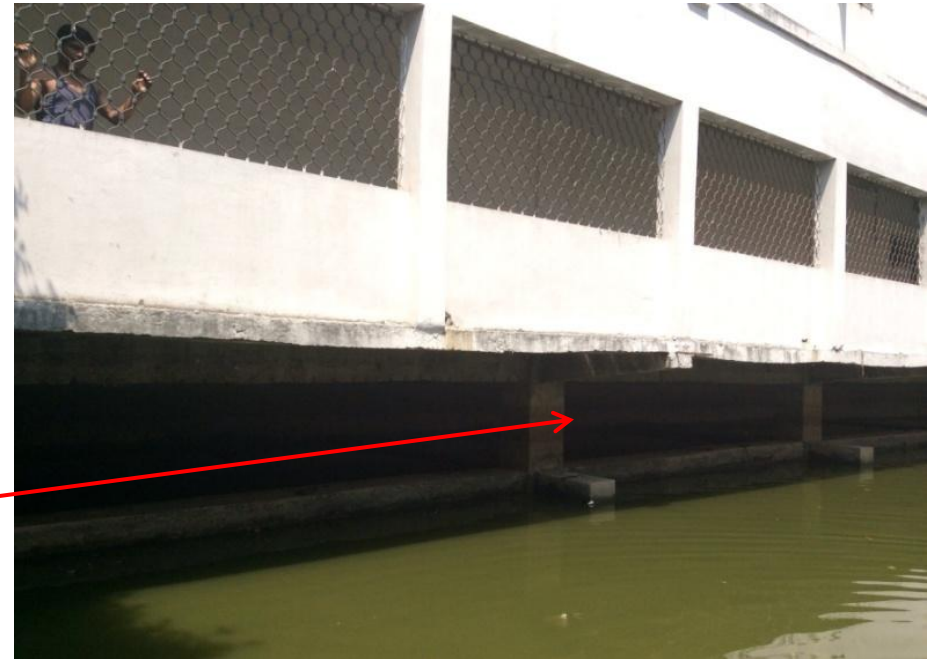
Part of ground floor slab is suspended over a pond.

The columns and retaining wall beneath the ground floor slab were inaccessible and could not be inspected.

The warehouse storage should be removed and the pond should be drained immediately so that the columns and wall can be checked for signs of distress.

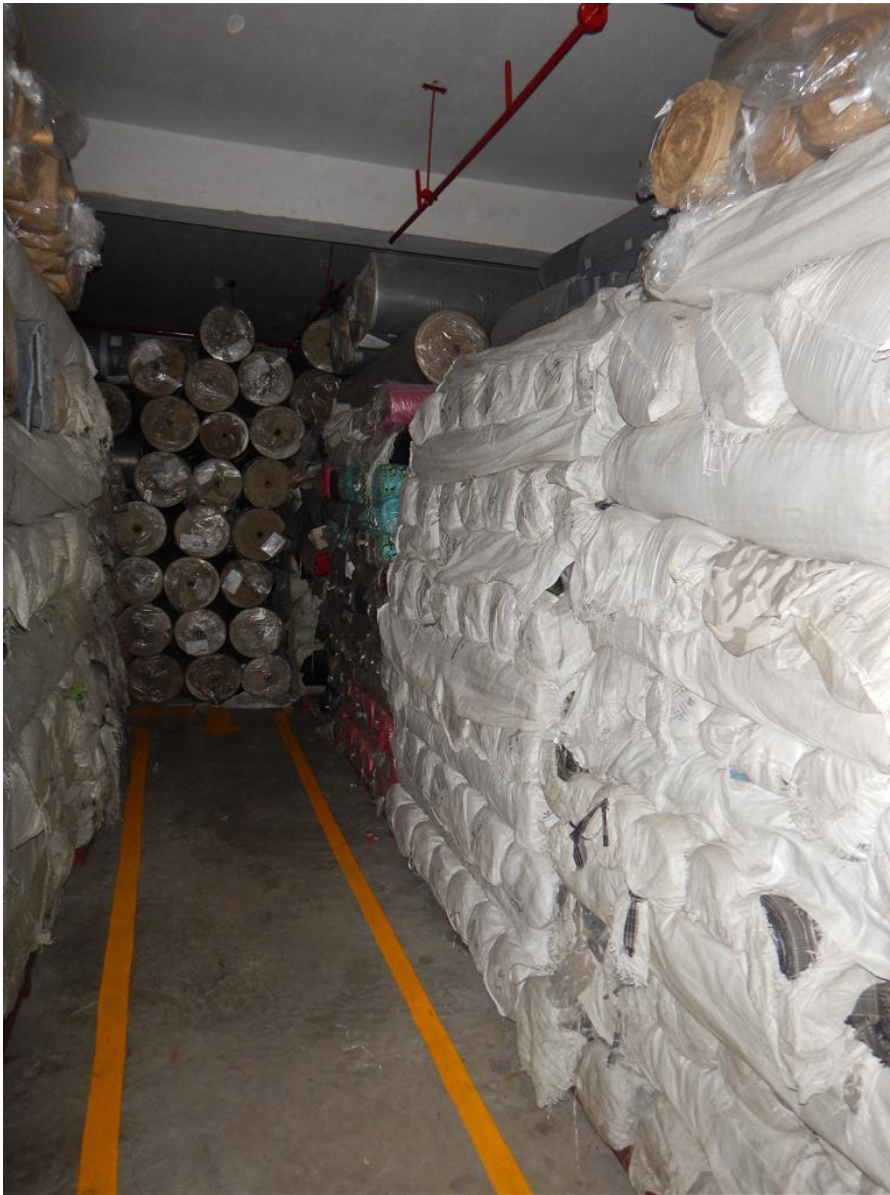
The ground floor slab in this area is subjected to high floor loads from storage of rolled materials.

Cursory calculations under the ground floor warehouse show edge column stresses are very high.

A qualified engineer should confirm that the ground floor columns, slabs and beams have sufficient capacity to support the loads including high storage loading at ground floor.

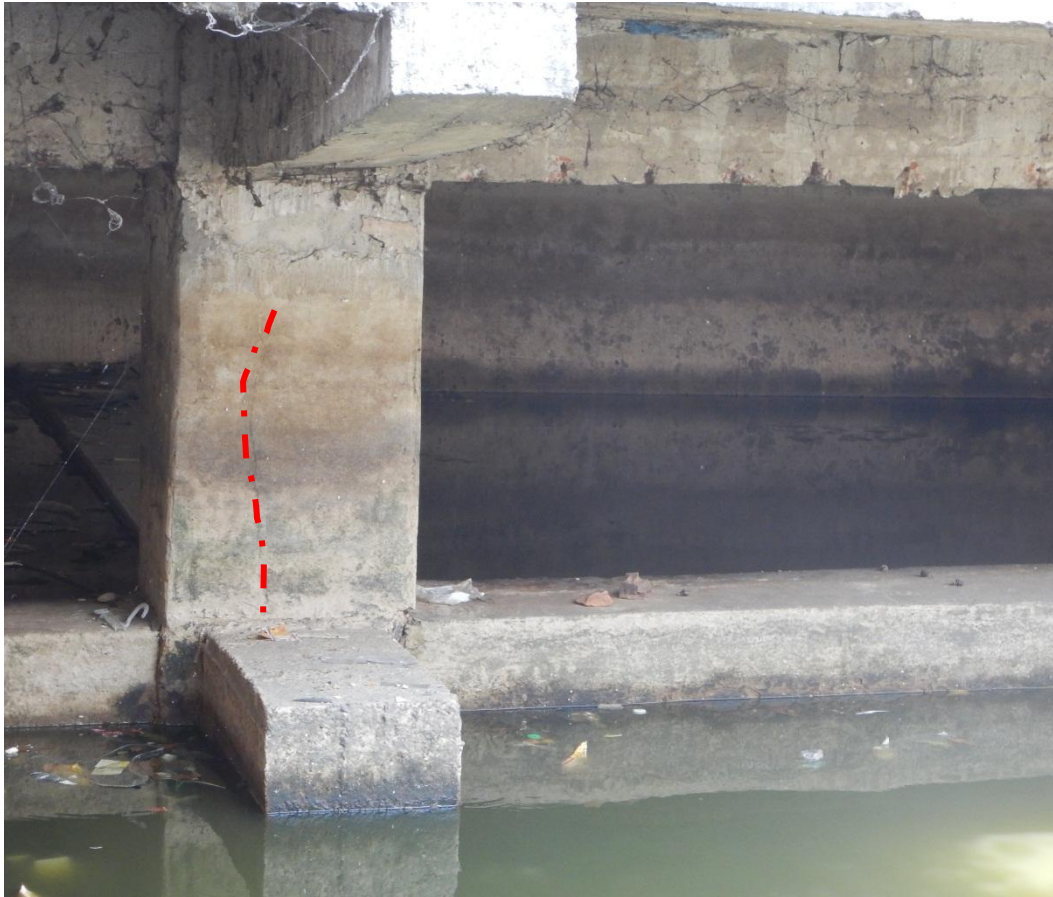
It was not possible to get close to the columns, however some vertical cracking may be apparent.

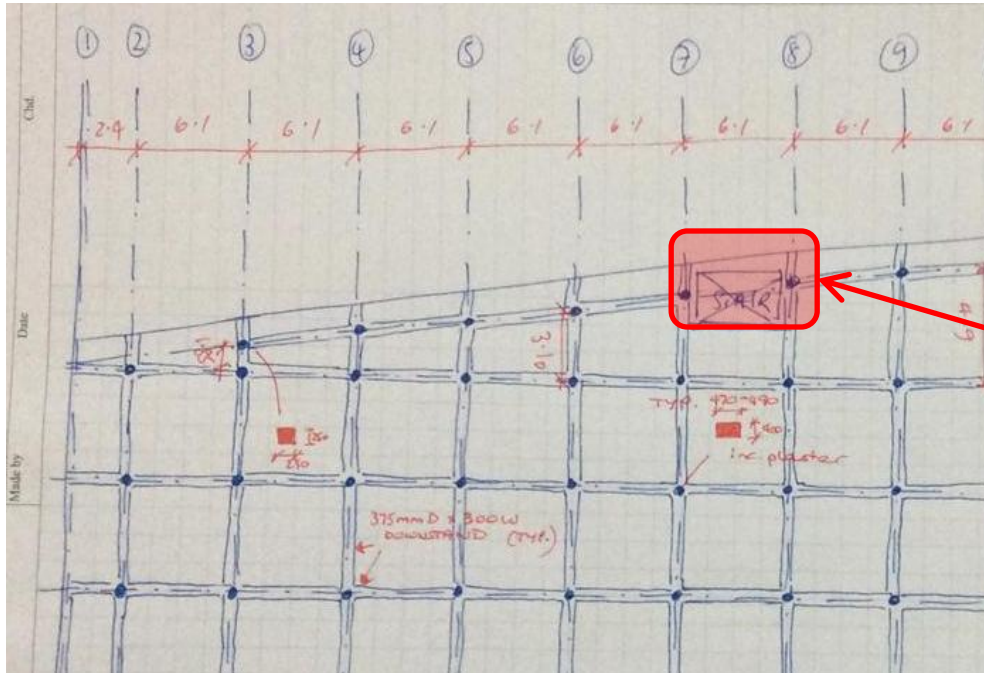
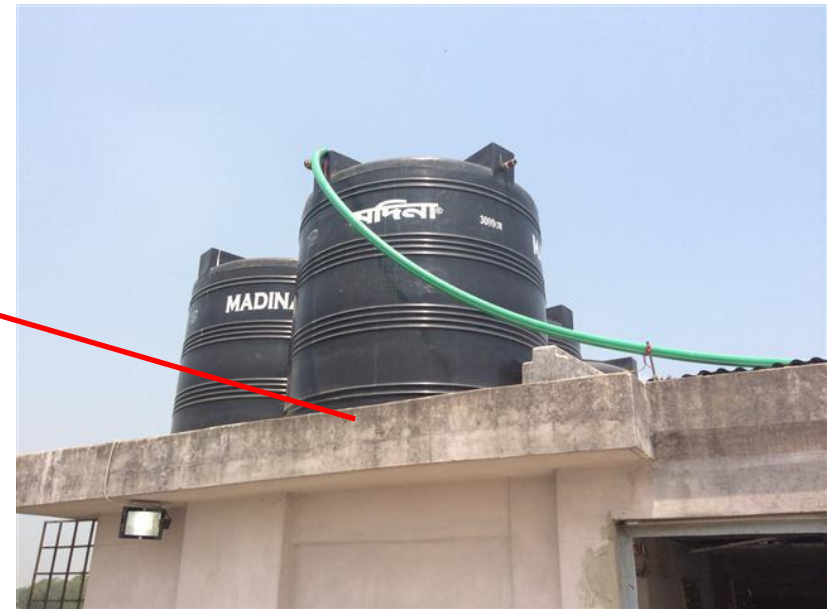
Water tanks on roof

Water tanks with a total capacity of 18000l are located on the roof above the stair core.

The stair lid slab spans between masonry walls which load the cantilevering roof slab below. There are signs of distress in the cantilevering beams at fifth floor level

It was unclear if the water tanks were supported on a plinth of any kind.

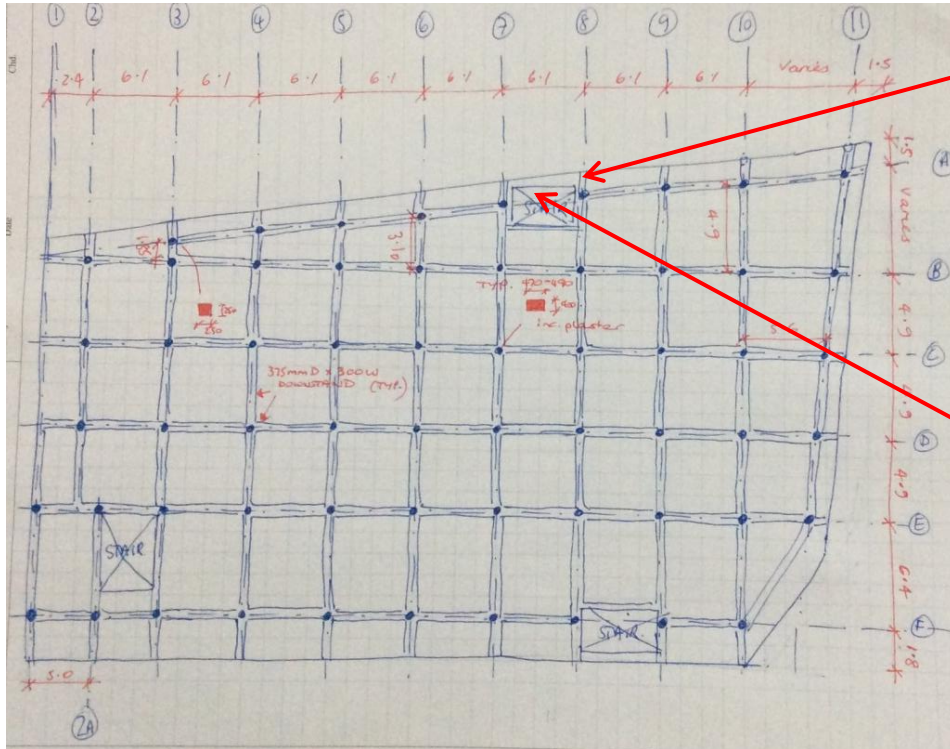
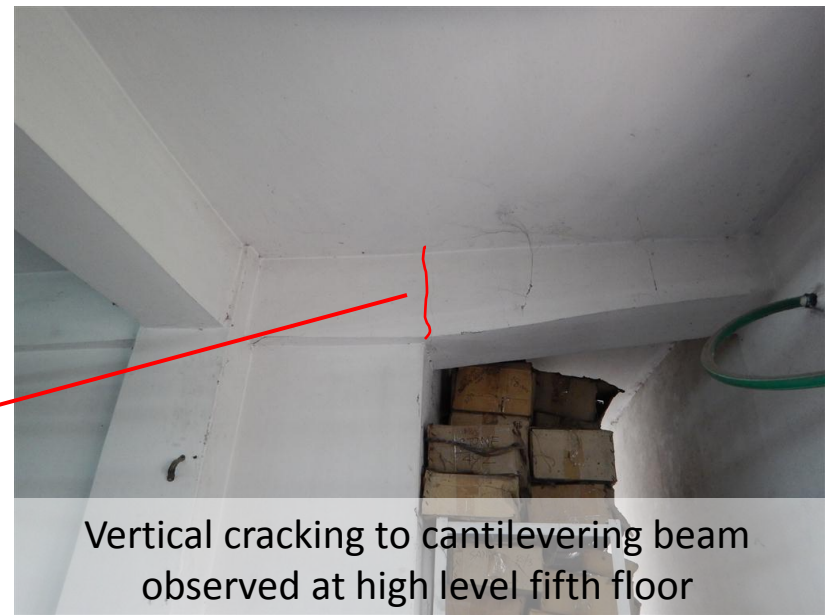
Vertical cracking to cantilevering beam observed at high level fifth floor

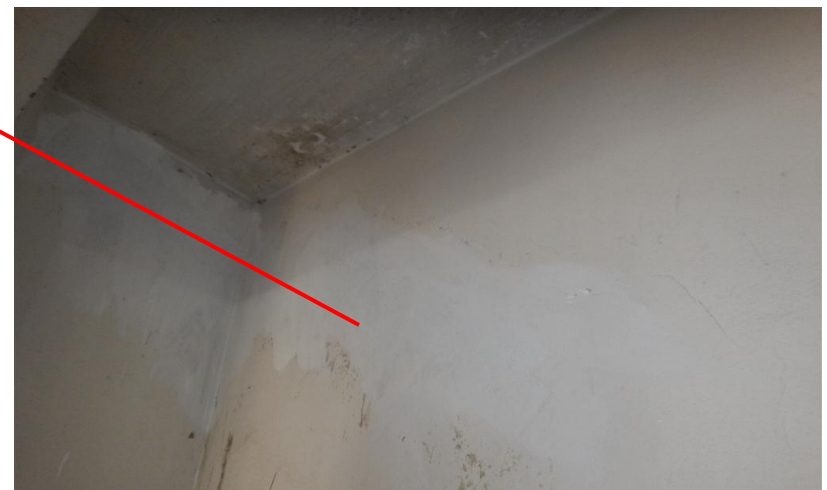
Horizontal and diagonal cracking observed in masonry wall directly below water tanks

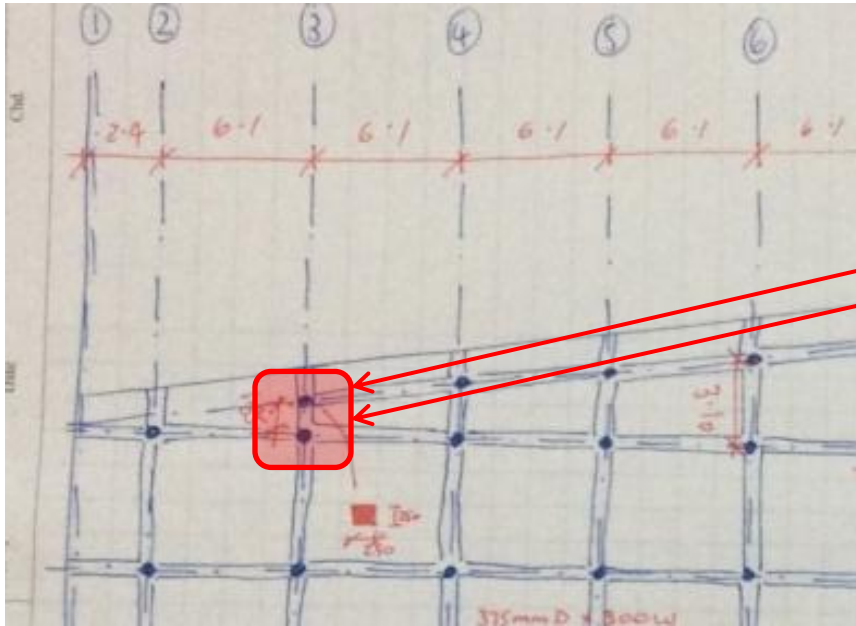
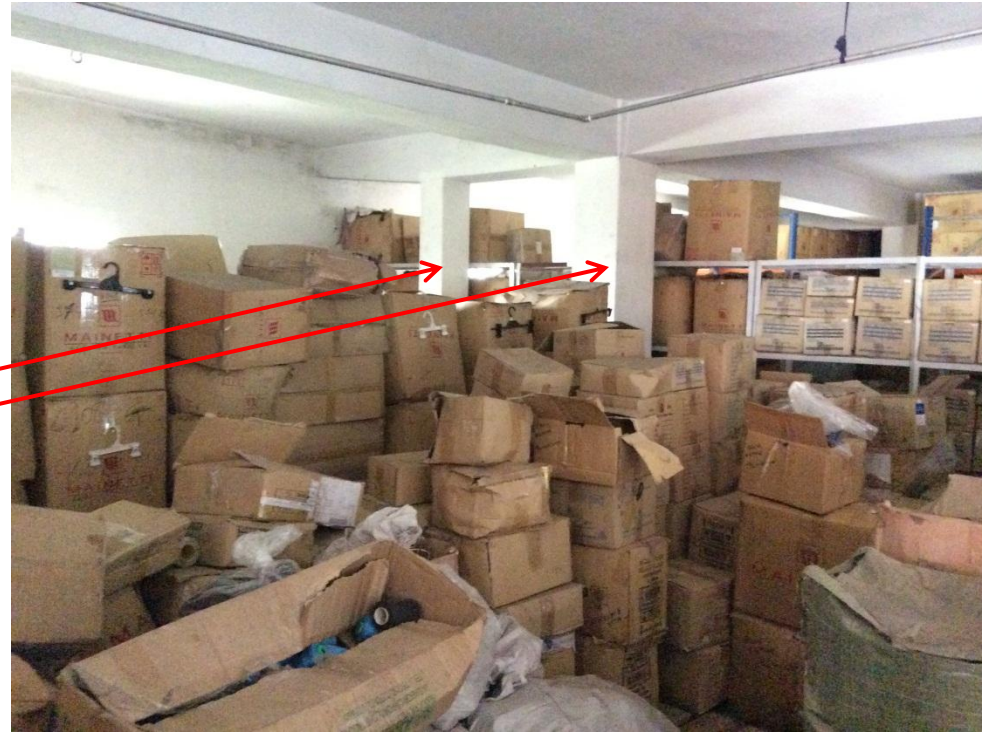
Small 250x250mm column (grid A3) located directly adjacent to typical edge column (grid B3).

Cursory calculations indicate that the stress in the small column is very high, however the adjacent column is capable of carrying the full load for both tributary areas.

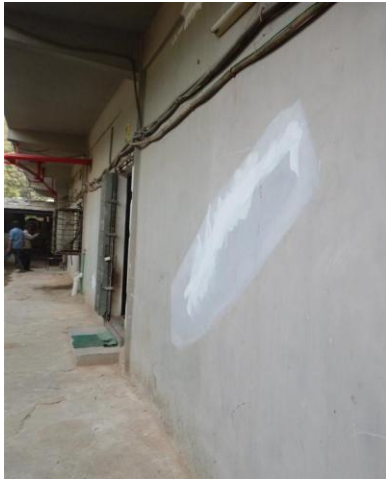
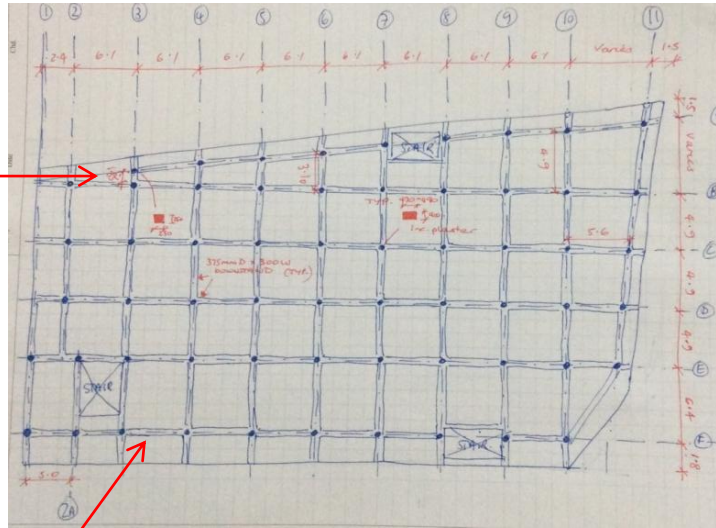
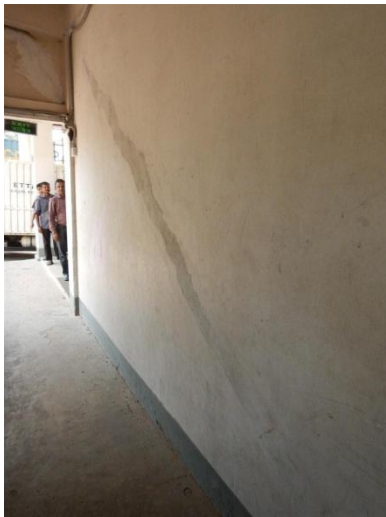
Diagonal façade cracking

Diagonal cracking was observed in the façade at ground floor in the locations noted, this may be a sign of foundation settlement.

A trial pit should be dug to confirm the foundation type and an engineering assessment should be carried out to confirm that the foundation type is suitable for the ground conditions.

The façade cracks should be monitored for further movement by installing tell-tails. Once movements have stopped cracks should be repaired to prevent on-going maintenance issues.

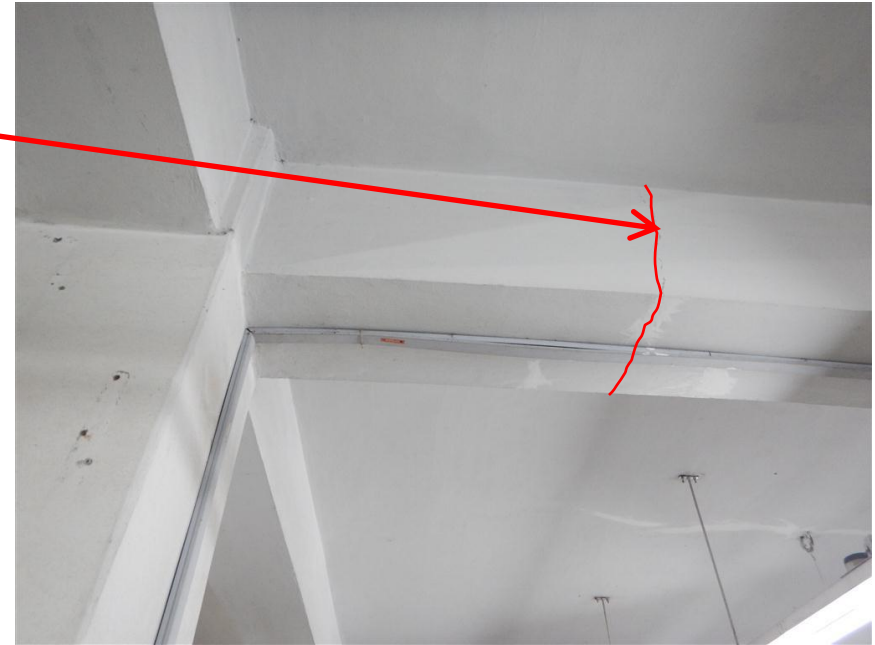
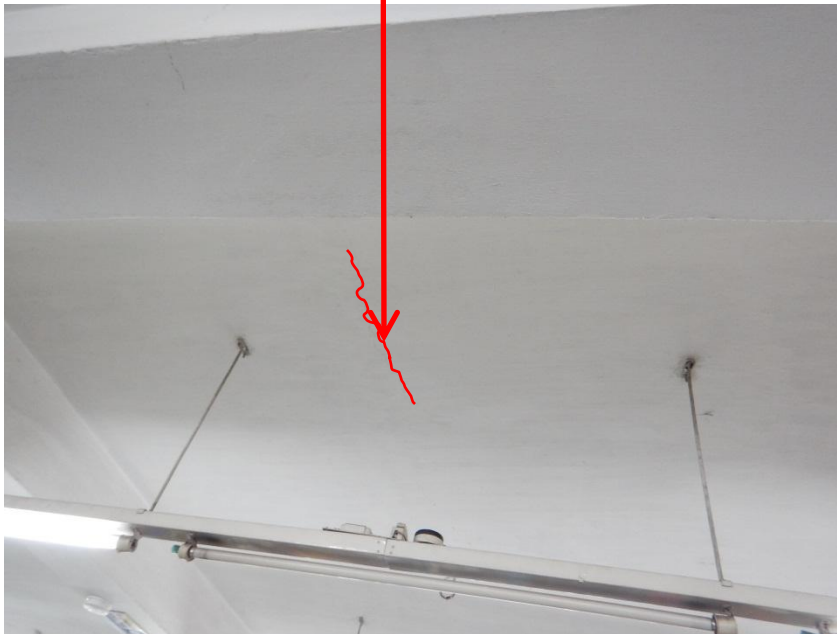
Beam Cracks

Flexural cracking in beams was observed at all levels.

Flexural cracking was observed from the fifth floor (underside of roof slab)

Cracks to be reviewed by removing plaster, to confirm that cracks do not extend into structural concrete.

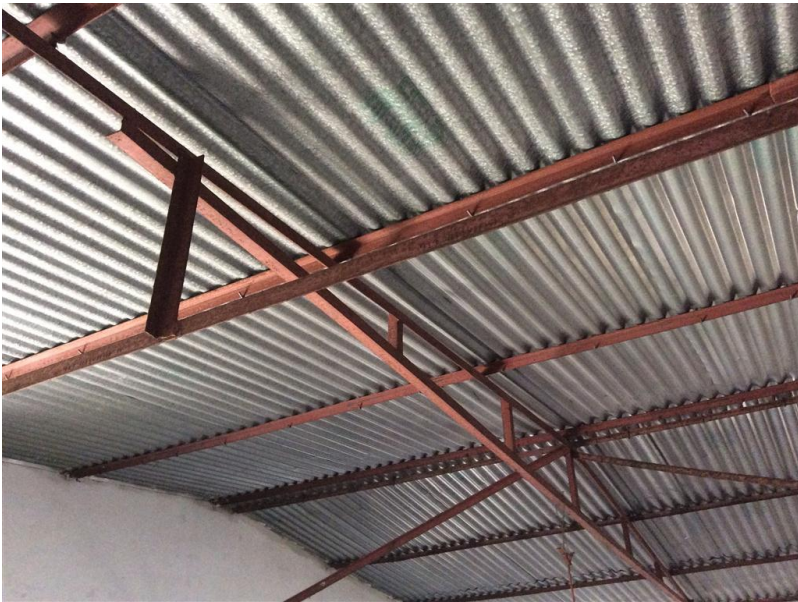
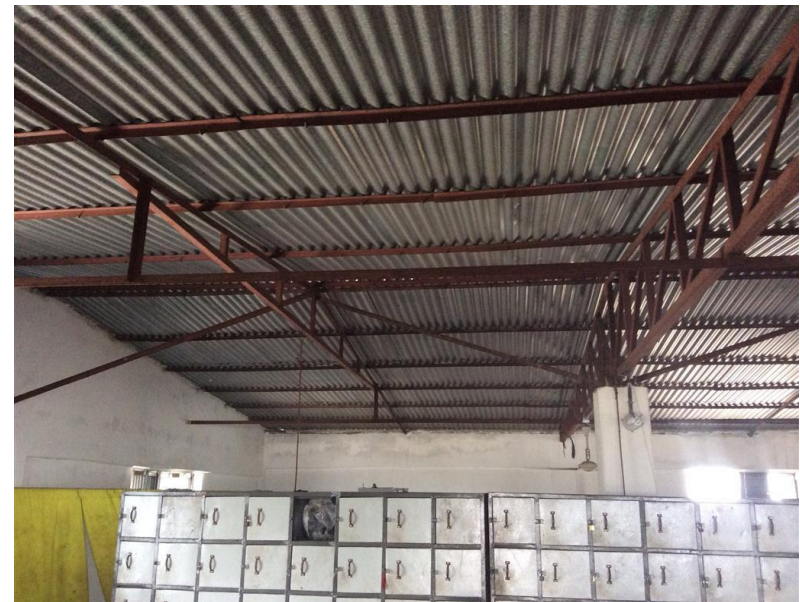
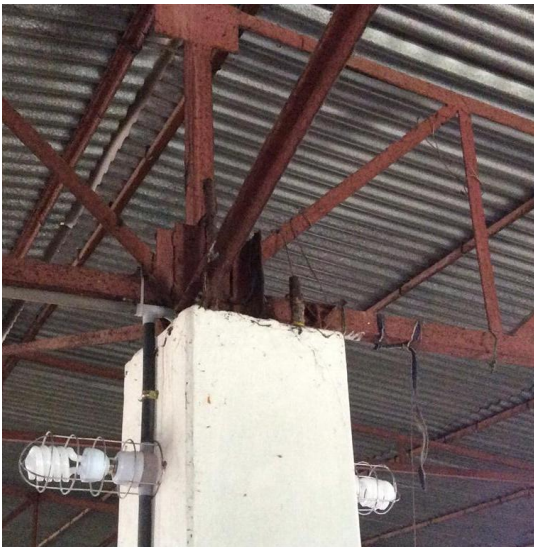
Non Engineered Steel Roof

Roof appears not to have been designed, there is no bracing in the roof sheet plane (corrugated iron sheet acts as diaphragm and is reliant on screwed connections), intermediate trusses do not span back to vertical structure. Connections do appear to have been designed for wind uplift load case. Qualified engineer to undertake design assessment of steel roof and confirm it has capacity for vertical and horizontal loading specified in BNBC

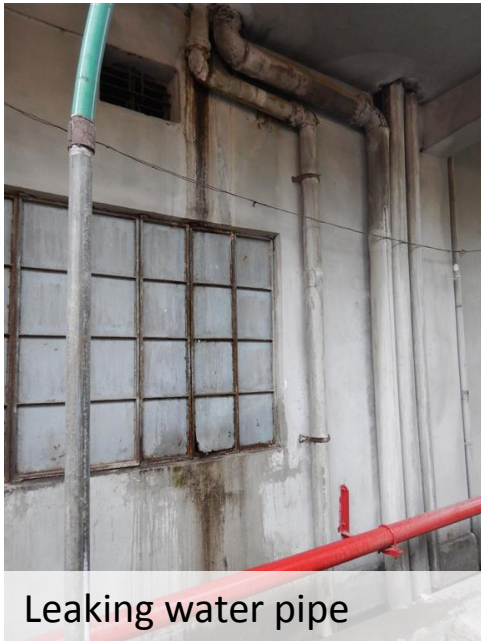
Leaking water pipe

Water observed leaking from downpipe onto generator shed roof. Signs of staining both externally and internally.

Leaking downpipe to be repaired.

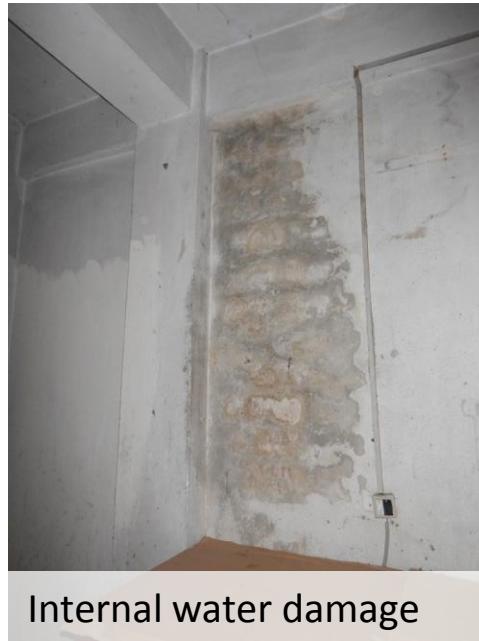
Internal water damage

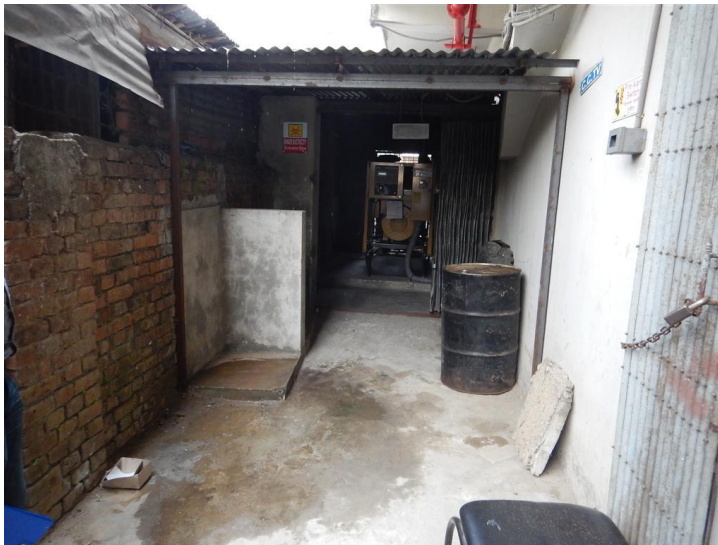
Water leak leading to structural damage

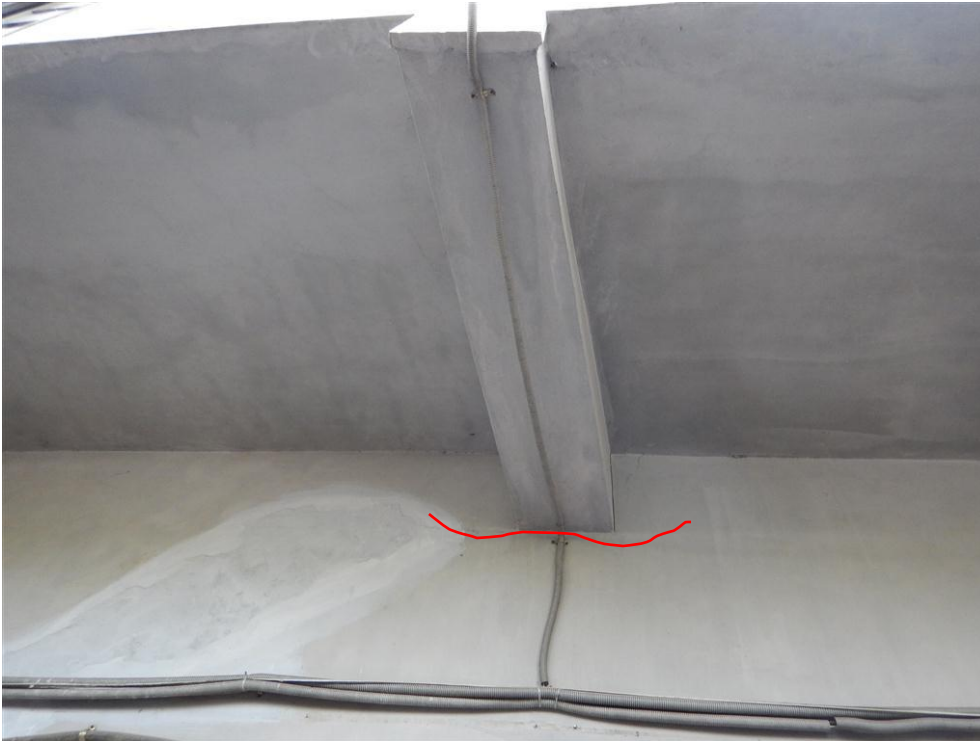
Horizontal cracks observed in masonry walls where cantilever floor beam has deflected and is now supported by masonry.

Horizontal cracks to masonry walls

Masonry wall is now providing support to first floor slab. No structural modifications to be made to wall (e.g. openings being created for doors or windows)

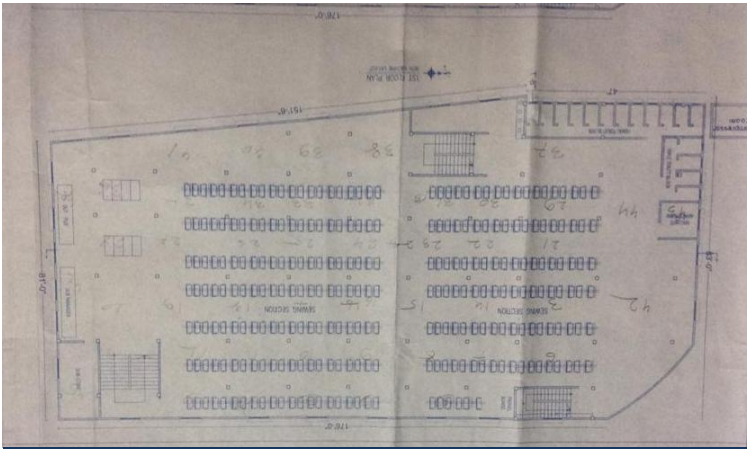
Factory layout drawing

No drawings for the RC superstructure or substructure was available, the foundation system is unknown. The factory layout and building permit drawings do not match the as-built frame.

Engineer to develop accurate drawings showing the as-built structure.
