Russel Garments (Unit-2)

East Delpara, Kutubpur, Fatullah, Narayangonj.
(23.66505N, 90.47964E)

22 April 2014

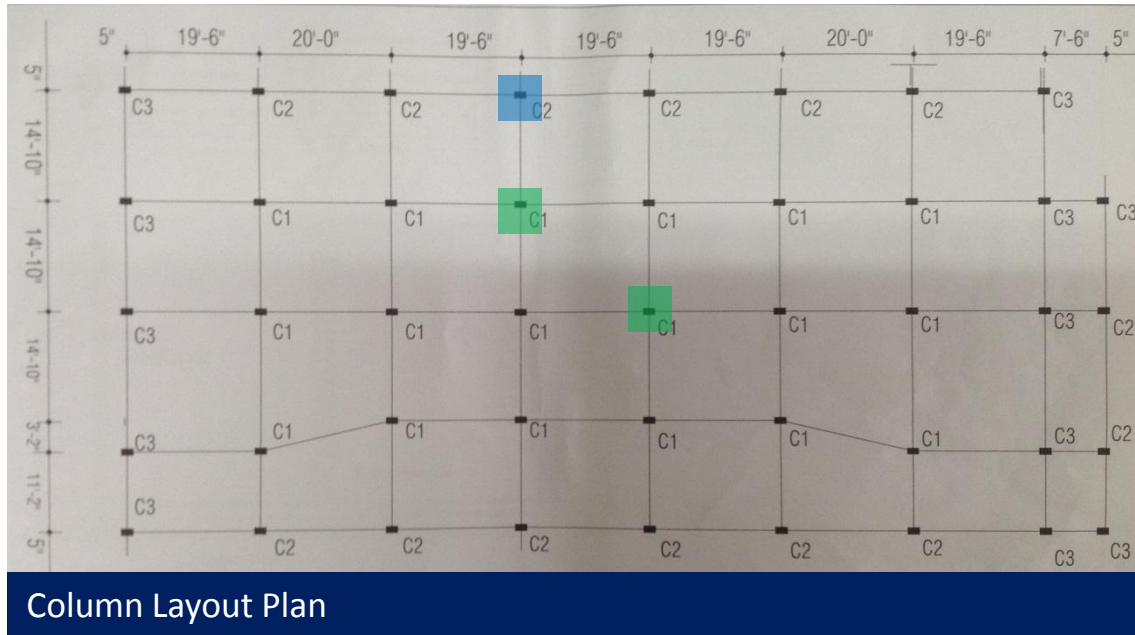
Column Stress Levels

Cursory calculations indicate that the working stress of the columns at Ground Floor level of the Main Factory Building are at a high level. Detailed Engineering Assessment required.

Columns Tested - Arup

Columns Tested - Bureau Veritas

- Building Engineer to review design, loads and column stresses in structure.
- A **Detailed Engineering Assessment** of Factory is to be commenced – see attached scope.
- Verify insitu concrete stresses by taking 100mm diameter cores from 4 (central) columns at ground floor level.

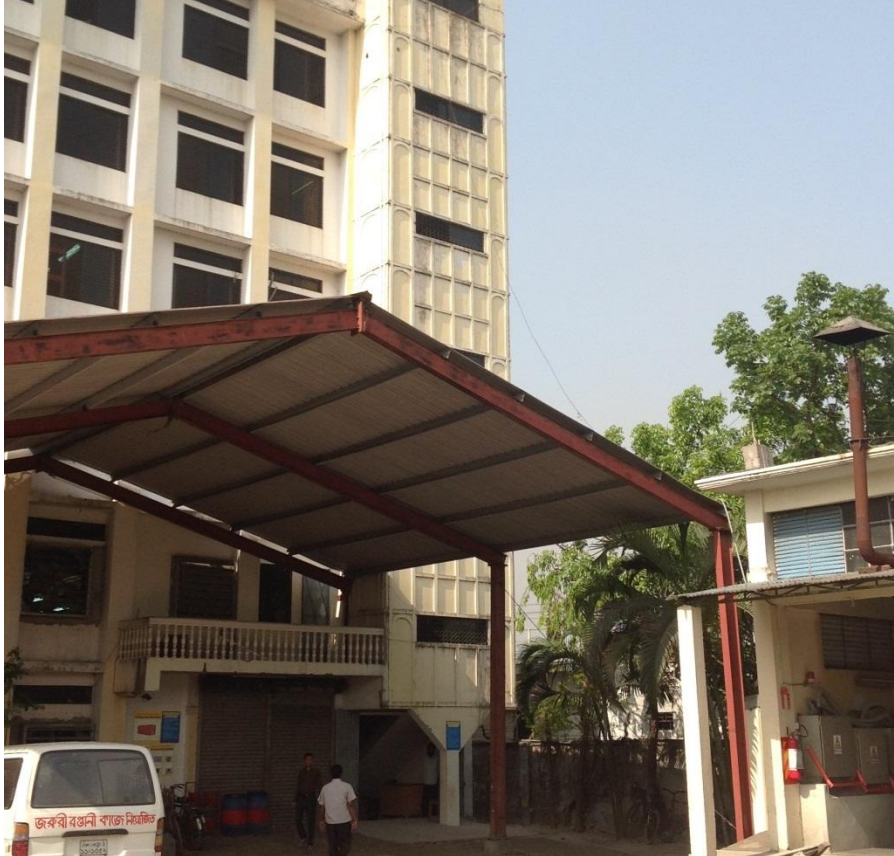
Staircore to North Elevation

Single column observed at Ground Floor level to the underside of the protruding landing of the North Staircore.

The column is not shown on the drawings. It is not clear whether this column is structural, or whether the slab cantilevers.

If column is structural ; Building Engineer to confirm if the column has been designed for impact loading and to ensure that adequate protection is provided.

If the column is non-load-bearing; Building Engineer to confirm that the slab has been adequately designed to support the floor and façade loading.

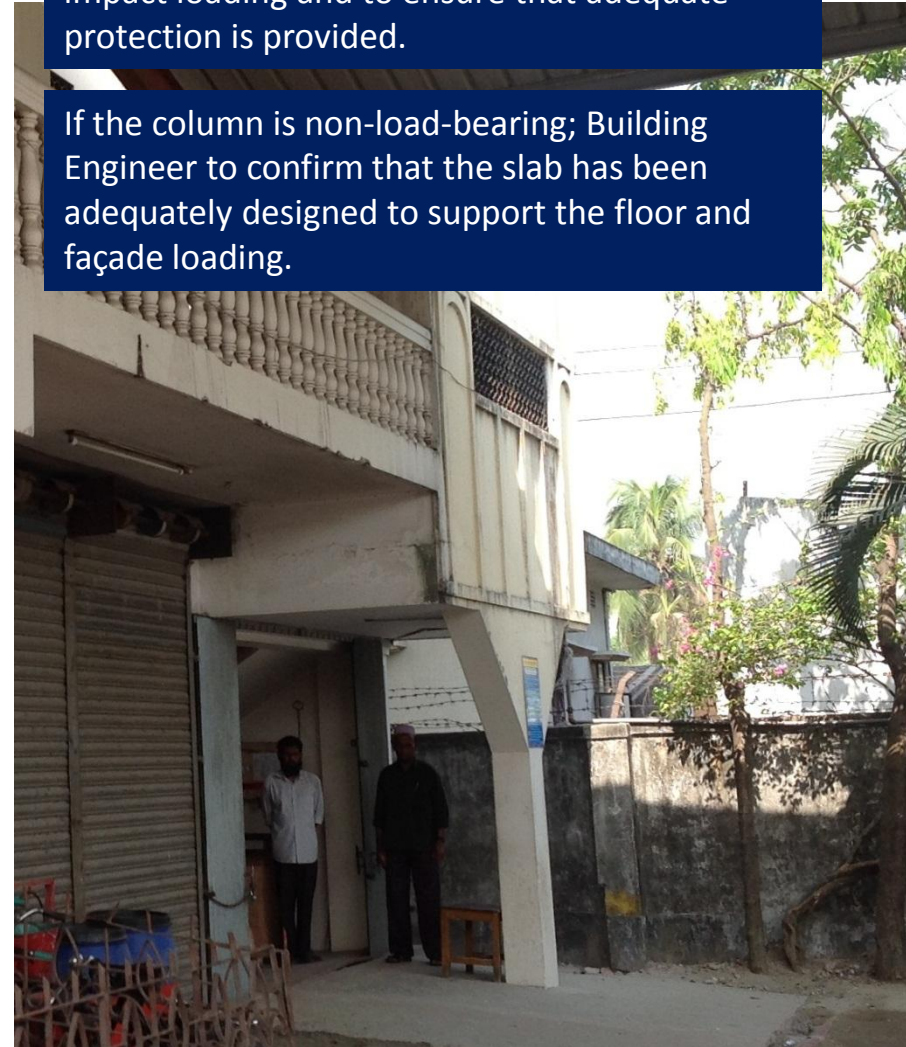
Column not shown on Structural Drawings

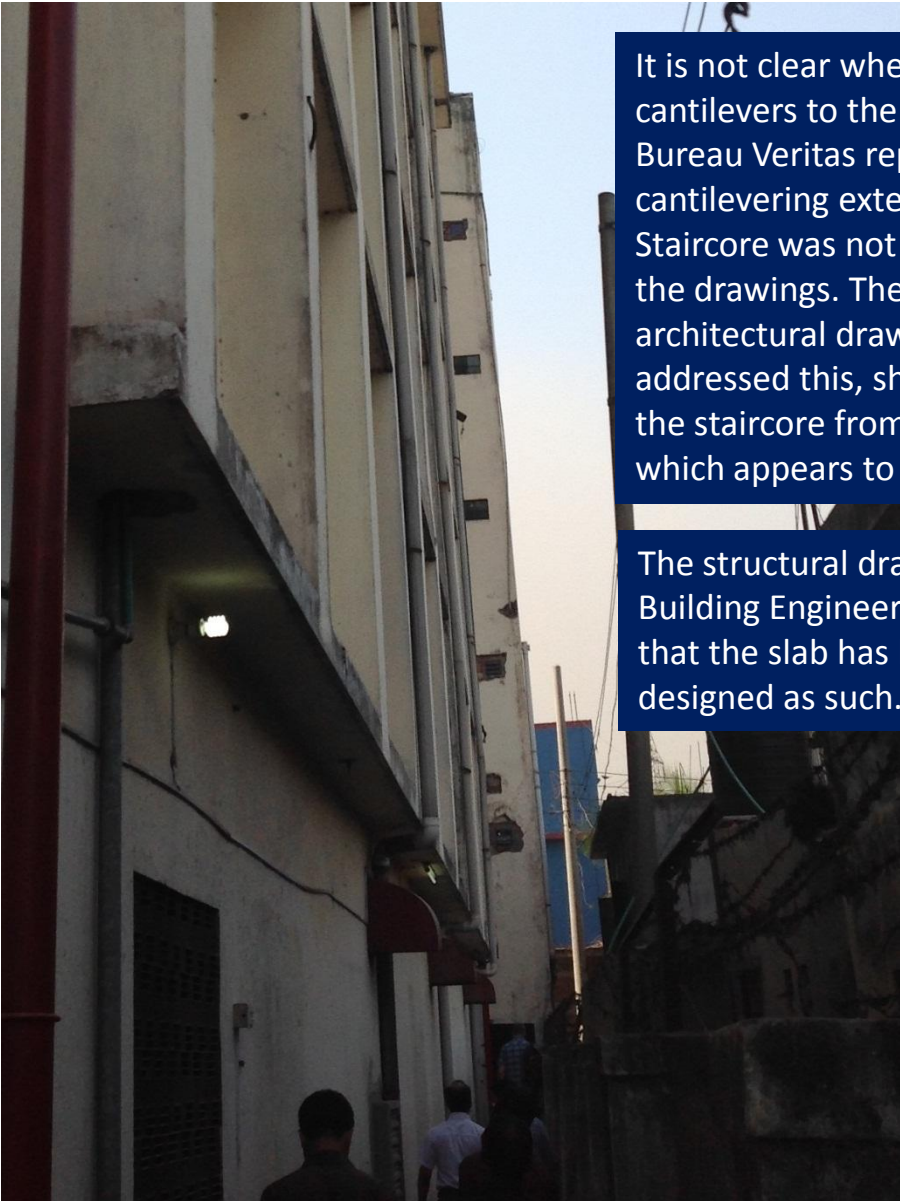
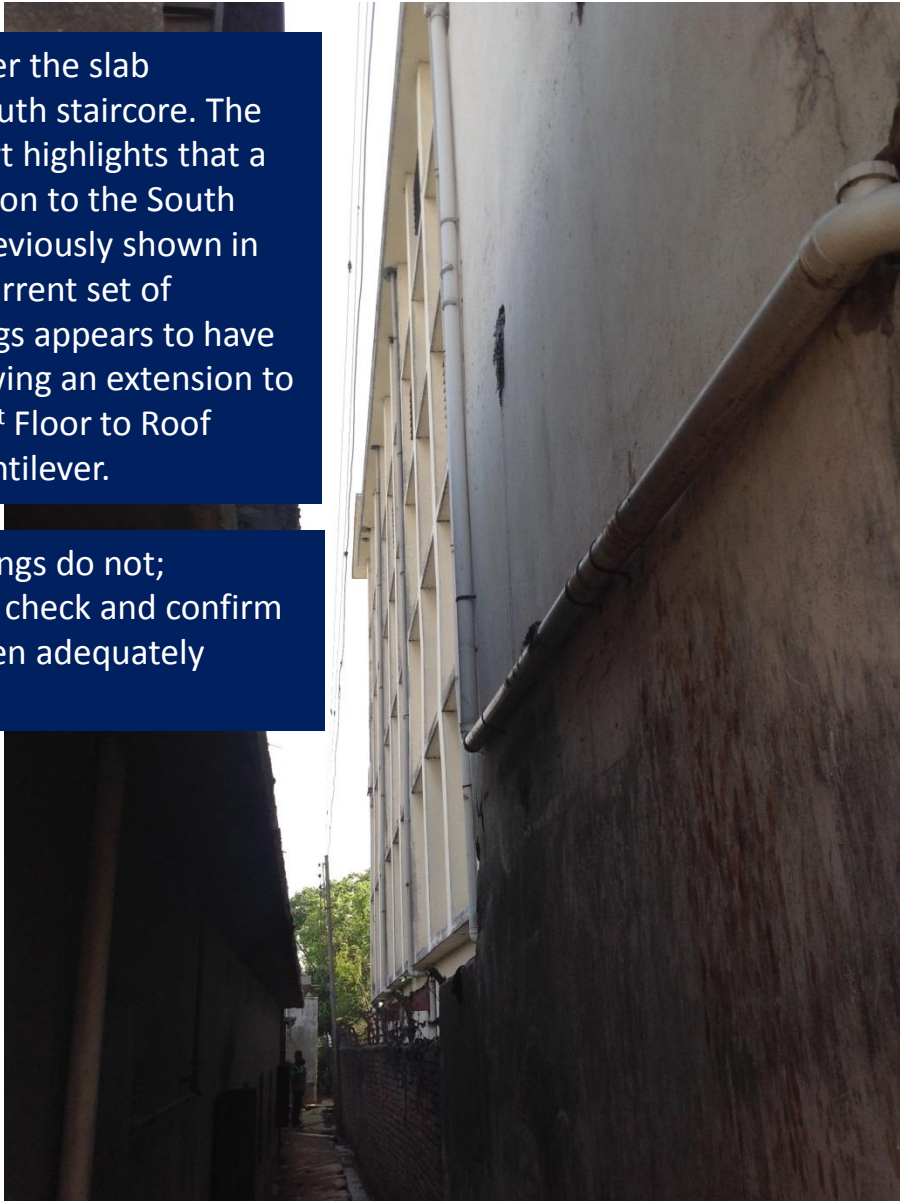
South Staircore to West Elevation

It is not clear whether the slab cantilevers to the South staircore. The Bureau Veritas report highlights that a cantilevering extension to the South Staircore was not previously shown in the drawings. The current set of architectural drawings appears to have addressed this, showing an extension to the staircore from 1st Floor to Roof which appears to cantilever.

The structural drawings do not; Building Engineer to check and confirm that the slab has been adequately designed as such.

Extension appears to be supported on perimeter wall

- As part of the Detail Engineering Assessment. The Building Engineer is to review the projecting areas of slabs to check if the slabs are cantilevered or there is an adequate vertical load path.

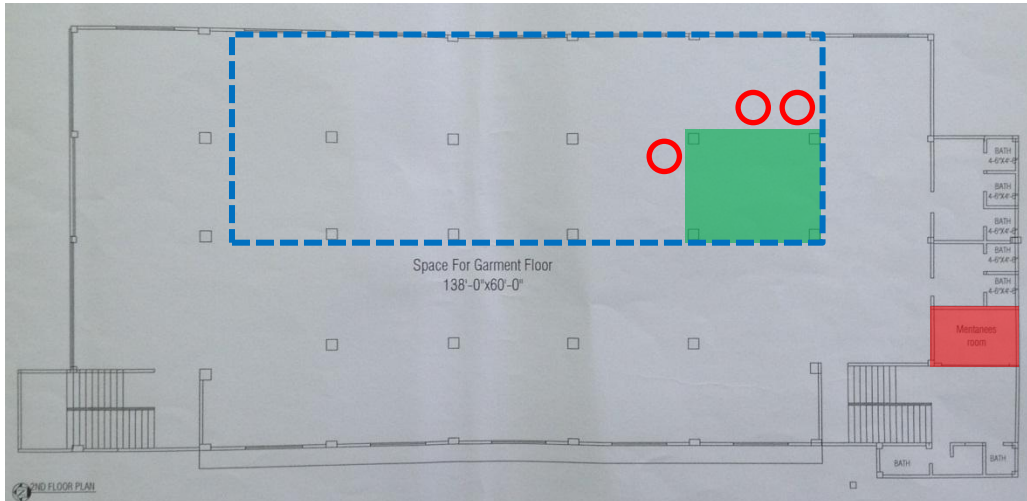
Typical Floor Plan of 7-storey Building

Areas of high loading were noted at the water tanks at Roof level, at the Finished Goods Storage area at 4th Floor level, and at the toilets at all floors, as well as at the 3rd Floor level storage area to the 4-storey building. Building Engineer to check that the different slab constructions have been adequately designed to accommodate this loading, and to develop a factory floor loading plan to include maximum floor loading capacities for each floor.

- Concrete 50000L Water Tank at Roof Level
- Plastic Water Tanks (3 no.) at Roof Level
- Extent of Finished Goods Storage Area at 4th Floor level
- Possible 800mm Build-up (Average) in Toilets to all Floors

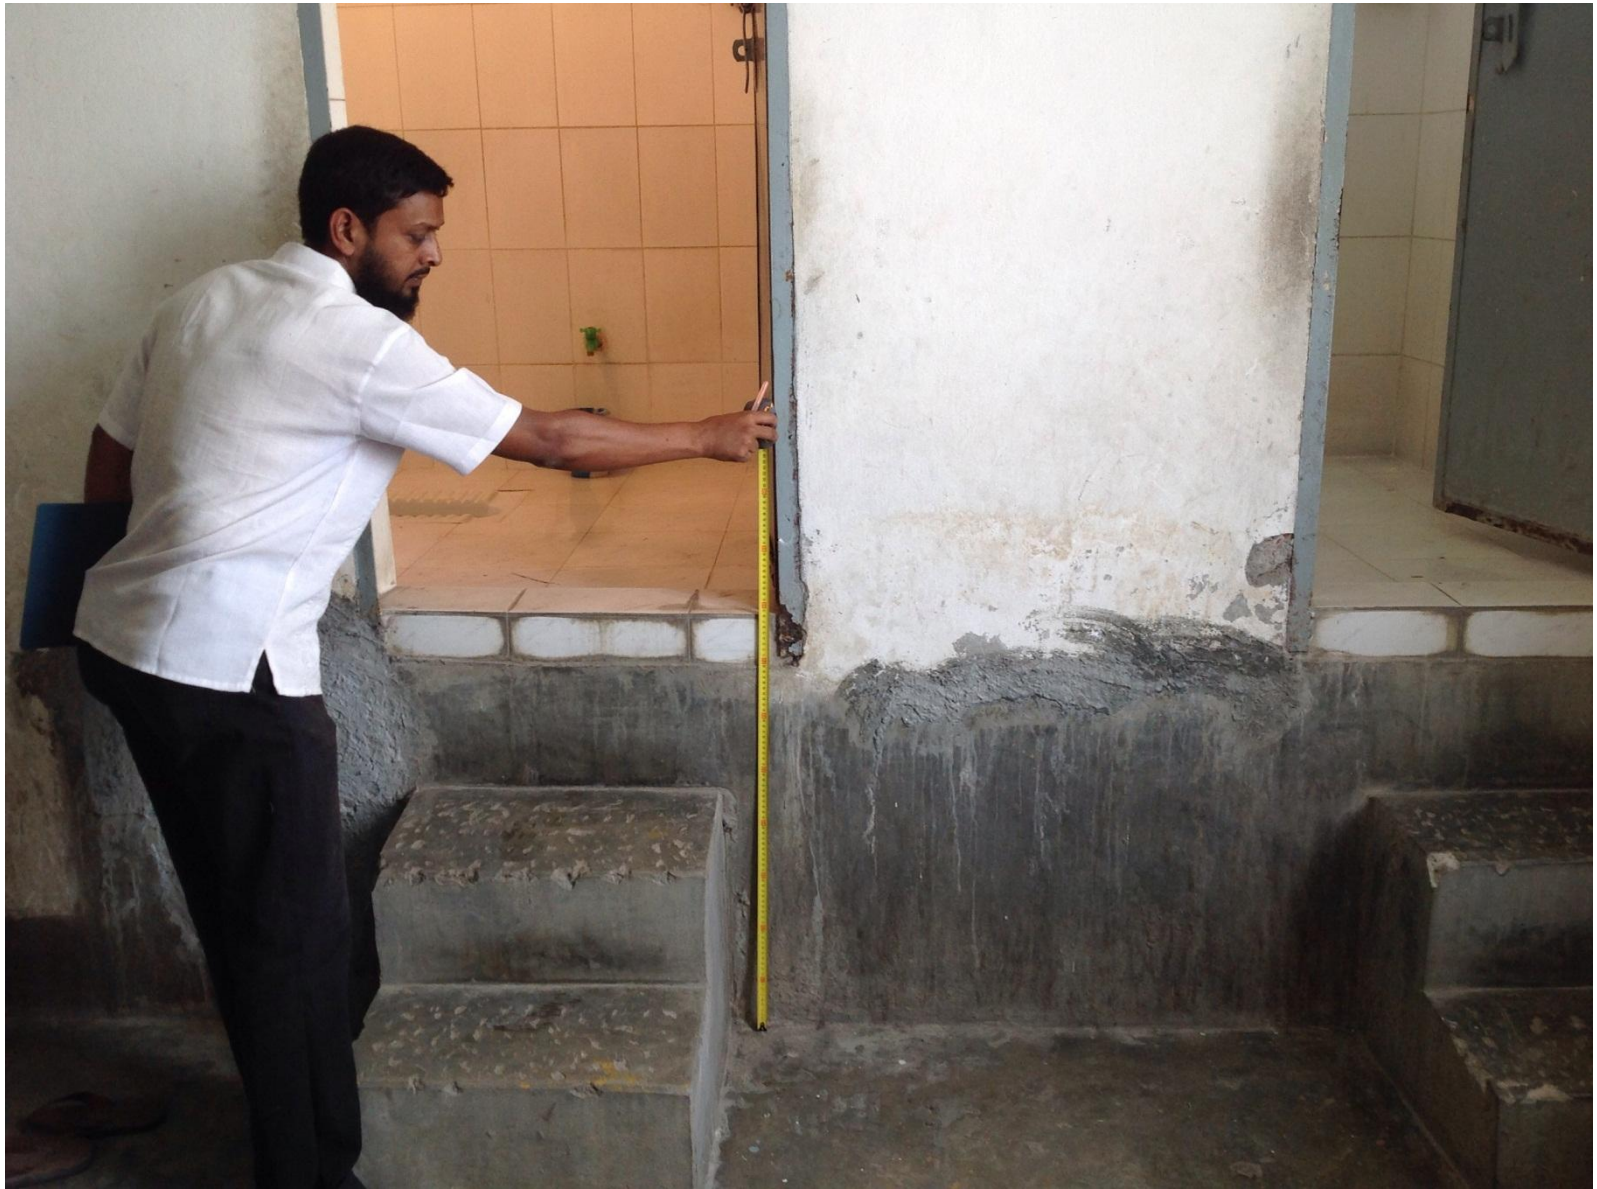
Possible 800mm Build-up (Average) in Toilet Area to South Staircore Half-Landing to all Floors

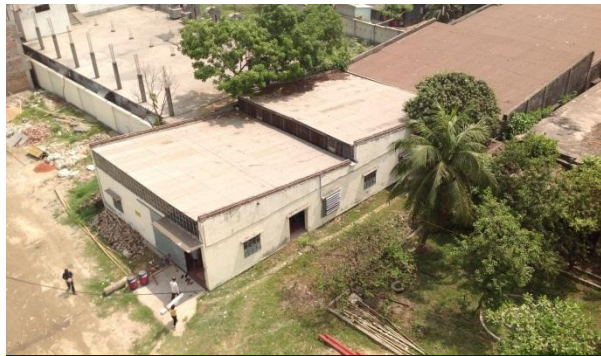
Godown Warehouse

The Godown Warehouse, comprising a lightweight steel-trussed roof on RC columns, does not appear to be engineered. The cross beams are deflecting excessively, there is no horizontal bracing to the roof, and the connections do not appear adequate. Similarly, the Entrance Canopy to the Main Factory Building, a lightweight steel structure, lacks adequate bracing. Building Engineer to review the design of these lightweight structures for lateral and uplift loading, and to implement any upgrade works as required.

- Building Engineer to check the design and capacity of the lightweight steel structures/connection details as part of the Detailed Engineering Assessment and make any necessary alterations.

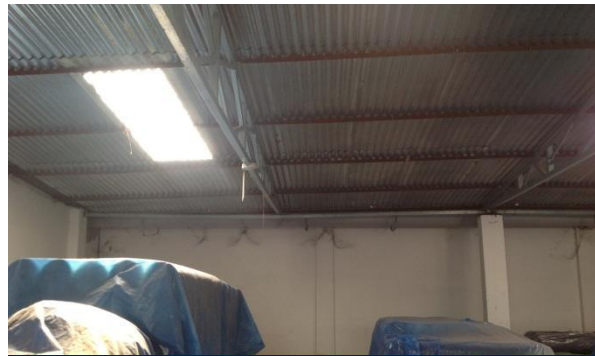
Deflection of Cross-Beams

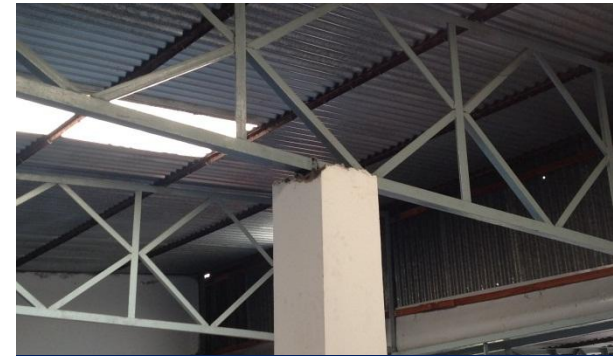
Truss to Column Connection Detail

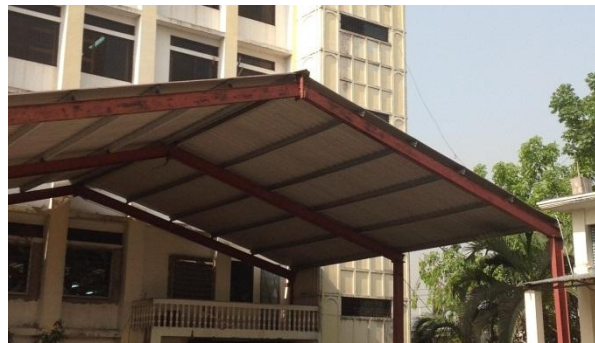
Lack of Horizontal Bracing to Entrance Canopy Roof

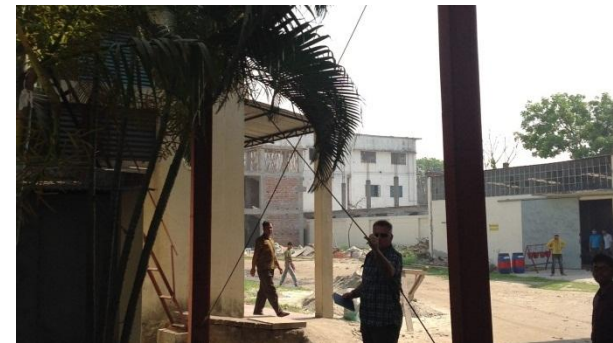
Loose Vertical Bracing to Entrance Canopy Frame

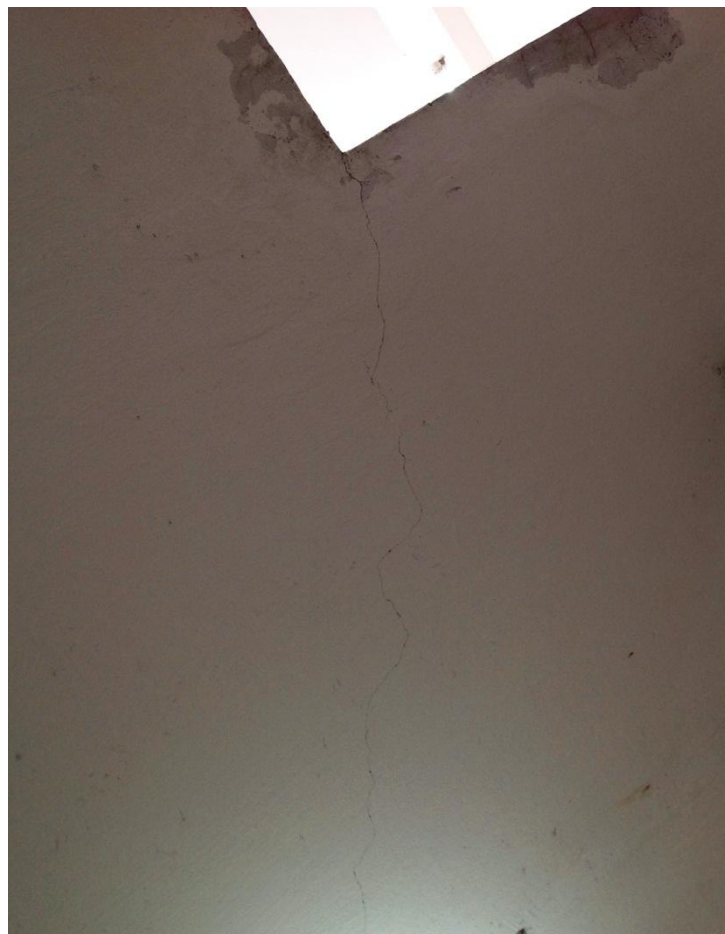
Cracking was observed to the soffit of a number of beams and slabs at 3rd, 4th, 5th and 6th Floor levels of the 7-storey Building. Cracking of the walls was also observed. Building Engineer to investigate cracking and carry out remedial works to the structure as required.

Hairline Cracking to Soffit of 6th Floor Slab

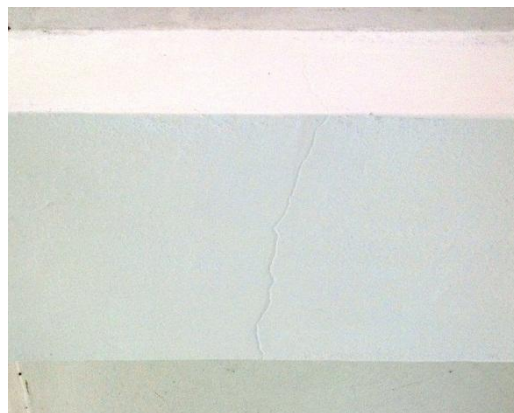
Filled Crack to 5th Floor Beam

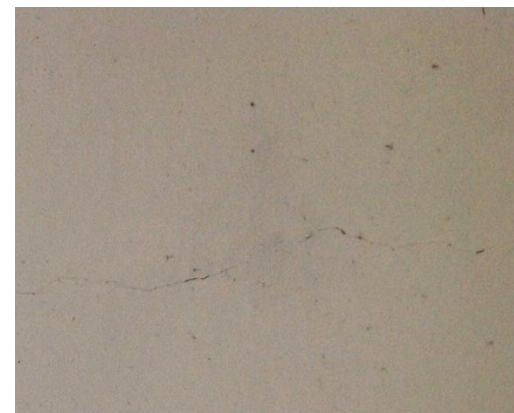
Hairline crack to 5th Floor Slab

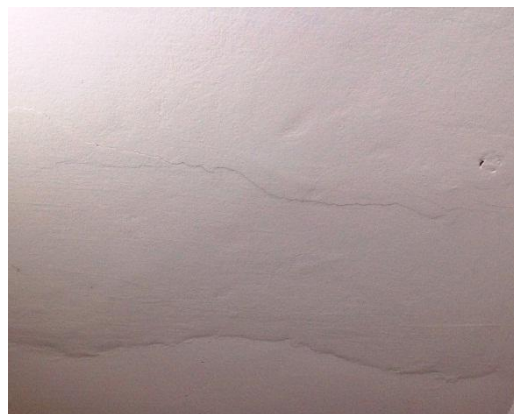
Hairline Crack to 3rd Floor Slab

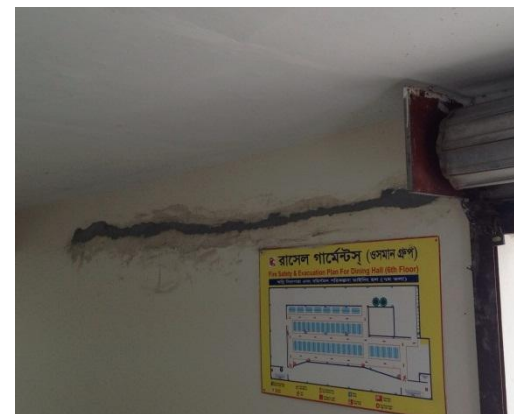
Filled Crack to 6th Floor Wall
