Logos Apparels Ltd. (10917)

No. 73, Ward No.06, Mouchak Kaliakoir, Gazipur Bangladesh

06.APRIL.2014

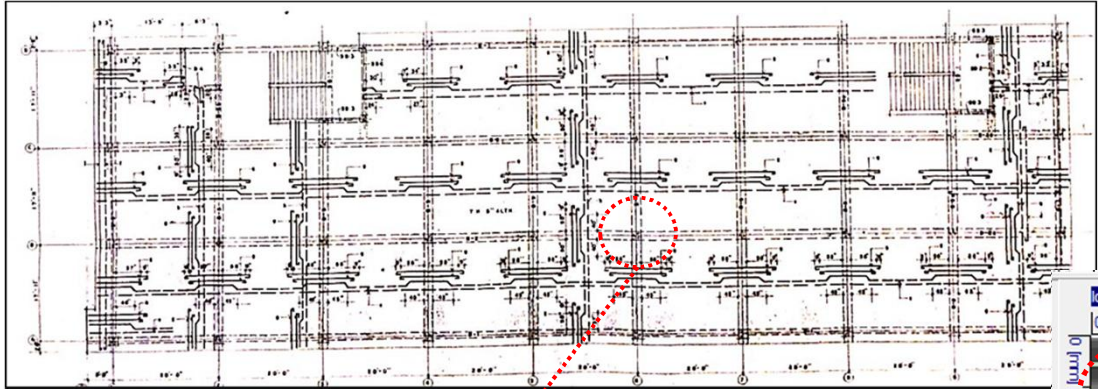
1st Priority 2 Concern

This area shows 5 longitudinal bars.

This column C2 at grid B6 was randomly checked with a Ferros scanning device.

This area shows 4 longitudinal bars.

The column C2 is supposed to have 5 bars each side.

ITEM 1: (1st Priority 2) An inconsistency of column reinforcement between structural design and as-built structure

The Ferroskan image shows an inconsistency with the reinforcement configuration between the structural design and the as-built structure.

- Building survey must be taken to verify the system with regard to reinforcement configuration
- Building engineer to verify the system to ensure the structural consistency between design and as-built structure

- Building engineer to check for non-compliance

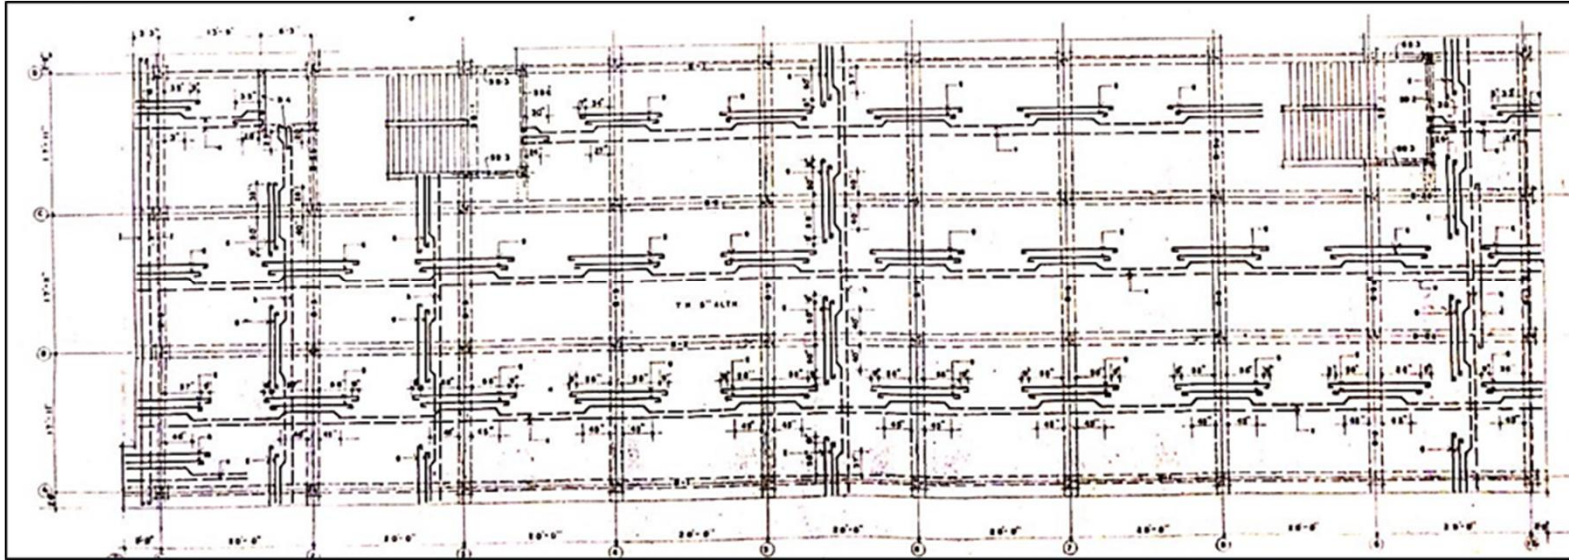
1st Priority 3 Concern

Typical 127mm concrete slab (5in)

- The slab appears to be thinner than what is required. The span/depth ratio of slab = $6090/127 = 47 > 38$
- The design seems to lack a long term deflection analysis consideration.

ITEM 2: (1st Priority 3) Depth of slab is very thin and the design seems to lack a consideration of long term deflection analysis.

Very thin slabs could result in excessive long term deflections

- Building Engineer to verify design and check with full compliance to design codes
- Long term deflection criteria to be justified

- If the slabs are found not to comply, then remedial details should be proposed and installed.
