# AMS International (Sweaters) Ltd.

34 Choydana, P.O. National University Gazipur-1704  
(23°57'43.9"N 90°22'47.2"E)

26 APRIL 2014

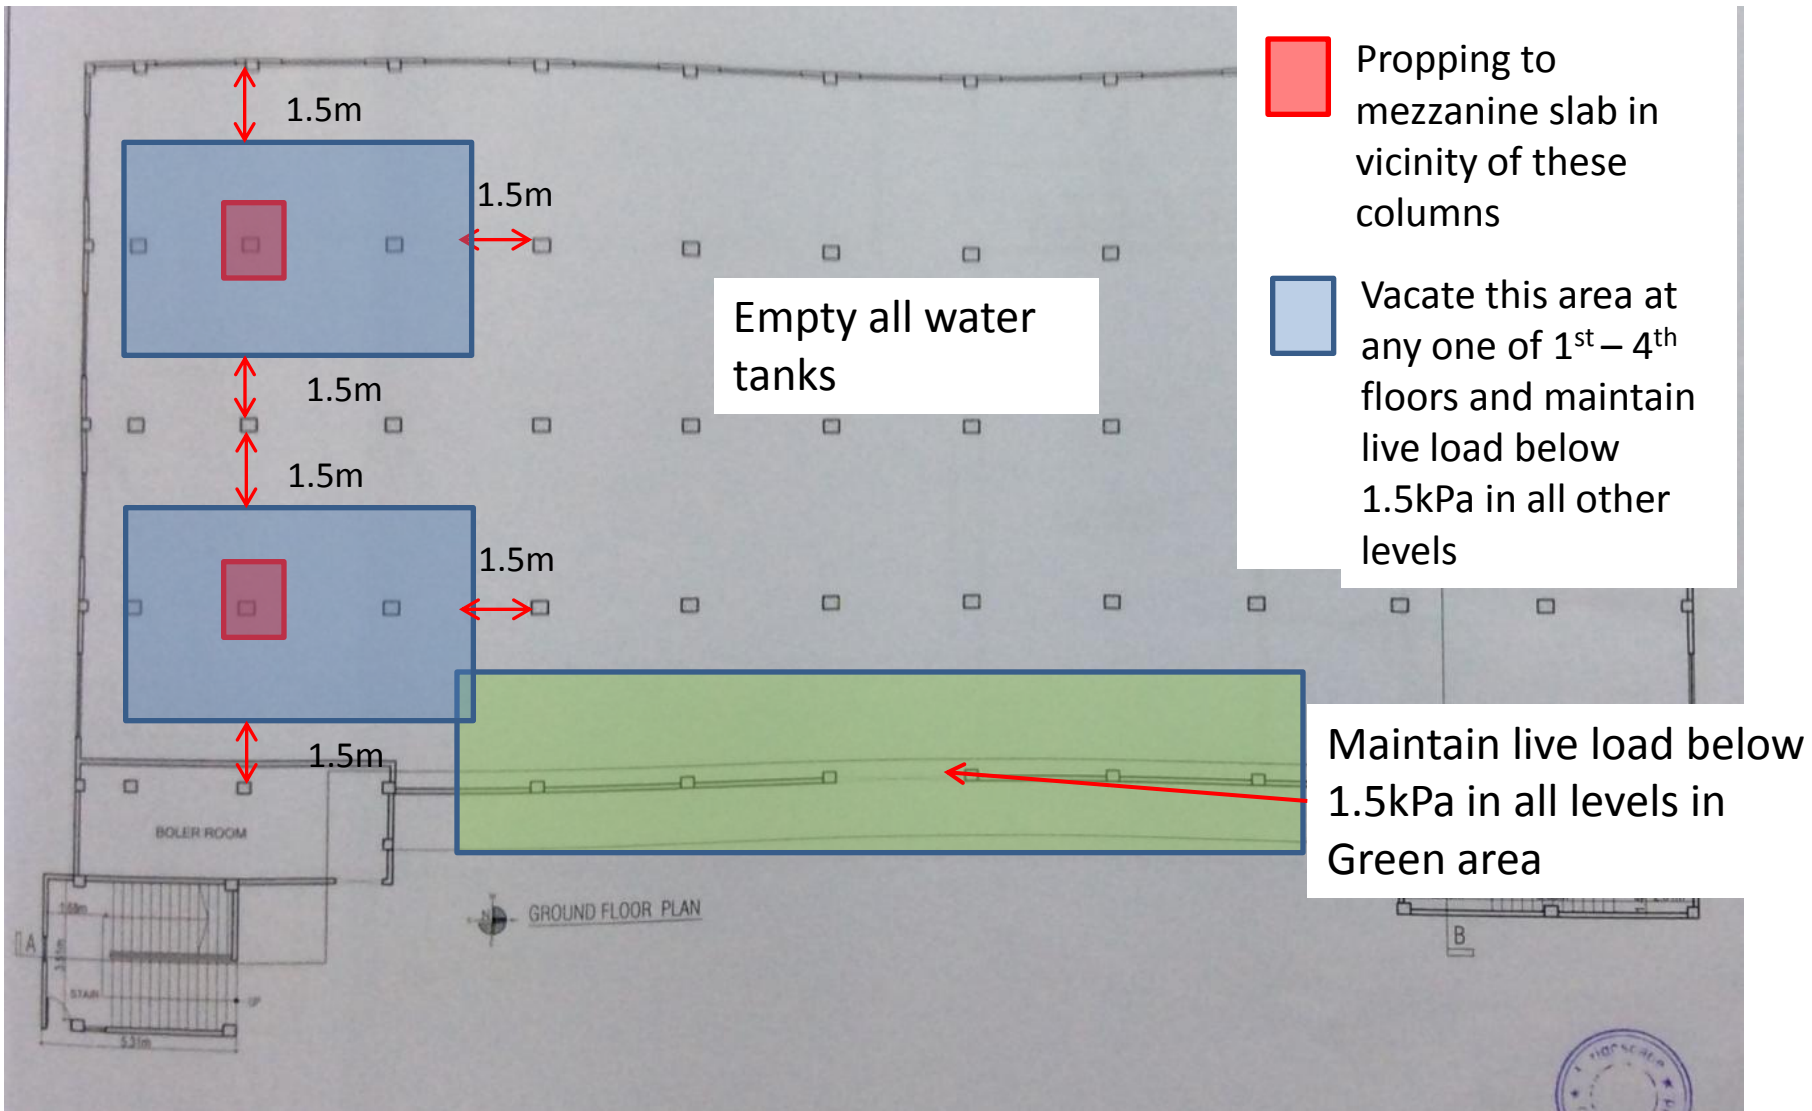
**We do have important and urgent concerns in relation to the adequacy of the structural columns.** Some columns appear to be stressed to levels that require immediate review. The following **immediate** actions are required to be carried out:

Location plan showing required load reductions

1. The water tanks on the roof should be emptied and should be relocated to a suitable position. The Building Engineer should confirm that the proposed location is capable of supporting water tank loading.

2. The areas highlighted on following page should be vacated at floors indicated and loads reduced to a maximum of 1.5kPa at all other levels
3. The mezzanine at ground floor should be propped down to the ground floor slab so it does not load the columns in question. The Building Engineer should determine the location and number of props required.

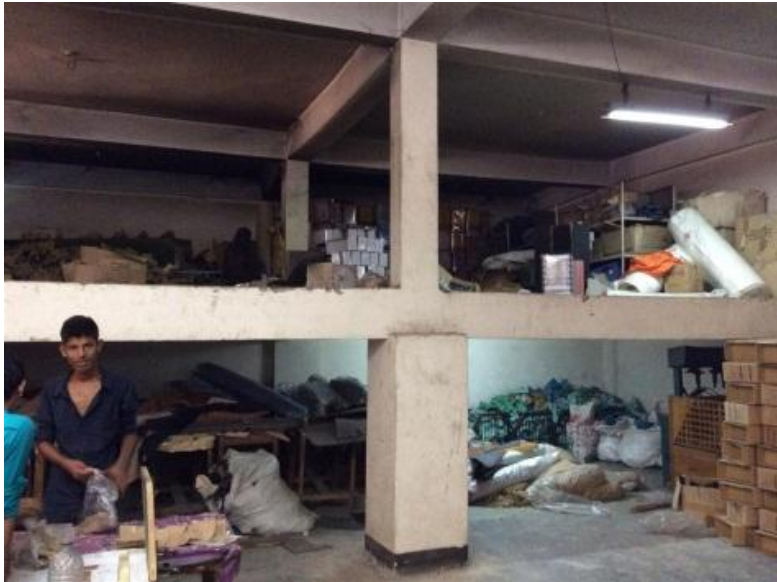
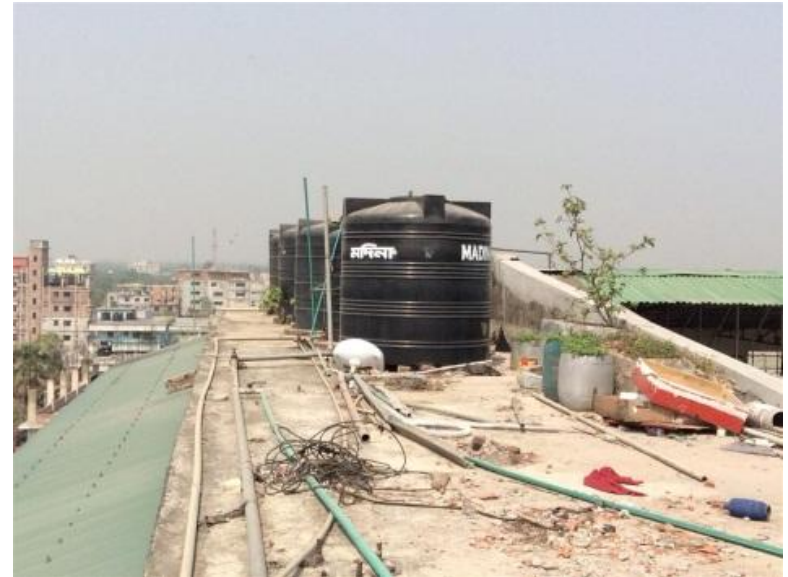
## Columns strength

**High column stresses  
Detail Engineering Assessment required**

**Outline calculations indicate that working stresses in the areas highlighted in the Executive Summary are high.  
Carry out load reductions as indicated in Executive Summary**

A Detail Engineering Assessment of the building is required (See attached Scope) .  
Engineer is to perform detailed calculations based on as-constructed dimensions, and  
carry out concrete tests to prove column size.

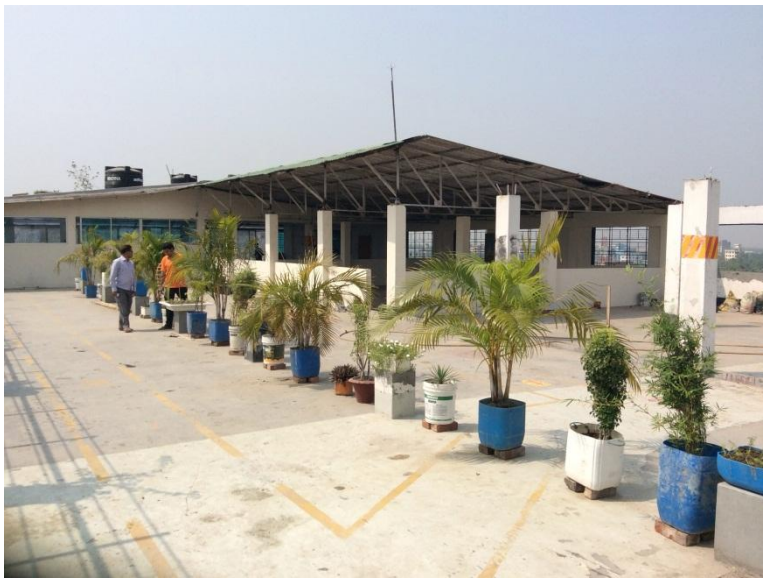
Building Permit for Building is for 5 storeys - the steel structure is not in scope of permit.  
Non-engineered lightweight steel roof addition does not appear to be strong enough to withstand severe wind events, with limited lateral stability system

- Building Engineer to survey and prepare as-built drawings for additional structure as part of Detail Engineering Assessment (see Item 1).
- Building Engineer to carry out design checks on additional structure as part of Detail Engineering Assessment, in particular resistance to wind uplift, given the current connection details

- Carry out any upgrade measures required as part of the design checks or remove structure

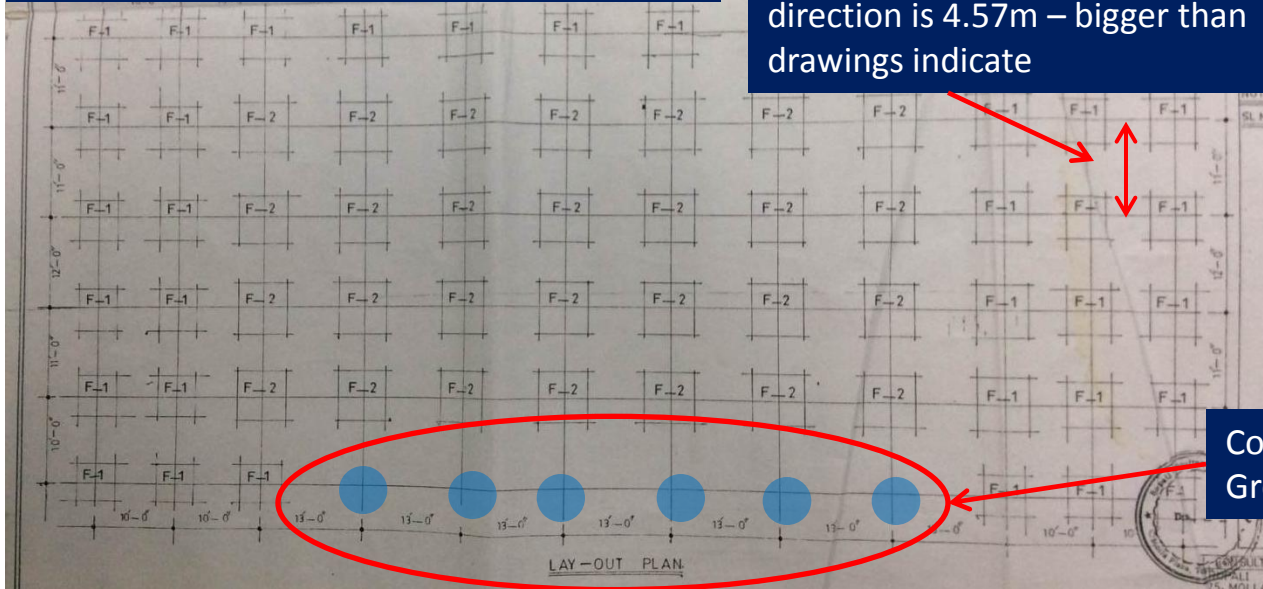
Floor plan on structural drawing (undated )

Typical grid spacing in this direction is 4.57m – bigger than drawings indicate

Columns in these locations from Ground to first not shown on drawing

- Building Engineer to carry out dimensioned as-built survey of the building
- Collect and produce accurate complete as-built drawings as part of Detail Engineering Assessment.

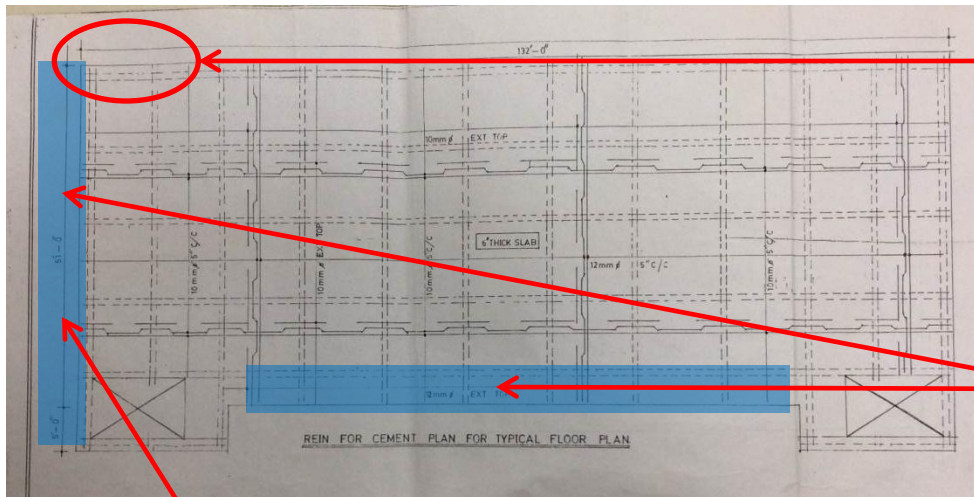
Perimeter structure is off grid in this area over full height of building

Slab cantilevers not shown or not shown accurately in areas indicated

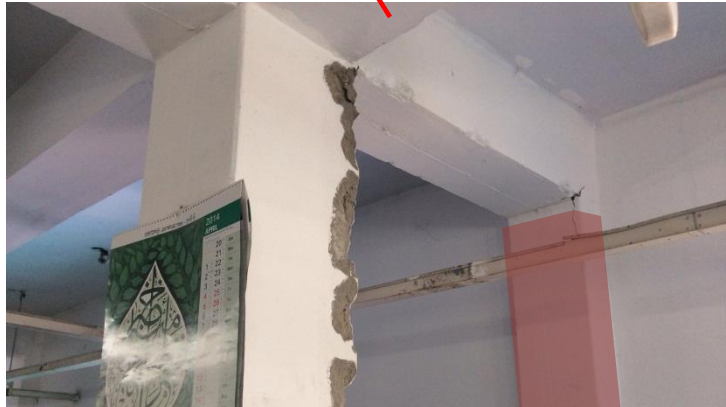
Extent of cantilever on south elevation (brick pier shaded)

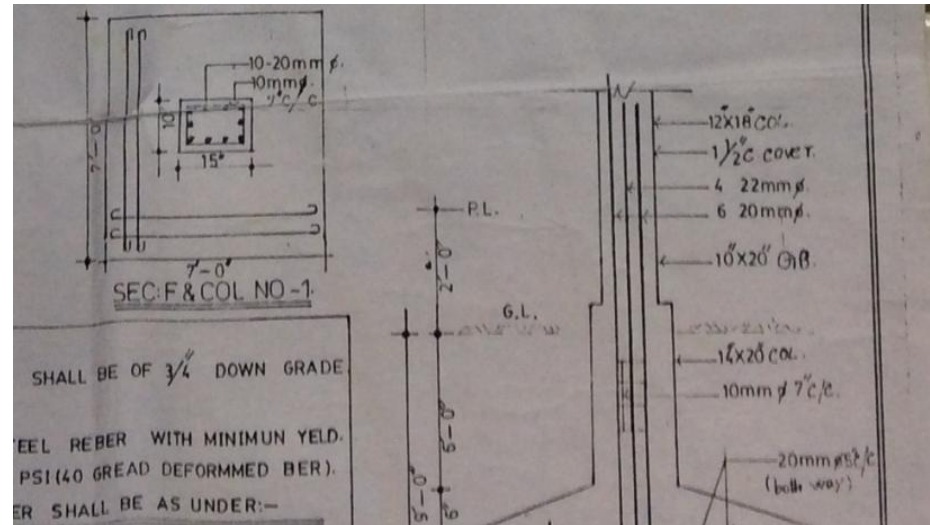
Columns are typically smaller than indicated on drawings.  
 Typical internal columns:  
 Specified: 300 x 450  
 Actual: 300 x 385
