FIRE SAFETY INSPECTION REPORT

**TEXEUROP (BD) LTD.
VOGRA, JOYDEVPUR**

ACCORD
on Fire and Building Safety in Bangladesh

July 13, 2014

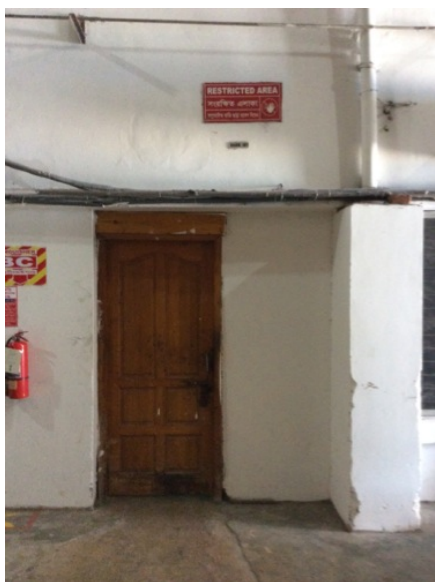
No.	Category	Finding	Recommendation	Remediation Timeframe
F-1	Fire Rated Construction	Hazardous materials room is not separated by fire-rated construction.	Separate the hazardous materials room by a minimum 2-hr fire-rated construction. Seal and/or protected all openings to maintain the required fire separations.	Within 3 months

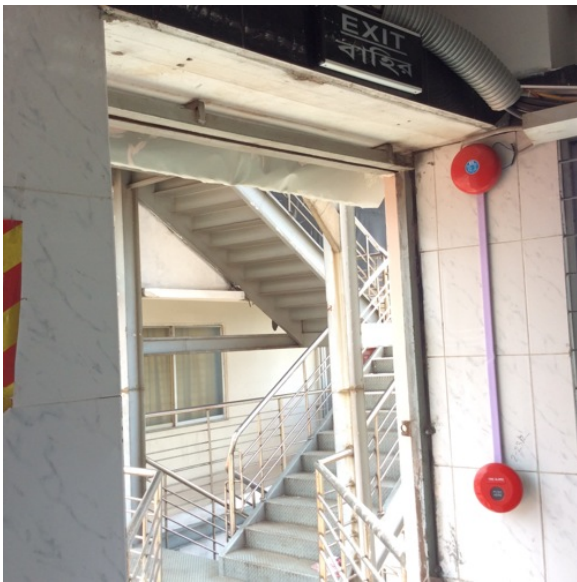
F-2	Fire Rated Construction	The exit stairs are not separated from work areas on each floor by fire-rated construction.	Provide minimum 1.5-hr fire rated doors and seal all unprotected openings to separate the exit stairs from work areas and other building spaces on all floor levels. Ensure that the fire doors are self-closing and positive latching and that they are provided with fire exit (panic) hardware where serving production floors.	Within 3 months
			If fire doors are required to be held open for functional reasons, provide automatic-closing devices tied to the fire alarm system.

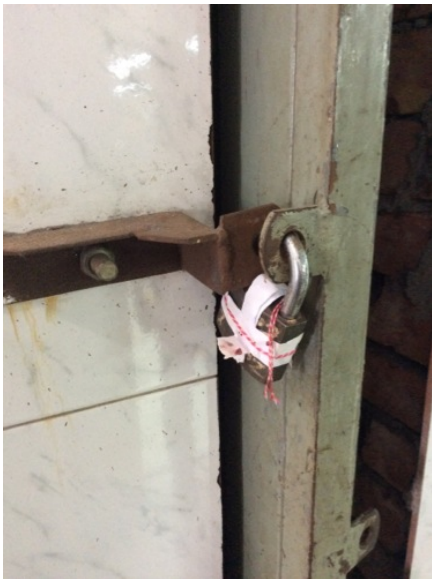
F-3	Fire Rated Construction	The exit discharge path serving the Dyeing Shed is less than 10 ft wide and is not separated from the building interior.	Seal all penetrations and openings to the interior of the building along the discharge path, up to a height of 10 ft., to provide a minimum 1-hr fire separation. Alternatively, provide a second remote discharge path to the public way (only include this if feasible).	Within 6 months
F-4	Egress	Egress doors with locking features are provided at building exits, exit stairs, and, exit discharges.	Remove locking features from all egress doors. If locks are required for security reasons, utilize special door locking features complying with NFPA 101.	Immediate

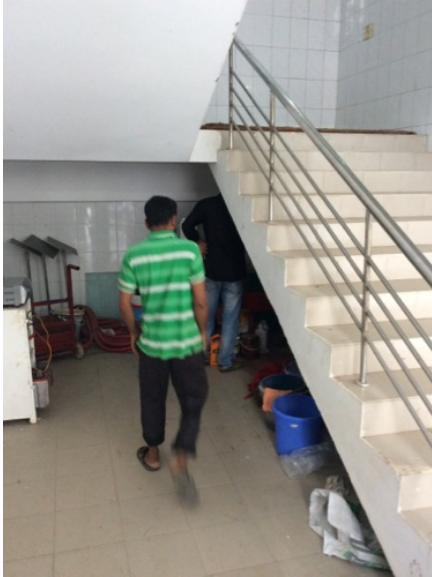
F-5	Egress	Storage was located on the ground floor in Stairs 2 and 4. An electrical panel without fire rated separations is located on the ground floor of Stair 1.	Remove all storage from exit stairs and egress paths. Relocate electrical panel or provide fire rate separations.	Immediate
-----	--------	---	--	-----------

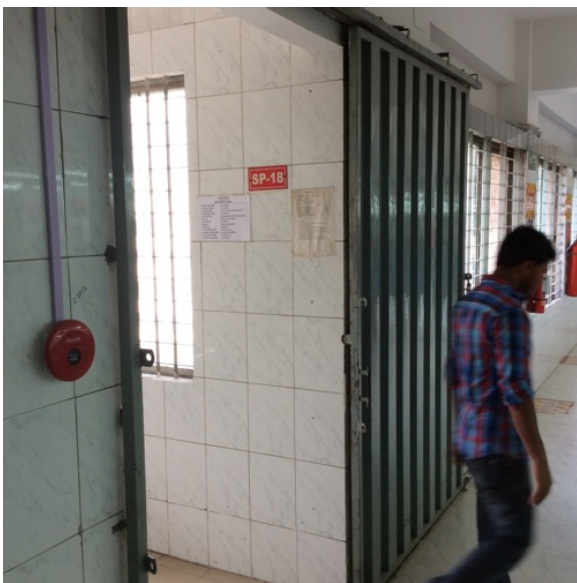
F-6 Egress

Sliding doors are provided at building exits, exit stairs, and exit discharges.

Replace all sliding doors along the means of egress with side-hinged, swinging egress doors.

If locks are required for security reasons, utilize special door locking features complying with NFPA 101.

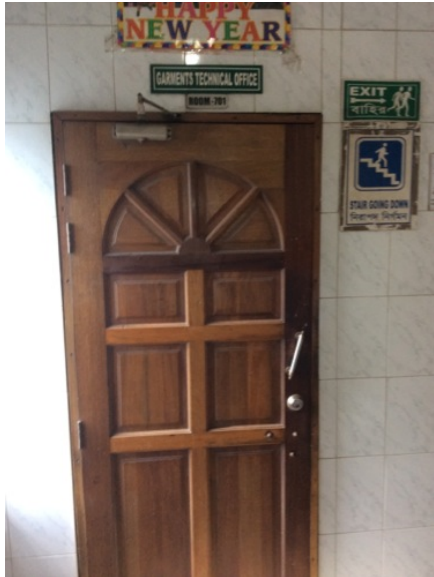
F-7	Egress	Exit stair door from the office to Stair 1 does not swing in the direction of egress travel.	Modify the egress door to swing in the direction of egress travel.	Within 3 months
-----	--------	--	--	-----------------

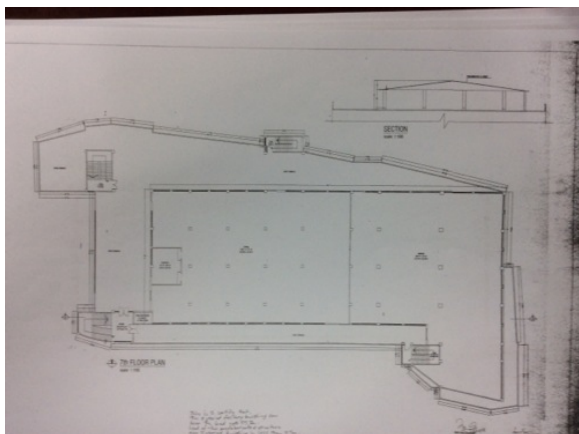
F-8	Egress	A single means of egress is provided from the women's dining area where the occupant load exceeds 49 persons.	Provide additional means of egress.	Within 3 months
-----	--------	---	-------------------------------------	-----------------

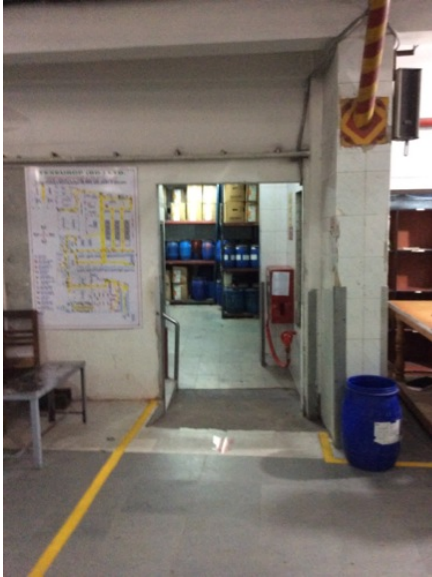
F-9	Egress	Stair 3 discharges inside the building.	Sufficient egress capacity is provided by Stairs 1, 2, and 4. Remove exit markings from Stair 3.	Within 6 months
-----	--------	---	---	-----------------

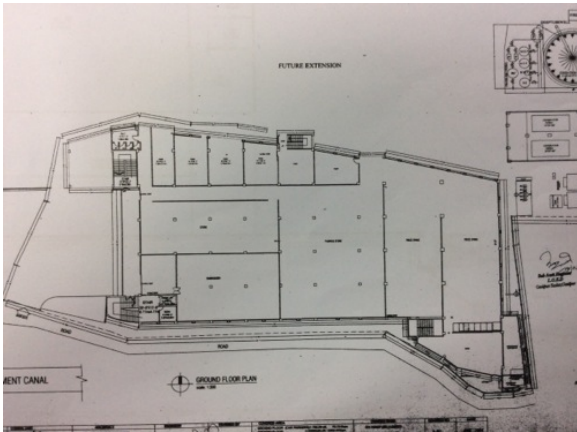
F-10	Egress	The exits are not remotely located from each other in the embroidery room such that a single fire event could compromise both exits.	Modify exit arrangement. OR Provide an additional exit. OR Provide sprinkler protection in accordance with NFPA 13.	Within 6 months
------	--------	--	---	-----------------

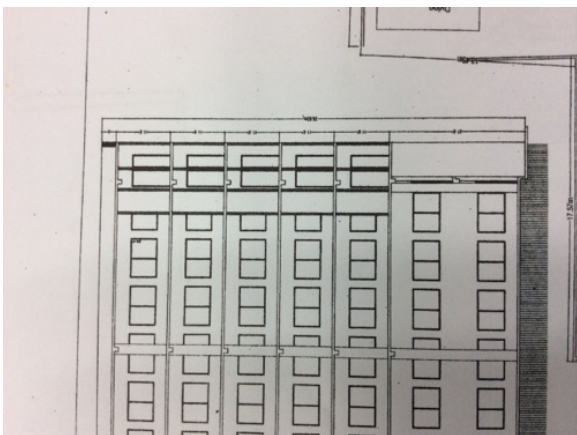
F-11	Fire Protection	The high-rise building has an occupied floor greater than 23m (75 ft) and is not provided with automatic sprinkler protection. The large occupant loads, heavy fuel loading, and anticipated extended egress times warrant sprinkler protection.	Provide automatic sprinkler protection throughout the building in accordance with NFPA 13.	Design within 6 months, install within 12 months
------	-----------------	--	--	--

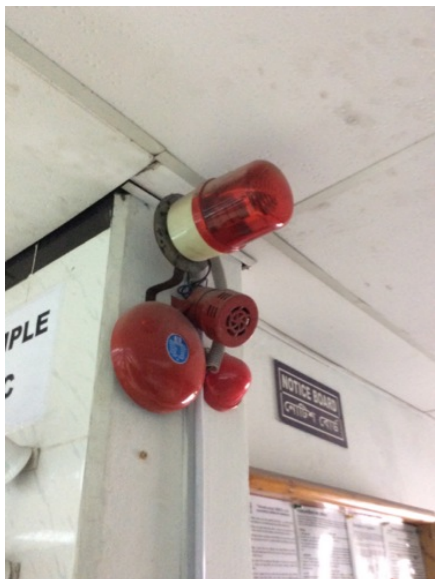
F-12	Fire Protection	Inspection, testing, and maintenance of the fire alarm system is not in accordance with NFPA 72.	Inspect, test and maintain the fire alarm system, and keep written records on-site, in accordance with NFPA 72.	Within 3 months
------	-----------------	--	---	-----------------

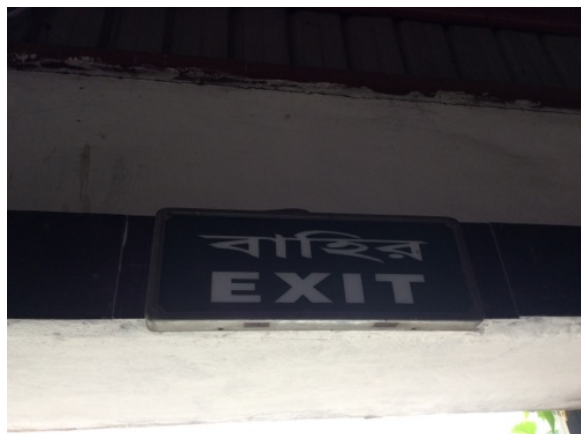
F-13	Egress Lighting	Exit signage not illuminated in one location.	Regularly inspect all exit signage and replace/install lights as needed to illuminate signs.	Within 1 month
------	-----------------	---	--	----------------

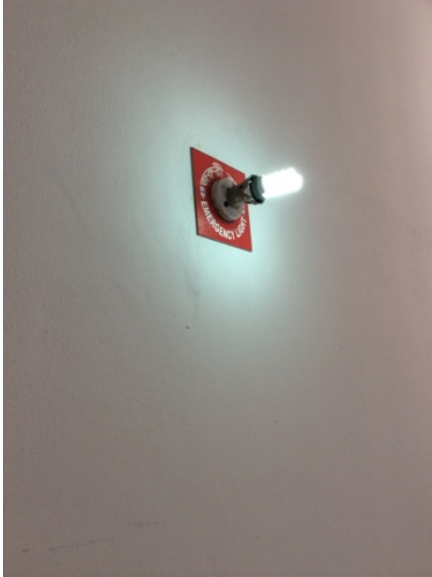
F-14	Egress Lighting	Inspection, testing, and maintenance for the emergency lighting system was not in accordance with The ACCORD standard.	Inspect, test and maintain the emergency lighting system in accordance with The ACCORD standard. Keep written records on-site.	Within 3 months
------	-----------------	--	--	-----------------
