# **FIRE SAFETY INSPECTION REPORT**

## **Golden Refit Garments Ltd (Extension)**

**ACCORD ID: 12593**

**Date: 14 November, 2016**

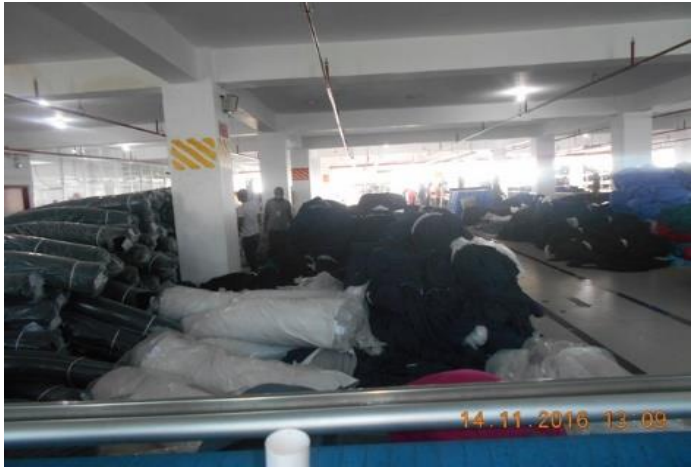
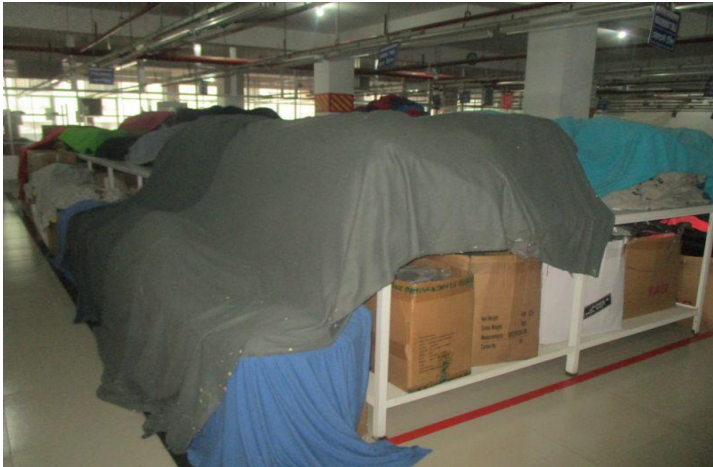
| SI No. | Category | Findings | Required Action | Remediation Time Frame |
|---|---|---|---|---|
| F-1 | Fire Rated Construction | Areas used for in-process storages of combustible materials are open to the factory floors. <b>Location:</b> 1st, 5th & 6th floors | <p>Provide defined storage areas and limit the storage arrangement as follows:-</p> <ol style="list-style-type: none"> <li>1. General Condition: Maximum height of 2.4m and maximum area of 23m<sup>2</sup>. Separate areas of unenclosed combustible storage by a minimum clear distance of 3m.</li> <li>2. If sprinkler protected: maximum height of 3.66m and maximum area of 93m<sup>2</sup>. Separate areas of unenclosed combustible storage by a minimum clear distance of 3m.</li> </ol> <p>or</p> <ol style="list-style-type: none"> <li>3. Enclose the storage area from the surrounding occupancy with a minimum 1 hour construction.</li> </ol> | Within 3 months |

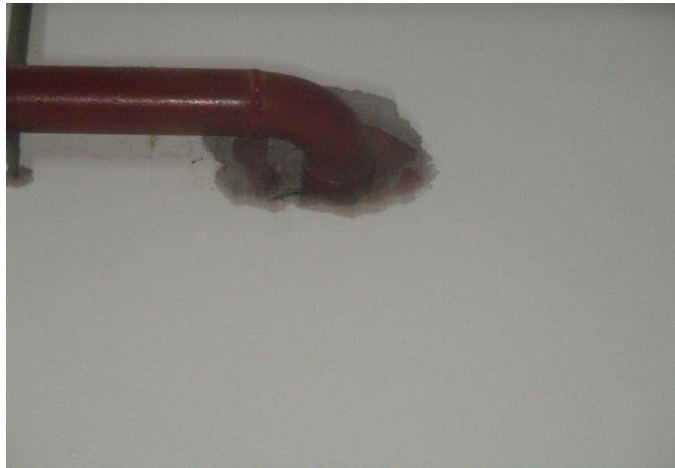
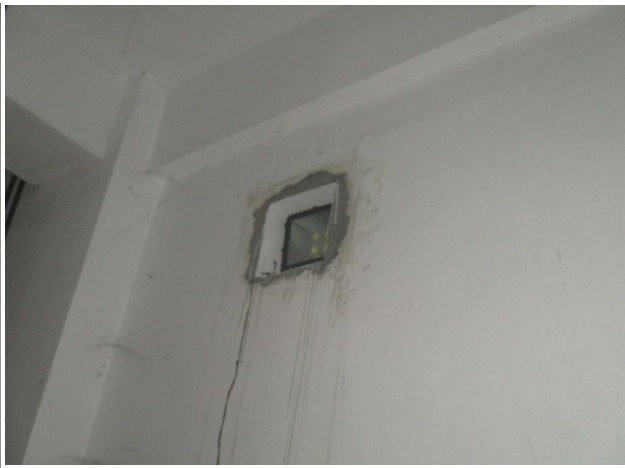
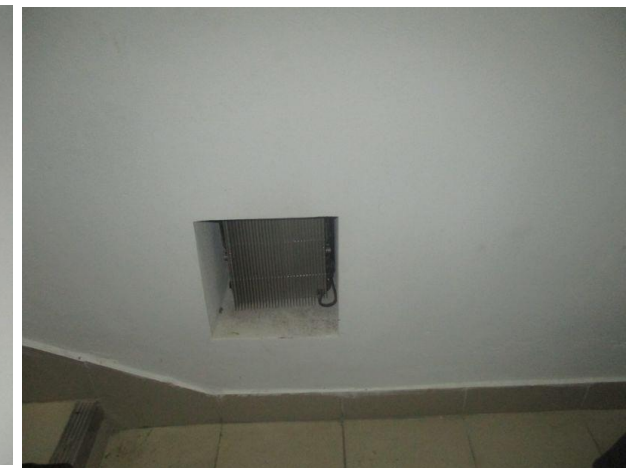
| F-2 | Fire Rated Construction | <p>Rooms used for storage of combustible materials are not separated from the surrounding areas due to unsealed penetrations. <b>Location</b> : Ground floor finished goods store (Penetrations due to lighting units &amp; hydrant pipes)</p> | <p>Rooms used for storage of combustible materials shall be separated from the surrounding occupancy with a minimum 1 hour fire rated construction. Seal all the penetrations to maintain the fire separation.</p> | Within 3 months |

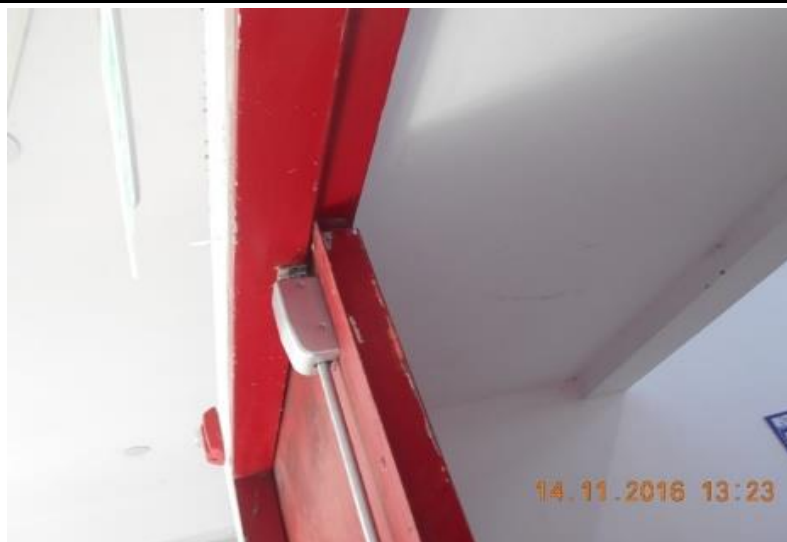
| F-3 | Fire Rated Construction | The double leaf fire doors provided at south-east exit stairs are not equipped with door co-ordinators. | <p>Provide door co-ordinators for double leaf fire doors for proper functioning.</p> <p>If fire rated doors are required to be held open for functional reasons, ensure automatic closing devices tied to the fire alarm system.</p> <p>Every door in a stair enclosure serving more than 5 stories shall be provided with re-entry unless it meets ACCORD standard 6.8.3.1</p> | Within 3 months |

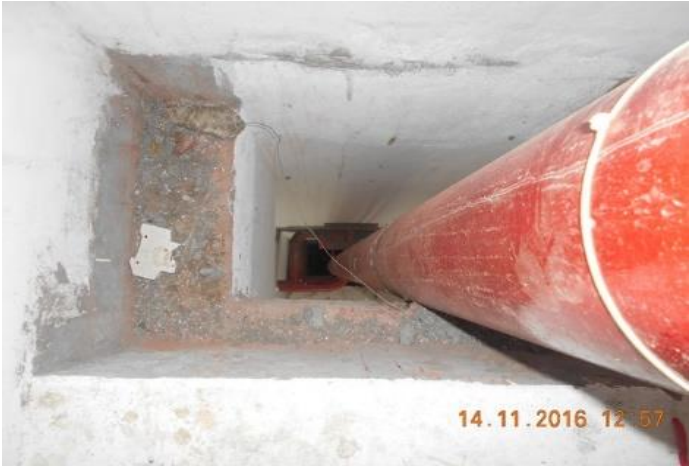
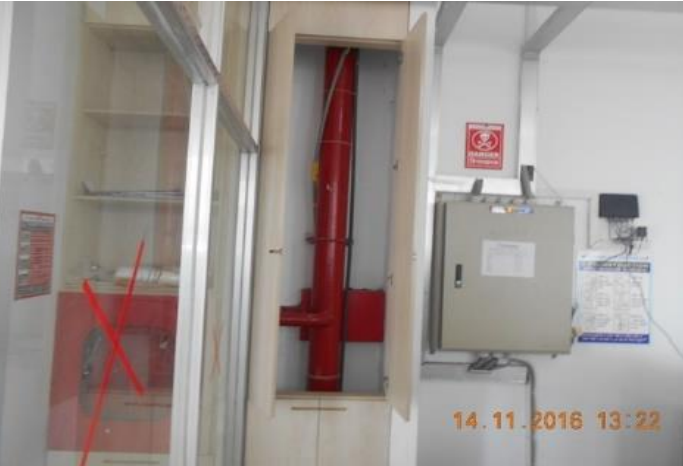
| F-4 | Fire Rated Construction | <p>Penetrations through fire rated floor/ceiling assemblies are found unsealed.</p> <p><b>Location:</b> South-East fire hydrant riser</p> | <p>Seal all penetrations and openings in floor/ceiling (full thickness of the floor/ceiling) assemblies by fire rated materials to maintain the fire resistance rating or, Provide a minimum 2-hr fire rated shaft to separate the utility risers from each floor if required.</p> | Within 3 months |

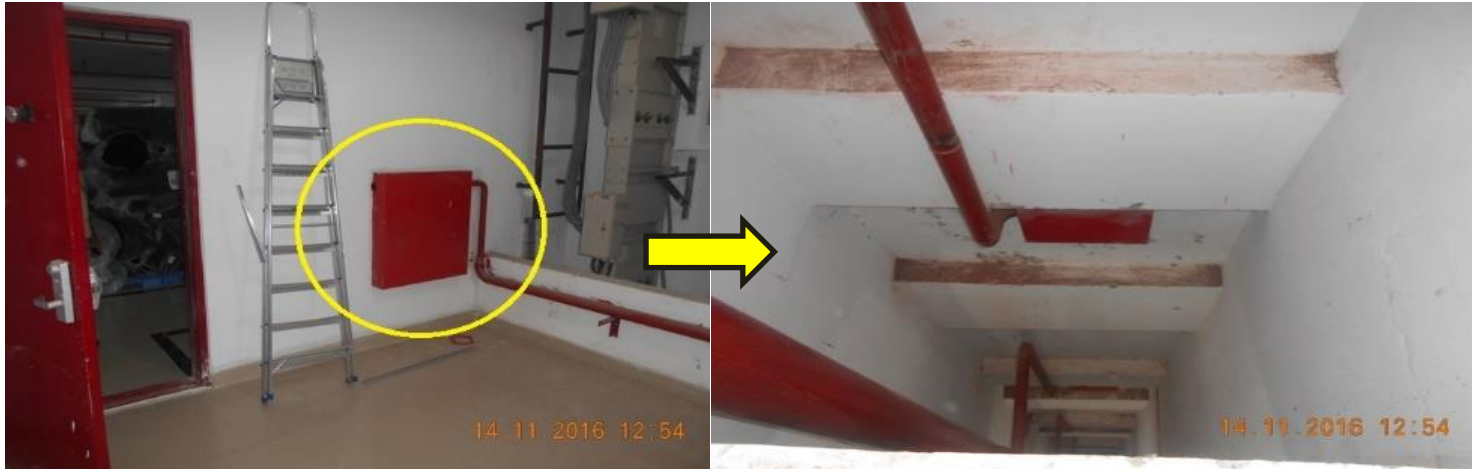
| F-5 | Fire Rated Construction | <p>The maintenance room is not separated by fire rated construction due to the penetrations created by hydrant boxes at every floor. <b>Location:</b> North-East side every floor</p> | <p>Provide a minimum 2-hr fire rated shaft to separate the utility risers from each floor if required<br/>or,<br/>Seal all penetrations and openings in floor/ceiling (full thickness of the floor/ceiling) assemblies by fire rated materials to maintain the fire resistance rating</p> | Within 3 months |

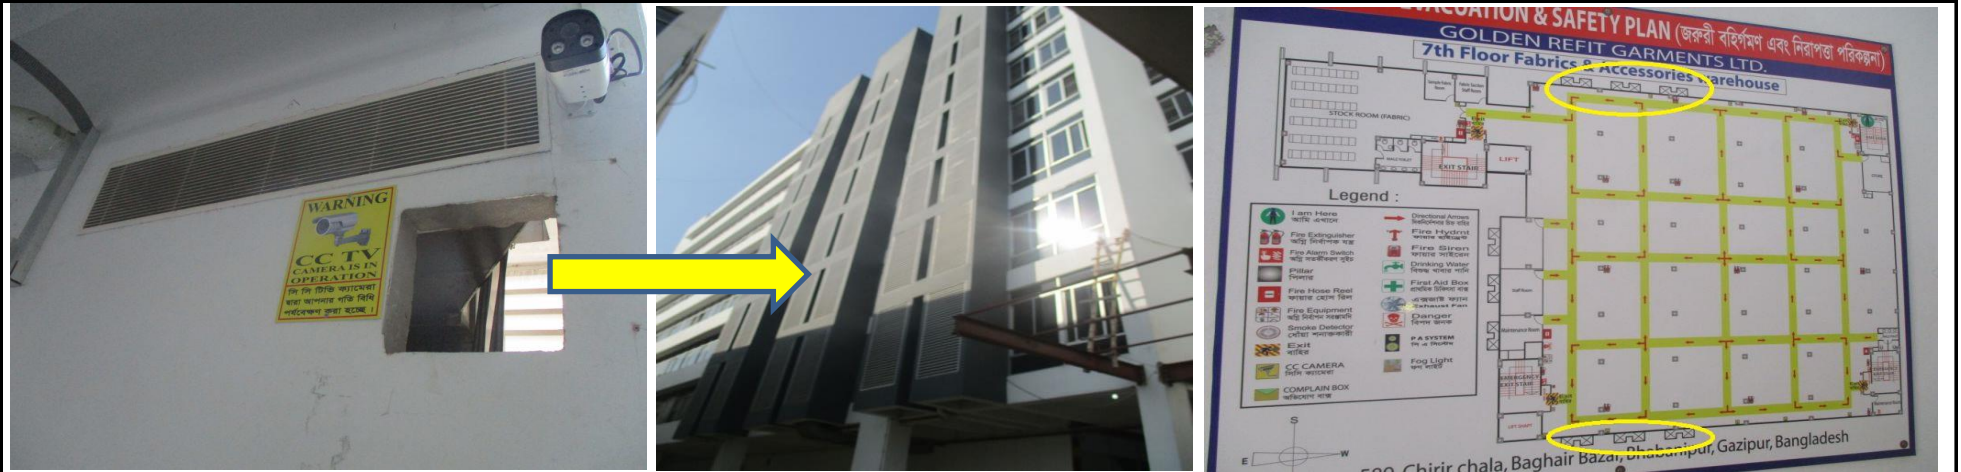
| F-6 | Fire Rated Construction | <p>External air ventilation shaft connecting all the floors is not properly separated from each production floor by fire rated construction.</p> <p><b>Location:</b> Air ventilation risers (South &amp; North side of the factory building)</p> | <p>Provide a minimum 2-hr fire rated construction to separate the ventilation shaft from each floor level.</p> <p>Seal all penetrations and openings in floors/ceiling assemblies to maintain the fire separation.</p> | Within 3 months |

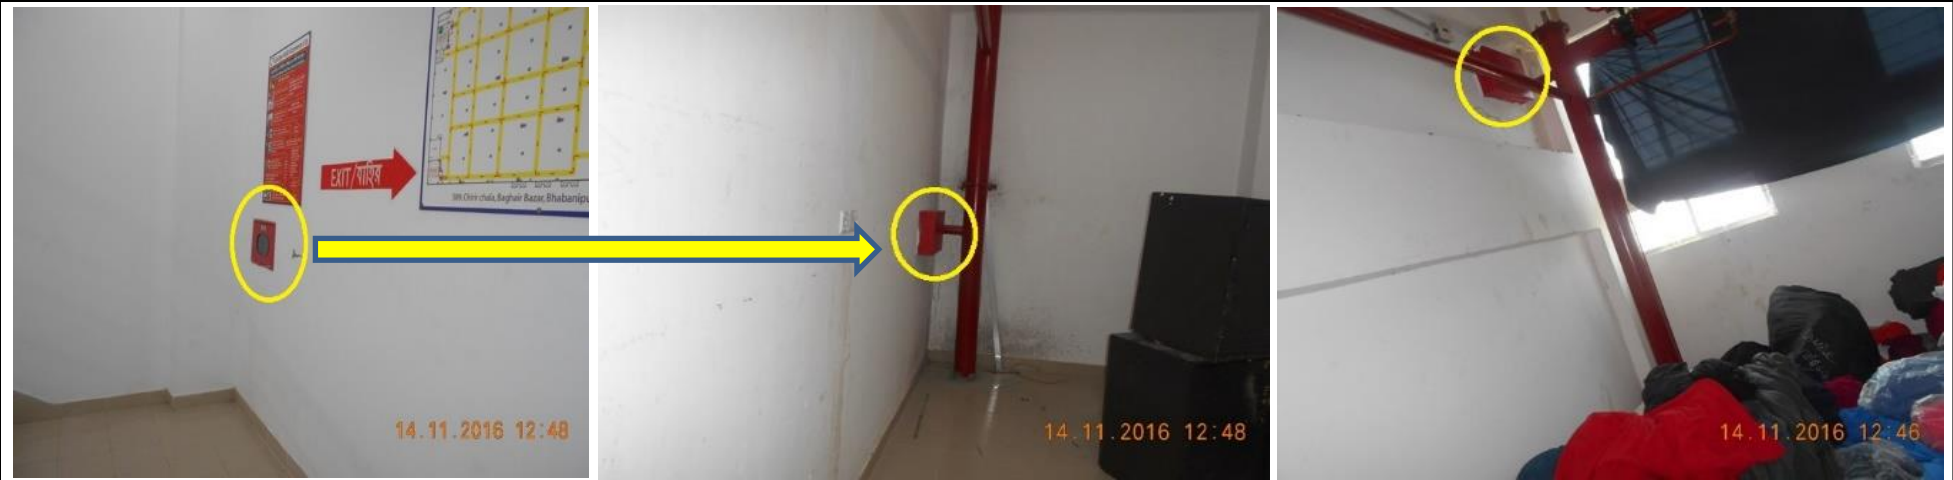
| F-7 | Fire Rated Construction | Unsealed penetrations due to the non rated hydrant boxes were located in the exit stair enclosures | Seal all penetrations and openings in exit stair enclosure walls to maintain the fire separations. | Within 3 months |

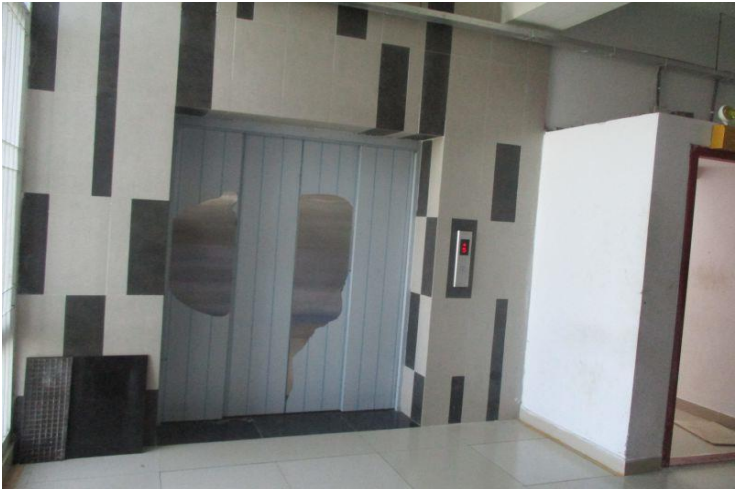
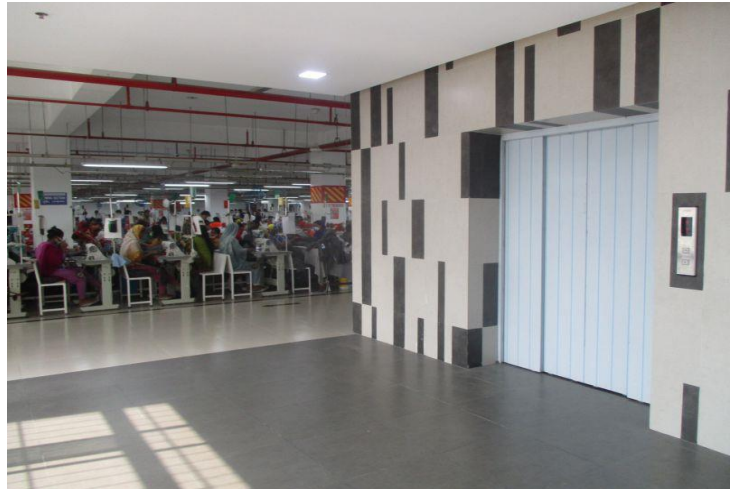
| F-8 | Fire Rated Construction | The openings of two elevator shafts discharging toward the processing floors are not fire rated. Though lift's door typically fire rated, but no credible certificate found for the lift's doors. | Provide a minimum 2-hr fire rated construction to separate the elevator shaft from each floor level. Protect the openings of shaft enclosure by providing minimum 1.5-hr rated opening protectives. | Within 3 months |

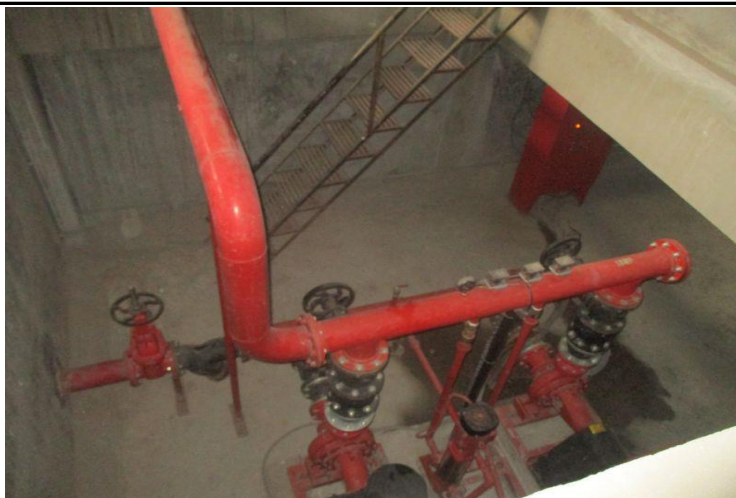
| F-9 | Fire Rated Construction | The fire pump room is not provided with adequate fire separation. <b>Location:</b> Underground (Facility Building) | Provide fire pump room with 2 hr rated fire separation when not sprinklered and 1 hr rated fire separation when provided with automatic sprinklers in accordance with NFPA 20<br>Or,<br>Physically separate the pump room from the protected building by a minimum of 50 ft. (15.3 m) in accordance with NFPA 13 & 20 | Within 3 months |

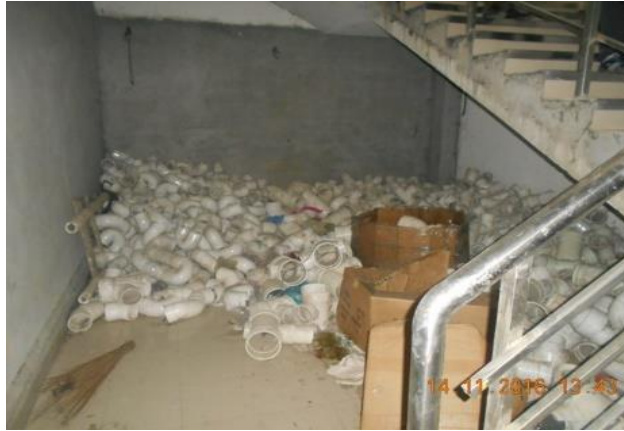
| F-10 | Egress | Storage was located in the exit north-west exit stairwell. | Remove all storage from exit stairs and egress paths. | Immediate |

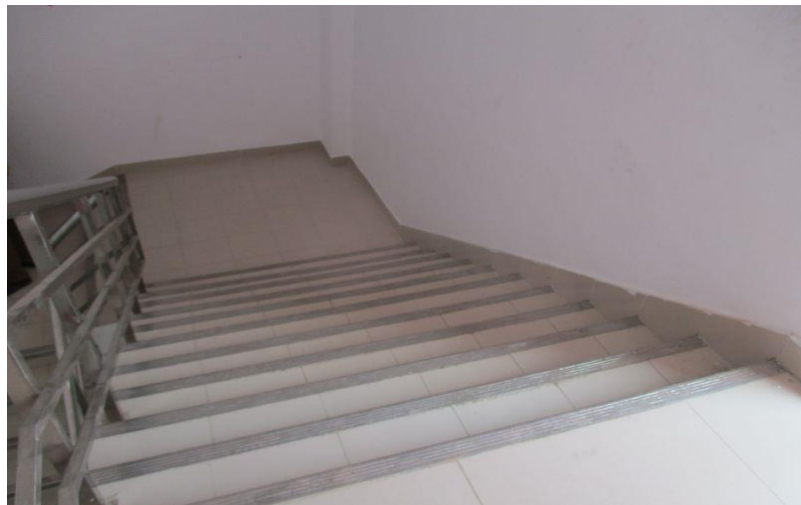
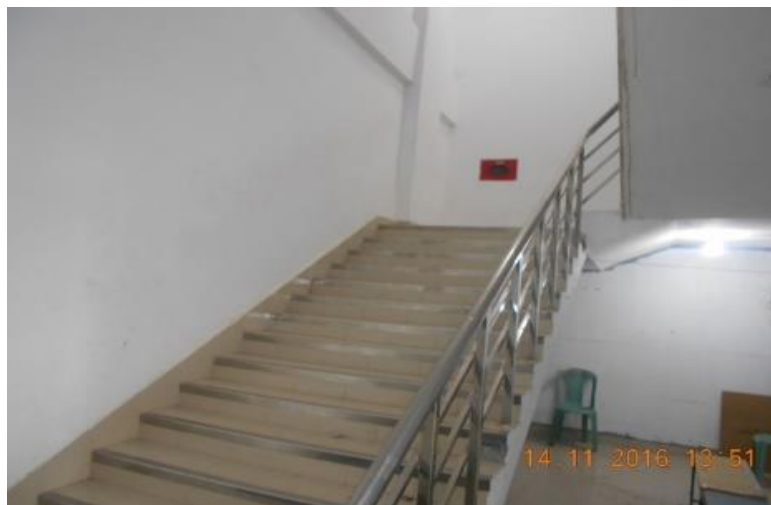
| F-11 | Egress | Handrails are not provided on both sides of each exit stairs on all floors. Having handrails on one side of said staircase, may pose as a falling hazard during evacuation. <b>Location: All stairs</b> | Provide handrails on both sides of the exit stair. New handrails shall have a minimum height of 865 mm (34 in.) and a maximum height of 965 mm (38 in.) as measured from the leading edge of the tread. Intermediate handrails shall be provided when the stair width exceeds 2.2 m (87 in.) | Within 3 months |

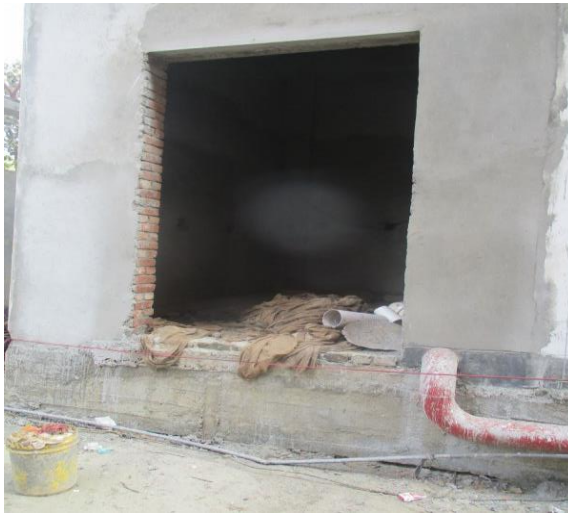
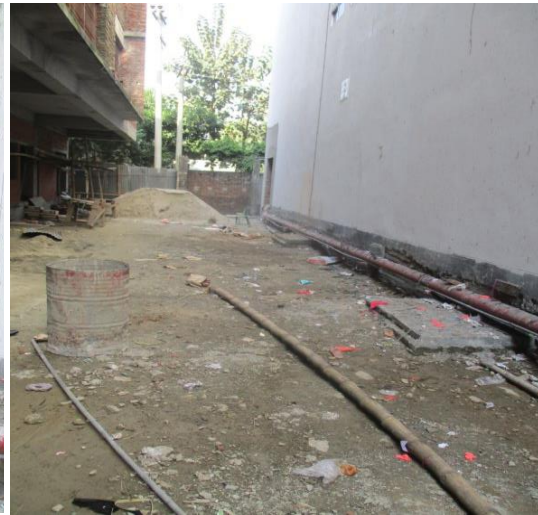
| F-12 | Egress | North-West exit stair does not have a proper exit discharge as well as the discharge path is unusable | Provide steps outside exit door from ground floor to courtyard and make a road / egress path for smooth discharge of occupants. Means of egress shall be maintained continuously free and clear of all obstructions | Within 1 month |

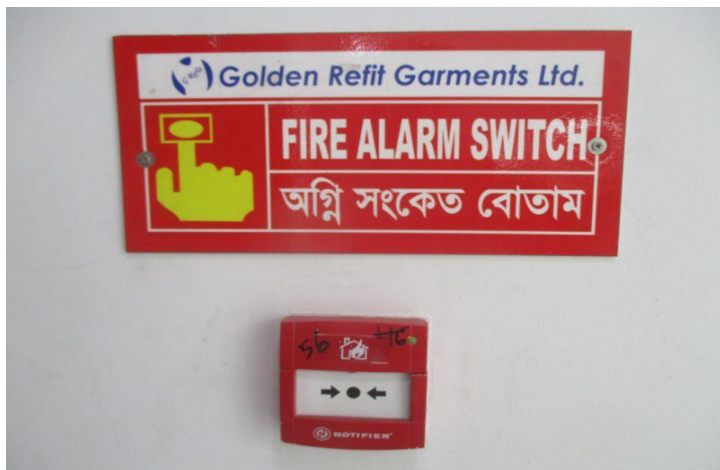
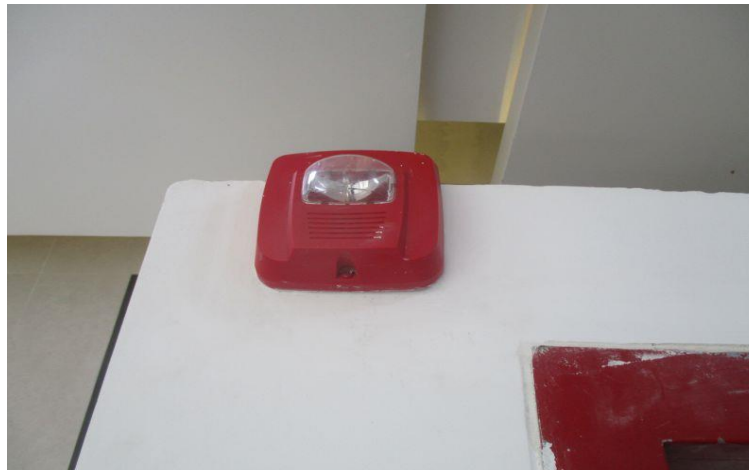
| F-14 | Fire Detection & Alarm System | Fire detection & alarm system installation requires detailed review to confirm compliance with NFPA 72 and ACCORD standards. | <p>Submit as built drawings, testing records, equipment certification and other relevant documentation to the ACCORD for review and approval, modification shall have to done as per the reviewed design (if required)</p> <p>Upon approval &amp; installation/modification the owner shall contact the Accord prior to conducting the final acceptance testing of the fire detection &amp; alarm system installation.</p> | Design within 1 month;<br>Modification of the system (if required) within 4 months |

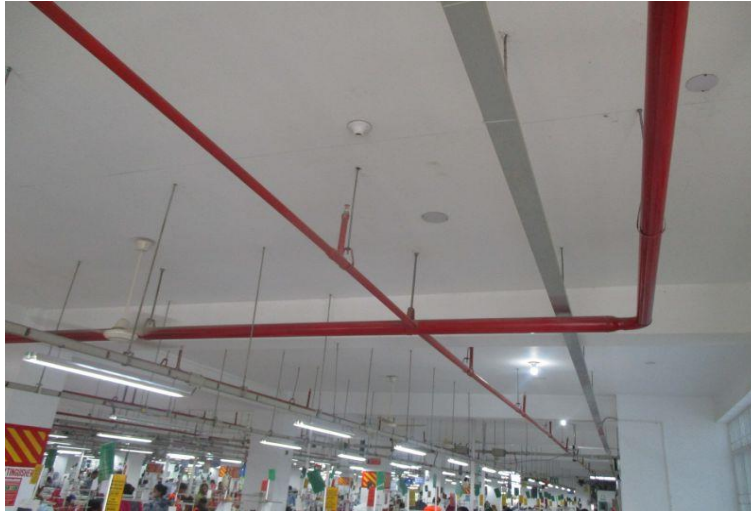
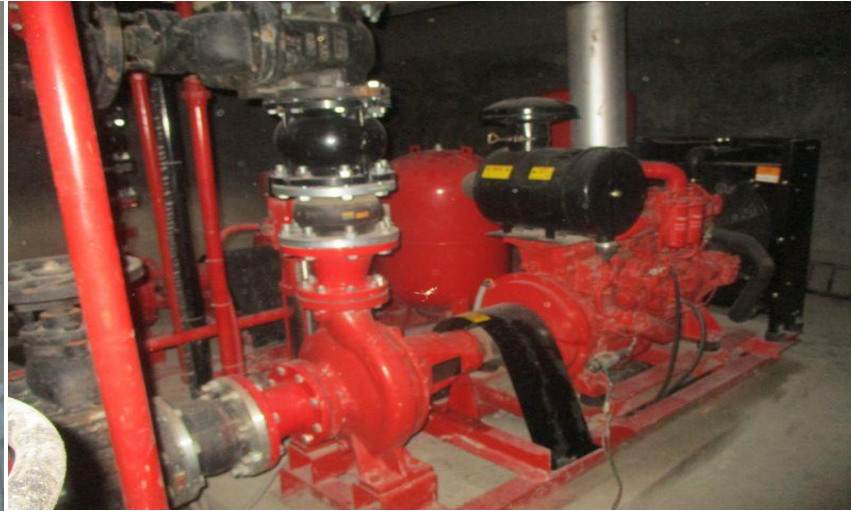
| F-15 | Fire Protection System | Sprinkler system installation requires detailed review to confirm compliance with NFPA 13 and ACCORD standards | <p>Submit as built drawings, testing records, equipment certification and other relevant documentation to the ACCORD for review and approval, modification shall have to done as per the reviewed design (if required)</p> <p>Upon approval &amp; installation/modification the owner shall contact the Accord prior to conducting the final acceptance testing of the sprinkler system installation.</p> | <p>Design within 1 month;<br/>Modification of the system (if required) within 6 months</p> |

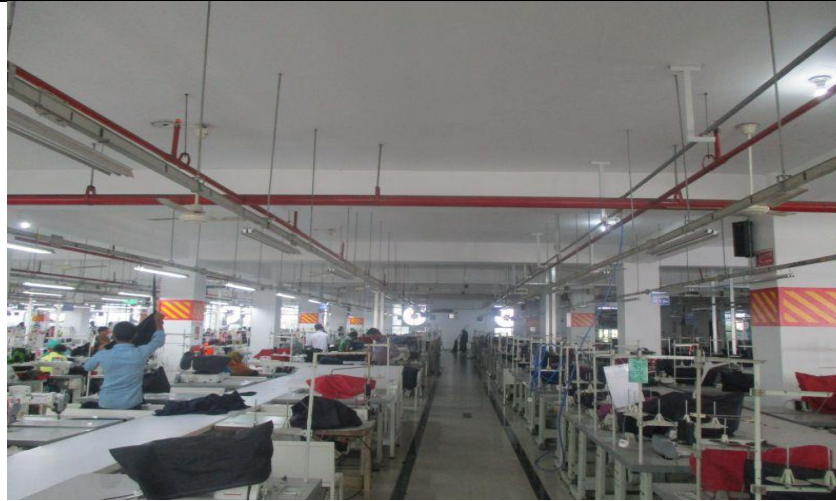
| F-16 | Egress Lighting | Based on the number and location of emergency lights observed, adequate illumination levels are not anticipated along all egress aisles/routes. <b>Location:</b> Several aisles of several floors | Test the emergency lighting system on each floor and provide additional emergency fixtures to provide adequate illumination along the means of egress. Provide a minimum illumination of 10 lux at the floor level within exit stairs and exit discharge paths and minimum 2.5 lux along all exit access aisles. | Within 3 months |
