# Iris Fashion Ltd. MK Fashions Ltd.

Dewan Idrish Road, Zirabo, Savar, Dhaka-1341  
(23.913390, 90.313304)  
11<sup>th</sup> March 2014

# Observations

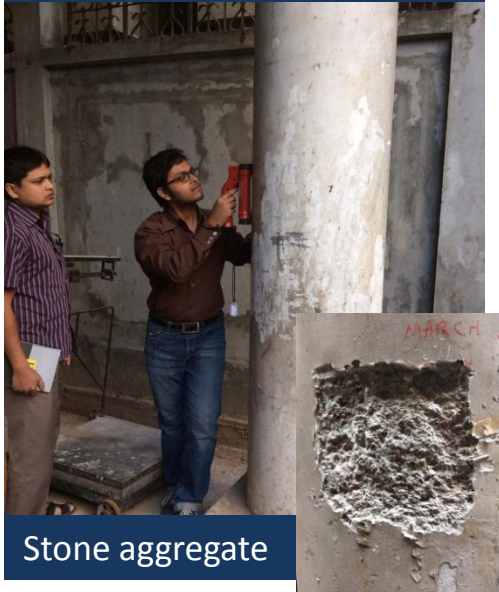
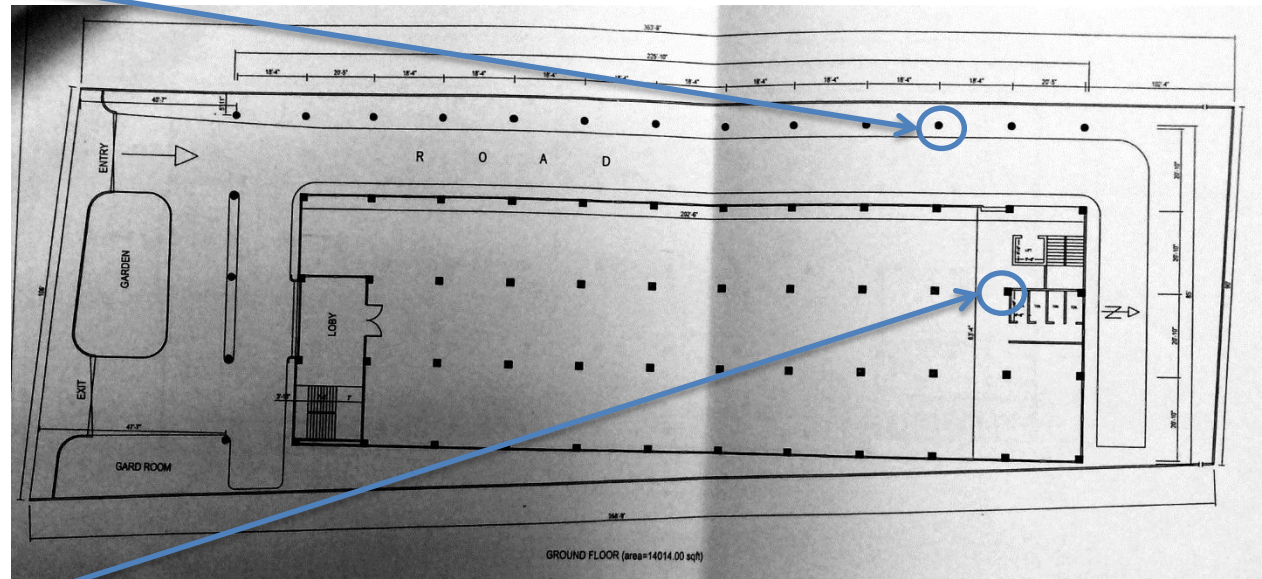
## Perimeter column tested

Stone aggregate

Opening up confirms aggregate type is stone throughout ground floor level columns.

Cursory calculations indicate working stress in some columns are high and warrant review and checking

| Item No. | Observation | Recommended Action Plan | Recommended Timeline |
|---|---|---|---|
| 1 | Verify concrete and reinforcement strengths in all columns | The fire fighting water tank at Level 9 in the area highlighted I (blue)s to be emptied. (Note the other fire fighting tank at this level may remain in use). | Immediate - Now |
| 4 | Verify concrete and reinforcement strengths in all columns | Factory Engineer to review design, loads and columns stresses in all columns. | Immediate - Now |
| 5 | Verify concrete and reinforcement strengths in all columns | Verify stress grade of reinforcement at Ground Floor by exposing steel in lightly loaded column. Verify insitu concrete strength either by 100mm diameter cores or existing cylinder strength data for cores from a minimum of 4 columns. | Immediate - Now |

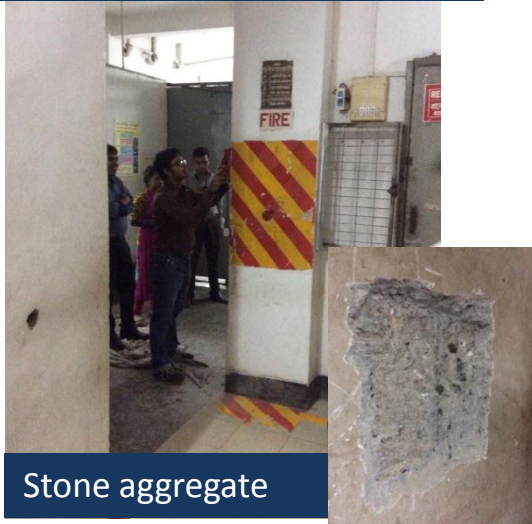
## Internal column tested

Stone aggregate

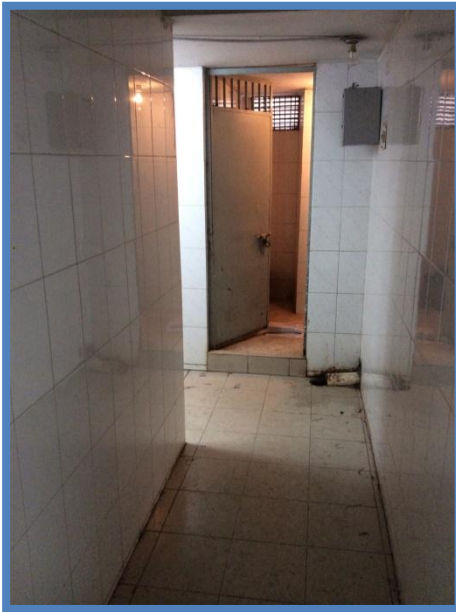
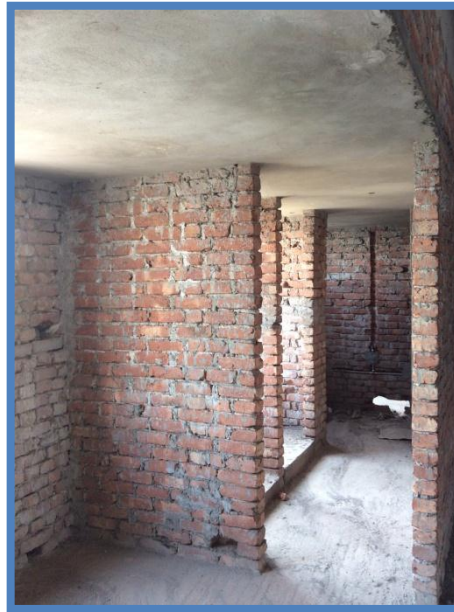
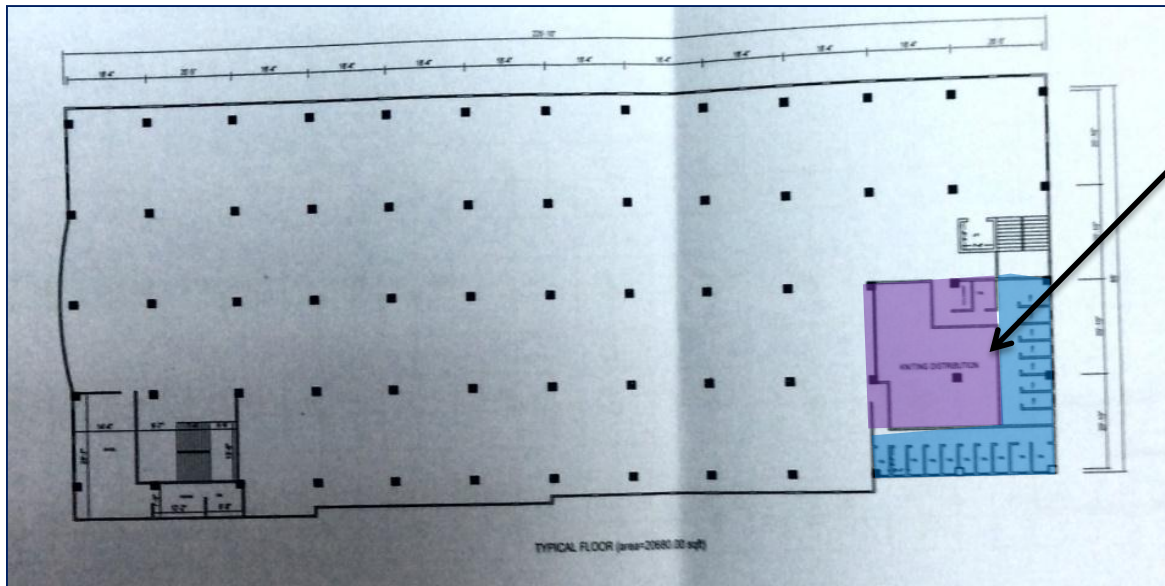
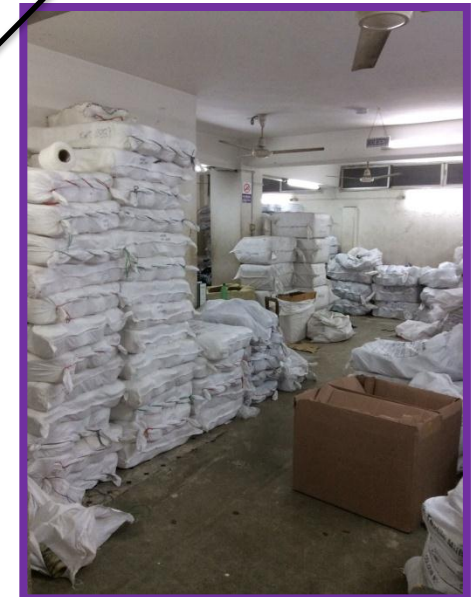
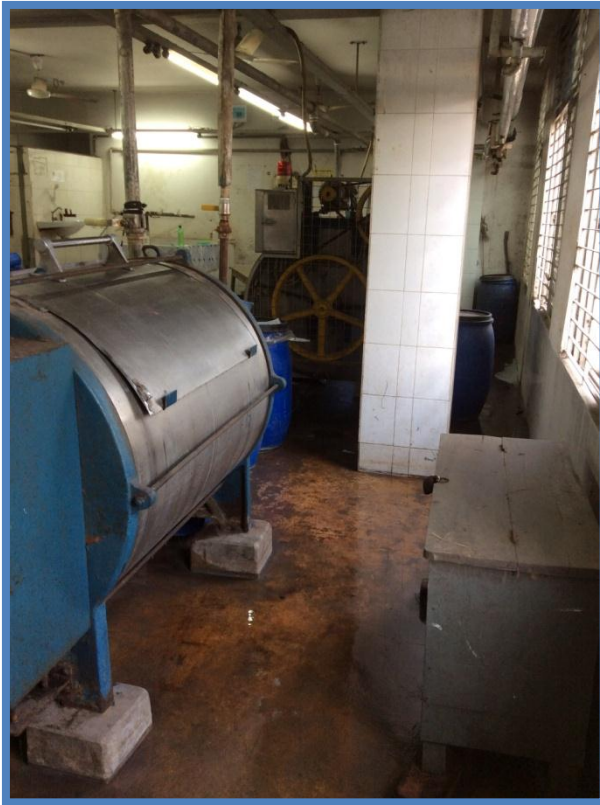
**Floor loading – toilet and storage areas**

High loads arising from heavy toilet floor build-up and dense arrangement of masonry partitions, sometimes cantilevering out from building column line.

Toilets are adjacent to main storage areas on all floors

Toilets and storage at this location on all floors

| Item No. | Observation | Recommended Action Plan | Recommended Timeline |
|---|---|---|---|
| 10 | Check on Column and Slab stresses due to high loading in toilet areas. | Building Engineer to ensure the structure is not loaded beyond capacity by the loading from high build up in toilet areas as part of the Detail Engineering Assessment. | 6-weeks |
| 11 | Check on Column and Slab stresses due to high loading in toilet areas. | Building Engineer to create controlled loading plans for all floors. | 6-weeks |

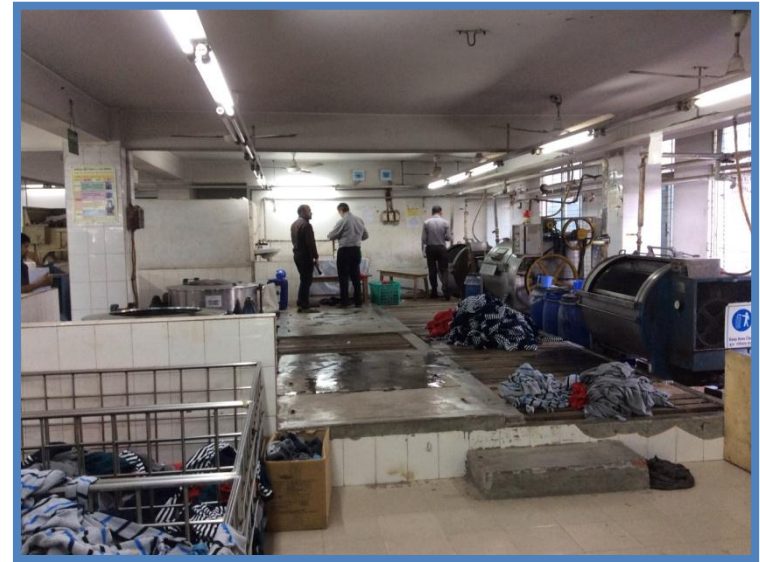
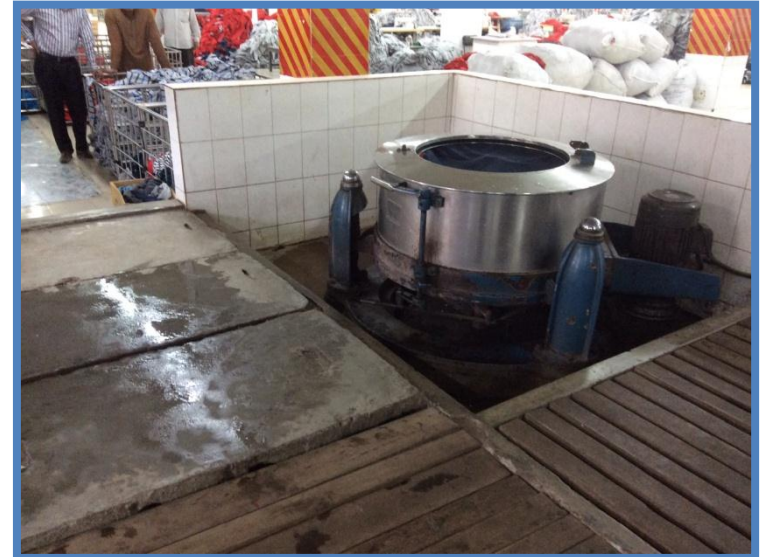
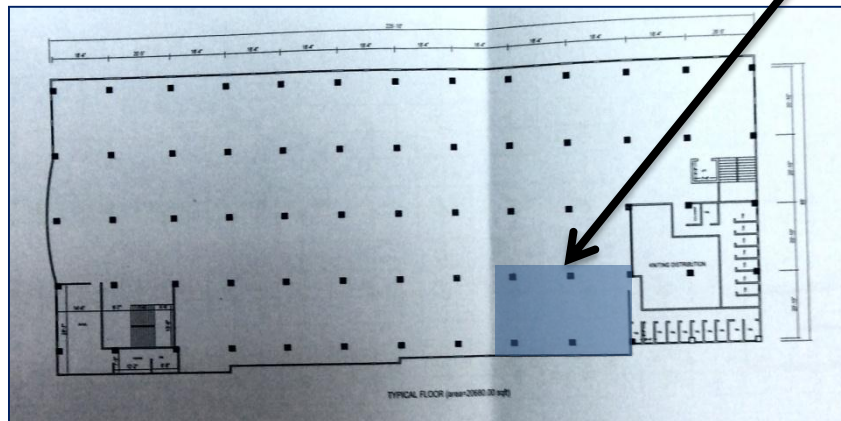
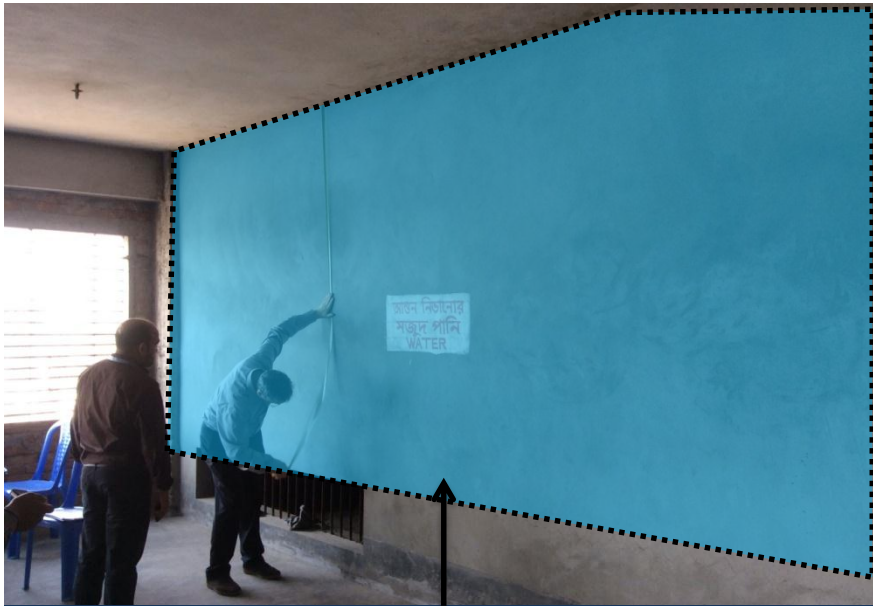
## Floor loading – washer areas

High local loads arising from heavy washer floor build-up and machines

Heavy washer build-up in this location on L1

| Item No. | Observation | Recommended Action Plan | Recommended Timeline |
|---|---|---|---|
| 13 | Check on Column and Slab stresses due to high loading in Washing/Drying area. | Building Engineer to ensure the structure is not loaded beyond capacity by the loading from high build up in Wash/Dry area as part of the Detail Engineering Assessment. | 6-weeks |
| 14 | Check on Column and Slab stresses due to high loading in Washing/Drying area. | Building Engineer to create controlled loading plans for all floors. | 6-weeks |

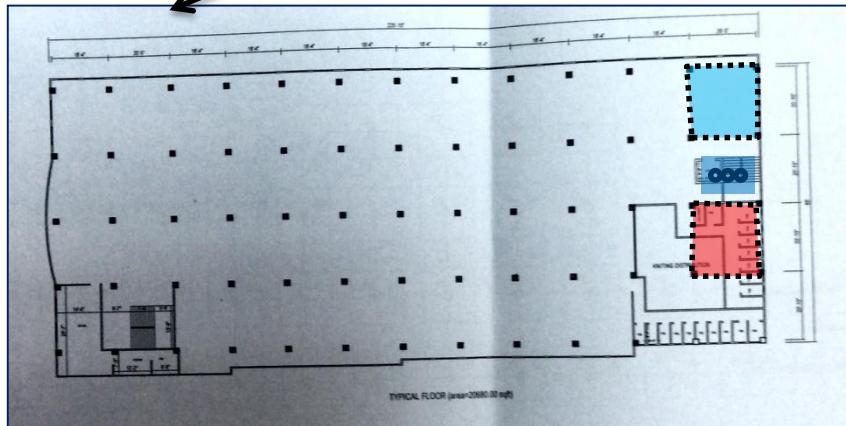
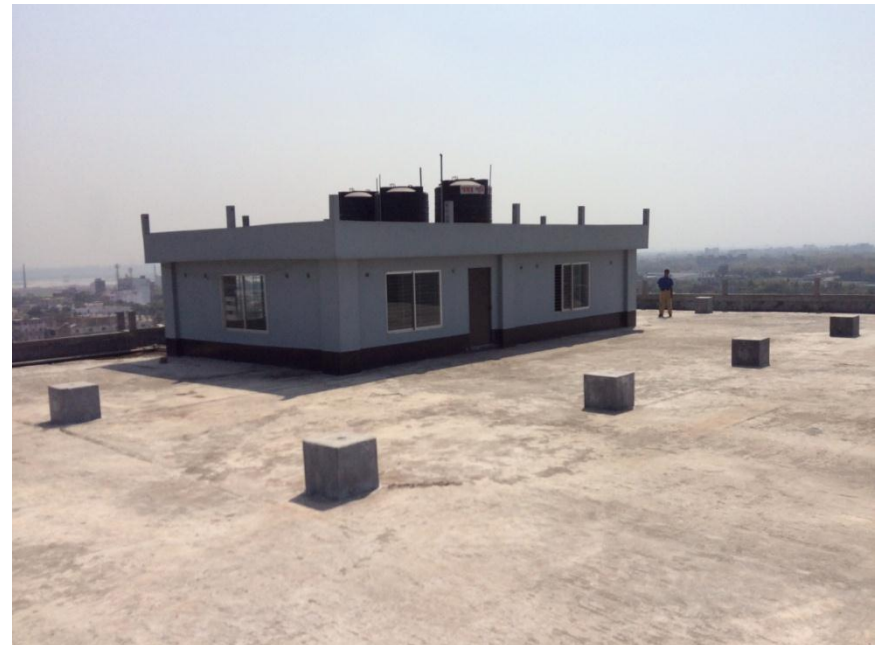
Water tank height 2.3m over 2 bays by stair core =  $23\text{kN/m}^2$

2 large concrete water tanks (Blue and red in diagram) at Level 9 by stair core not shown on drawings add significant load to supporting structure. Some concern with Red shaded tank and column loading

Other loading also arises from a group of 3 large plastic tanks at roof level over the stair core

| Item No. | Observation | Recommended Action Plan | Recommended Timeline |
|---|---|---|---|
| 16 | Large water tank loading over stair core – concerns over column and slab stresses. | Building Engineer to ensure the structure is not loaded beyond capacity by the loading from the water tank as part of the Detail Engineering Assessment | 6-weeks |
| 17 | Large water tank loading over stair core – concerns over column and slab stresses. | Building Engineer to create controlled loading plans for all floors | 6-weeks |

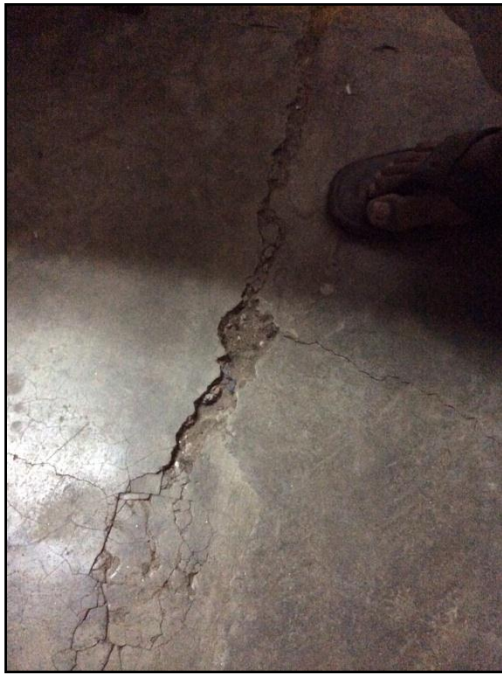
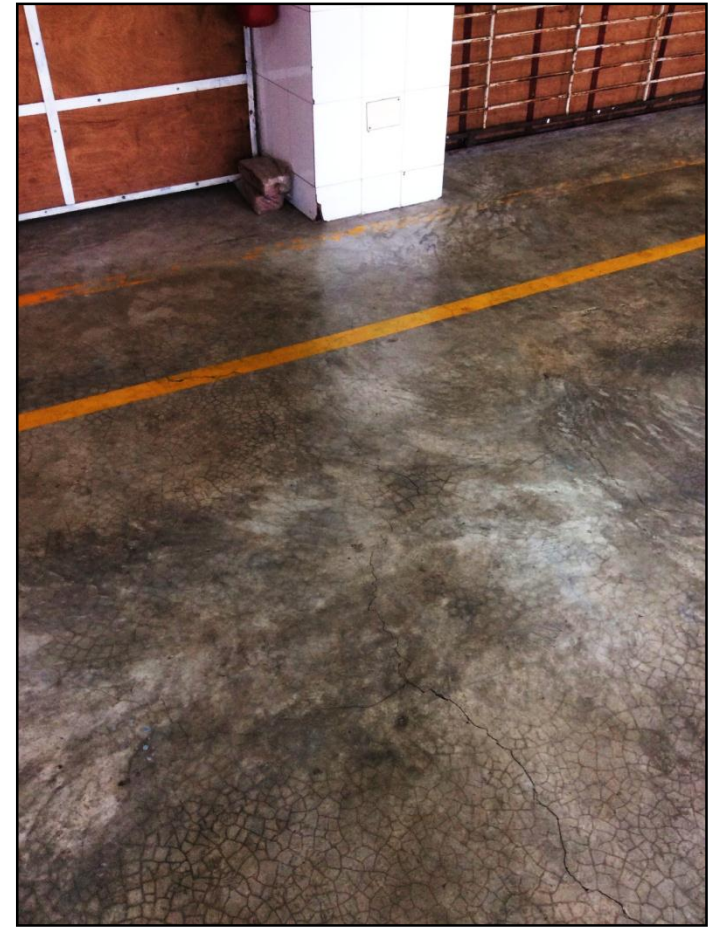
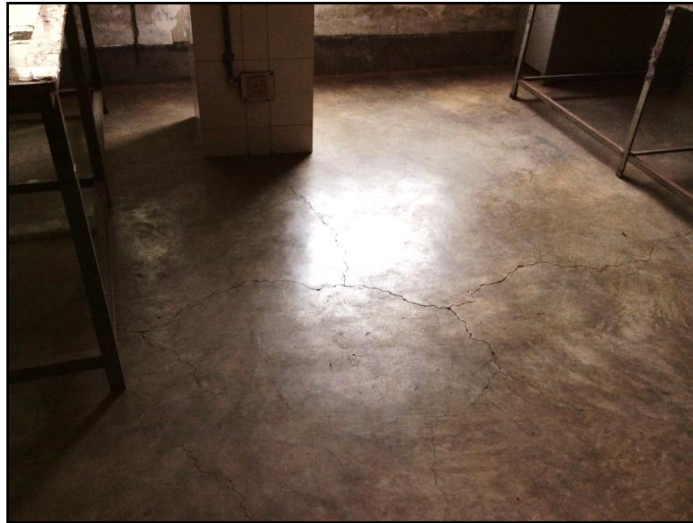
## Cracks to slabs

Some crazing and hairline cracks on slab surface. Generally crazing with no clear pattern, with some cracking running along beam lines. Some evidence that the cracking may only extend into the finishes in areas where the screed had debonded from the slab

| Item No. | Observation | Recommended Action Plan | Recommended Timeline |
|---|---|---|---|
| 18 | Cracking in surface of slab at Level 1 | Engineer to investigate crack source/cause. | 6-weeks |
| 19 | Cracking in surface of slab at Level 1 | If cracks are structurally significant, remove all items above the slab and close working areas below the affected areas . Engineer to Check design, specify repairs and strengthening of the slab if necessary. | 6-weeks |

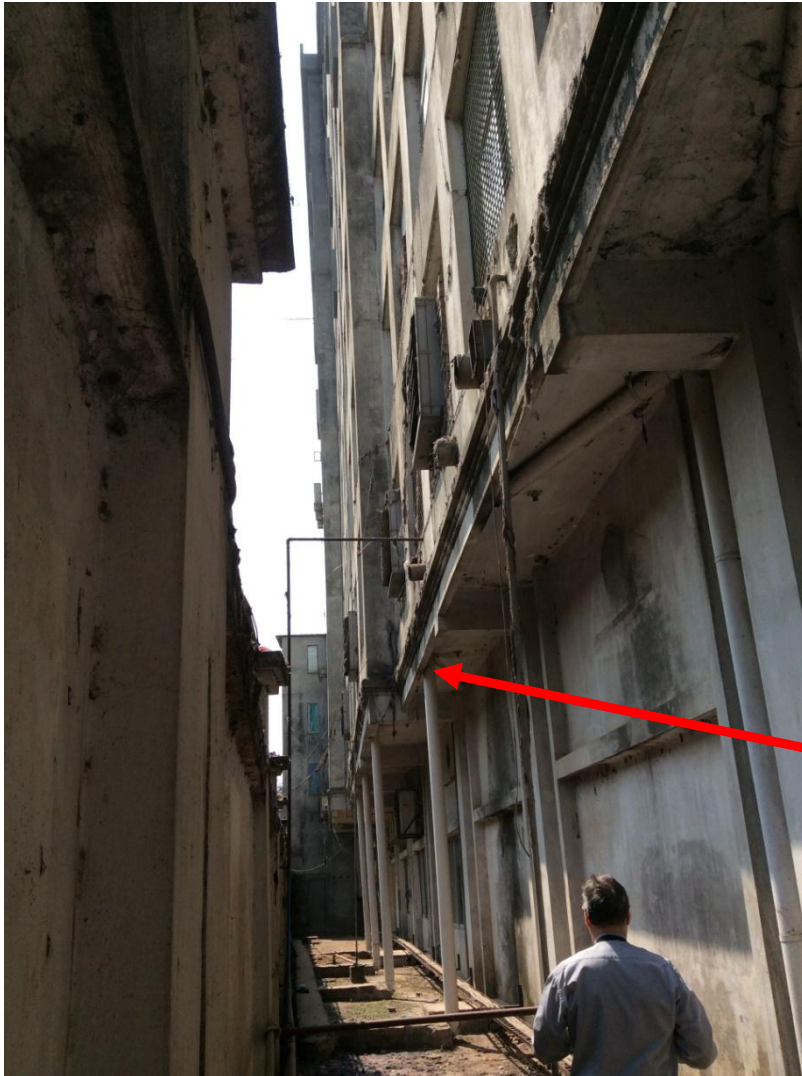
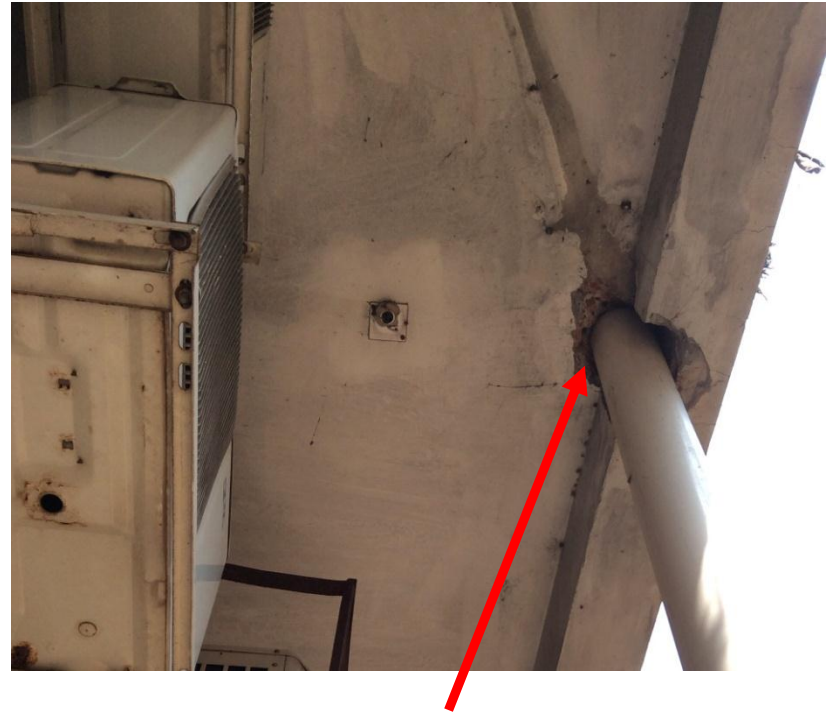
Notches through possible edge beams of cantilevers at 1<sup>st</sup> floor seen

Concern with Holes for services passing through structural beams and slabs.

Holes made through beams

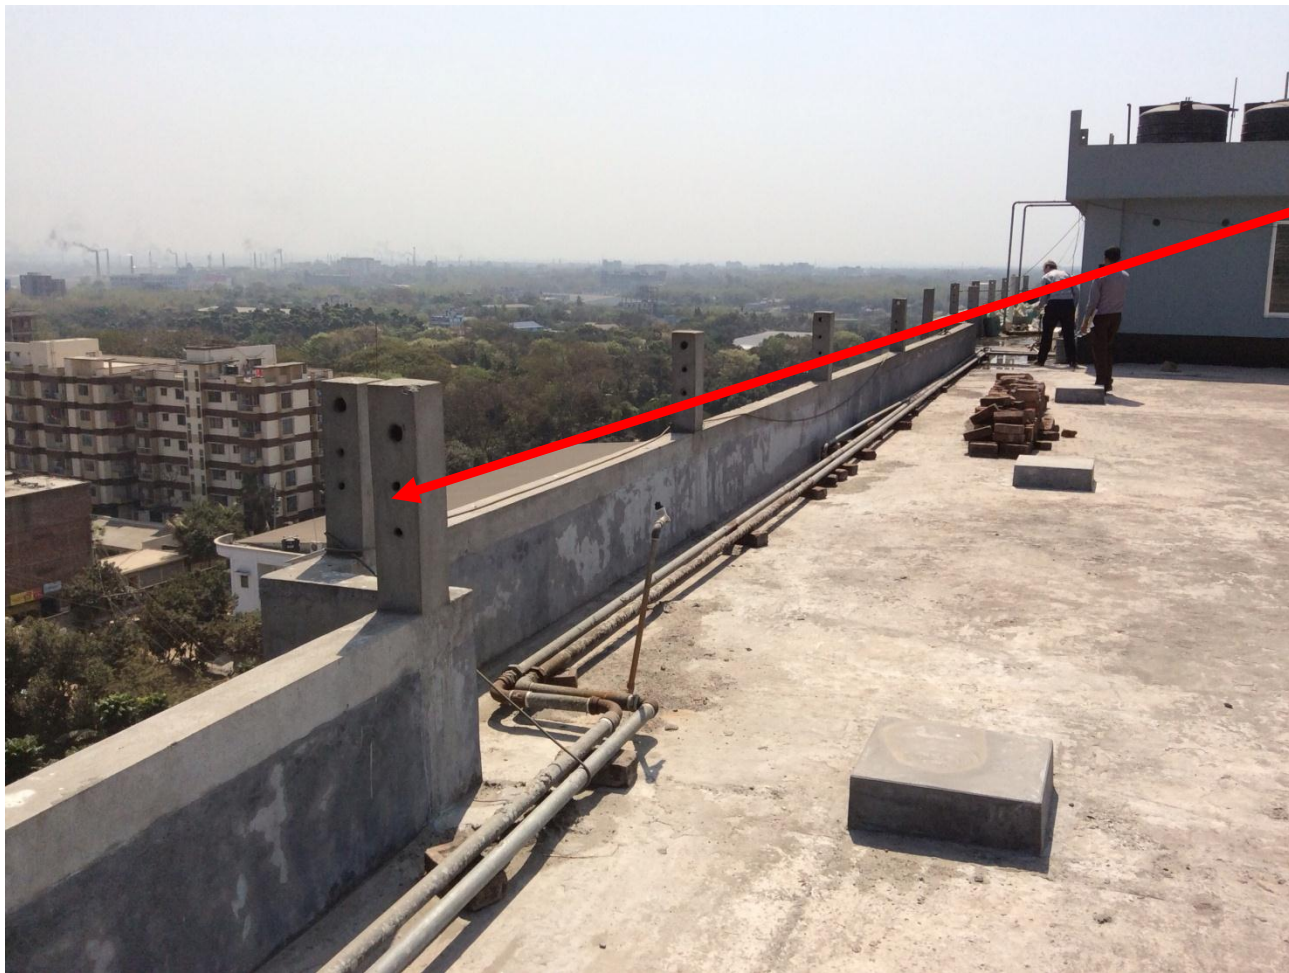
Roof edge protection incomplete

Edge protection around roof currently incomplete, leaving parapets lower than waist height.

| Item No. | Observation | Recommended Action Plan | Recommended Timeline |
|---|---|---|---|
| 20 | Complete parapet guarding at roof | Restrict access to area until infill work complete | 6-weeks |
| 21 | Complete parapet guarding at roof | Complete infill between existing parapet posts around roof perimeter. | 6-months |

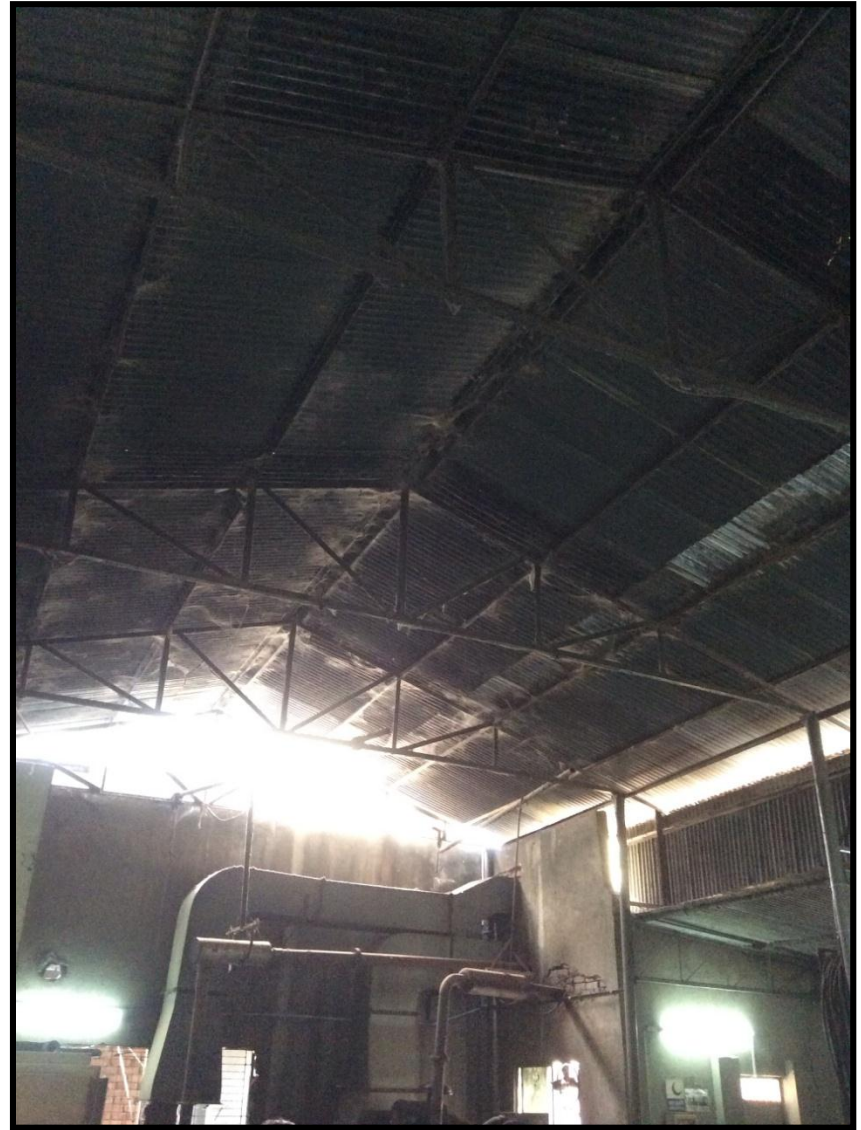
**Non engineered structure**

Lightweight steel roof appears light and unbraced and storm event may cause significant damage.

| Item No. | Observation | Recommended Action Plan | Recommended Timeline |
|---|---|---|---|
| 22 | Non engineered steelwork to shed housing generator | Building engineer to check the structures and propose additional reinforcements and stability system, if required | 6-weeks |
| 23 | Non engineered steelwork to shed housing generator | Additional works if required to be completed | 6-months |
