# Sams Attire Ltd

Bhuiyan Tower, Plot No. 10, Jamgora, Ashulia Road, Savar, Dhaka  
(23.93670N, 90.28447E)

11 March 2014

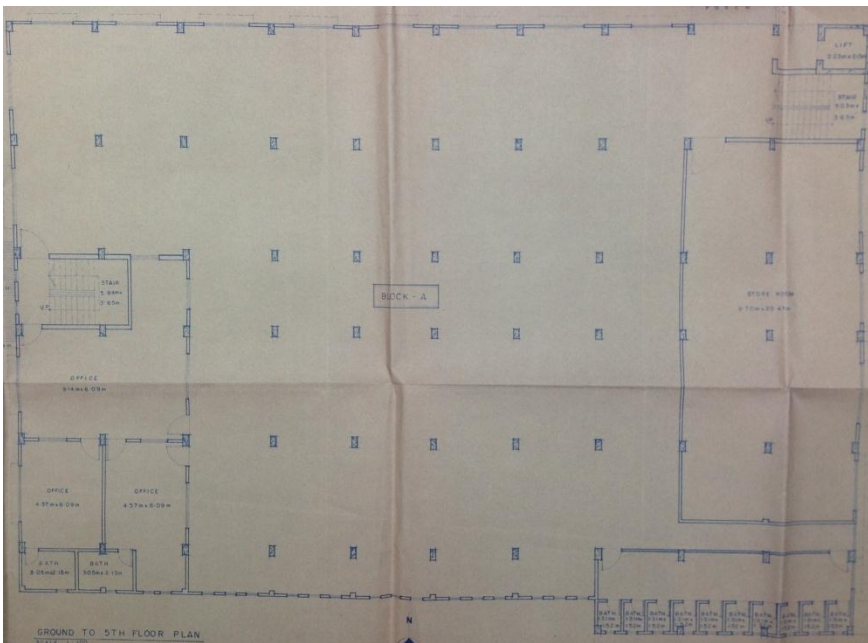
Typical column layout

**Columns appear to be stressed in excess of  
normal design limits**

**Cursory calculations indicate column working stress is in excess of normal design limits.**

**Building Engineer is to perform detailed calculations including a Detail Engineering Assessment (See attached scope) and concrete tests to prove column size and (if required):**

- Reduce loads by vacating floors
- Reinforce columns

| Item No. | Observation | Recommended Action Plan | Priority |
|---|---|---|---|
| 1 | Columns appear to be stressed in excess of normal design limits | Maintain current use of the floors and do not change use or increase occupation, either of which could increase loading. | Immediate - Now |
| 2 | Columns appear to be stressed in excess of normal design limits | Factory Engineer to review design, loads and stresses in all columns. | Immediate - Now |
| 3 | Columns appear to be stressed in excess of normal design limits | Verify insitu concrete strength either by 100mm diameter cores or existing cylinder strength data for cores from 6 columns. Verify reinforcement within as built columns. | Immediate - Now |
| 4 | Columns appear to be stressed in excess of normal design limits | A Detail Engineering Assessment of Factory to be commenced, see attached Scope. | Immediate - Now |

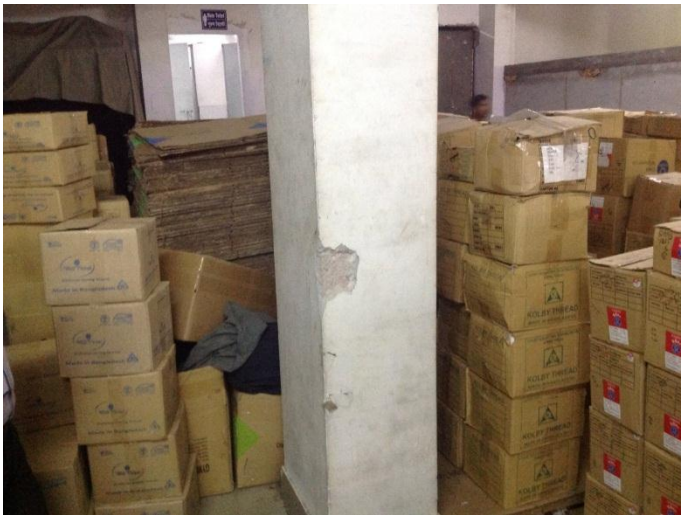
Tested Ground Floor Column – Brick Chips

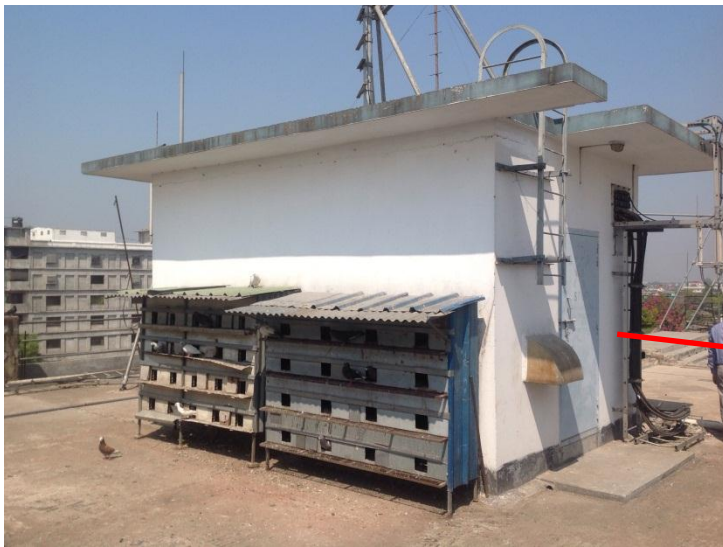
# **Structural adequacy of concrete roof slab and columns to support antenna house and water tanks**

Roof Antenna House

Building Engineer to check that concrete roof slab and columns have been designed to accommodate loads from Antenna house and water tanks.

| Item No. | Observation | Recommended Action Plan | Priority |
|---|---|---|---|
| 8 | Structural adequacy of concrete roof slab and columns to support antenna house and water tanks | Building Engineer to carry out design calculations to verify that roof beam/slab and columns have sufficient capacity to support fully filled water tanks and antenna house. | 6-weeks |

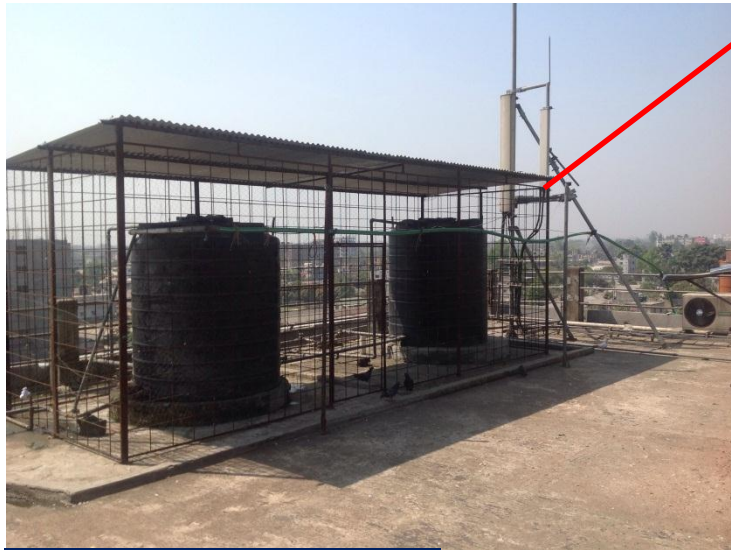
Plastic Water Tanks

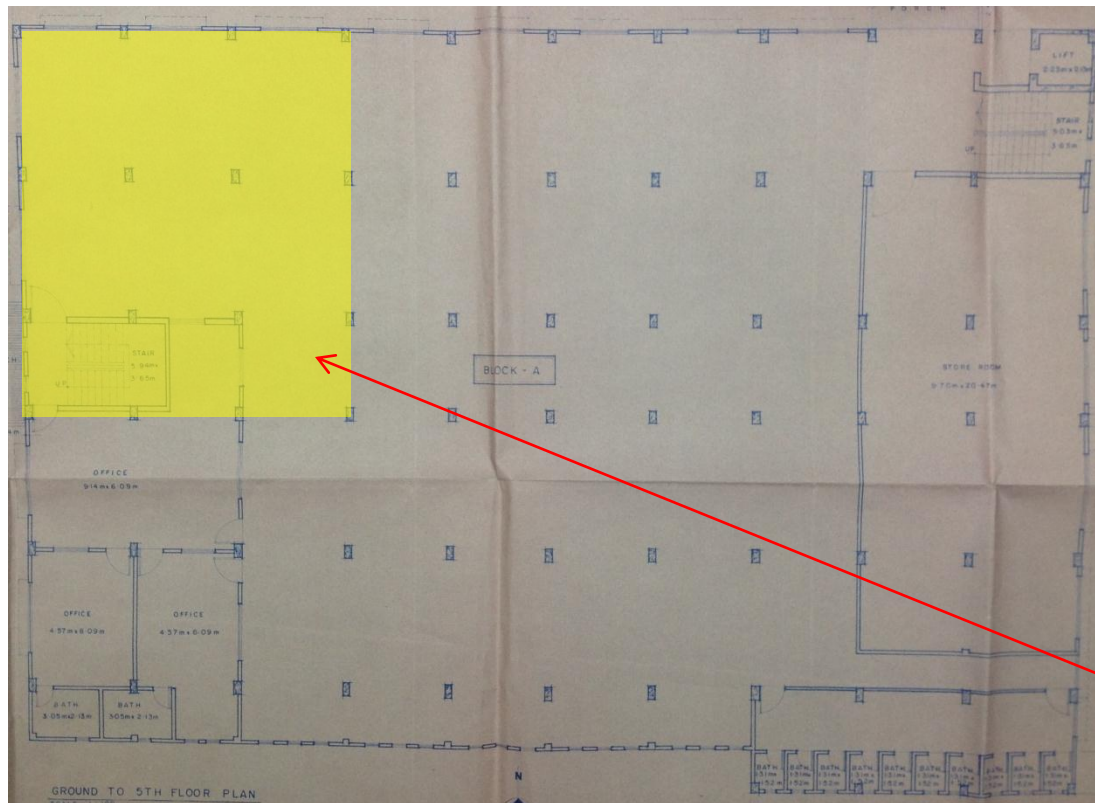
Floor Plan – Export Carton Area/Accessories Store

# Management of storage loads

Building Engineer to prepare controlled loading plans for all floors which will designate where storage can be placed and to what height.

| Item No. | Observation | Recommended Action Plan | Priority |
|---|---|---|---|
| 9 | Management of storage loads | Produce and actively manage a loading plan for all floor plates within the factory giving consideration to floor capacity and column capacity. (Refer to Item 1) | 6-weeks |

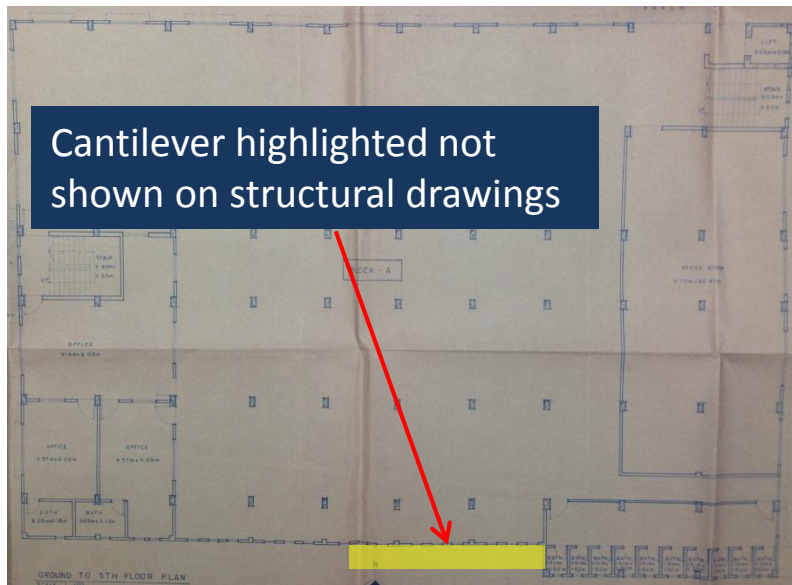
Typical floor plan

Cantilever highlighted not shown on structural drawings

Building Engineer to survey as-built structure and update drawings including verification of steel structure at roof level

| Item No. | Observation | Recommended Action Plan | Priority |
|---|---|---|---|
| 11 | Structural drawings not consistent with the as-constructed arrangement of the factory | As part of Detail Engineering Assessment, Building Engineer to commence survey of as-built structure and update drawings. | Immediate - Now |

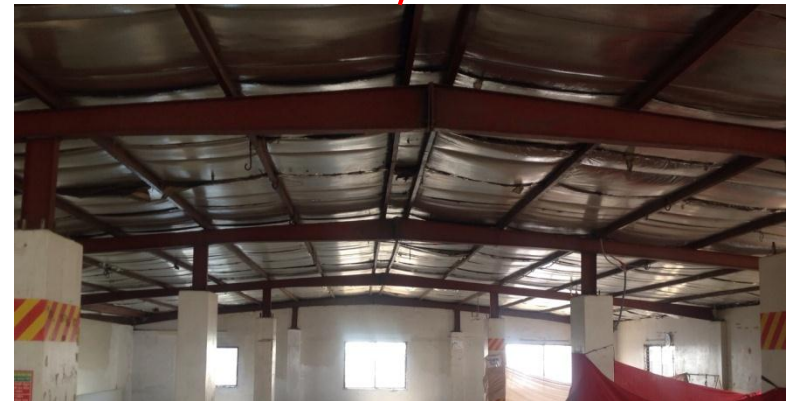
Steel structure at roof level not shown on structural drawings

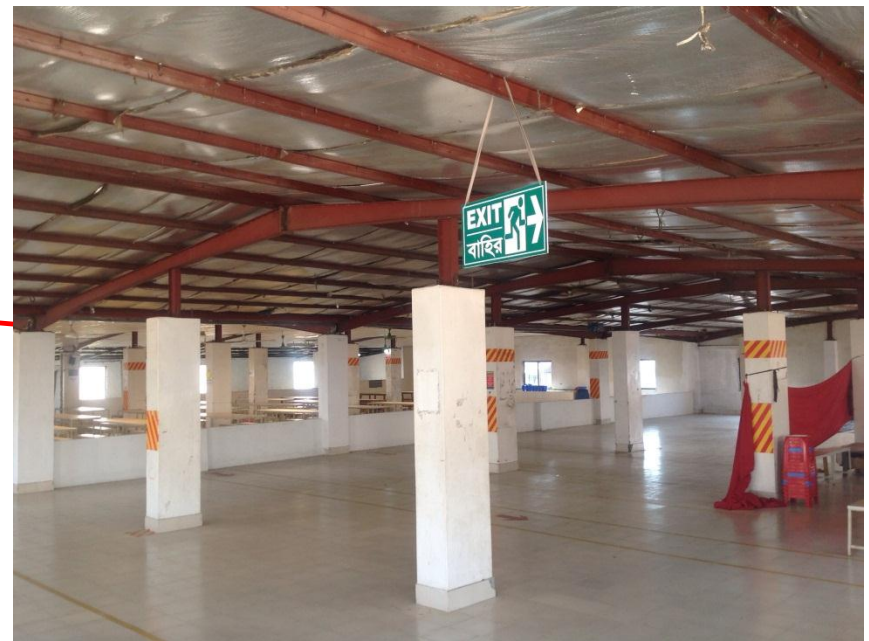
Roof structure to Dining Area

Dining area structure not shown on structural drawings.

Building Engineer to check design of steel rafter allowing for notch in the steelwork for the roof gutter.

| Item No. | Observation | Recommended Action Plan | Priority |
|---|---|---|---|
| 15 | Check required to confirm that the steel roof rafters over the dining area are adequately designed to allow for notch in the steelwork for the roof gutter | Steel roof to dining area should be designed by the Building Engineer and a design check carried out to confirm that the steel roof rafters are adequately designed to allow for notch in the steelwork for the roof gutter | 6-weeks |

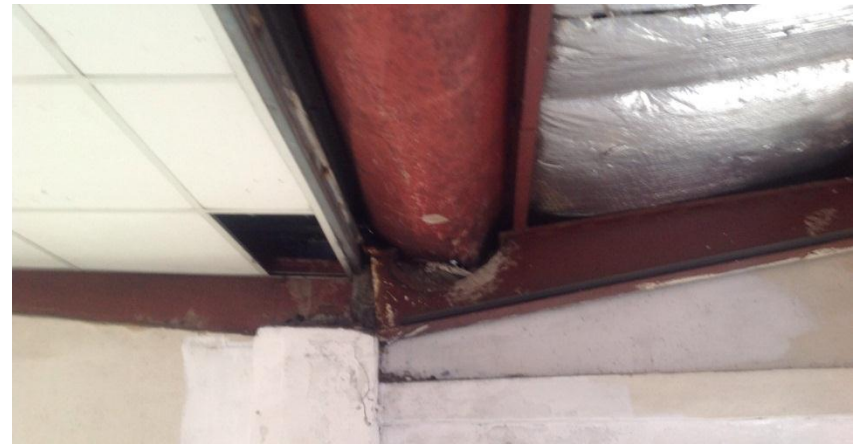
**Check required to confirm that the steel roof  
rafters over the dining area are adequately  
designed to allow for notch in the steelwork for  
the roof gutter**

Steel Rafter – notched for gutter

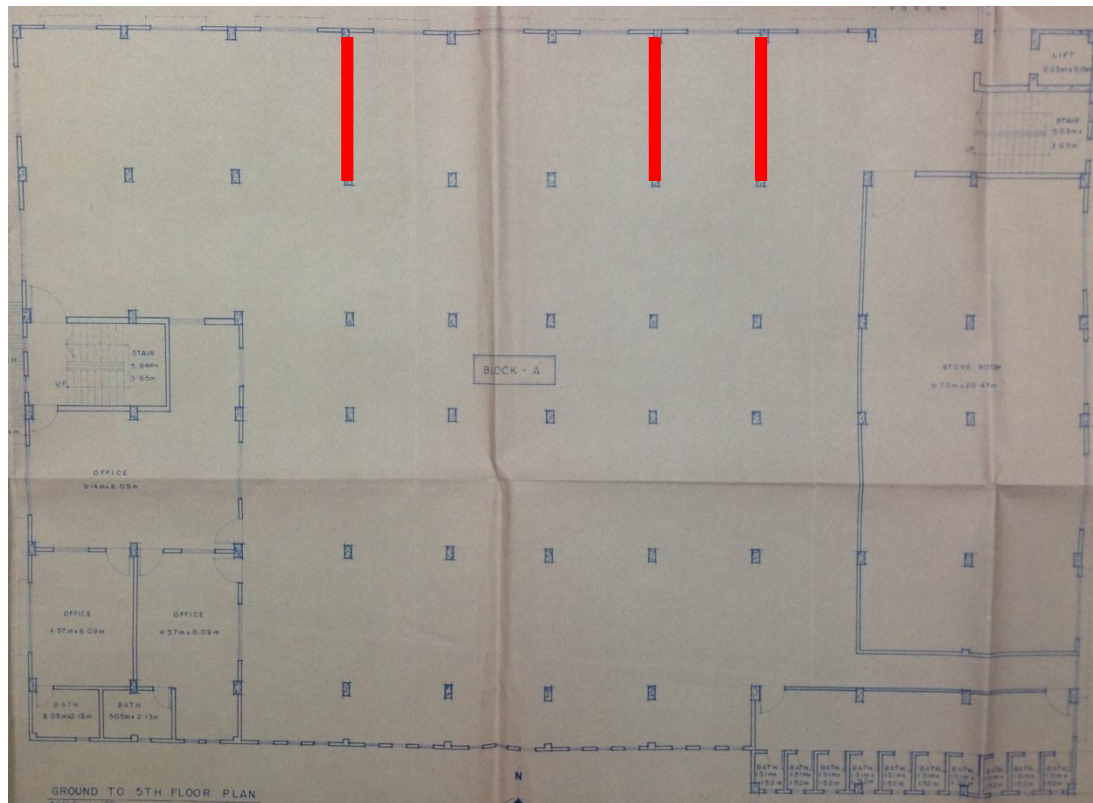
Floor Plan

# **Hairline cracking of beams on the 4<sup>th</sup> floor soffit**

Crack Locations

Beam cracks to be reviewed by removing plaster to confirm that cracks do not extend into structure.

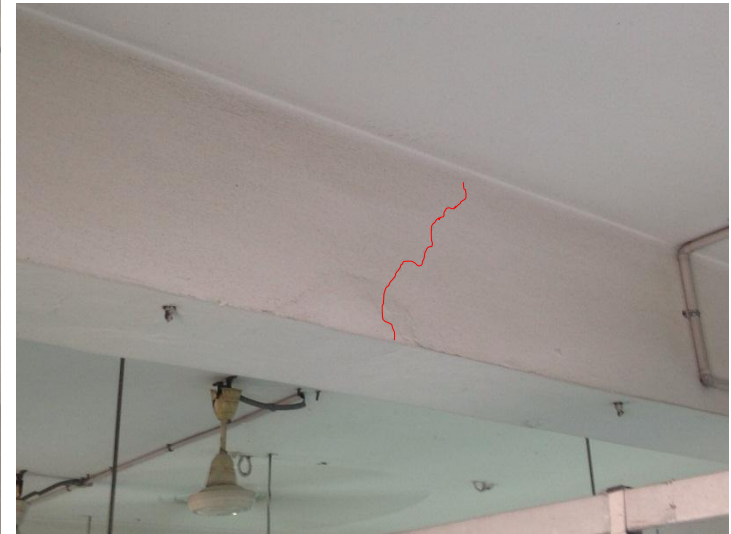
Beam Cracking

| Item No. | Observation | Recommended Action Plan | Priority |
|---|---|---|---|
| 16 | Hairline cracking of beams on the 4th floor soffit | Sections of plaster finish to beams to be removed to investigate if cracks penetrate the building structure. Building Engineer to review further if cracks are found to penetrate into building structure. | 6-weeks |
| 17 | Hairline cracking of beams on the 4th floor soffit | Carry out repair remedial works as required. | 6-weeks |

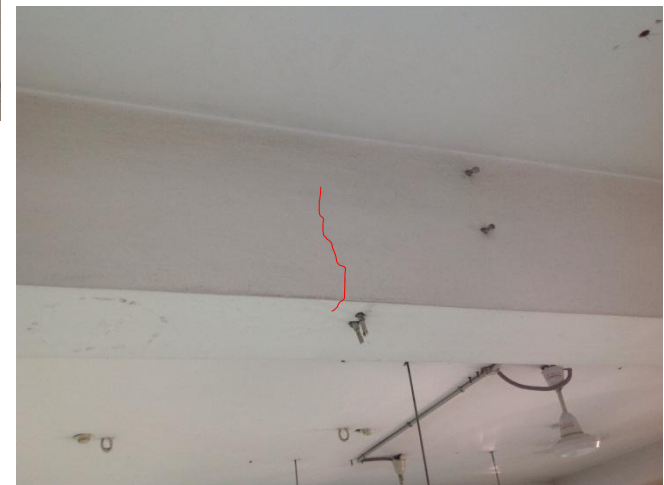
Beam Cracking
