# Monira Knit Apparels Ltd. Colour Fashion Ltd.

191, West Masdair, Fatullah, Narayanganj-1400  
(23.628361N, 90.485250E)

12 April 2014

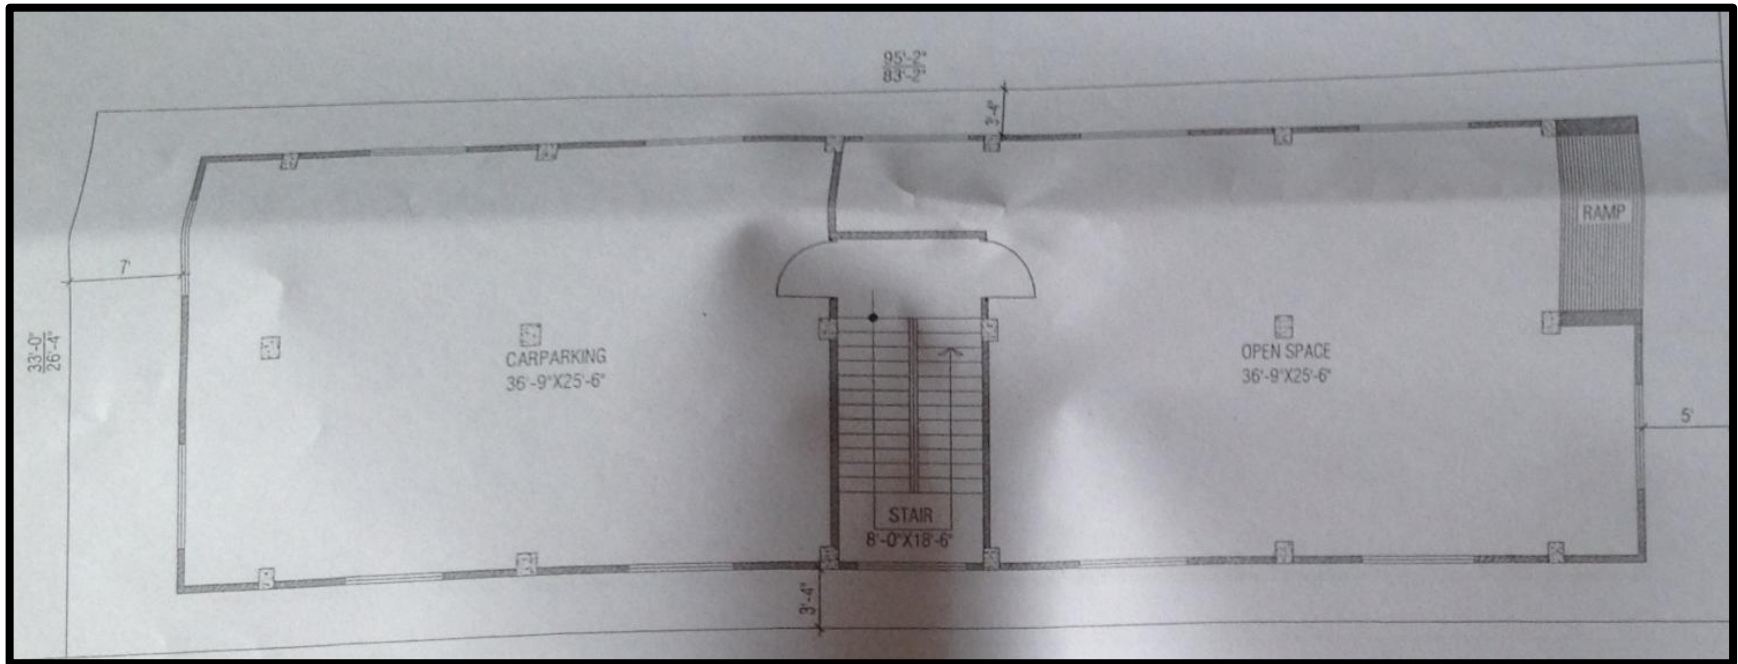
High Stress Levels in Columns

Outline calculations indicate all columns at the Ground Floor and Level 1 are highly stressed under their current loading condition.

| Item No. | Observation | Recommended Action Plan | Recommended Timeline |
|---|---|---|---|
| 1 | Stress levels in Columns | Factory Engineer to review design, loads and columns stresses in all columns | <b>Immediate - Now</b> |
| 2 | Stress levels in Columns | Verify insitu concrete stresses either by 100mm diameter cores from 4 columns or existing cylinder strength data.<br>Verify grade of steel reinforcement used | <b>Immediate - Now</b> |
| 3 | Stress levels in Columns | A Detailed Engineering Assessment of Factory to be commenced, see attached Scope | <b>Immediate - Now</b> |
| 4 | Stress levels in Columns | Detailed Engineering Assessment to be completed. | <b>6-weeks</b> |
| 5 | Stress levels in Columns | Make structural alterations as advised by Engineer. | <b>6-weeks</b> |
| 6 | Stress levels in Columns | Produce and actively manage a loading plan for all floor plates within the factory giving consideration to floor capacity and column capacity. | <b>6-weeks</b> |
| 7 | Stress levels in Columns | Continue to implement load plan | <b>6-months</b> |

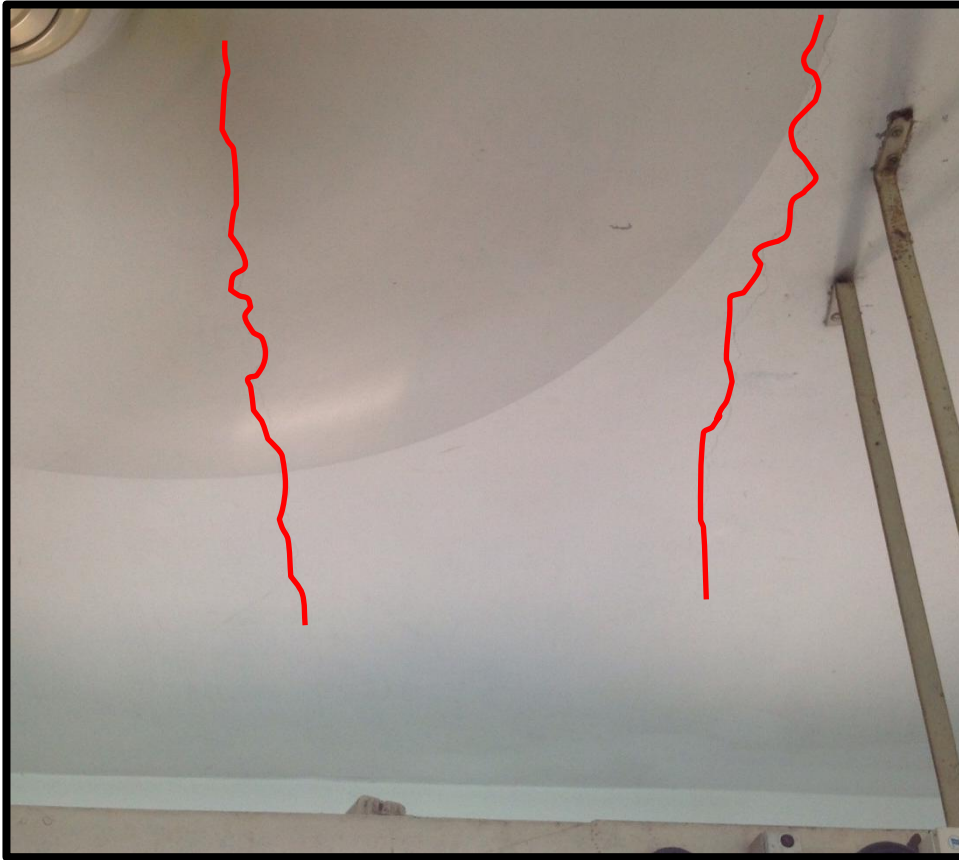
**Flexural Cracking in Floor Slab Soffits**

**Flexural cracking was observed in flat slab soffit at most levels.**

| Item No. | Observation | Recommended Action Plan | Recommended Timeline |
|---|---|---|---|
| 8 | Flexural cracking in floor slab soffits | Engage an Engineer to investigate if the cracking is structural or exists only in the render, as part of the Detailed Engineering Assessment noted in item 1. | 6-weeks |
| 9 | Flexural cracking in floor slab soffits | Engineer is to undertake checks for flexural and punching shear capacity. | 6-weeks |
| 10 | Flexural cracking in floor slab soffits | Carry out any remedial work as directed by the Engineer. | 6-months |

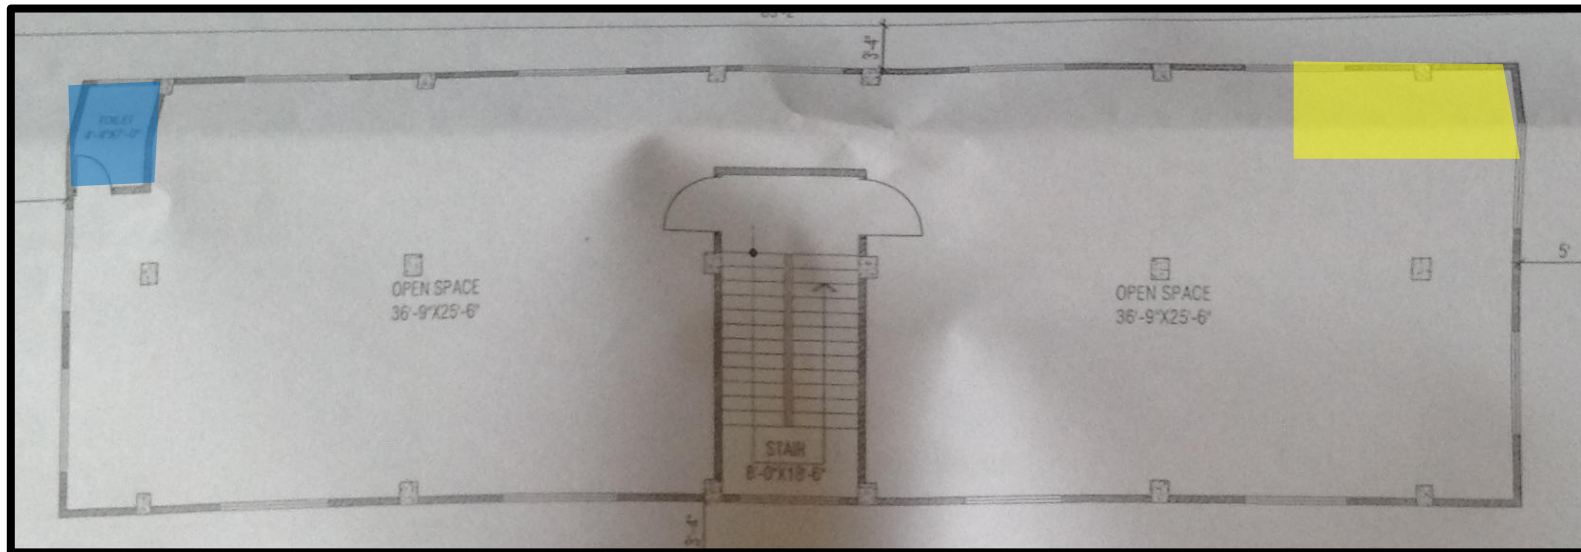
High Loading in Toilet Areas on Cantilevers

High loading was observed on cantilevers, especially in toilet areas with floor build-up.

Toilets at Levels 1 & 6

Toilets at Levels 2-5

| Item No. | Observation | Recommended Action Plan | Recommended Timeline |
|---|---|---|---|
| 11 | High loading in toilet areas on cantilevers | Engage an Engineer to investigate if the applied loading can be safely carried by the slabs and by the columns, as part of the Detailed Engineering Assessment as noted in item 1. | 6-weeks |
| 12 | High loading in toilet areas on cantilevers | Carry out load reduction and/or any remedial work as directed by the Engineer. | 6-months |

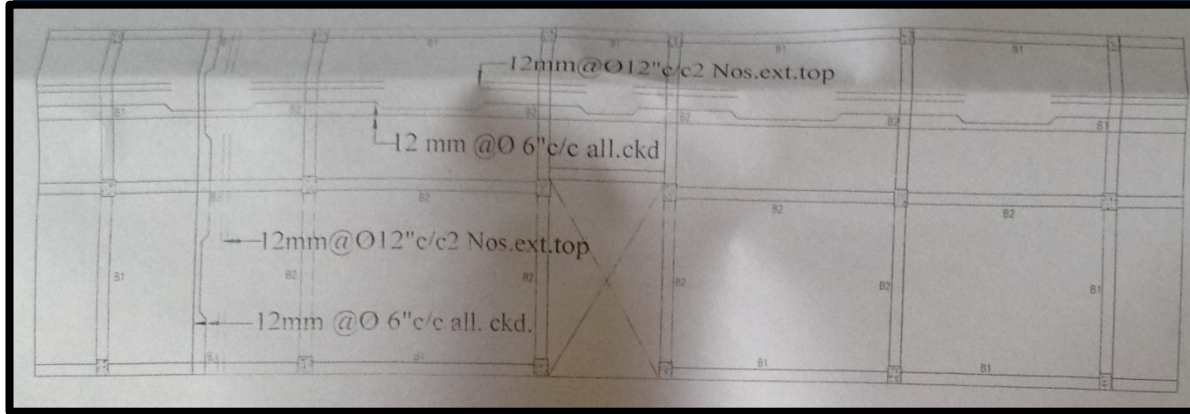
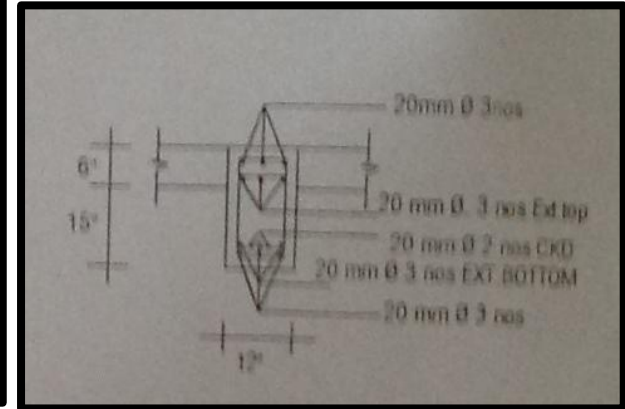
Structural drawings indicated a slab and beams system while the building was entirely flat slab.

- Number of bars in columns
- Grid dimensions
- Slab thickness
- Structural system (beams vs. flat slab)

| Item No. | Observation | Recommended Action Plan | Recommended Timeline |
|---|---|---|---|
| 13 | Discrepancies between drawings and actual observations | Engage an Engineer to prepare full “as built” engineering drawings , as part of the Detailed Engineering Assessment (refer to Priority Action 1 above). | 6-weeks |

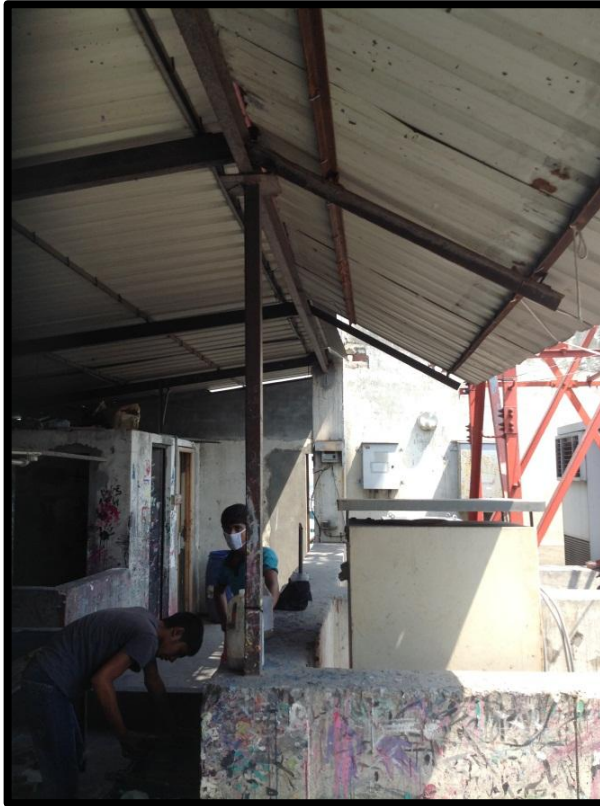
**Building Steel Roof**

## Lightweight steel structures lack bracing and appear non-engineered

| Item No. | Observation | Recommended Action Plan | Recommended Timeline |
|---|---|---|---|
| 16 | Lightweight steel structures lack bracing and appear non-engineered | Building engineer to check the capacity and stability system of the lightweight roofs and stairs and make any necessary alterations. | 6-months |

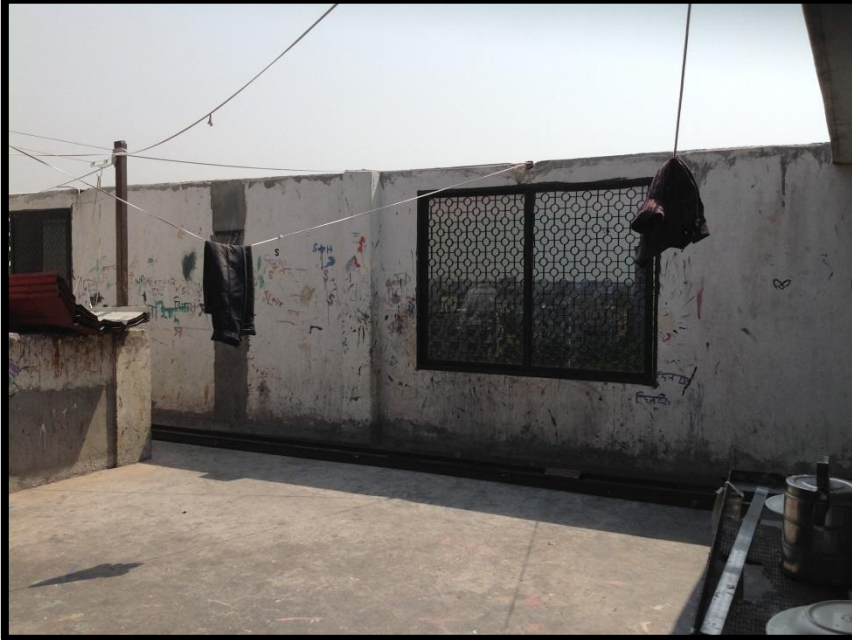
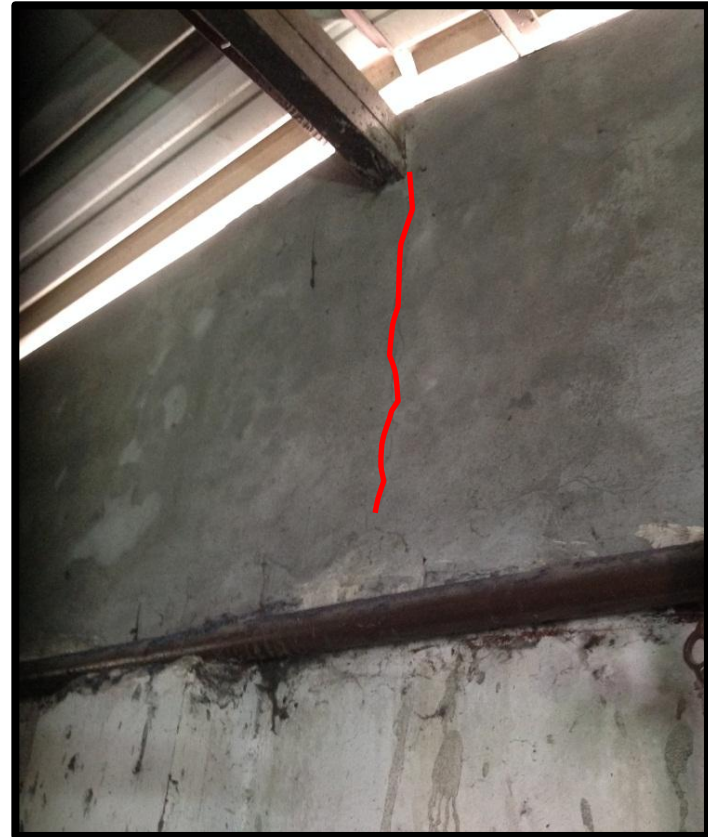
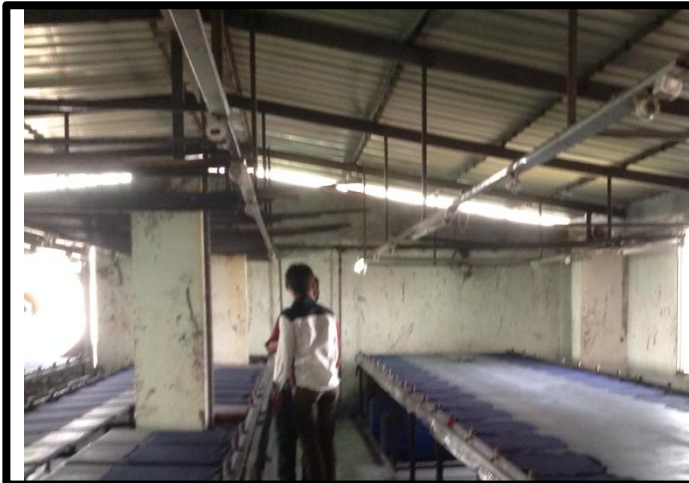
Freestanding wall at Roof Level support steel roof beams. Evident cracking in walls.

| Item No. | Observation | Recommended Action Plan | Recommended Timeline |
|---|---|---|---|
| 14 | High freestanding walls at Roof Level. | Engage an Engineer to investigate the structural capacity of the freestanding external walls at roof level, as part of the Detailed Engineering Assessment as noted in item 1. | 6-weeks |
| 15 | High freestanding walls at Roof Level. | Make structural alterations as advised by the Engineer. | 6-months |
