# Mother Color Ltd.

160, Shashongaon, Enayetnagar, Fatullah, Narayangonj, Bangladesh  
(23.627807N, 90.474703E)

12 APRIL 2014

# Observations

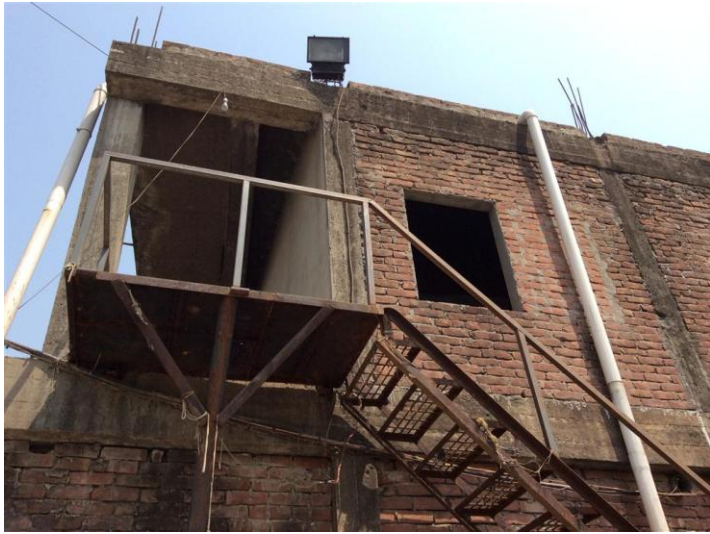
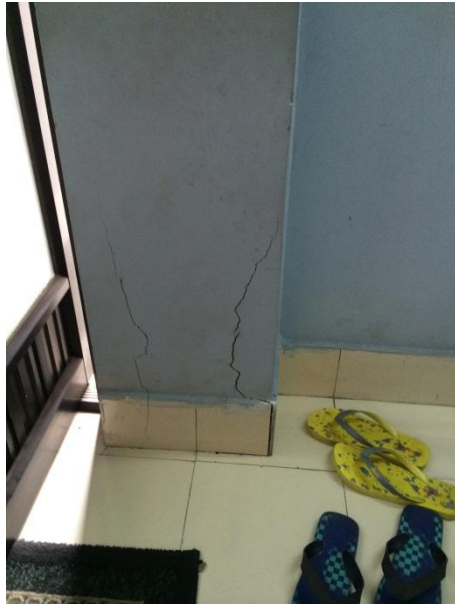
# Out-building Vertical column cracks

Vertical cracks observed in concrete outbuilding at first floor level. IMMEDIATE ACTION REQUIRED:

Generally the undocumented out-building has two-way spanning slabs supported on downstand beams.

An off-grid column has been constructed between the ground and first floor, connected directly to the slab. The construction of this column could not be confirmed.

- Water tank to be drained.
- Floor beams at first floor and roof level to be propped through to ground floor.

An Engineering Assessment should be carried out for this building, to assess the column design and whether the off-grid column will punch through the slab. See photos overleaf.

| <b>Item No.</b> | <b>Observation</b> | <b>Recommended Action Plan</b> | <b>Recommended Timeline</b> |
|---|--|---|---|
| 1 | Out-building - Substantial cracks in three 1st floor columns | Water tank on the roof to be drained. | <b>Immediate - Now</b> |
| 2 | Out-building - Substantial cracks in three 1st floor columns | Floor beams at first floor and roof level to be propped through to ground floor. | <b>Immediate - Now</b> |
| 3 | Out-building - Substantial cracks in three 1st floor columns | Verify insitu concrete stresses by 100mm diameter cores from min. 4 columns. | <b>Immediate - Now</b> |
| 4 | Out-building - Substantial cracks in three 1st floor columns | Building Engineer to review concrete structure in terms of loadings, including punching shear for slab over lone column. | <b>Immediate - Now</b> |

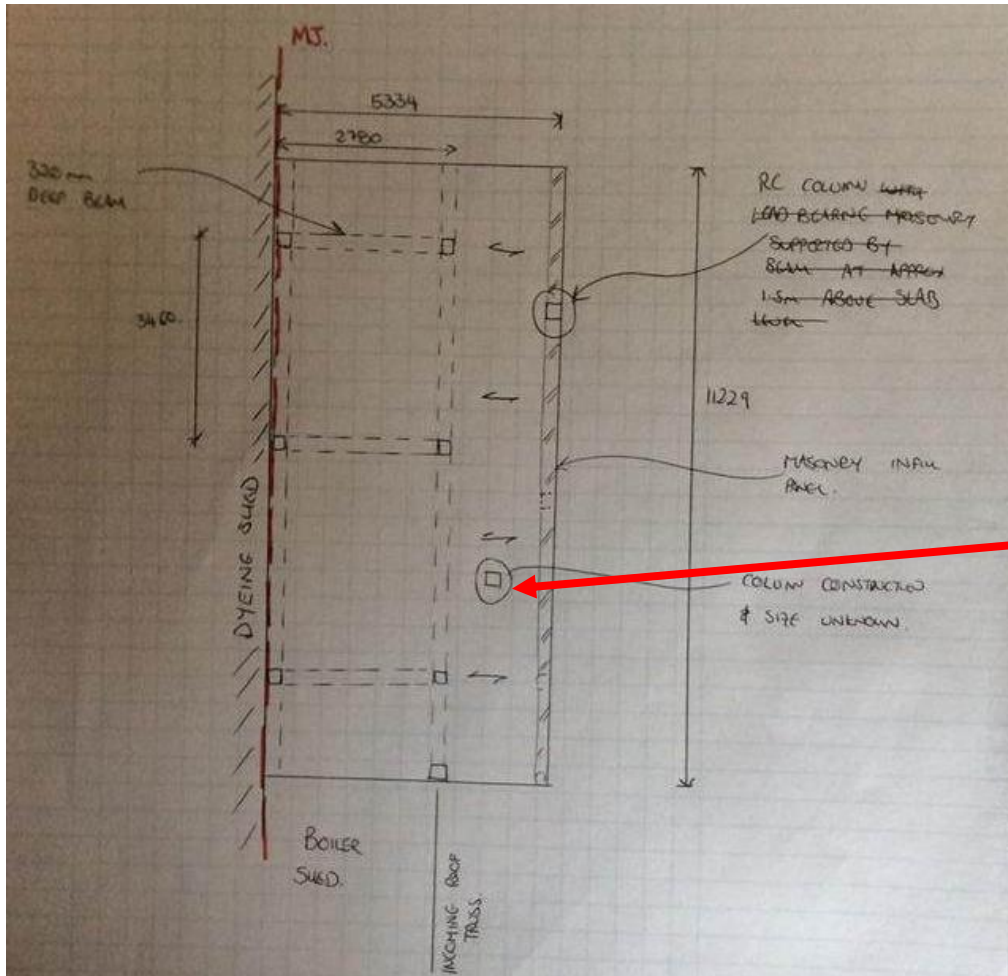
Ground floor column layout, showing first floor downstand beams over.

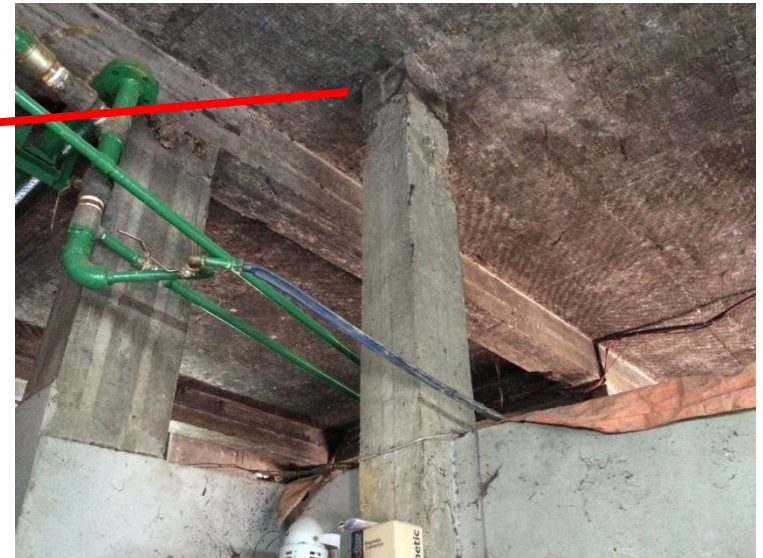
This column stops at underside of first floor

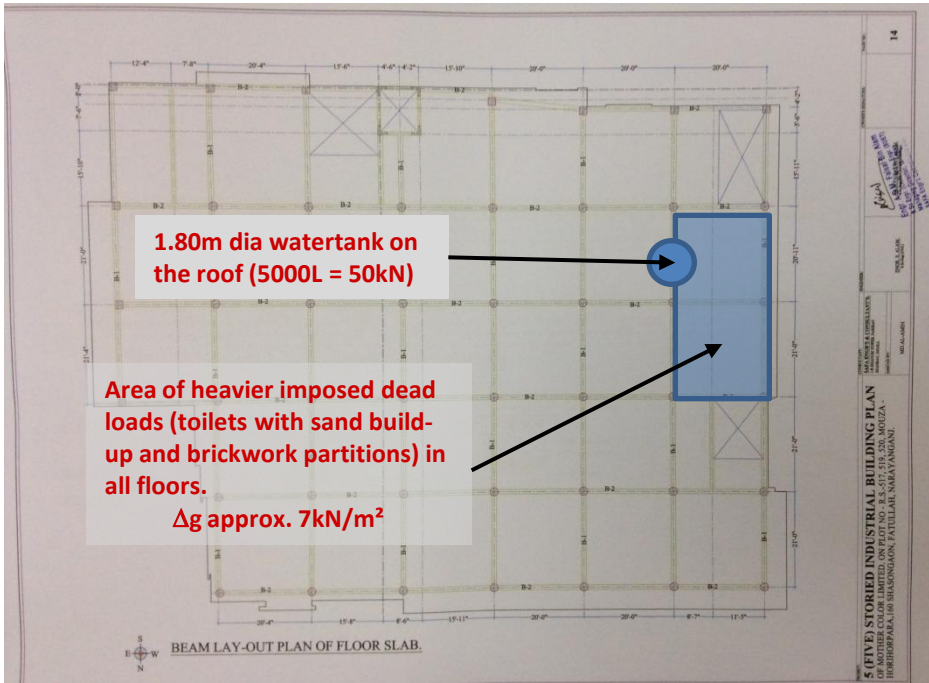
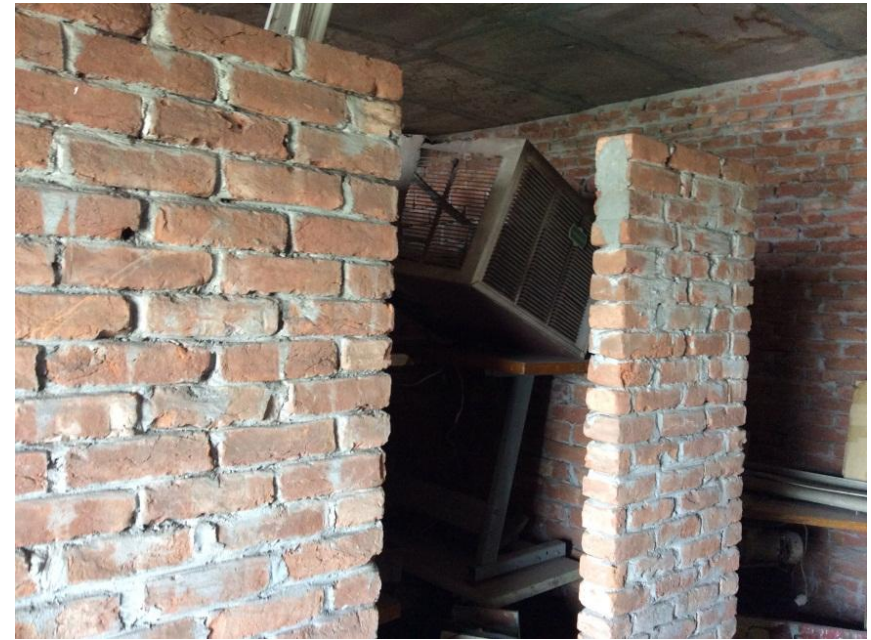
# **Main Building: Highly-stressed columns at Ground Floor**

Whilst the reinforcement drawings for the columns presented at the meeting show 20 bars of D18 to D25, the Ferros scanner has confirmed only 16 bars for the circular columns at ground floor. This matches the number of bars sticking out at roof level where bar diameter is also 16mm.

Highly Stressed Column near toilets

| Item No. | Observation | Recommended Action Plan | Recommended Timeline |
|---|---|--|---|
| 9 | Main Building - Check column stresses and verify concrete strengths in ground floor columns | Factory Engineer to review design, loads and column stresses in area highlighted above. | <b>Immediate - Now</b> |
| 10 | Main Building - Check column stresses and verify concrete strengths in ground floor columns | Verify insitu concrete stresses by 100mm diameter cores in min. 4 no. non-critical columns | <b>Immediate - Now</b> |
| 11 | Main Building - Check column stresses and verify concrete strengths in ground floor columns | A Detail Engineering Assessment of Main Building to be commenced, see attached scope | <b>Immediate - Now</b> |

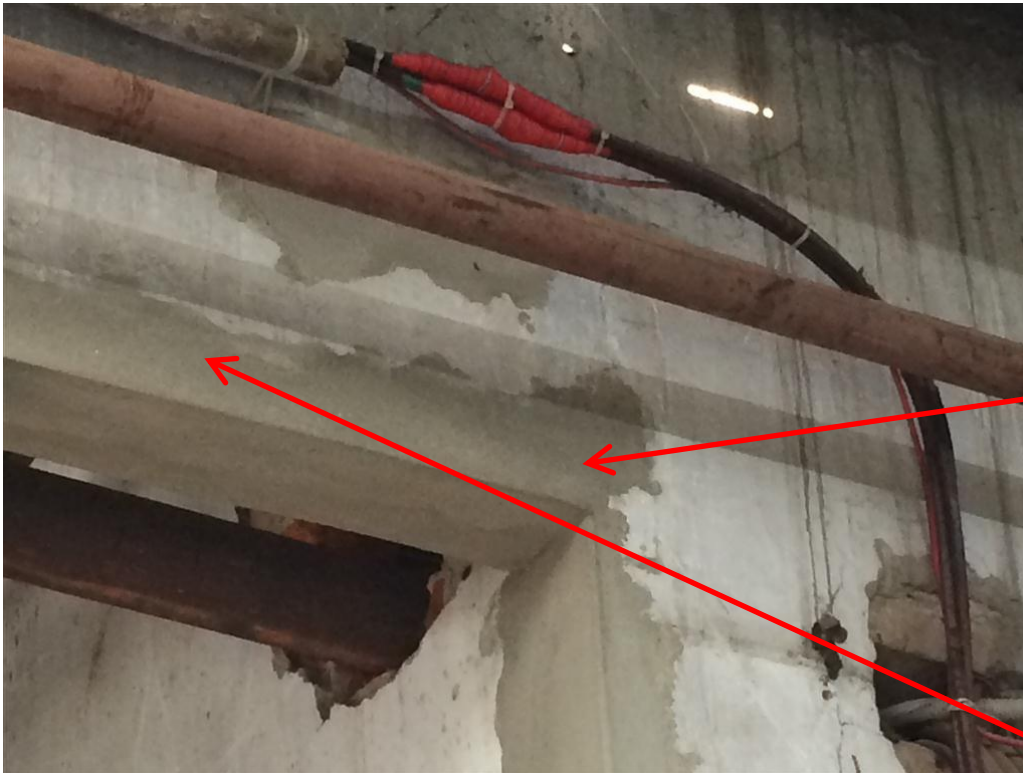
## Lintels in dyeing shed

Openings in dyeing sheds appear to have no lintels. Engineer to design suitable lintel to span between masonry walls.

Finishes to be removed to confirm whether lintel has been provided. If not, opening to be propped to prevent bricks falling and injuring building users.

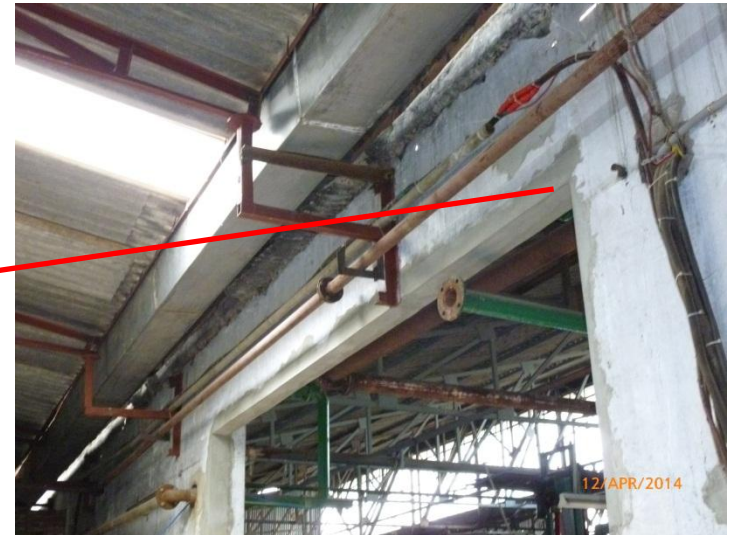
Load-bearing masonry wall

**Dyeing shed – lintels may be inadequate**

Opening to be propped to prevent bricks falling and injuring building users.

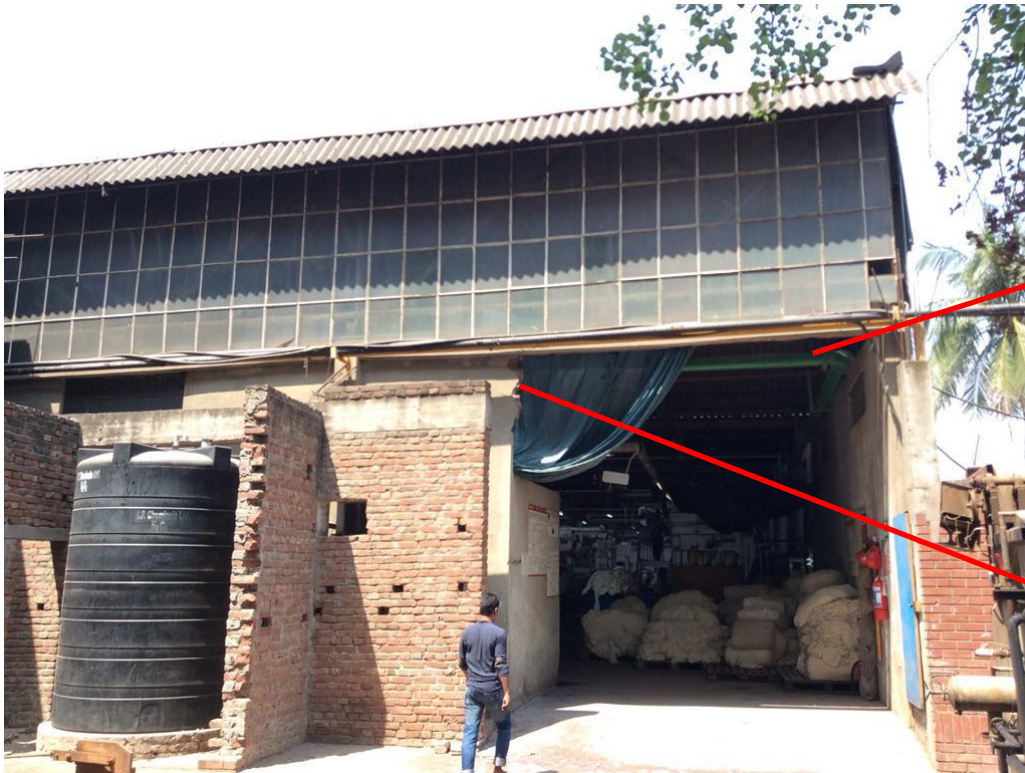
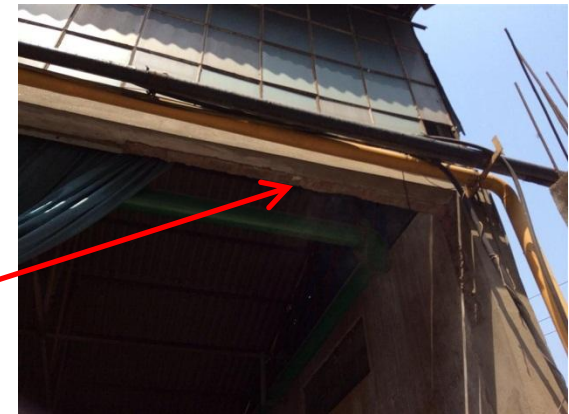
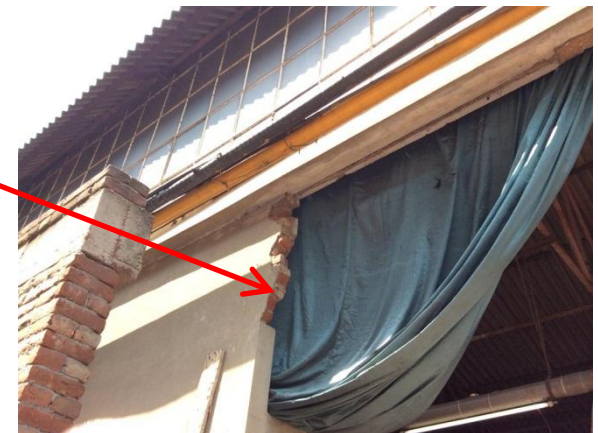
**Dyeing shed – lintels may be inadequate**

| <b>Item No.</b> | <b>Observation</b> | <b>Recommended Action Plan</b> | <b>Recommended Timeline</b> |
|---|---|---|---|
| 17 | Dyeing Shed - Inadaquate lintels over large openings | Openings to be propped to prevent bricks falling off and injuring building users. | <b>Immediate - Now</b> |
| 18 | Dyeing Shed - Inadaquate lintels over large openings | Lintel to the back of the building to be checked to verify the material (brick or concrete). If brick then immediate propping required. | <b>Immediate - Now</b> |
| 19 | Dyeing Shed - Inadaquate lintels over large openings | Suitable lintels to be designed by qualified engineer and installed above opening. | <b>6-weeks</b> |

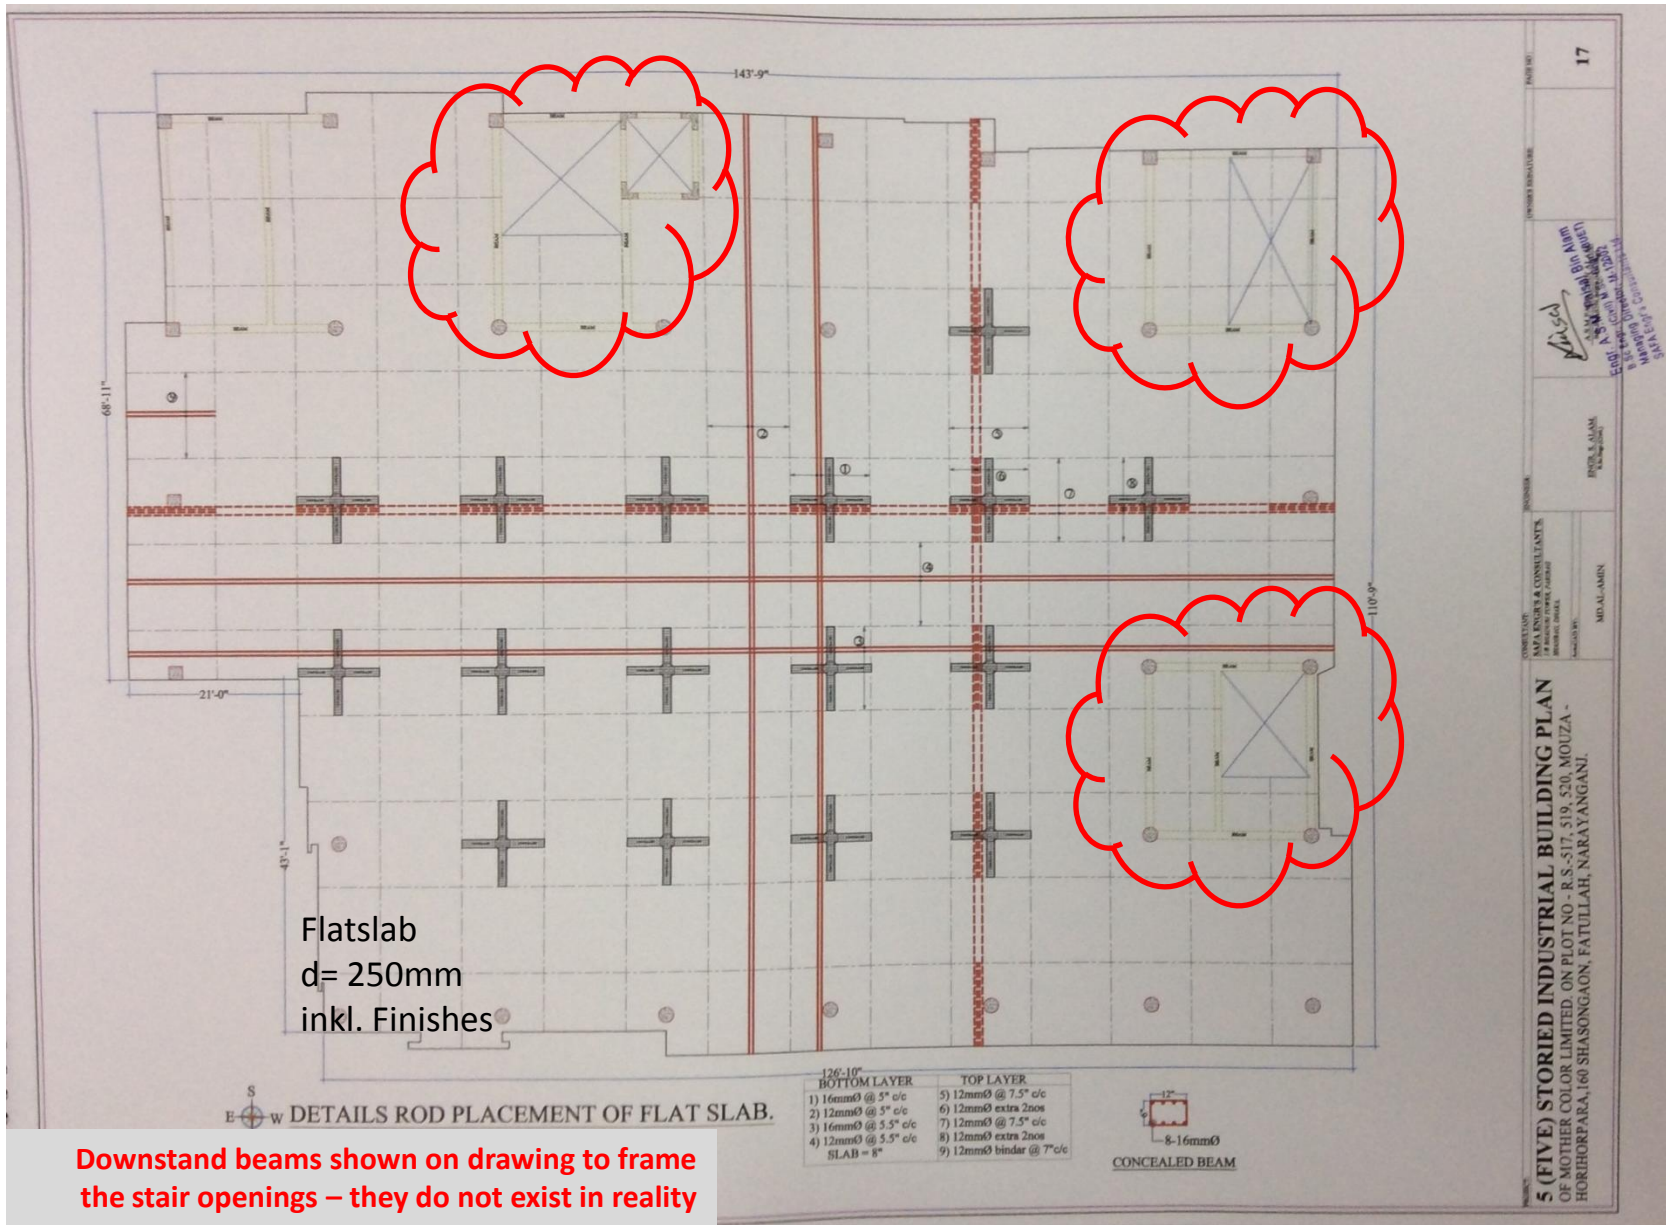
## Slab above 1st Floor and 2nd Floor

**Main Building:  
Missing beams to frame the stair openings (at  
all levels with flat slabs)**

| Item No. | Observation | Recommended Action Plan | Recommended Timeline |
|---|---|---|---|
| 23 | Flat slab design of 1st and 2nd floors in main building | As part of Detail Engineering Assessment (see Item 2), structural calculations to be carried out for the flat slab without the downstand beams around stair cores, to assess bending stresses and shear stresses in the slab and punching checks. Loads to be taken into account according to norms and incl. all partition walls and finishes observed on site | 6-weeks |
| 24 | Flat slab design of 1st and 2nd floors in main building | Carry out strengthening as may be required arising from results of calculations. | 6-months |

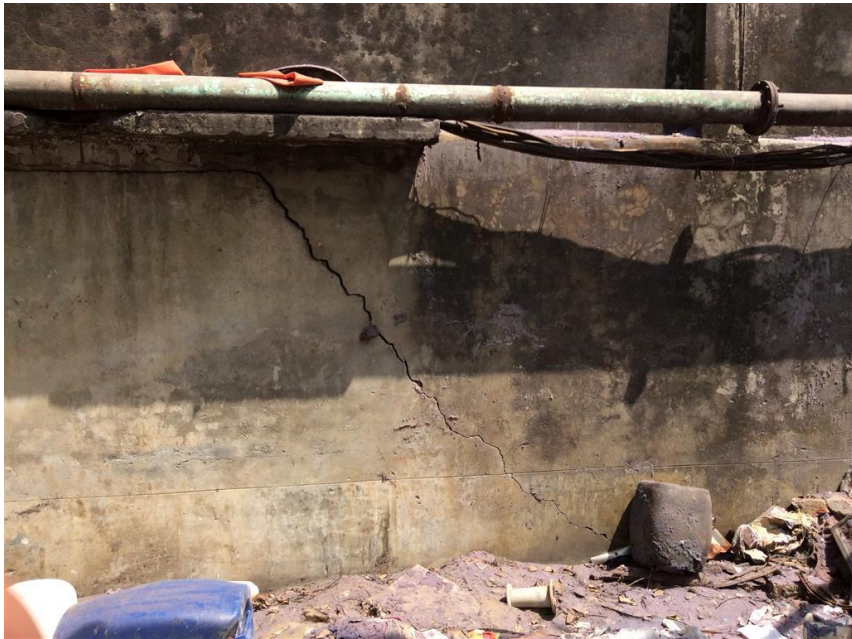
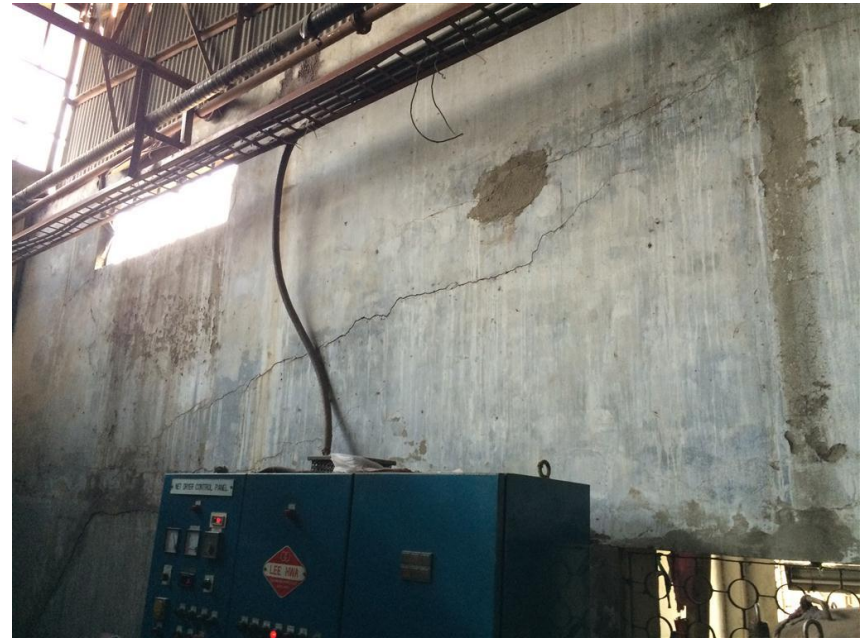
# **Dyeing Shed Cracks in brick walls**

### Cracks in masonry infill panels

## Dyeing shed - Masonry panel cracks

Engineer to assess the lateral stability of the masonry panels and whether the stability of shed under lateral loads has been compromised.

Wall should be repaired to prevent on-going maintenance issues.

| <b>Item No.</b> | <b>Observation</b> | <b>Recommended Action Plan</b> | <b>Recommended Timeline</b> |
|---|--|--|---|
| 27 | Dyeing Shed - Cracks in brick walls | Building engineer to assess whether masonry panels have sufficient horizontal restraint to prevent collapse. | <b>6-weeks</b> |
| 28 | Dyeing Shed - Cracks in brick walls | Implement any remedial works arising from assessment. | <b>6-months</b> |

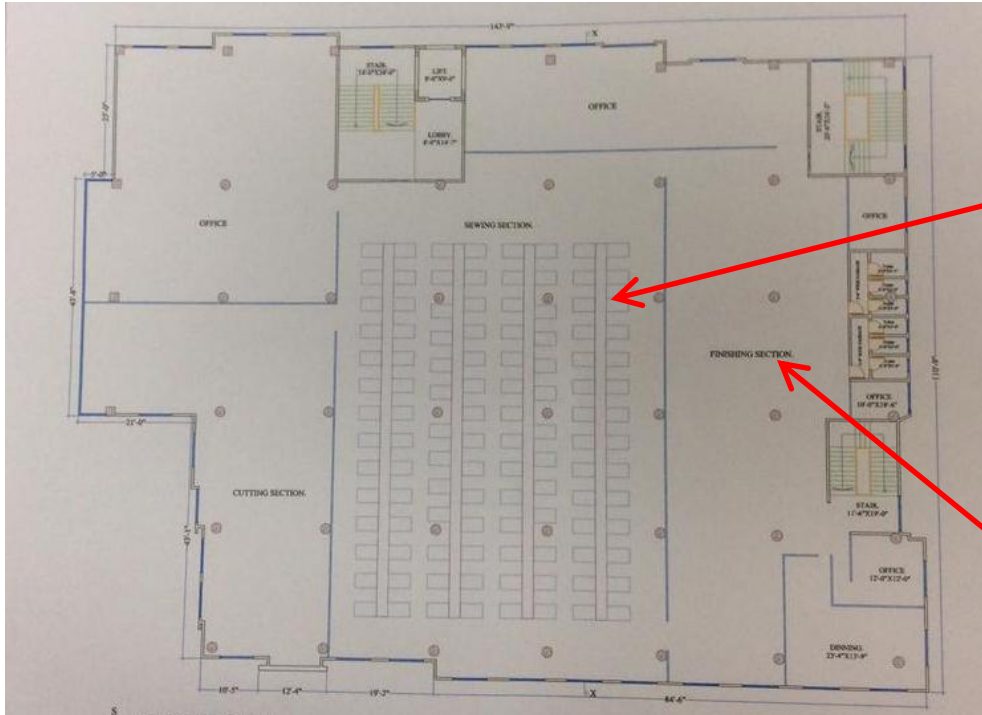
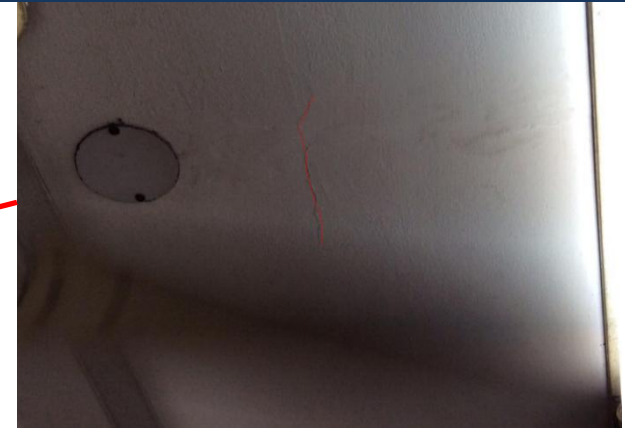
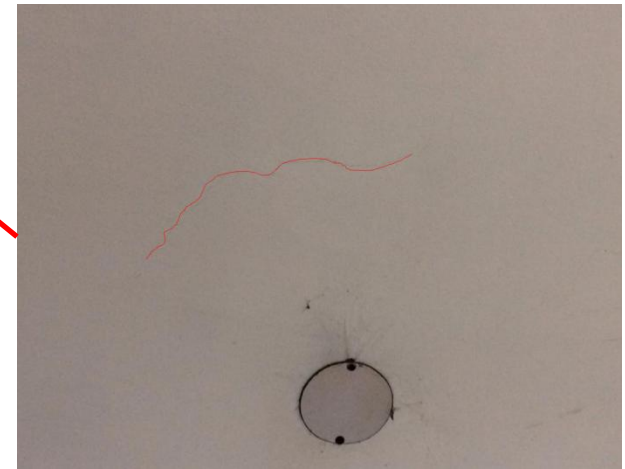
# Main Building Slab Cracking

## Cracking in slabs

Beam cracks to be reviewed by removing plaster to confirm whether cracks extend into structure.

| <b>Item No.</b> | <b>Observation</b> | <b>Recommended Action Plan</b> | <b>Recommended Timeline</b> |
|---|--|--|---|
| 29 | Main Building - Hairline cracks in beams on the underside of 3rd floor | Sections of plaster finish to beams to be removed to investigate if cracks penetrate the building structure | <b>6-weeks</b> |
| 30 | Main Building - Hairline cracks in beams on the underside of 3rd floor | Building Engineer to carry out design check on beams to following investigation | <b>6-months</b> |

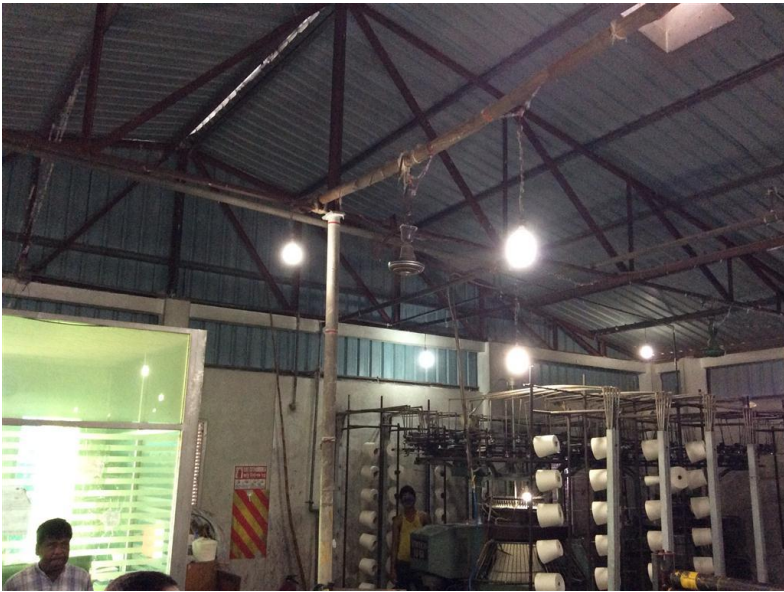
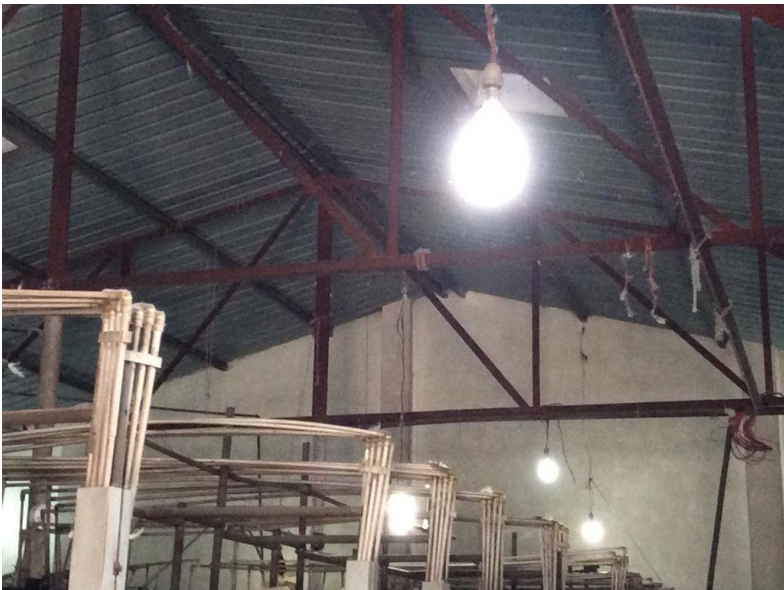
## Steel roof design

- A steel tube has been positioned at mid-span of each truss, apparently to provide further vertical support. Building engineer to assess whether prop has sufficient capacity (it has no horizontal restraint at the top in one direction) and whether there are adequate foundations.
- Truss design to be checked to assess whether it can support the applied loading. Truss design should take into account the fact that the purlins do not line up with truss nodes, thereby applying additional bending to the top chord (steel angle).
- Roof purlins bear directly on masonry wall at the back. Restraint to be checked.

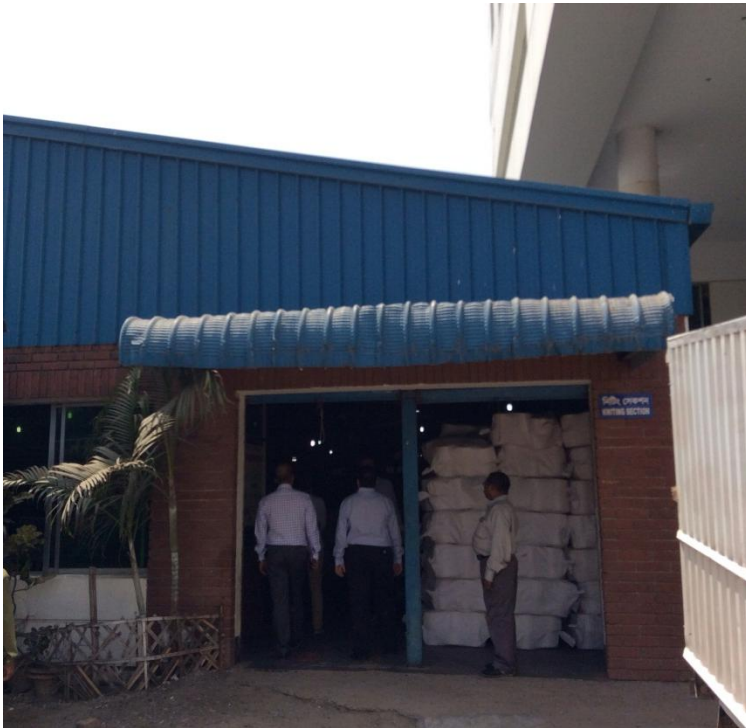
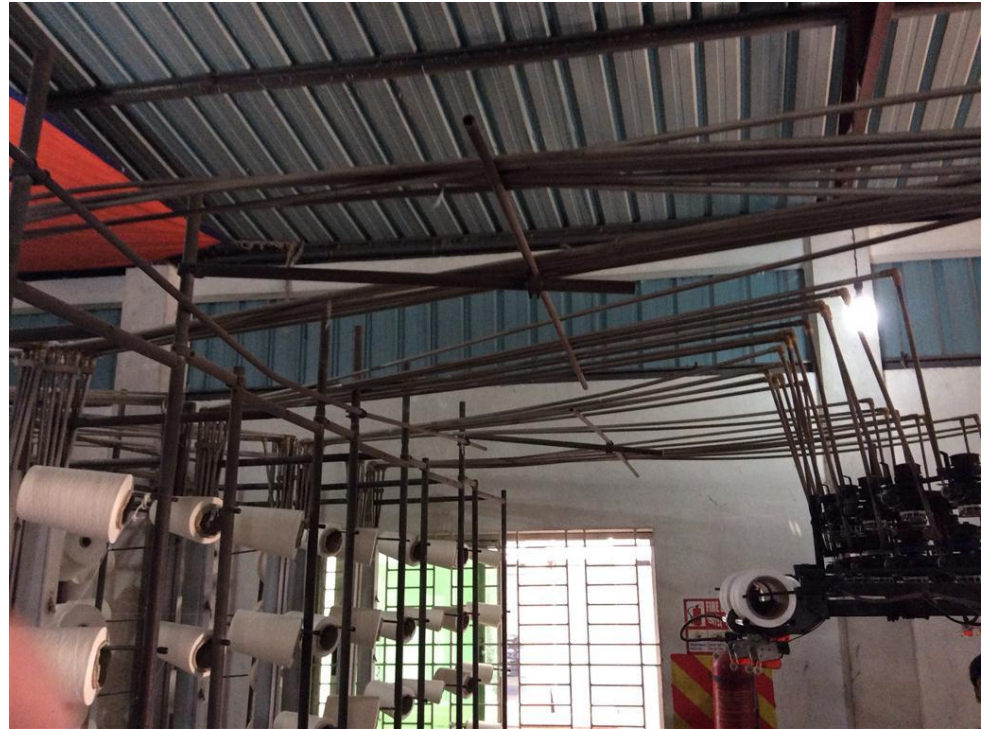
Knitting shed sheds have no roof bracing elements. Stability system of these sheds appears incomplete. In-plane bracing may be required.

Connections between roof trusses and concrete columns could not be inspected. Engineer to assess whether connections are designed to resist wind uplift forces.

## Knitting shed - Stability system

| <b>Item No.</b> | <b>Observation</b> | <b>Recommended Action Plan</b> | <b>Recommended Timeline</b> |
|---|--|--|---|
| 33 | Steel Sheds - Horizontal stability of roof structures. | Building engineer to carry out a stability analysis and provide additional stability system if necessary. | <b>6-months</b> |

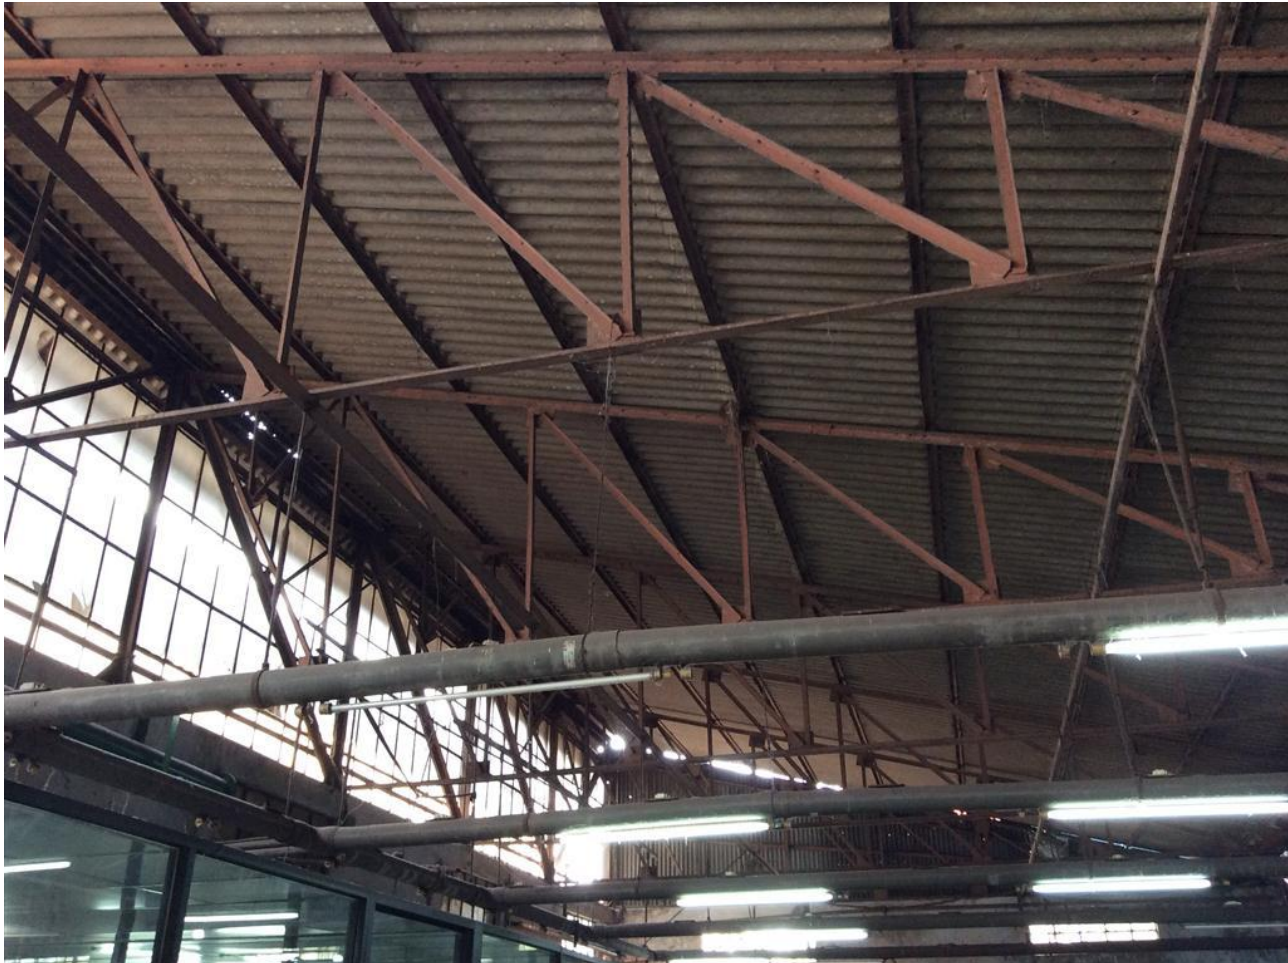
Dyeing sheds have no roof bracing elements. Stability system of these sheds appears incomplete. In-plane bracing in roof may be required.

## Stability system – Dyeing shed

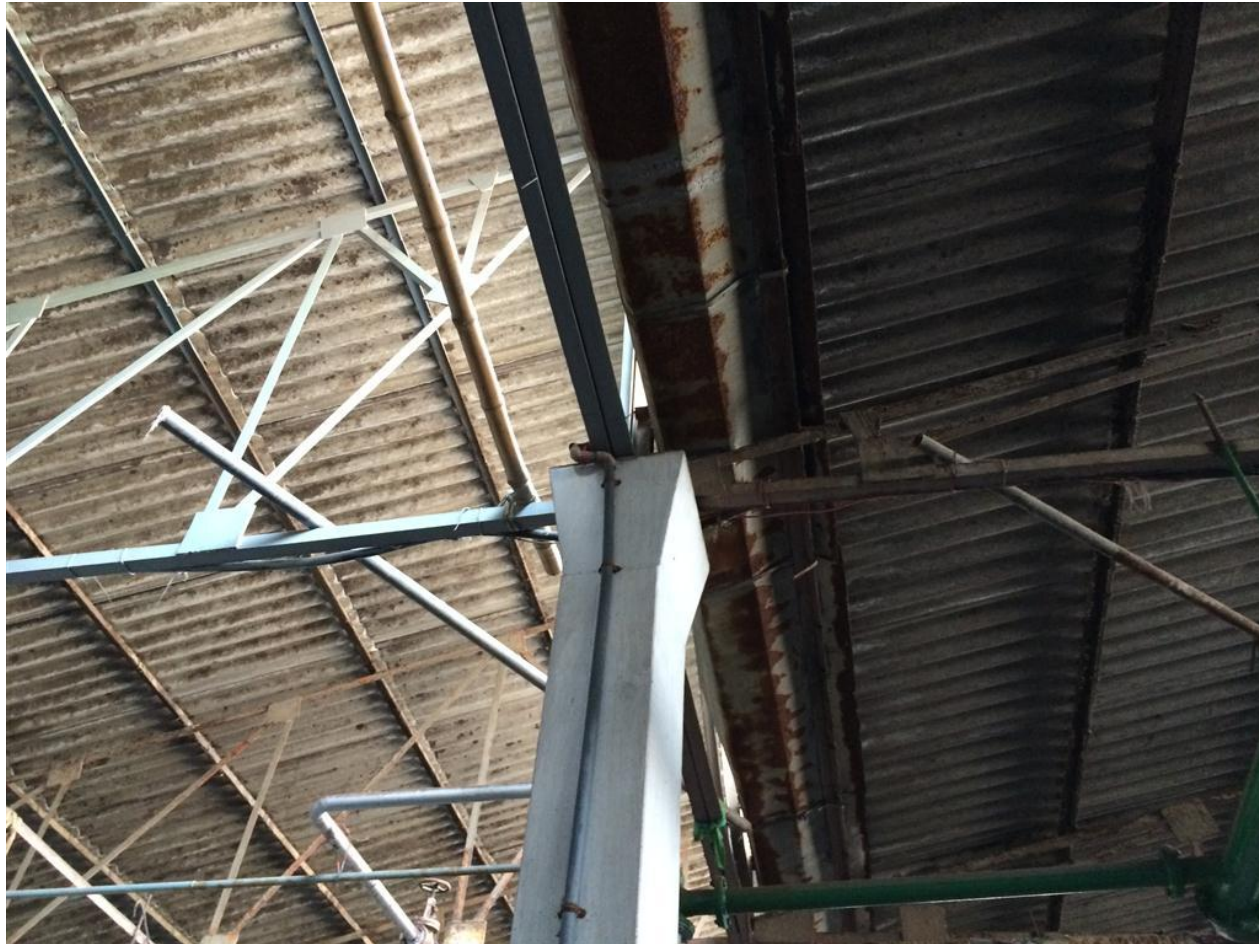
Connections between roof trusses and concrete columns could not be inspected.  
Engineer to assess whether connections are designed to resist wind uplift forces.

**Roof connections – Dyeing shed**

| <b>Item No.</b> | <b>Observation</b> | <b>Recommended Action Plan</b> | <b>Recommended Timeline</b> |
|---|--|--|---|
| 32 | Steel Sheds - Horizontal stability of roof structures. | Building engineer to check whether steel/concrete connections have been designed for wind uplift forces. | <b>6-months</b> |

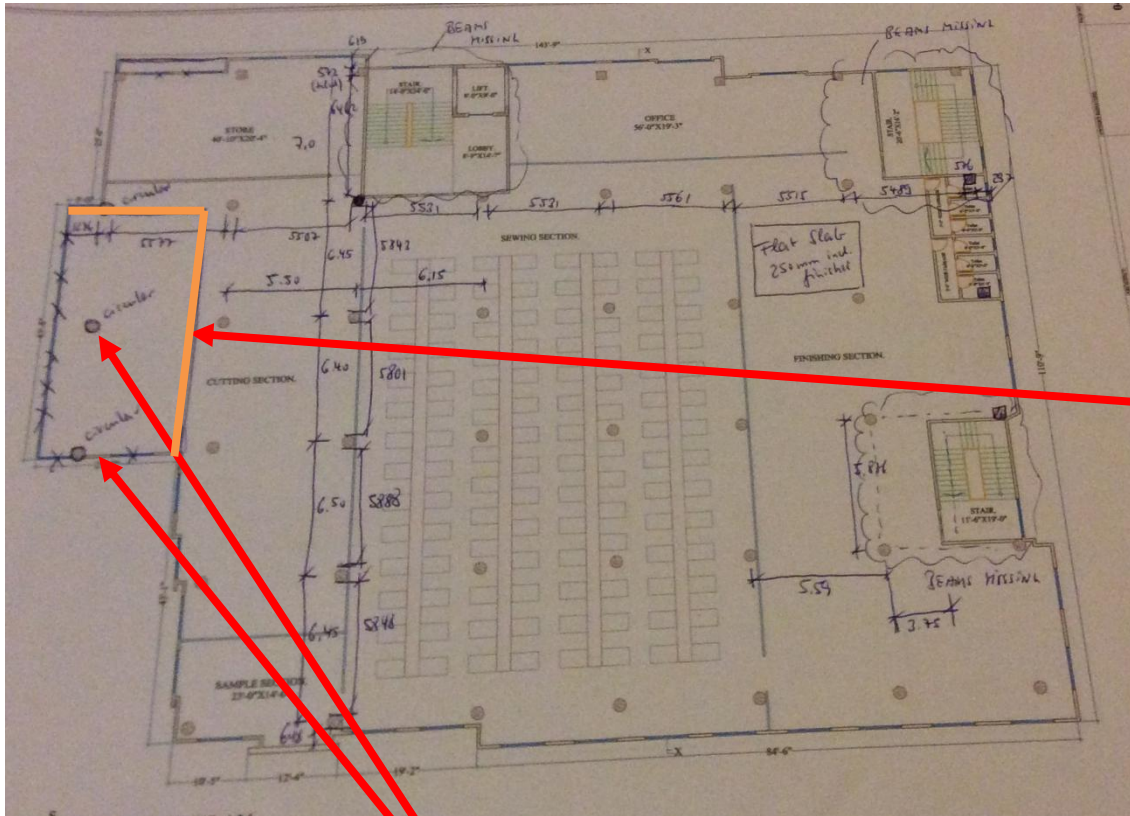
Slab edge at first floor is not as shown on drawing. Columns are unrestrained at first floor. Engineer to confirm that column has sufficient capacity to carry applied loading

Columns are circular in reality, not square

Inconsistencies between the record drawings and as-built frame.  
Engineer to produce as-built drawings that accurately reflect frame construction

## Documentation Issues – Main Building

| <b>Item No.</b> | <b>Observation</b> | <b>Recommended Action Plan</b> | <b>Recommended Timeline</b> |
|---|--|--|---|
| 34 | No record of relevant Structural Documentation | As part of Detail Engineering Assessment for Main Building (see Item 2), Building Engineer to provide as-built drawings for this building. | <b>6-weeks</b> |

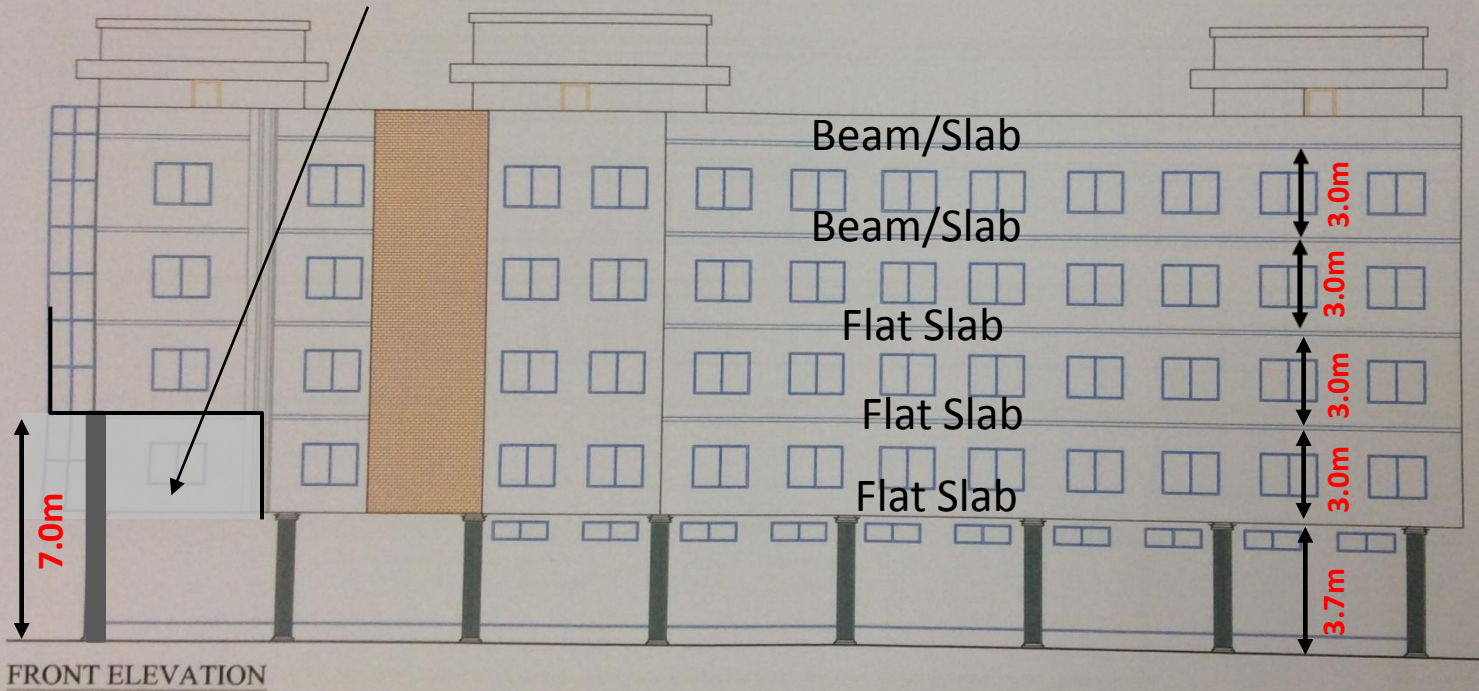
# Longitudinal Cross Section

Depending on where the section is taken, the edge column is double-height.  
 Section / Elevation and Floor plan for 1st show a different extent of the slab in this area than is actually the case

Approximate extent of slab at first floor (not correctly shown on existing drawings)
