# Tanzila Textile Ltd.

Baroypara, Ashulia, Savar, Dhaka.  
(24.017986, 90.243410)  
12 April 2014

# Observations

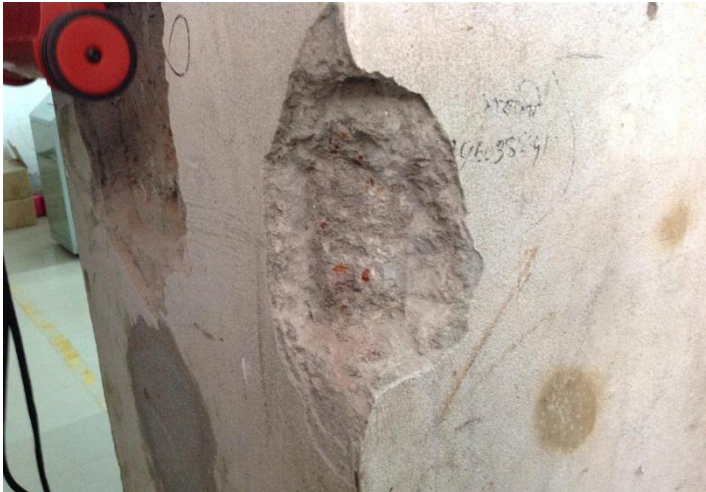
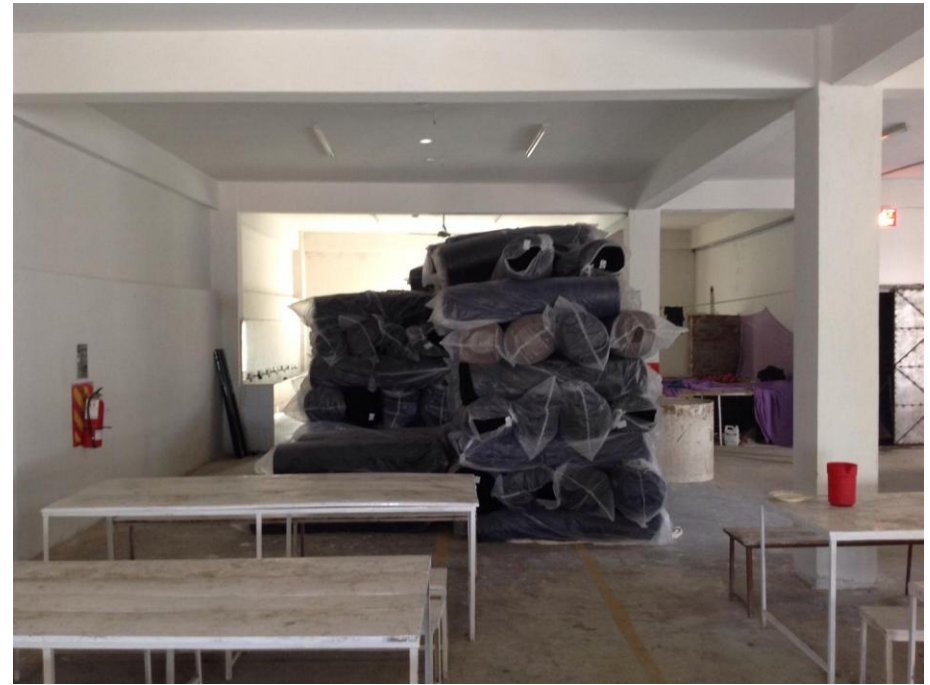
**Highly stressed column**

# Highly Stressed Columns (Building 03)

**Cursory calculations indicate  
column at high working stress**

**Brick Aggregate**

**Engineer is to perform detailed calculations and  
concrete tests to prove column as built is  
sufficient. Pending results of this assessment,  
reduce loads by removing fabric stored on  
suspended floors.**

| Item No. | Observation | Recommended Action Plan | Recommended Timeline |
|---|---|---|---|
| 1 | Highly Stressed Columns – Building 3 | Remove fabric storage at level 1 | Immediate - Now |
| 2 | Highly Stressed Columns – Building 3 | Ensure no additional loads relating to construction work are added (e.g. finishing or roof screeds) prior to confirmation of column capacity by the building Engineer | Immediate - Now |
| 3 | Highly Stressed Columns – Building 3 | Factory Engineer to review design, loads and columns stresses in all Building 3 columns taking cognisance of as built structural arrangement and construction materials used | 6-weeks |
| 4 | Highly Stressed Columns – Building 3 | Verify in-situ concrete stresses either by cores or existing cylinder strength data for the internal columns in Buildings 3 | 6-weeks |

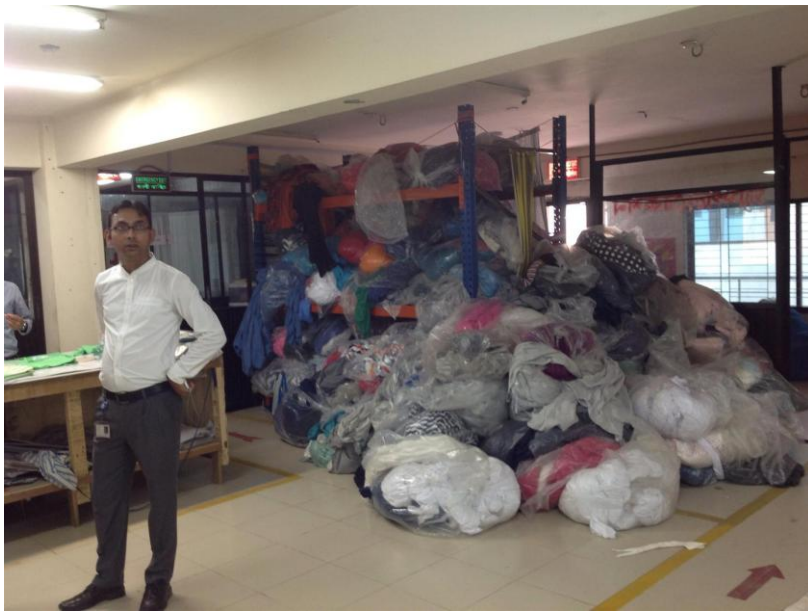
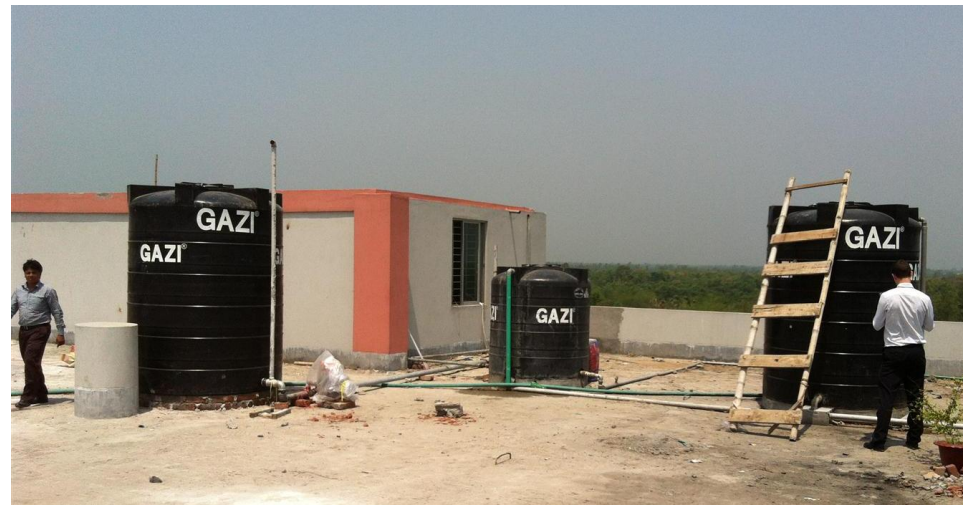
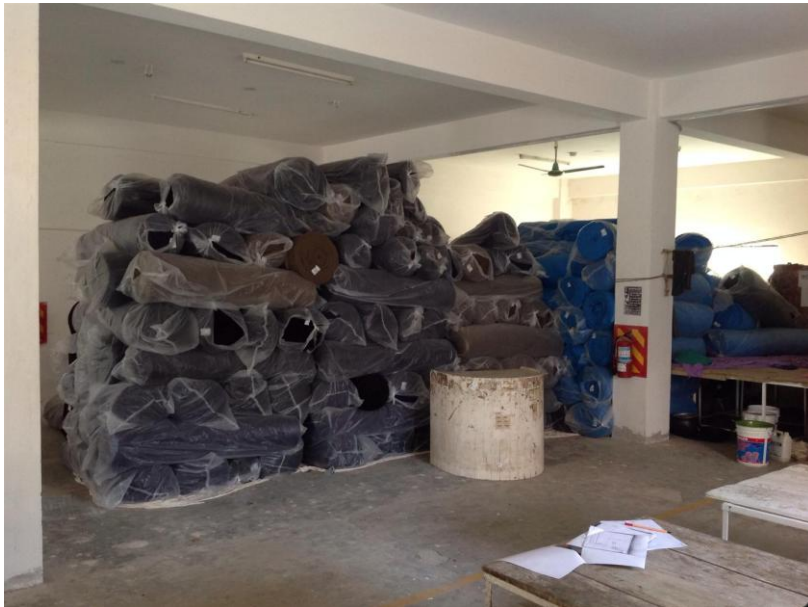
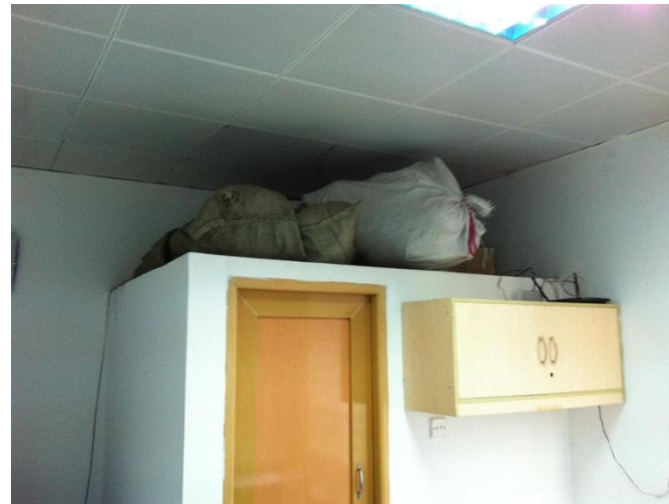
# **Localised Areas of High Loading (Building 1, 2 & 3)**

**Areas of localised high loading on suspended structure observed in all 3 buildings (including brickwork partition & toilet block loads).**

| Item No. | Observation | Recommended Action Plan | Recommended Timeline |
|---|---|---|---|
| 7 | Localised Areas of high loading | Maintain current use of the floors and do not change use or increase occupation or loading prior to completion of safe loading plans by the building engineer | Immediate - Now |
| 8 | Localised Areas of high loading | Building Engineer to create controlled loading plans for all floors, which account for existing solid partition loads, extra finishes, heavy fixed items etc. and are based on the structural capacity of supporting slabs, beams and columns. | 6-weeks |

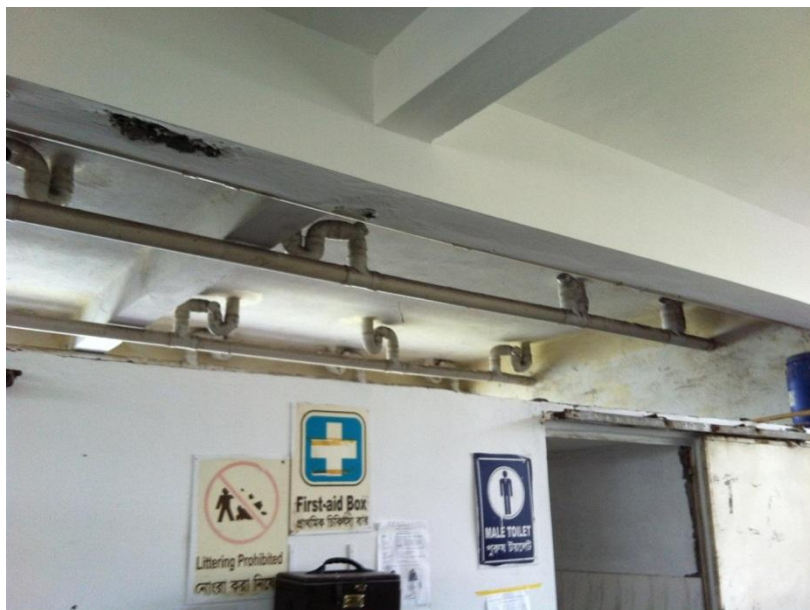
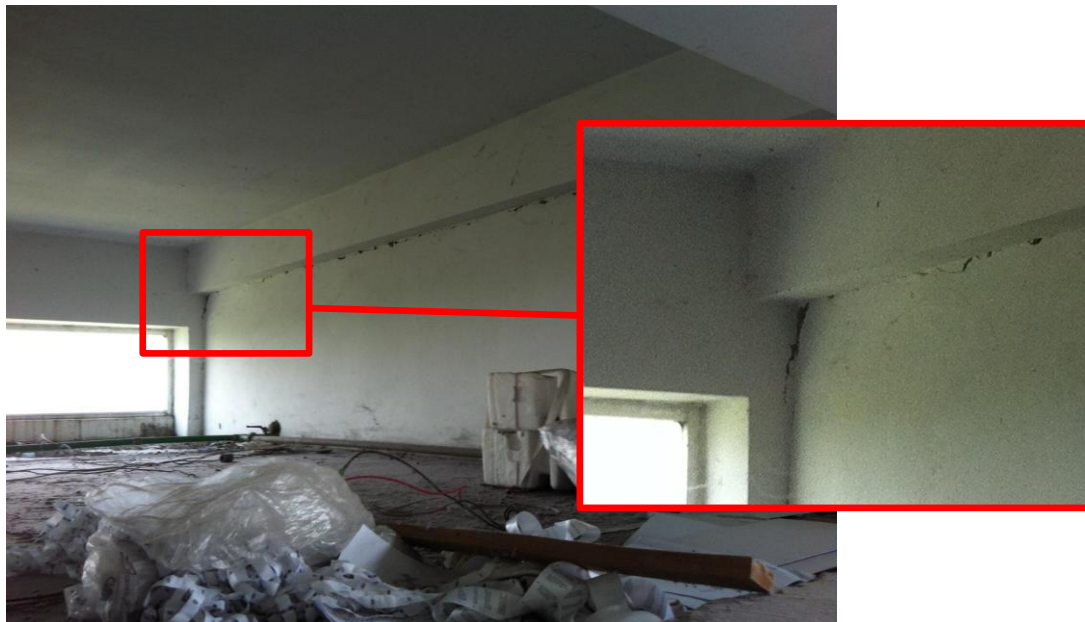
## Localised High Loading

The structural arrangement for a typical bay is used to support loading from additional build-up on slab, solid partition walls and secondary ceiling slab in toilet areas.

Cracking evident along interfaces with masonry infill.

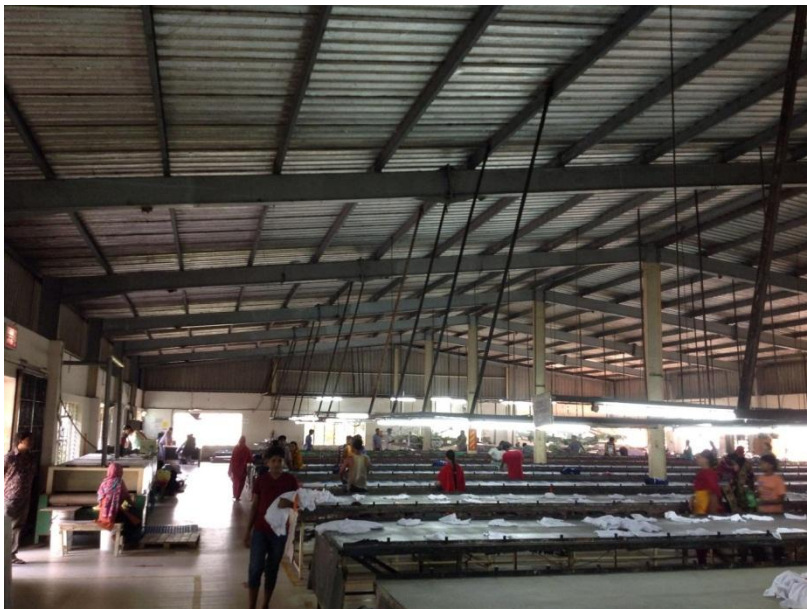
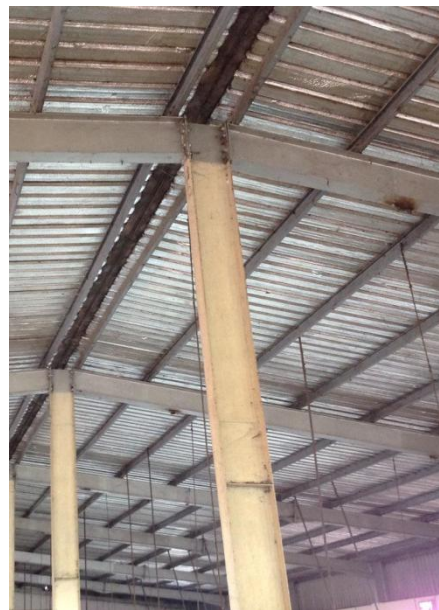
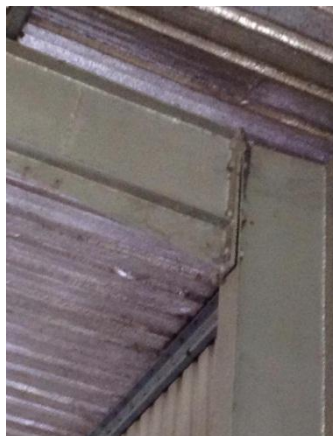
# **Single Storey Industrial Building Structural Issues (Building 3)**

- No in plane roof cross bracing observed
- No out of plane lateral bracing to portal frames other than partial height masonry infill walls

- No capping plate at apex endplate connection
- Engineering design intent unclear at eaves haunch

- No design information for the steel frame included in structural drawings
- No foundation for central column shown on drawings

| Item No. | Observation | Recommended Action Plan | Recommended Timeline |
|---|---|---|---|
| 11 | Single Storey Industrial Building Structural Issues (Building 3). Structural Lateral Stability of Single Storey Industrial Building (Building 2) | Undertake Detailed Engineering Assessment of Building 3. Particular attention to structural stability, steelwork connection details, the as built concrete frame and determining the foundation systems used is required | 6-weeks |

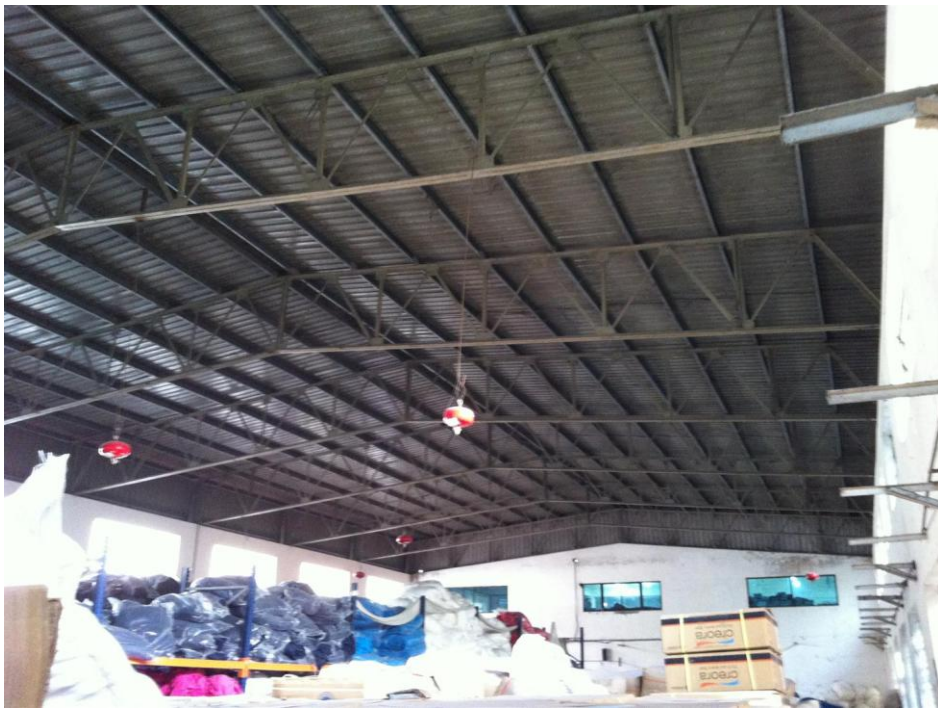
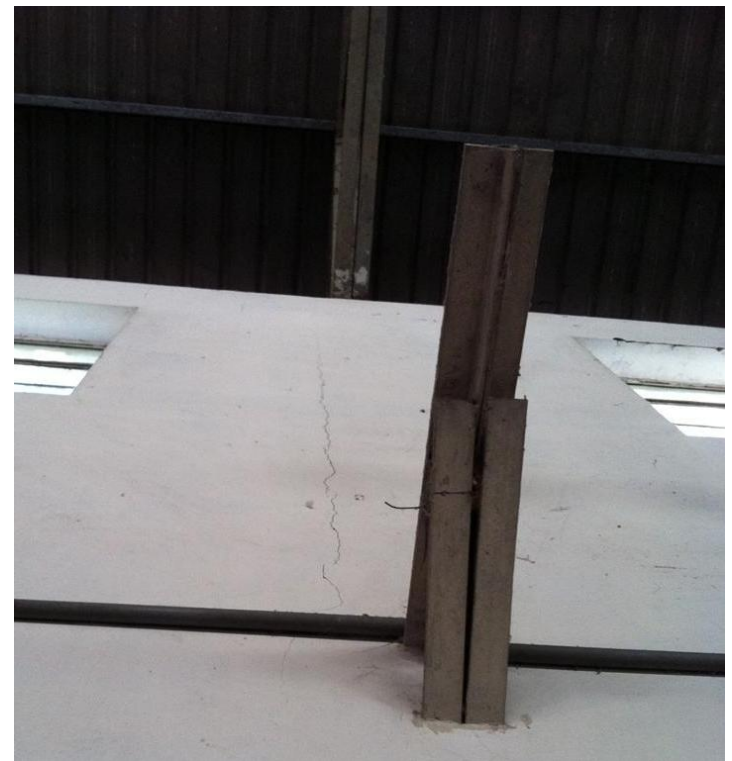
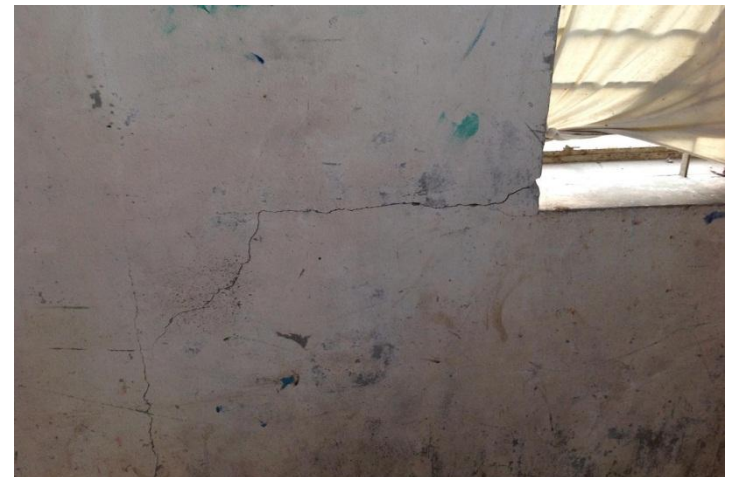
# **Structural Lateral Stability of Single Storey Industrial Building (Building 2)**

**Building 2:**  
No in plane roof bracing observed.

Building stability appears to rely on RC columns and masonry infill perimeter walls cantilevering approx. 6.23m from the foundation. Foundation type is unknown.

Evidence of distress within masonry infill perimeter wall at interface with RC structure.

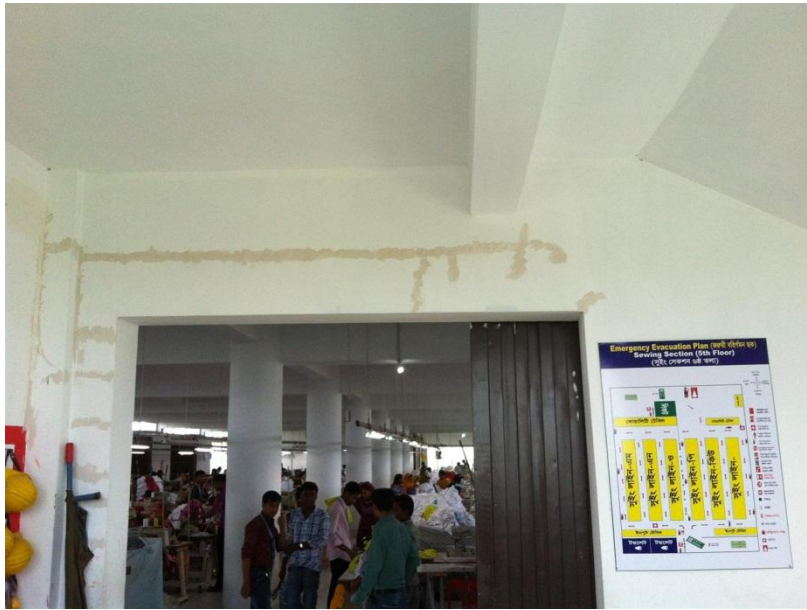
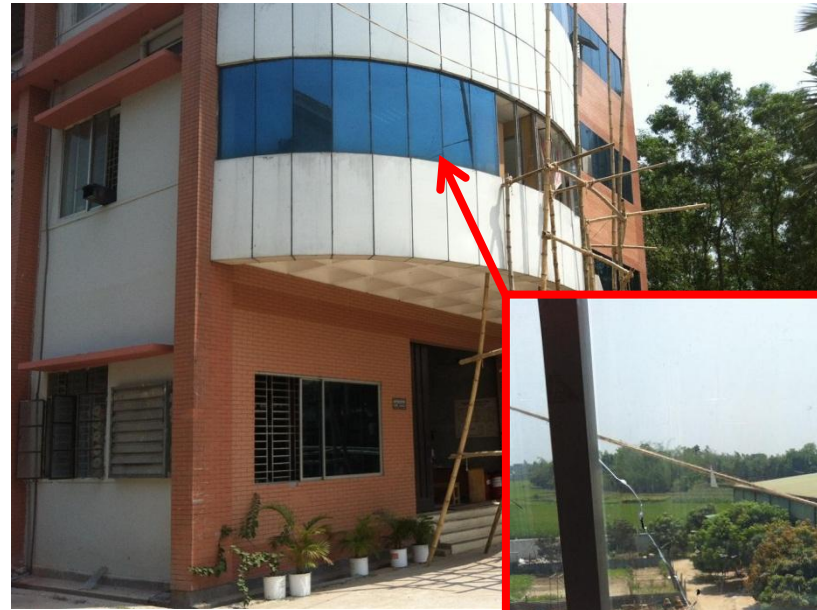
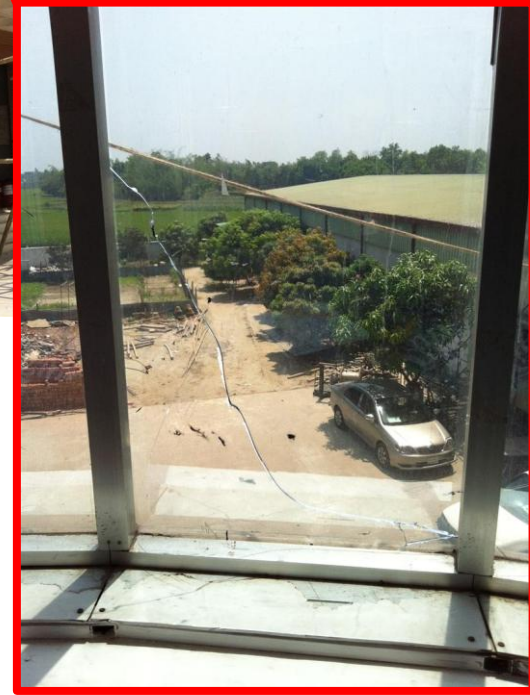
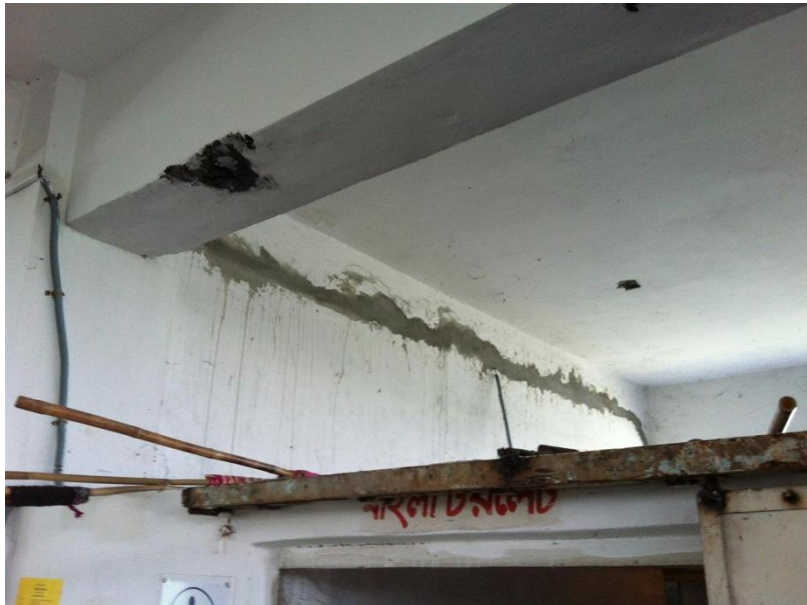
## Evidence of Distress

Signs of distress and repair of cracking on finish to structural beams, slabs and masonry infill panels. Broken glass at cantilevered façade.

| Item No. | Observation | Recommended Action Plan | Recommended Timeline |
|---|---|---|---|
| 14 | Evidence of distress and brick chip aggregate in structural beams and slabs (Building 1) | Building engineer to organise sufficient coring (100mm min) to determine the in-situ strength of reinforced concrete beams and slabs | 6-weeks |
| 15 | Evidence of distress and brick chip aggregate in structural beams and slabs (Building 1) | Building engineer to review design of all beams and slabs on the basis of actual in-situ strengths and advise appropriate load limits and strengthening if required | 6-weeks |

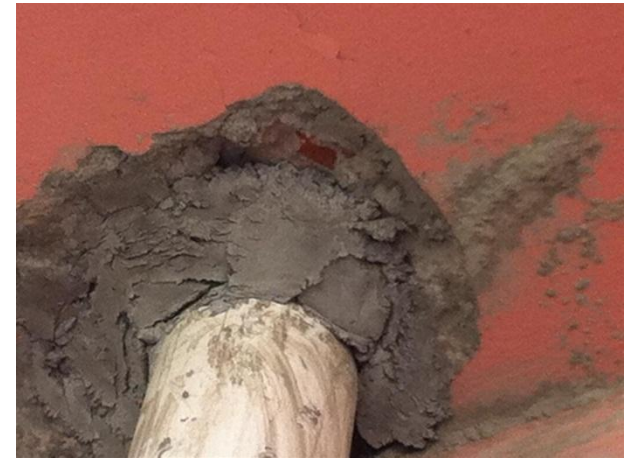
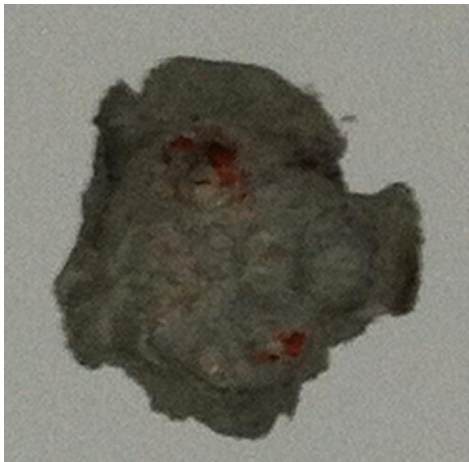
**Unspecified aggregate in slabs**

**Structural design documents specify stone chip aggregate. Brick chip aggregate observed at a number of locations in the slab.**

**Not clear if brick chip aggregate concrete achieves minimum compressive strength required by design.**

**May be manifested as cracking and excessive deflection.**

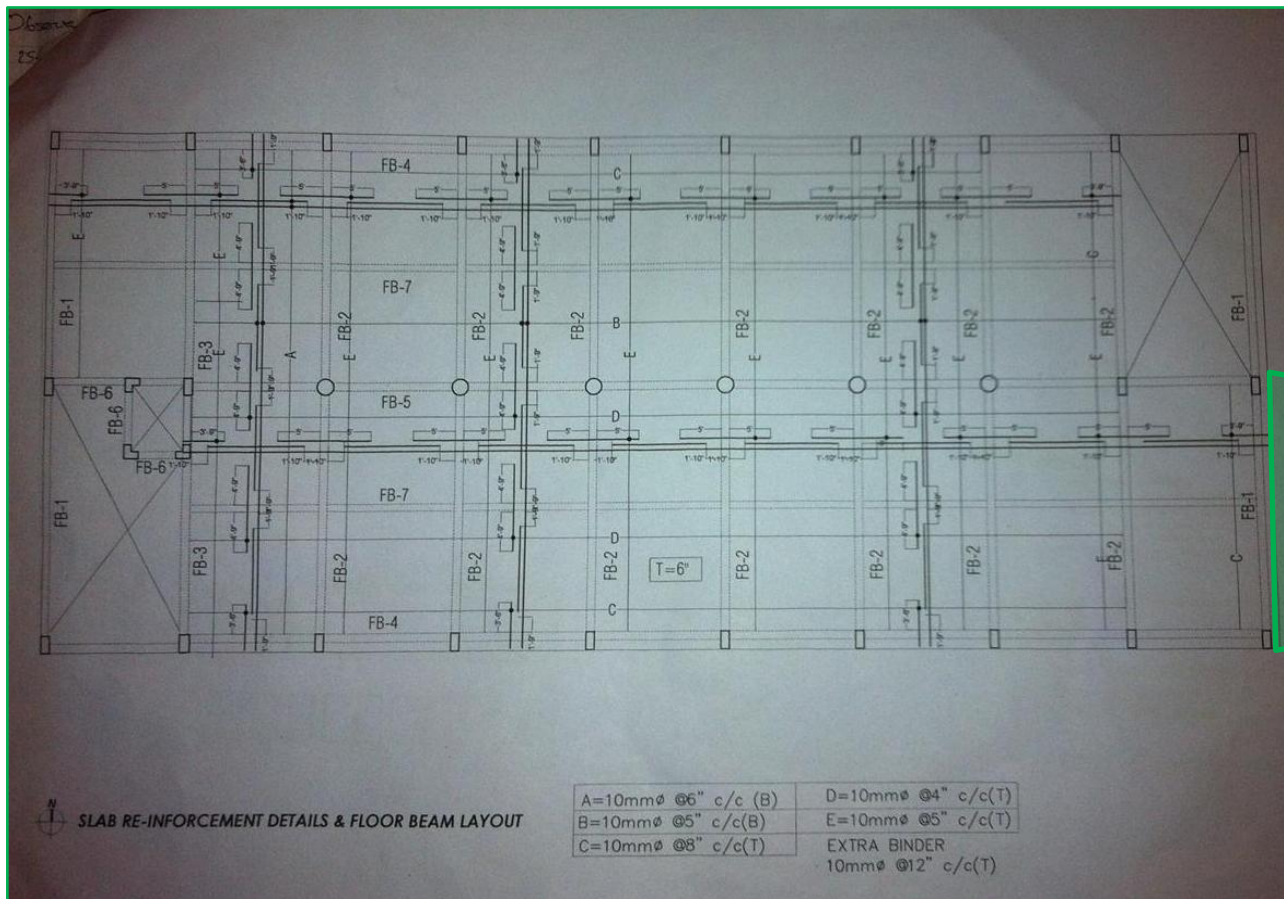
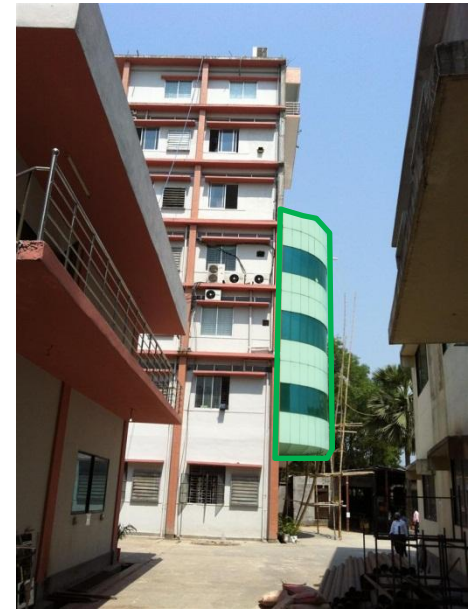
**Cantilever on 4 floors not shown on structural drawings**

| Item No. | Observation | Recommended Action Plan | Recommended Timeline |
|---|---|---|---|
| 20 | Lack of Relevant Documentation Discrepancies between Design & Construction | Undertake a detailed as built survey of building 1, 2 and 3 recording all undocumented structures and extensions | 6-weeks |

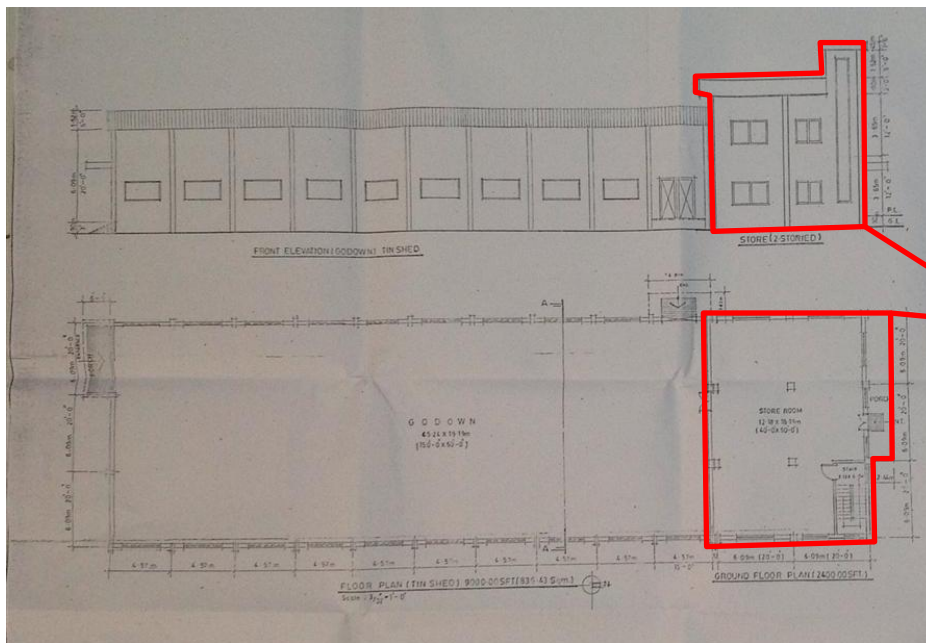
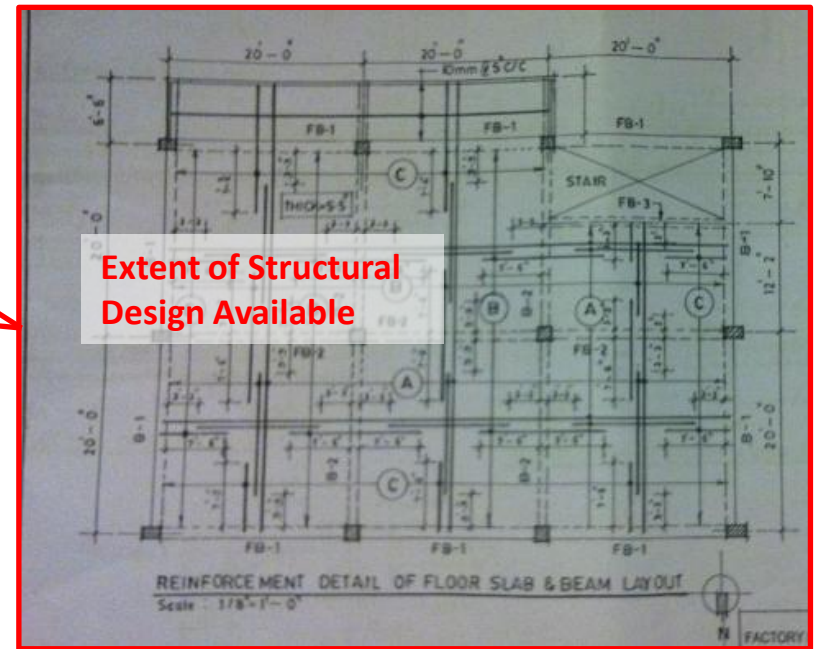
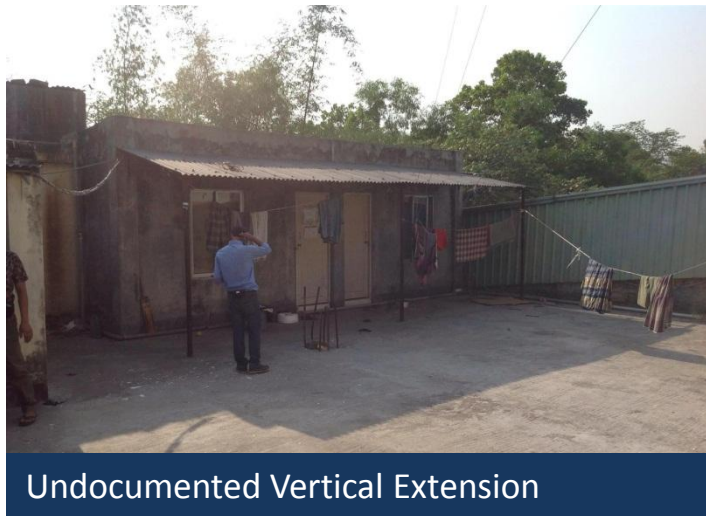
Undocumented Vertical Extension

- No relevant details for significant steel and concrete structure including trusses, connection details, reinforced concrete structure, foundations, ground floor slab details.
- Concrete strength  $f_c' = 3000\text{psi}$  specified for design, brick chip aggregate observed in slabs and columns.

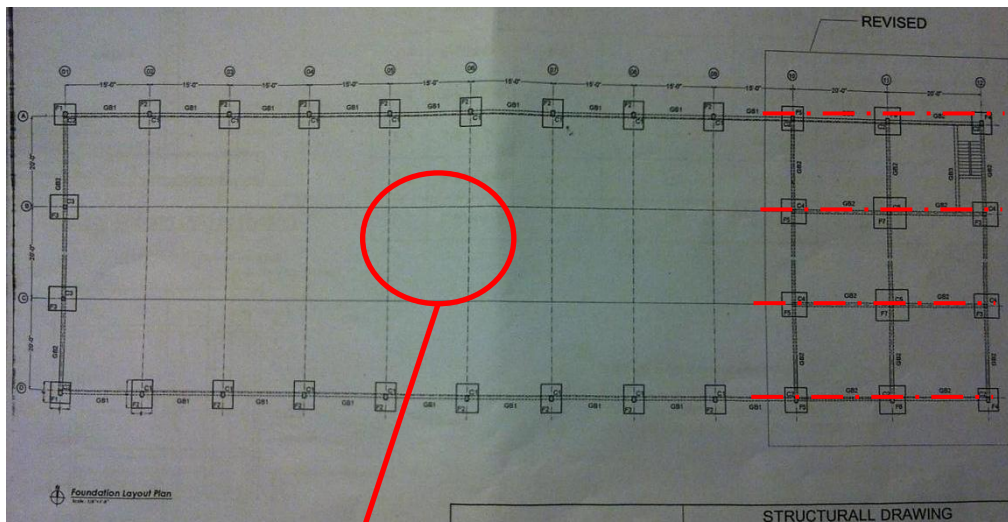
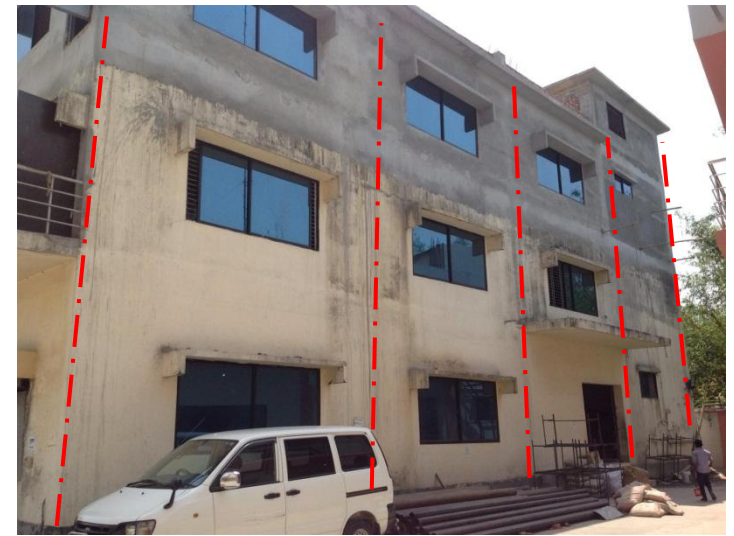
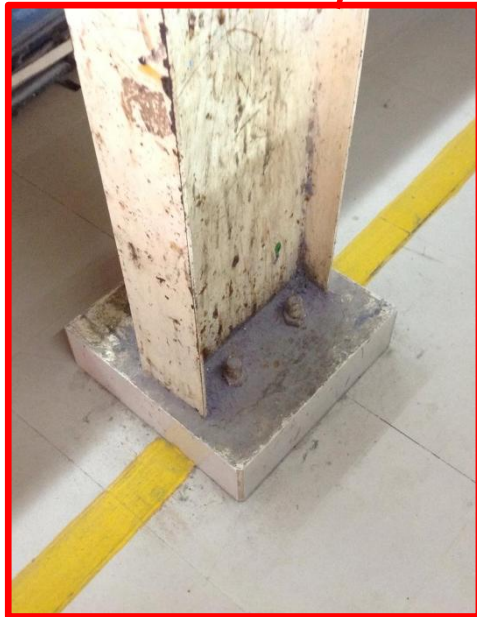
Building 2

- Incorrect general arrangement for concrete structure (number of bays does not match construction).
- No relevant details for significant steel structure.
- No foundations detailed for central column to portal frame.
- Well graded stone specified, brick chip aggregate observed in slabs and columns.
- Stairs not constructed as per design drawings (position of landing beam).
- Toilet extension not recorded.

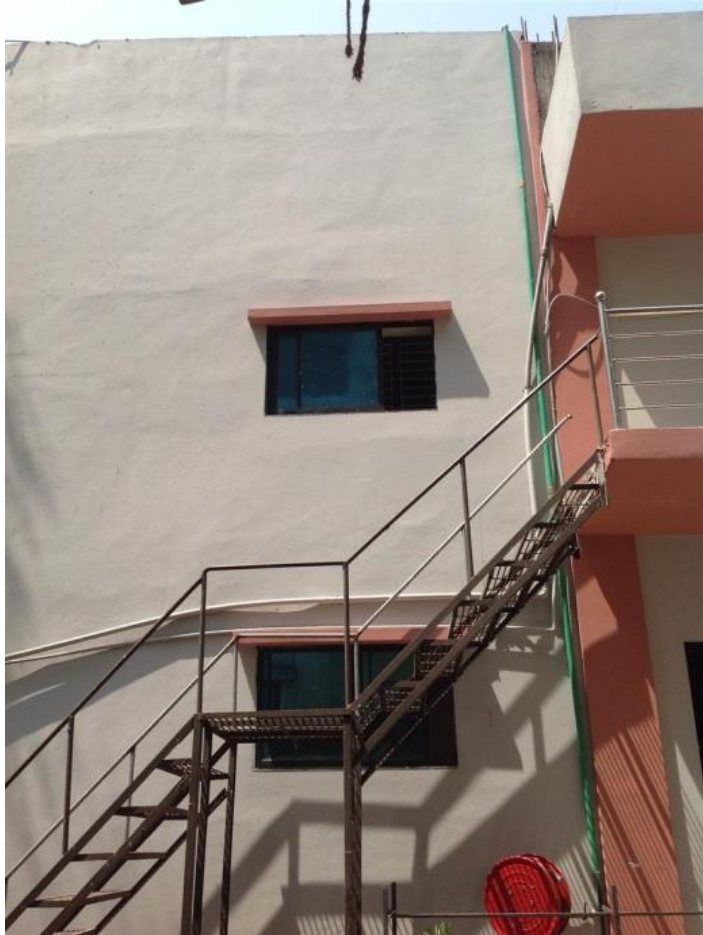
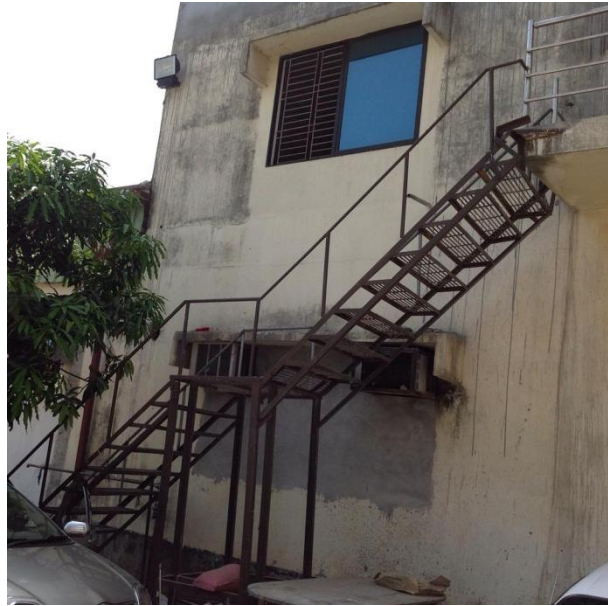
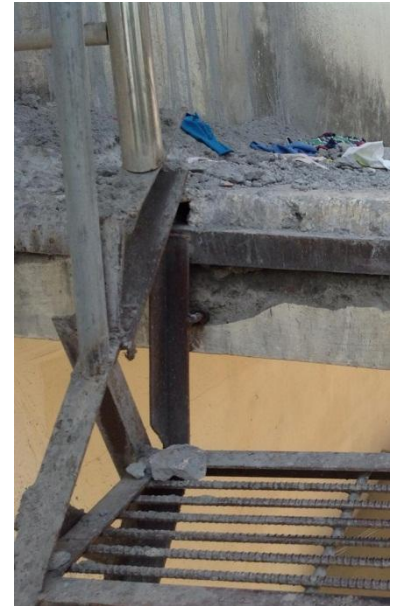
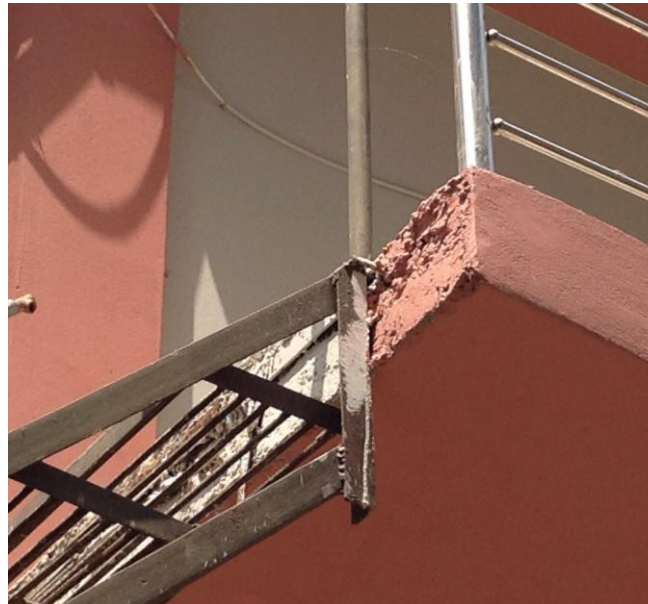
External steel stairs do not appear to be engineered.  
Fixed to structure by tack welds to rebar.

| Item No. | Observation | Recommended Action Plan | Recommended Timeline |
|---|---|---|---|
| 24 | Undocumented and non-engineered structures and stairs | Prop all external steel escape stairs at steel stringer adjacent to connection to concrete landing. Building engineer to supervise propping immediately | <b>Immediate - Now</b> |
| 25 | Undocumented and non-engineered structures and stairs | Building Engineer to review escape stairs structural elements and all connection details for full access loads on stairs | <b>6-weeks</b> |

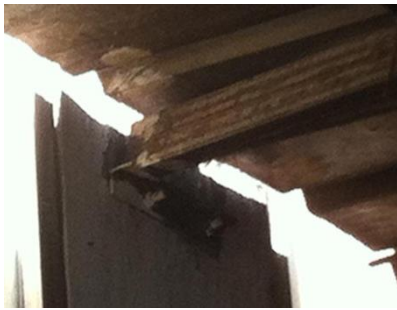
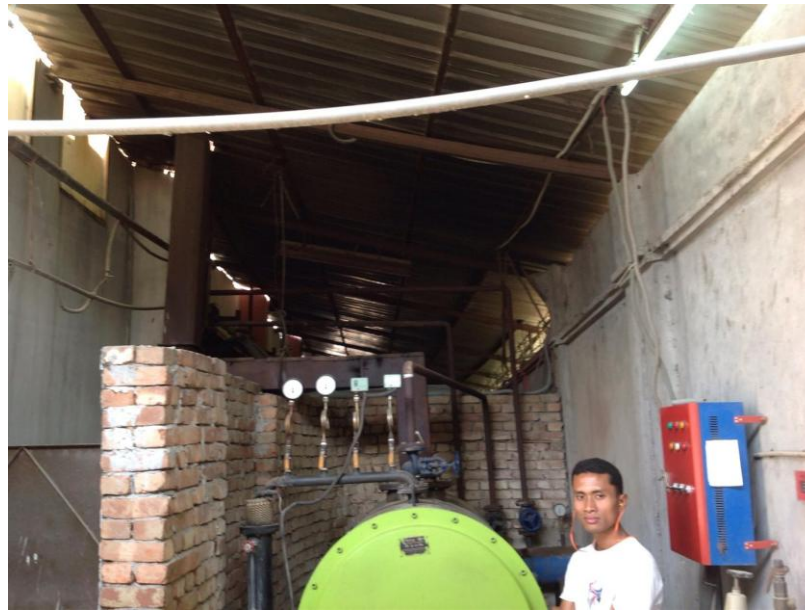
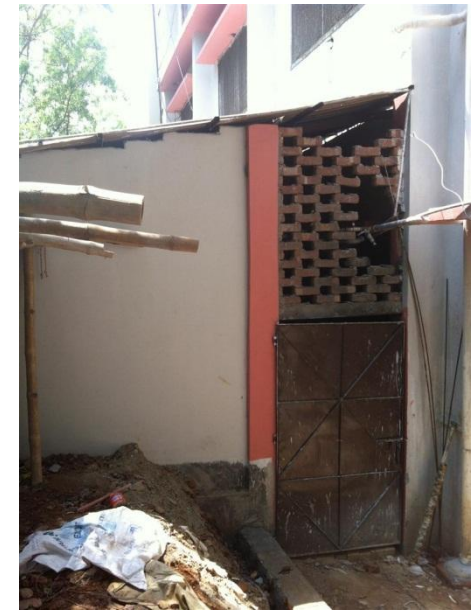
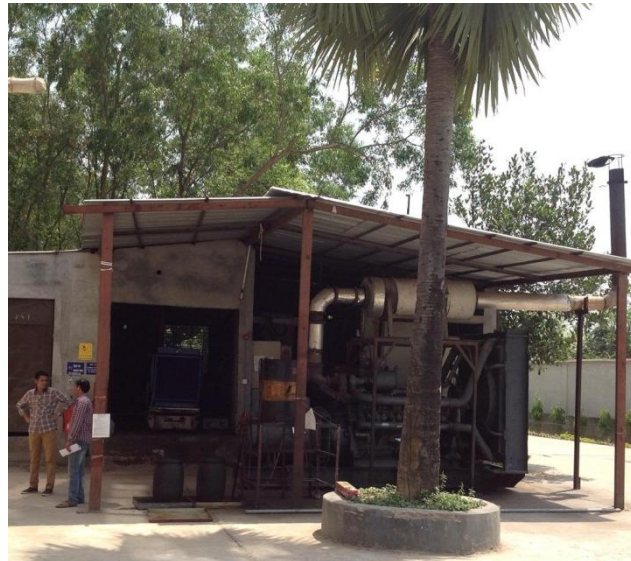
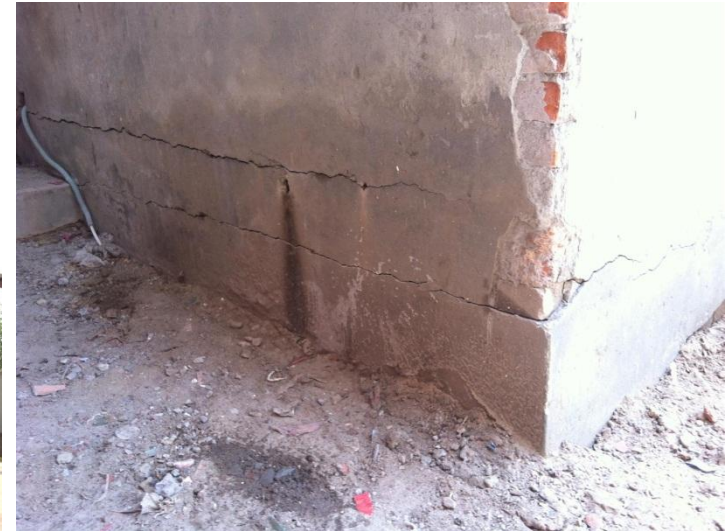
**Non-engineered external buildings used for a number of support functions. Some fixings to principal structures. Distress visible on a number of elements.**

| Item No. | Observation | Recommended Action Plan | Recommended Timeline |
|---|---|---|---|
| 28 | Undocumented and non-engineered structures and stairs | Factory Engineer to review single storey support buildings, taking account of loads applied to principal structures and advise on any strengthening works required. | <b>6-weeks</b> |
